EAGLESWOOD

EAGLESWOOD TOWNSHIP

Eagleswood Township
Municipal Code 1508
— Survey Form Site

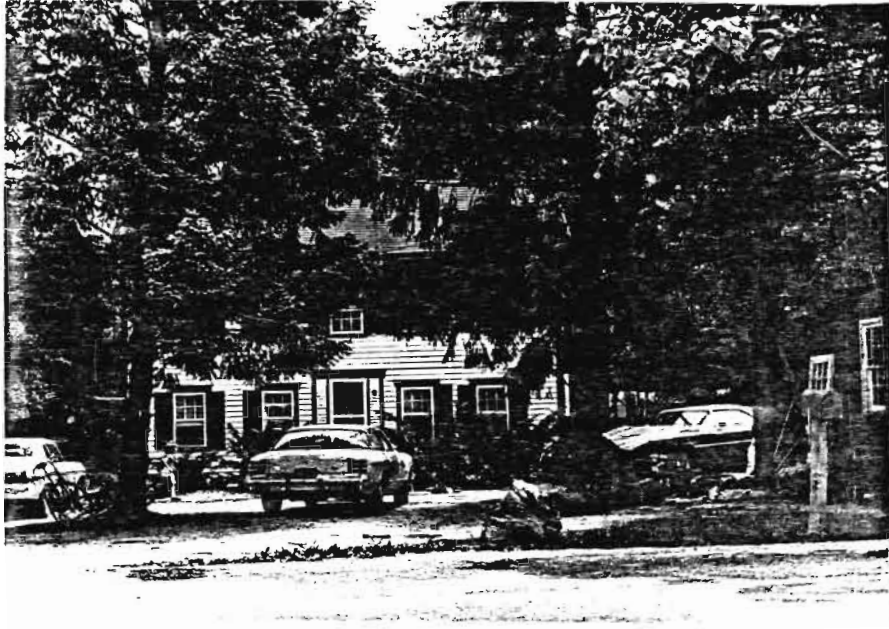
1508-L59

Route 9 / Staffordville

2½ story, 5 bay, asbestos siding, gable roof with returns. 6/6 windows and a center door with transom and sidelights are among the building's original features. The house is typical of mid 19th century architecture: it is 2½ stories, 5 bays and contains a center door, returns and 6/6 windows.

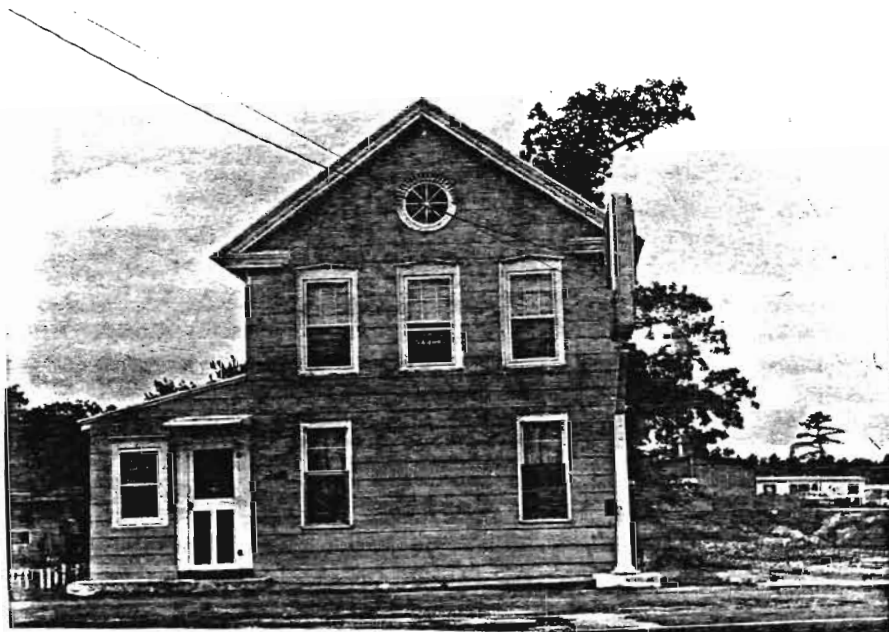
1508-L60

Main Street / Staffordville (across from Dinner Point Road)

2½ story, 3 bay, asbestos siding, gable roof faces road. The gable roof has cornice returns. A bull's eye window with spinwheel muntins is located on the facade gable peak. 6/6 windows are found on all sides, within decorative window surrounds. A two bay lean-to addition is found on the south end.

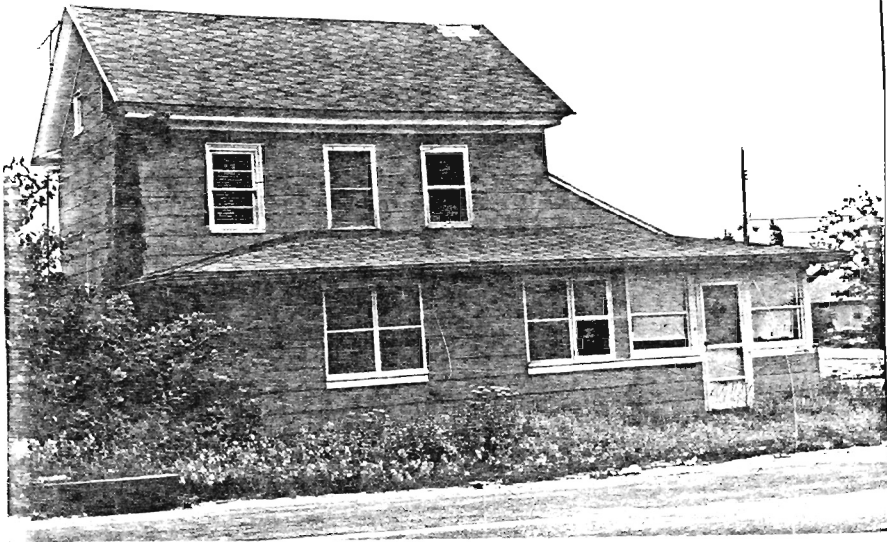
1508-L67

Dinner Point Road and Main Street / Staffordville

2½ story, 3 bay, asbestos siding, gable roof. A molded cornice runs along the perimeter of the building. The building has been altered by modern windows and siding. The structure is at an angle to the main road.

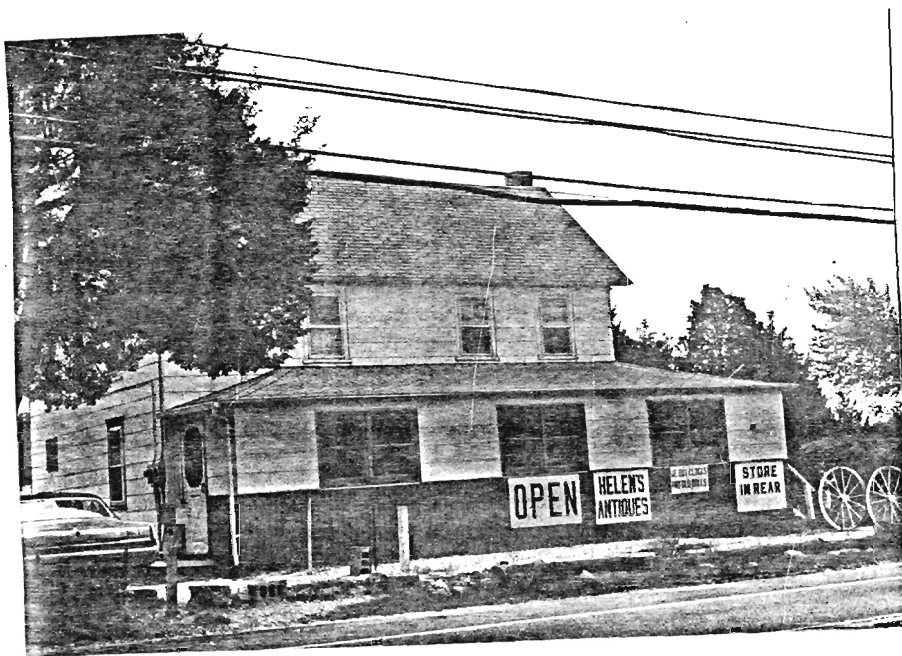
1508-L62

Helen's Antique Store / Main Street / Staffordville (across from Eagleswood Village

2½ story, 4 bay, asbestos exterior, gable roof. An enclosed porch has altered the facade. 2/2 windows are employed. This late 19th century building has many rear additions.
