LOCATION OF CITY SEWERS

LOCATION OF CITY SEWERS
Adjacent To
INDUSTRIAL PLANTS
Bordering
ARTHUR KILL IN NEW JERSEY

Re: Location of City sewer lines with relation to industrial plant sites in the area adjacent to the Arthur Kill on New Jersey shore.

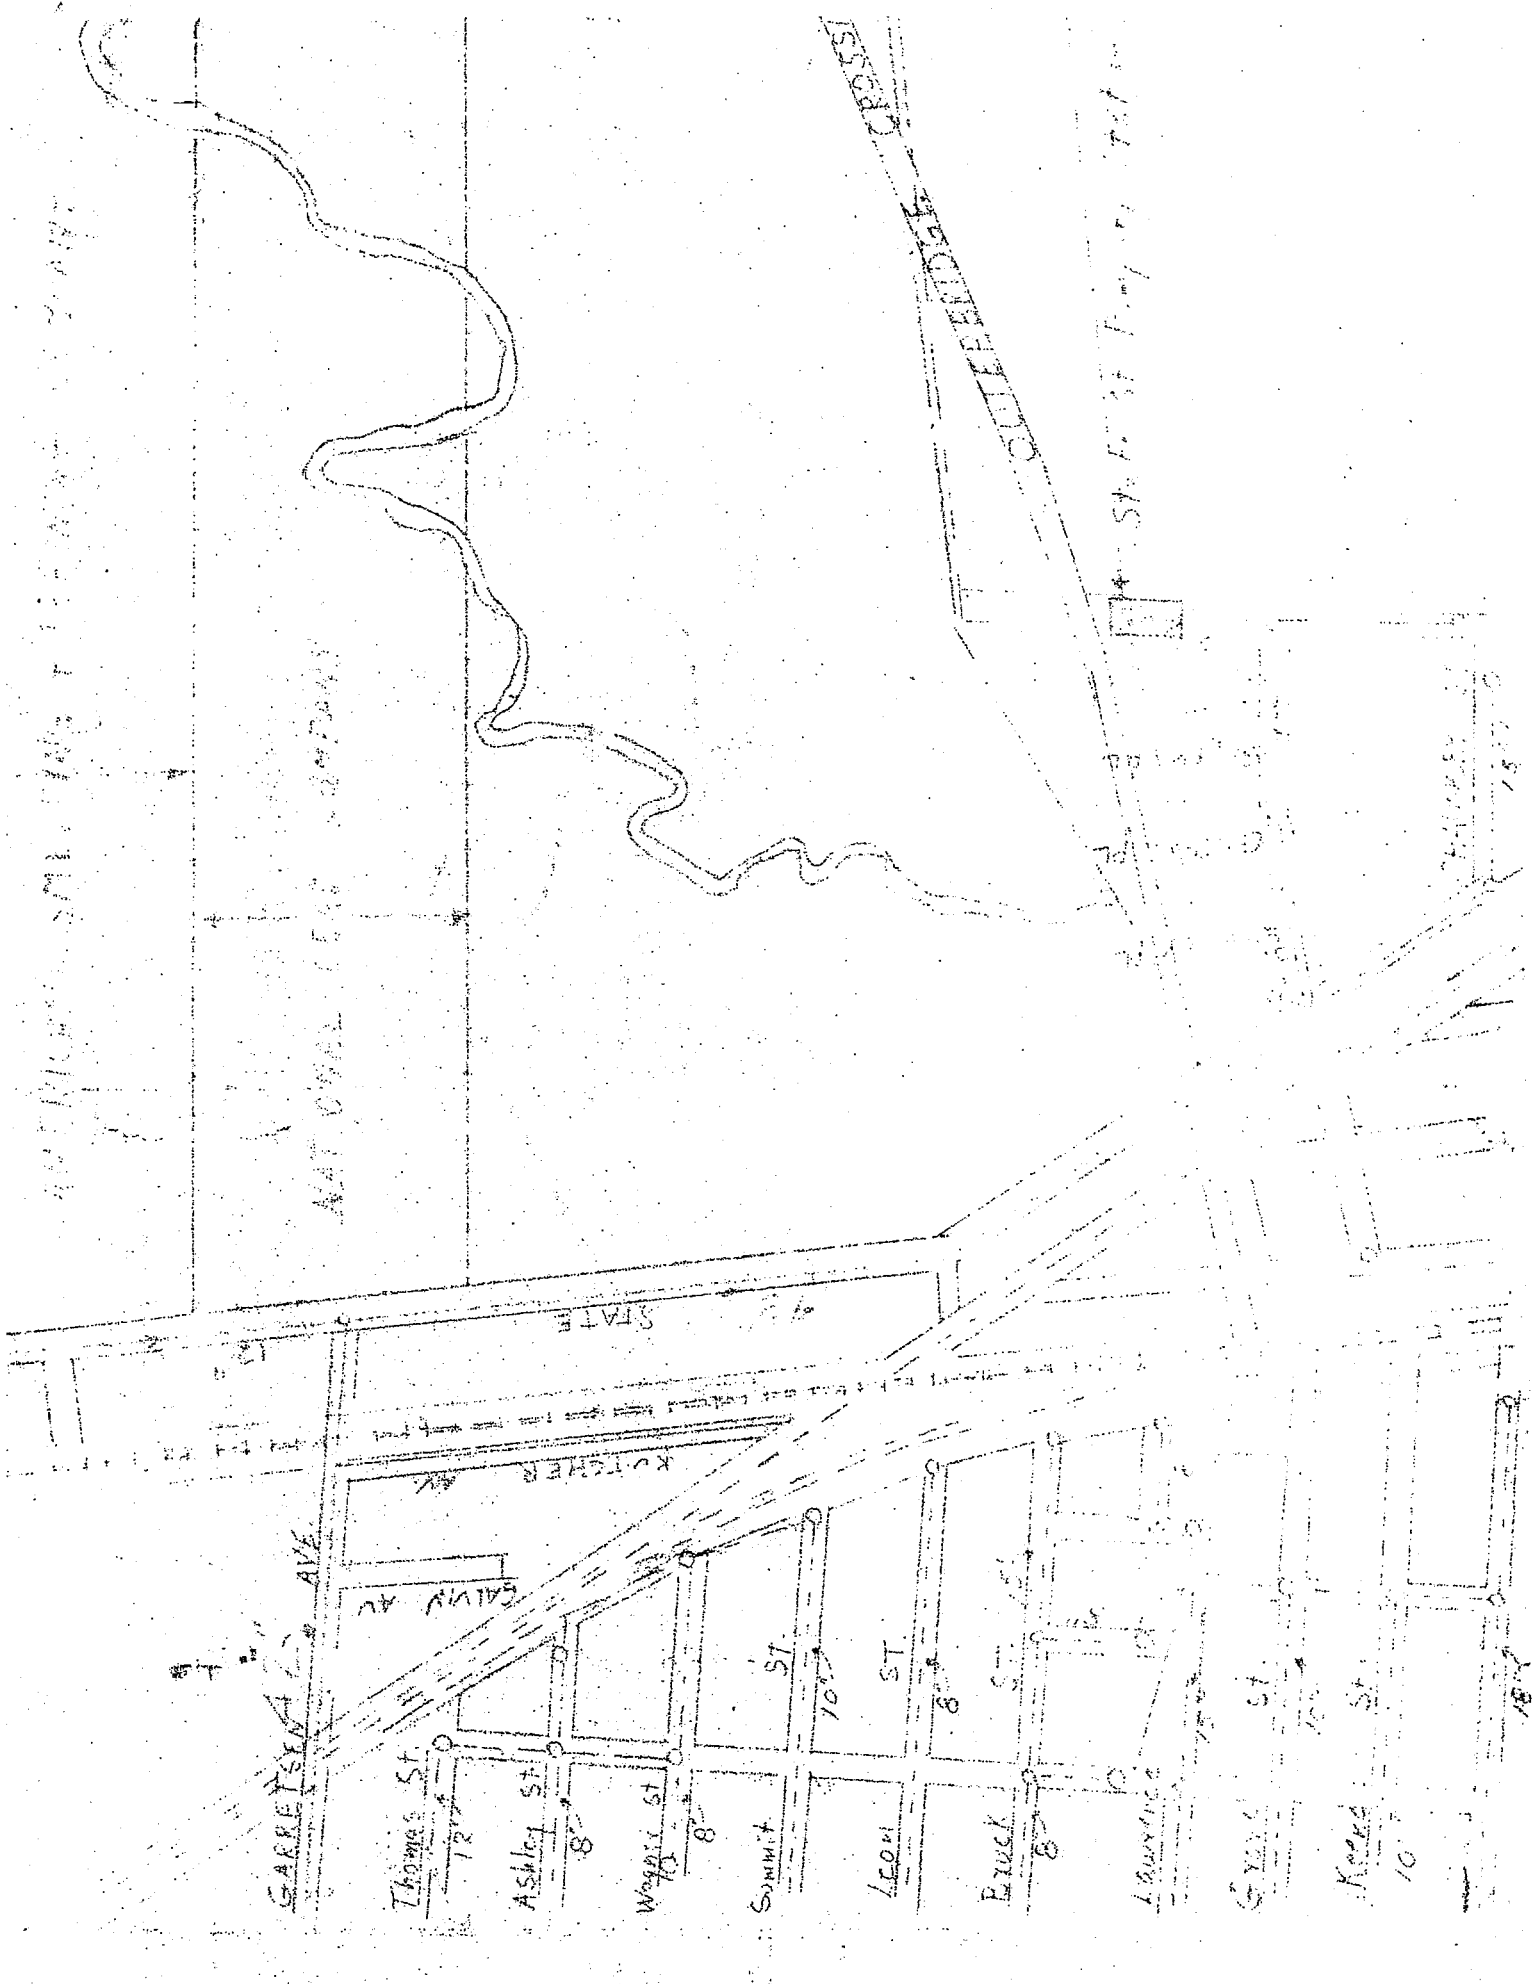
This plant which is situated on the Arthur Kill and bound on the north by California Oil Company and on the south by National Lead Company, has the alternative of discharging its waste material to the 48" interceptor sewer or a 12" sewer which connects with the 48" interceptor at the intersection of State Street and Garretsen Avenue. This plant fronts on State Street. No information is available as to the volume and nature of their discharge to the Arthur Kill.
