Rockaway River Priority Stream Segment Study

***Pathogenic Indicator and Pollutant Track Down Evaluations
Rockaway River Watershed
January 23, 2006***

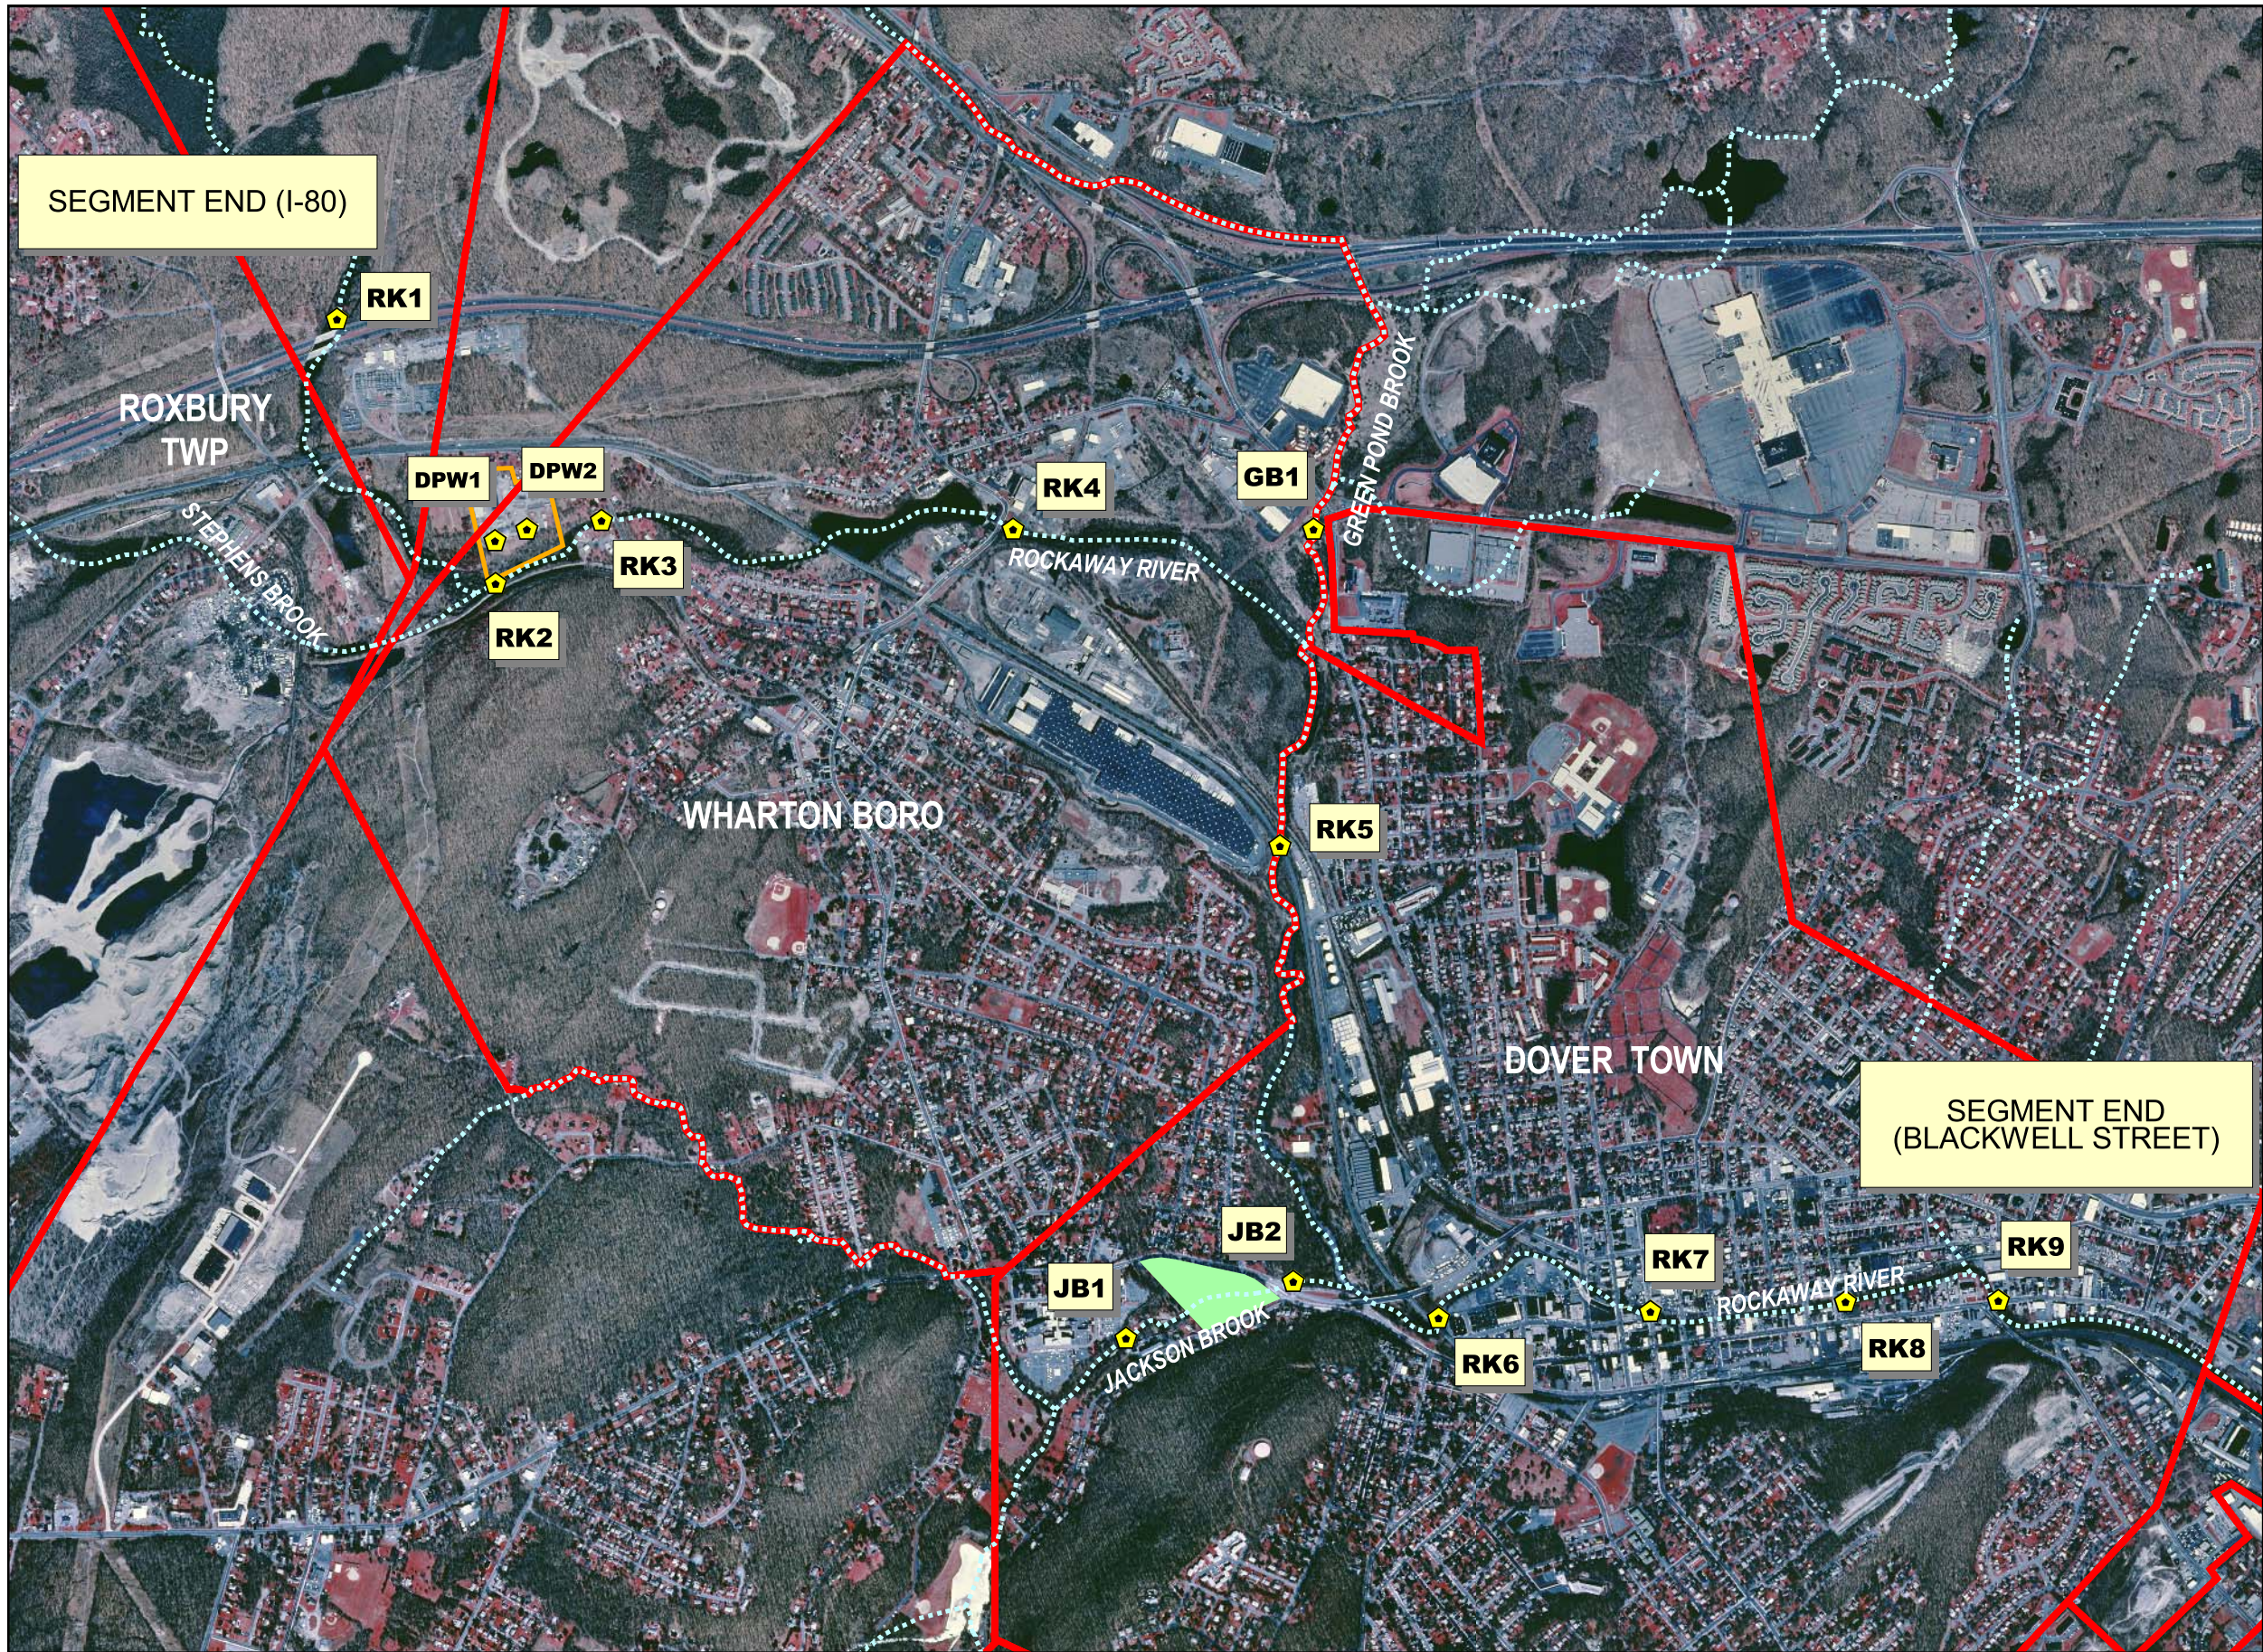
Figure 1
Proposed Sampling Sites

Figure 1 also details the locations of three additional sample stations (RK7a, SB1, and MKB). The rationale for the addition of these stations is presented later in this report.

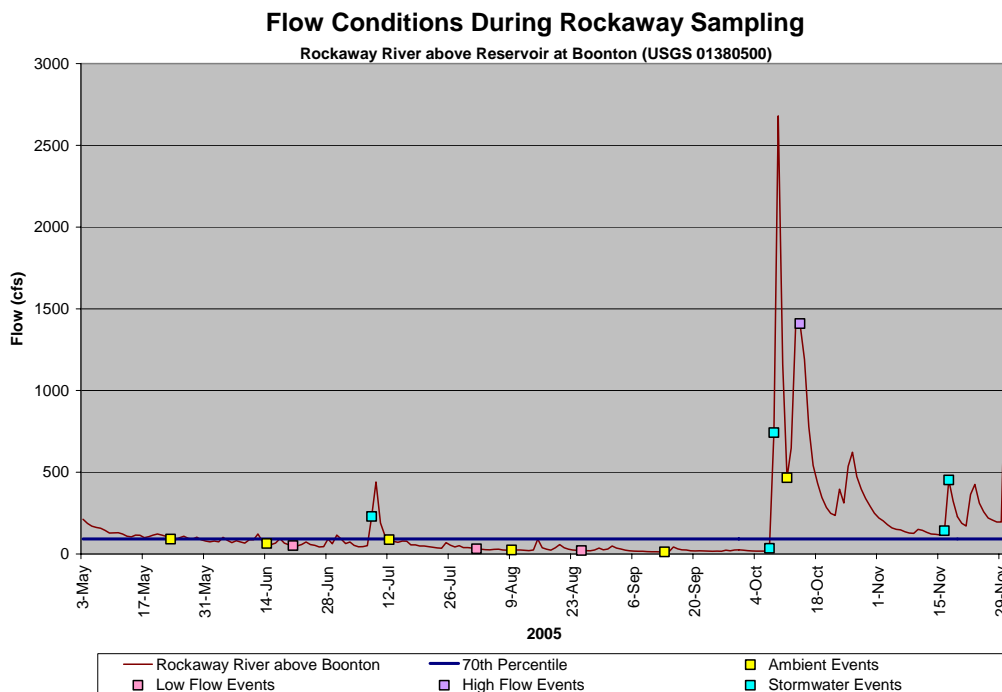
Figure 2.

Low-flow sampling occurred on June 20, 2005; August 1, 2005; and August 25, 2005, when measured flow at USGS station 01380500 did not exceed d70, the stream flow that is exceeded 70% of the time. Low-flow grab sampling was performed at eleven (11) stations. The parameters measured at all locations were fecal coliform, pH, temperature, dissolved reactive phosphorus, total phosphorus, TDS and TSS. During low flow events, composite sampling at two locations (RK3 and RK8), for the analysis of TDS and TSS, was initiated 24 hours prior to the collection of the grab samples. In addition, dissolved reactive phosphorus and total phosphorus were measured only at stations RK4 and RK6.

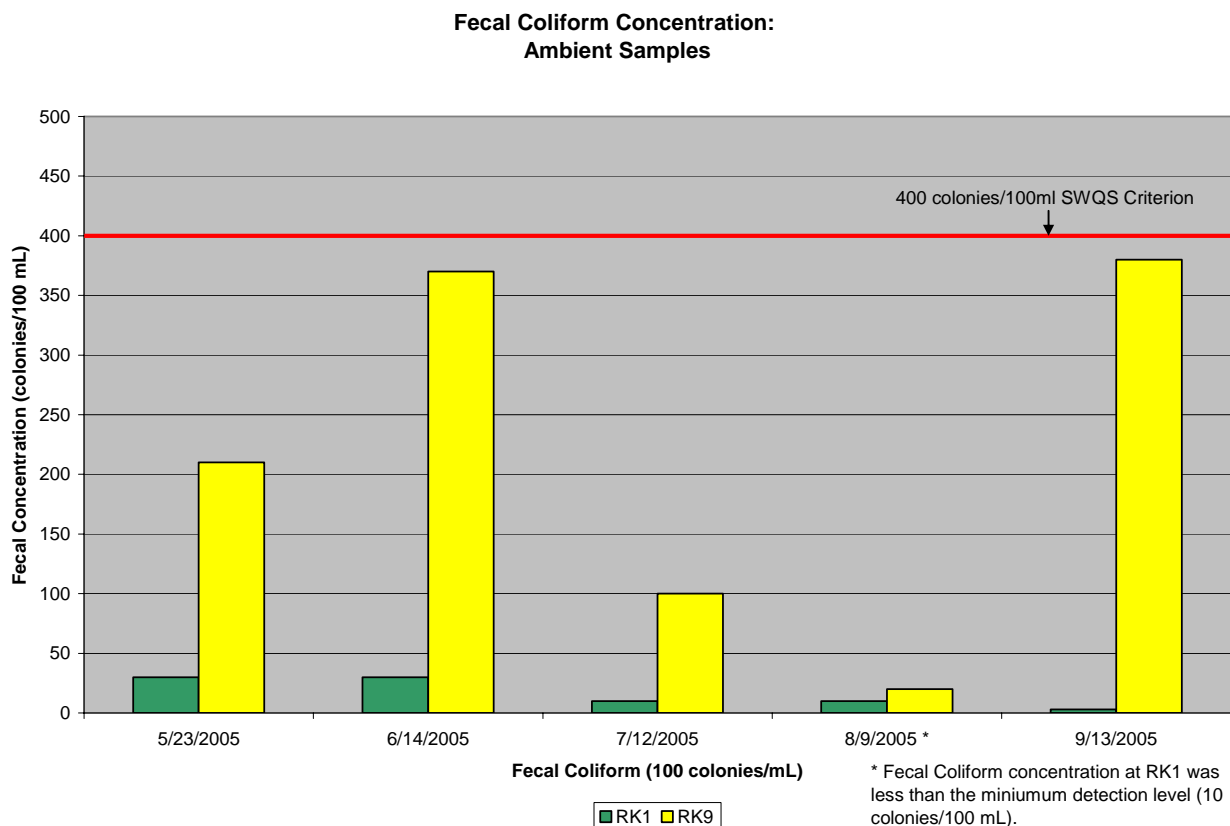
Figure 3.

A summary of the laboratory results for the sampling conducted between May and November 2005 is presented in Appendix A. In the study area, the Rockaway River is classified by NJDEP as FW2-NT. Figures 3 and 4 show sampling results compared with applicable criteria for fecal coliform concentrations in the Surface Water Quality Standards (SWQS) during the ambient and low flow sampling events. All locations met the 400 colonies/100ml SWQS during all of these sample events. It is evident from this data that during the ambient and low-flow sampling events fecal coliform concentrations increase as samples are collected further downstream.

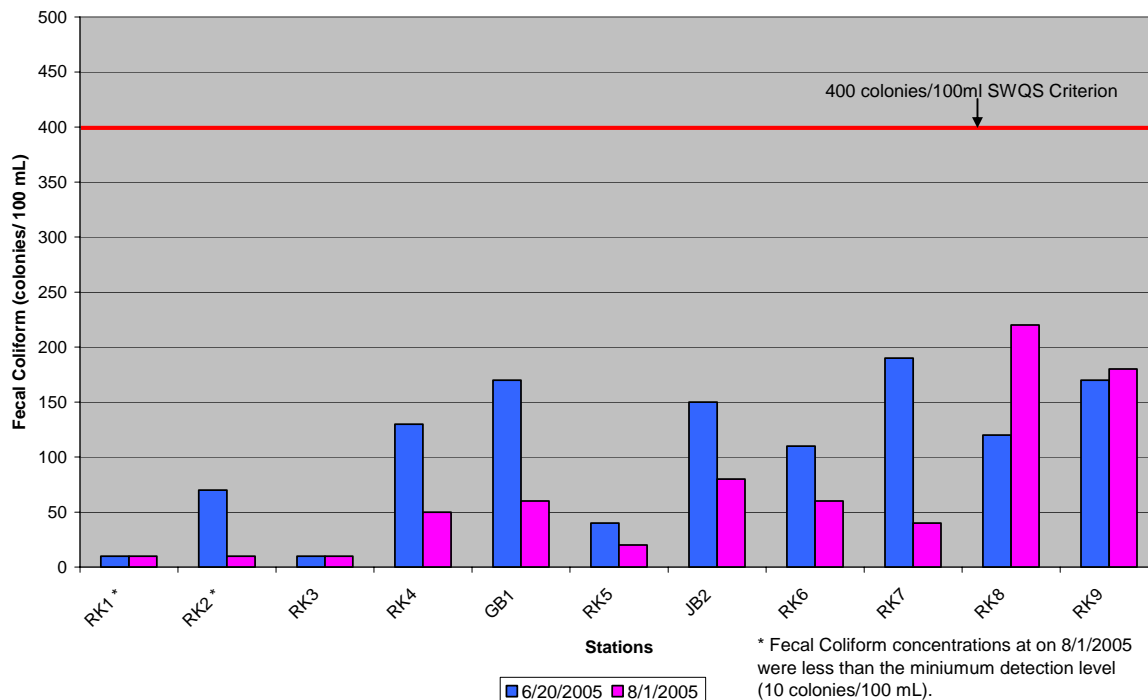
Figure 4.

**Fecal Coliform Concentration:
Low Flow Sample Events**

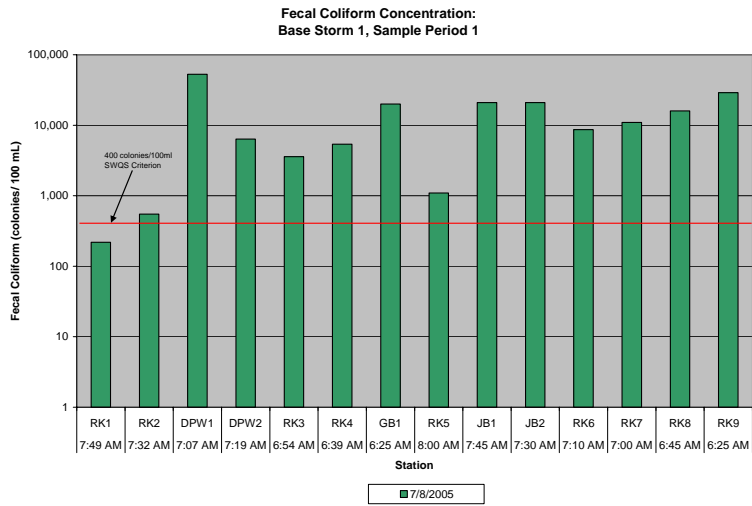
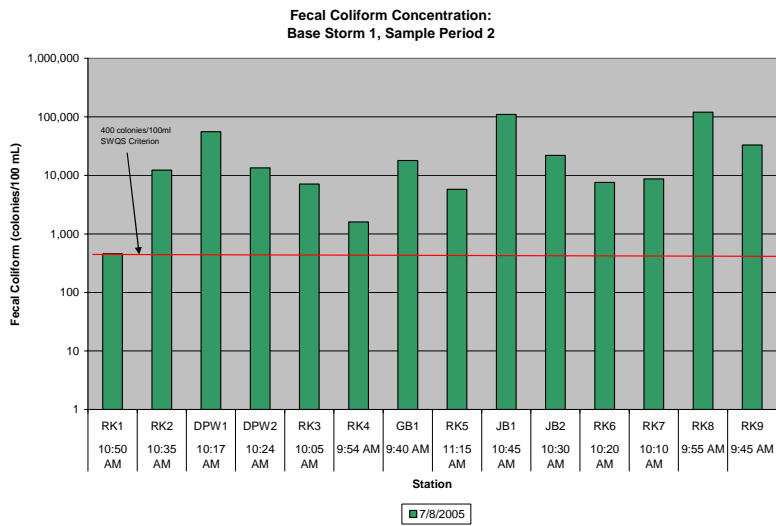
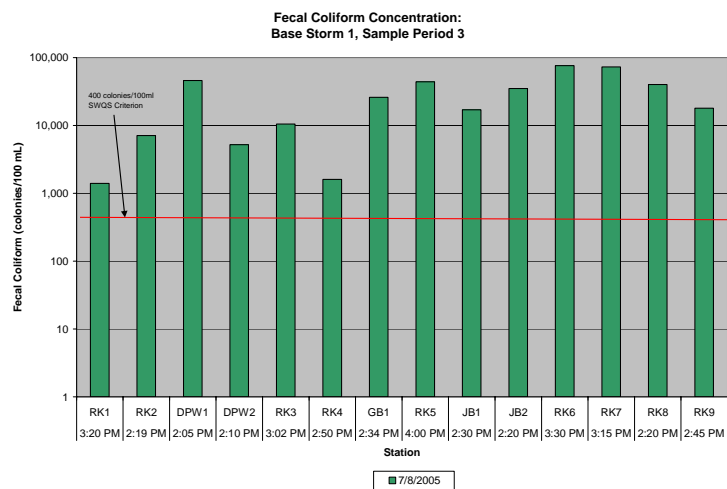
Figure 5.

Figures 5 and 6 show sampling results compared with applicable criteria for fecal coliform concentrations in the SWQS during the base line storm water sampling events (note the use of a logarithmic scale to show fecal coliform concentrations). During the first baseline storm water event, all locations, with the exception of the first sample collected at station RK1, exceeded the 400 colonies/100ml SWQS coliform concentration during all three rounds of sampling. During the second baseline storm water event, a majority of the samples again exceeded the 400 colonies/100ml SWQS coliform concentration. The exceptions were all samples collected at RK4, and the initial samples collected at RK1, RK3, RK5 and RK6. In addition, the second sample collected at RK1 met the 400 colonies/100ml SWQS. It is evident from this data that during the baseline storm water sampling events fecal coliform concentrations increase significantly as samples are collected further downstream.

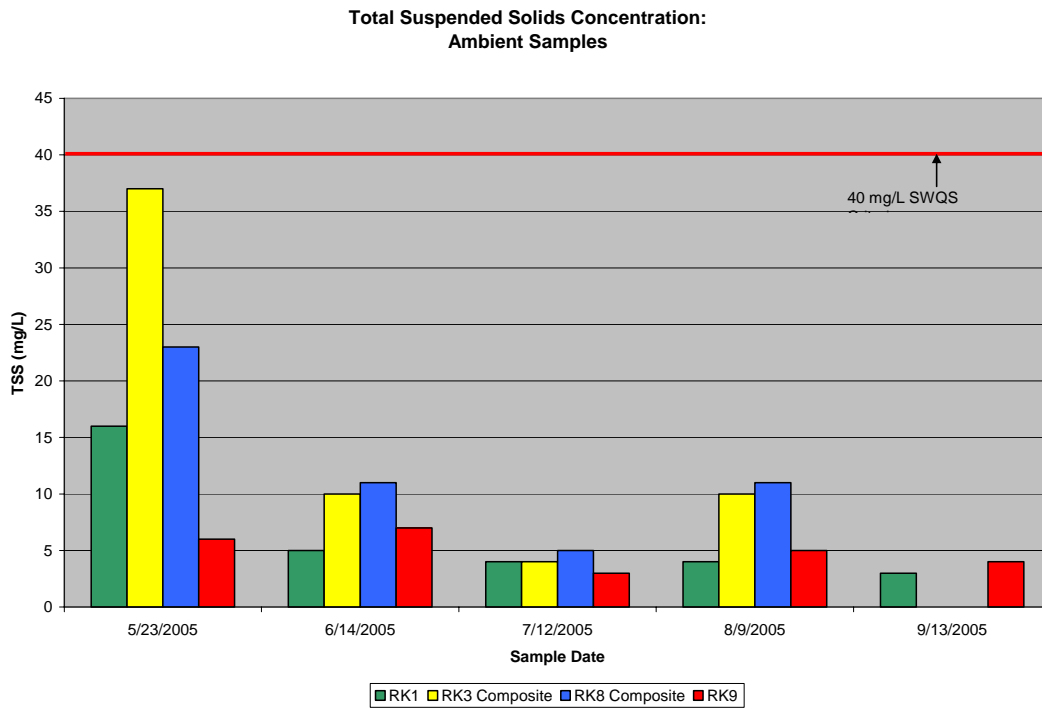
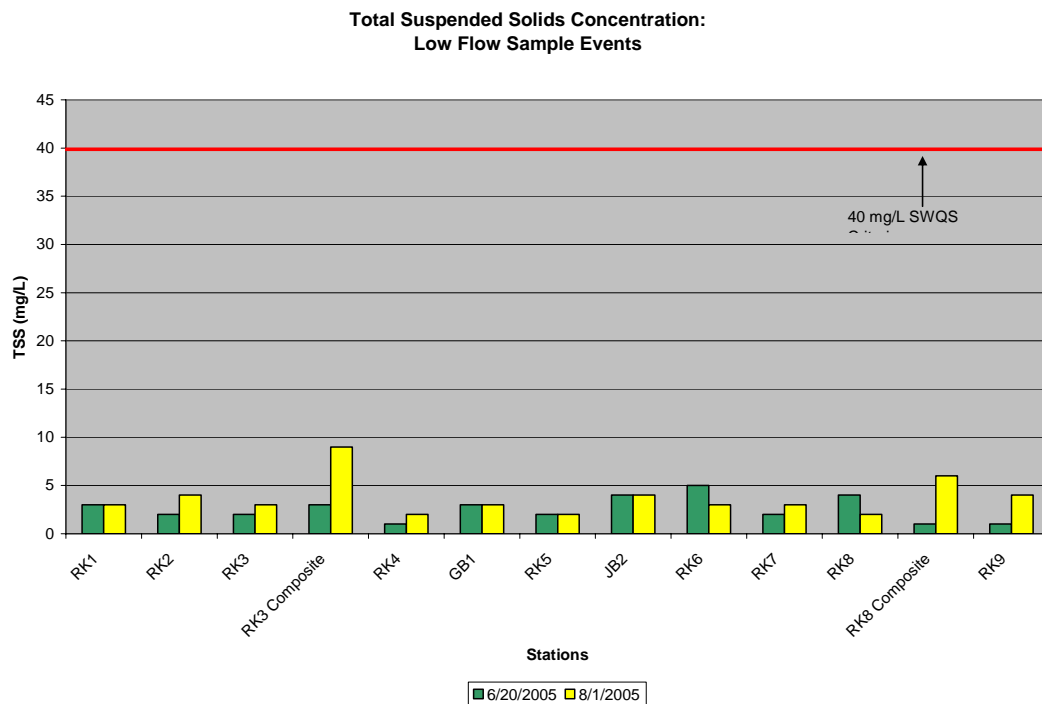
Figure 9.

Total suspended solids refer to the particles that will not pass through a glass fiber (approximately 2-micron) filter. High concentrations of TSS can result in a high load of adsorbed toxics or bacteria and increased turbidity. Additionally, high TSS can increase water temperature and inhibit productivity by blocking light. Sources of TSS include industrial and municipal discharges, storm water runoff, and eroding stream banks. Figures 9 and 10 detail observed TSS concentrations during the sampling events.

For all ambient and low flow event samples, TSS was below the 40 mg/l SWQS for FW2-NT waters. Ambient composite samples were not collected on September 13 due to sampler malfunctions. All values that exceeded the TSS standard were during storm events, which suggest that control of TSS loading to the Rockaway River should focus on removal of suspended solids in storm water runoff.

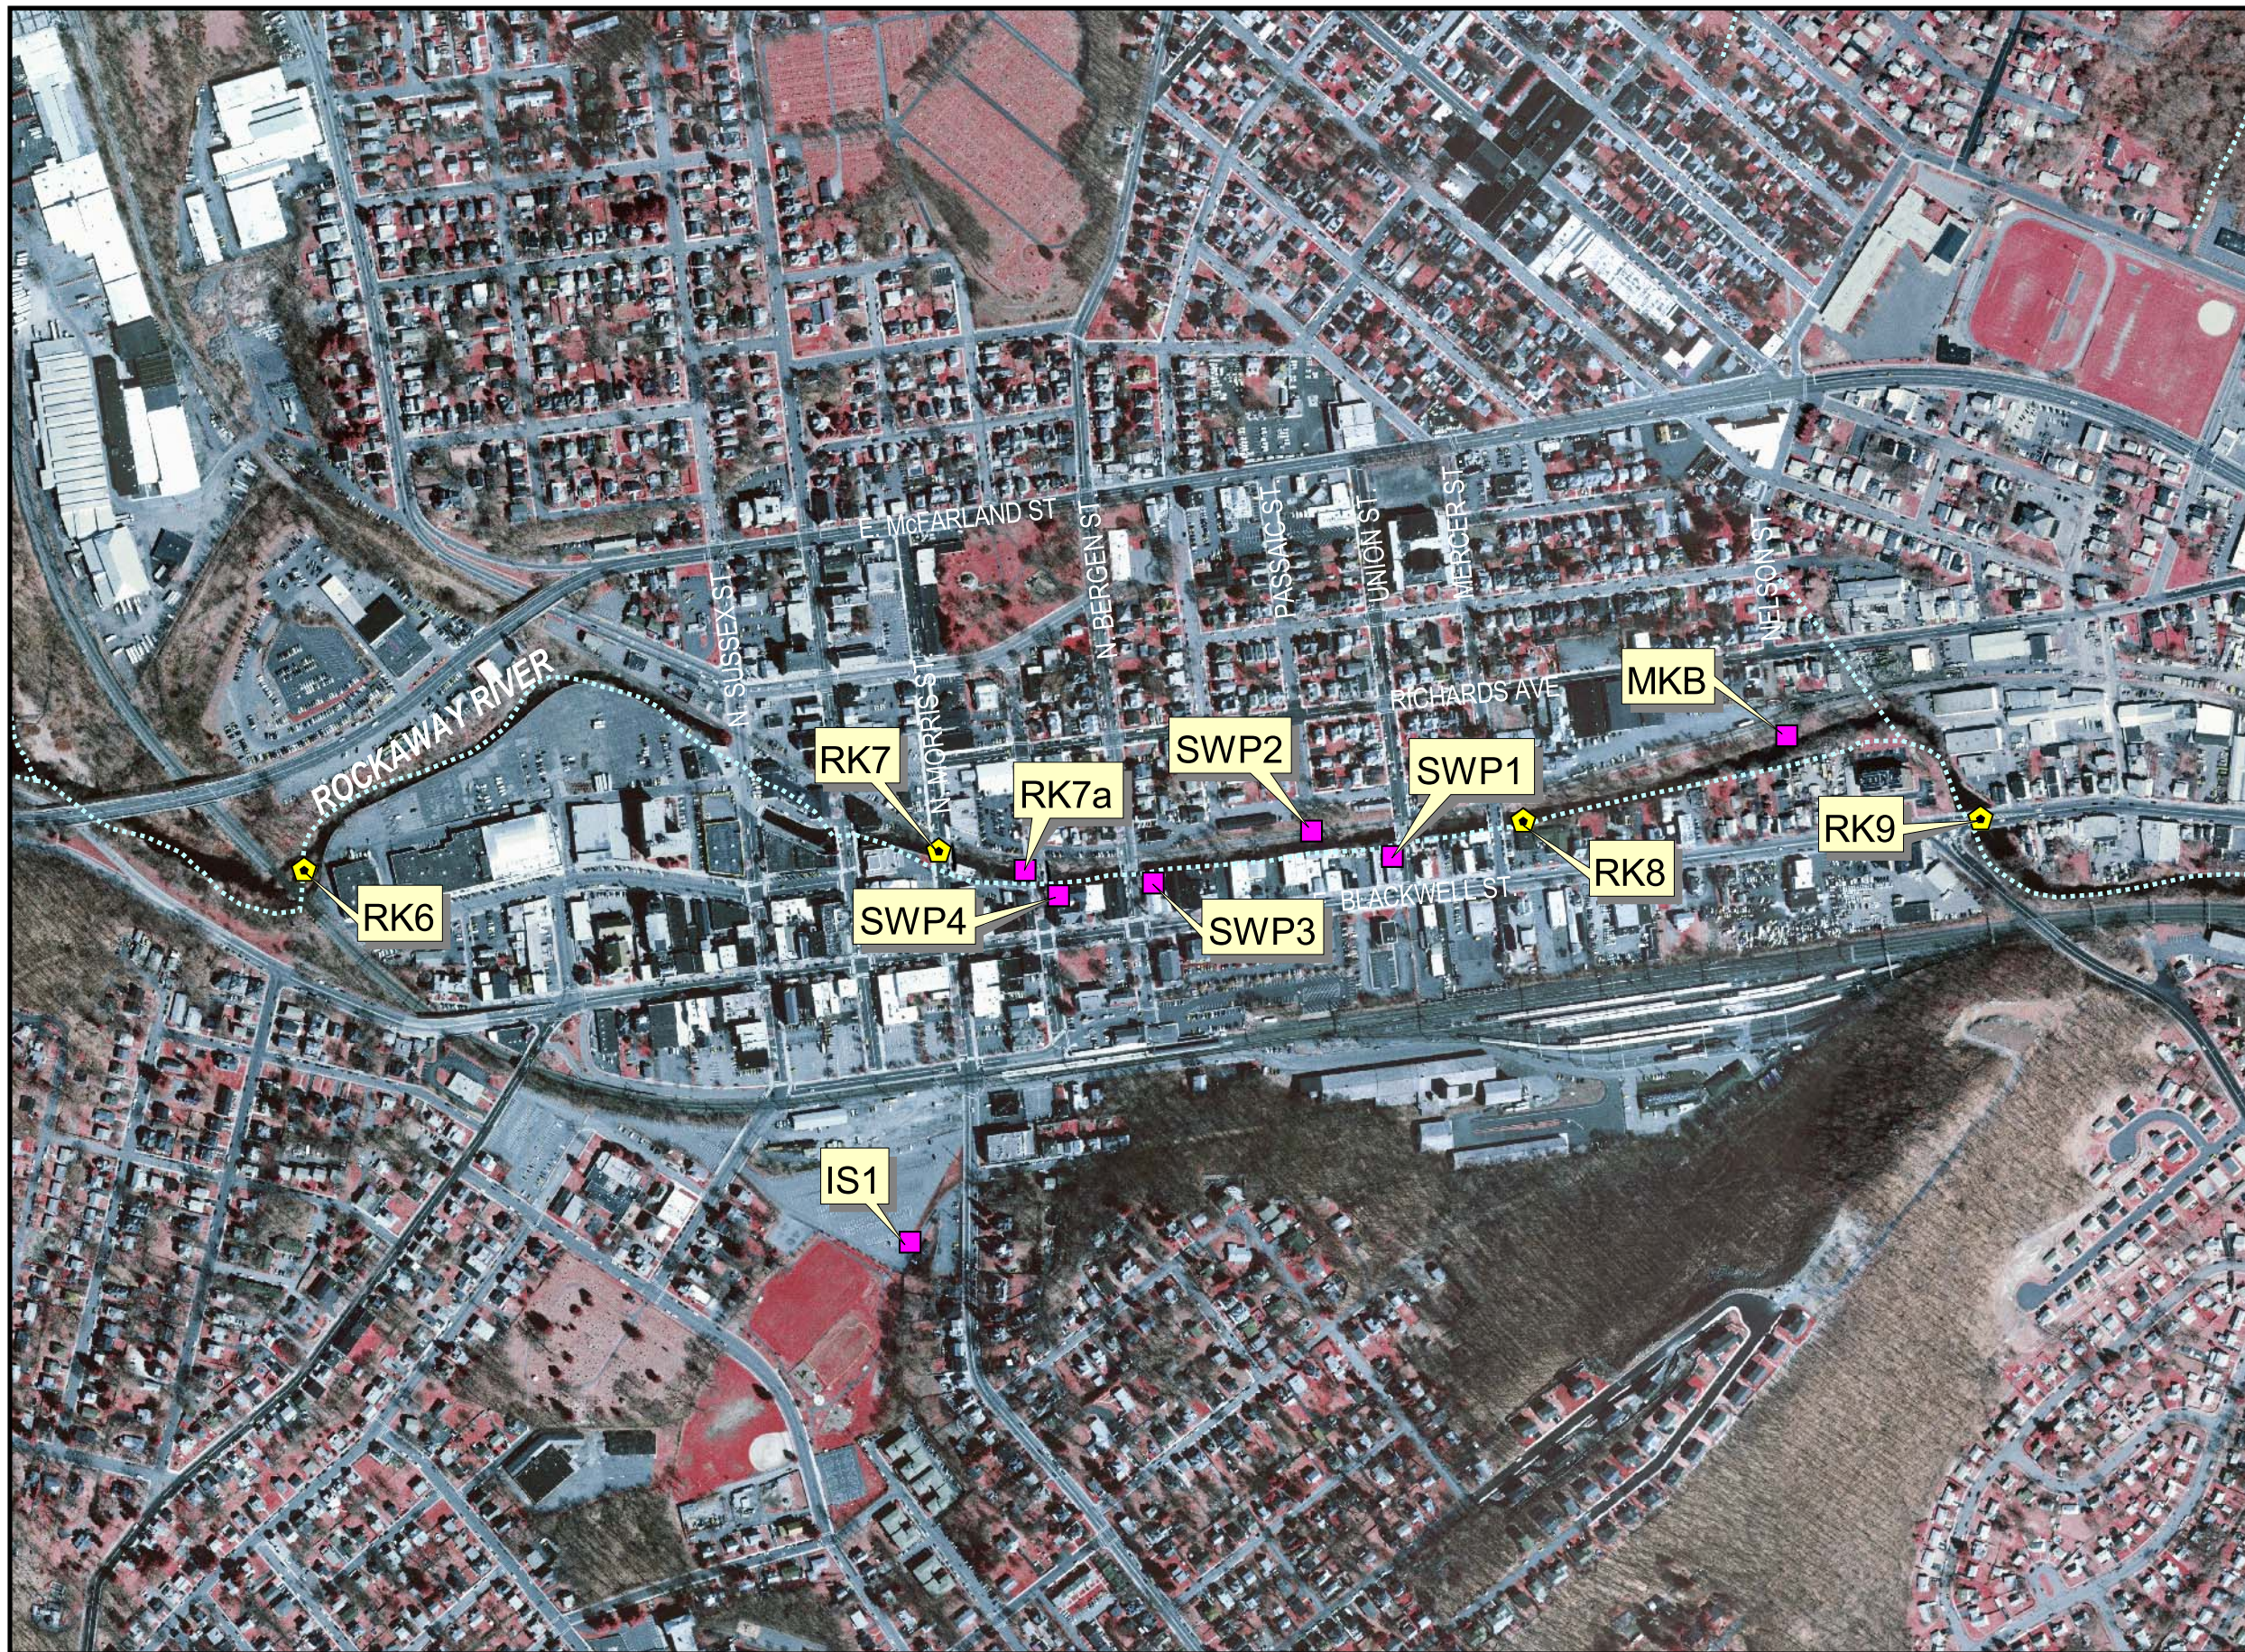
- Storm Water Sampling Stations
- River Sampling Sites
- Rivers and Streams

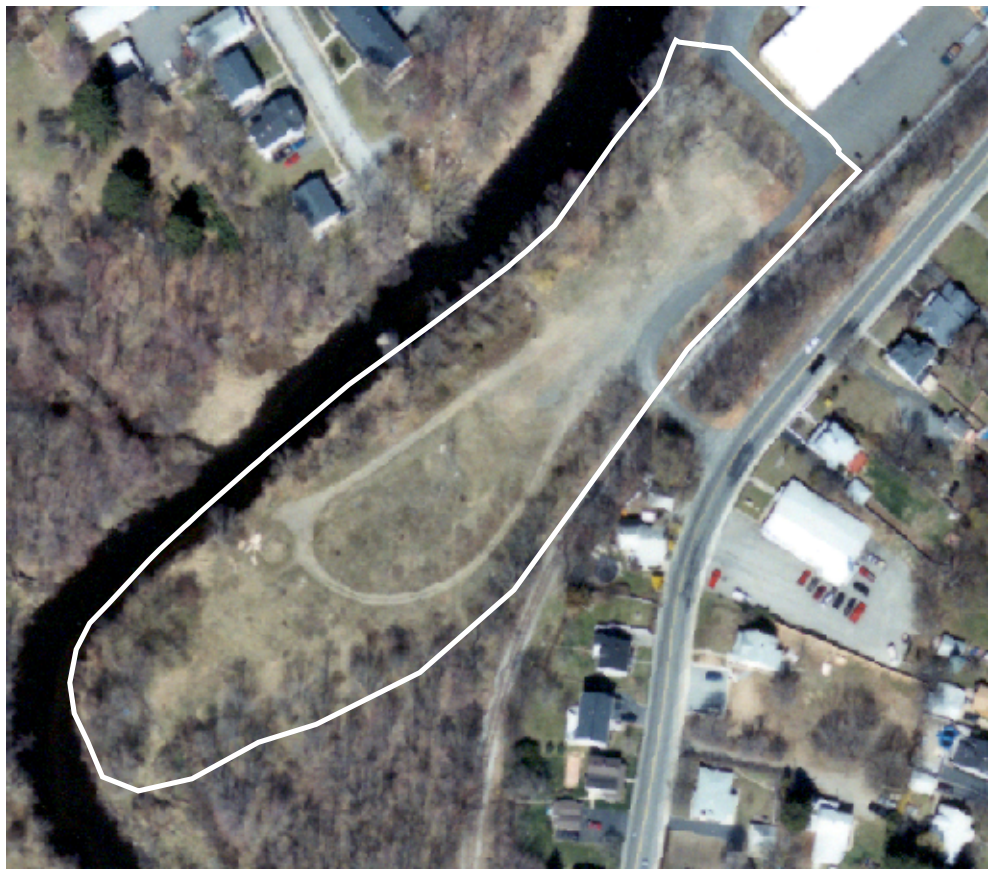
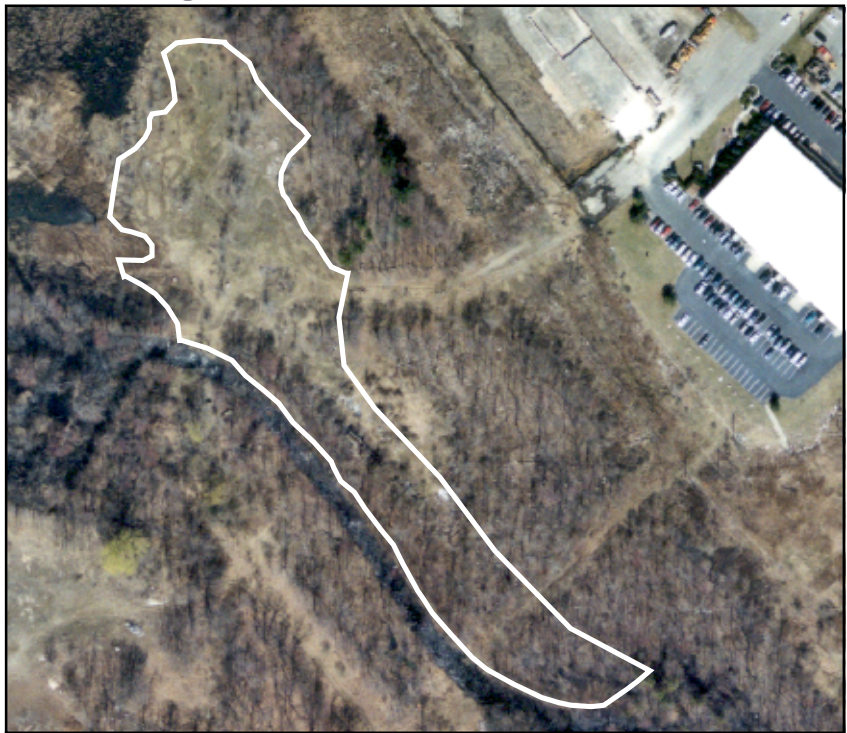
Figure 6. Site JB-3: Conceptual Restoration Design for the Upper Rockaway Flood Control and Ecosystem Restoration Study.

Based on the site visit, it appears that the river was channelized through this area in the past and that the excavated material was side-cast along the eastern bank of the river to create an artificial earthen berm and/or exaggerated streambank. The berm is approximately 25 feet wide and between 6 to 8 feet above the normal river surface, and there is no evidence that the river water is able to breach the berm. These past activities have significantly altered the hydrology in this

- JB-3 (Burnt Meadow Brook-River Woodland Reserve). This site is an approximately 2.52 acre parcel of land that consists of a narrow vegetated berm, disturbed upland, and remnant forested floodplain. The site is located in Wharton, near the Shop Rite shopping complex located on West Clinton, and is bordered by the Rockaway River to the west. It appears that the river was channelized through this area in the past and that the excavated material was side-cast along the eastern bank of the river to create an artificial earthen berm and/or exaggerated streambank. These past activities have significantly altered the hydrology in this area and have adversely impacted the former floodplain. As a result, the Rockaway River flows very quickly downstream through this narrow channel. The proposed restoration at this site includes removing the earthen berm, placing the excavated material on the disturbed upland areas, and replanting the area with herbaceous ground cover. This work will significantly improve fish habitat by restoring the original streambed and floodplain and adding a diversity of habitats that are not currently available. The widening of the current riverbed through the removal of the berm will also provide secondary benefits such as a reduction in water velocities, and reestablishment of natural water and sediment storage in the floodplain during storm events.

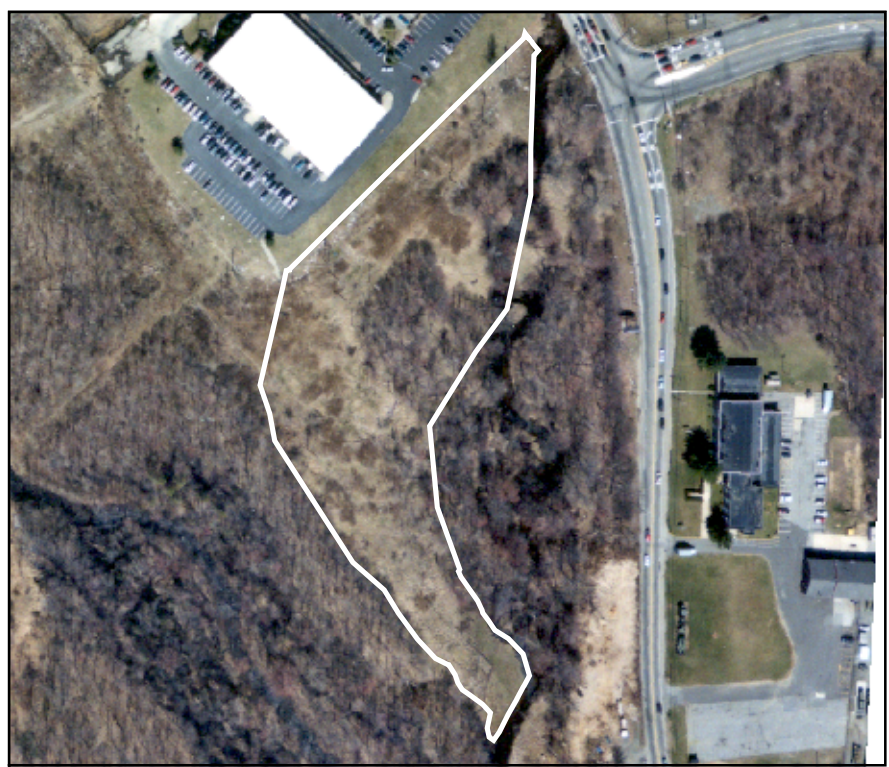
Figure 7. Site JB-8: Conceptual Restoration Design for the Upper Rockaway Flood Control and Ecosystem Restoration Study.

Existing Environment

Flow Direction
↘

- JB-8 (Jackson Brook Sub-basin-Drainage 646 Wharton). This site is an approximately 3.9 acre parcel of land located on an active powerline right-of-way in Wharton, near the intersection of Mount Pleasant Avenue and West Clinton (Route 15). The site is bordered on the northeast by the West Clinton Bridge, on the east by Green Pond Brook, on the south by the Rockaway River and a large forested wetland, and on the northwest by the roller rink parking lot. The site is dominated by common reed (*Phragmites australis*), a highly opportunistic, fast colonizing plant species that is regularly found in

Site JB-8 is an approximately 3.9 acre parcel of land located on an active powerline right-of-way in Wharton, near the intersection of Mount Pleasant Avenue and West Clinton (Route 15). The site is bordered on the northeast by the West Clinton Bridge, on the east by Green Pond Brook, on the south by the Rockaway River and a large forested wetland, and on the northwest by the roller rink parking lot. The site is dominated by common reed (*Phragmites australis*), a highly opportunistic, fast colonizing plant species that is regularly found in disturbed wetland areas.

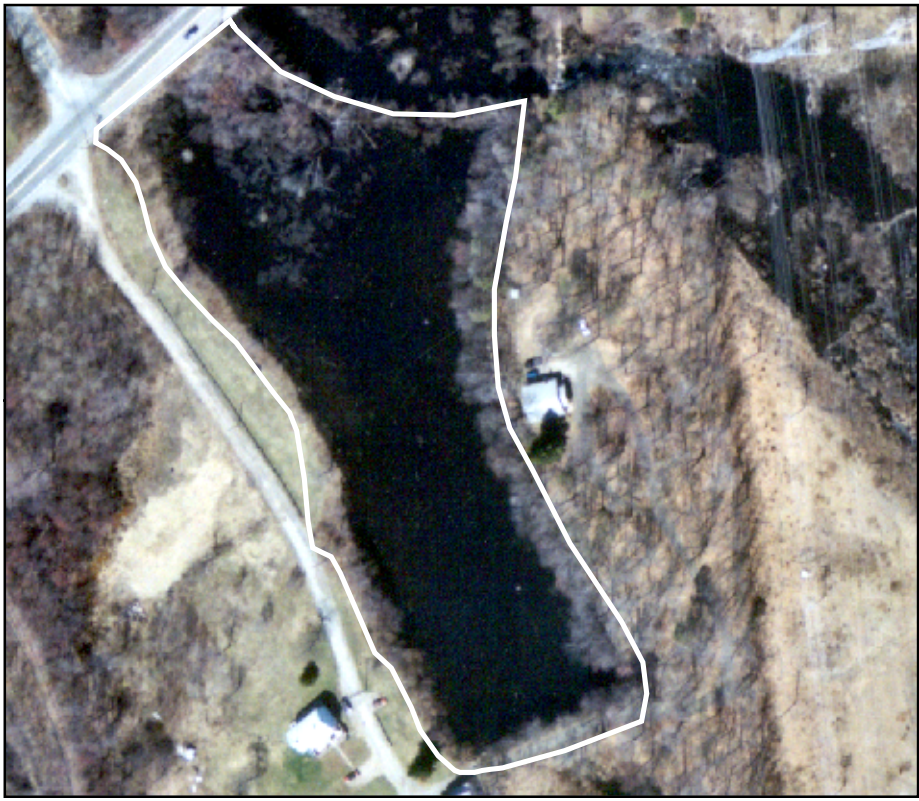
- Created Open Water/Emergent
- Created Open Water/Submerged Aquatic Vegetation
- Created Deep Water
- Created Scrub-shrub

Preliminary restoration activities identified for Mill Pond based on current site conditions include improving fish and wildlife habitat diversity, as well as reducing high velocity flows and downstream sediment loading during storm events. Fish and wildlife habitat improvements include reconfiguring the elevation of the berm to a consistent height above the river's surface water height; excavating accumulated pond sediments creating areas of deepwater habitat to enhance the diversity of fish habitat and species; and, reconstructing the existing man-made culvert to ensure adequate pond drainage (Figure 8).

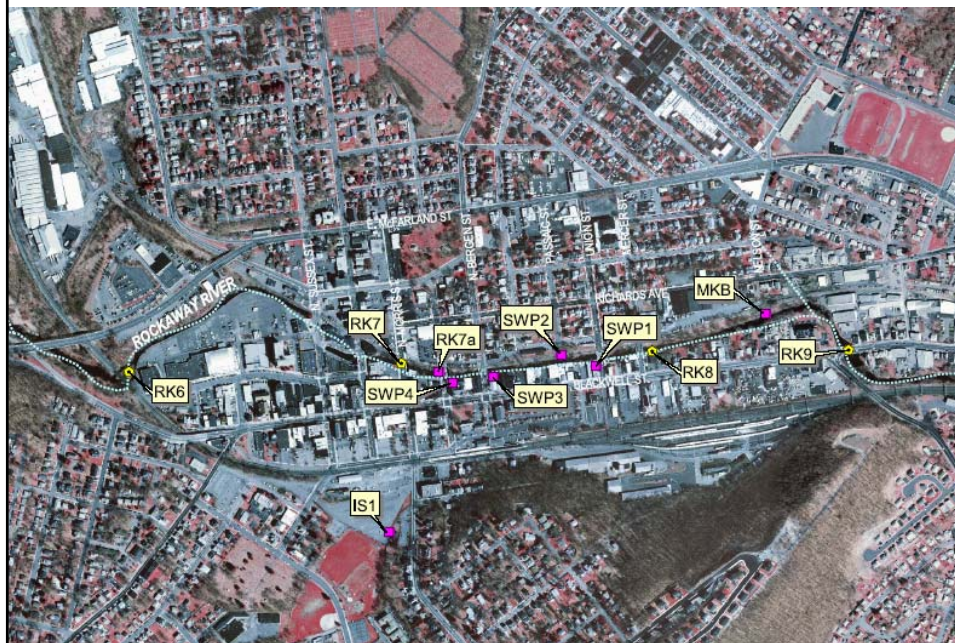
Stormwater Pipe Sampling Map

- Targeted sampling in downtown Dover
- Sample 5 stormwater outfalls discharging directly to Rockaway River between RK6 and RK9
- Isolate stormwater drainage areas to evaluate potential fecal coliform sources

- Four (4) storm water pipes in Dover were selected to better understand the fecal coliform loading identified in the urbanized areas. The selected storm water pipes were identified on storm water maps obtained from the Town Engineer in Dover. The four selected storm water pipes were in the vicinity of the highest in-stream concentrations that were observed in the two baseline storm events and were identified as follows:

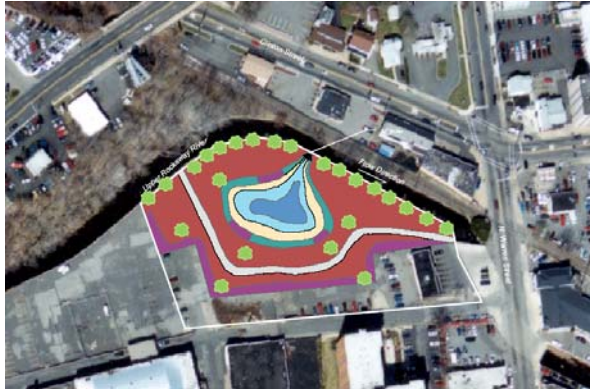
JB-5

- 3 acre site
- Filled pond (Dover Mill Pond)
- Reconstruct floodplain wetland hydrology
- Treat urban stormwater
- ~\$258,659 (USACE 2004)

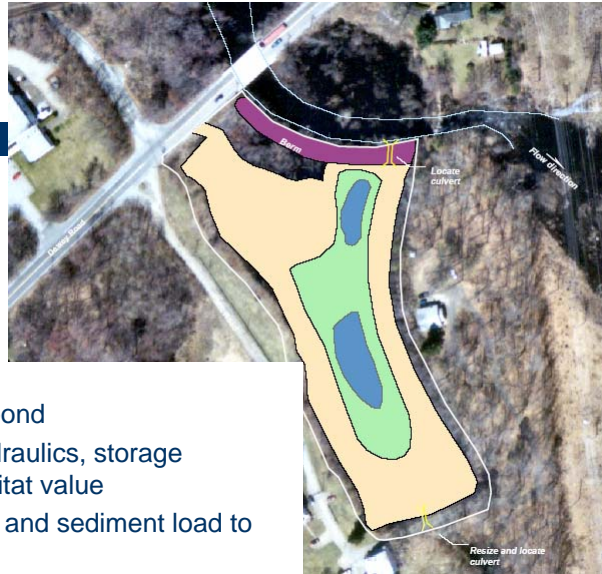
UR-1

- 8.6 acre site
- Existing shallow pond
- Improve pond hydraulics, storage capacity, and habitat value
- Reduce velocities and sediment load to Rockaway River
- ~\$126,270 (USACE 2004)

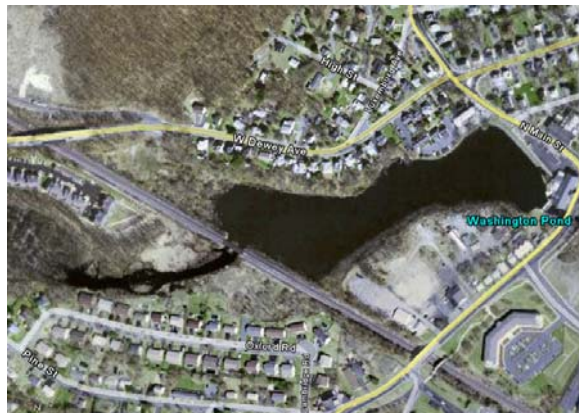
Washington Forge Pond

- 9.5 acre site
- Open space acquisition opportunity
- Improve flood storage and habitat value
- Improve management of privately owned shoreline areas

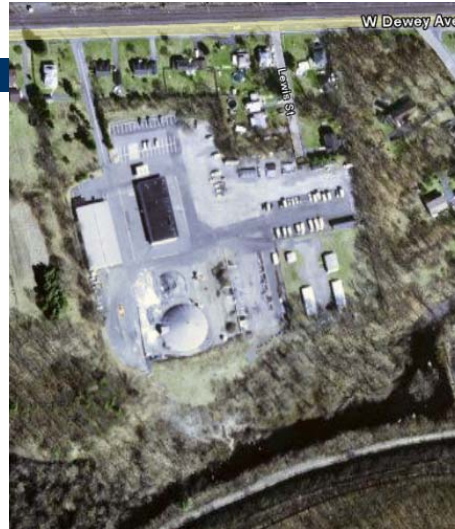
Morris County DPW Project

- 6 acre site
- Install stormwater BMPs to treat runoff discharging directly to flood plain areas and the Rockaway River
- Designs Complete and NJDEP Permits obtained December 2005
- Installation planned for Spring 2006
- ~\$100,000 in 319(h) grant funds and ~\$50,000 in kind match

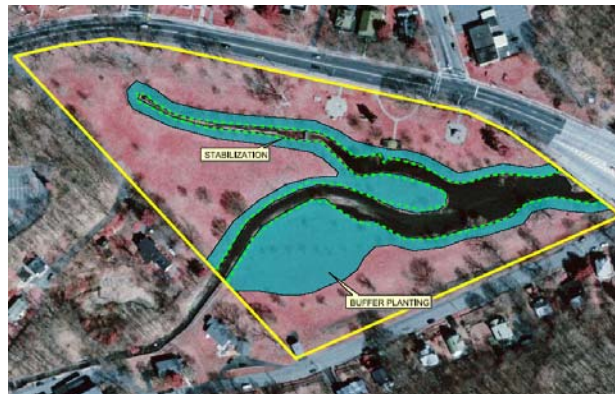
Hurd Park Shoreline Restoration

- 4 acre site
- Implement goose management and install shoreline buffers totaling 1.5 acres to treat overland flow and deter waterfowl
- Design and permitting 2006
- Installation target of Spring 2007
- ~\$200,000 in 319(h) grant funds and ~\$20,000 in kind match

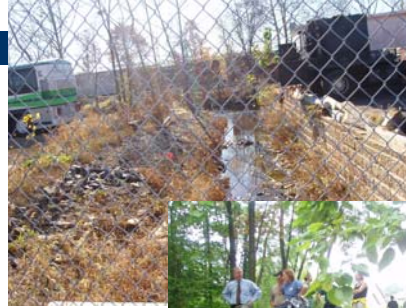
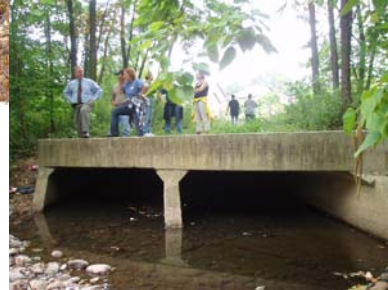
McKeel Brook Stormwater BMPs

- Focus on reducing velocities and sediment in streams, storm sewers and downstream Rockaway River
- Design stormwater drainage Improvements
- Reestablish natural drainage connections
- Daylight storm sewers
- Design and install “first flush” stormwater diversions
