#### THE ALEXAUKEN CREEK WATERSHED PROTECTION PLAN 319(h) Grant # RP05-084

Princeton Hydro, LLC 1108 Old York Road Suite 1 Post Office Box 720 Ringoes, New Jersey 08551 908-237-5660

February 2011

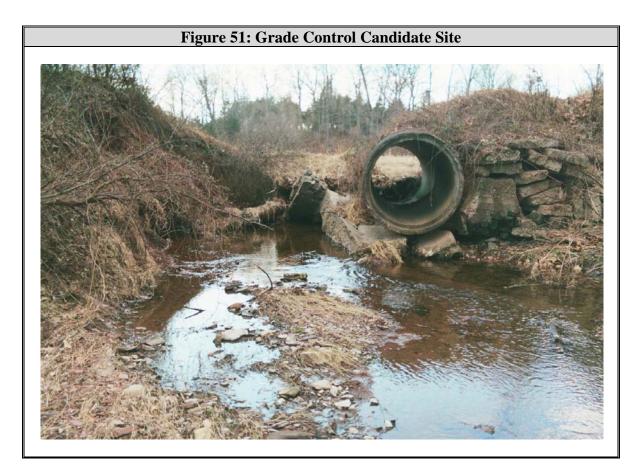
The removal of the stream obstruction located in the watershed (Figure 51) would certainly require a grade control structure post-removal, likely a cross vane. In this setting a cross vane would stabilize any head cut, connect the hydraulic jump above and below the obstruction, and align flow through the center of the channel.
