## **TENAKILL BROOK WATERSHED RESTORATION & PROTECTION PLAN**

Developed by the Rutgers Cooperative Extension Water Resources Program  
Funded by the New Jersey Department of Environmental Protection  
RP 07-001

January 22, 2013

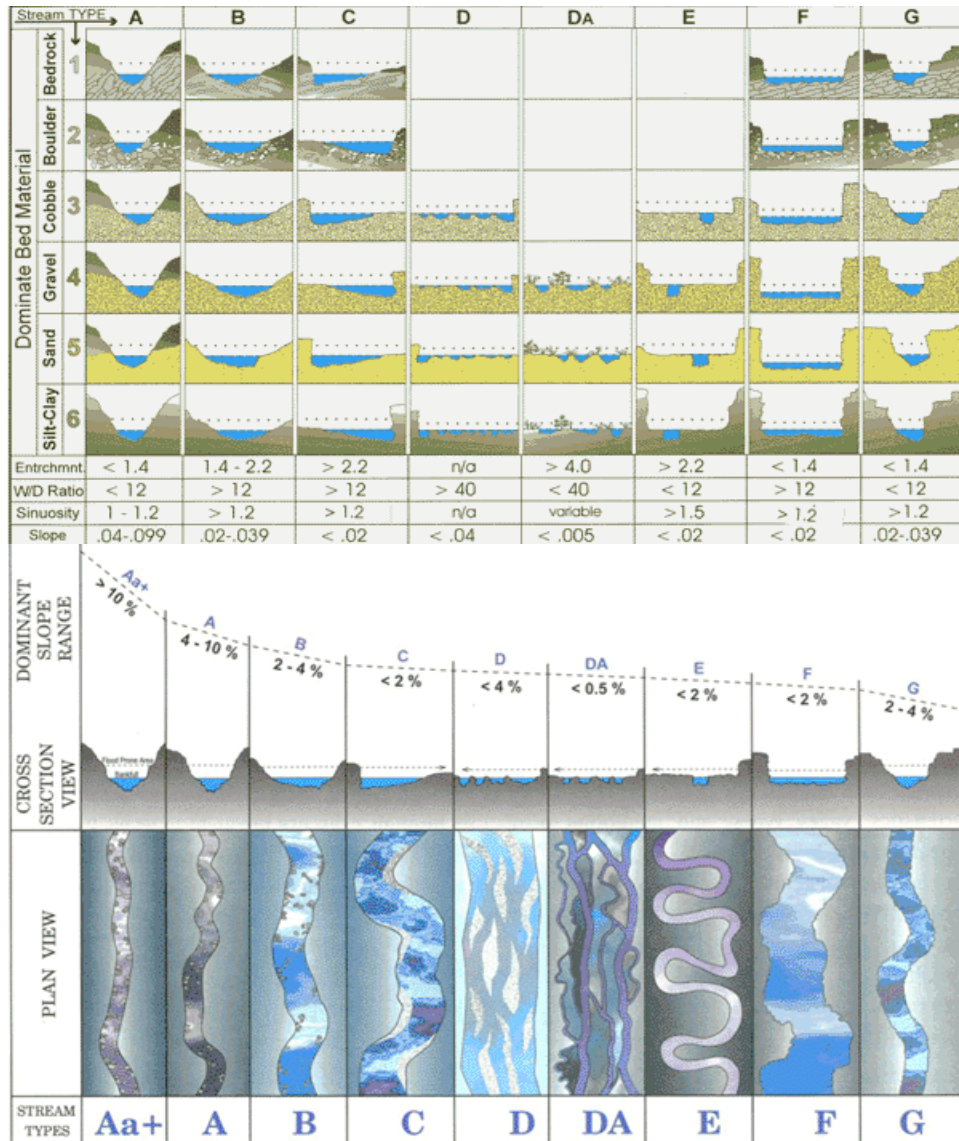
**Figure 13: Rosgen stream classification cross section, plan and profile views (Rosgen, 1994).**

The Rosgen Stream Classification System uses six morphological measurements for classifying a stream reach – entrenchment, width/depth ratio, sinuosity, number of channels, slope and bed material particle size. These criteria are used to define eight major stream classes with approximately 100 individual stream types (Figure 13). The Rosgen System uses bankfull discharge to represent the stream-forming flow and relates all the morphological characteristics to bankfull conditions. For the Tenakill Brook Watershed, the Rosgen Stream Classification System was used to determine the stream types of various reaches within the watershed (Natural Resource Conservation Services [NRCS], 2007).

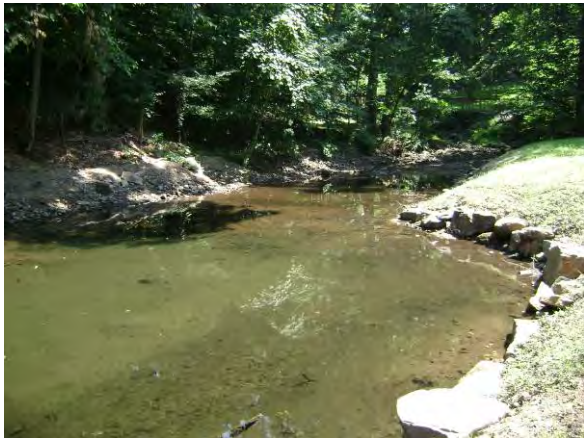
**Figure 17a: Poor bank stability in CB1. (Photo: RCE Water Resources Program)**

Channelized sections of the stream were observed (Figure 17b), as well as significant barriers to fish passage (Figure 17c). This may be a significant issue to trout populations as the upper portion of the Cresskill Brook is classified for trout production (Figure 5).

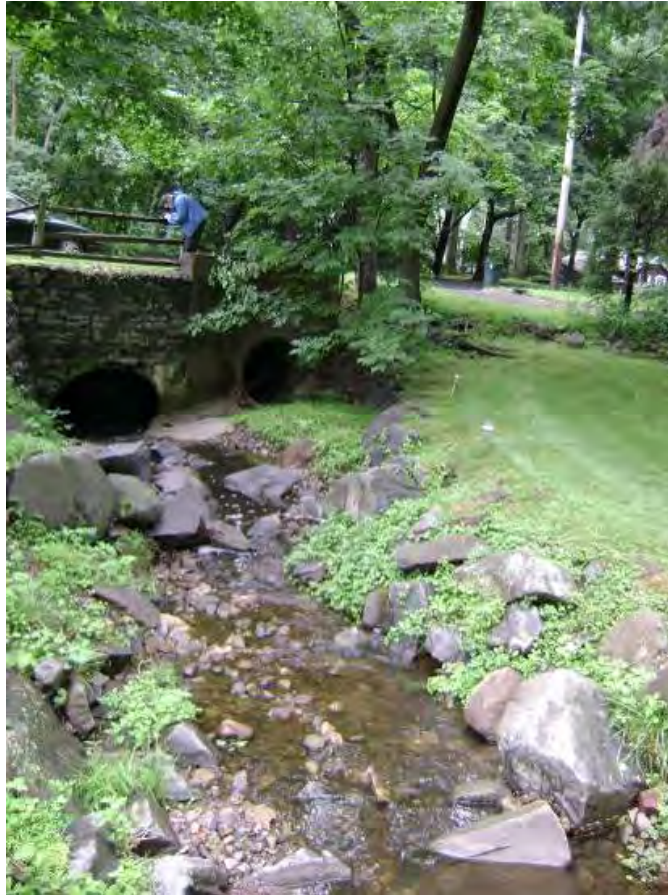
**Figure 18: Poor riparian buffer in DB1.  
(Photo: RCE Water Resources Program)**

As with other subwatersheds, reaches along Demarest Brook were scored “poor” for bank stability (Table 9). This may be due to the poor riparian buffers observed at many of the reaches (Figure 18).

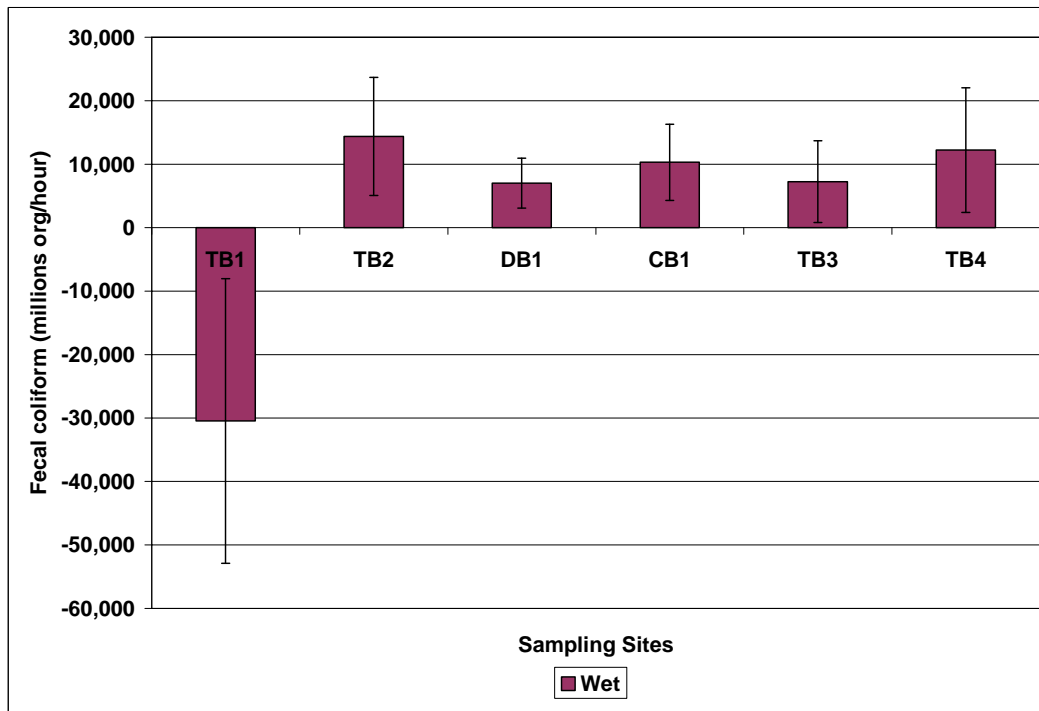
Figure 20: Comparison of hourly fecal coliform (FC) load by subwatershed under dry (A) and wet (B) conditions.

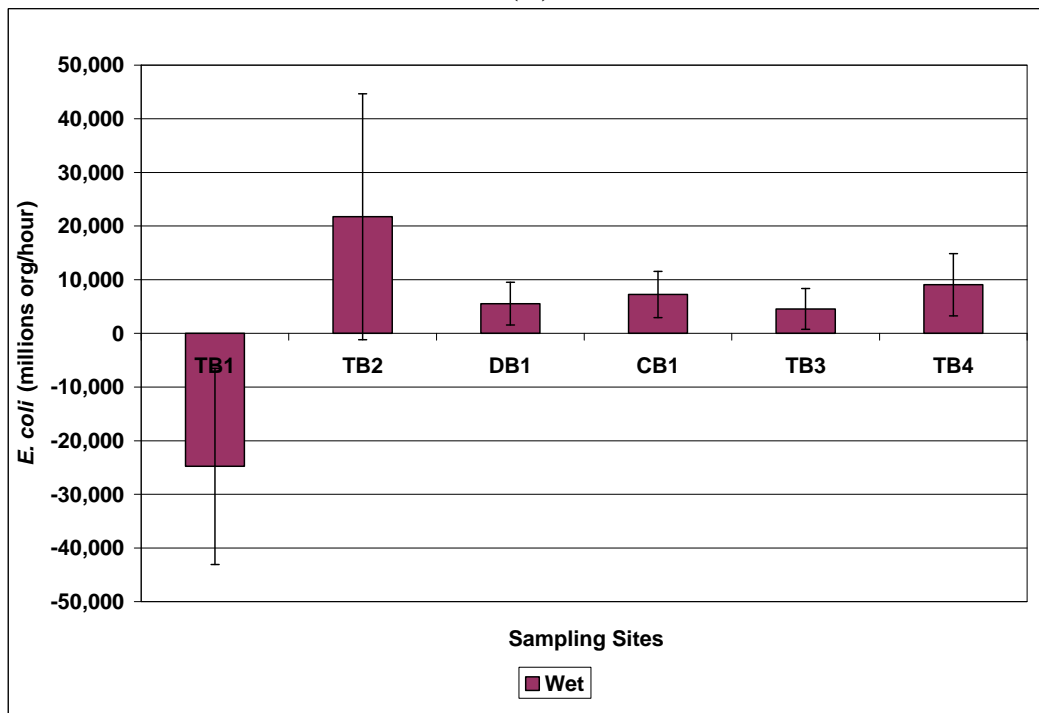
*E. coli* loads were calculated in the same manner as TP and fecal coliform loads and were also compared between wet and dry events (Figures 21A-21B). *E. coli* loads were greater in six of the seven subwatersheds during wet sampling events (Figure 21B). This is the same pattern seen in the fecal coliform data (Figures 20A-20B). Only subwatershed TB1 had lower loadings during wet events (Figure 21B). The TB2 subwatershed, which has the highest loads of *E. coli* during wet weather, is a sink for *E. coli* during dry weather in the Tenakill Brook Watershed (Figure 21A). The suspected loss mechanisms for fecal coliform (e.g., assimilation and predation) would also reduce *E. coli* levels upstream of these locations.

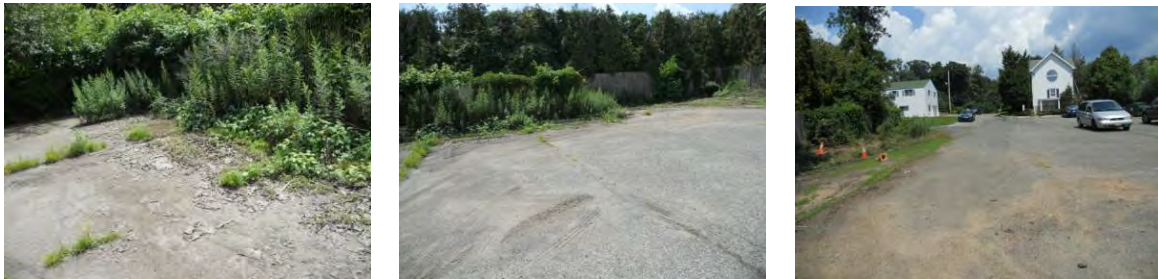
<b><u>Project Identifier</u></b>		<b><u>Geographic Coordinates</u></b>	
CB1_AI	a	N40° 56' 48.6"	W073° 55' 32"
<p><b><u>Site Description and BMP Implementation Opportunities:</u></b> The site is Sotheby's parking lot located near 99 Rionda Court. When replacing existing asphalt, pervious pavement should be considered.</p>

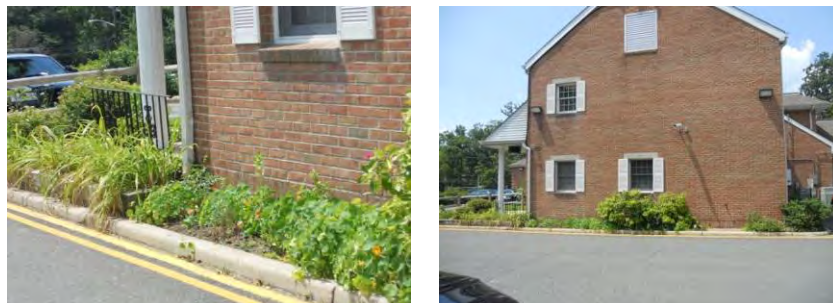
<b><u>Project Identifier</u></b>		<b><u>Geographic Coordinates</u></b>	
CB1_AI	b	N40° 56' 54.7"	W073° 55' 43.6"
<p><b><u>Site Description and BMP Implementation Opportunities:</u></b> The site is Alpine Borough Hall, located near 2 School House Lane. The site has a large building which should be disconnected from adjacent impervious surfaces via rain barrels or rain gardens. Due to the public nature of this location, a rain barrel workshop would work well to demonstrate the importance of stormwater management and implementation of BMPs in improving watershed health.</p>

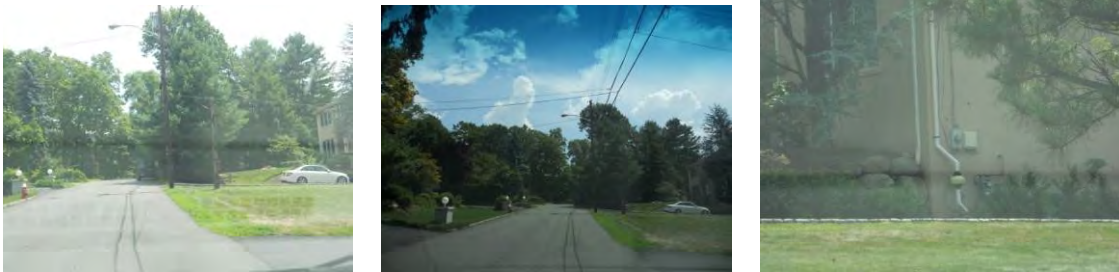
<b><u>Project Identifier</u></b>		<b><u>Geographic Coordinates</u></b>	
DB1_AI	b	N40° 57' 22.4"	W073° 55' 25"
<p><b><u>Site Description and BMP Implementation Opportunities:</u></b> The site is a residential neighborhood of large homes nearest to Schaffer Road. BMP opportunities include downspout disconnection by residential involvement and their use of rain barrels or onsite rain gardens. Homeowners should be offered an educational workshop addressing the importance and benefits of stormwater management and BMP implementation, such as <i>Stormwater Management in Your Backyard</i> and/or <i>Streamside Living</i>.</p>

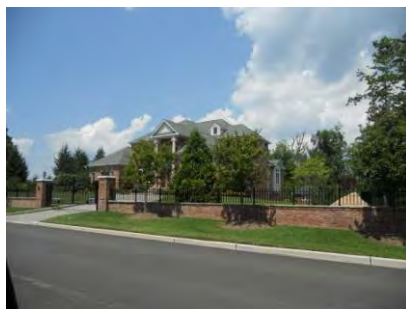
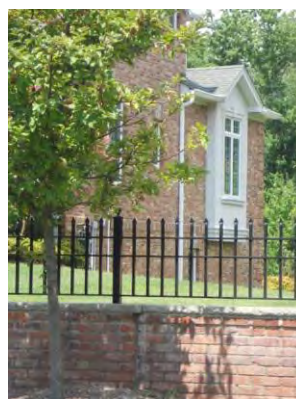
<u>Project Identifier</u>		<u>Geographic Coordinates</u>	
DB1_AI	c	N40° 57' 15.8"	W073° 55' 23.6"
<p><b>Site Description and BMP Implementation Opportunities:</b> The site is a residential neighborhood of large homes nearest to Audrey Urban Court. BMP opportunities include downspout disconnection to be done with residential involvement and use of rain barrels or onsite rain gardens. Homeowners should be offered an educational workshop addressing the importance and benefits of stormwater management and BMP implementation, such as <i>Stormwater Management in Your Backyard</i> and/or <i>Streamside Living</i>.</p>

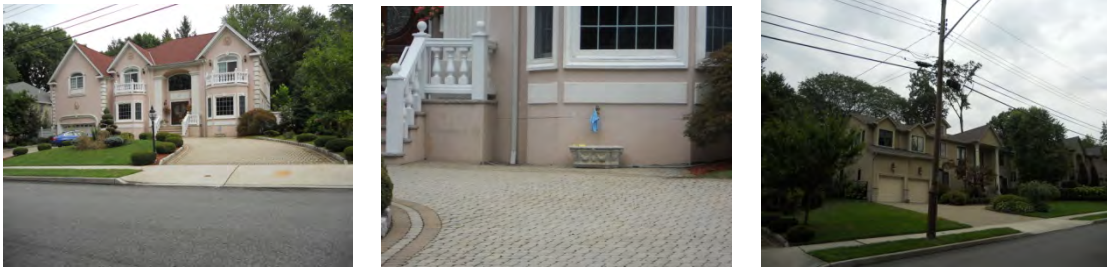
<b><u>Project Identifier</u></b>		<b><u>Geographic Coordinates</u></b>	
DB1_CI	a	N40°57'32.7"	W073°56'45.7"
<p><b><u>Site Description and BMP Implementation Opportunities:</u></b> The site is a residential block on Maplewood Road of about 18 homes. Homes are large with directly connected downspouts. BMPs such as rain barrels or rain gardens should be used to disconnect impervious cover from homes. Homeowners should be offered an educational workshop addressing the importance and benefits of stormwater management and BMP implementation, such as <i>Stormwater Management in Your Backyard</i> and/or <i>Streamside Living</i>.</p>

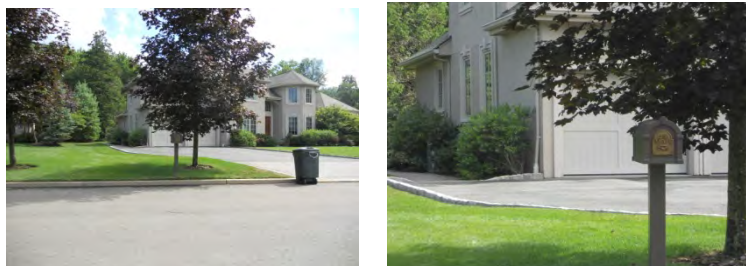
<b><u>Project Identifier</u></b>		<b><u>Geographic Coordinates</u></b>	
DB1_CI	b	N40°57'37.5"	W073°56'35.8"
<p><b><u>Site Description and BMP Implementation Opportunities:</u></b> The site is a residential block on Blackledge Court. Homes are large with directly connected downspouts and no sidewalks. Roadside vegetated swales and disconnection should be implemented at this site. Disconnection should be done via rain barrels or rain gardens. Homeowners should be offered an educational workshop addressing the importance and benefits of stormwater management and BMP implementation, such as <i>Stormwater Management in Your Backyard</i> and/or <i>Streamside Living</i>.</p>

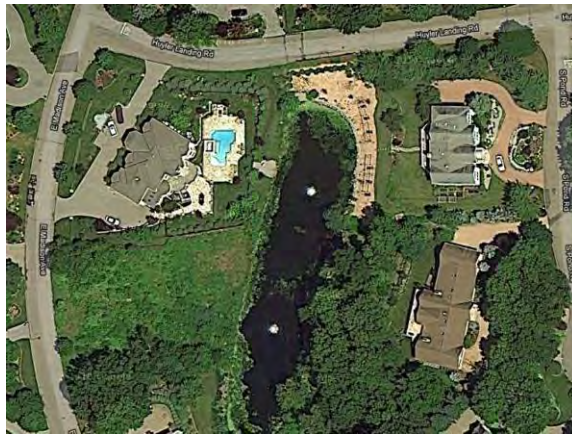
<b><u>Project Identifier</u></b>		<b><u>Geographic Coordinates</u></b>	
CB1_Cr	a	N40° 55' 57.35"	W73° 56' 45.42"
<p><b><u>Site Description and BMP Implementation Opportunities:</u></b> The site is a residential neighborhood with a pond nearest to Huyler Landing Road and South Pond Road, with a limited buffer. Most homes have directly connected impervious surfaces. Disconnection should be an effective BMP and should be done via rain barrels or rain gardens, depending on residential involvement and space availability. Homeowners should be offered an educational workshop demonstrating the importance and benefits of stormwater management and BMP implementation, such as <i>Stormwater Management in Your Backyard</i> and/or <i>Streamside Living</i>.</p>

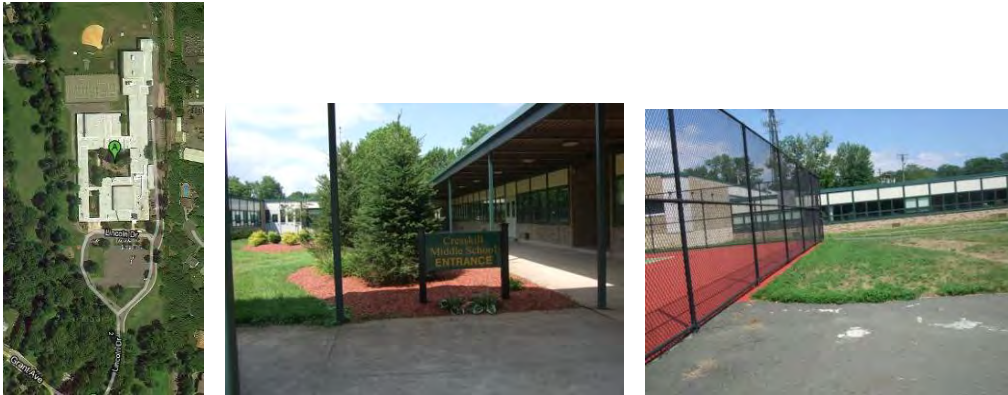
<b><u>Project Identifier</u></b>		<b><u>Geographic Coordinates</u></b>	
TB2_Cr	a	N40° 56'41.75"	W73° 57'51.04"
<p><b><u>Site Description and BMP Implementation Opportunities:</u></b> The site is Cresskill Middle and High School, located on 1 Lincoln Drive. The front parking lot should be retrofitted with pervious pavement. The storm drains in the parking lot discharge directly to the creek. The drain at the entrance of the middle school should be surrounded with a rain garden, using the existing drain as an overflow. Another rain garden should be implemented near the tennis court. The buffer near the creek should be enhanced. The performance of the basin in the back, near the tennis court, should be retrofitted to enhance its pollutant removal capabilities. The schools should be offered education workshops on the importance of stormwater management, such as <i>Stormwater Management in Your School Yard</i>.</p>

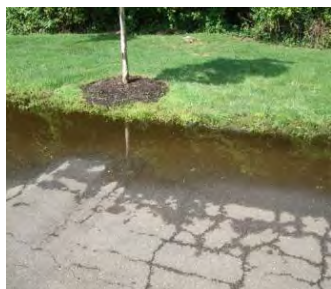
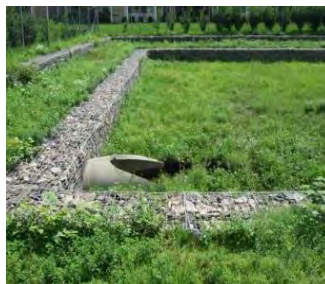
<u>Project Identifier</u>		<u>Geographic Coordinates</u>	
TB2_Cr	c	N040°56'17.08"	W073°57'46.422"
<p><b><u>Site Description and BMP Implementation Opportunities:</u></b> The site consists of condominiums and a senior living center. The stream behind the development has a high quality buffer. BMP recommendations for this site include disconnection of all downspouts by installing rain barrels and/or rain gardens. The parking lot is in average condition, with some potholes; when it is replaced, pervious pavement should be considered. Behind the senior living center, some flooding is occurring; a rain garden would help capture some of the stormwater. Residents of the community should be offered an educational workshop demonstrating the importance and benefits of stormwater management and BMP implementation, such as <i>Stormwater Management in Your Backyard</i> and/or <i>Streamside Living</i>.</p>

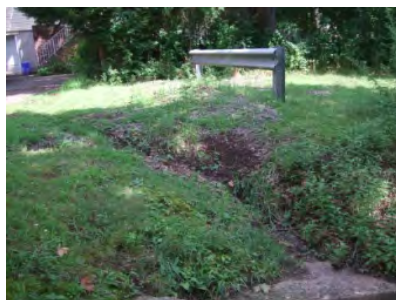
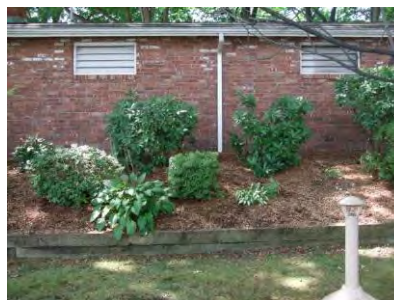
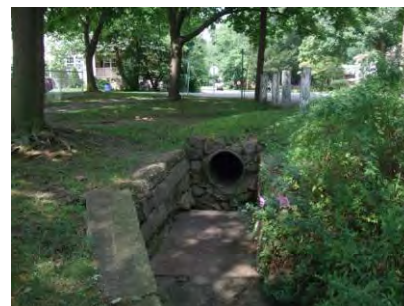
<u>Project Identifier</u>		<u>Geographic Coordinates</u>	
TB2_Cr	d	N040°56'19.1682"	W073°57'54.63"
<p><b><u>Site Description and BMP Implementation Opportunities:</u></b> The site is a recreational area, located off of 3<sup>rd</sup> Street that consists of a recreation center and a municipal pool. BMP opportunities include disconnection of downspouts on the Cresskill Club building and the Cresskill Municipal Pool facility. A rain garden site can be installed on the corner of Evergreen Avenue and 5<sup>th</sup> Street where erosion is occurring.</p>

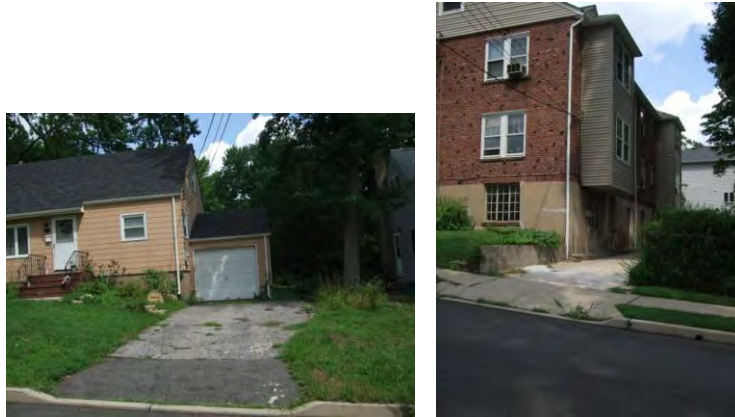
<u>Project Identifier</u>		<u>Geographic Coordinates</u>	
TB2_Cr	e	N040°56'23.0238"	W073°58'16.0602"
<b><u>Site Description and BMP Implementation Opportunities:</u></b> The site is a residential area, centered on Magnolia Avenue. The majority of the downspouts in this residential area are directly connected. BMP implementation includes disconnection of these downspouts via rain gardens and rain barrels.

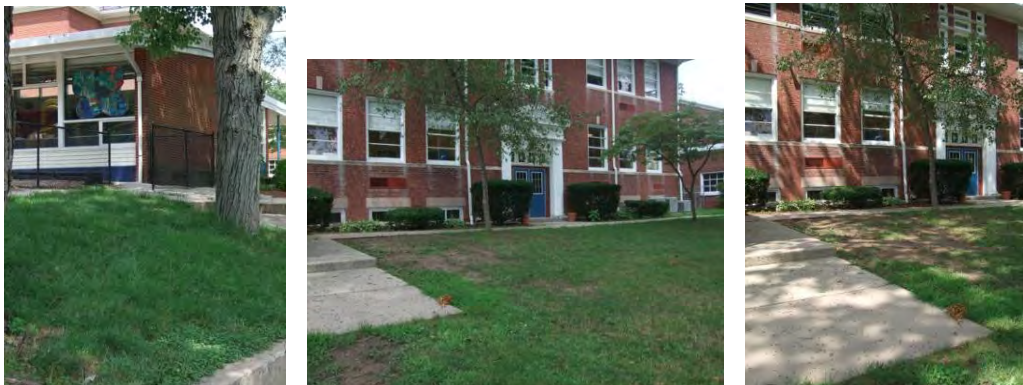
<u>Project Identifier</u>		<u>Geographic Coordinates</u>	
TB2_Cr	f	N040°56'51.4242"	W073°58'5.3904"
<b><u>Site Description and BMP Implementation Opportunities:</u></b> The site is the Edward H. Bryan School, located off of Brookside Avenue. The school is currently under construction, however opportunities for BMPs exist. There is a possible rain garden site in front of the school via downspout disconnection that would have to be routed underneath the sidewalk. The parking lot across the street from the school should be retrofitted with pervious pavement. Educational opportunities also exist (i.e., offer the <i>Stormwater Management in Your School Yard</i> curriculum to the school's students).

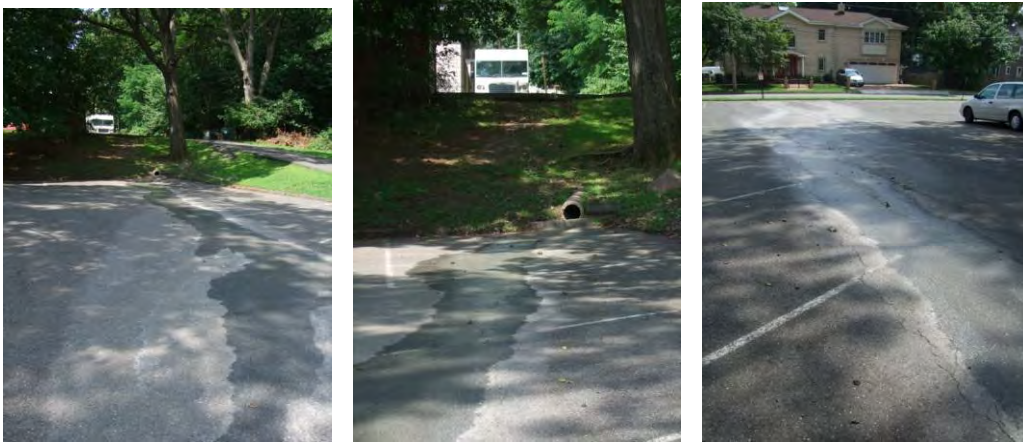
**Site Description and BMP Implementation Opportunities:** The site is the Saint Therese School, located off of Merrifield Way. The large parking lot behind the school has a culvert that currently empties onto it. Adding permeable pavement near the culvert could help capture some of the stormwater that is emptying into the parking lot. Educational opportunities also exist (i.e., offer *Stormwater Management in your Schoolyard* curriculum to the school's students).

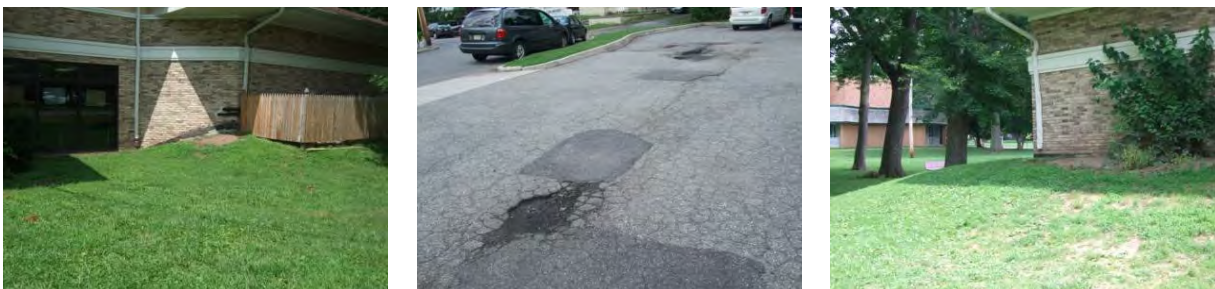
<u>Project Identifier</u>		<u>Geographic Coordinates</u>	
TB2_Cr	l	N040°56'32.1828"	W073°57'38.9484"
<b>Site Description and BMP Implementation Opportunities:</b> The site is Cresskill Library. The parking lot, with many potholes, could be replaced with permeable asphalt. Furthermore, there are plenty of possible rain garden locations. The rain garden would collect, treat, and infiltrate the stormwater from the rooftop of the building. Due to the public nature of the site, educational opportunities exist to demonstrate the importance of stormwater management via BMP implementation, such as <i>Stormwater Management in Your Backyard</i> and/or <i>Streamside Living</i> .

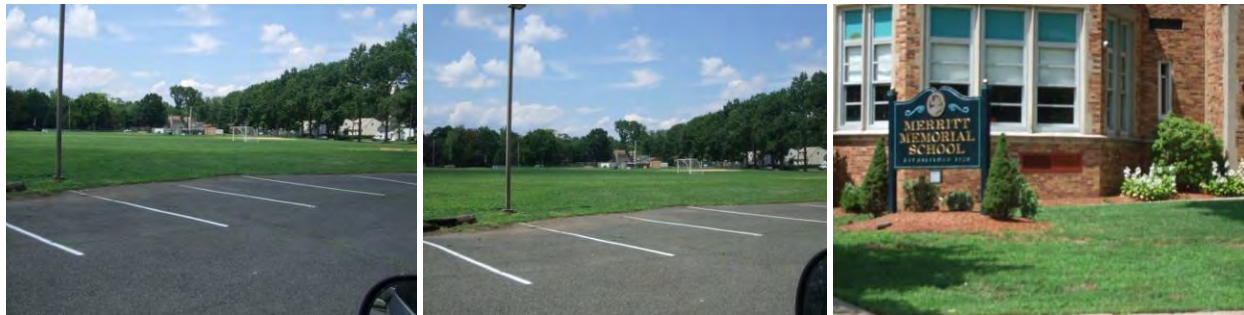
<u>Project Identifier</u>		<u>Geographic Coordinates</u>	
TB2_Cr	m	N040°56'33.9324"	W073°57'35.2404"
<p><b>Site Description and BMP Implementation Opportunities:</b> The site is the Merritt Memorial School located off of Margie Avenue. There is a possible rain garden site behind the school near a field. Educational workshops should be offered to the students and teachers discussing the importance of stormwater management and benefits of BMP implementation, such as the <i>Stormwater Management in Your School Yard</i> curriculum.</p>

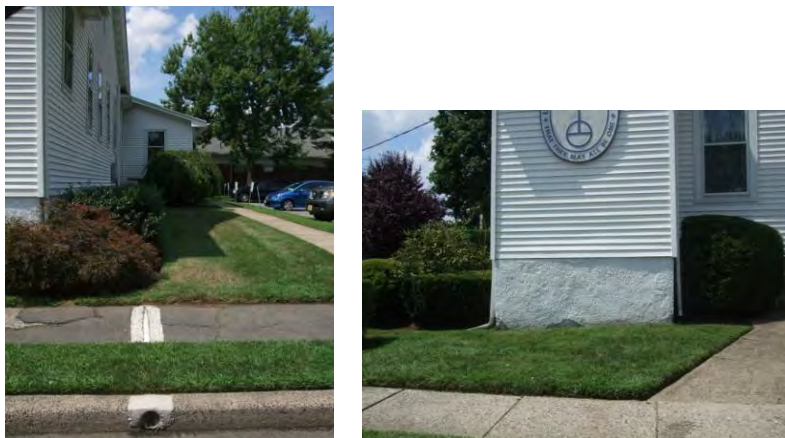
<u>Project Identifier</u>		<u>Geographic Coordinates</u>	
TB2_Cr	n	N040°56'30.9264"	W073°57'37.3284"
<p><b>Site Description and BMP Implementation Opportunities:</b> The site is the United Church of Christ, the Cresskill Congregational Church. The parking lot is in poor condition and should be replaced with pervious pavement. Another BMP opportunity is for a rain garden in the back of the church.</p>

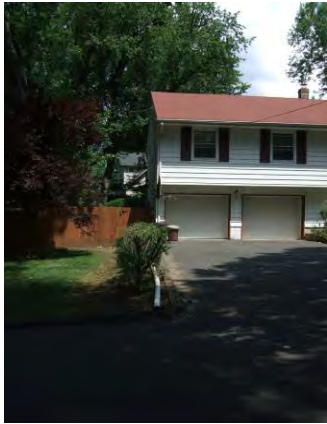
<u>Project Identifier</u>		<u>Geographic Coordinates</u>	
TB2_Cr	o	N040°56'39.1842"	W073°57'26.784"
<p><b>Site Description and BMP Implementation Opportunities:</b> This is a residential site, which includes streets such as Morningside Avenue, South Street, and Weil Place. Homes are directly connected. Disconnecting the downspouts via rain barrels and/or rain gardens is proposed. Educational workshops should be offered to homeowners discussing the importance of stormwater management and the benefits of BMP implementation, such as <i>Stormwater Management in Your Backyard</i> and/or <i>Streamside Living</i>.</p>

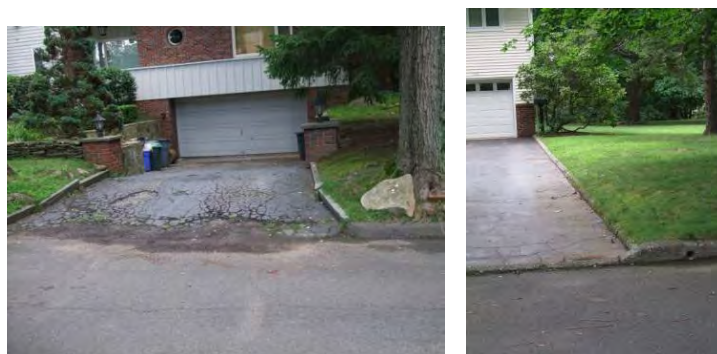
<u>Project Identifier</u>		<u>Geographic Coordinates</u>	
TB2_Cr	q	N040°56'12.2238"	W073°57'13.4568"
<p><b>Site Description and BMP Implementation Opportunities:</b> This is a residential site, which centers on Oak Street. A sloped down driveway on Oak Street offers opportunity for pervious pavement. The majority of homes are directly connected and should be disconnected via rain barrels and/or rain gardens. Oak Street offers an opportunity for a residential green street. Educational workshops should be offered to homeowners discussing the importance of stormwater management and the benefits of BMP implementation, such as <i>Stormwater Management in Your Backyard</i> and/or <i>Streamside Living</i>.</p>

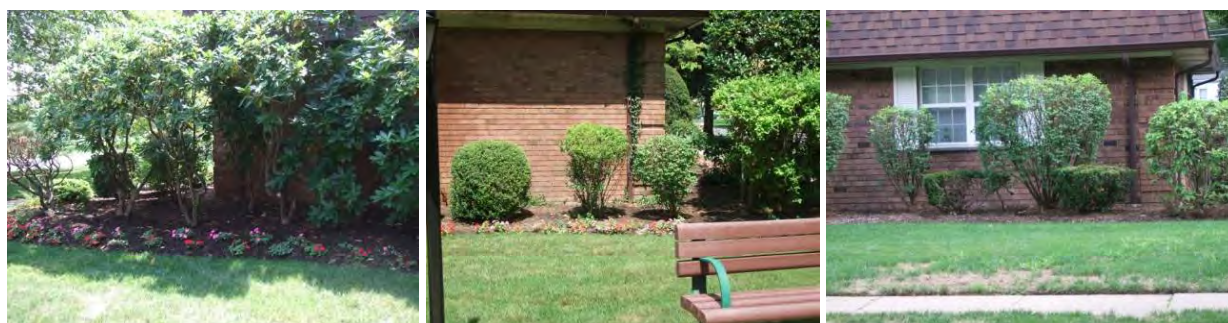
<u>Project Identifier</u>		<u>Geographic Coordinates</u>	
TB2_Cr	r	N040°56'41.9856"	W073°57'43.9704"
<p><b>Site Description and BMP Implementation Opportunities:</b> This is a residential site, called the Brentwood Manors, with a series of townhouses. There is a possible rain garden site in the center of the courtyard that would collect runoff from the rooftops of the buildings. Another opportunity for a BMP exists between two residential townhouses; by extending the landscaping, a mirroring rain garden could be implemented around an existing park bench. Educational workshops for residents discussing the importance of stormwater management and the benefits of BMP implementation should be offered, such as <i>Stormwater Management in Your Backyard</i> and/or <i>Streamside Living</i>.</p>

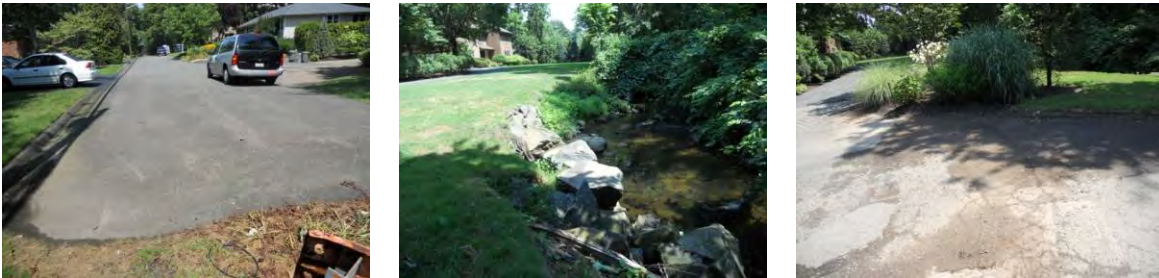
**Site Description and BMP Implementation Opportunities:** This site is located within a residential area. The brook is accessible from a location near Sunset Road. Residential lawns contain little to no buffers. The street is adjacent to the brook and little buffer exists. Pervious pavement at end of street could be implemented to limit water flow into the stream along with buffer enhancement. Currently a concrete bank exists along the waterway to prevent erosion; this could be replaced with vegetation depending on the storm flow rates. Native vegetation and landscaping along the banks could be installed to prevent runoff and erosion. Also, homeowners should be offered educational workshops on the importance of stormwater management and implementation of BMPs along with streamside living workshops, such as *Stormwater Management in Your Backyard* and/or *Streamside Living*.

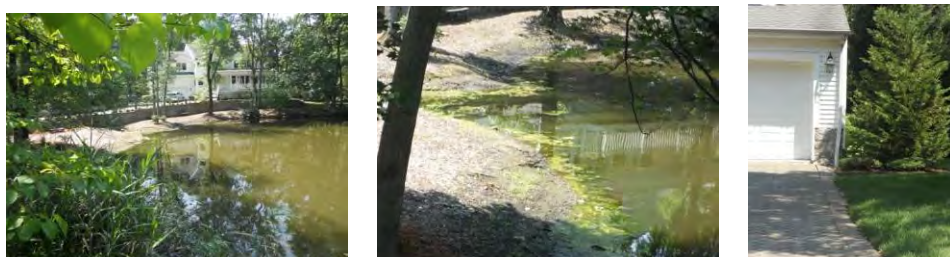
**Site Description and BMP Implementation Opportunities:** The site has a pond located at the end of Lauren Pond Court. The pond has algae on the surface and at the shoreline. Downspout disconnection should be completed with rain barrels or rain gardens. Rain gardens should be installed on residential lawns to receive runoff from the street where applicable. A vegetated buffer near the water's edge should be planted to filter out pollutants in runoff. Also, homeowners should be offered workshops on the effects of fertilizers and other materials and the importance of stormwater management and implementation of BMPs, such as *Stormwater Management in Your Backyard* and/or *Streamside Living*.

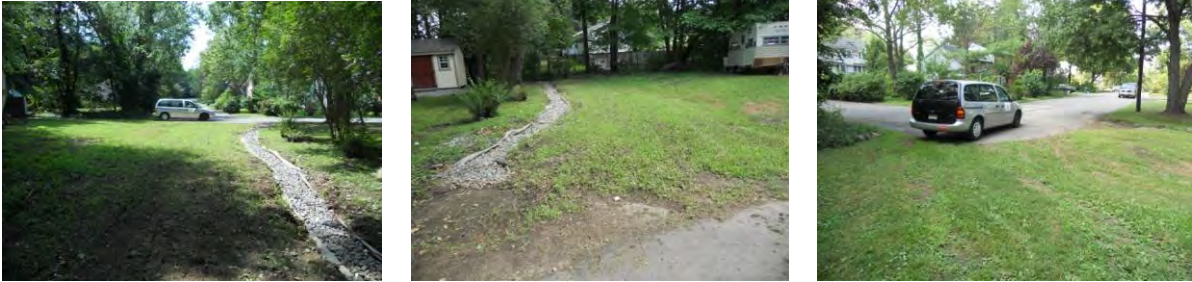
<u>Project Identifier</u>		<u>Geographic Coordinates</u>	
CB1_De	c	N40° 56' 35.8"	W073° 56' 51.8"
<p><b>Site Description and BMP Implementation Opportunities:</b> The site is the intersection of Glenwood and Cypress Roads. The lake is located north of Glenwood Avenue. Rain gardens should be installed on resident's property to capture runoff both from street and rooftops. Roadside swales also could be implemented where streets are without sidewalks, to capture road runoff, preventing sediments, fertilizers and other pollutants from reaching the lake. Also, homeowners should be offered educational workshops on the importance of stormwater management and implementation of BMPs, such as <i>Stormwater Management in Your Backyard</i> and/or <i>Streamside Living</i>.</p>

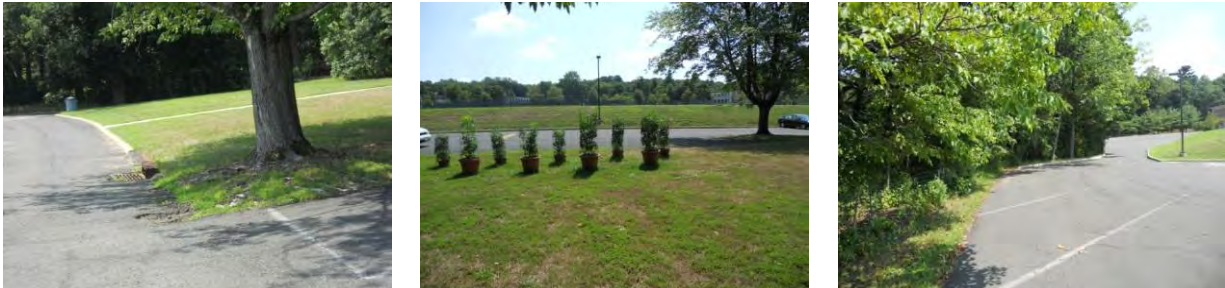
<u>Project Identifier</u>		<u>Geographic Coordinates</u>	
CB1_De	d	N40° 56' 37.4"	W073° 56' 47.8"
<p><b>Site Description and BMP Implementation Opportunities:</b> The site is the Academy of the Holy Angels School parking lot. The lot is adjacent to a lake (only 15 feet away) where little buffer currently exists. A rain garden off of the parking lot should be installed to collect runoff and infiltrate stormwater. Educational workshops should be presented to students on the importance of stormwater management and implementation of BMPs, such as <i>Stormwater Management in Your School Yard</i>.</p>

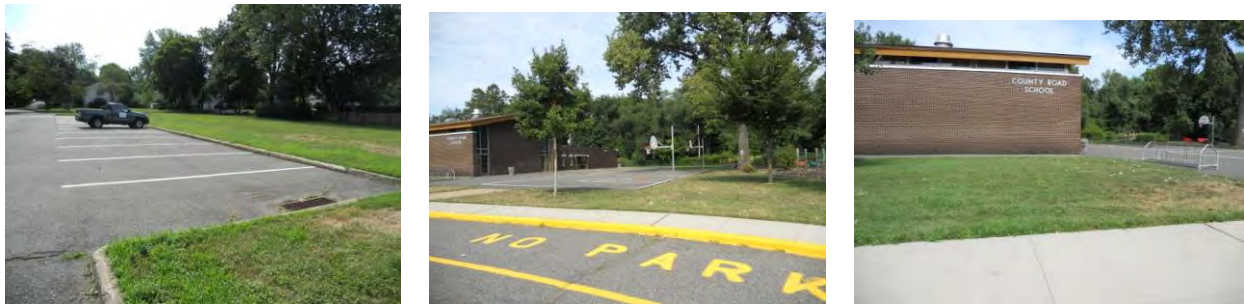
<b><u>Project Identifier</u></b>		<b><u>Geographic Coordinates</u></b>	
DB1_De	a	N40°57'06.3"	W073°57'17.4"
<p><b><u>Site Description and BMP Implementation Opportunities:</u></b> The site is County Road Elementary School, located at 69 Lake Road. The current standard asphalt parking lot and basketball courts could be retrofitted with pervious asphalt. A rain garden in front of the school between the entrance and the court should be installed to collect runoff from courts and rooftop. Students and teachers should be offered an educational workshop such as <i>Stormwater Management in your Schoolyard</i> to address the importance and benefits of stormwater management and BMP implementation.</p>

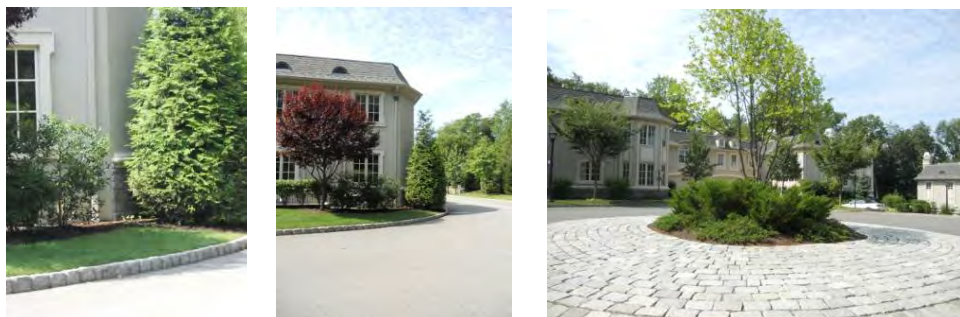
<b><u>Project Identifier</u></b>		<b><u>Geographic Coordinates</u></b>	
DB1_De	b	N40°57'08.3"	W073°56'40.4"
<p><b><u>Site Description and BMP Implementation Opportunities:</u></b> The site is Bellaire Townhouses, a residential housing complex, located at 386 Hardenburgh Avenue. Most of the housing unit's roofs are directly connected. The rooftops should be disconnected with rain gardens and/or rain barrels. The center court currently has pavers and shrubs that could be replaced with a rain garden. Homeowners should be offered an educational workshop addressing the importance and benefits of stormwater management and BMP implementation, such as <i>Stormwater Management in Your Backyard</i> and/or <i>Streamside Living</i>.</p>

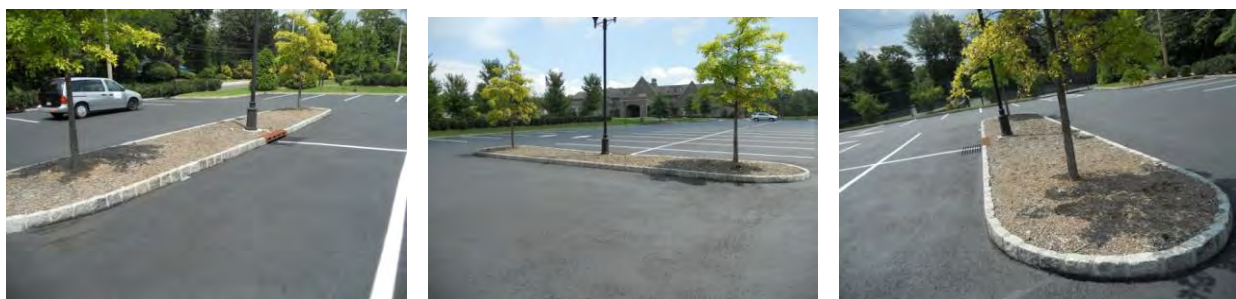
<u>Project Identifier</u>		<u>Geographic Coordinates</u>	
DB1_De	c	N40°57'10.4"	W073°56'7.3"
<b>Site Description and BMP Implementation Opportunities:</b> The site is Alpine Country Club located at 72 Anderson Avenue. The site consists mainly of a large parking area, about 25,000 square feet. Islands exist with storm drains, which could be retrofitted with Filterra™ planter boxes or standard rain gardens. Rain gardens may also be effective with curb cuts along edges of the parking lot. The most direct BMP for limiting stormwater runoff issues would be to replace a portion of the lot with pervious pavement.

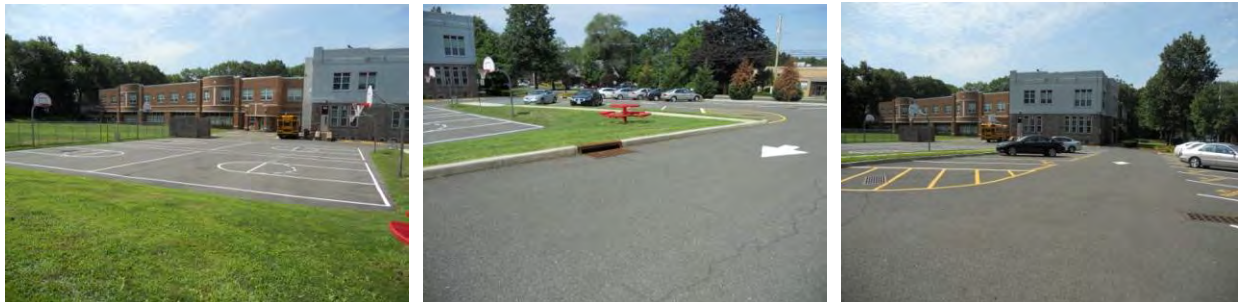
<b><u>Project Identifier</u></b>		<b><u>Geographic Coordinates</u></b>	
TB1_De	a	N40°57'34.4"	W073°57'34.8"
<p><b><u>Site Description and BMP Implementation Opportunities:</u></b> The site is Demarest Middle School, located at 27 Orchard Road. Opportunities for BMP implementation include pervious pavement on the basketball court and parking spots and the implementation of Filterra™ planter boxes for a storm drain near the basketball court. These BMPs would allow groundwater recharge, and the Filterra™ box would filter water before it enters the storm line. Educational workshops demonstrating the importance of stormwater management and BMP implementation should be offered to the school, such as the <i>Stormwater Management in Your School Yard</i> curriculum.</p>

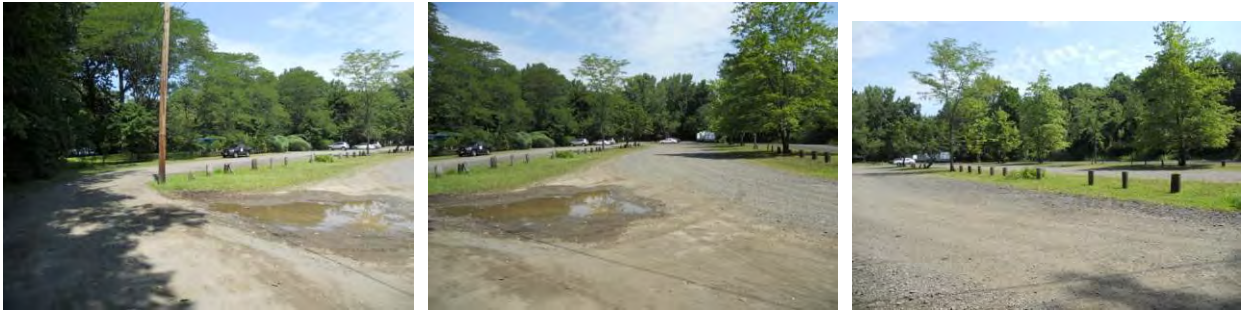
<u>Project Identifier</u>		<u>Geographic Coordinates</u>	
TB1_De	c	N40°57'48.6"	W073°57'50.6"
<p><b>Site Description and BMP Implementation Opportunities:</b> The site is Demarest Swim Club located at 98 Old County Court. The current parking lot is gravel with grassed islands. Existing conditions offer stormwater little chance to infiltrate due to the level of compaction of gravel areas where puddles are still present days after rainfall. The parking lot should be retrofitted with pervious pavement and rain gardens should be installed in the islands of the parking lot.</p>

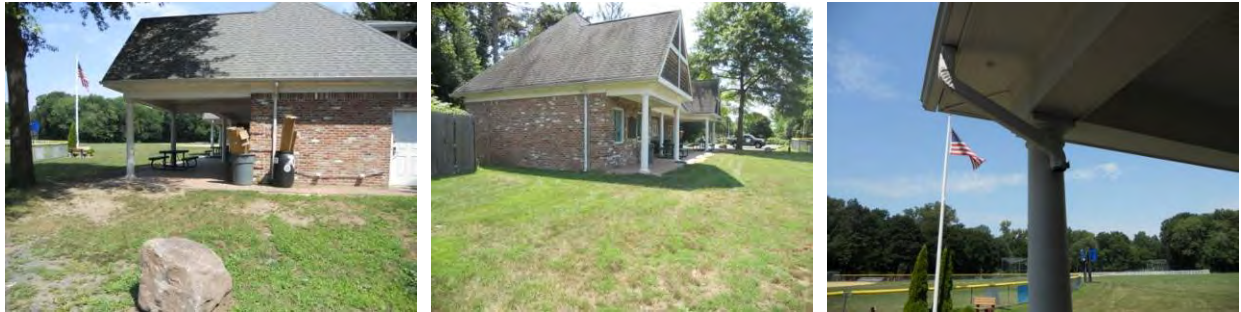
<u>Project Identifier</u>		<u>Geographic Coordinates</u>	
TB1_De	d	N40°57'34.4"	W073°57'48.9"
<p><b>Site Description and BMP Implementation Opportunities:</b> The site is a recreational park, Wakelee Field, located at 273 County Road. The site consists of multiple athletic fields and an associated building. The rooftop area of the building is approximately 2,000 square feet. A rain garden should be implemented to collect, treat, and infiltrate a portion of rooftop runoff. An informative sign near the garden would be beneficial to guests of the park.</p>

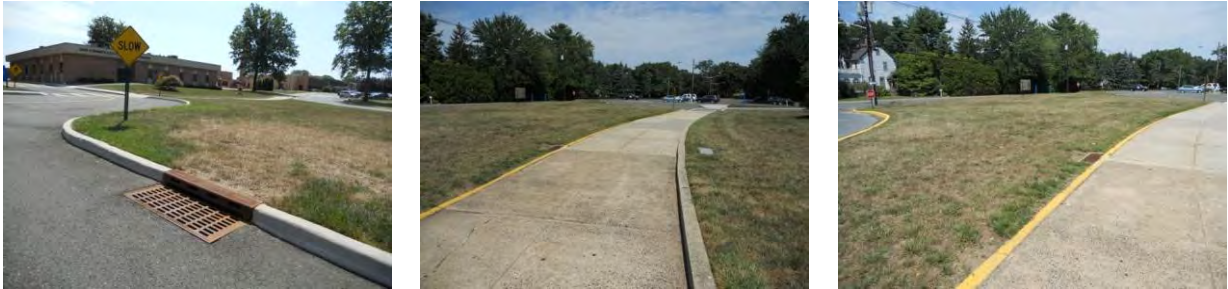
<u>Project Identifier</u>		<u>Geographic Coordinates</u>	
TB1_De	g	N40°57'29.7"	W073°58'26.8"
<p><b>Site Description and BMP Implementation Opportunities:</b> The site is the Northern Valley Regional High School located at 180 Knickerbocker Road. A rain garden should be implemented in front of the building in a grassed area, overflowing to the existing storm drain.</p>

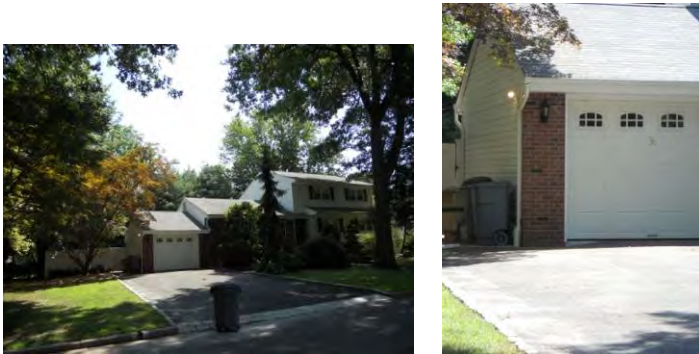
<u>Project Identifier</u>		<u>Geographic Coordinates</u>	
TB1_De	h	N40°57'29.7"	W073°58'20.8"
<p><b>Site Description and BMP Implementation Opportunities:</b> The site is a residential neighborhood consisting nearest to Prescott Street and Madison Avenue. Homes should be disconnected with rain barrels and/or rain gardens. Educational workshops should be offered to homeowners to illustrate the importance and benefits of stormwater management and BMP implementation, such as <i>Stormwater Management in Your Backyard</i> and/or <i>Streamside Living</i>.</p>

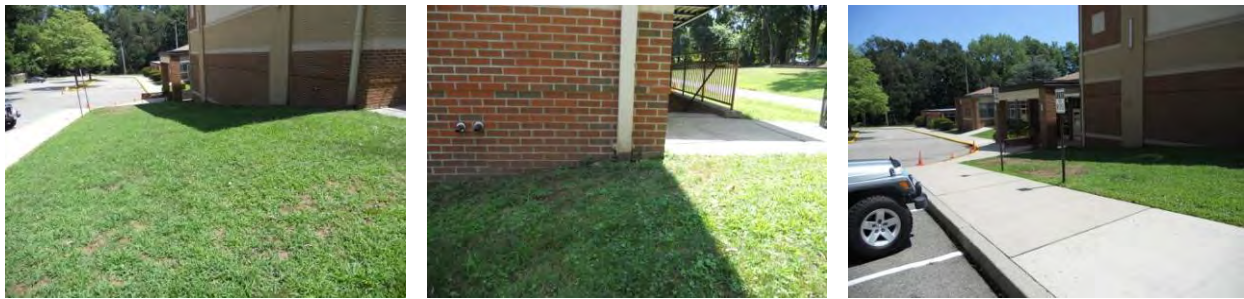
<b><u>Project Identifier</u></b>		<b><u>Geographic Coordinates</u></b>	
TB2_De	a	N40°57'21.8"	W073°58'19.4"
<p><b><u>Site Description and BMP Implementation Opportunities:</u></b> The site is the Luther Lee Elementary School located at 24 Prescott Street. The site has a large building that is directly connected. A sloped grassed area on the right side of the building offers an opportunity for terracing rain gardens with overflows into one another. Disconnecting the building with rain gardens and/or rain barrels should also be considered. Educational workshops should be offered to students and teachers discussing the importance of stormwater management and benefits of BMP implementation, such as <i>Stormwater Management in Your School Yard</i>.</p>

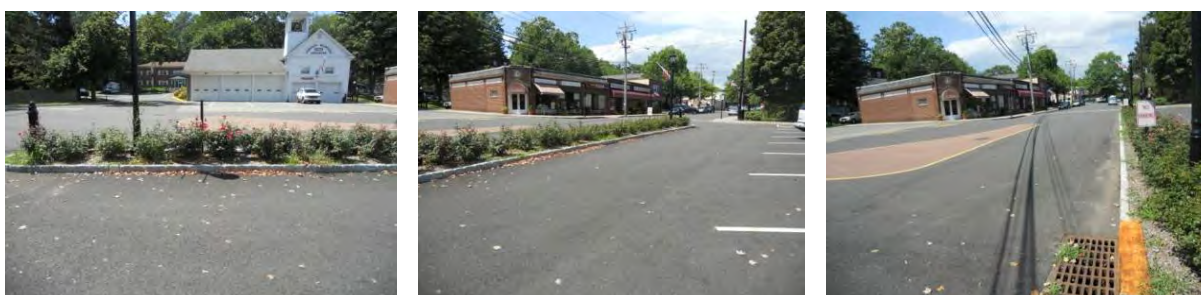
<u>Project Identifier</u>		<u>Geographic Coordinates</u>	
TB2_De	c	N40°57'22.7"	W073°57'48.2"
<p><b>Site Description and BMP Implementation Opportunities:</b> The site is located at 32 Park Street in front of the volunteer fire house. The current condition of the street is good, but a large area of impervious surfaces is present. The proposed BMP is the implementation of a green street. This should be comprised of pervious pavement and rain gardens. An informative sign should be installed to display to the community the importance of stormwater management and BMP implementation.</p>

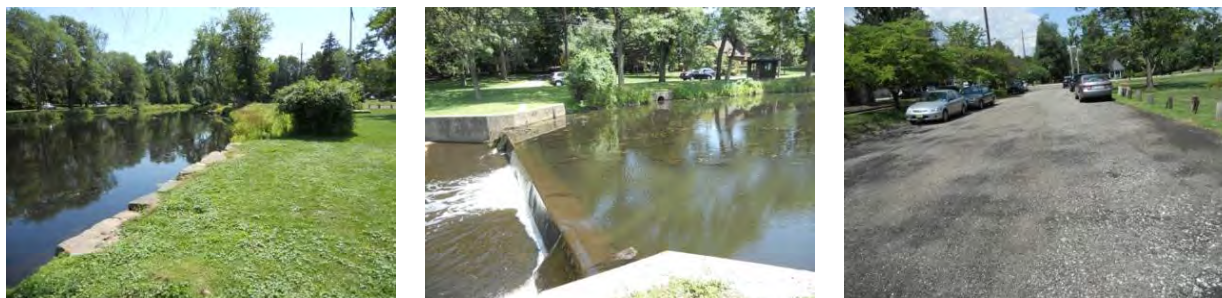
<u>Project Identifier</u>		<u>Geographic Coordinates</u>	
TB2_De	d	N40°57'23.6"	W073°57'48.3"
<p><b>Site Description and BMP Implementation Opportunities:</b> The site is Demarest Pond located off County Road. The site consists of a grassed area, parking area, and a large pond. The pond is in fair condition and has a buffer only along some areas around the pond. The buffer should be increased along more areas of the pond's shoreline to prevent runoff pollutants from entering the pond. The buffer will also prevent easy access for geese and droppings from entering the water. The nearby parking area should be retrofitted with pervious pavement; the area is approximately 10,000 square feet.</p>

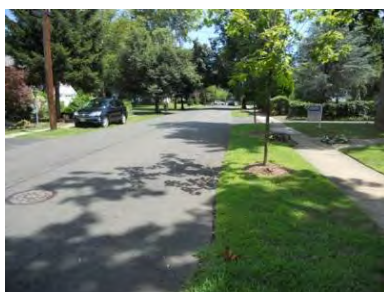
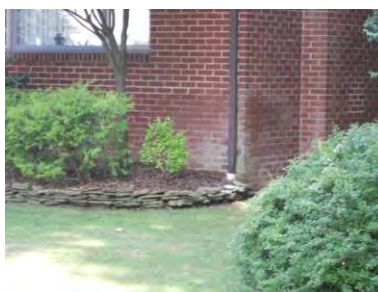
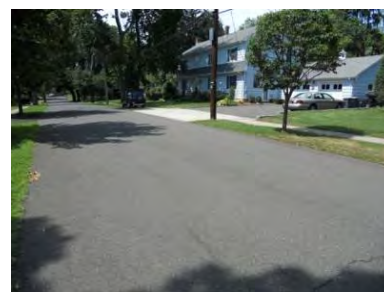
<u>Project Identifier</u>		<u>Geographic Coordinates</u>	
TB2_De	e	N40°57'21.7"	W073°57'28.9"
<b>Site Description and BMP Implementation Opportunities:</b> The site is a residential neighborhood nearest to 15 Central Avenue. The neighborhood has no curbs; roadside vegetated swales would be an effective BMP. In addition to disconnecting roadways, the rooftops of the homes should be disconnected as well via rain barrels and rain gardens. Homeowners should be offered educational workshops demonstrating the importance of stormwater management and BMP implementation, such as <i>Stormwater Management in Your Backyard</i> and/or <i>Streamside Living</i> .

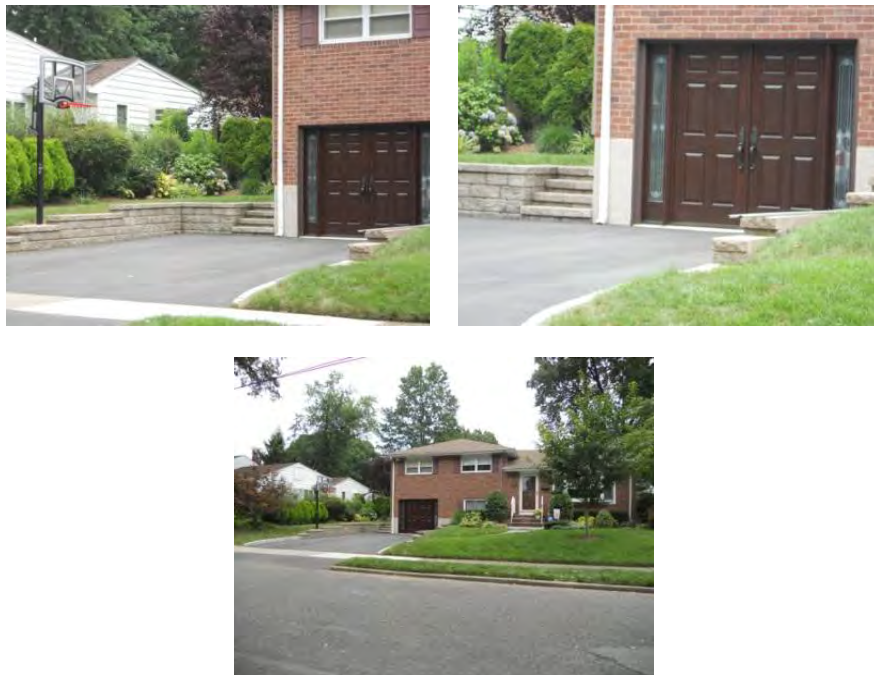
<b><u>Project Identifier</u></b>		<b><u>Geographic Coordinates</u></b>	
TB1_Du	a	N40°57'12.9"	W073°58'44.8"
<p><b><u>Site Description and BMP Implementation Opportunities:</u></b> The site is a residential neighborhood nearest to 79 Garfield Street. The site consists of homes that are directly connected. The main recommended BMP is downspout disconnection via rain barrels and/or rain gardens. Homeowners also should be offered educational workshops to demonstrate the importance and benefits of stormwater management and BMP implementation, such as <i>Stormwater Management in Your Backyard</i> and/or <i>Streamside Living</i>.</p>
