## **TENAKILL BROOK WATERSHED RESTORATION & PROTECTION PLAN**

Developed by the Rutgers Cooperative Extension Water Resources Program  
Funded by the New Jersey Department of Environmental Protection  
RP 07-001

January 22, 2013

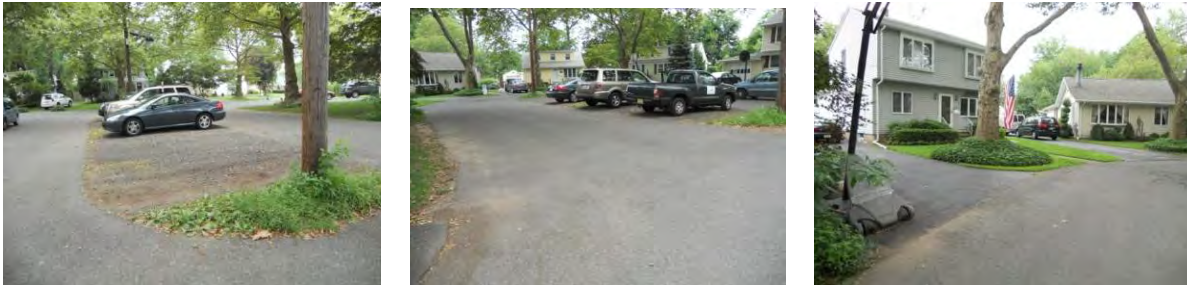
<b><u>Project Identifier</u></b>		<b><u>Geographic Coordinates</u></b>	
TB2_Du	a	N40°56'54.2"	W073°58'38.3"
<p><b><u>Site Description and BMP Implementation Opportunities:</u></b> The site is a residential cul-de-sac with a parking area in the center on Revere Drive. The parking area is approximately 2,000 square feet. Homes are directly connected. Rooftops should be disconnected by rain gardens and/or rain barrels. The roads can be disconnected by roadside rain gardens since no curbs or sidewalks exist. Pervious pavement in the parking area could be implemented to reduce stormwater volumes. Homeowners should be offered educational workshops demonstrating the importance of stormwater management and BMP implementation, such as <i>Stormwater Management in Your Backyard</i> and/or <i>Streamside Living</i>.</p>

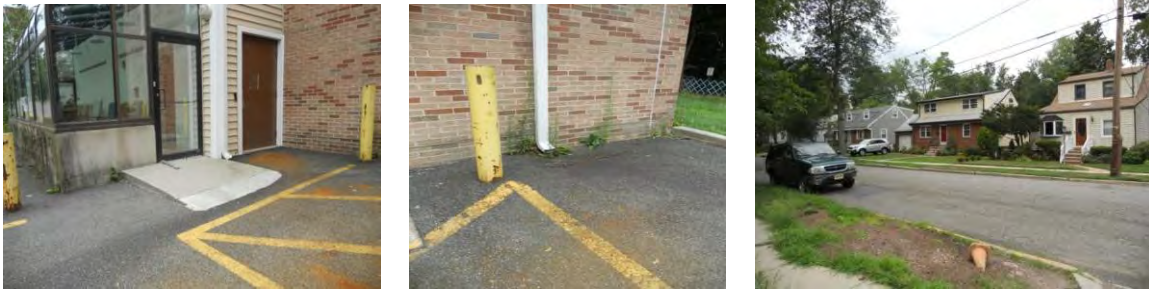
<b><u>Project Identifier</u></b>		<b><u>Geographic Coordinates</u></b>	
TB4_En	a	N40° 54'41.9"	W73° 58'35.3"
<p><b><u>Site Description and BMP Implementation Opportunities:</u></b> The site is a residential neighborhood nearest to Pleasant Avenue. The proposed BMP for this site includes downspout disconnection to limit the flow of stormwater reaching the roadway. Disconnection should be completed with residential involvement with rain barrel and/or rain garden installation programs. Homeowners should also be offered educational workshops addressing the importance of storm water management and BMP implementation, such as <i>Stormwater Management in Your Backyard</i> and/or <i>Streamside Living</i>.</p>

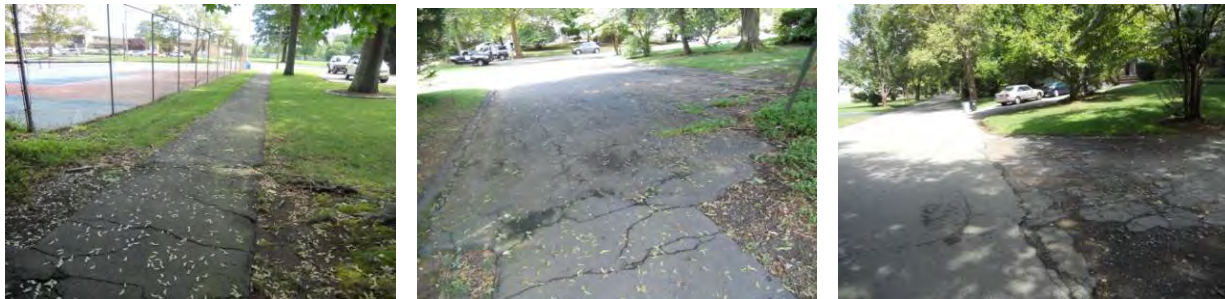
<b><u>Project Identifier</u></b>		<b><u>Geographic Coordinates</u></b>	
TB1_Ha	b	N40°57'44.3"	W073°58'32.2"
<p><b><u>Site Description and BMP Implementation Opportunities:</u></b> The site is located within a residential neighborhood nearest to an alley on Franklin Street. The current condition of the alley and sidewalk is very poor. The alleyway should be replaced with pervious pavement to promote infiltration and limit stormwater runoff to nearby water ways. Educational workshops should be offered to homeowners discussing the importance of stormwater management and benefits of BMP implementation, such as <i>Stormwater Management in Your Backyard</i> and/or <i>Streamside Living</i>.</p>

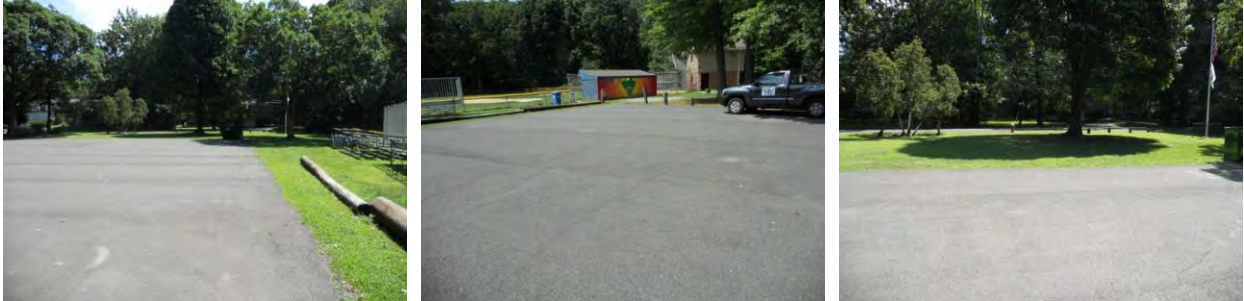
<u>Project Identifier</u>		<u>Geographic Coordinates</u>	
TB1_Ha	c	N40°57'51.5"	W073°58'50"

**Site Description and BMP Implementation Opportunities:** The site is Haworth Centennial Park located at 156 Delaware Street. The site consists of a parking lot of approximately 14,000 square feet. This lot could be retrofitted with pervious pavement and/or installation of rain gardens downgradient of the lot to collect, treat and infiltrate stormwater runoff. Informative signage should be installed to inform the community of actions and benefits of BMP implementation and hazards of stormwater runoff.

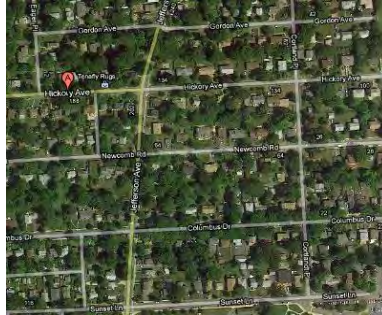
<b><u>Project Identifier</u></b>		<b><u>Geographic Coordinates</u></b>	
TB2_Te	a	N40° 55' 58.1916"	W073° 58' 8.4966"
<p><b><u>Site Description and BMP Implementation Opportunities:</u></b> The site is a residential neighborhood of about five streets and 100 homes on ¼ acres lots. About ¾ of the homes are directly connected. Rooftops should be disconnected by rain gardens and/or rain barrels. Roadside vegetated swales may be installed where no curbs or sidewalks exist. Homeowners should be offered an educational workshop demonstrating the importance and benefits of stormwater management and BMP implementation, such as <i>Stormwater Management in Your Backyard</i> and/or <i>Streamside Living</i>.</p>

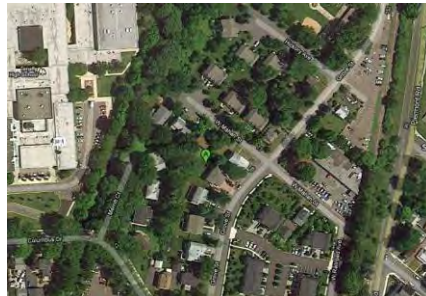
<b><u>Project Identifier</u></b>		<b><u>Geographic Coordinates</u></b>	
TB2_Te	b	N 40° 55' 55.7688"	W073° 57' 52.6212"
<p><b><u>Site Description and BMP Implementation Opportunities:</u></b> The site is a residential neighborhood of about 10 acres, including an auto shop on West Manhattan Street. BMP opportunities at the auto shop include disconnection of downspouts and implementation of pervious pavement in locations such as parking spots. Homeowners should be offered an educational workshop demonstrating the importance and benefits of stormwater management and BMP implementation, such as <i>Stormwater Management in Your Backyard</i> and/or <i>Streamside Living</i>.</p>

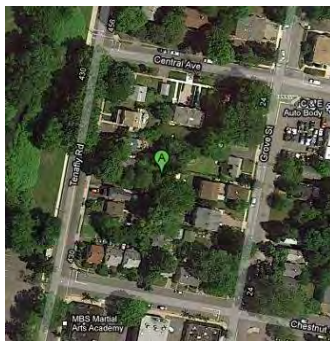
<u>Project Identifier</u>		<u>Geographic Coordinates</u>	
TB2_Te	d	N0 40° 55' 42.0384"	W073° 57' 57.2358"
<p><b>Site Description and BMP Implementation Opportunities:</b> The site is a residential block consisting of Tenafly Road, Central Avenue, and Grove and Chestnut Streets. The site has about 25 houses on ¼ acre lots with many of the homes directly connected. Disconnection of the homes should be completed by using rain barrels and/or rain gardens. Homeowners should be offered educational workshops demonstrating the benefits of stormwater management and BMP implementation, such as <i>Stormwater Management in Your Backyard</i> and/or <i>Streamside Living</i>.</p>

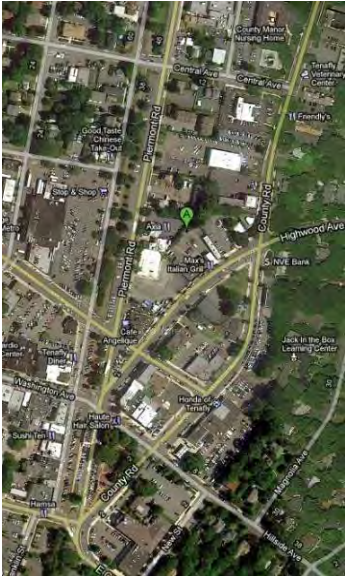
<u>Project Identifier</u>		<u>Geographic Coordinates</u>	
TB2_Te	e	N40° 55' 37.50"	W73° 57' 48.91"

**Site Description and BMP Implementation Opportunities:** The site is a commercial, downtown area located off Piermont Road, from West Mahan Street south to West Clinton Ave. Near the south end of the site, at intersection of West and East Clinton Avenue is Our Lady of Mount Carmel Church. At the church, BMP implementation suggestions include downspout disconnection and use of rain barrels. Near the downtown portion of the site, pervious pavement should be considered at the walkway along the railroad tracks, parking areas along railroad, the Tenafly Music Academy, and the back lot of Tenafly Pet Supply and O2 Fitness club. Also, rain gardens could be installed around the CVS parking lot.

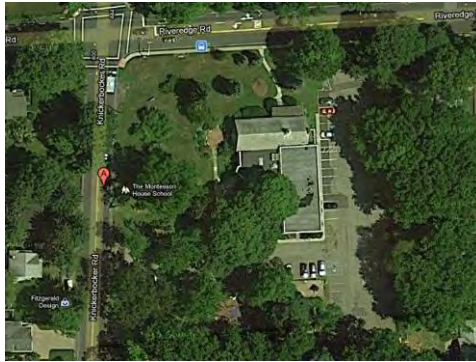
<b><u>Project Identifier</u></b>		<b><u>Geographic Coordinates</u></b>	
TB4_Te	a	N40° 55'30.03"	W73° 58'8.92"
<p><b><u>Site Description and BMP Implementation Opportunities:</u></b> The site is Tenafly Montessori Academy, located at 426 Knickerbocker Road. The BMP for the site includes a rain garden in front of the building to disconnect the impervious cover and promote groundwater recharge. The existing driveway could be replaced with pervious pavement. Additionally, educational workshops addressing the importance of stormwater management should be offered, such as <i>Stormwater Management in Your School Yard</i>.</p>

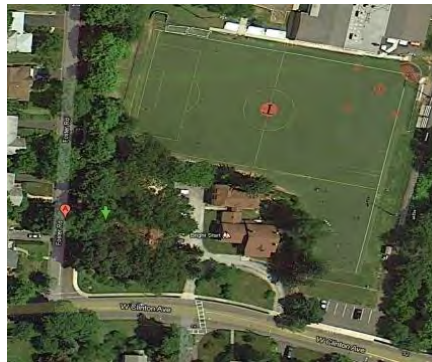
<b><u>Project Identifier</u></b>		<b><u>Geographic Coordinates</u></b>	
TB4_Te	b	N40° 55'30.85"	W73° 58'12.32"
<p><b><u>Site Description and BMP Implementation Opportunities:</u></b> The site is a recreation area, Froggy Playground. Native vegetation should be added to the slope along the sidewalk to prevent erosion on the site, and in turn preventing sediment from entering waterways.</p>

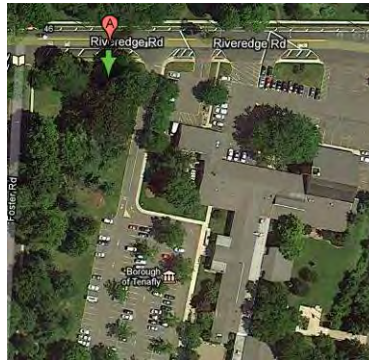
<u>Project Identifier</u>		<u>Geographic Coordinates</u>	
TB4_Te	c	N40° 55'39.08"	W73° 58'10.54"
<p><b>Site Description and BMP Implementation Opportunities:</b> The site is at the Tenaflly Municipal Court, Borough Hall, Library, and Youth Center. The Brook is located behind the library, and there is debris and oil in the Brook. The rooftop of Borough Hall could be disconnected with a rain garden near its entrance. Rain barrels could be installed at the Youth Center. Educational workshops should be offered addressing the importance of stormwater management and BMP implementation.</p>

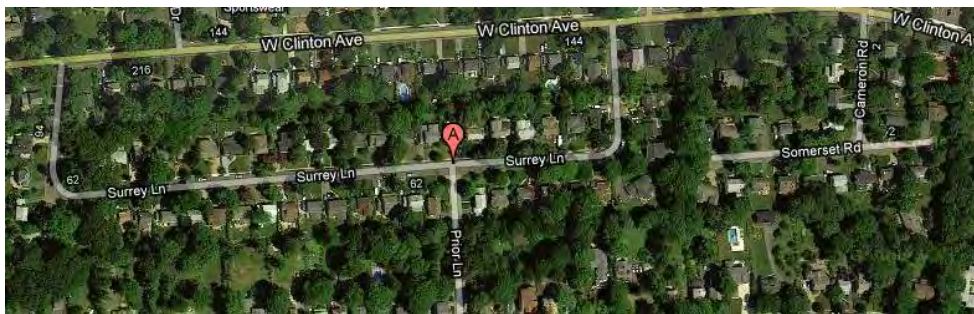
<u>Project Identifier</u>		<u>Geographic Coordinates</u>	
TB4_Te	d	N40° 55'27.10"	W73° 58'10.3"
<p><b>Site Description and BMP Implementation Opportunities:</b> The site is a residential neighborhood consisting of 4 streets, including Prior Lane and Somerset Road, and about 70 homes on ¼ acre lots. About 69% of homes are directly connected. Rooftops should be disconnected by residential rain gardens and/or rain barrels. Homeowners should be offered educational workshops addressing the importance of stormwater management and BMP implementation, such as <i>Stormwater Management in Your Backyard</i> and/or <i>Streamside Living</i>.</p>

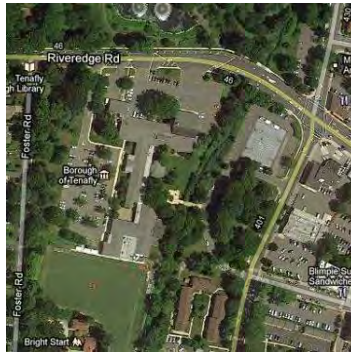
<u>Project Identifier</u>		<u>Geographic Coordinates</u>	
TB4_Te	g	N40° 55'37.76"	W73° 58'00.29"
<p><b>Site Description and BMP Implementation Opportunities:</b> The site is Tenaflly Municipal Parking Lot located nearest Riveredge and Tenaflly Roads. BMPs for this site include installation of curb cuts and rain gardens down gradient of the lot and replacing existing asphalt on basketball court with pervious pavement. Informative signage should be installed on site to illustrate to the community the importance of stormwater management and BMP implementation.</p>

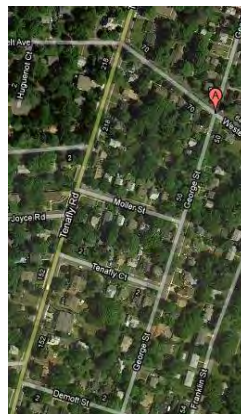
<u>Project Identifier</u>		<u>Geographic Coordinates</u>	
TB4_Te	h	N40° 55' 9.8646"	W73° 58'8.4174"
<p><b>Site Description and BMP Implementation Opportunities:</b> The site is a residential neighborhood consisting of 6 streets, including Westevelt Road and Moller Street, and about 120 homes on ¼ acre lots. About 61% of homes are directly connected and should be disconnected by residential rain gardens and/or rain barrels. Homeowners should be offered educational workshops addressing the importance of stormwater management and BMP implementation, such as <i>Stormwater Management in Your Backyard</i> and/or <i>Streamside Living</i>.</p>

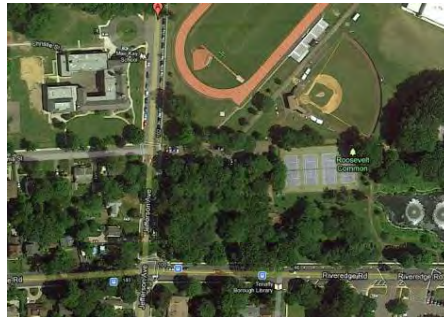
**Site Photos:**

<b><u>Project Identifier</u></b>		<b><u>Geographic Coordinates</u></b>	
TB6_Te	a		
<p><b><u>Site Description and BMP Implementation Opportunities:</u></b> The site is Roosevelt Commons and Mac Kay School. The location consists of a large lake that had a vegetated buffer planted in 2009 to increase water quality. Posted around the lake is “Water Quality &amp; Habitat Enhancement Project. No Mow Zone.” The Mac Kay School has opportunities for BMPs, including downspout disconnection, pervious pavement, and rain gardens at two locations, one around the catch basin and one in front of the school. Educational workshops on the importance of stormwater management BMPs should be presented to the school, such as <i>Stormwater Management in Your School Yard</i>.</p>

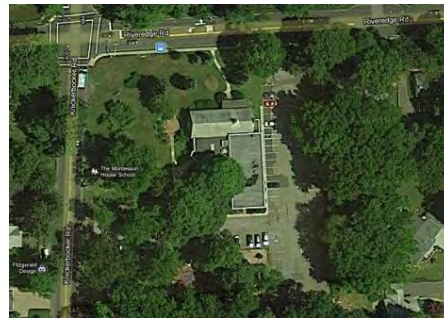
**Site Photos:**

<b><u>Project Identifier</u></b>		<b><u>Geographic Coordinates</u></b>	
TB6_Te	b		
<p><b><u>Site Description and BMP Implementation Opportunities:</u></b> The site is The Montessori House School, located at the intersection of Riveredge and Kinckerbocker Roads. The large parking lot could be replaced with pervious pavement. Existing downspouts should be disconnected by using rain barrels and/or rain gardens. Educational workshops on the importance of stormwater management for the health of water bodies should be presented to the school, such as the <i>Stormwater Management in Your School Yard</i> curriculum.</p>

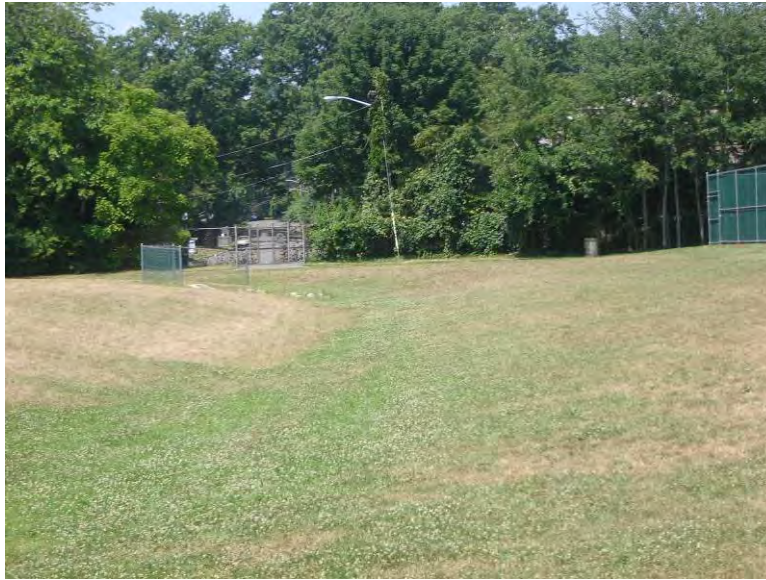
**Figure 2: Photograph of swale to be vegetated.**

Figure 2: Photograph of swale to be vegetated.

<p><u>Existing Conditions:</u> The drainage swale and detention basin are located behind Tenaflly High School near the athletic fields. Athletic fields and parks attract large populations of Canada geese. The drainage swale discharges into a detention basin and both of these structures manage the stormwater runoff from all the athletic fields. The drainage area for this stormwater management system is approximately 16.25 acres of fields. The vegetation in the drainage swale and detention basin currently consists solely of turfgrass. The existing stormwater management system is not sufficient to treat runoff from the athletic fields. Studies have shown that detention basins alone do not remove pollutants from stormwater runoff very well and only reduce the quantity of stormwater. Considering the system's potential for poor removal of pollutants and the drainage area includes known areas with Canada goose waste, this site is a source of bacteria in the Tenakill Brook Watershed that needs to be mitigated.</p>

<p><u>Proposed Solutions:</u> The Water Resources Program proposes a two part solution for the Tenaflly High School athletic fields.</p> <p>The first part is re-vegetating the detention basin and swale. Clusters of turfgrass will be replaced with native warm season grasses, herbaceous plants, sedges, ferns and a minimum amount of woody vegetation. Over time, this new vegetation will expand past the boundaries of the initially-planted clusters to cover the entire basin and swale. The new vegetation will increase the infiltration capacity of the detention basin. The basin will not need to be mowed on a weekly basis, as it is now. The vegetation should be allowed to grow tall to increase its ability to filter nutrients and sediment out of stormwater runoff. The tall vegetation will have a deeper and more complex root structure allowing the basin to infiltrate greater amounts of water during each storm event.</p> <p>The second part of the solution is to create a small berm or series of berms that surround the outlet of the basin. The berm(s) would only be about 1 foot high and composed of a permeable material, such as coconut fiber logs or ¾ inch clean stone secured with fabric. The purpose of the berm(s) is to increase the amount of time stormwater is retained in the basin. The berm(s) would constrict the flow of runoff for small but frequent storms while not interfering with the basin's ability to prevent flooding for larger storms because larger flows of runoff would flow over the berm(s).</p>

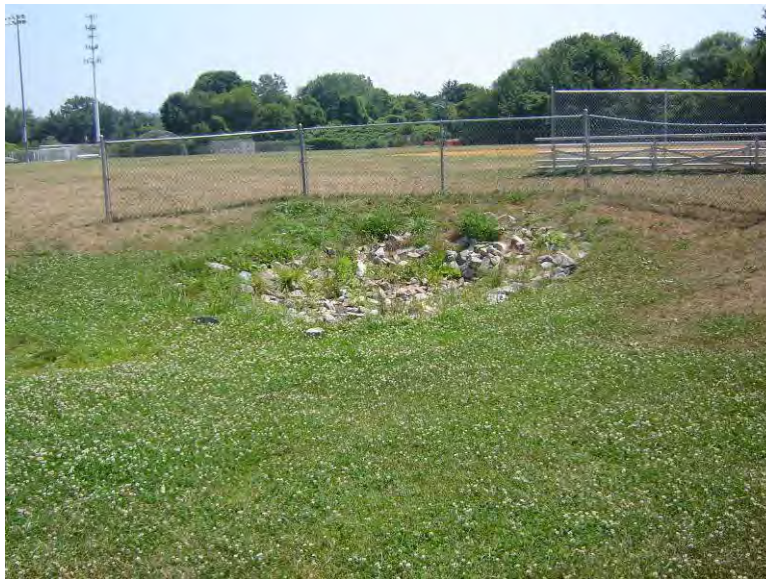
**Figure 3: Photograph of swale inlet to undergo a retrofit.**

Figure 3: Photograph of swale inlet to undergo a retrofit.

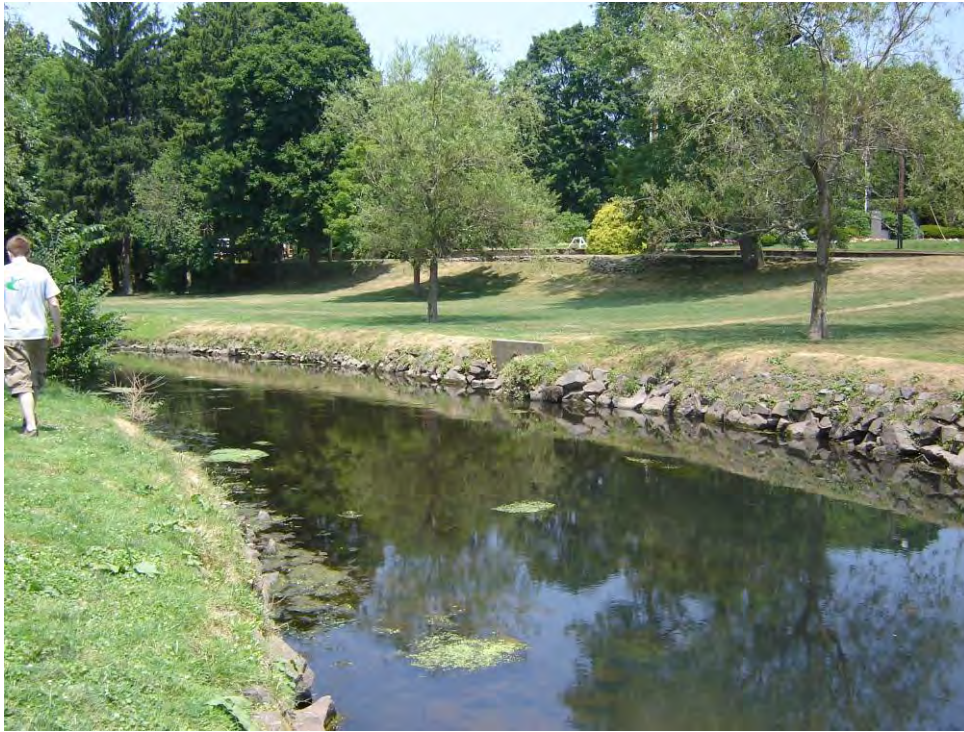
**Figure 2: Portion of Demarest Pond unprotected by buffers (facing downstream).**

Figure 2: Portion of Demarest Pond unprotected by buffers (facing downstream).

<p><u>Existing Conditions:</u> Demarest Pond Park is approximately 7.8 acres. About half of the pond is surrounded by a buffer. There is approximately 1,280 linear feet of unprotected shoreline. The park is mostly comprised of turf grass with the exception of some trees and a few shrubs. On each side of the pond, the landscape gently slopes towards the pond. The park provides a great feeding ground for Canada geese. Canada geese can always be found at the park, as well as goose waste throughout the park. This goose waste is one of the sources of bacteria found in the Tenakill Brook Watershed. Goose waste can stay on the ground for several weeks. Stormwater runoff gathers bacteria from the waste on the surface and carries it to the pond. The park also provides many access points for the geese to enter the water due to the lack of a vegetated buffer in spots surrounding Demarest Pond making the park even more attractive to the geese.</p>

<p><u>Proposed Solutions:</u> The purpose of the proposed project is to turn an appealing site for geese into an undesirable one. If the Canada geese do not find the site appealing they will not visit the site, therefore, the site stops being a source of bacteria to the watershed. The geese are drawn to parks for a few reasons: turf grass provides an ample food supply; geese prefer sites that provide easy access to a waterway; geese feel safe at locations with no obstructions blocking their view from potential predators. All of these conditions exist at Demarest Pond Park.</p> <p>First, a geese deterrent service such as the 'Geese Police' should be hired to scare Canada geese from the site. A geese deterrent service brings dogs to locations at different times of the day and different days of the week. These random times prevent the geese from learning a pattern of when 'Geese Police' are at the site and when they are not. Over a period of time, the geese will learn not to visit the site anymore because of the geese deterrent system. This service can be expensive as a long term solution because the geese will always return to an appealing site to check for predators. Therefore, unless the features of the site change, the geese deterrent service will need to continue for the existence of the park.</p> <p>A 15 meter (~50 feet) vegetative buffer should be installed along the entire shoreline of Demarest Pond. The vegetative buffer should be comprised of warm season grasses and herbaceous plants. The vegetation in the buffer should be allowed to grow very tall. Ideally, the buffer should only be mowed once a year during the</p>

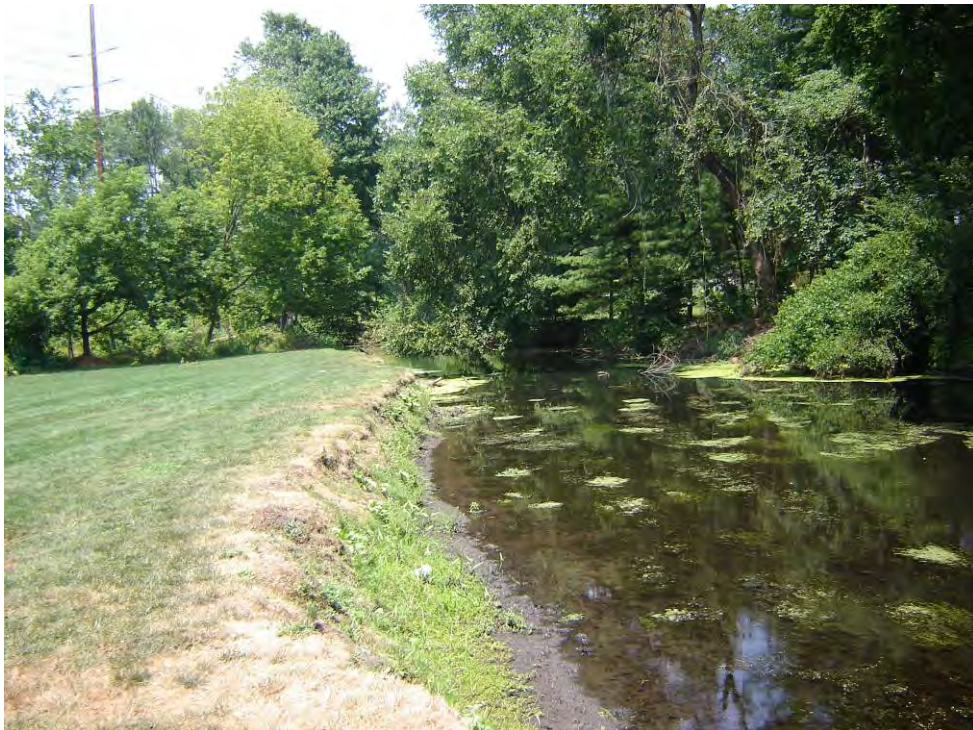
**Figure 3: Unprotected shoreline along Demarest Pond.**

Figure 3: Unprotected shoreline along Demarest Pond.

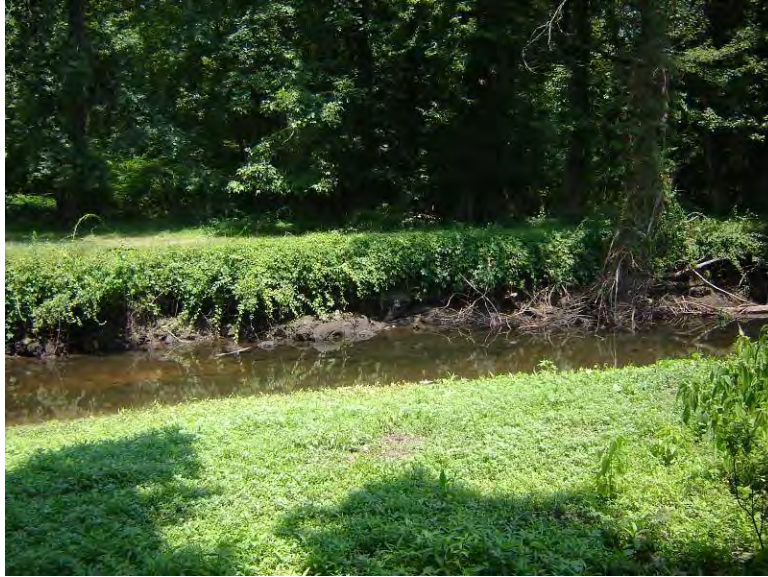
**Figure 2: Photograph of unstable streambanks along Tenakill Brook at Memorial Park.**

Figure 2: Photograph of unstable streambanks along Tenakill Brook at Memorial Park.

<p><u>Existing Conditions:</u> Memorial Park is located in Closter Borough along Harrington Avenue. Memorial Park covers approximately 6.3 acres, and the entire park drains to the Tenakill Brook. Geese are often found at the park, contributing to excessive amounts of bacteria in the water from their feces. There is little to no vegetative buffer in certain areas along the Tenakill Brook, so water is easily accessible by Canada geese from the grassy areas of the park. Also, the streambanks are heavily incised and very unstable. Upon conducting the Channel Evolution Model, the Water Resources Program determined that the Brook is in stage 2. A stream in stage 2 has headcuts present, exposed bedrock, exposed cultural features, sediment deposits are absent or sparse, and the streambank slopes are greater than 1:1, which are contributing factors to excessive erosion of the banks as sediment is washed into the Tenakill Brook.</p>

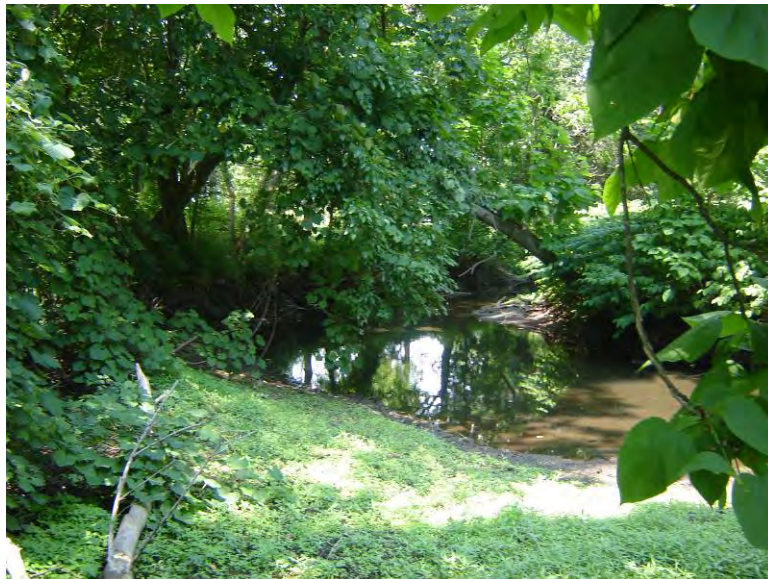
**Figure 3: Photograph of the poor quality buffer along Tenakill Brook at Memorial Park.**

Figure 3: Photograph of the poor quality buffer along Tenakill Brook at Memorial Park.

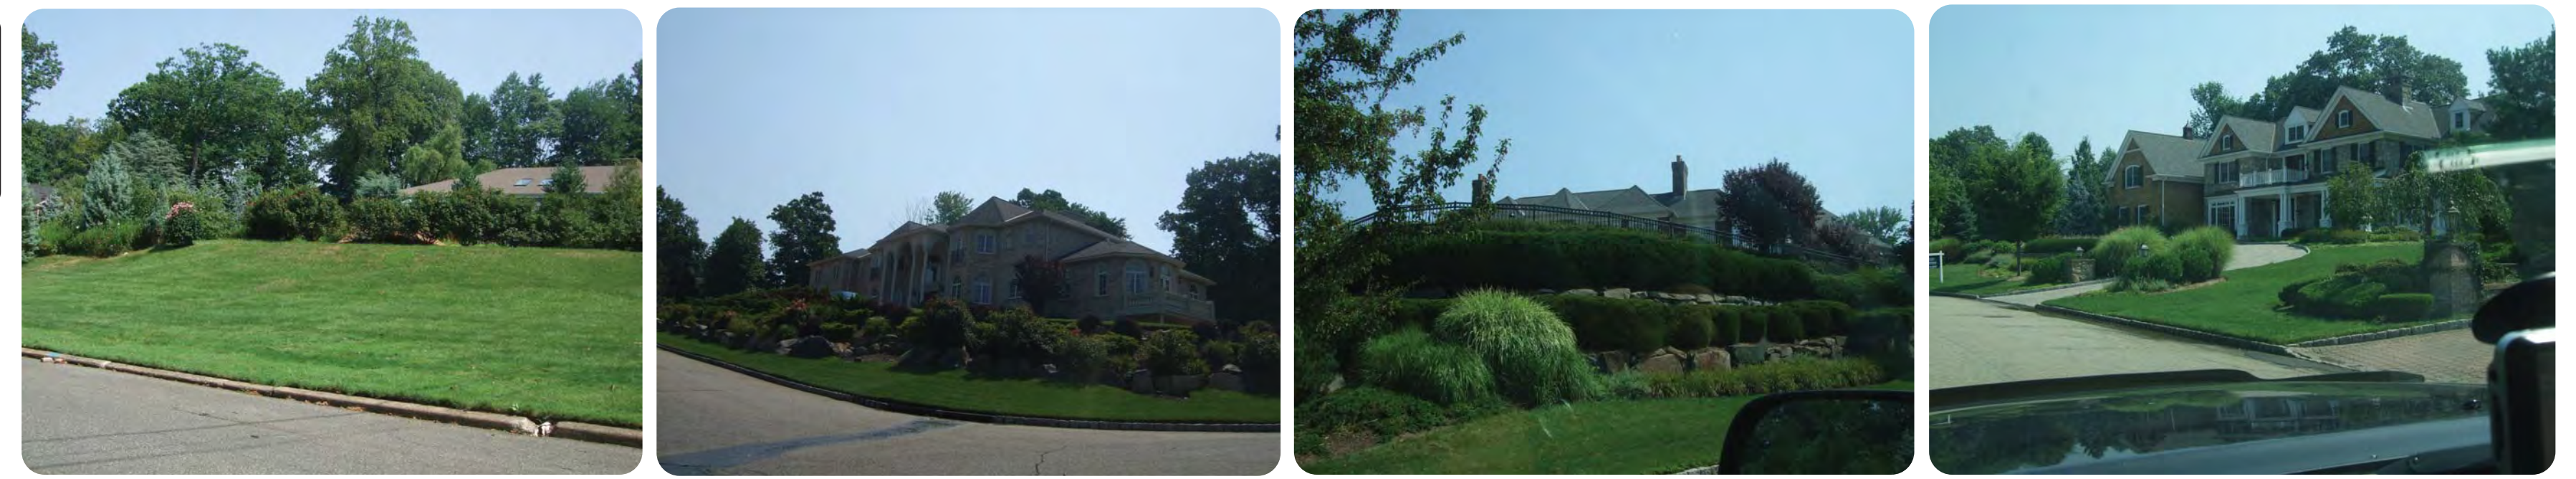
### SITE PLAN

Site Plan depicts a neighborhood of the Tenakill Brook Watershed that should implement a Streamside Living Program to help mitigate the harmful development impacts to the Tenakill Brook. This could be implemented throughout many of the neighborhoods in the Tenakill Brook Watershed.
