# **THE SIDNEY BROOK WATERSHED PROTECTION PLAN**

HUC-14 02030105020070 Raritan River South Branch (River Road to  
Spruce Run)

**Princeton Hydro, LLC  
1108 Old York Road  
Suite 1, Post Office Box 720  
Ringoes, NJ 08551  
908-237-5660**

**June 2010  
Revised December 2011  
Revised May 2012**

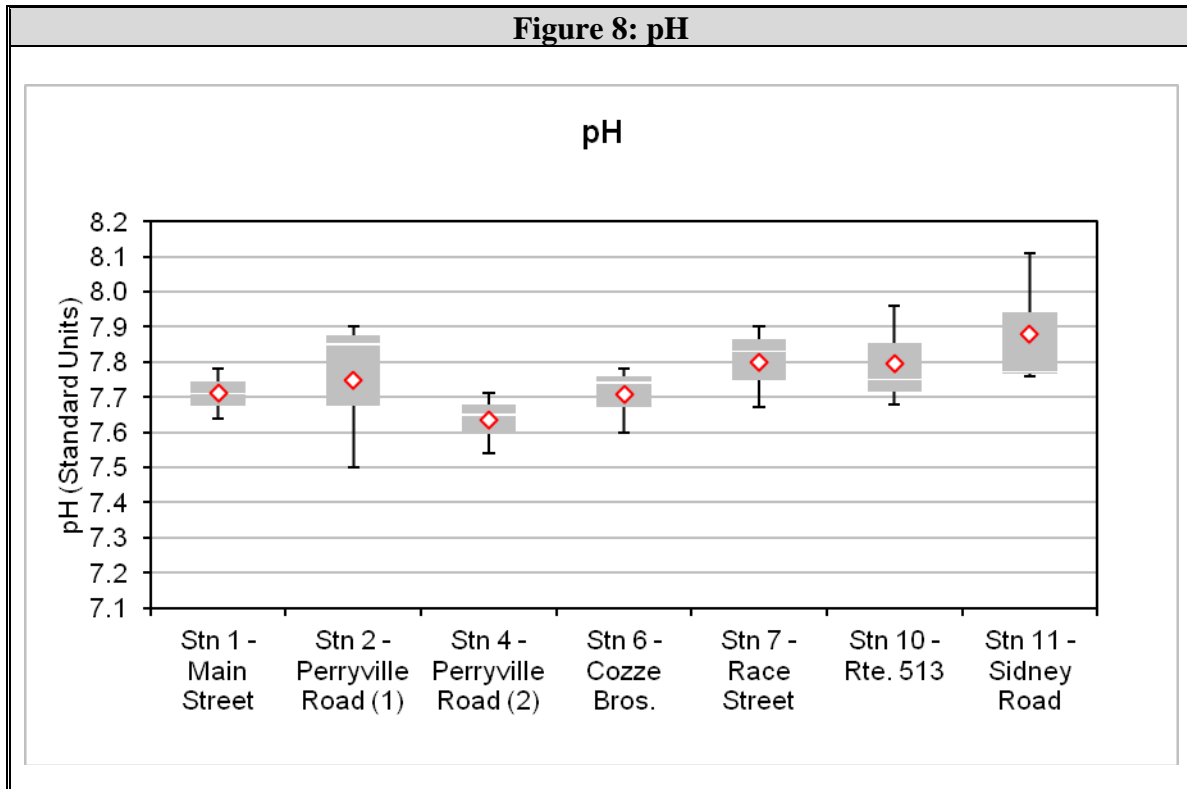
value approached the applicable criterion (Figure 8). It should be noted that pH tended to increase slightly moving down through the watershed. This is consistent with the increased influence of the drainage of carbonate lithology in the lower portions of the watershed as well as suspected increases in primary production. In turn this is consistent with the slightly lower values measured at Station 4 which does not drain carbonate formations. Overall, pH values measured in Sidney Brook are ideal for supporting an array of freshwater aquatic biota.

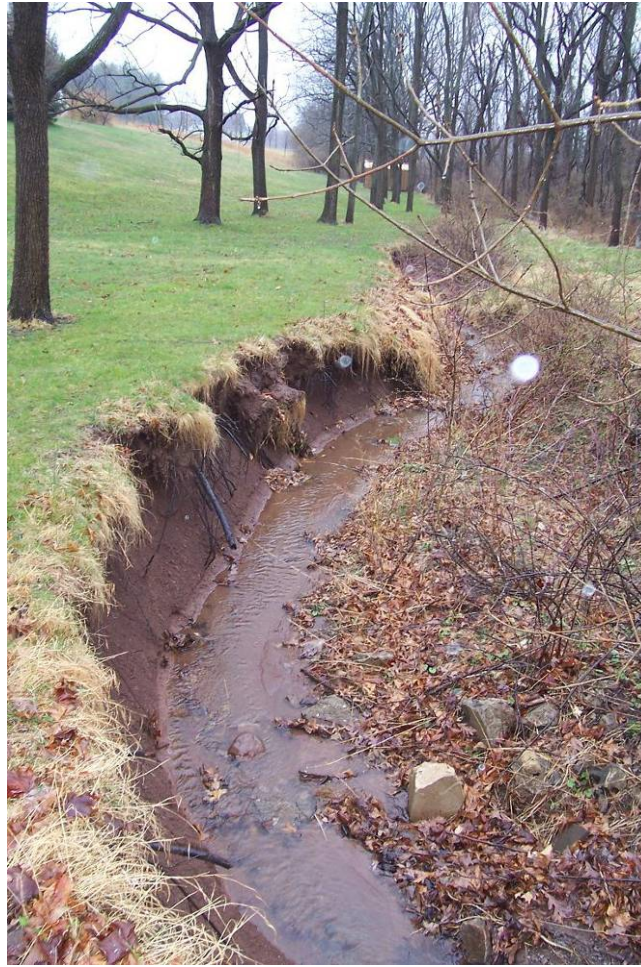
**Figure 21: Lawn Encroachment to Bank**

The ideal solution is to simply establish no-mow zones in at least a 50' buffer extending from the top of both banks where vegetation is allowed to simply grow unimpeded. In some senses this type of buffer is already stipulated in various technical regulations and municipal stream buffer and stream corridor ordinances, but existing lawns and "routine" maintenance is often granted exemption. While the establishment of no-mow zones seems simple there will certainly be some resistance to comply, especially with a 50' buffer that may comprise a large portion of maintained lawns or smaller residential lots. A compromise would be to establish as an absolute minimum a 10' riparian no-mow zone to at least establish the vegetation necessary to maintain bank integrity, decrease erosion, and provide at least some shading and other associated functions. While this should probably be adopted as ordinance and applied to existing maintained lawns, with obvious enhanced protections already in place for new development, education will probably be the strongest tool in promoting this practice and effectively conveying the benefits listed above will be crucial in this conversion.

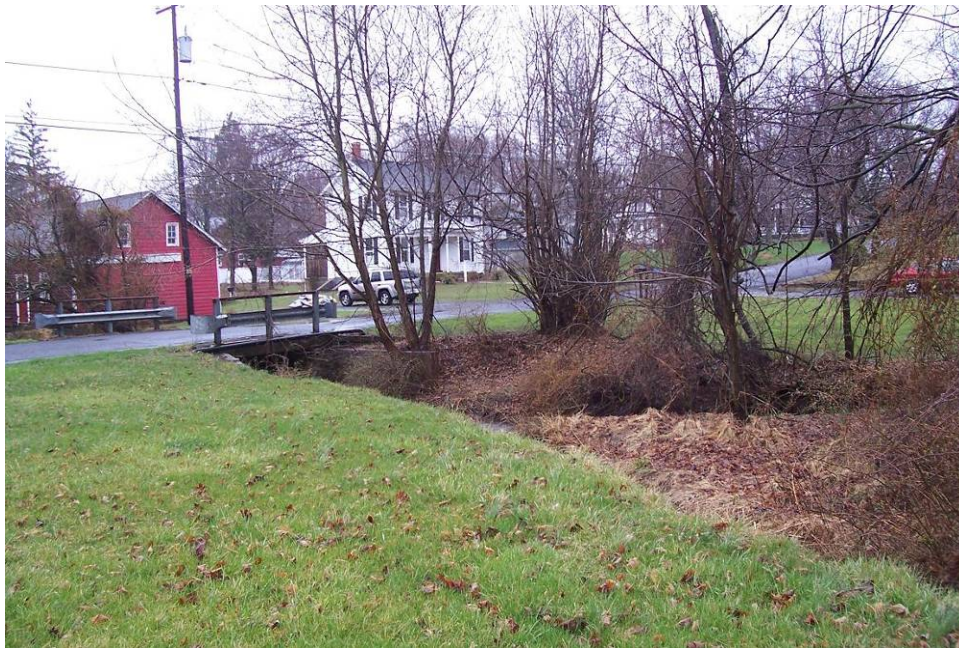
**Figure 22: Lack of Riparian Buffer**

Prior to initiating planting site preparation may be necessary to remove debris and invasive plants. The planting or re-planting of riparian buffer proposed here is designed to restore functionality and work within the confines of a selected site with minimal earthmoving. More intensive streambank stabilization projects requiring extensive engineering, excavation, and grading that incorporate planting will be discussed elsewhere in this document. For the most part buffer planting should be relatively low intensity and require primarily hand tools to dig holes to insert plants. Coir fiber mats may be installed in areas where there is extensive soil disturbance to help herbaceous vegetation become established, but other materials, like coir fiber logs that are typically installed along the toe of the bank, are not consistently effective in riparian settings and may not persist after bank full discharge events. The relatively low key planting and removal of vegetation can, for the most part, be conducted without securing permits although consultants and sponsors collaborating on the design and installation need to be cognizant of potential restrictions.

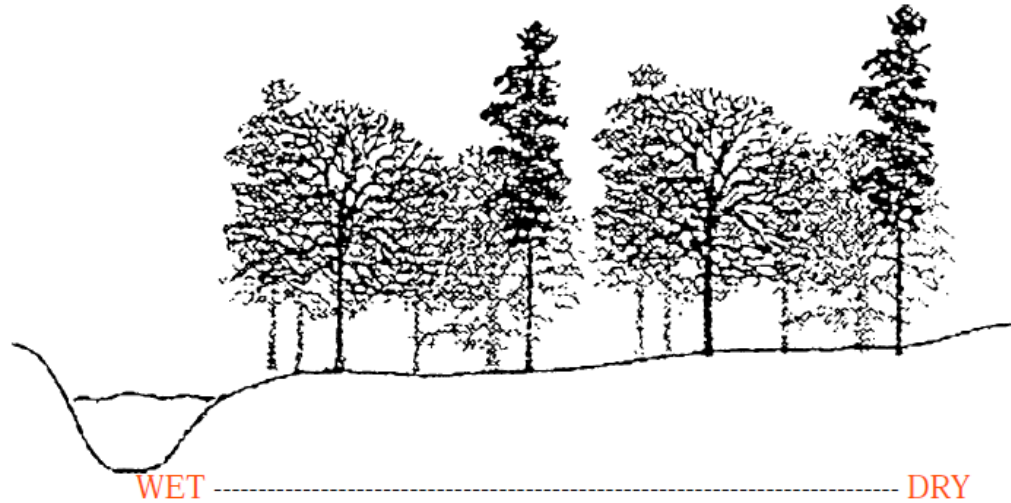
**Figure 24: Riparian Planting Zones**

As mentioned above several different plant types are to be utilized in the planting plan. While all plant types should be incorporated together the composition will change when moving away from top of bank such that wetland indicator species or those adapted for periodic inundation will be placed closer to the channel with a gradient shift towards upland species with increasing distance from stream. As such, the idealized planting plan would consist of three zones corresponding roughly to the bank, the floodplain, and the terrace (although different sources adopt widely varying naming schemes) with each zone incorporating the three plant types as seen below (Figure 24).

**Figure 5. Sample Planting Recommendations According to Moisture Conditions**

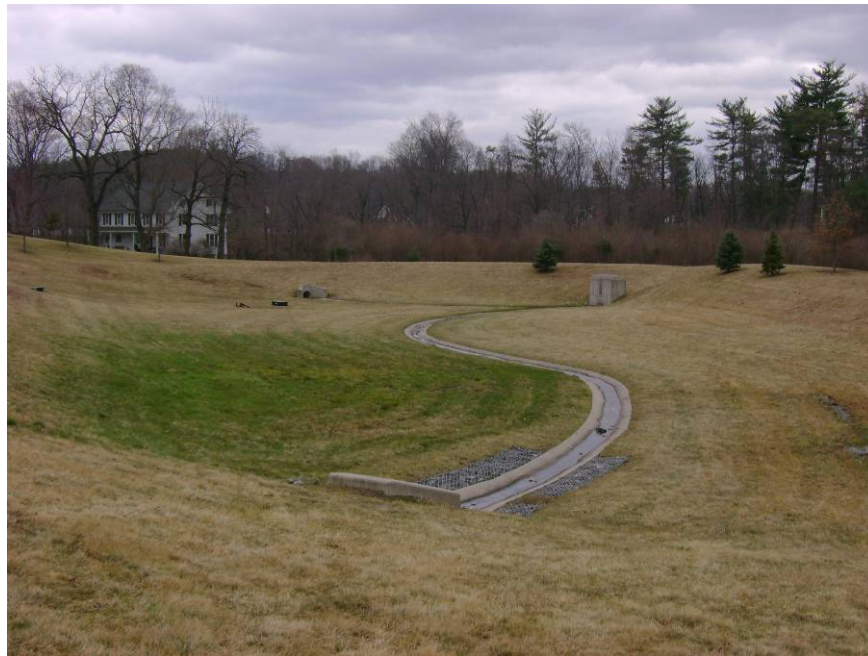
**Figure 25: Detention Basin**

These systems, while attenuating peak flows, offer very little volume reduction with no infiltration capacity and limited evaporation. Other components of the design also limit other aspects of NPS control. Conventional and extended detention basins continue to be constructed with concrete low flow channels, as illustrated in this detention basin located in the watershed in Figure 25, which do a poor job of treating first-flush stormwater runoff, which typically contains the highest levels of solids, nutrients, metals, and other pollutants. Extended detention and wet ponds also raise water temperatures contributing to summer stream warming.

This type of structural BMP still has utility, especially in larger catchments, but is reflective of an older design philosophy less concerned with treatment and volume reduction and primarily focused on peak flow attenuation. For new development it is recommended that these systems be replaced with other structural BMP's such as bioretention systems, stormwater wetlands, and infiltration designs that utilize wetland vegetation and other components to increase evapotranspiration, improve filtering and solids removal capacity, and reduce volumes. These newer systems also offer increased aesthetic and habitat value as well as less maintenance demand related to mowing after initial planting. For existing detention basins and wet ponds several retrofits options should be considered. The first option is to retrofit outlets and control structures to add detention time, particularly during the first-flush, thus effectively converting conventional detention basins to extended detention basins or further to wet ponds; this type of retrofit will be discussed further in this section. The second option is to convert existing systems to infiltration systems where soils allow or stormwater wetlands and bioretention features otherwise; the benefits and design standards of these systems including conversions will be discussed in the following section.

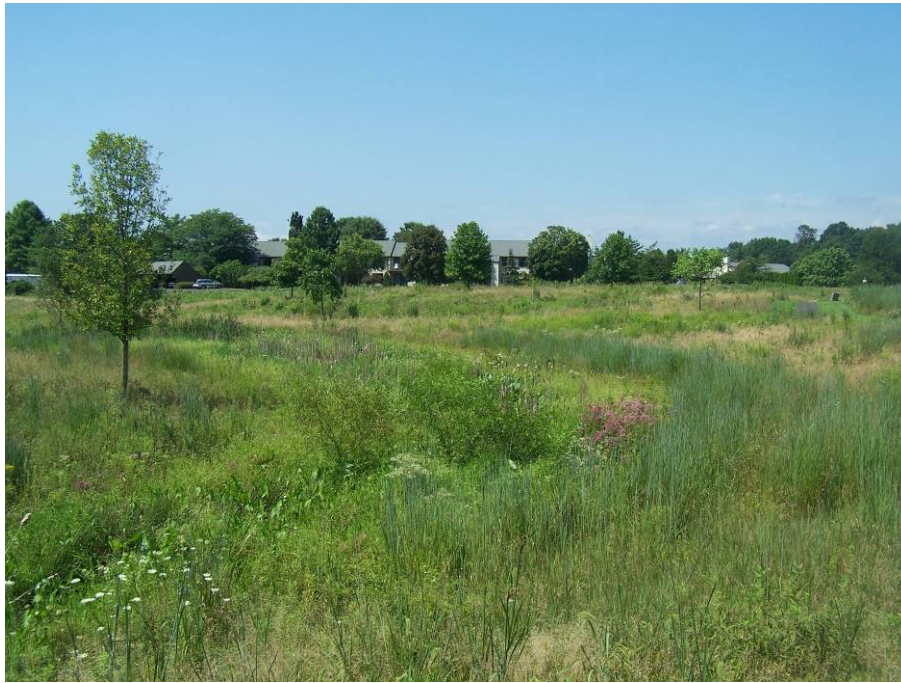
**Figure 29: Constructed Stormwater Wetland**

For the most part these systems share many of the same components including engineered berms, control structures, sediment forebays, general basin morphometry, and storage capacity. The primary difference lies in the utilization of plant materials, and secondarily in extending the linear flow path or increasing sinuosity. The extended detention basin has no specific vegetative component other than a non-native groundcover requiring mowing, while the stormwater wetland has high and low marsh communities composed of wetland plants as well as trees. The small difference, as mentioned above, provides a great array of benefits to a standard design. The image provided below is an example of a retrofitted detention basin, which is nearly indistinguishable from a natural wetland (Figure 29).

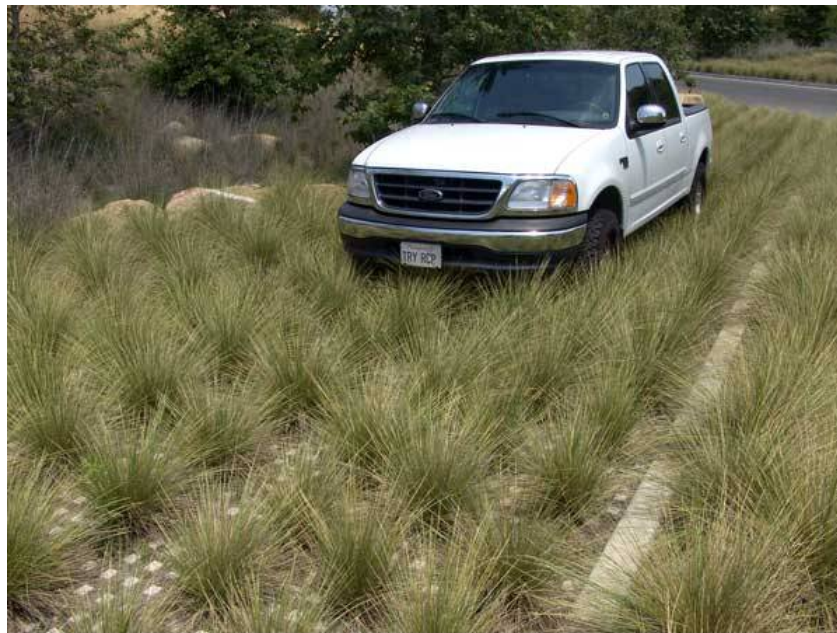
**Figure 35: Turf Blocks**

Maintenance requirements vary between the systems, but can be relatively intense. Permeable pavement in particular requires routine maintenance with seasonal sweeping and high pressure washing to remove captured solids and maintain open pore spaces. In paver systems the burden is reduced but those with integrated vegetation require care of the plant materials. Snowplowing, which is a concern in New Jersey, must be conducted with care in paver systems to avoid displacement of the pavers. As with other infiltration devices site soil conditions can be a primary determinant of their applicability and they cannot be located where there is a chance of hazardous materials release that could contaminate the groundwater.

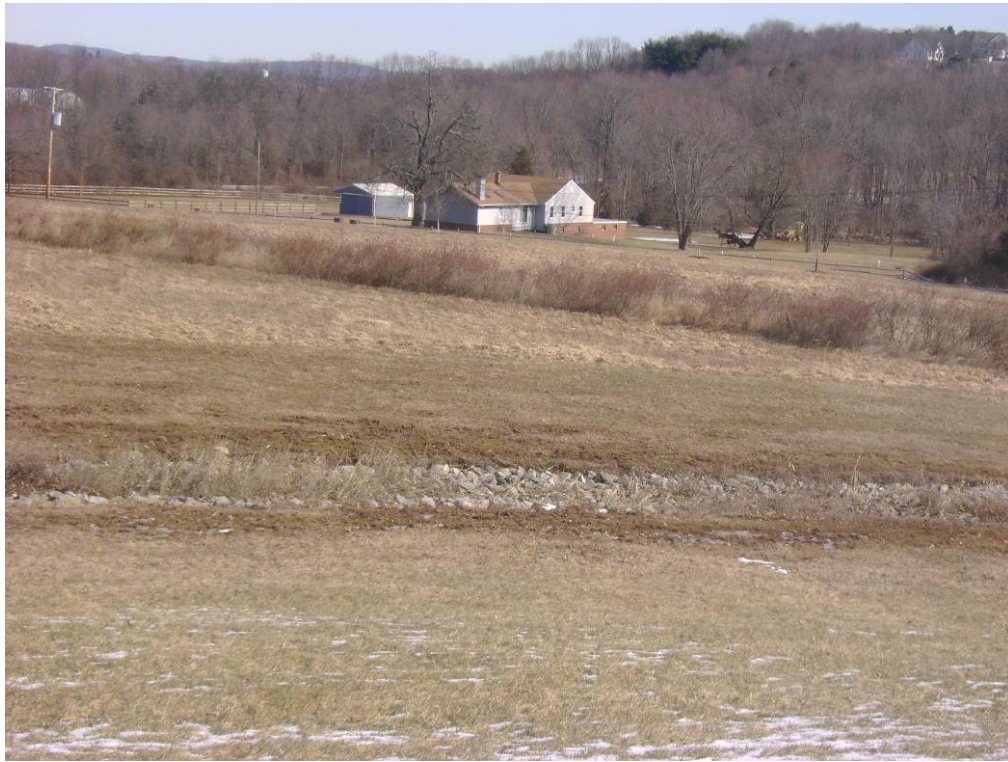
**Figure 37: Vegetated Swale Candidate Site**

The simplest design is the grassed swale, which is simply a grass lined swale constructed in maintained lawn space. Because the grass is typically mowed in this design, the amount of treatment in this system is quite limited and is generally valuable only for pre-treatment to other BMP's and in limiting erosion. A vegetated swale, sometimes referred to as a dry swale, has a similar channel morphometry, generally trapezoidal with modest slopes, but is planted with a variety of native plants including trees to provide mechanical filtration and maintain channel stability. These systems may also incorporate very small check dams within the channel to reduce velocities and provide short term detention. Figure 36 illustrates a conceptual design of a vegetated swale and a location within the watershed where such a design may be implemented (Figure 37). Wet swales are similar to dry swales but also incorporate small permanent pools and function more closely to a series of linked wetland cells.

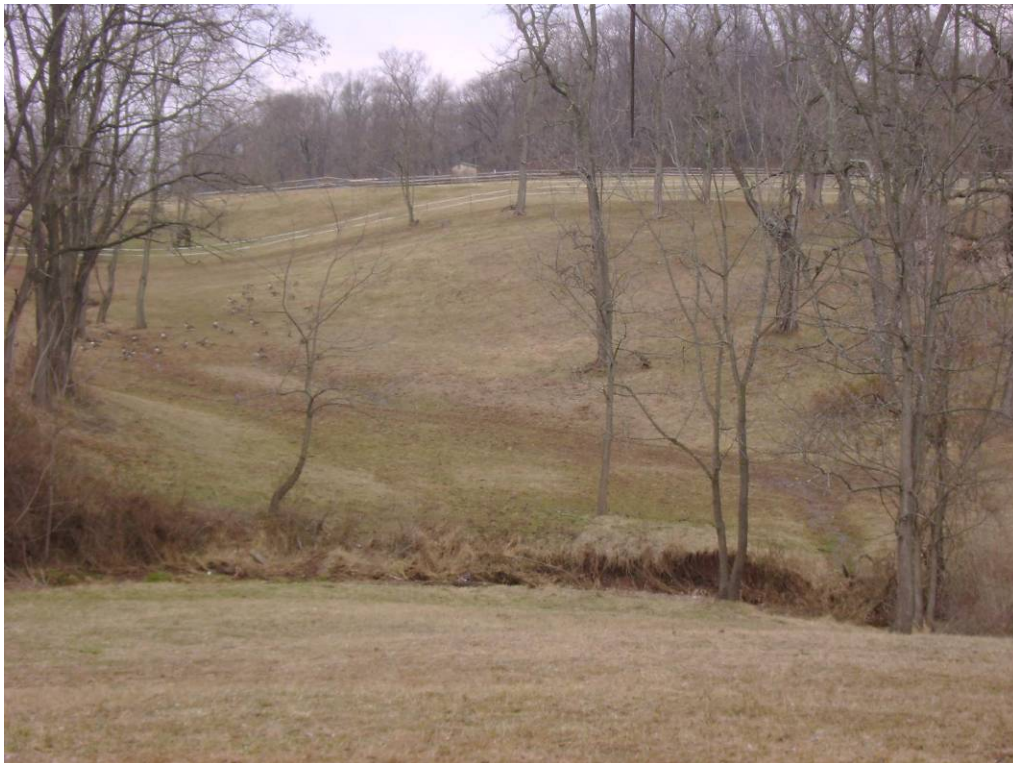
**Figure 39: Vegetative Filter Candidate Site**

Vegetative filters are related to swale features but are designed to treat sheet flow and not concentrated flow in a channel. As such they are oriented perpendicular to the flow path and parallel to elevation contours on a slope, and are generally sited on grades of less than 5%. In some senses vegetative filters mimic the function of riparian buffers and native forests. The figure below (Figure 38) illustrates the schematic of a vegetative filter while Figure 39 shows a candidate site.

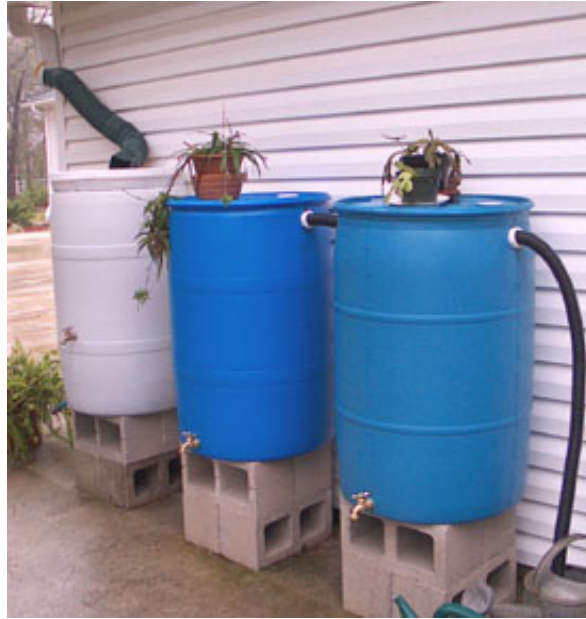
**Figure 40: Rain Barrels**

The installation of rain barrels that intercept rainfall from roof surfaces via the downspouts reduces the overall higher flows that result from increased runoff velocities from these impervious surfaces. Essentially, these barrels capture rainfall that would otherwise serve as a transport vector for nutrients and sediments (Figure 40). In addition,

the water contained within rain barrels serves as a water source for uses such as residential irrigation of gardens and lawns helping to conserve water resources. Costs for rain barrels are entirely based on initial material expenditure with little in the way of upkeep. Rain barrels may be converted from recycled food barrels or purchased from many environmental retailers, in many different styles which match a home's exterior, and pre-fitted with spouts.

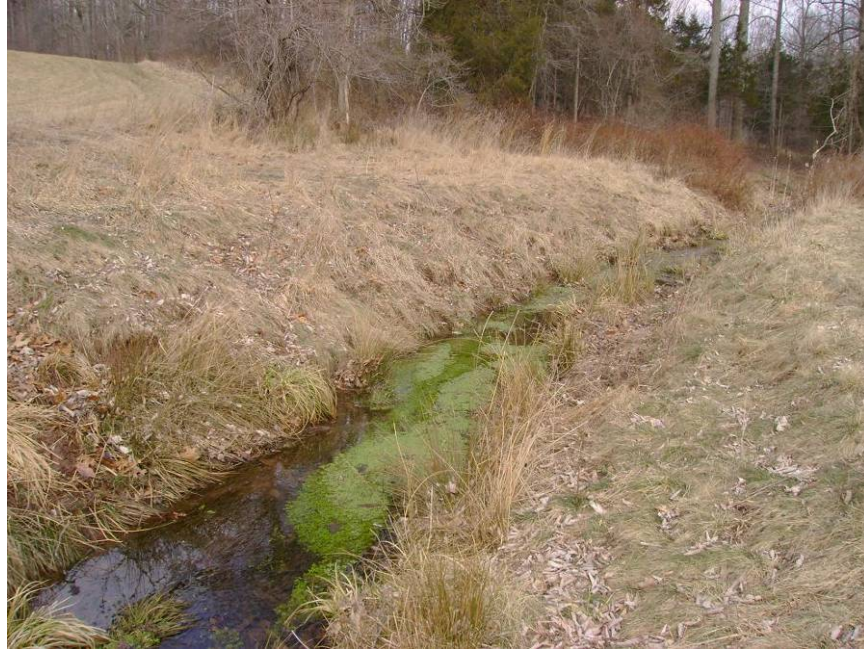
**Figure 43: Planting Candidate Site**

river birch (*Betula nigra*). Candidate sites for simple planting as a stand-alone measure would include those with mild erosion and a lack of riparian vegetation (Figure 43).

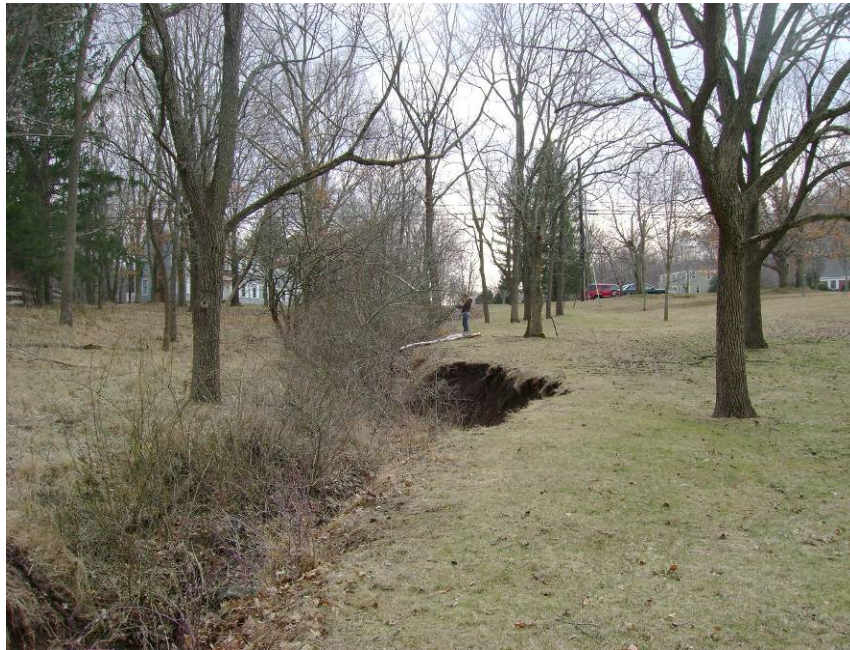
**Figure 46: Bank Grading Candidate Site**

Bank grading is also useful for stabilizing banks especially when paired with plantings and toe protections, and is often seen on outside bends or along long eroded runs. More complex bank grading, including major excavation in channels that are extremely incised, may be performed to create a new floodplain. More generally though, bank grading is used to reduce the hydraulic angle of incidence thus decreasing erosive forces along the outside bend, allowing excessive flows to reach the floodplain, and providing stable substrate for planting using brush mattresses and fascines, or armoring with riprap which significantly increases the roughness coefficient. The slope of the grade varies with the desired outcome, but a 3:1 slope is often desired for most planting exercises or other bioengineering. A grading or slope flattening detail is provided below (Figure 45) and would be the preferred stabilization method for the site depicted in Figure 46.

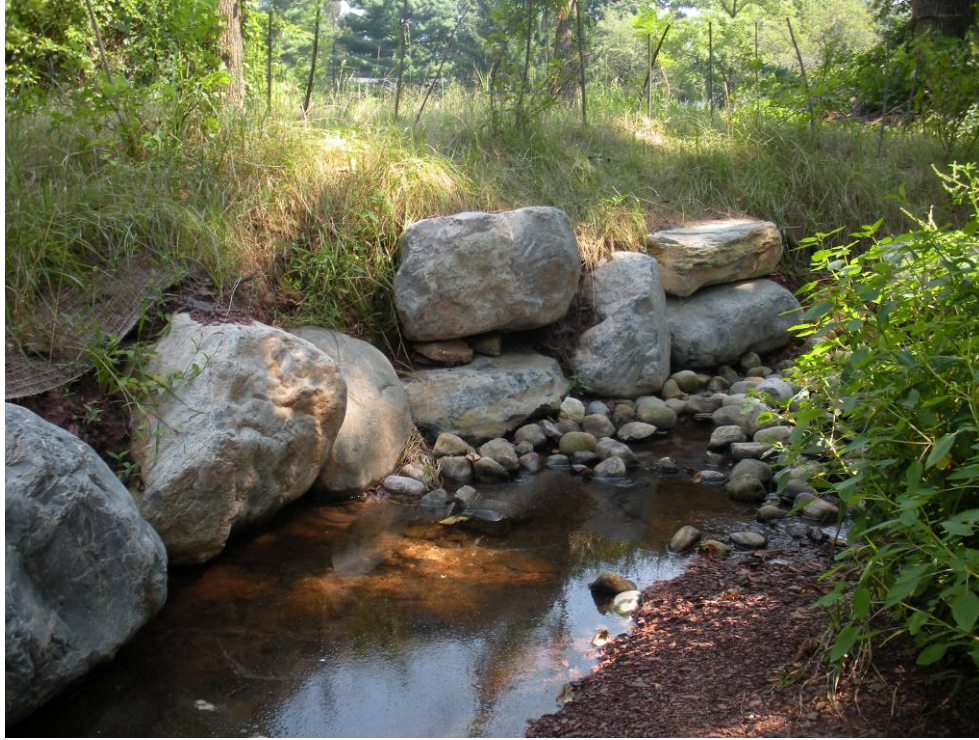
**Figure 48: Boulder Toe Protection**

Boulder toe protection designs function similarly to rootwad to provide bank stability and prevent erosion along outside bends utilizing large boulders instead of trees. In addition to protecting the toe of the bank the boulders may be stacked as necessary to provide additional armoring higher up the bank. Design specifications are generally mutable but the resistive boulders should be placed to achieve approximately 50% embedment. Bank grading and the placement of fill material behind the boulders are usually encouraged. The material behind the boulders is usually planted with woody vegetation. A boulder toe design is shown below (Figure 48).

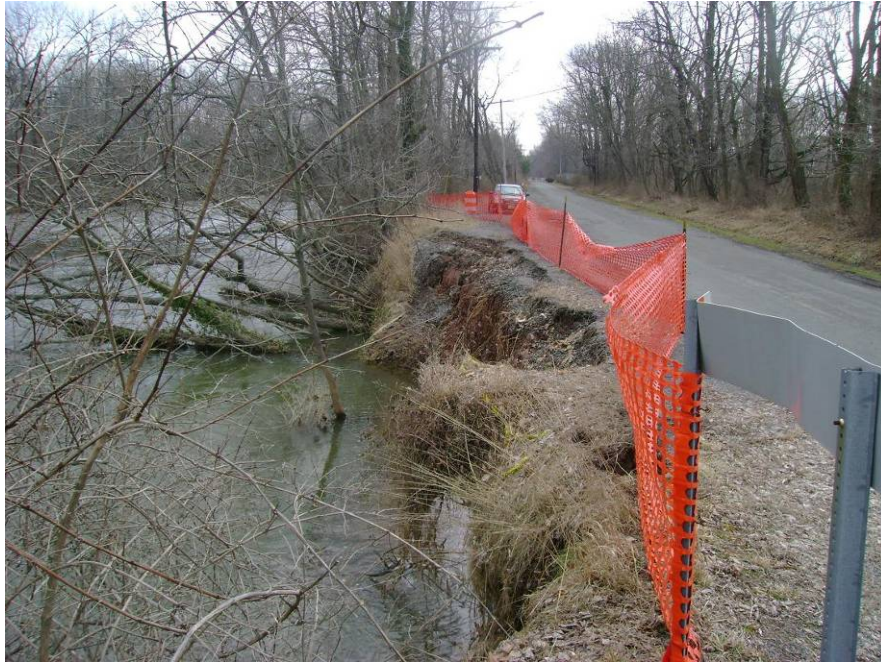
**Figure 50: Potential Gabion Placement**

Gabions are large wire cages filled with coarse rock, similar to the material used in riprap applications. Gabions have several advantages over riprap related to the cages which provide increased structural integrity and thus allow smaller rock to function as a single unit or be placed where larger rock would be required in a riprap placement. For this reason gabion baskets can be used in much steeper applications, and may be placed almost vertically without concern for the angle of repose (the angular limit at which loose materials can be stacked), which is an important consideration where space is a defining limitation. There are several other gabion designs including gabion mattresses, which are much shallower than baskets with a larger footprint and gabion sacks which is mesh sack filled with rock. Both of these designs must be placed on flatter slopes than baskets. Gabions are almost always filled in place which aids greatly in their installation. As mentioned above gabions may be vegetated as discussed above and shown in Figure 49 below. The successive image (Figure 50) identifies a location in the Sidney where gabion baskets may be required to withstand high shear forces eroding the bank in order to protect the road situated at the top of bank.

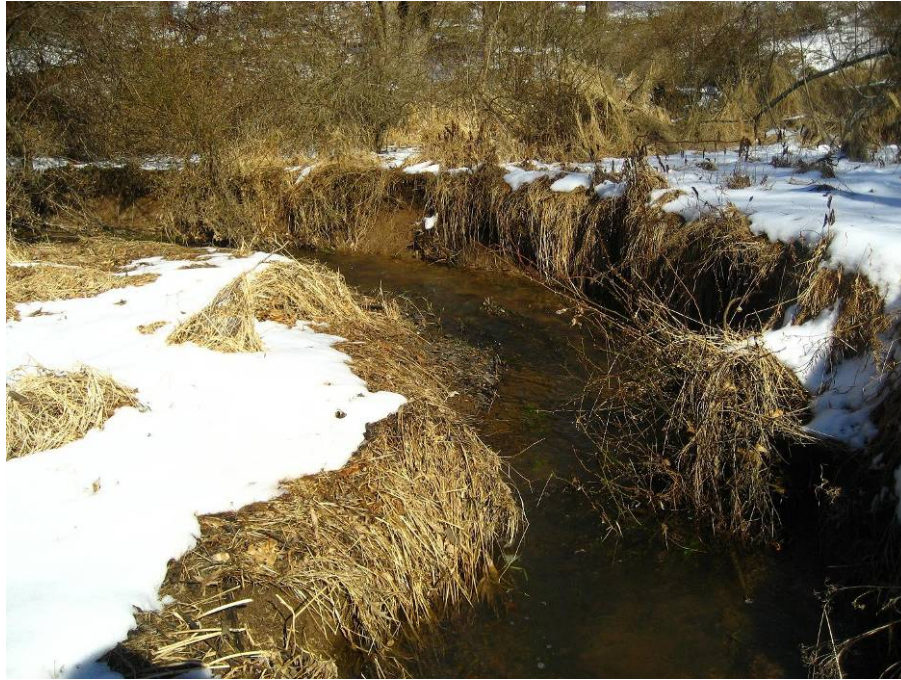
**Figure 52: Flow Deflection Candidate Site**

The image below (Figure 52) would likely be a good site in the Sidney watershed to implement a flow deflection solution. Such a design would deflect the heaviest flows

away from the bank, and a J-hook design would provide scour to minimize sediment deposition and provide some larger and hydraulically more complex features in the stream bed which would promote better in-stream habitat for fish and macroinvertebrates.

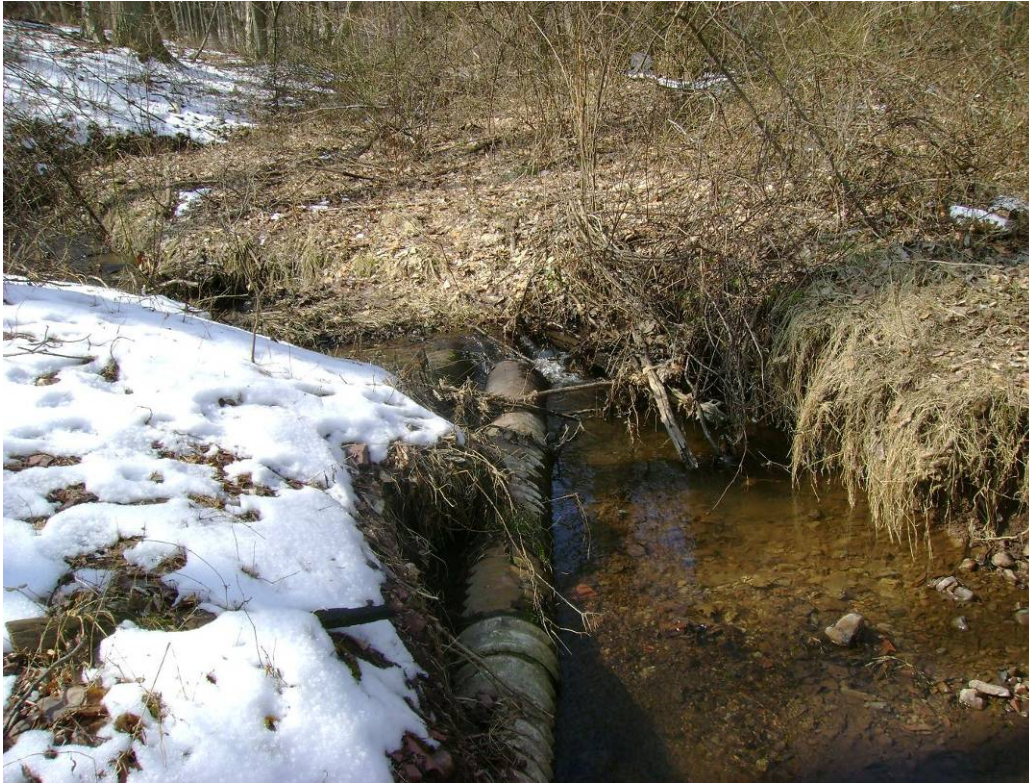
The obstruction shown below (Figure 55) is an interesting case and another example where grade control should be utilized. In this image a pipe is currently acting as a grade control device and is preventing a head cut from migrating upstream, but is also subject to failure itself; it is interesting to note that the configuration of this pipe also likely exacerbates the undercutting on the far bank. In this case a rock riffle or a cross vane would be placed immediately downstream of the pipe to protect the pipe, prevent headcut migration, limit bank undercutting, and reconnect the stream bed on either side of the hydraulic jump to improve fish passage.

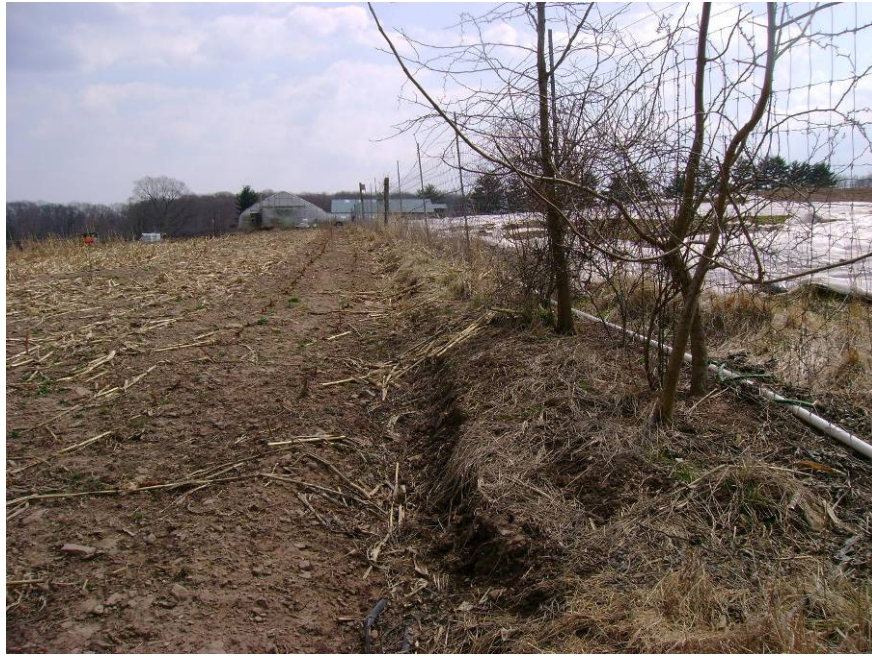
**Figure 56: Eroded Ditch**

Grassed waterways and diversion methods should be strongly considered for implementation throughout the watershed. As a result of topography many of the fields in the watershed are sloping and are situated close to the tributary network. As such, management of runoff and water in general is a concern in these fields, and many drainage features discharge directly to adjacent tributaries. Because of the direct discharge field drainage features have an even greater potential to deliver eroded sediments directly to the stream. In the image provided below (Figure 56) a small swale located in the watershed is showing signs of erosion and thus serves as vector for both solids and nutrient loading to the stream.

The implementation of grassed waterways would be ideal for this situation. Like vegetated swales discussed in the structural BMP section above, the grassed waterway is merely an agricultural application of the same principles in residential and other settings. Namely, grassed waterways utilize a permanent groundcover to provide surface stability to prevent erosion and the vegetative filtering and removal of suspended sediments in directed runoff. The following detail, taken from a Princeton Hydro engineering plan shows a schematic view of a grassed waterway with tributary diversion situated on the contour (Figure 57). While additional diversions are not required, especially if there is adequate riparian vegetation at the toe of the field or a vegetated field border, grassed waterways should be considered for the Sidney.

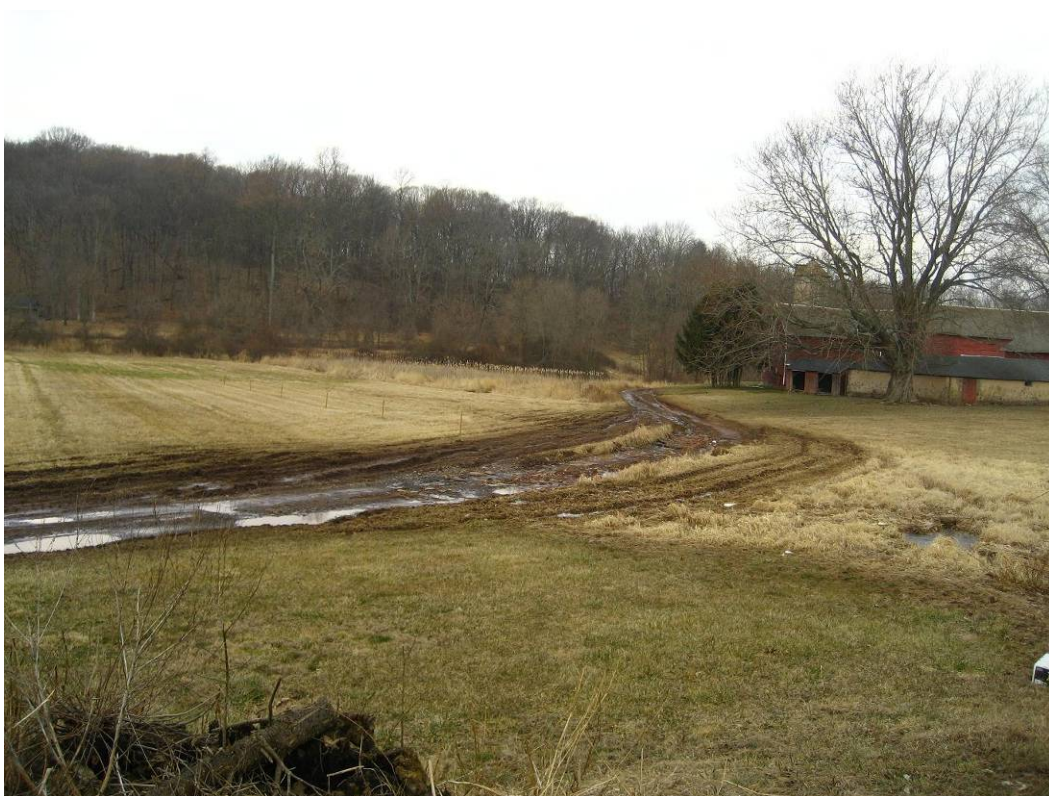
**Figure 58: Unimproved Agricultural Stream Crossing**

Finally, stream fencing and crossing improvements should be considered to limit in-stream erosion, solids loading, and bank instability. While livestock access to tributaries in the watershed seems to be limited, agricultural crossings of water features including swales, marshes, and wet areas, may be relatively common as depicted below (Figure 58).

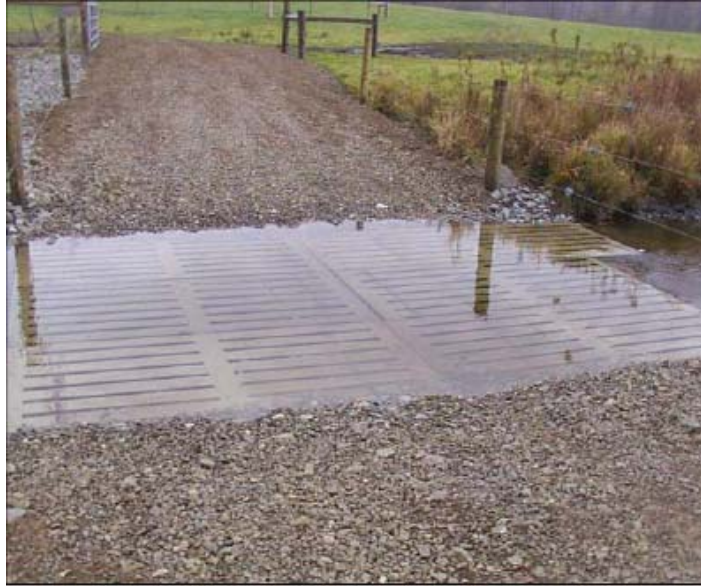
**Figure 59: Improved Agricultural Stream Crossing**

There are a variety of simple fixes, one of the most popular being the hog panel stream crossing with gravel driveways, and where livestock cross, fencing (Figure 59). These solutions can significantly reduced localized bed instabilities, which can result in the formation of migrating head cuts and erosion upstream, and solids loading to the stream.

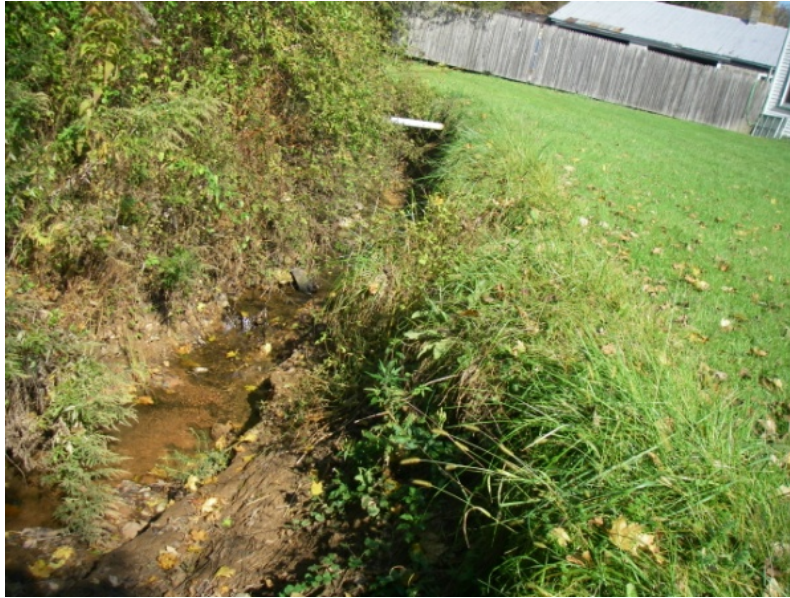
**Figure 64: Restoration Site 4**

There is a large area of lawn next to the stream, which is incised and eroded. Stream stabilization could be considered to address the bank erosion issues at this location, which is addressed in the Princeton Hydro suggested projects, and in addition the culvert under Main Street needs mitigation. However, use of vegetation to replace the lawn area could help stabilize the banks to a certain extent. Approximately 100 feet of buffer area approximately 20 feet wide is recommended for the left bank of this reach. The estimated cost for this project is less than \$200.

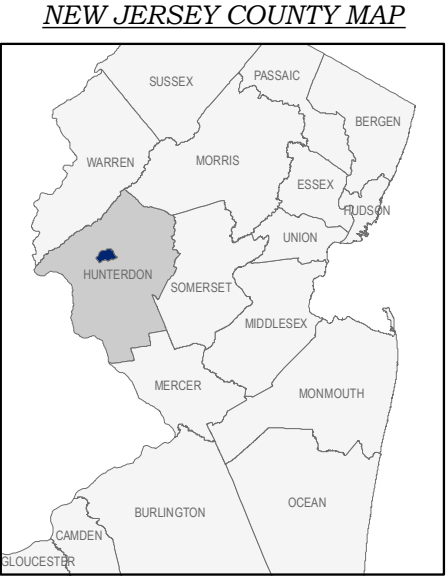
**FEMA FLOOD ZONES**

- A - 100-yr Floodplain (No base flood elevations determined)
- AE - 100-yr Floodplain (Base flood elevations determined)
- X500 - 500-yr FloodPlain
- X - Areas outside of 500-yr Floodplain

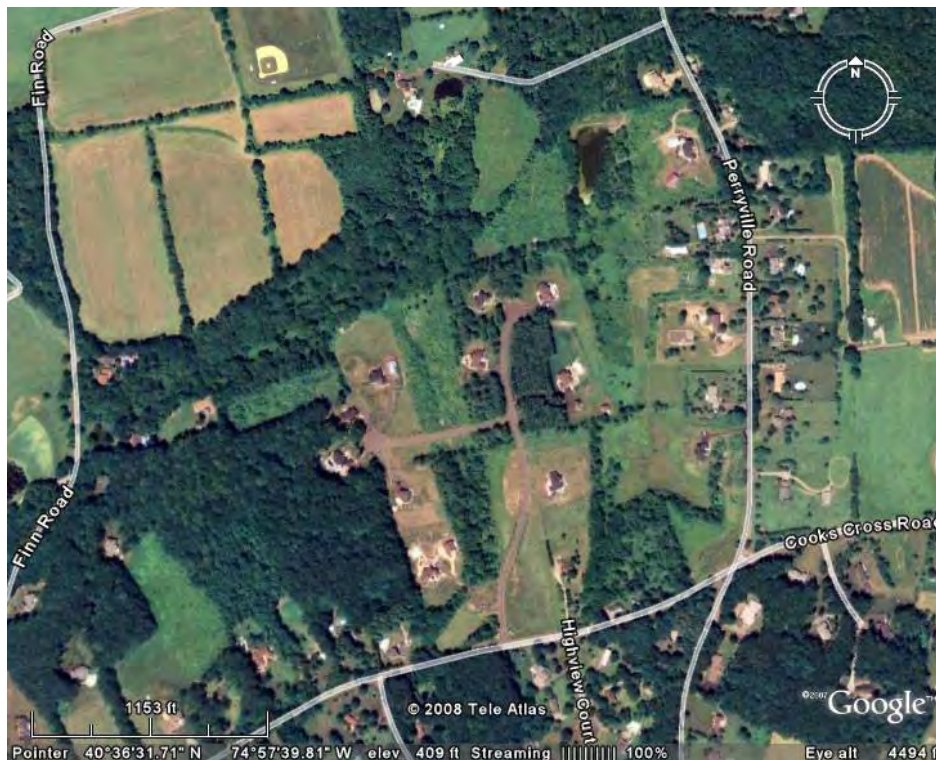
*The Sanctuary Development and pond in the top corner are depicted in this aerial. This development was recently constructed and is not displayed on the report figures, which are based on the NJDEP 2002 aeriels.*

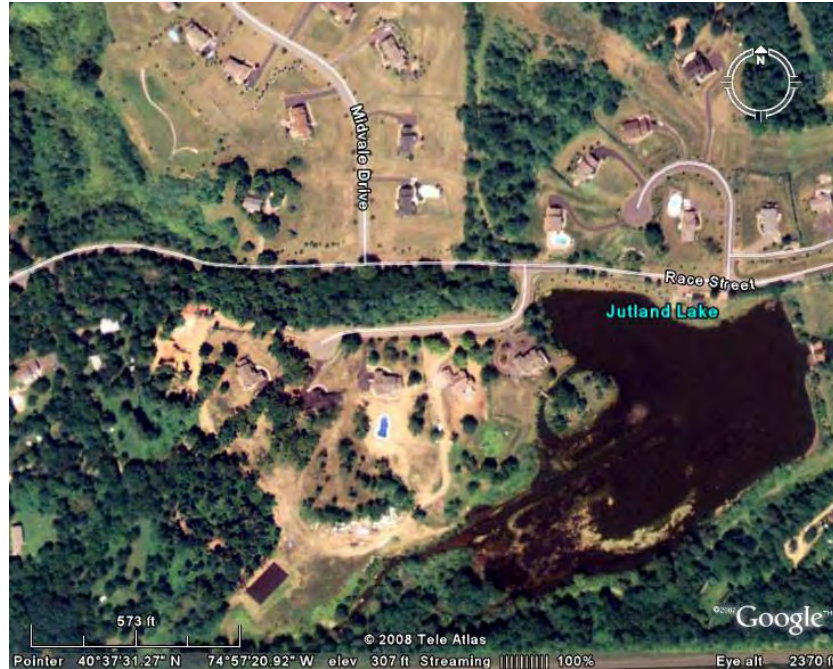
*The Lakeside Estates and Jutland Lake are depicted in this aerial, and sediment depositional areas in the Lake are visible.*

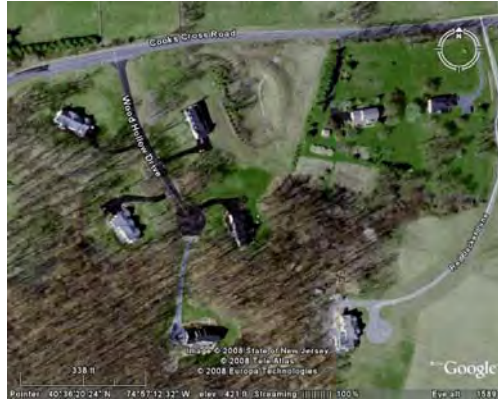
Runoff to reach D begins along Cooks Crossing Road. A stormwater detention basin that serves approximately 16 homes in the Wood Hollow Road development discharges directly to the Cooks Crossing Road, and high storm flows overwhelm the road drainage swales. While the Woods Hollow basin is well maintained, the discharge directly to the roadway is a poor design. The discharge from the basin's 2 foot outfall floods Cooks Crossing Road and causes erosion and flooding downstream. An upstream road swale also accepts street flow, but it may need modifications and regrading to direct flow to the basin. Additional drainage from homes and the roadway is intercepted into the road drainage swales and street sewer systems, adding to the downstream flooding. This detention basin should be evaluated and possibly modified to a retention basin to reduce flows and flooding on Cooks Crossing Road. In addition, the road swales may need widening and modifications to convey this runoff in a manner that reduces downstream flooding of the road and properties. Ownership and maintenance responsibilities for this basin are unknown, and may rest with a small homeowner association (Block 30, lot 1.13).

*Woods Hollow Road Basin discharges directly to Cooks Crossing Rd.*

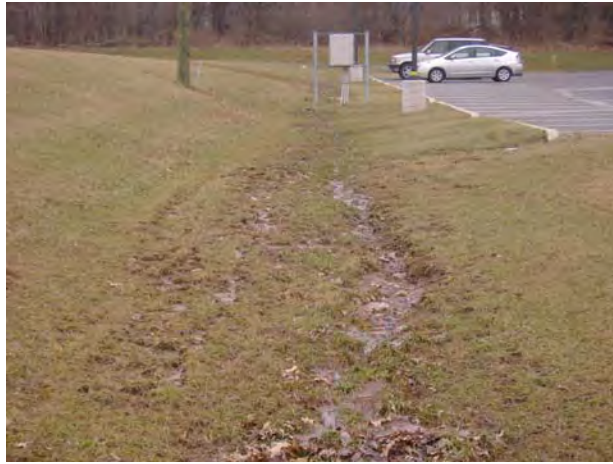
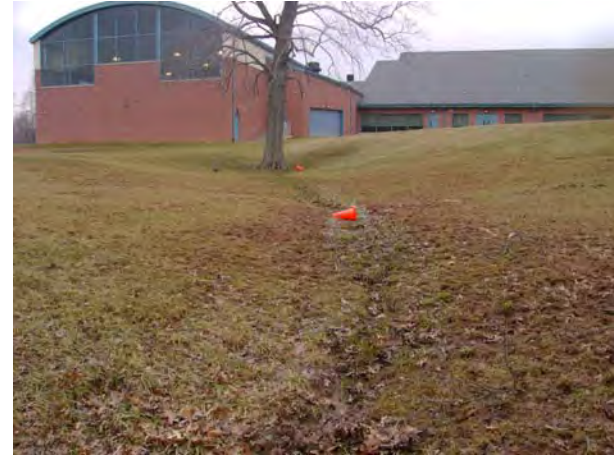
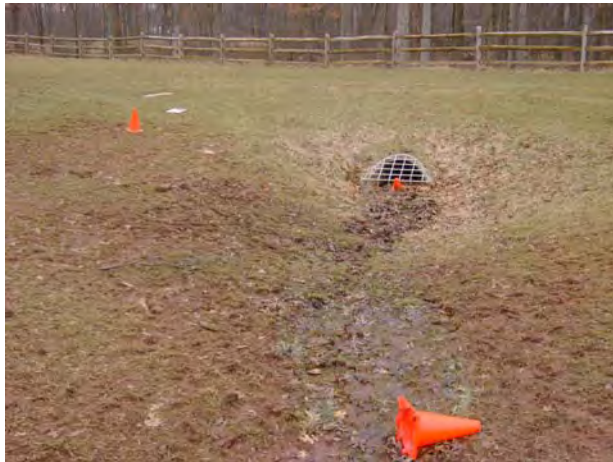
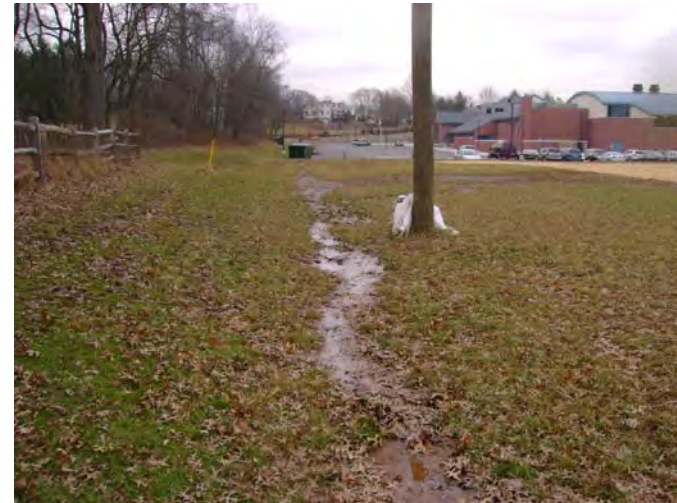
# Reach J -Union Elementary School Drainage

Improve with plantings and less mowing

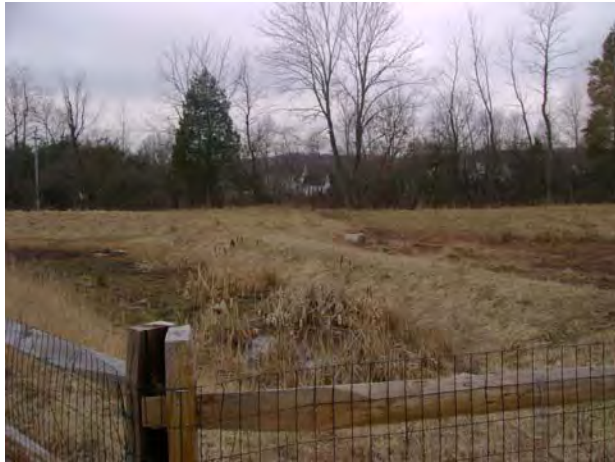
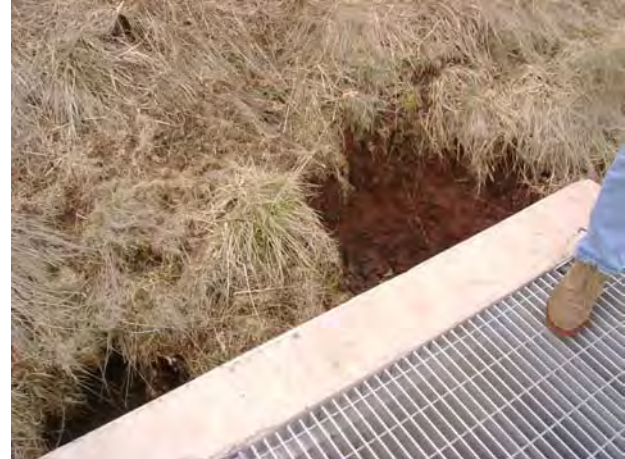
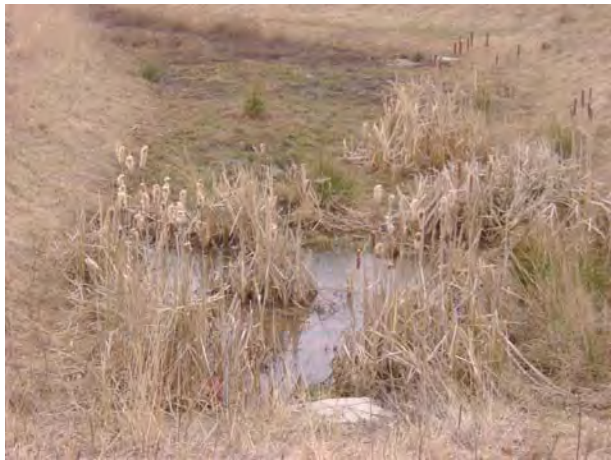
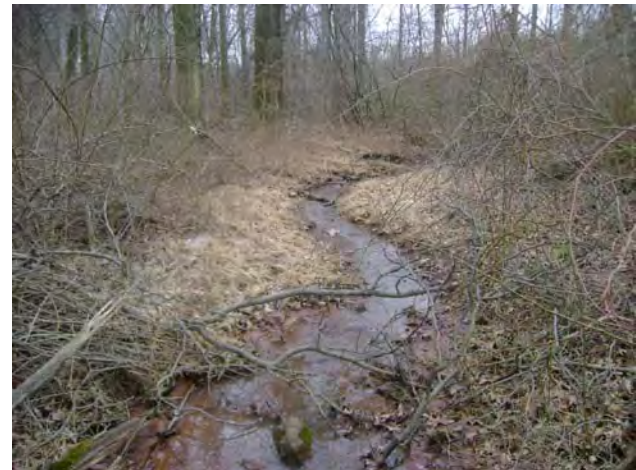
# J- Elementary School Basin 1

Unmapped drainage areas &  
wetlands
