# **THE SIDNEY BROOK WATERSHED PROTECTION PLAN**

HUC-14 02030105020070 Raritan River South Branch (River Road to  
Spruce Run)

**Princeton Hydro, LLC  
1108 Old York Road  
Suite 1, Post Office Box 720  
Ringoes, NJ 08551  
908-237-5660**

**June 2010  
Revised December 2011  
Revised May 2012**

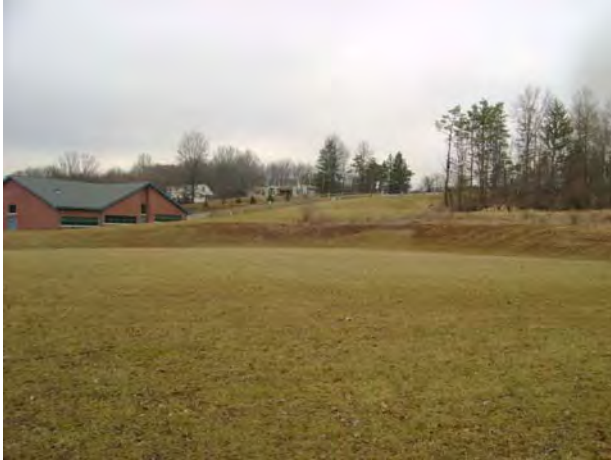
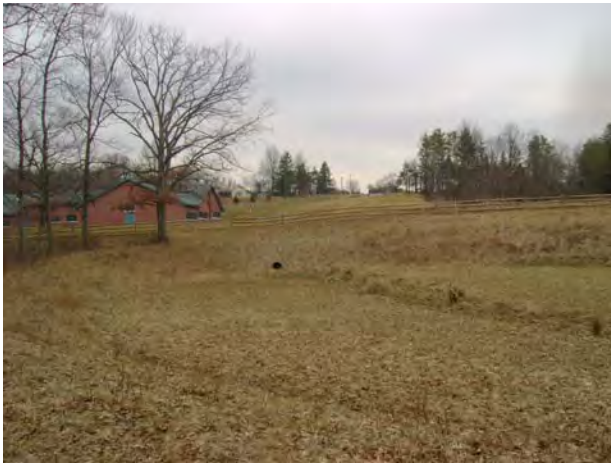
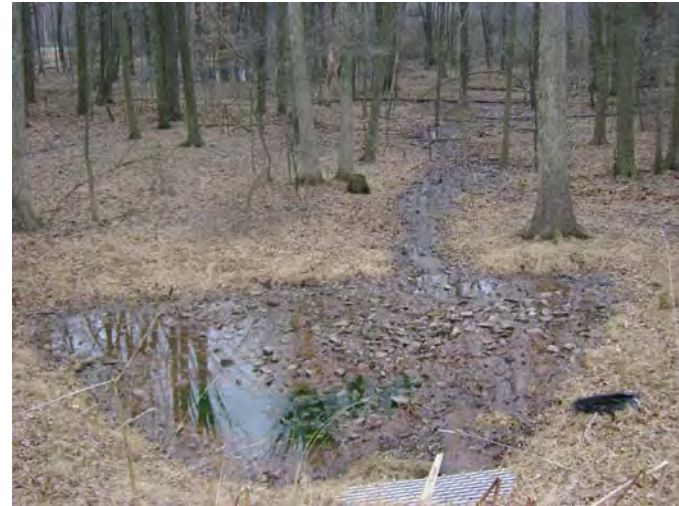
# J – Elementary School Basin 2

Steep slopes,  
unmapped streams  
and wetlands.

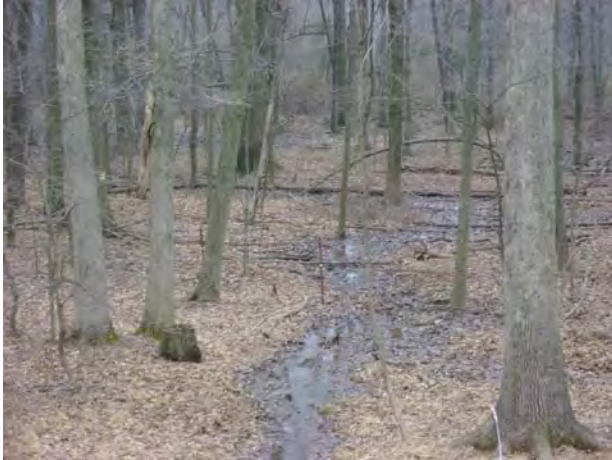
# J – Elementary School Drainage from Basin 2

Unmapped streams,  
wetlands, possible  
vernal pools.

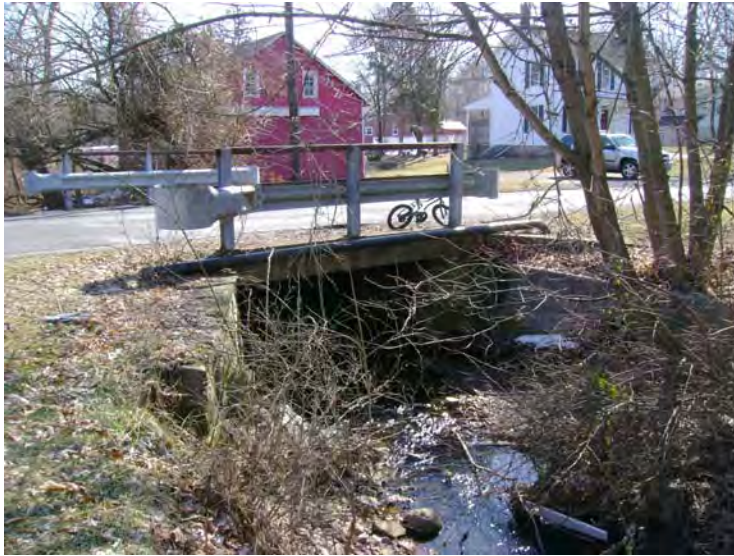
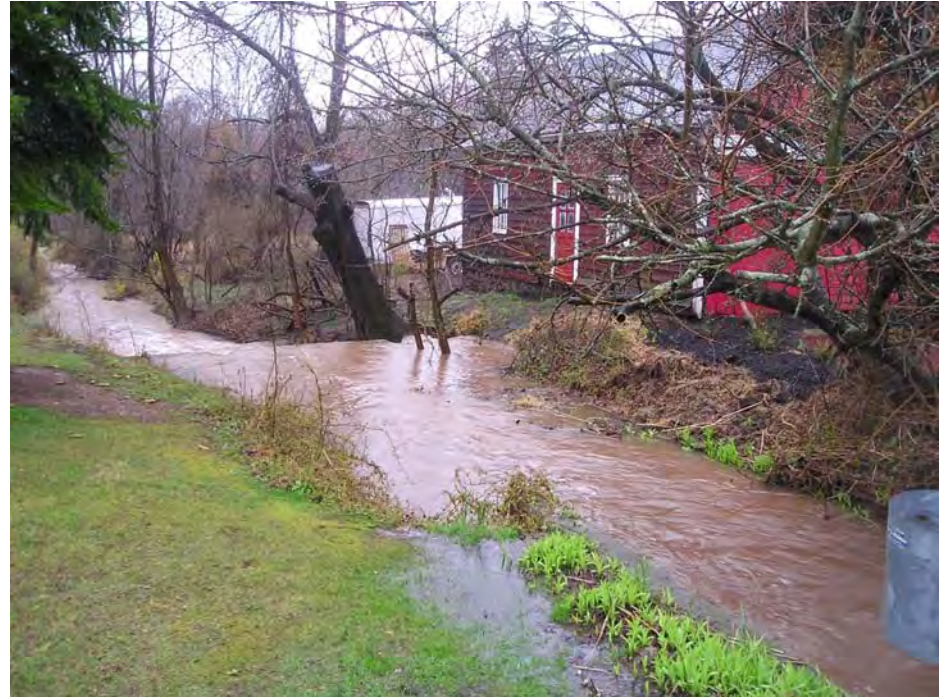
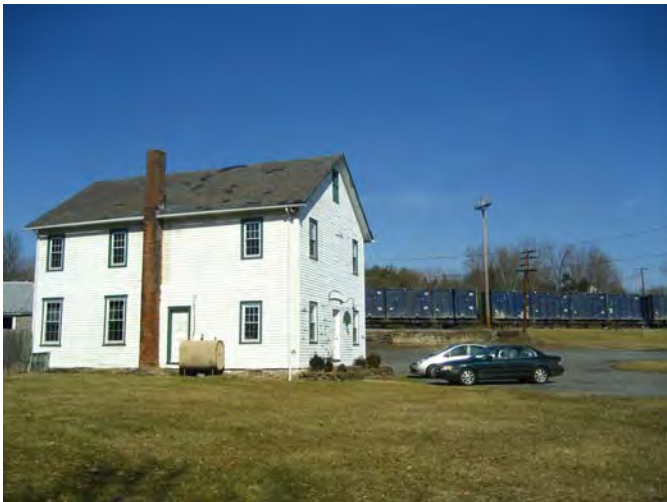
# Reach J - Main Street

**Eroded stream banks and flooding are concerns on Main Street.**

**High algae levels could indicate nutrient loadings.**

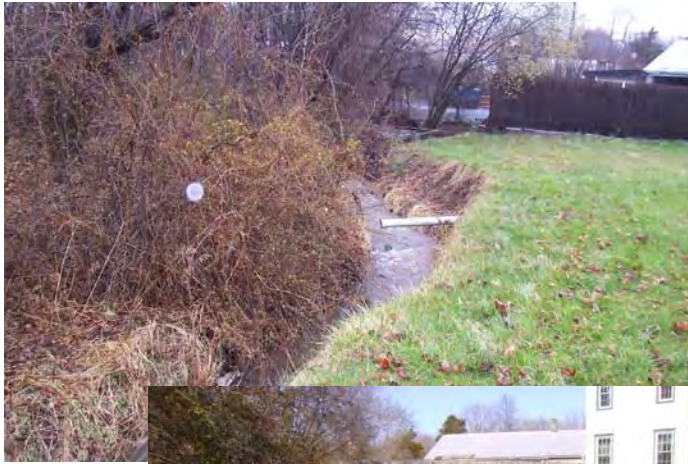
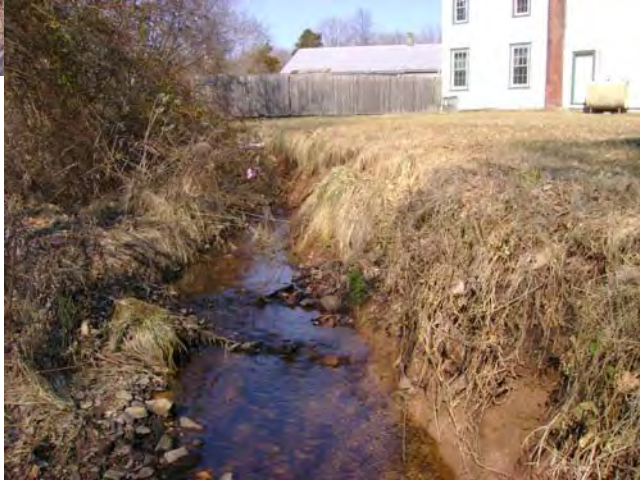
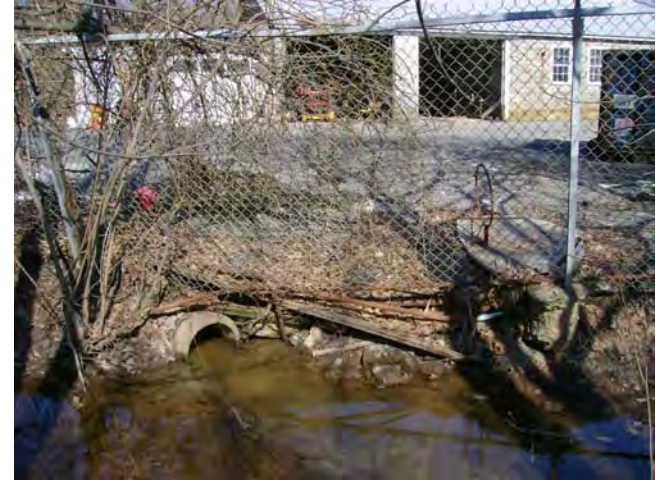
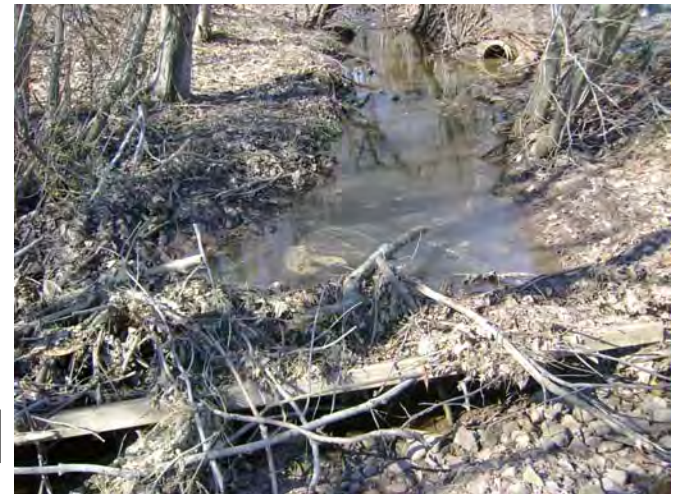
# J – Township Historic Bldg & Public Works Yard

Discharge pipe, 3-4 ft eroded  
banks, runoff, & debris

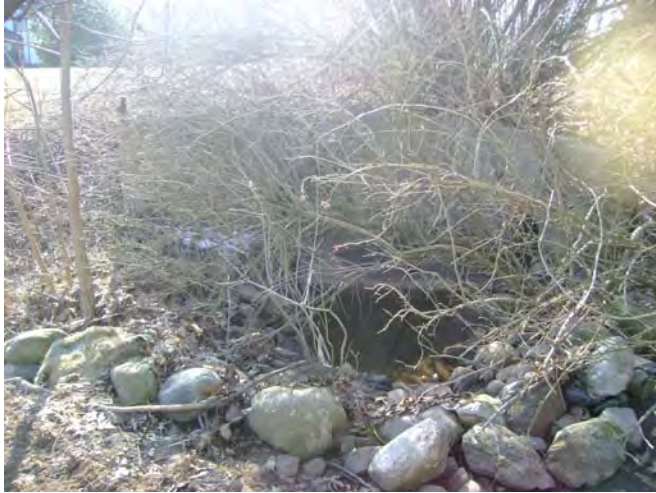
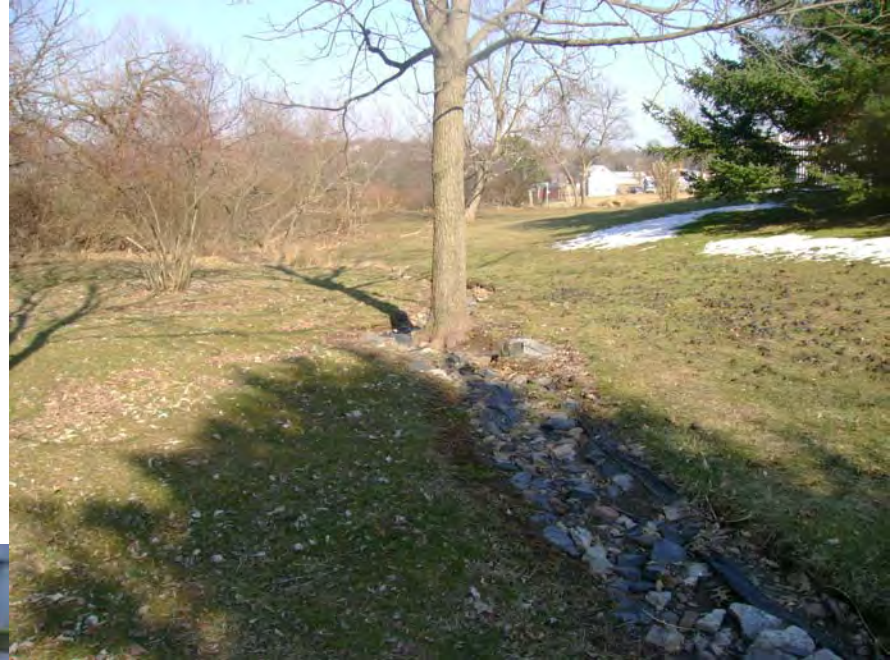
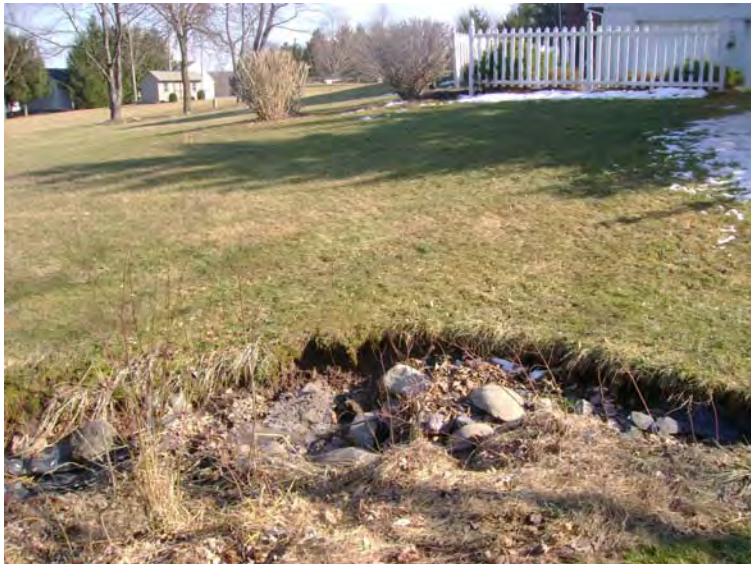
# Reach J – Wolf Farm Development

A large 48-inch stormwater culvert crosses under Wolf Farm Road, and slight erosion of the downstream tributary was noted. Stormwater for the development is directed via street storm sewers to a wetland stormwater basin in the corner of Stonebridge Road. Previous regulations allowed this basin to be privately owned and maintained, and significant maintenance to remove vegetative growth from the outfalls is needed (Block 21, lot 29.12). Downstream of this outfall stream banks were eroded by 2-4 feet on both sides, just upstream of the Main Street crossing. Evidence of high fast flows, flooding, erosion and down trees were also noted downstream of Main Street (Block 21, lot 19). Slight erosion (2 feet) was observed downstream from the crossing with Perryville Road. New and older homes in the area rely on septic systems that may be impacting stream water quality, and significant brown algae growth was noted in the stream Reach J up and downstream from Main Street. PVC pipes discharging to the stream were observed, and are likely from sump pumps.

Maintenance on outfalls,  
eroded banks, voluntarily  
reduce mowing &  
increase stream buffers

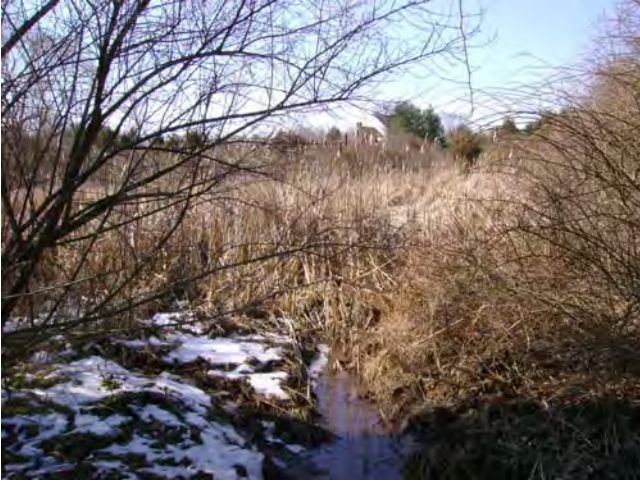
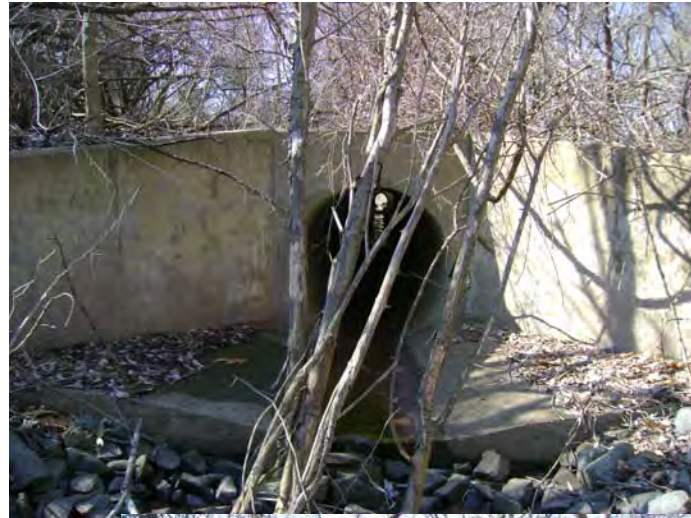
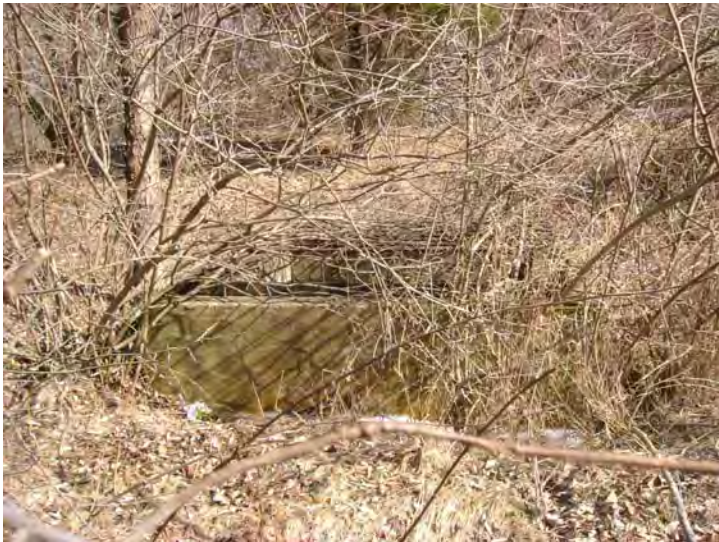
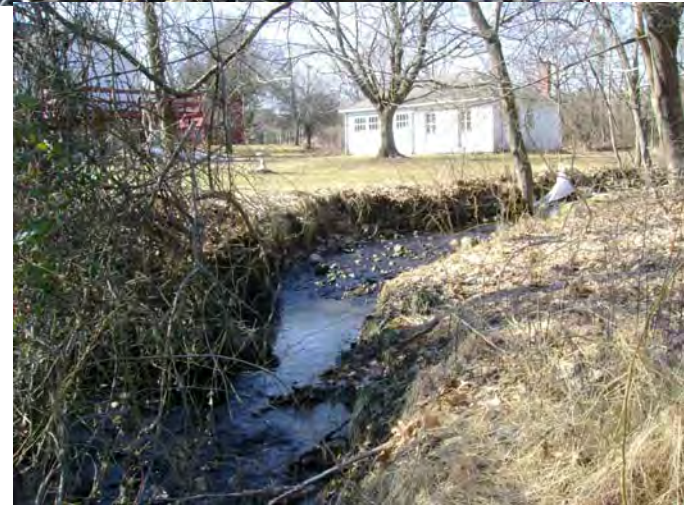
# J- Wolf Farm Basin & Outfalls

**Outfall maintenance needed, protect stream buffers & address eroded stream banks. Algae prevalent in stream.**

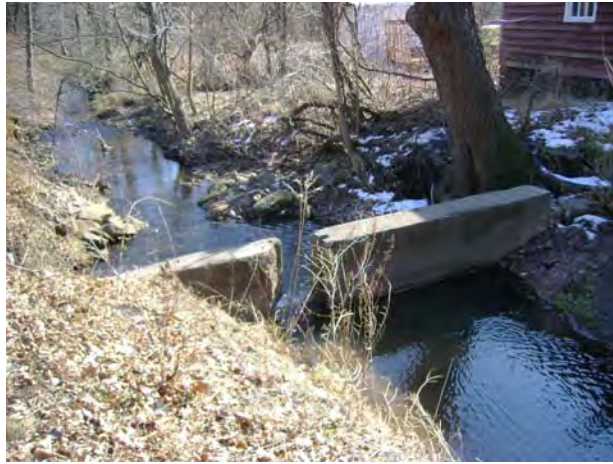
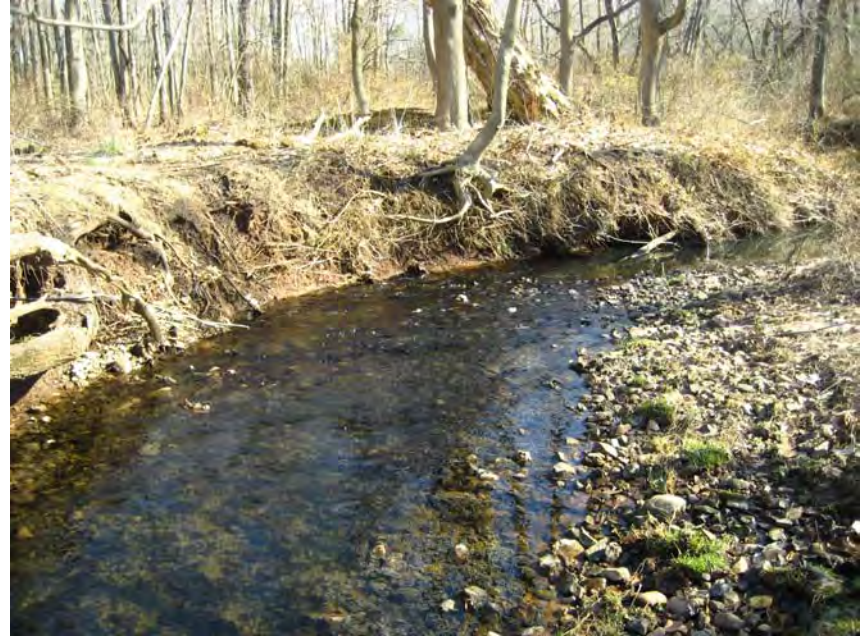
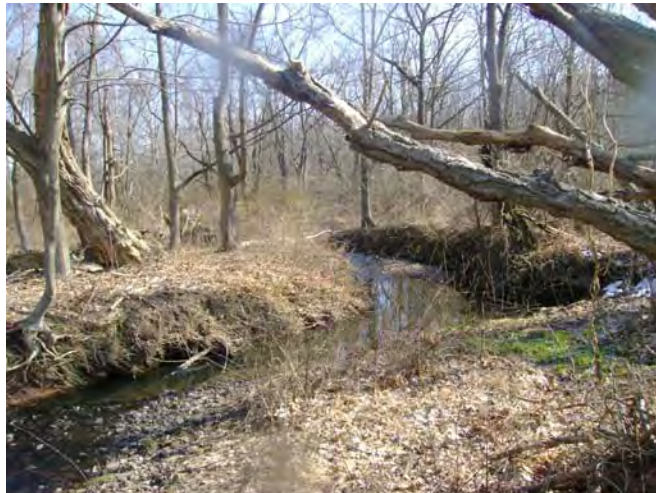
# J – Downstream Main Street

Address eroded stream banks, flooding concerns, prevalent algae, increase stream buffers.

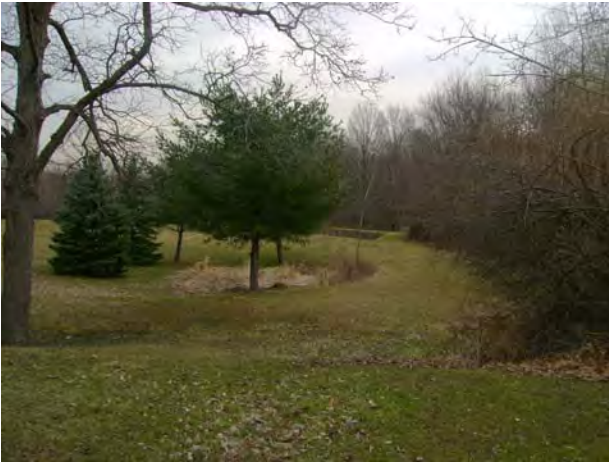
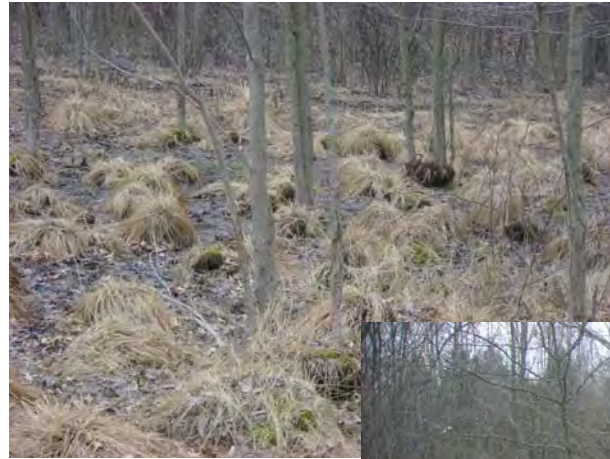
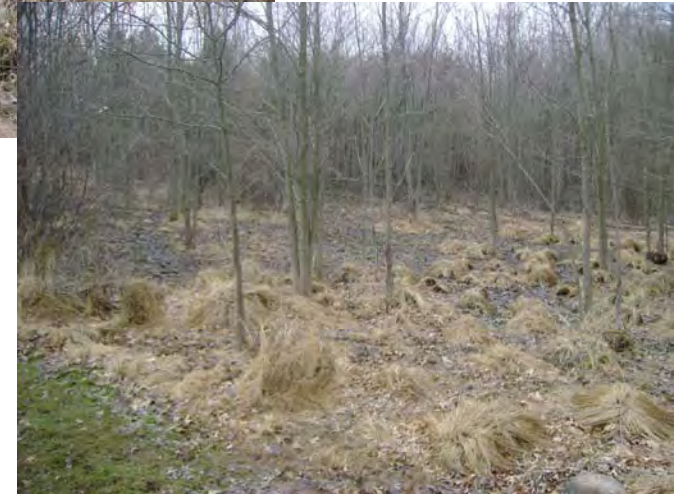
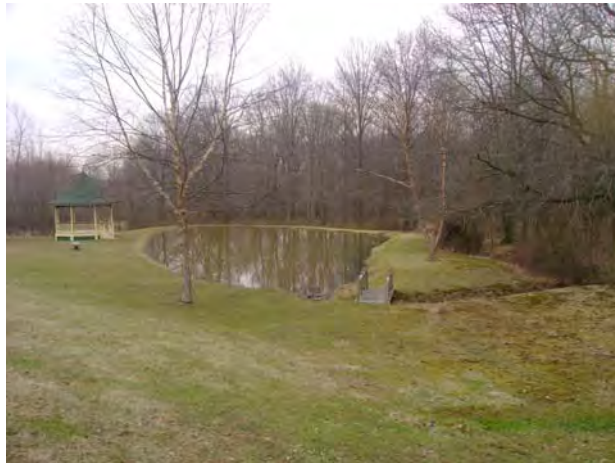
# Reach K Tributary – Kenneth Place

- **Newly mapped KT2 tributary**
- **SW basin & private pond- geese & deer present**
- **Possible bog turtle habitat – reduce mowing.**

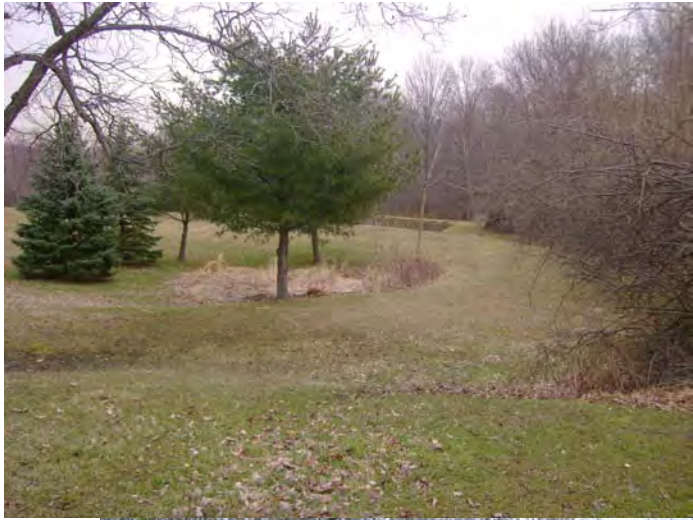
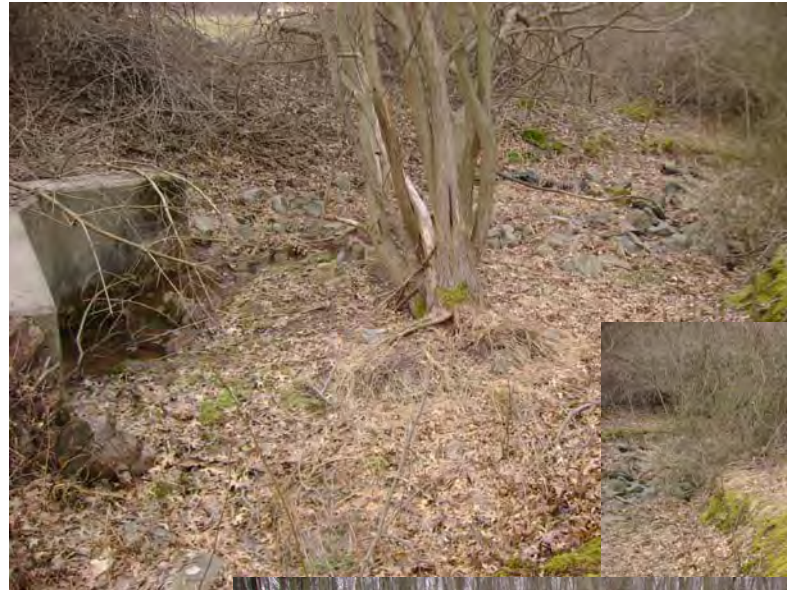
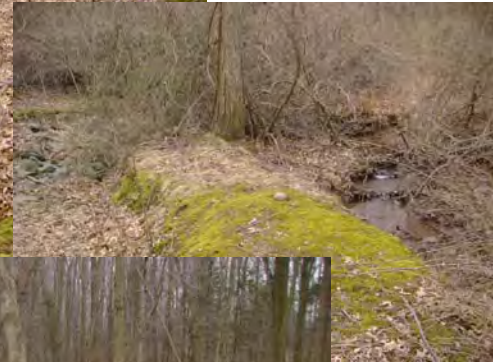
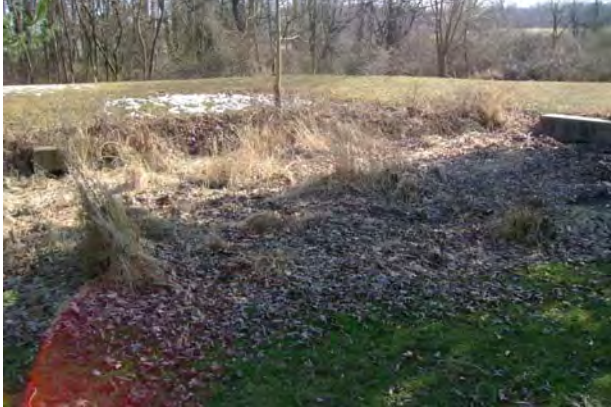
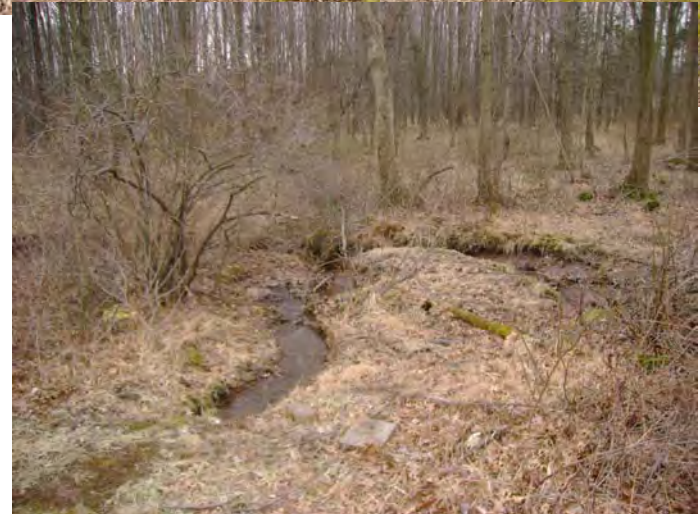
# KT2 Tributary – Kenneth place

Address basin & outfall maintenance, eroded stream bank, reduce mowing.

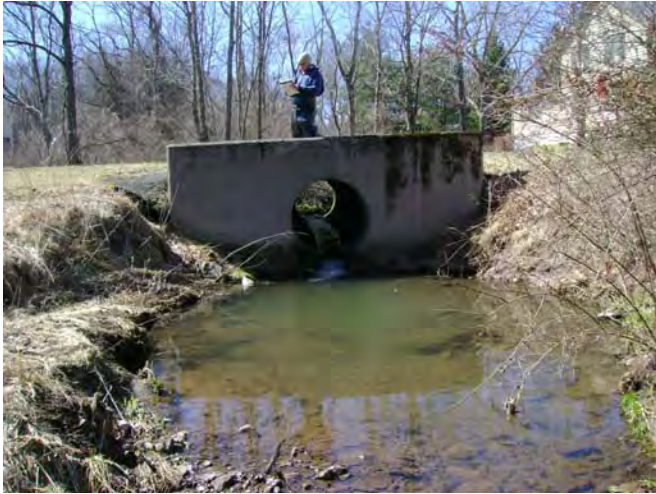
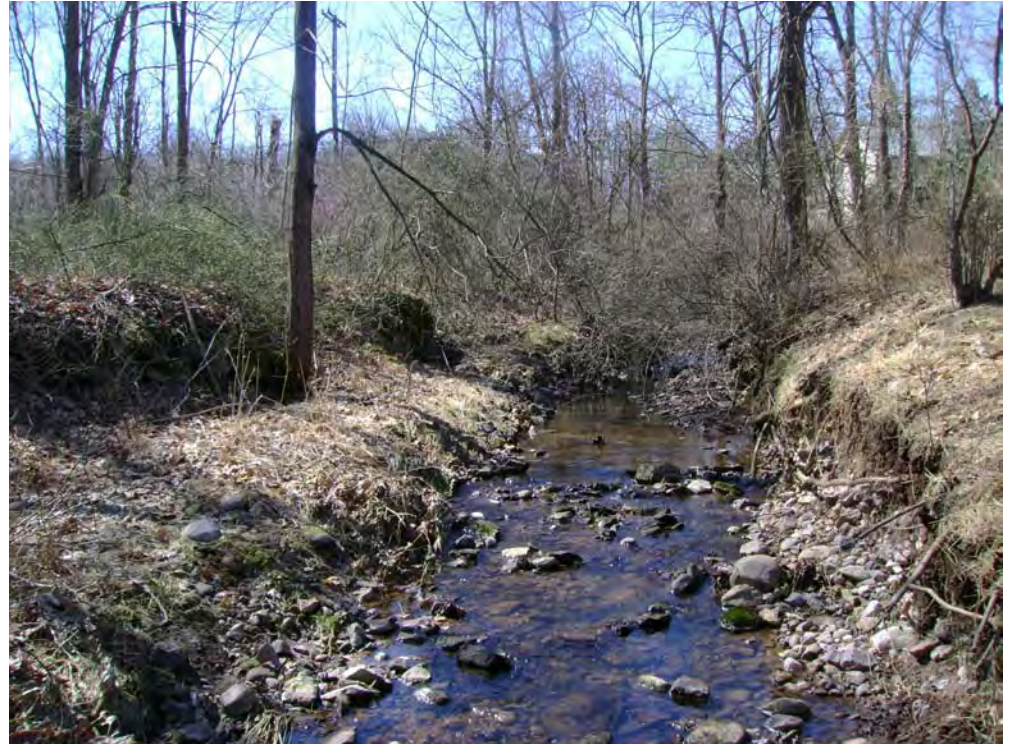
# KT2 Tributary at Finn Rd

- 48 inch culvert,
- significant 2-3 ft eroded streambanks on both sides.
- Historic landfill on right stream bank

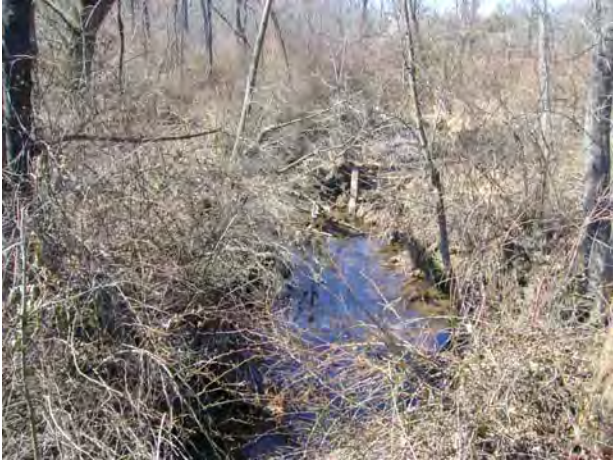
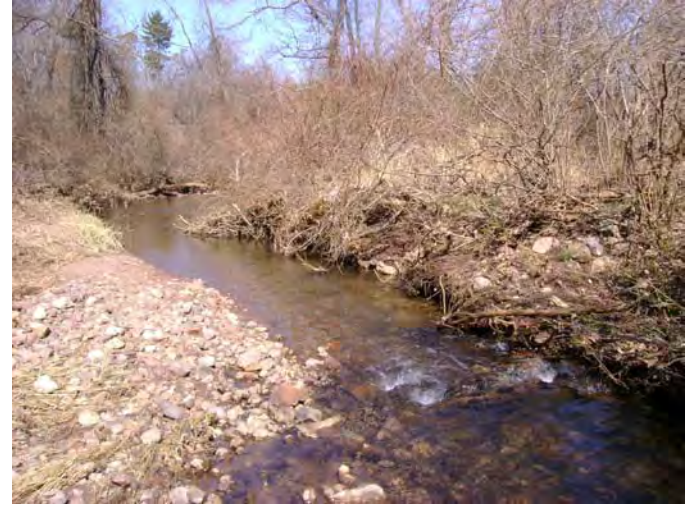
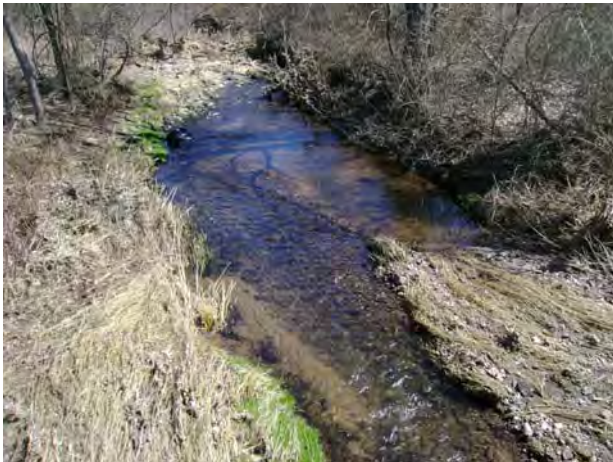
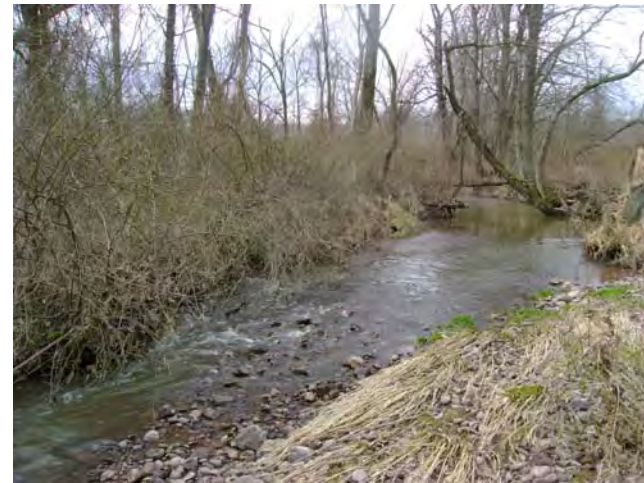
# Reach J at Perryville Rd

**Stream receives high storm flows, loose substrate, some erosion and deposition, intact forested buffer and floodplain. Fish present.**

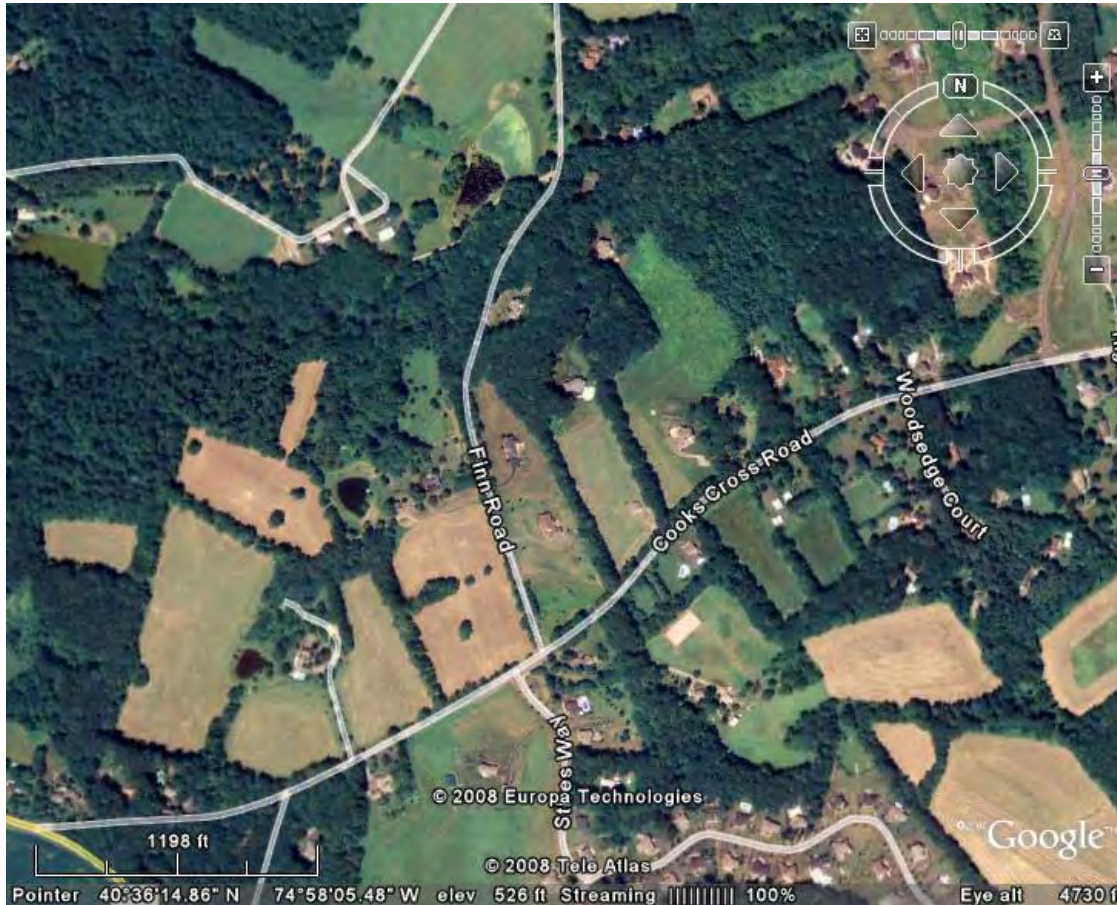
# Reach I – Series of 4 Ponds

- Reach I includes a series of 4 ponds with 2-3 ft eroded stream banks below each outfall, possibly caused by high volume discharges.
- Each pond becomes turbid after storms.
- Stream Buffers include intact forests and wetland habitats.

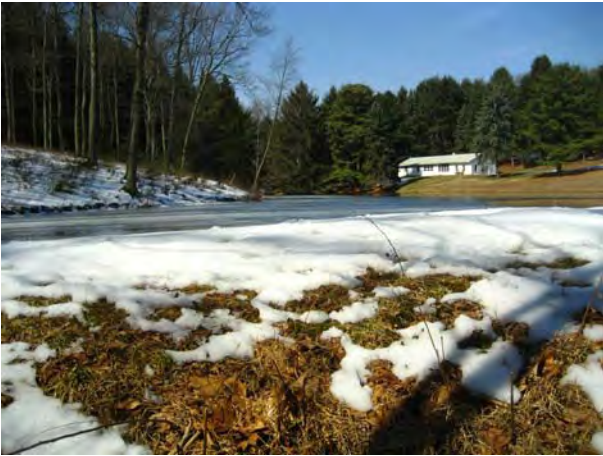
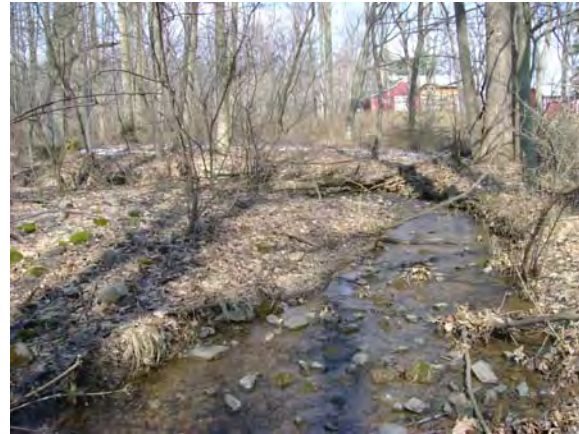
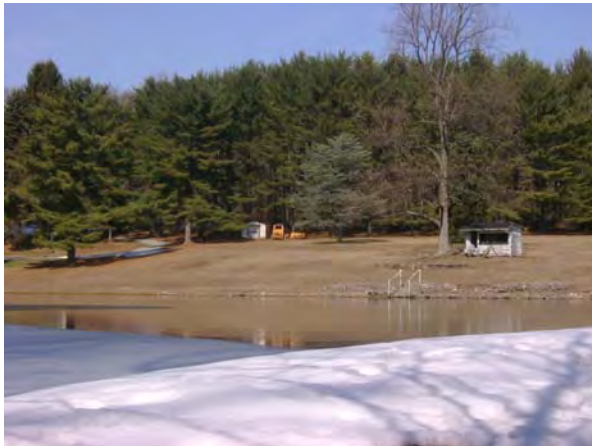
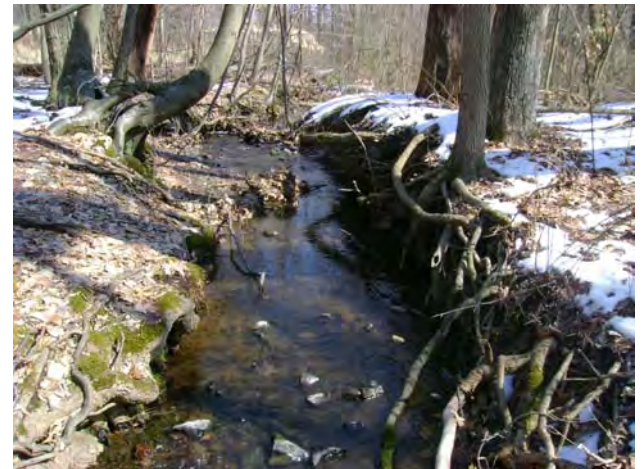
# Reach I- Pond #1

Pond #1 is >2 acres with a 2 ft outfall and 2-3 ft eroded stream banks below the outfall, possibly caused by high discharges. Stream Buffers include intact forests and wetland habitats.

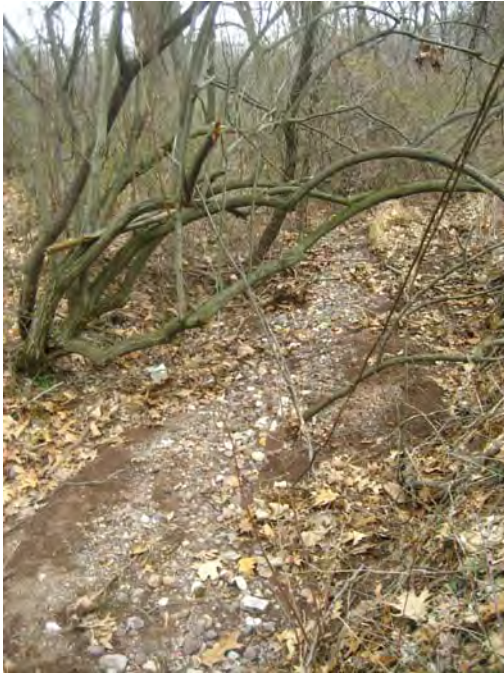
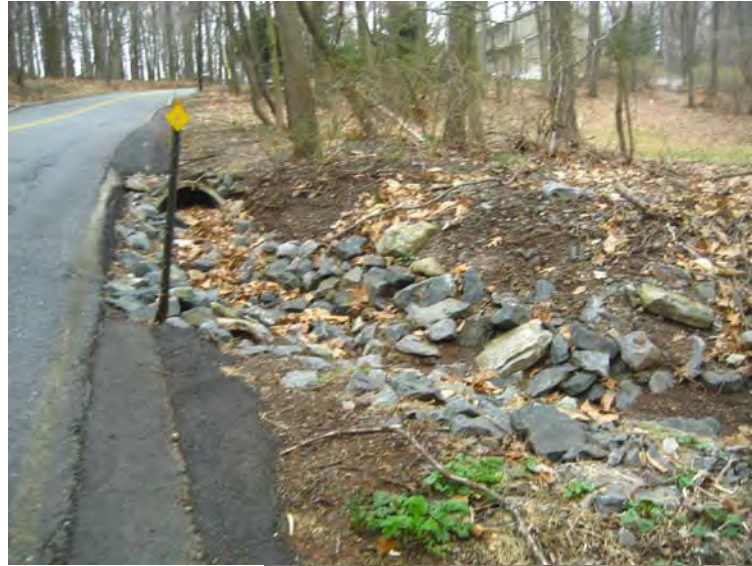
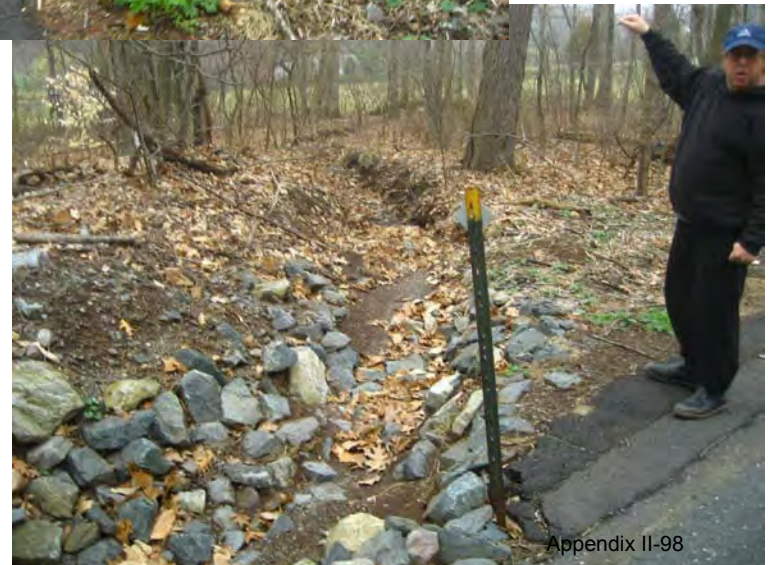
# Reach I –Cooks Crossing Rd Goldberg Farm

Runoff from Cooks Crossing Rd causing erosion, pond turbidity and flooding downstream.

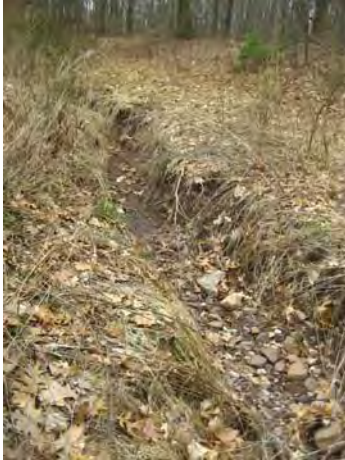
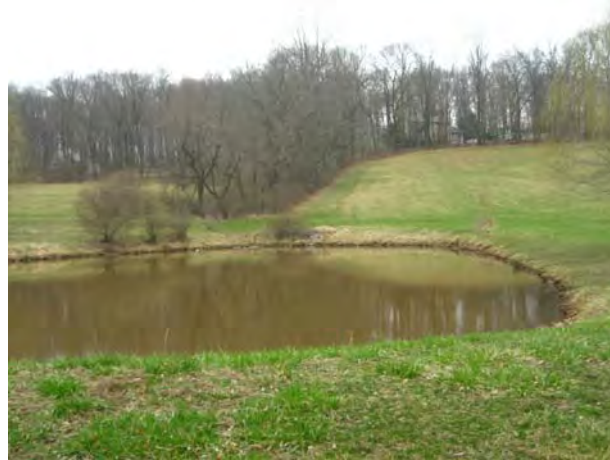
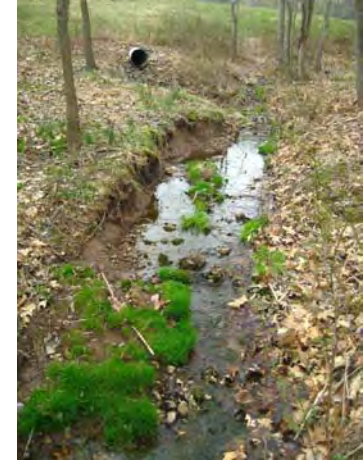
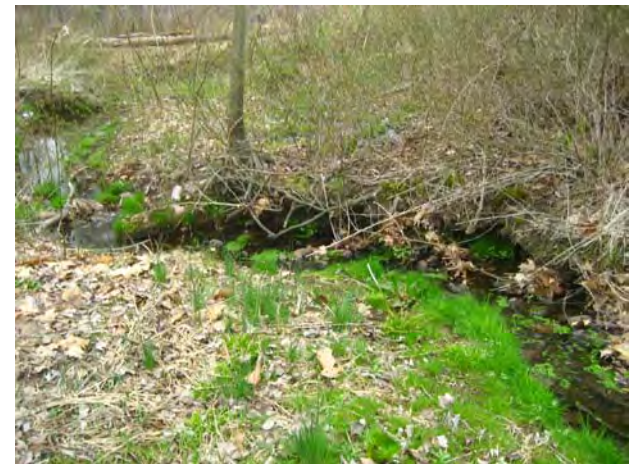
# Reach I – Pond #2

1-2 ft eroded tributaries to  
pond and after pond.

Pond becomes muddy or  
turbid with sediment after  
each rain.

Geese present at pond.

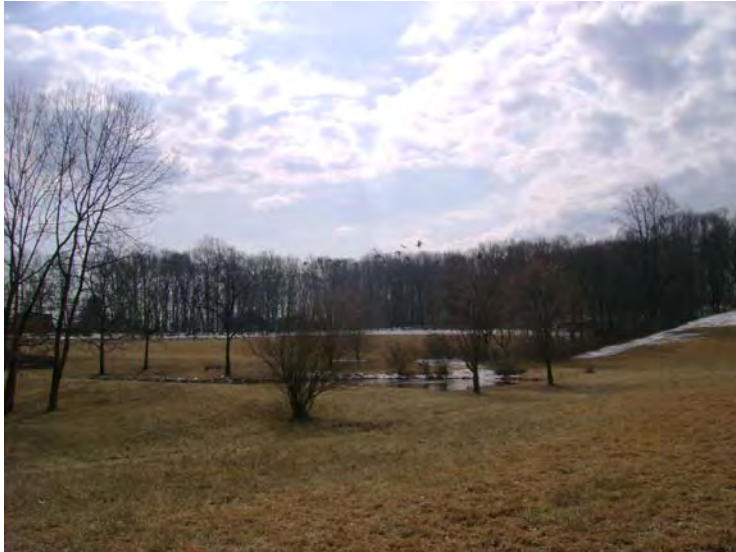
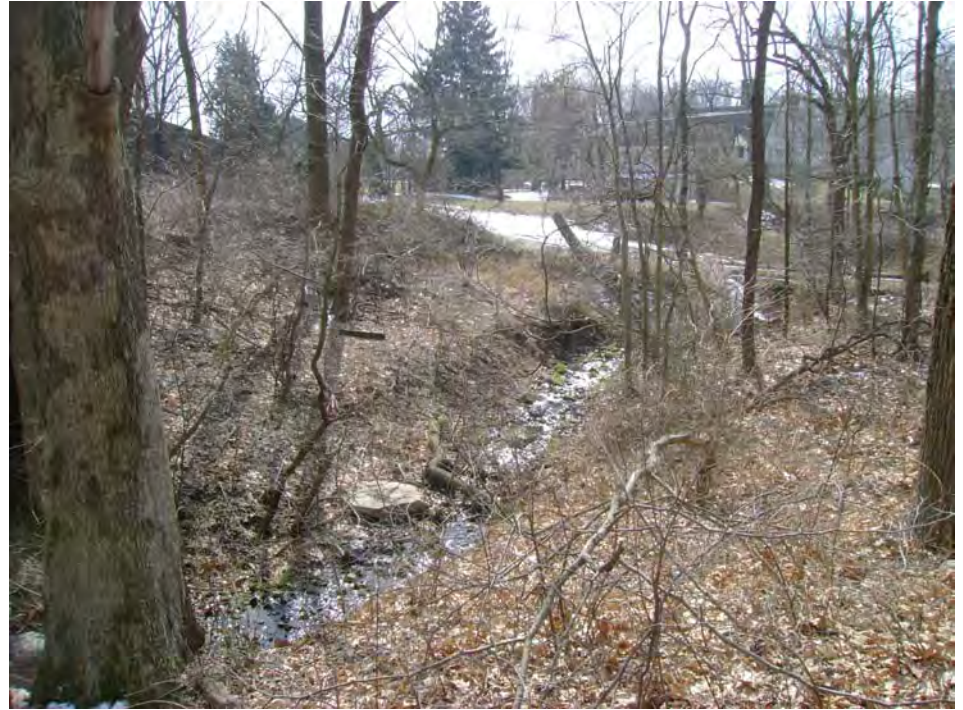
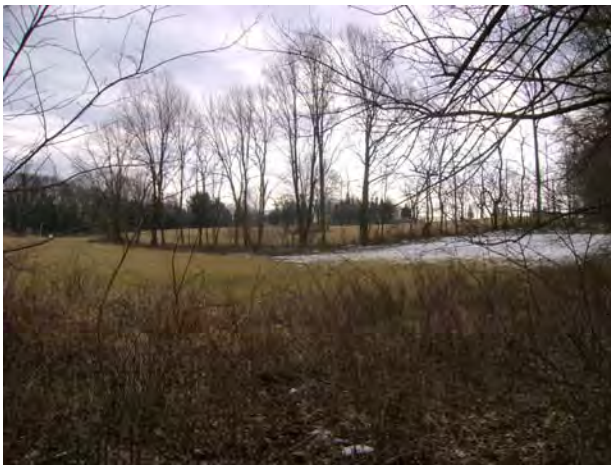
# Reach I- Downstream of Pond #2

Reach I includes 2-3 ft  
eroded stream banks  
below pond #2.

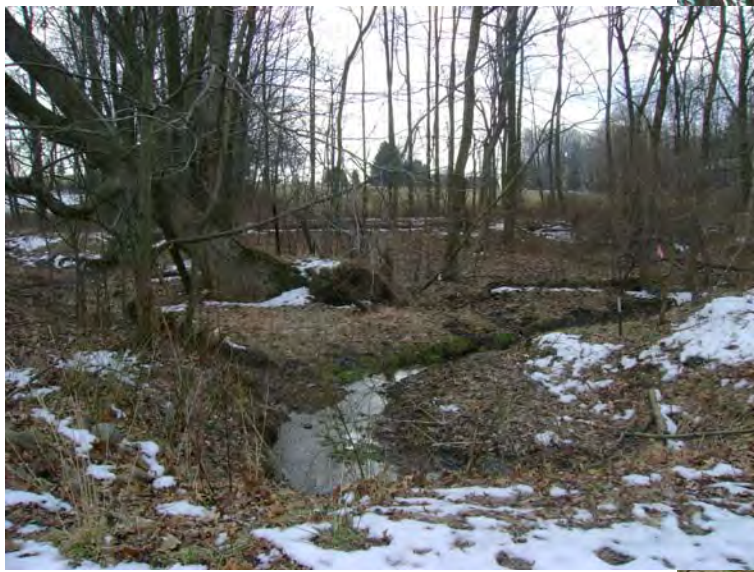
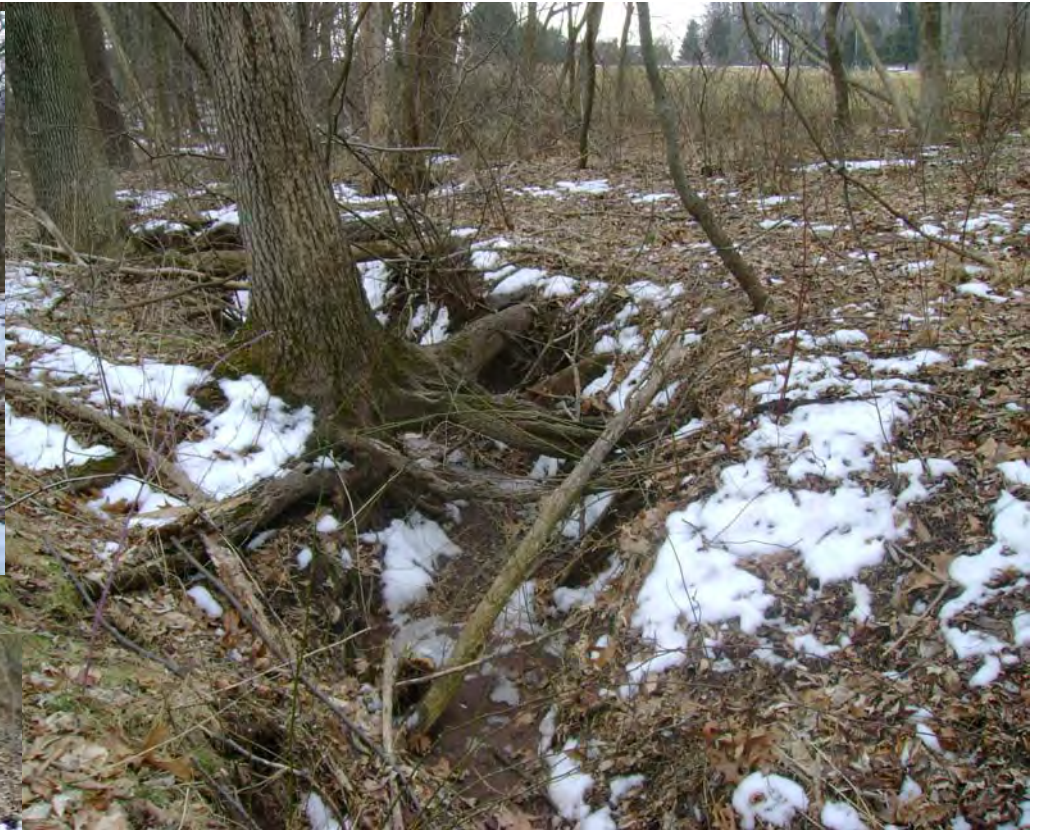
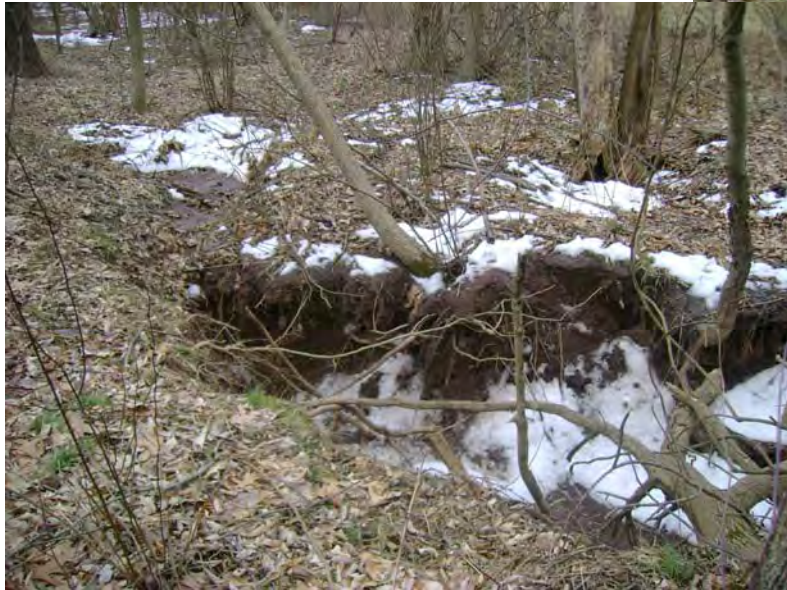
# Reach I – Upstream of Pond #3

**Tributary receives runoff from Cooks Crossing Rd & farm fields. Runoff is eroding or undermining tree line, and adding silt to pond #3.**

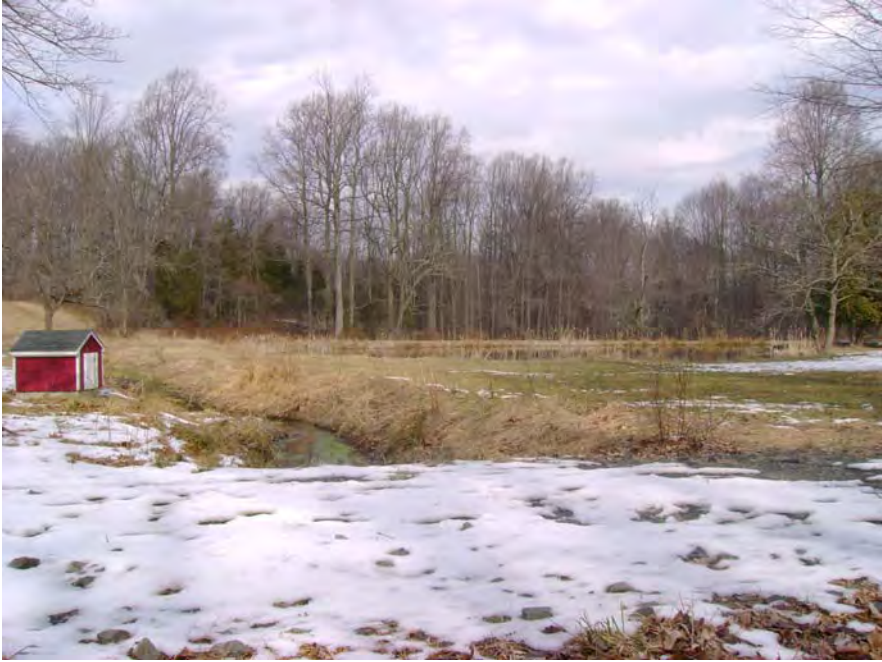
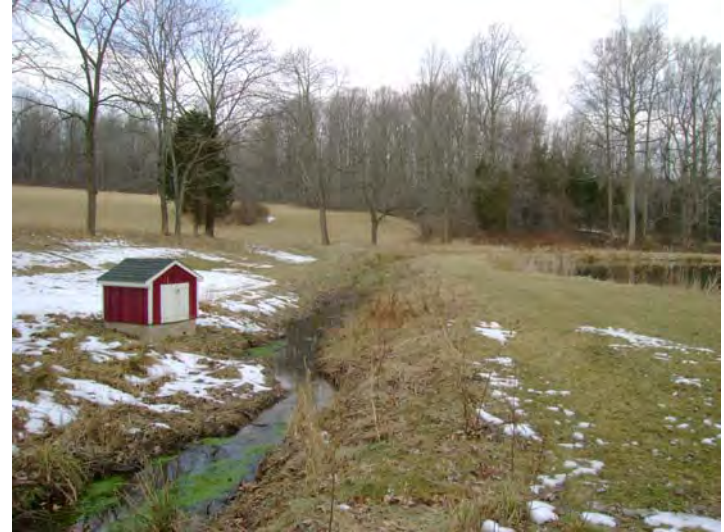
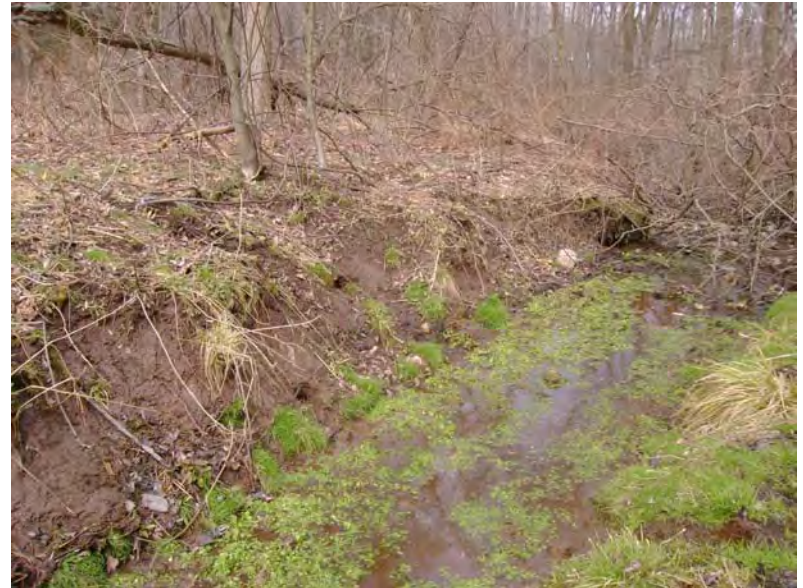
# Reach I- Pond #3

**Extensive erosion (2-3 ft) was noted throughout this segment, both above and downstream of the pond and outfalls. Steep slopes and high runoff from fields & pond contribute to the erosion.**

**Geese & duckweed present along pond and downstream.**
