# **THE SIDNEY BROOK WATERSHED PROTECTION PLAN**

HUC-14 02030105020070 Raritan River South Branch (River Road to  
Spruce Run)

**Princeton Hydro, LLC  
1108 Old York Road  
Suite 1, Post Office Box 720  
Ringoes, NJ 08551  
908-237-5660**

**June 2010  
Revised December 2011  
Revised May 2012**

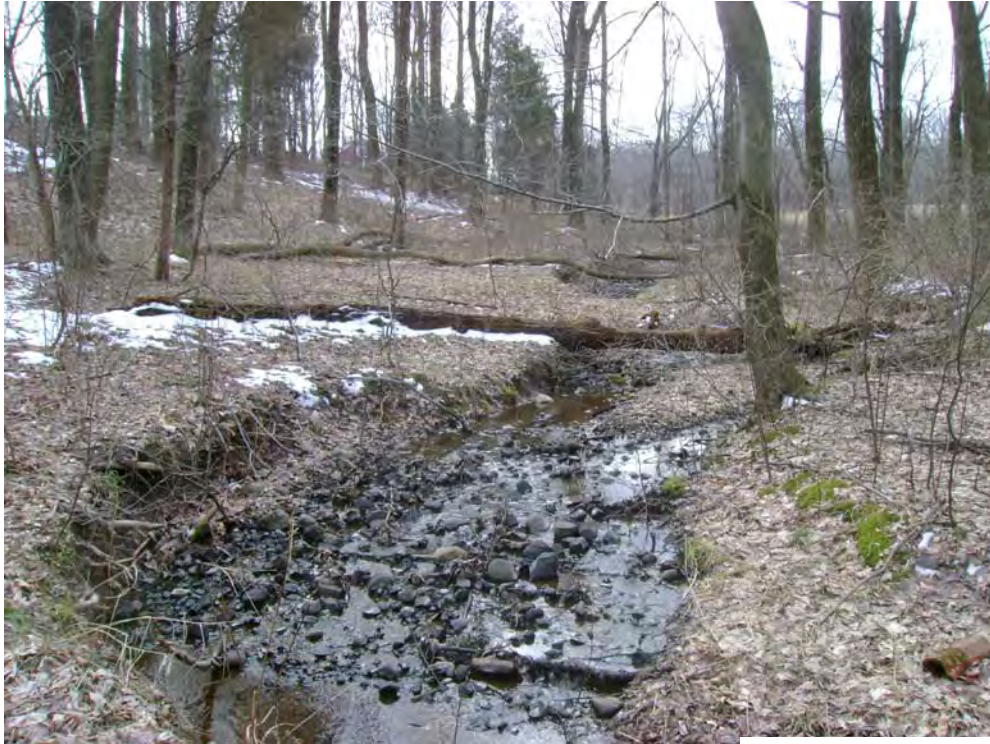
**Extensive erosion (2-3 ft) was noted throughout this segment, above and downstream of pond #3.**

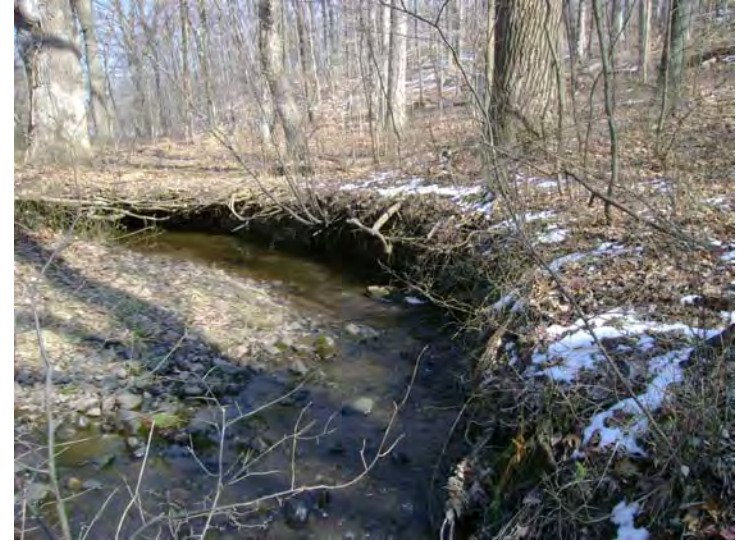
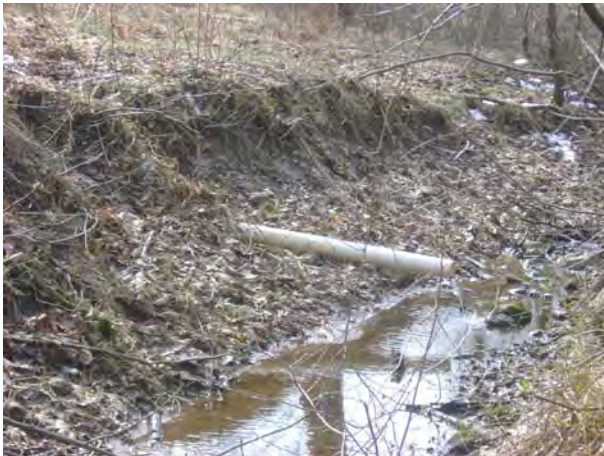
# Reach I- Below Pond #3

**Steep slopes and high runoff contribute to the erosion, buffers are intact forests and wetlands.**

**A PVC Outfall was observed and foam was noted downstream.**

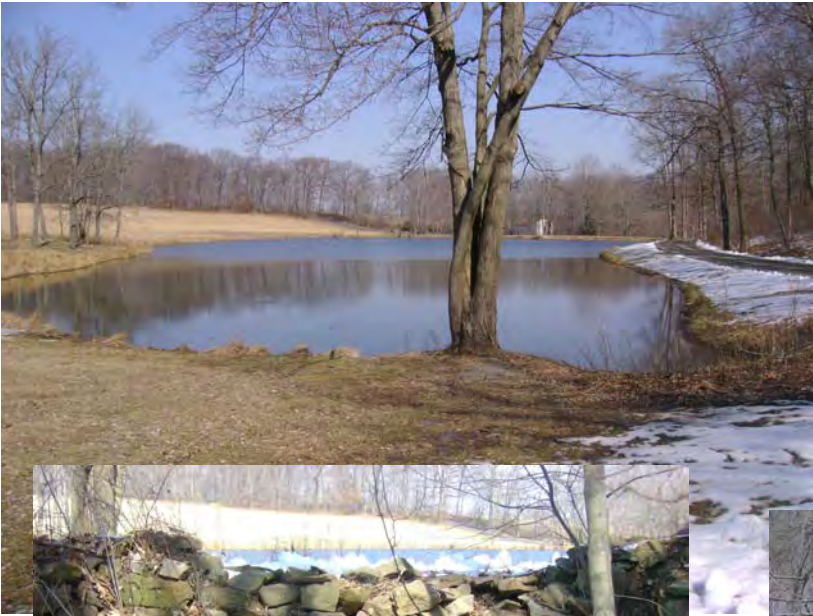
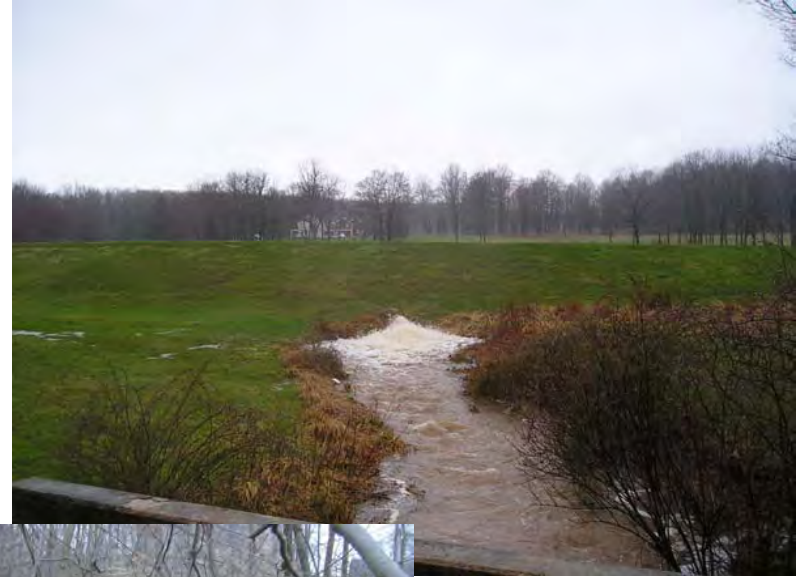
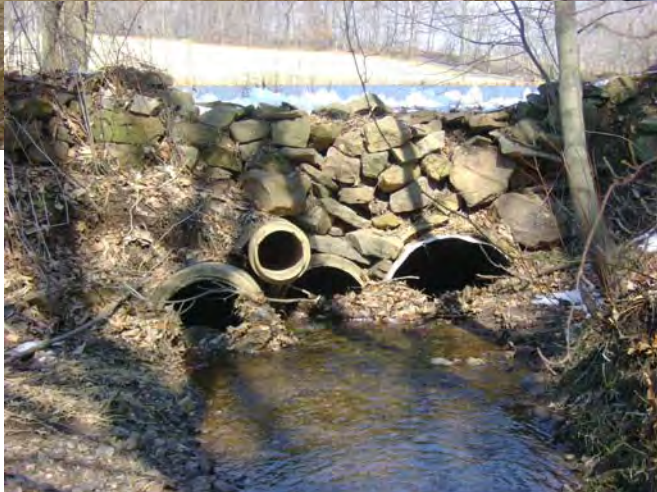
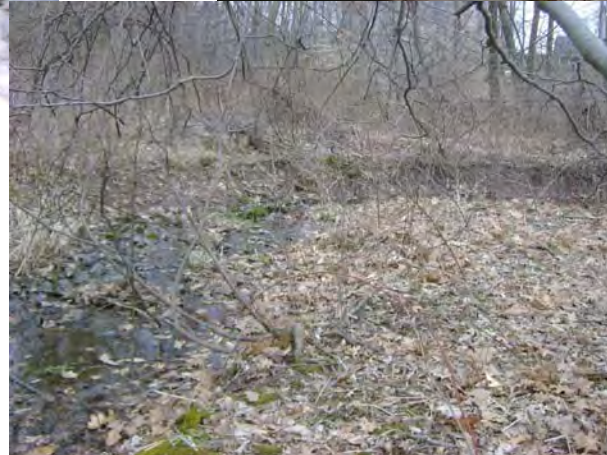
# Reach I – Finn Rd Pond #4

Land use by Pond #4 is primarily hayfields and flooding and erosion is evident downstream of the 2 ft outfall.

The inlets and dam for pond #4 may need repair. Each pond receives heavy sediment depositions from storm runoff.

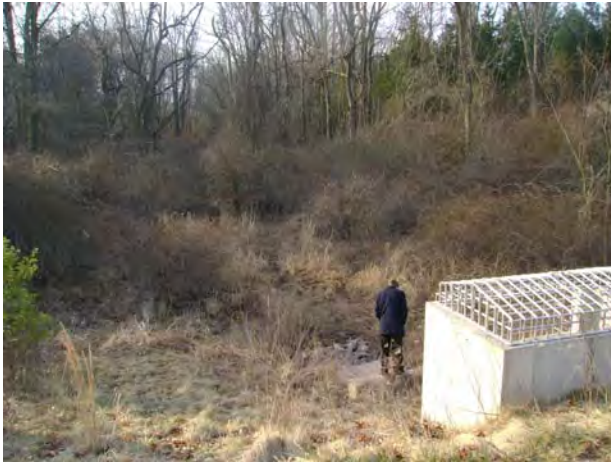
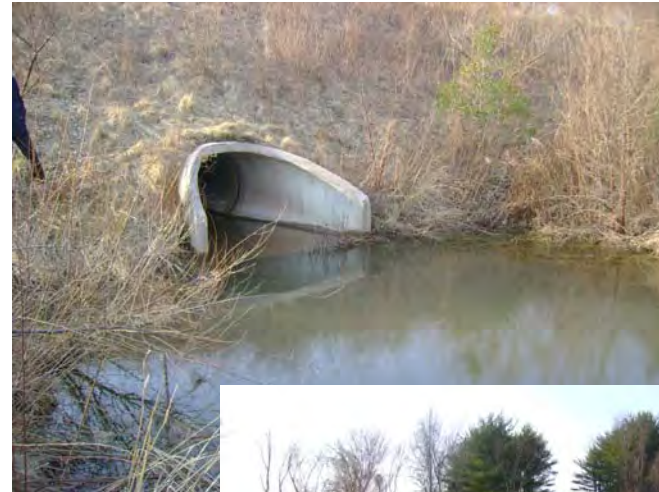
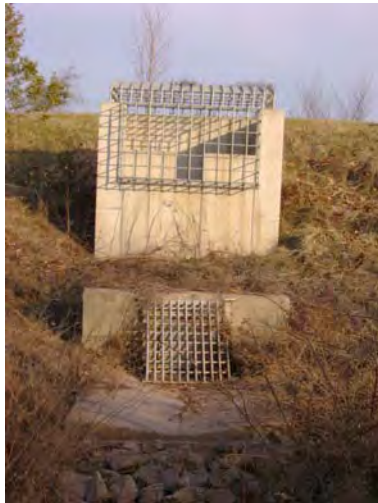
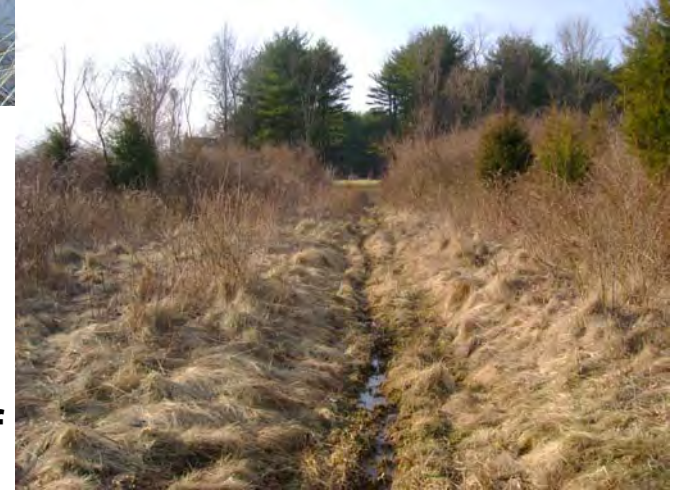
# Reach H Tributary 1

- **2 tributaries were mapped for Reach H**
- **Some runoff is retained by a created large wetland basin**
- **Some roadway runoff is directed to a long grassed swale without detention**

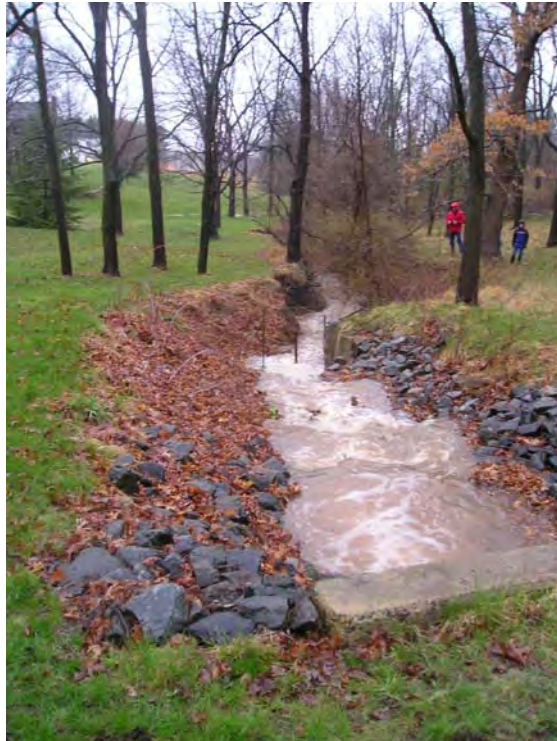
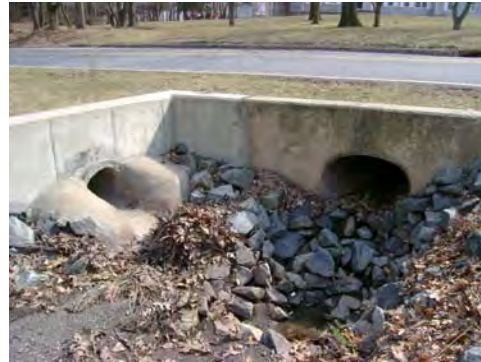
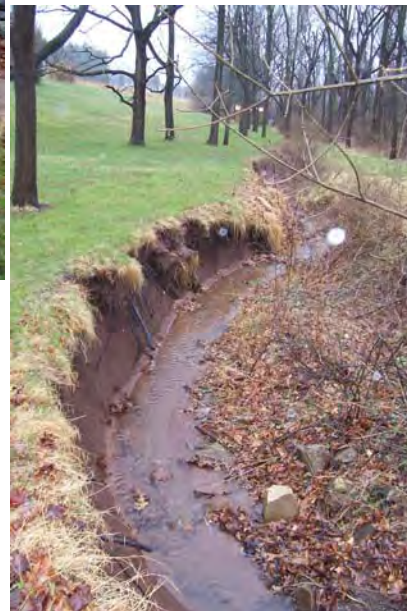
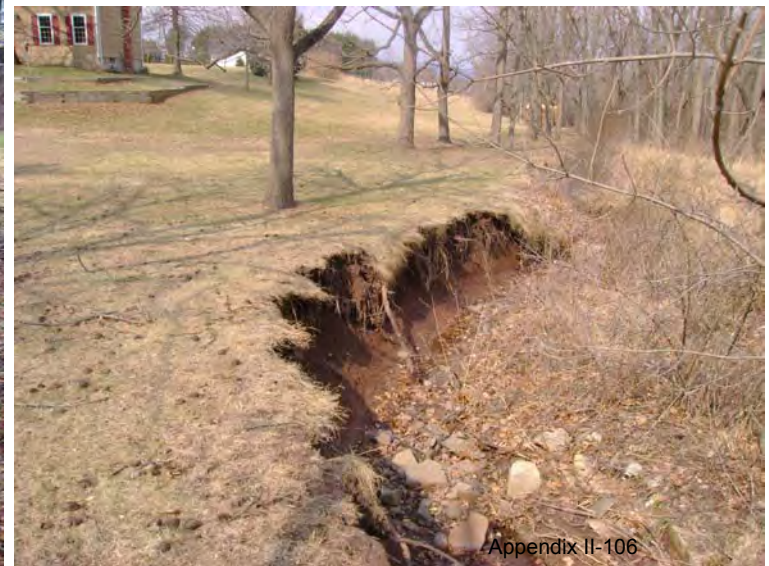
# Reach H Tributary 2

Over 8 storm sewer road inlets discharge to the outfall at High View Ct. with excessive flows and velocities, eroding the stream banks extensively.

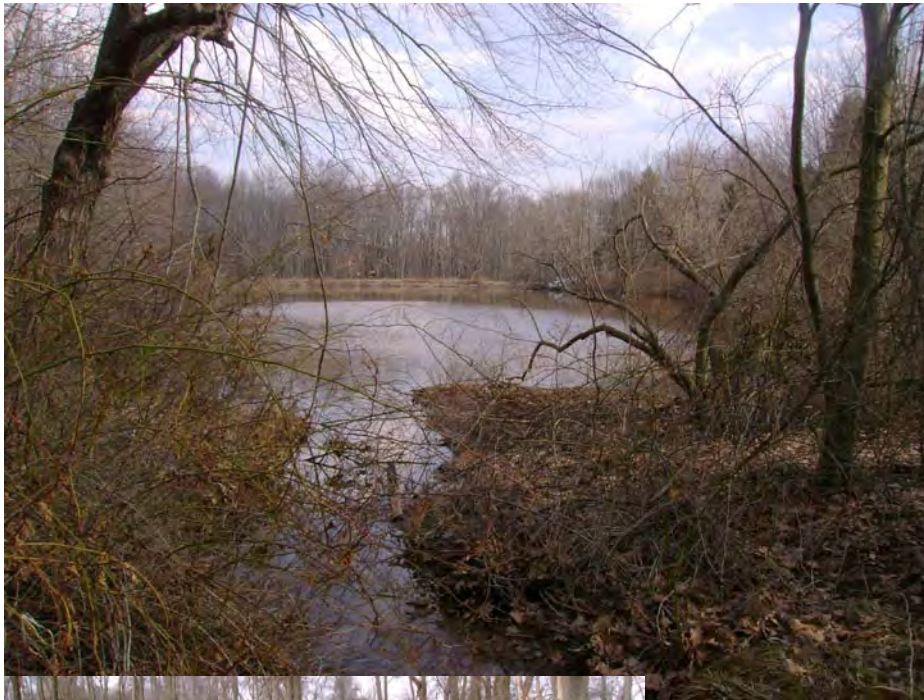
High runoff and erosion from Reach HT2 & High View Ct cause sediment depositions in the pond and cause additional downstream flooding & erosion.

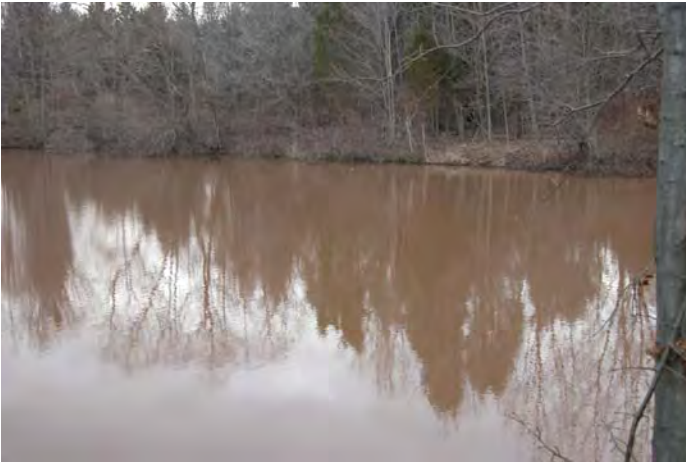
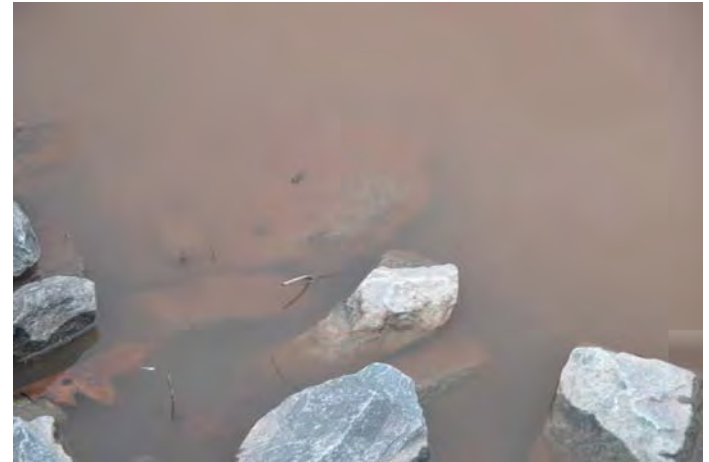
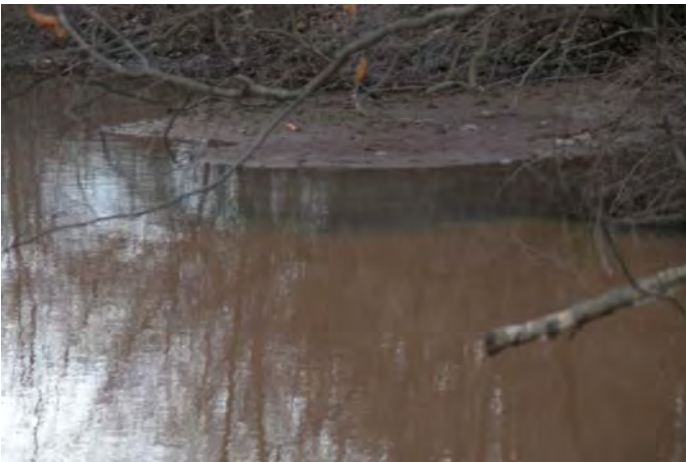
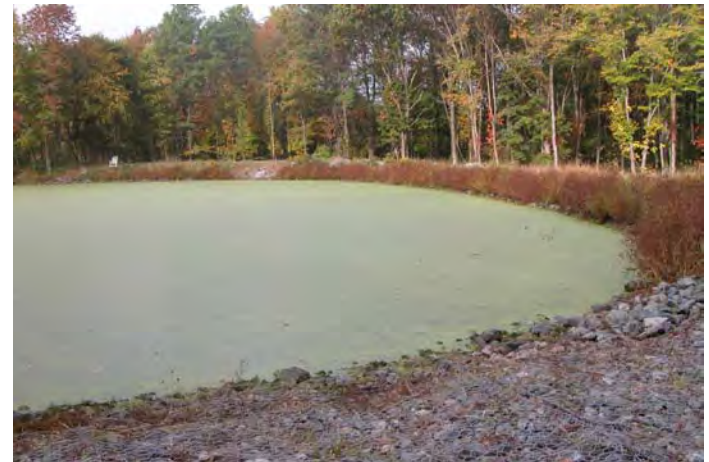
# Sanctuary Pond

**High runoff and erosion cause very turbid conditions in the pond, sediment depositions, and contribute to algal blooms each summer.**

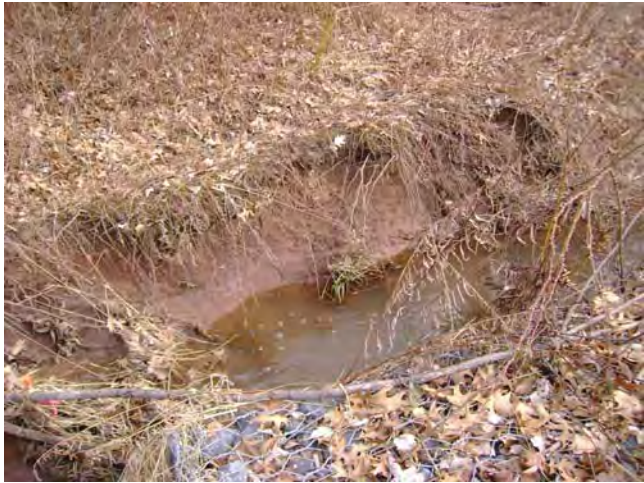
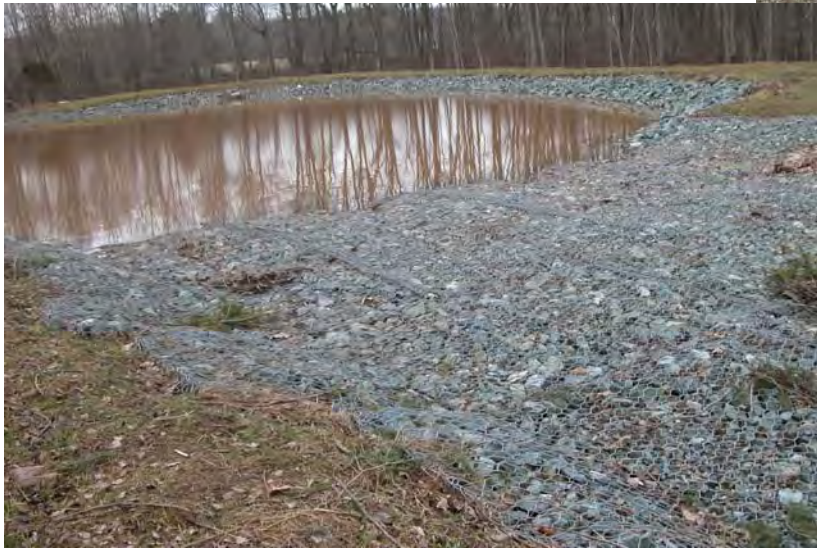
# HT2 Discharge from -Sanctuary Pond

**Runoff from High View Ct cause sediment depositions in the pond, and additional downstream erosion and flooding. Spillway improvements may be needed to reduce the frequent discharges over the spillway, causing additional erosion.**

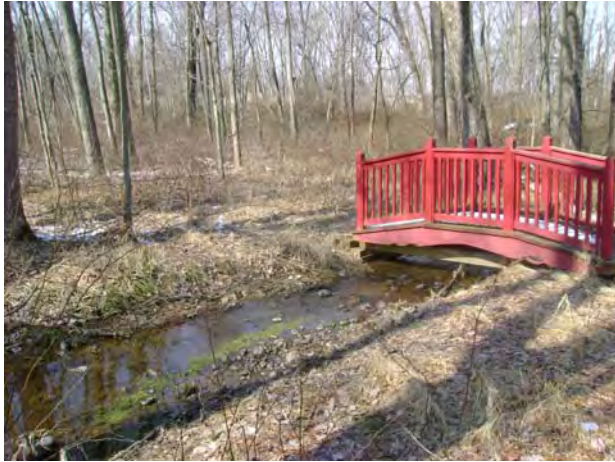
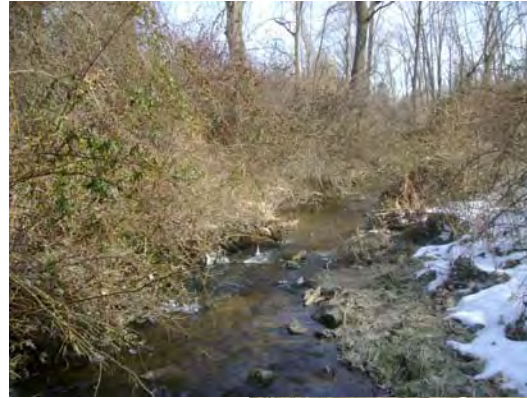
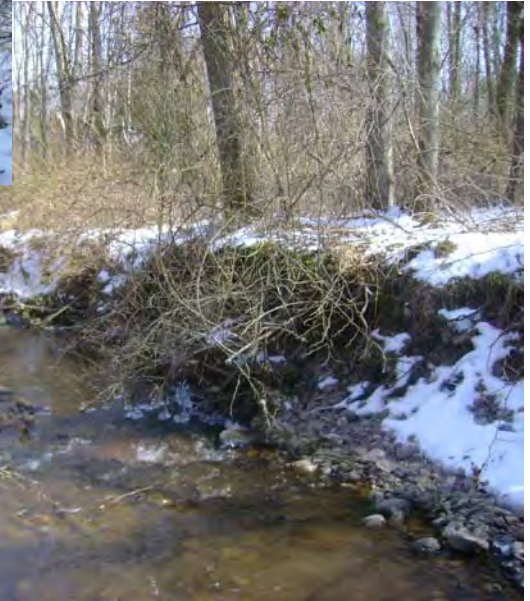
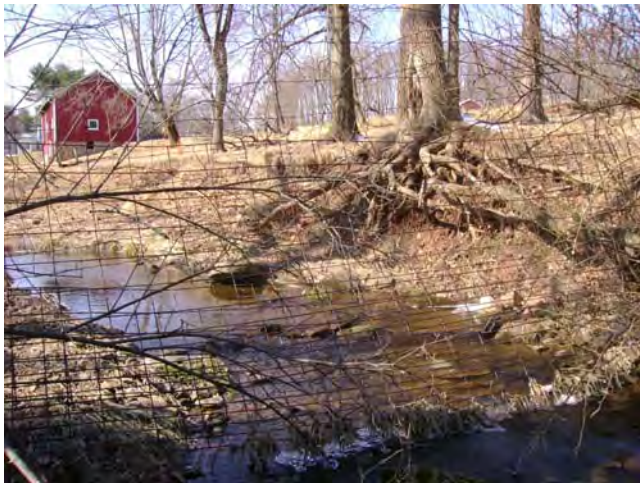
# Main Stem of Reach H Downstream of The Sanctuary

**High runoff from Reach HT2, High View Ct & the Sanctuary pond cause additional downstream erosion and flooding.**

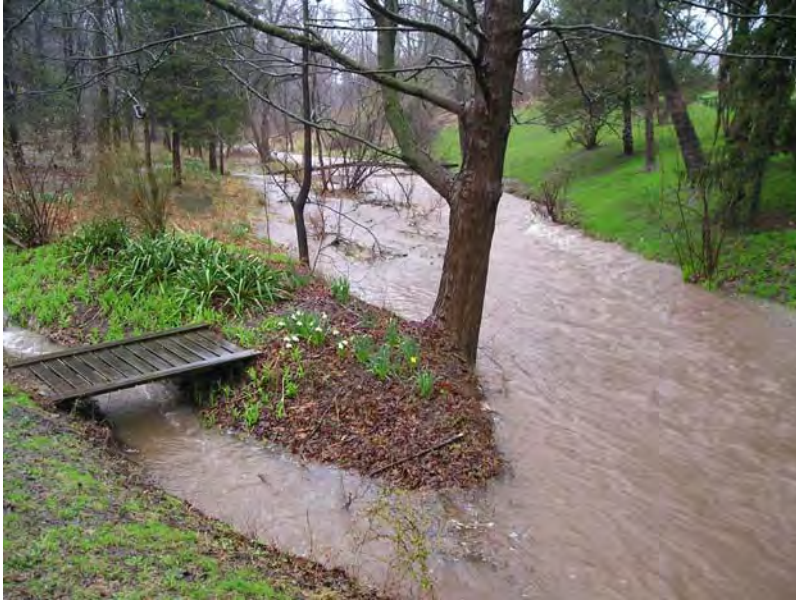
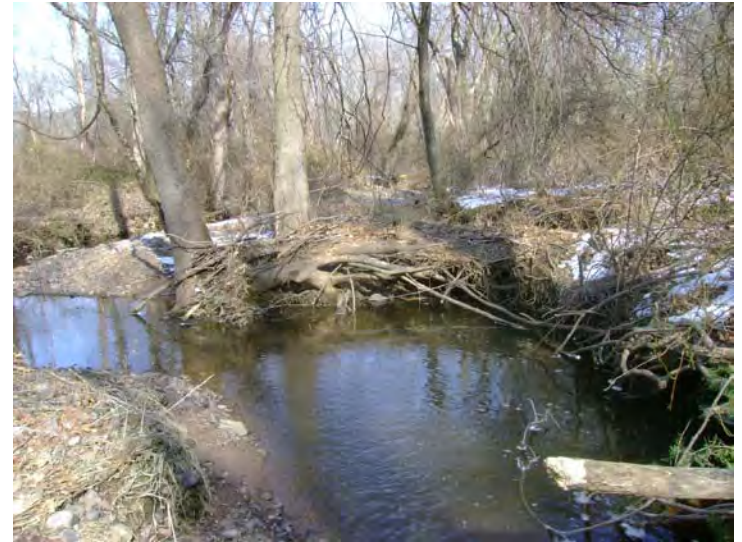
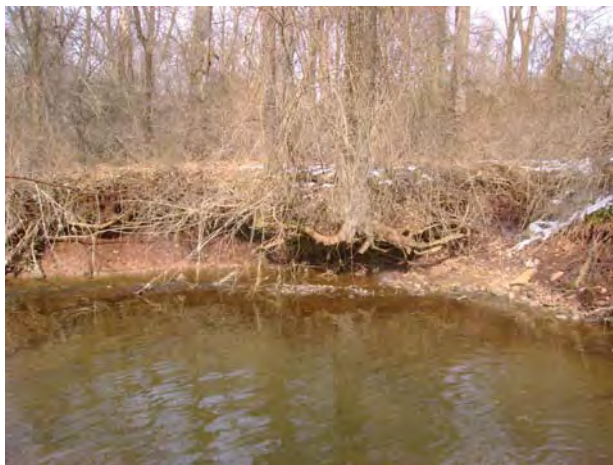
# Reach G – Perryville Rd Crossing

**High stormwater flows cause 2-3ft erosion and sediment deposition along Reach G.**

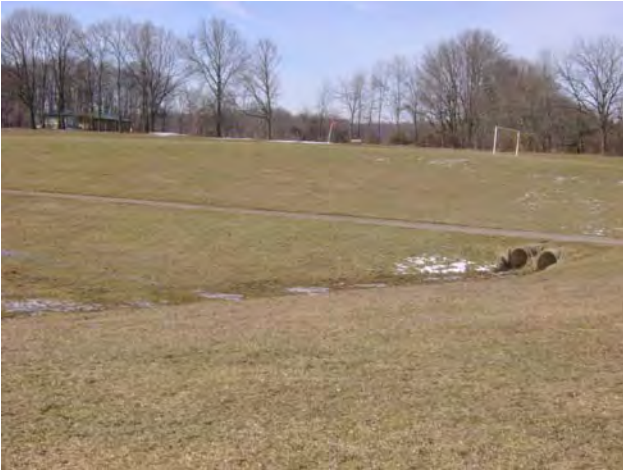
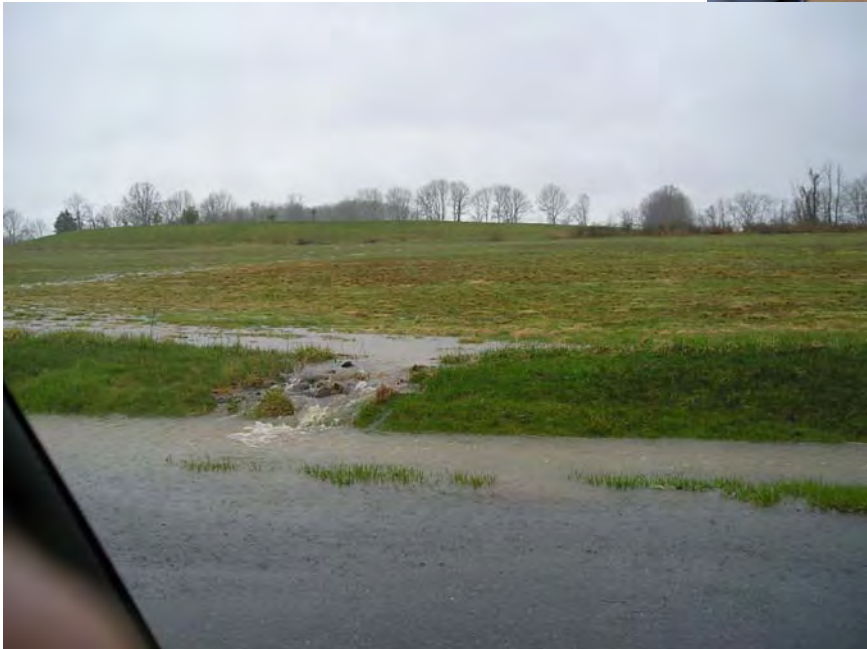
# Reach G -Finn Park & Perryville Rd

**Uncontrolled runoff from Finn Park causes significant flooding on Perryville Rd.**

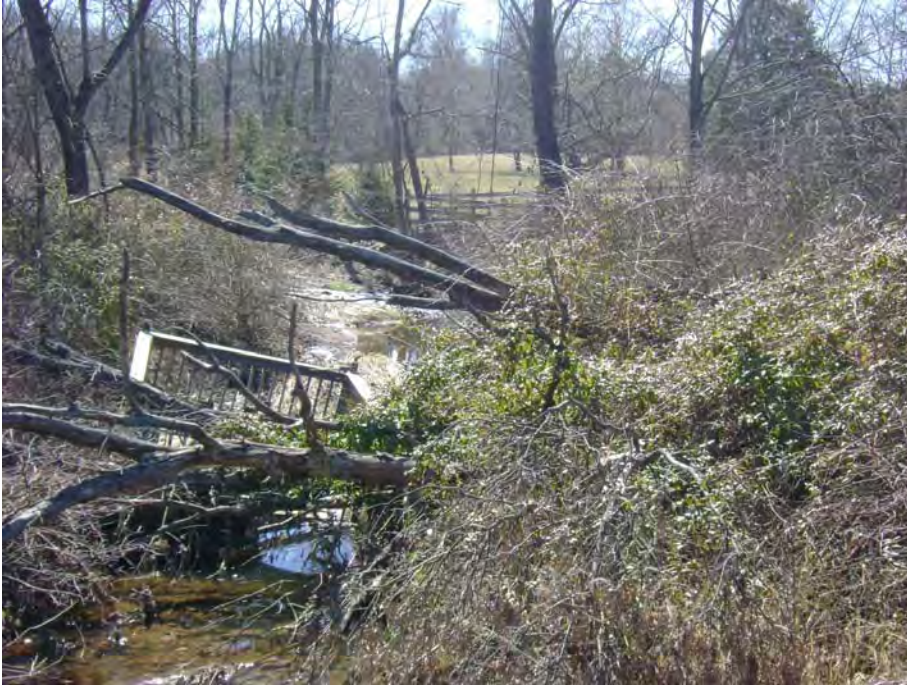
Flooding along Perryville Rd caused a deck to be washed into Reach G of Sidney Brook by Hill & Dale Rd.

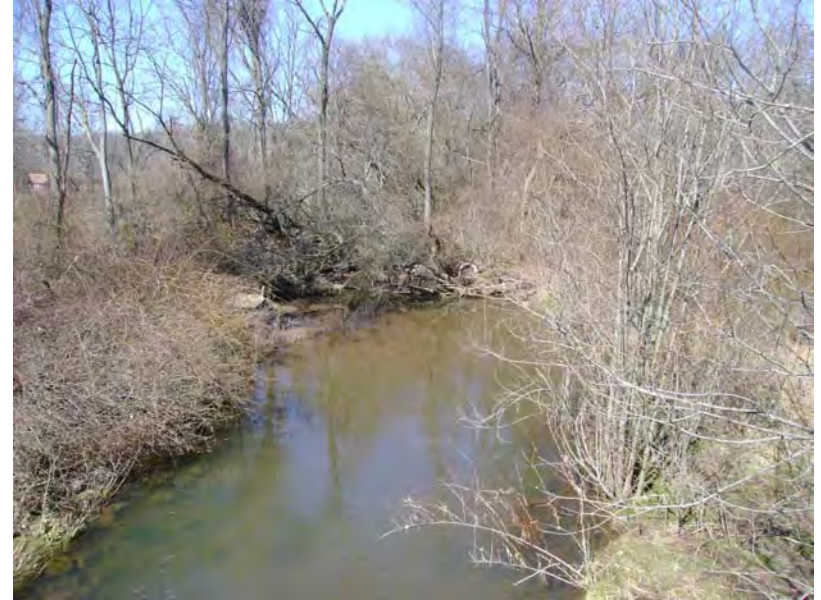
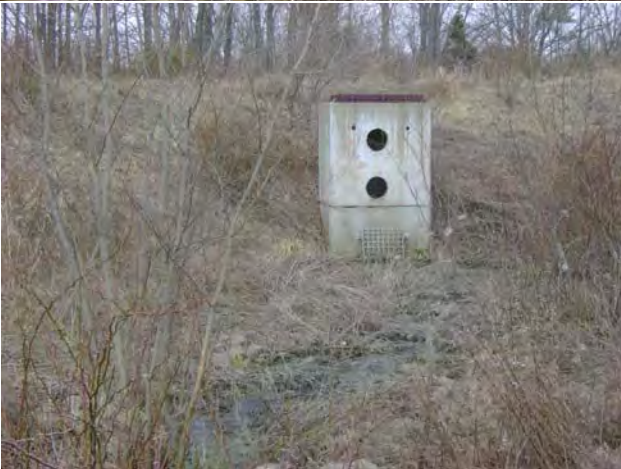
# Reach G- Crestview Development

Reach G has intact forested buffers, working retention basin, and a healthy stream morphology in this portions.

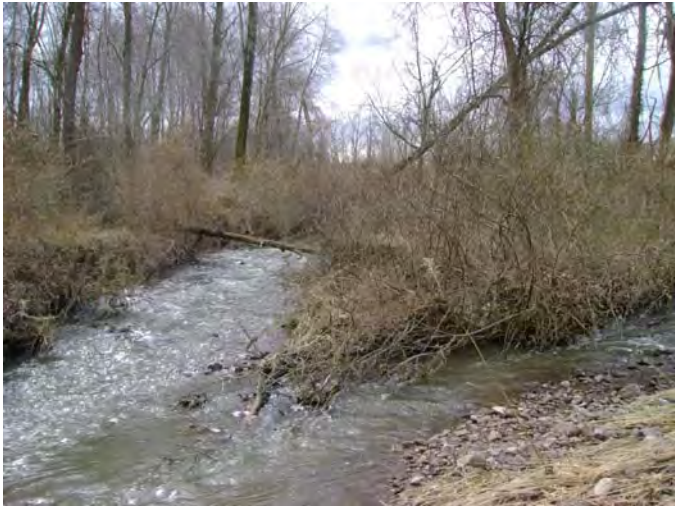
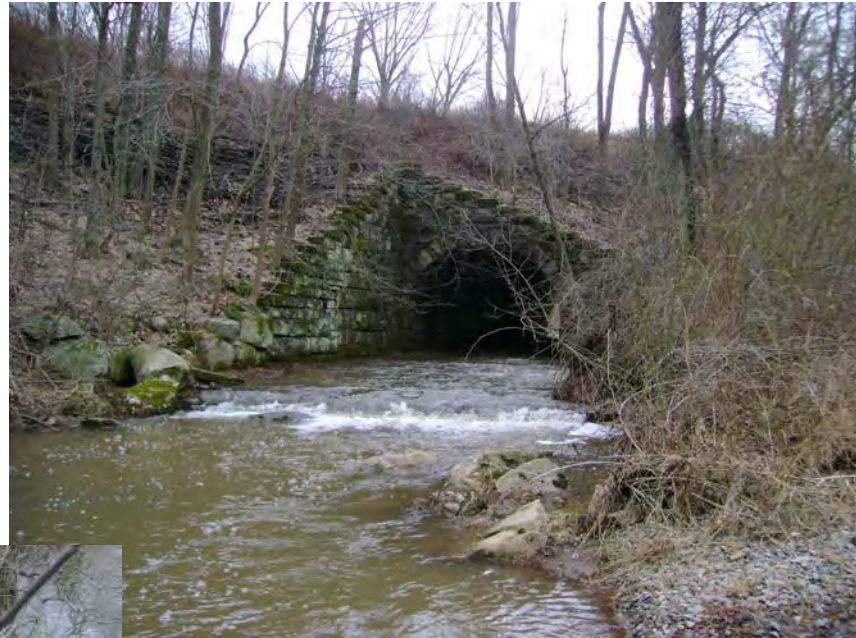
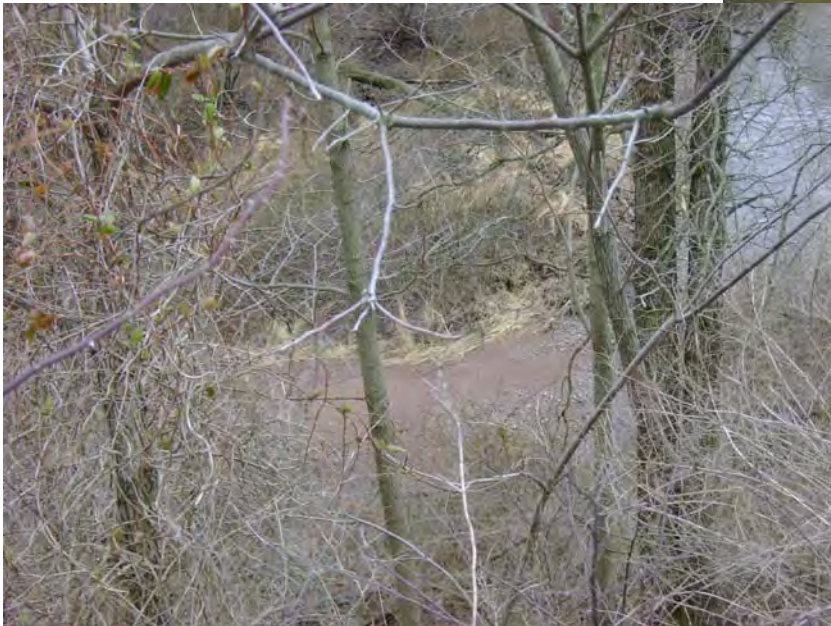
# Confluence of Reach J and G

Some sediment noticeable at  
confluence of Reach J & G.  
Stream flows under train  
trestle into the Jutland  
Lakeside Lake.

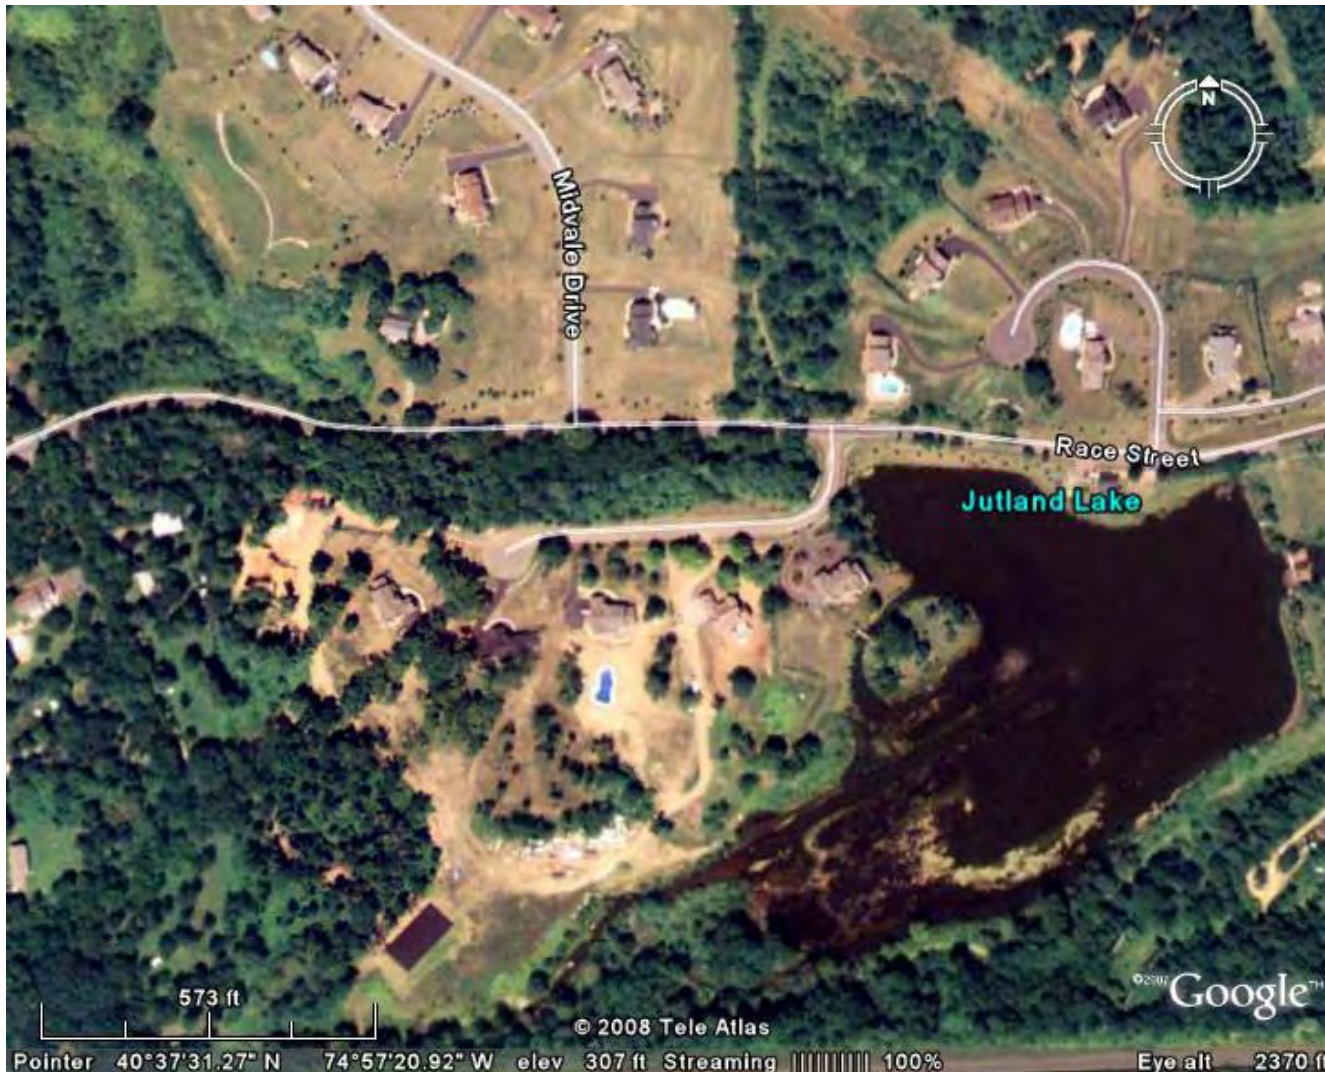
# Reach F- Jutland Lakeside Estates

Heavy sediment loadings & depositions noticeable at inlet to Lakeside Estates from confluence of G & J.

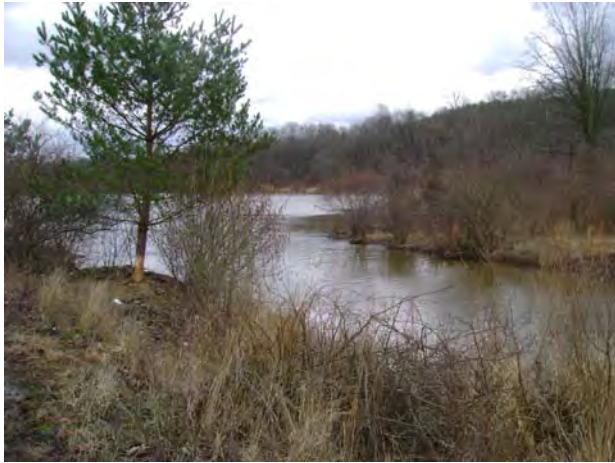
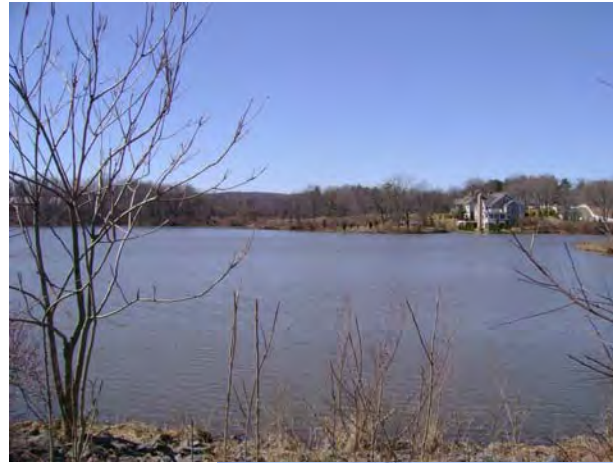
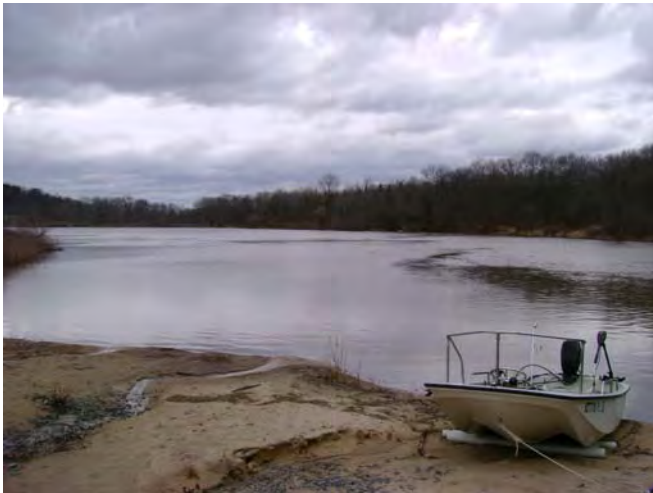
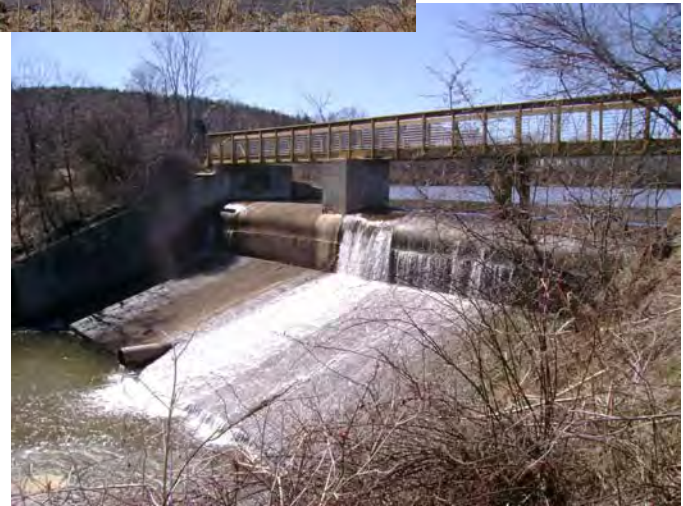
# Reach F- Jutland Lakeside Estates

Heavy sediment depositions occurs at Lakeside Estates.

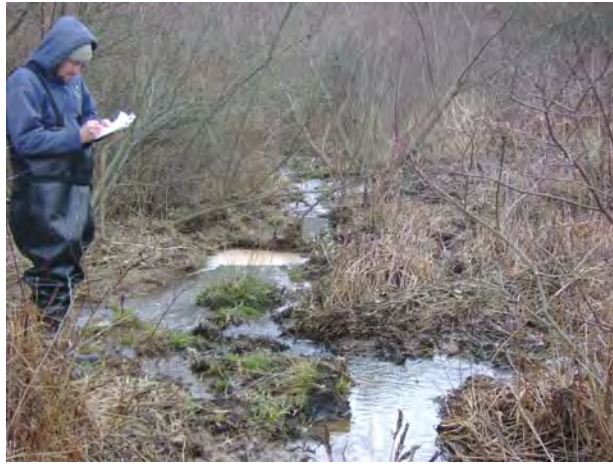
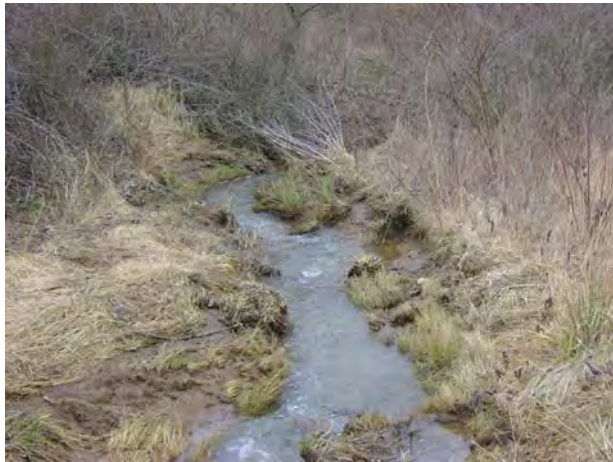
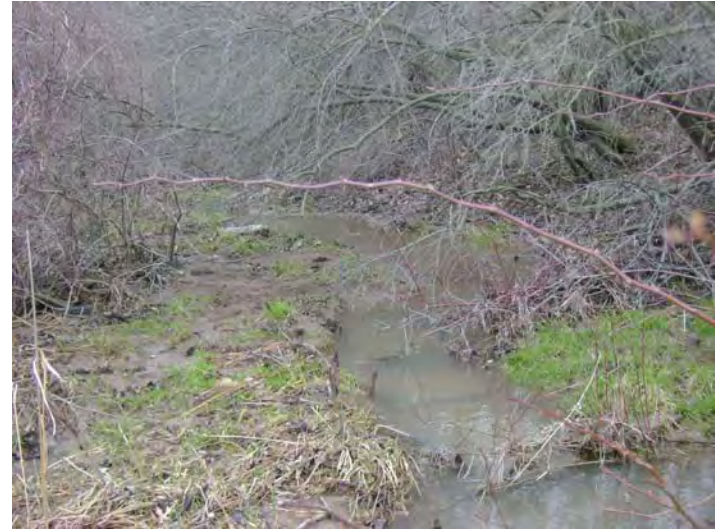
# F Tributary 1- Midvale Road

Added unmapped tributary  
F1.

Wetland and tributary  
receives runoff from  
Midvale Development.

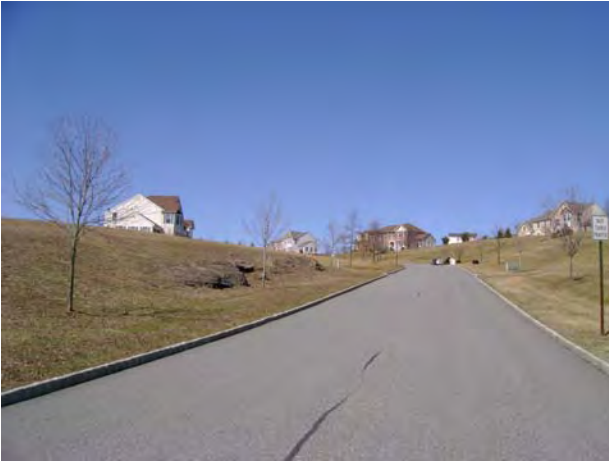
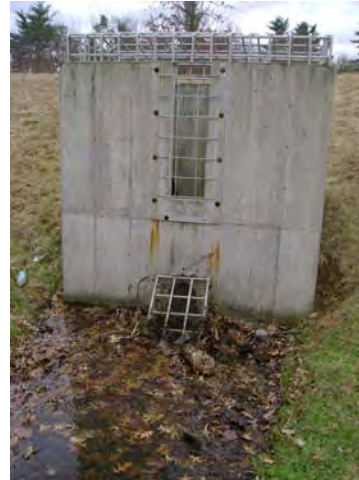
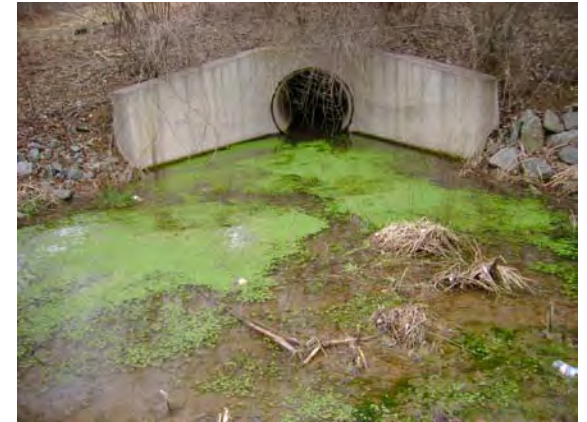
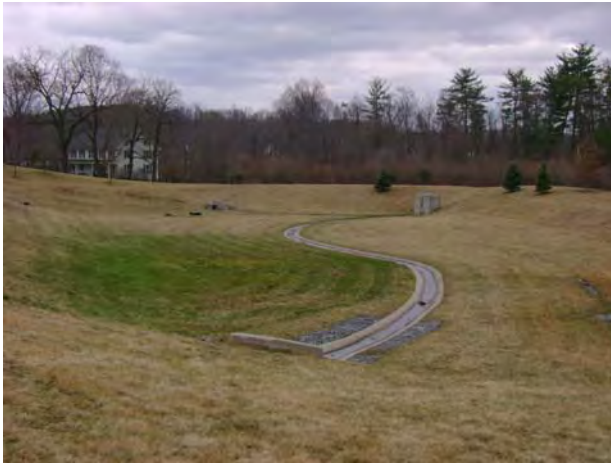
# F1 Tributary – Midvale Rd Basin

Steep slopes, impervious cover and little vegetative canopy contributes to high runoff flows, along with high fertilizer loading.

Duckweed present at outfall.

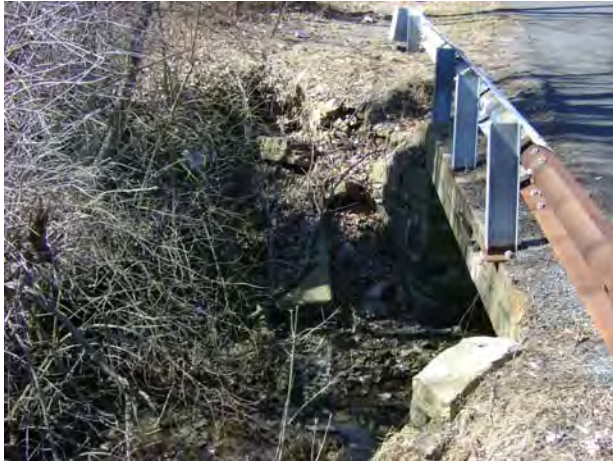
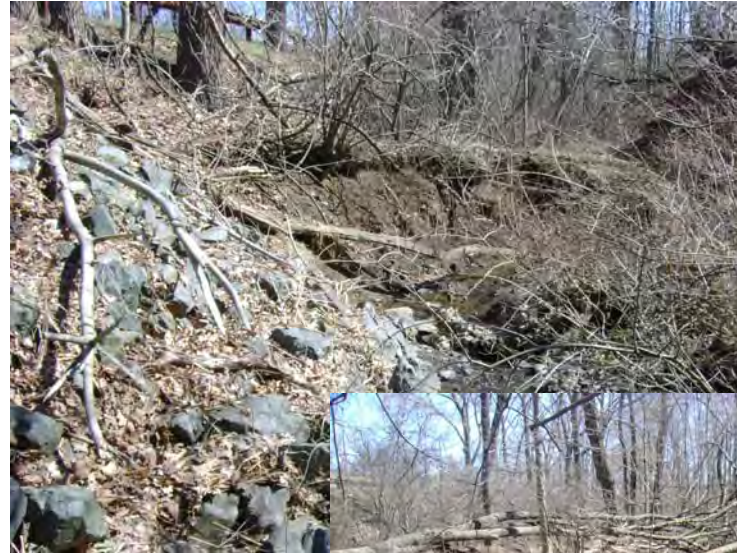
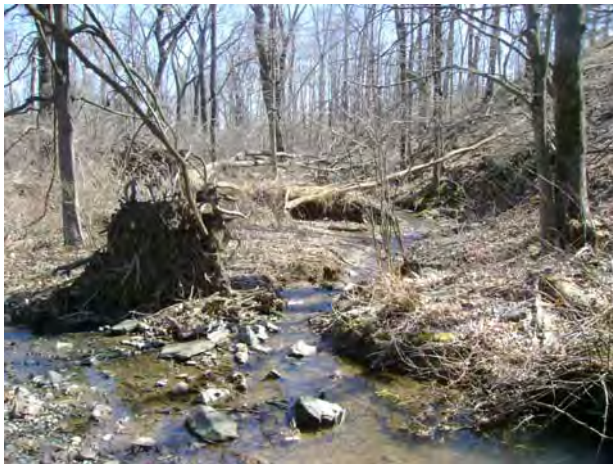
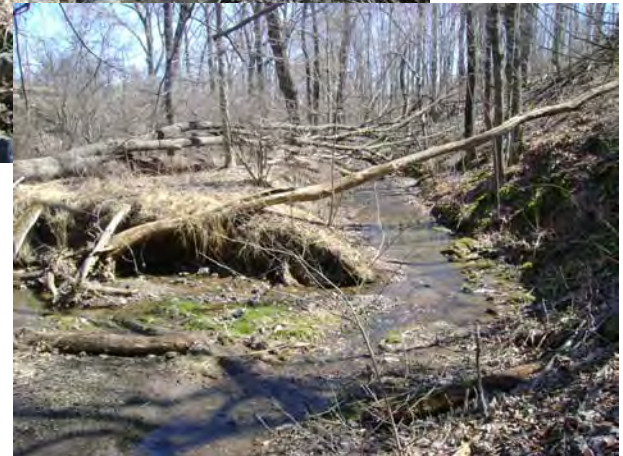
# F1 Tributary – Lakeside Estates

**High flows from Midvale Development caused significant erosion, oxbow formation, and could undermine Race Street, as well as contributing sediment to Lakeside lake.**

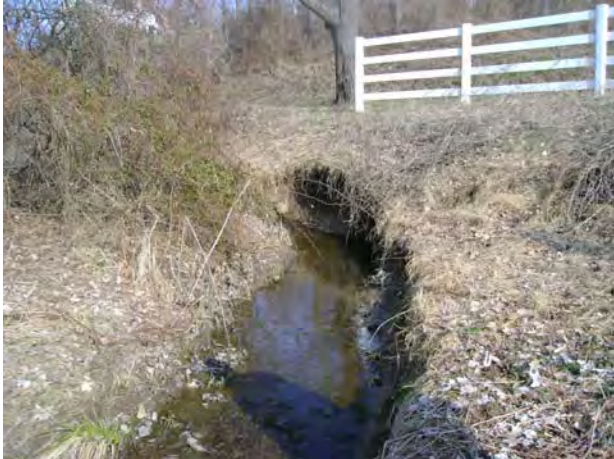
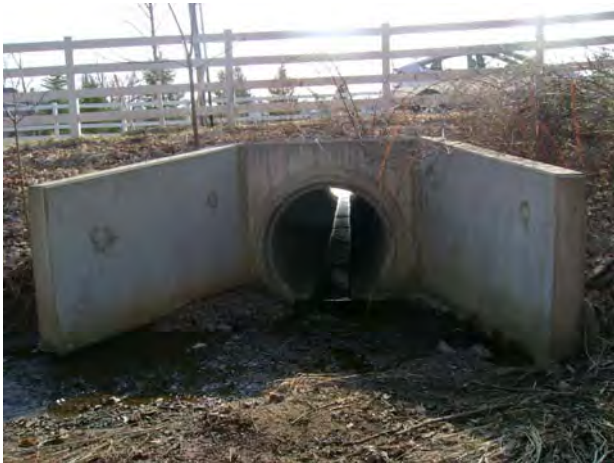
# F1 Tributary- Lakeside

High flows from Midvale Development caused significant erosion, and contribute sediment to Lakeside lake.

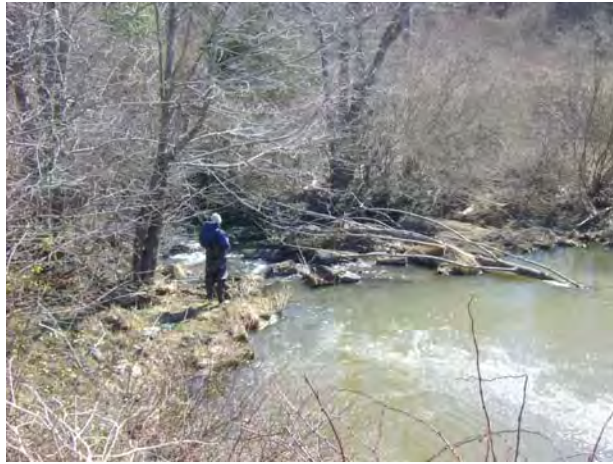
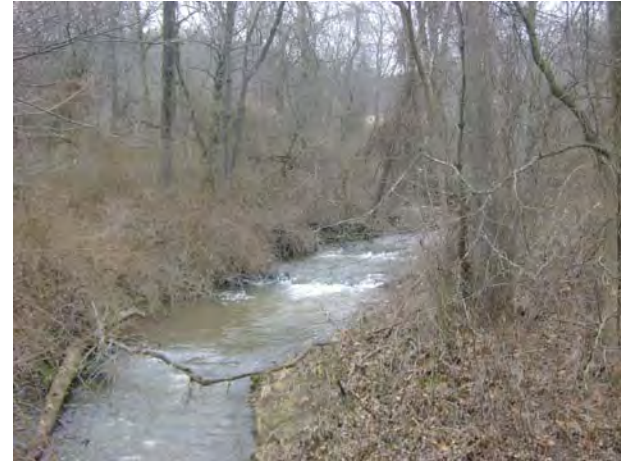
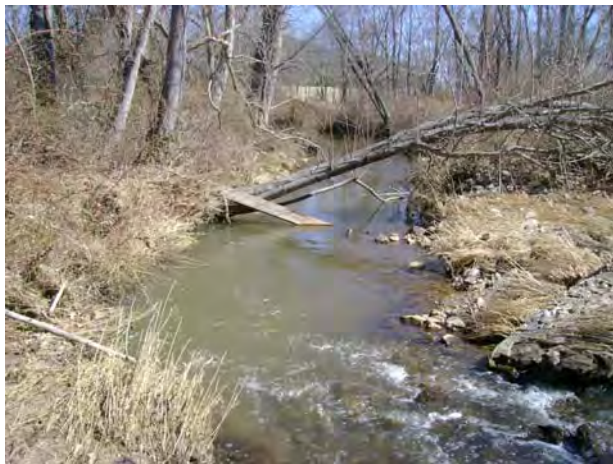
# Reach E Downstream of Lakeside Dam

Reach E has an intact forested buffer and floodplain, but receives high stormwater flows. Access was limited in this section.
