# **THE SIDNEY BROOK WATERSHED PROTECTION PLAN**

HUC-14 02030105020070 Raritan River South Branch (River Road to  
Spruce Run)

**Princeton Hydro, LLC  
1108 Old York Road  
Suite 1, Post Office Box 720  
Ringoes, NJ 08551  
908-237-5660**

**June 2010  
Revised December 2011  
Revised May 2012**

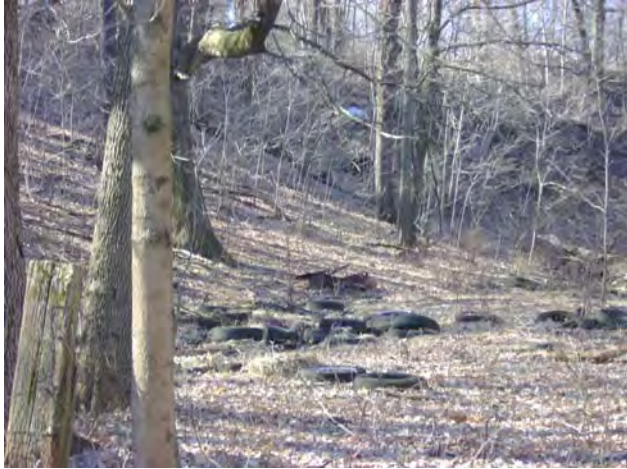
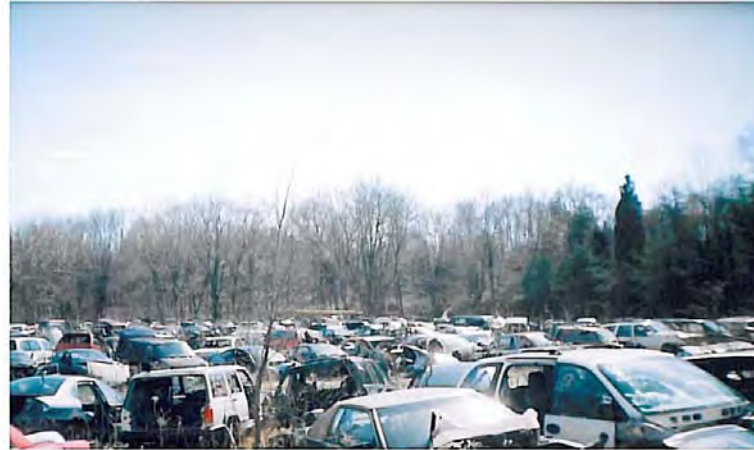
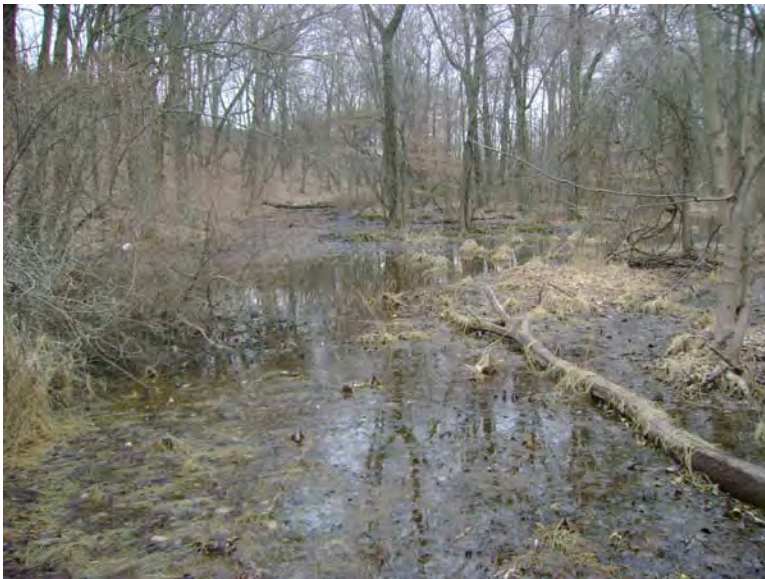
# E Main Stem – Race Street Cozzi Junkyard

**Access was limited to this reach.**

**A tributary under the train trestle was not observed, but >50 tires were found near ravine.**

**Possible large vernal pool observed near bridge crossing to junkyard.**

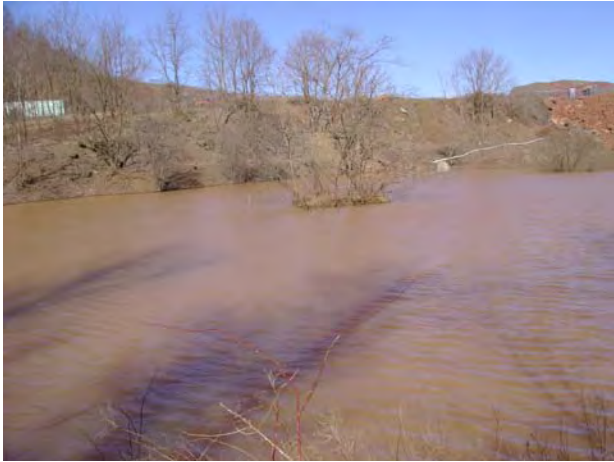
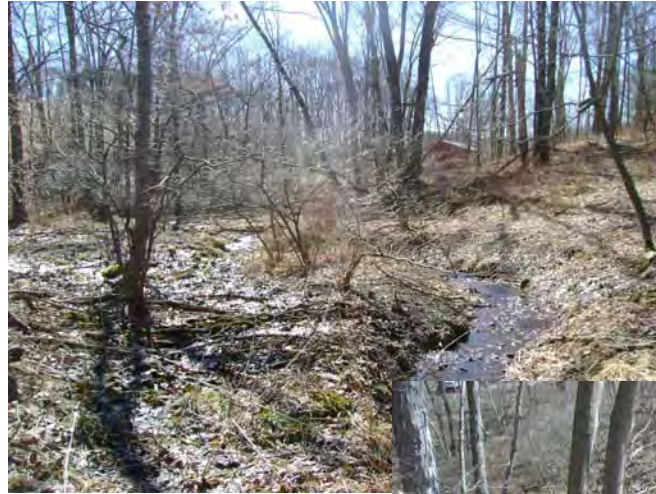
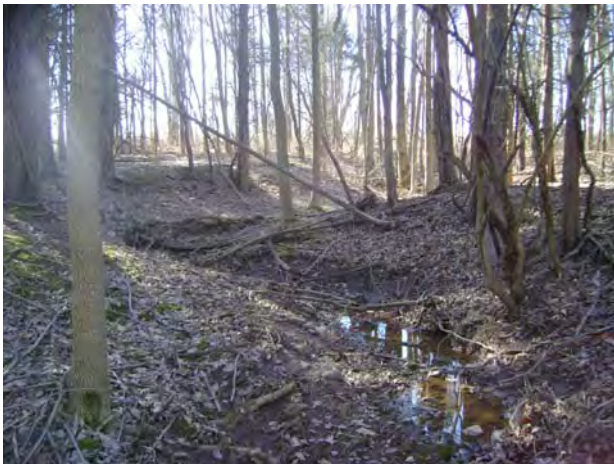
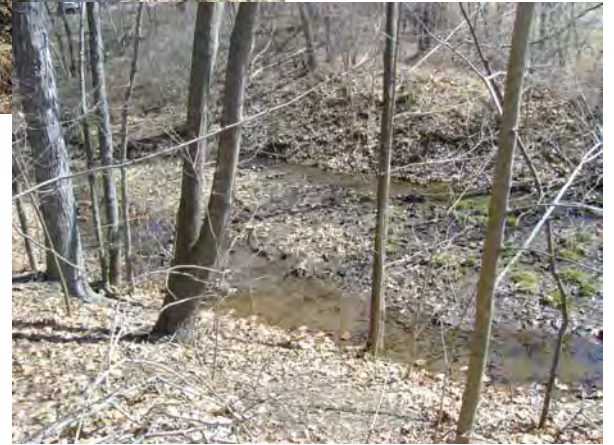
# Reach E - Quarry Tributary

Quarry pond was heavily silted, but downstream tributary was clear, with intact forested buffers, and no observed erosion.

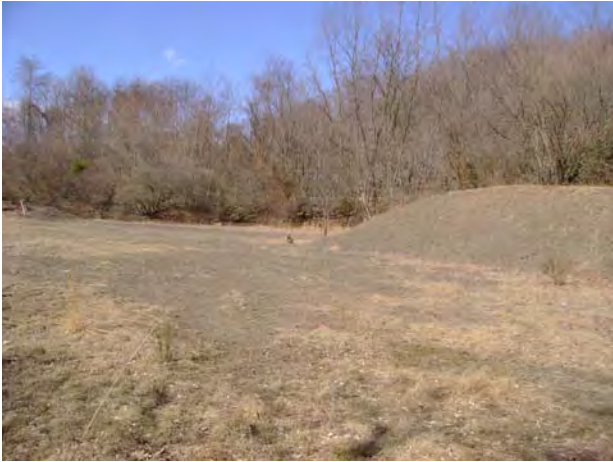
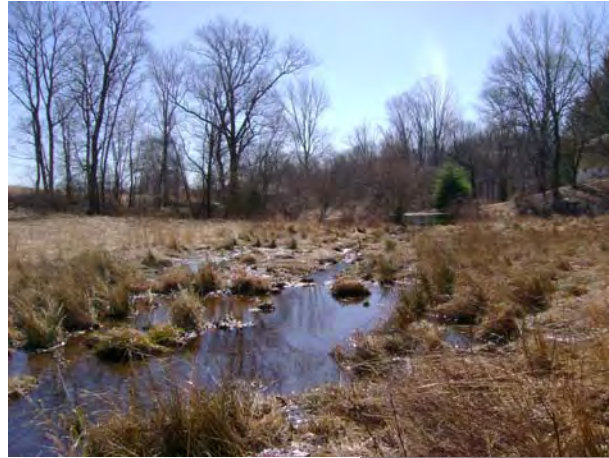
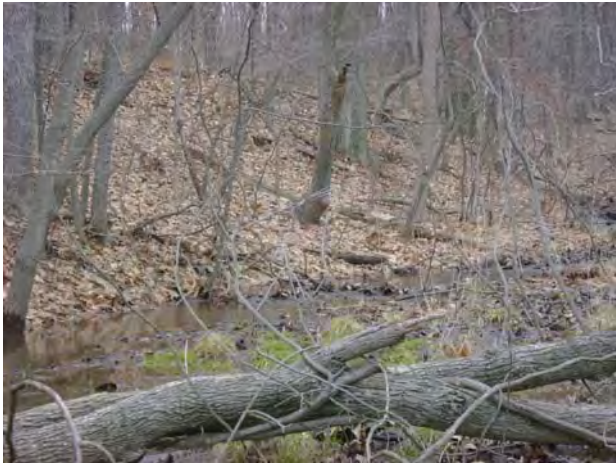
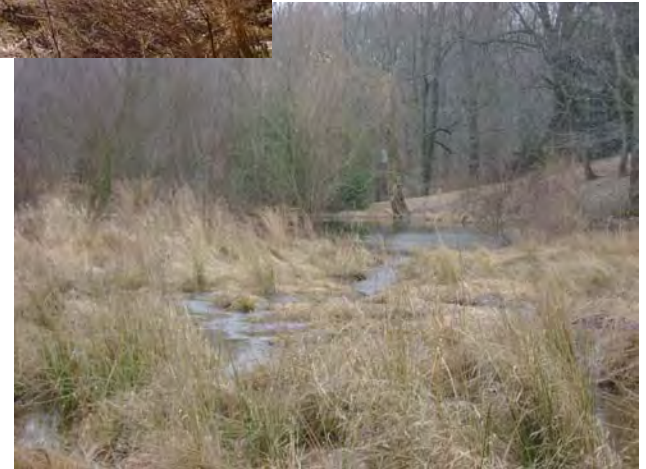
# E Quarry Tributary

Mapped new tributary, former gun club site, & bog wetland habitat.

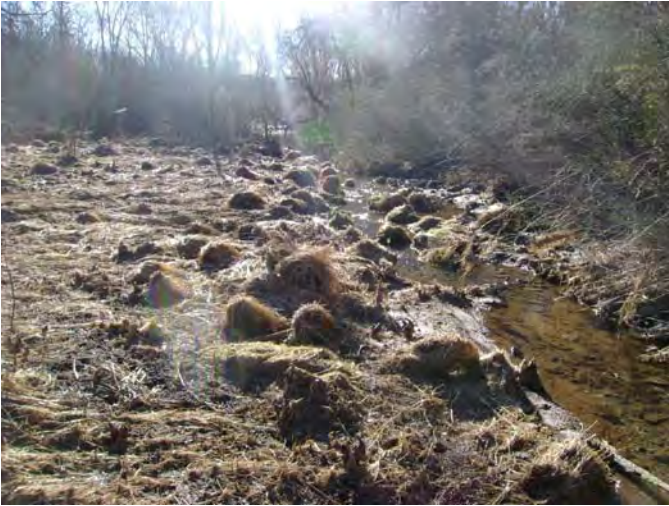
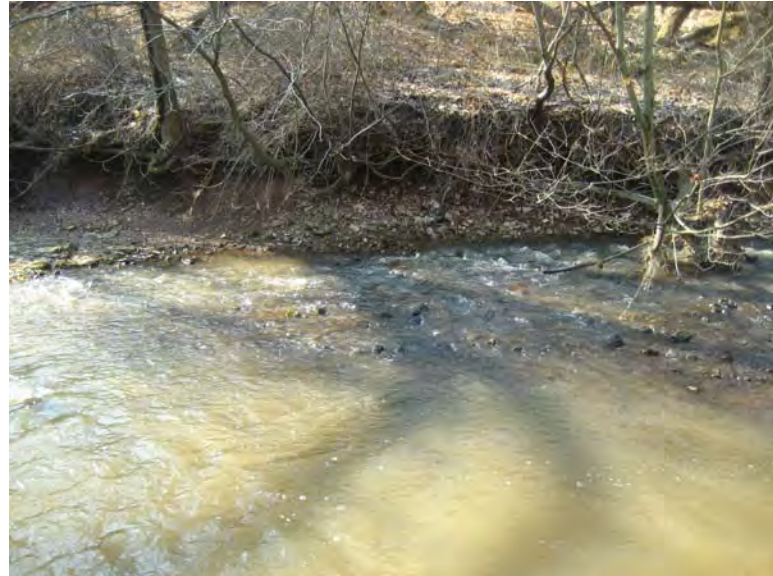
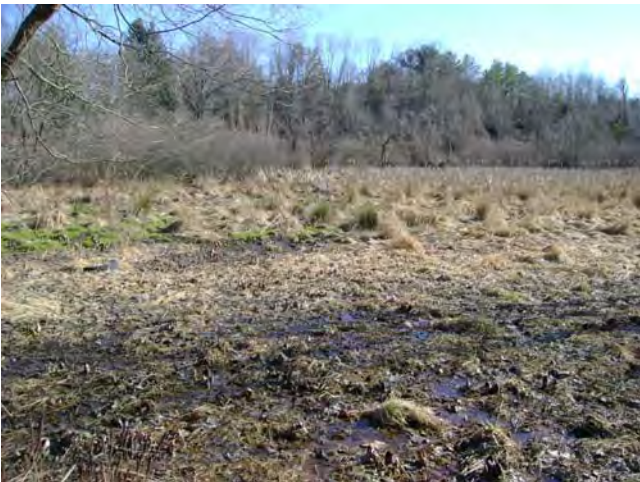
# Reach C Main Stem upstream of Race Street

Reach C includes a wide intact floodplain with wetland meadows and forested wetland buffers.

Possible bog turtle habitat was observed, with Tussock sedge hummocks.

Reach C is bordered by steep slopes along the train line, where some erosion occurs. High flows can be very turbid.

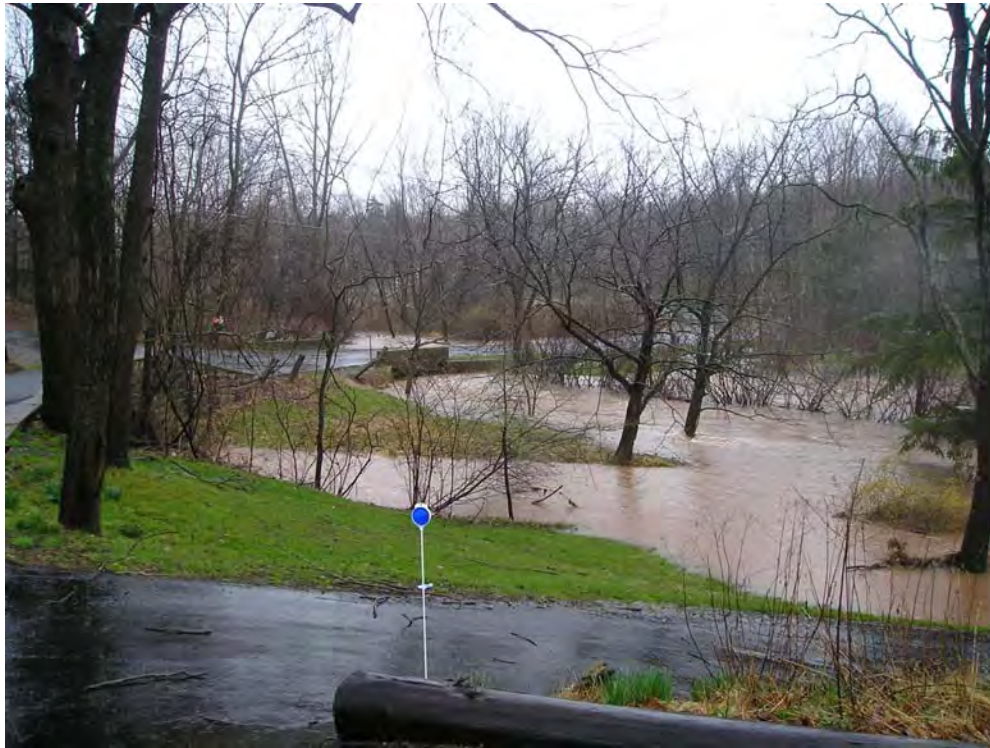
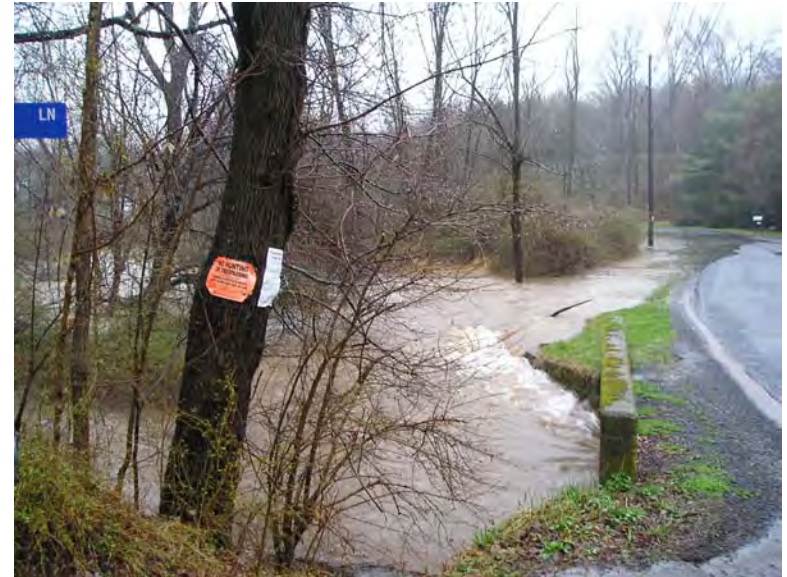
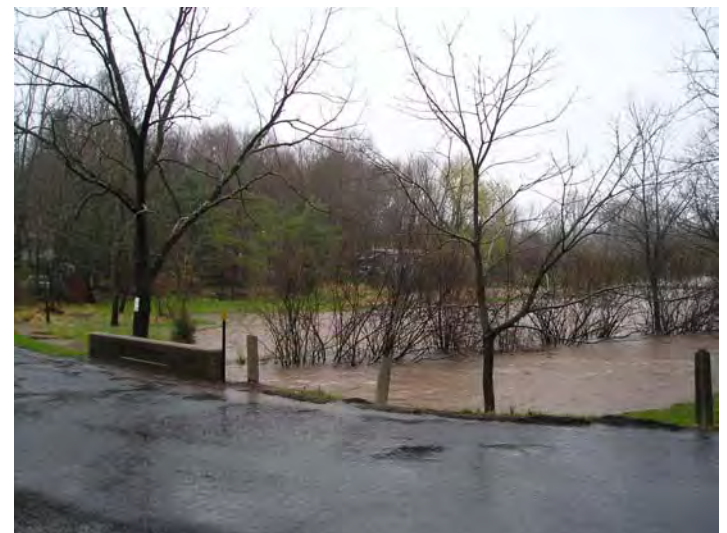
# Flooding at Race Street – Reach C

- Major flooding occurs at the Race Street bridge, and road closings are frequent.
- Major construction to elevate Race Street over the stream may be needed.

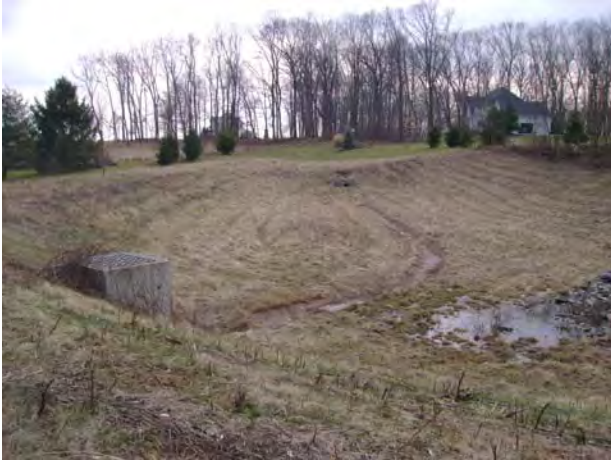
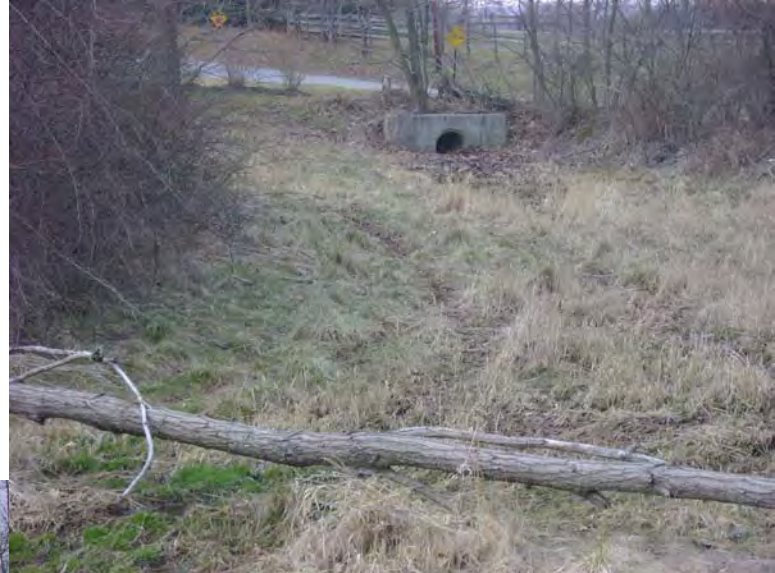
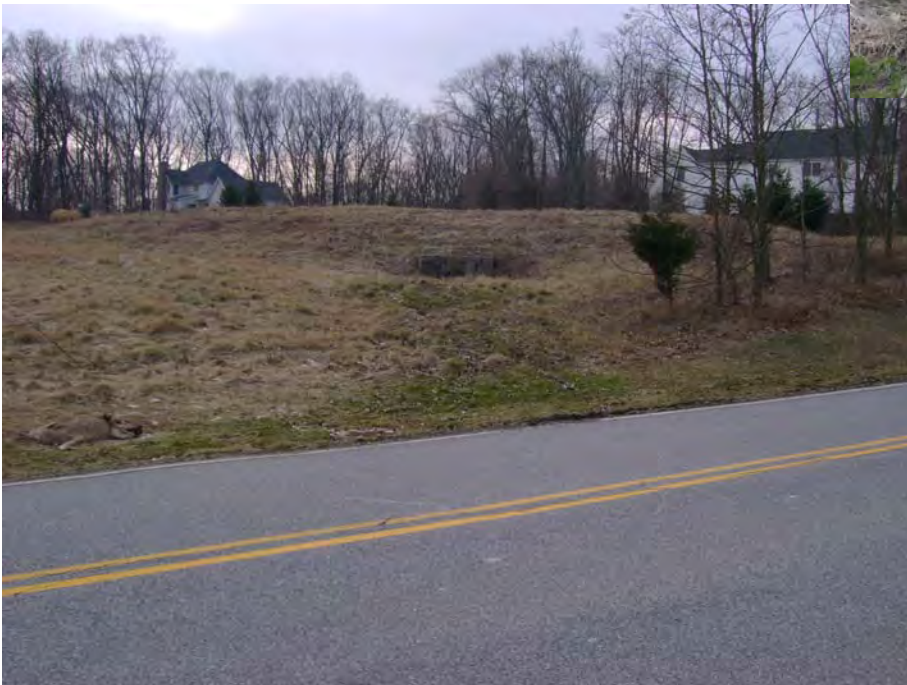
# Reach D – Cooks Crossing Road

Outfall for Woodedge  
Development discharges  
directly to road swale –  
causing downstream  
flooding and erosion.

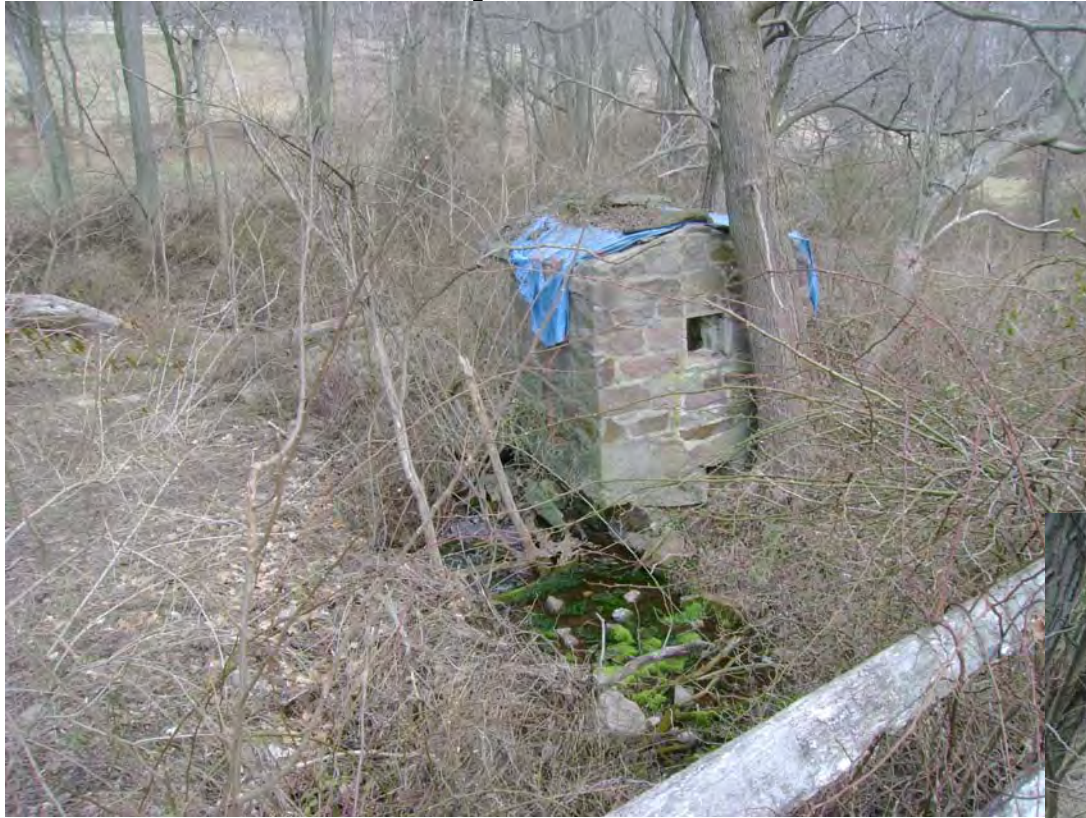
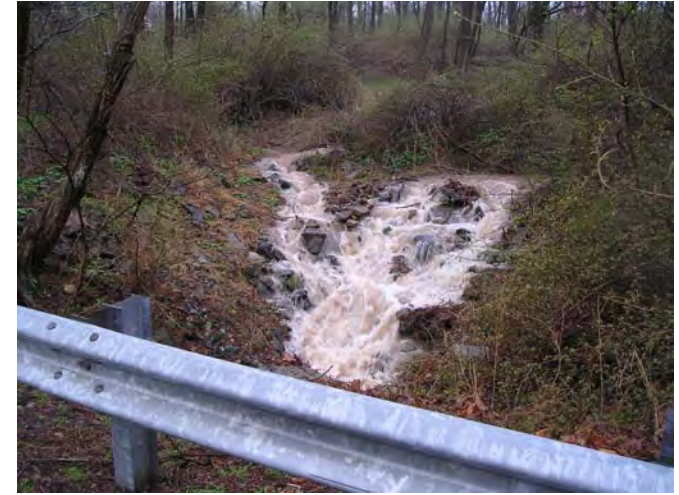
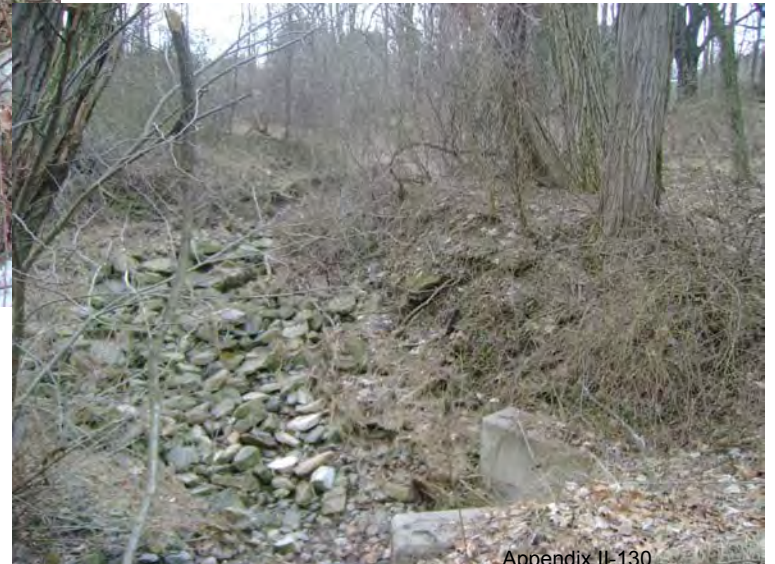
# D – Cooks Crossing Rd Outfall Impacts at Sodres Farm

Road runoff undermining spring house & eroding tributaries

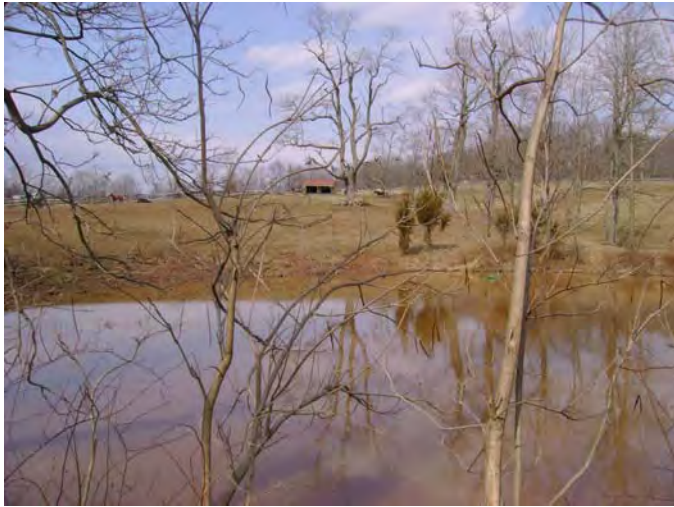
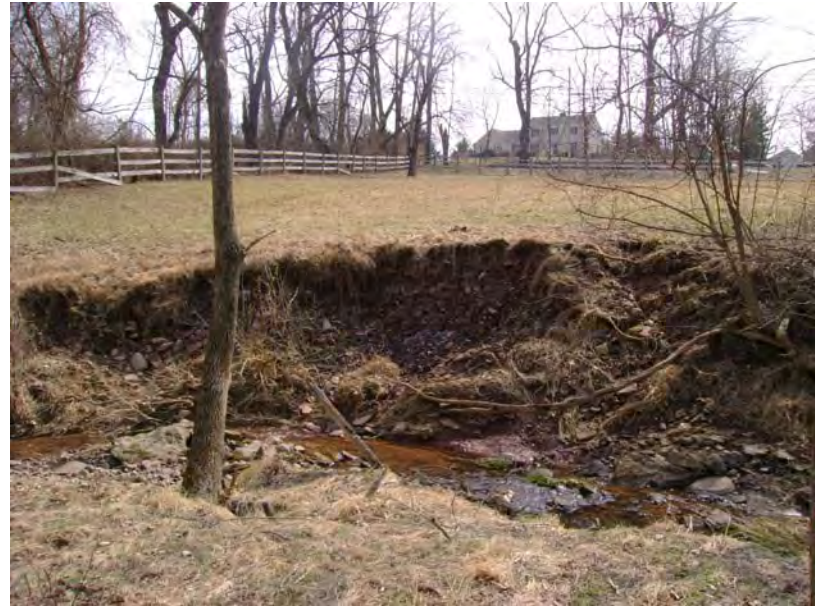
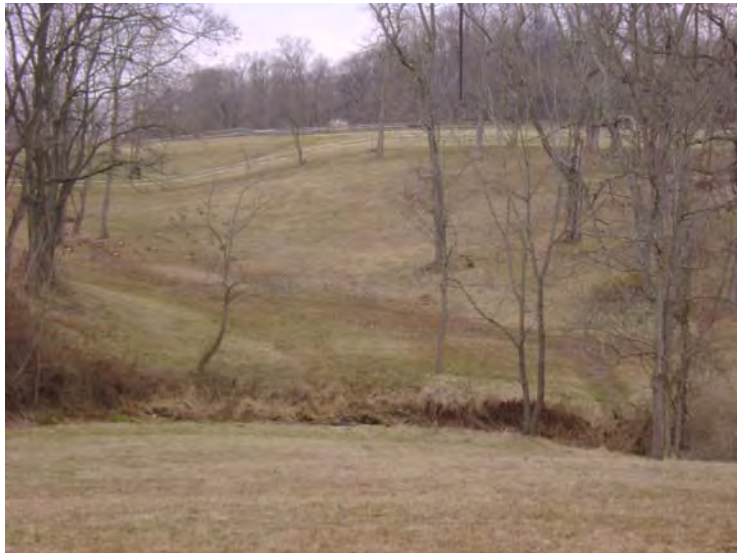
# D – Sodres Farm

High sheet flow from fields,  
turbid pond, severe 4 ft  
erosion downstream.

Horses & geese contribute  
to water quality issues.

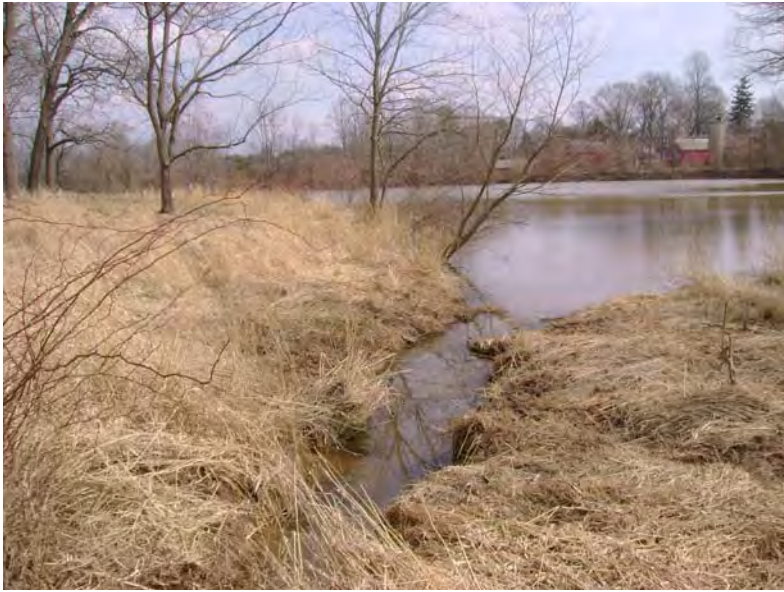
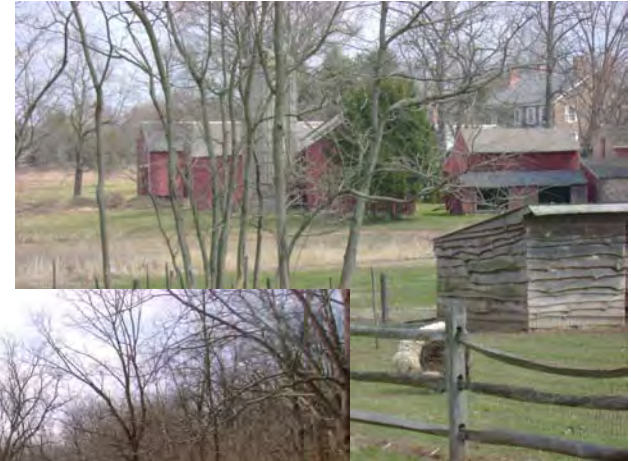
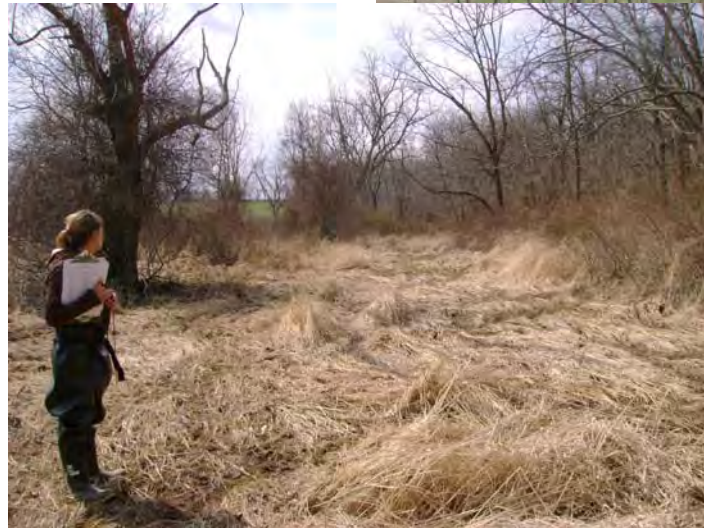
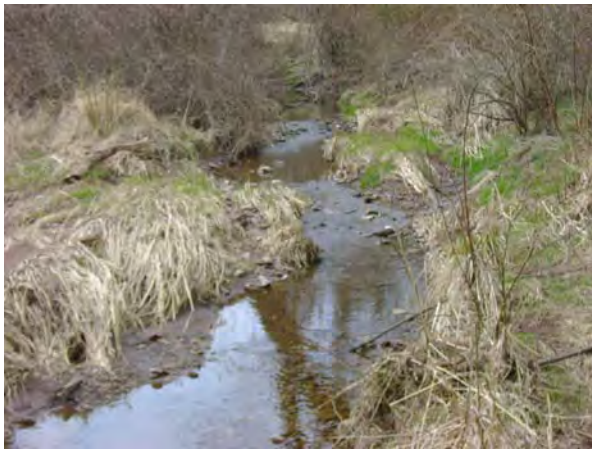
# D – Peaceful Farm

High runoff from Cooks Crossing Rd overflows narrow tributary and spreads out >50 ft.

Sediment deposition noted over banks. Causing pond turbidly and downstream flooding.

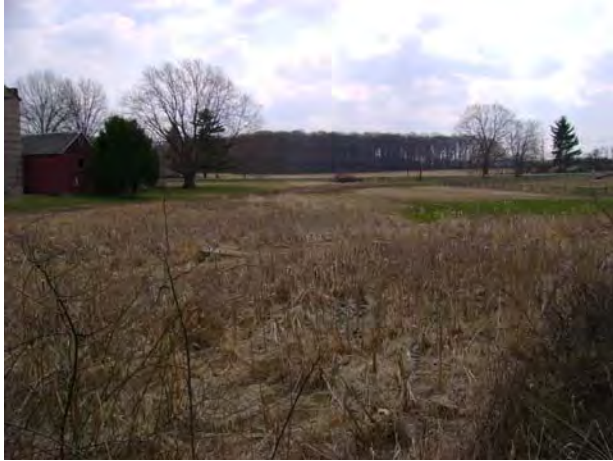
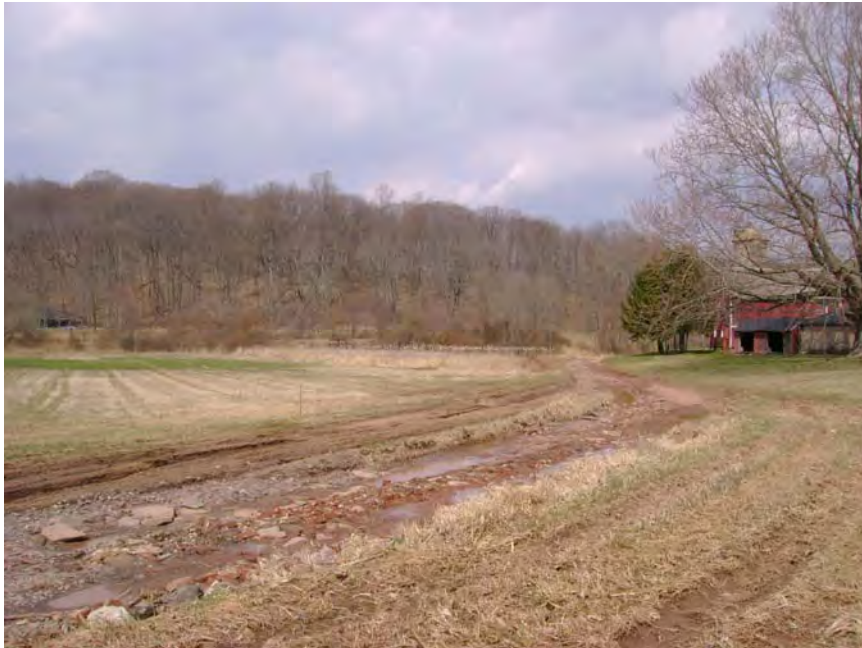
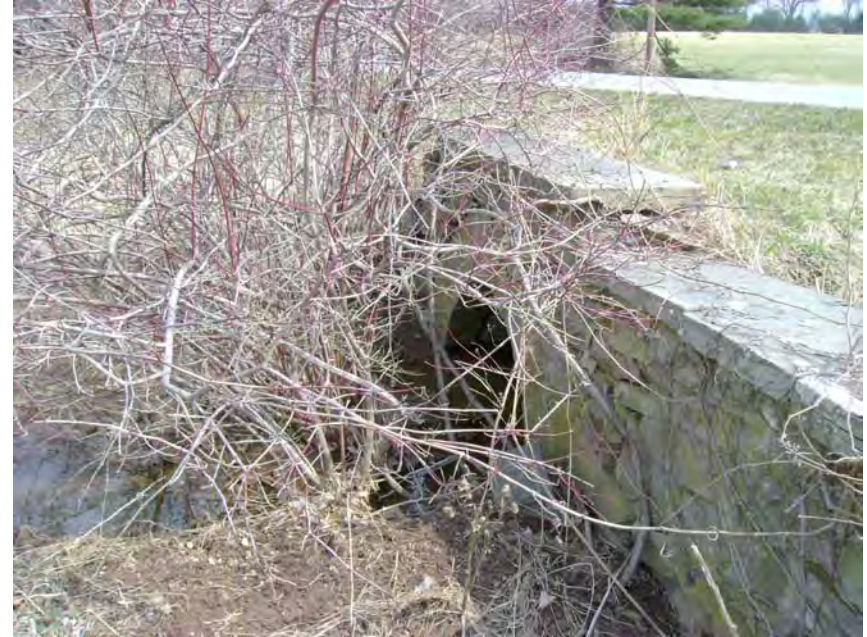
# Reach D -Peaceful Farm Rte 513

**Historic stone outfall on County Rte 513 is in need of repair.**

**Discharge from this outfall runs across the farm access road and field.**

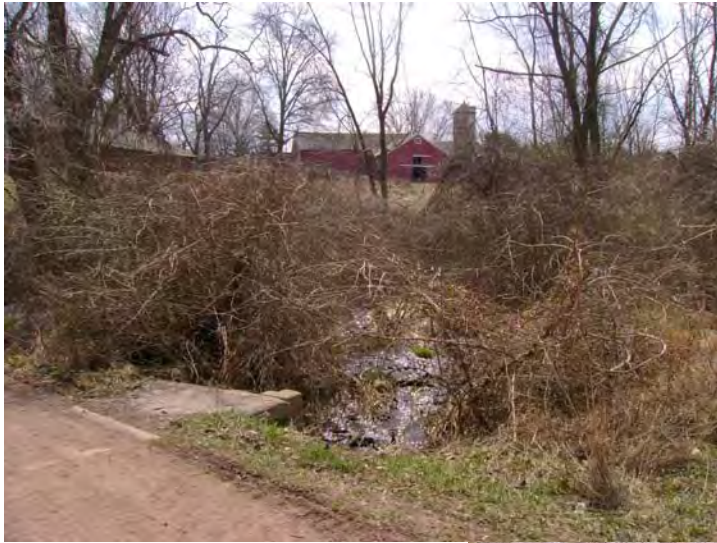
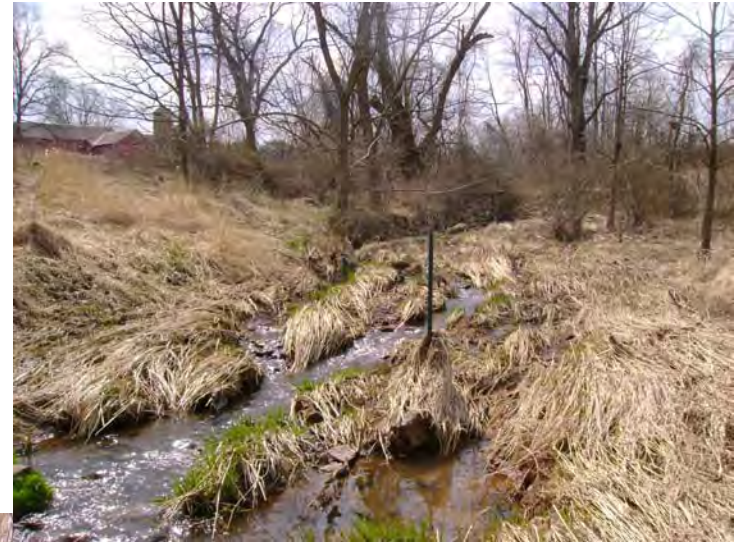
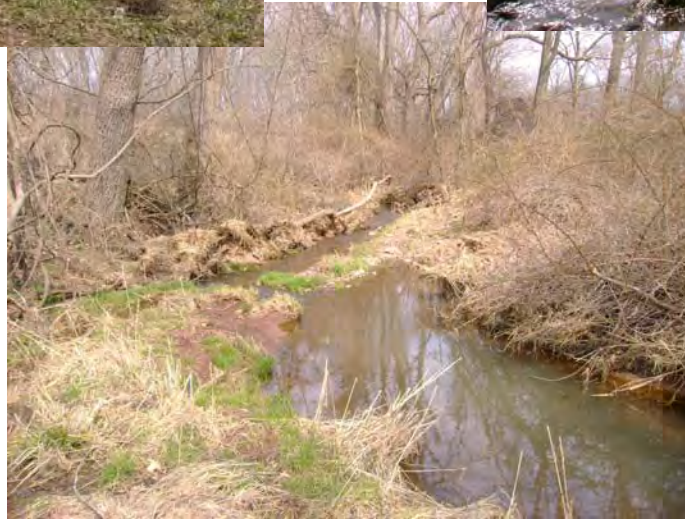
# D – Downstream of Peaceful Farm

**Downstream of the Peaceful Farm pond the stream appears clear and healthy and stream banks are stable.**

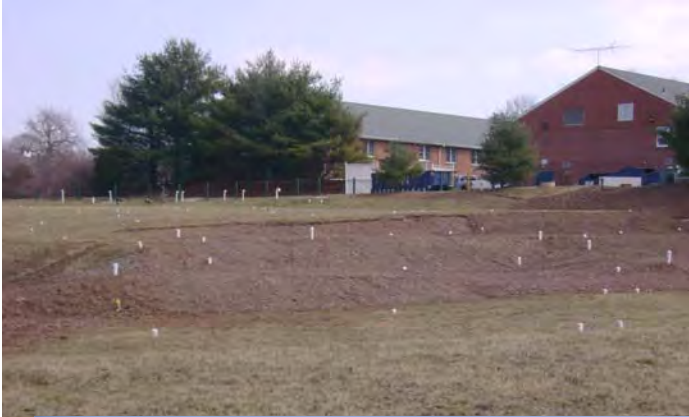
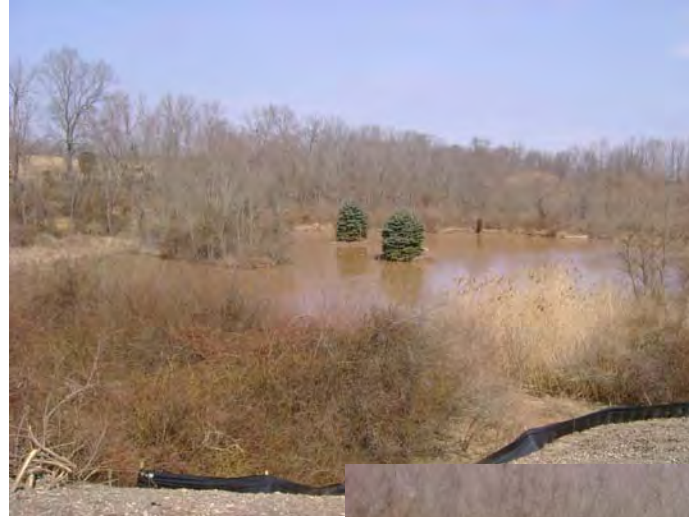
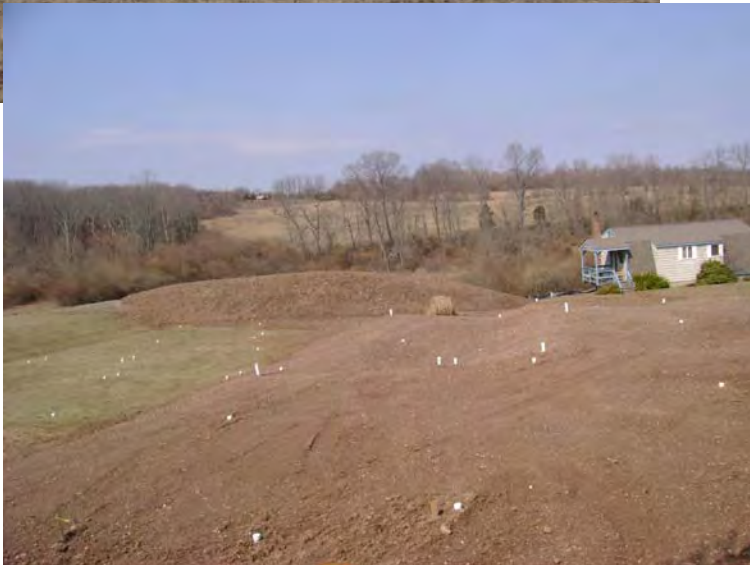
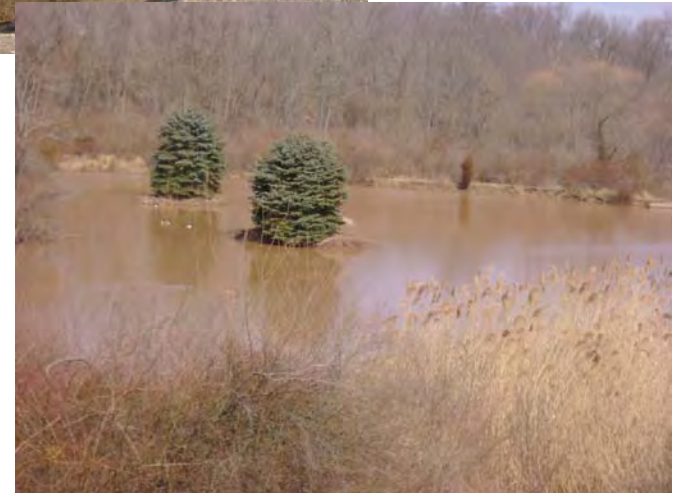
# Reach D -Care Center

Septic system for the Care Center nursing home was under repair in March 2008. Sediment controls were installed but pond was very turbid. Could not access upstream of pond due to thick multi flora rose

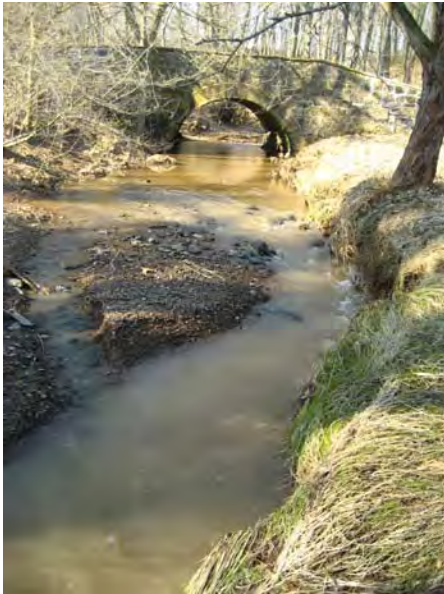
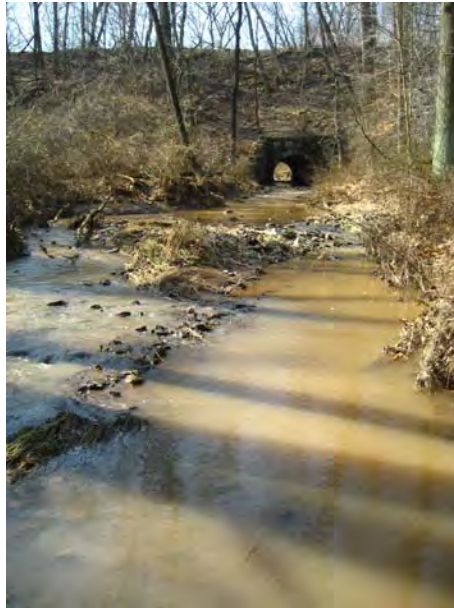
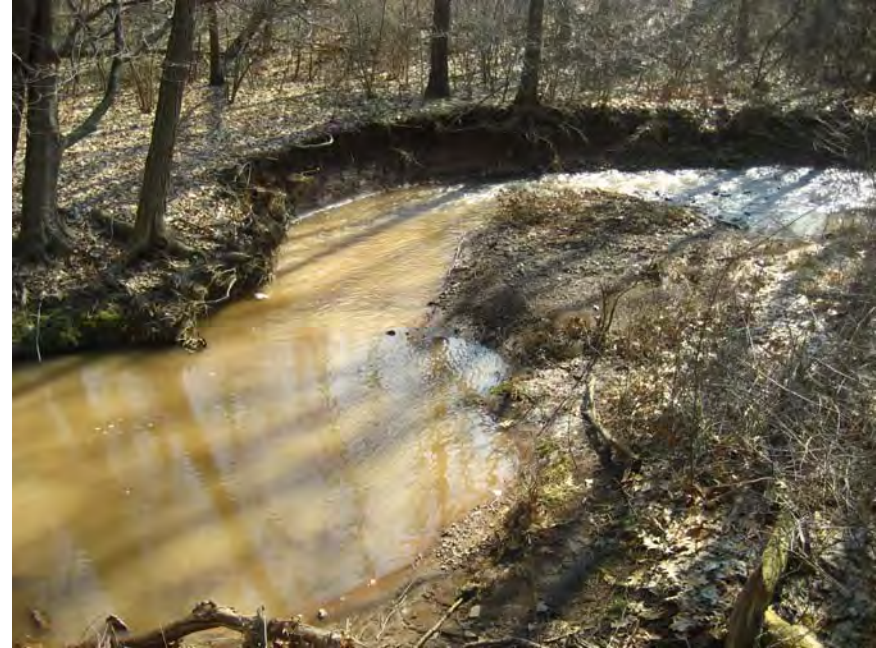
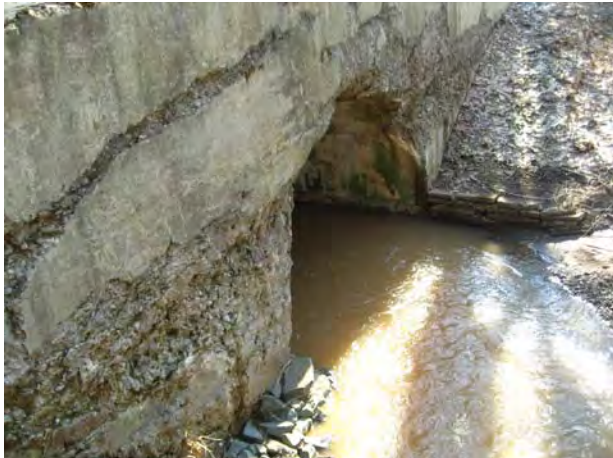
# Reach D- Upstream of Race Street

**Reach D very turbid this day. Historic Bridge at Hilltop Rd needs repair.**

**D flows under train trestle and erodes bend 3 ft for a length > 100 ft.**

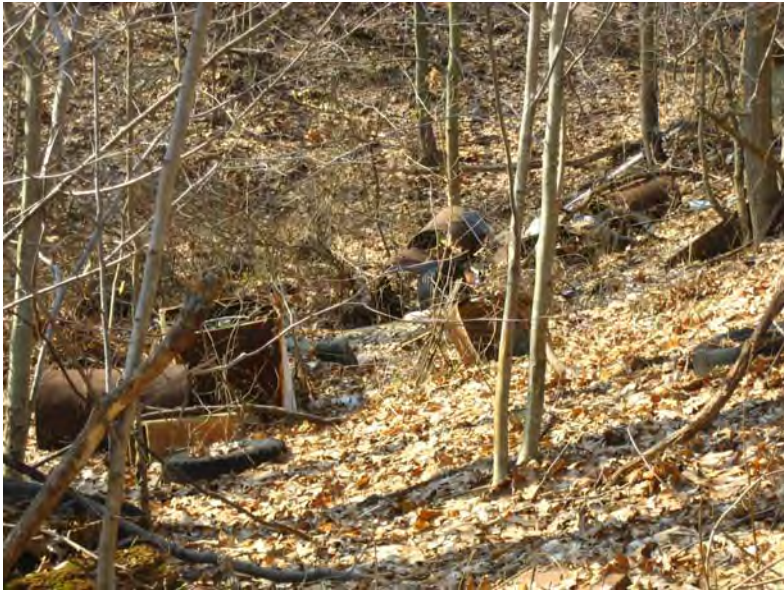
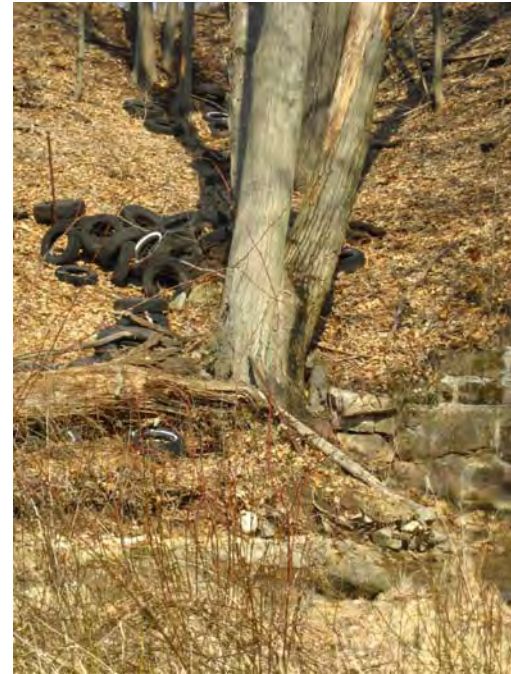
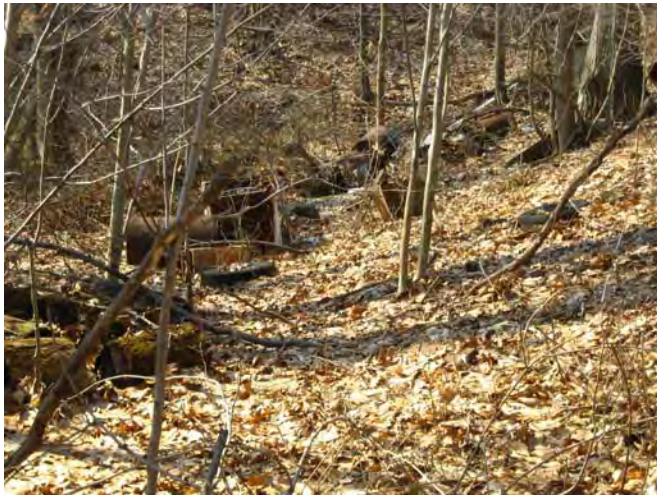
# Reach D – Cleanup Areas

**Drums and debris north of train trestle should be removed by township or property owner.**

**Tires south of train trestle should be removed by township or property owner.**

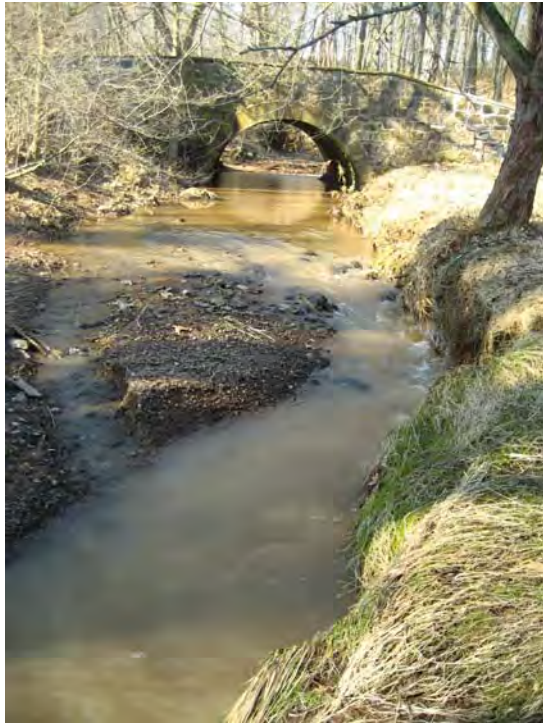
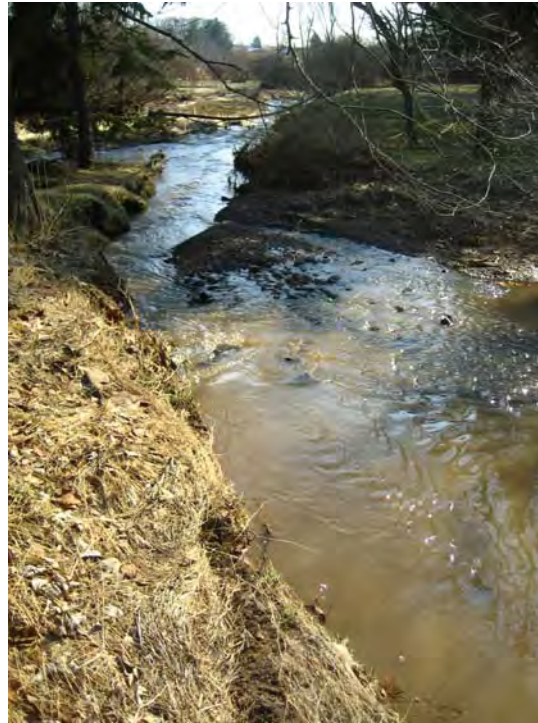
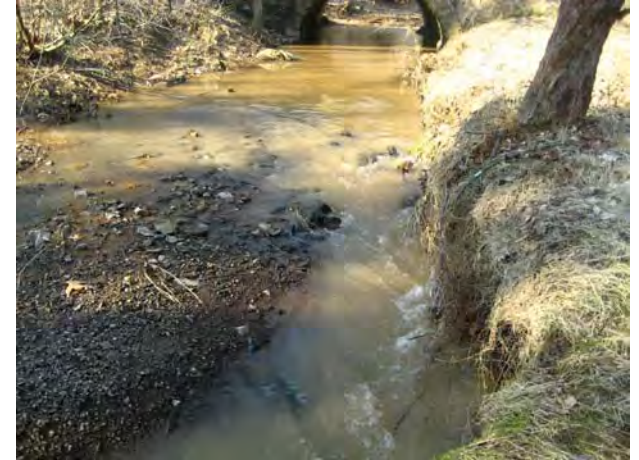
# Reach B – Downstream of Race Street

**High turbid flows, slightly eroded stream banks, frequently flooded floodplain.**

**Sediment deposition noted and a floodwall/ retaining wall by resident is in need of repair.**

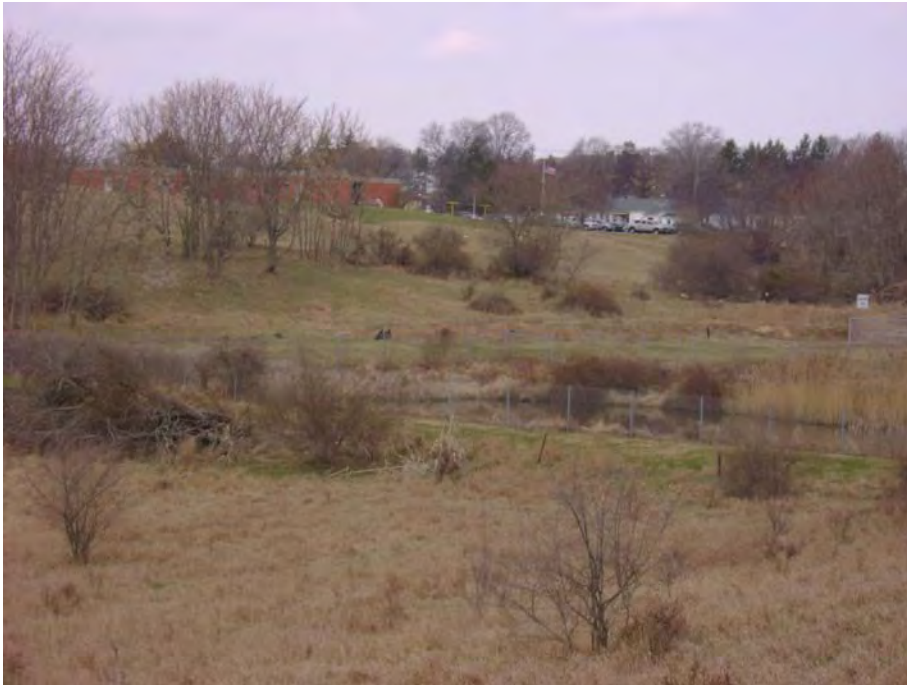
**Reach B is fed from runoff and discharges from the Prison pond.**

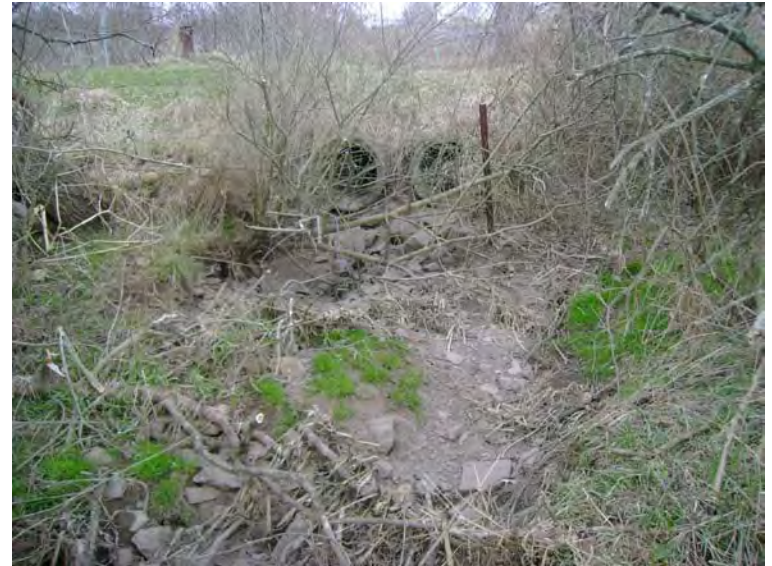
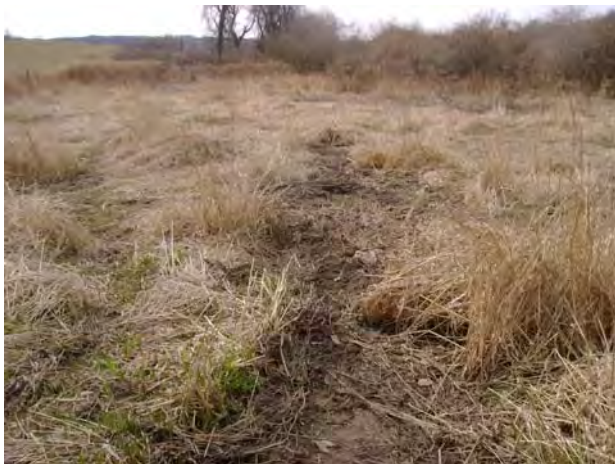
# Reach B- Prison Pond

**Discharges via two 24 inch pipes to a wetland and swale, but the runoff infiltrates into the ground and a defined stream bank was not observed.**

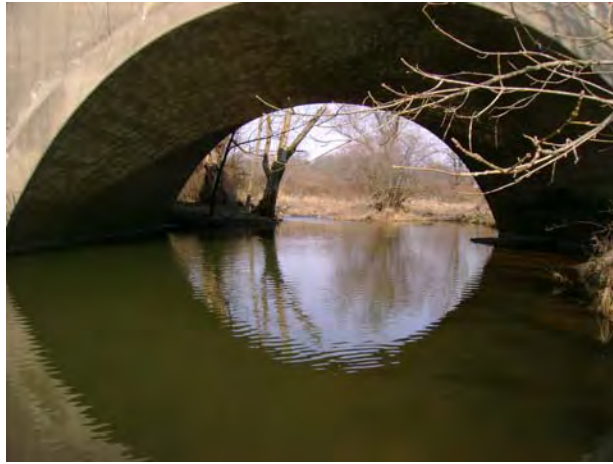
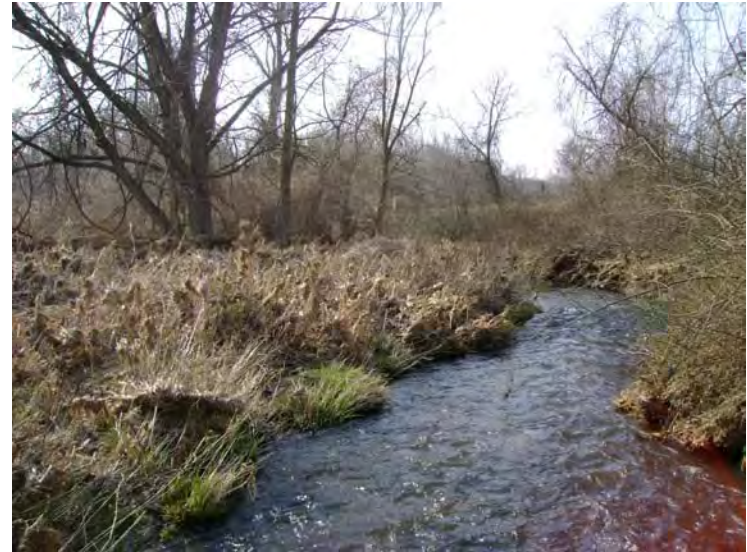
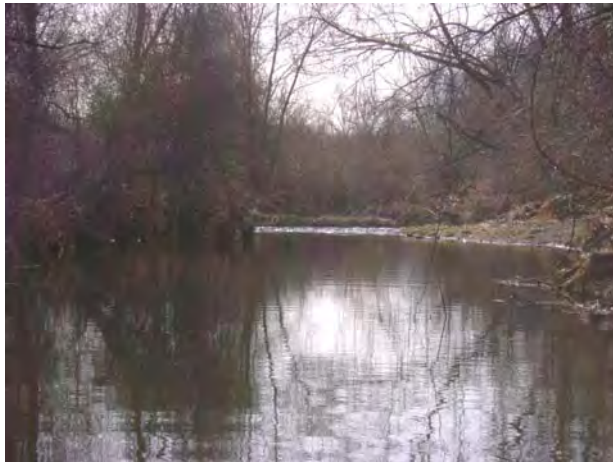
# Reach B-Downstream of Rte 513 Bridge

Intact buffers and floodplain.  
Deep fishing pool by bridge,  
with 1-2 foot sediment  
deposition by pool.
