# **THE SIDNEY BROOK WATERSHED PROTECTION PLAN**

HUC-14 02030105020070 Raritan River South Branch (River Road to  
Spruce Run)

**Princeton Hydro, LLC  
1108 Old York Road  
Suite 1, Post Office Box 720  
Ringoes, NJ 08551  
908-237-5660**

**June 2010  
Revised December 2011  
Revised May 2012**

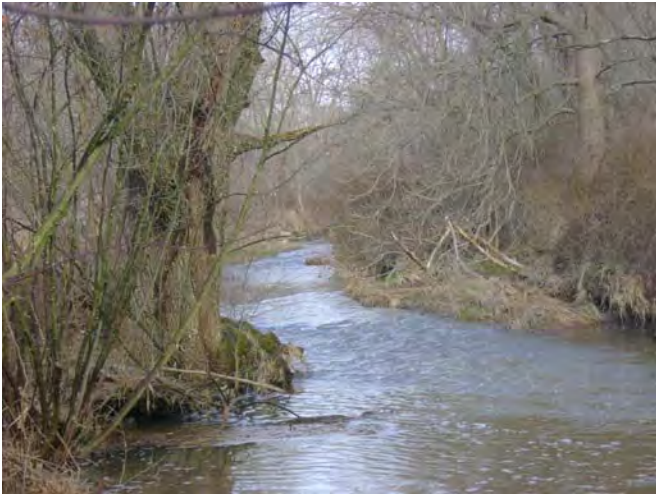
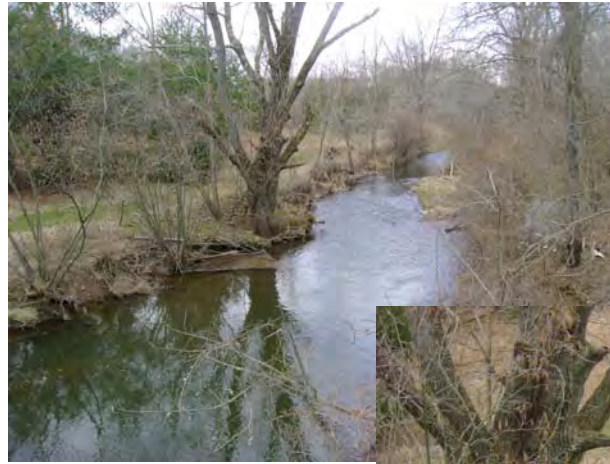
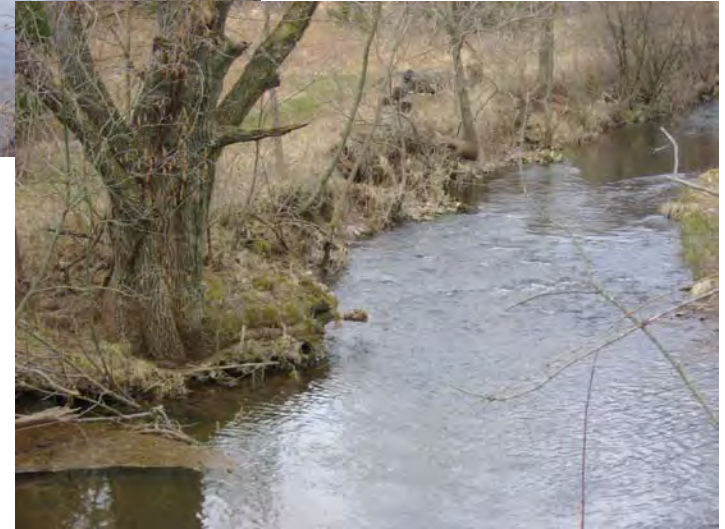
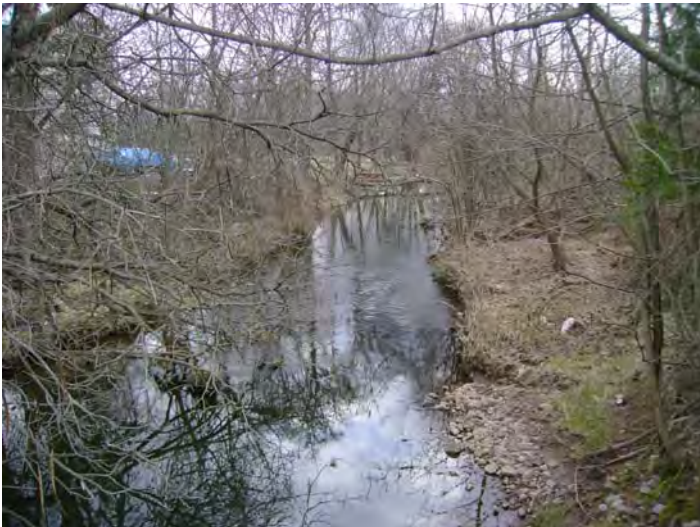
# Reach A – Sidney Rd Bridge

3-4 foot eroded banks upstream of bridge. Deep pool by bridge, with some sediment deposition.

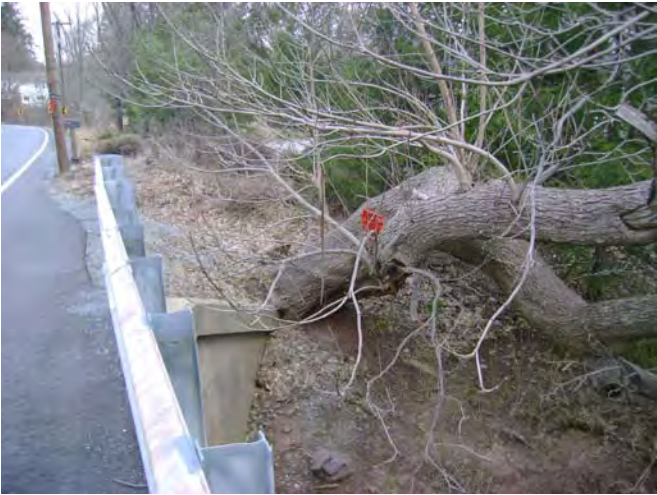
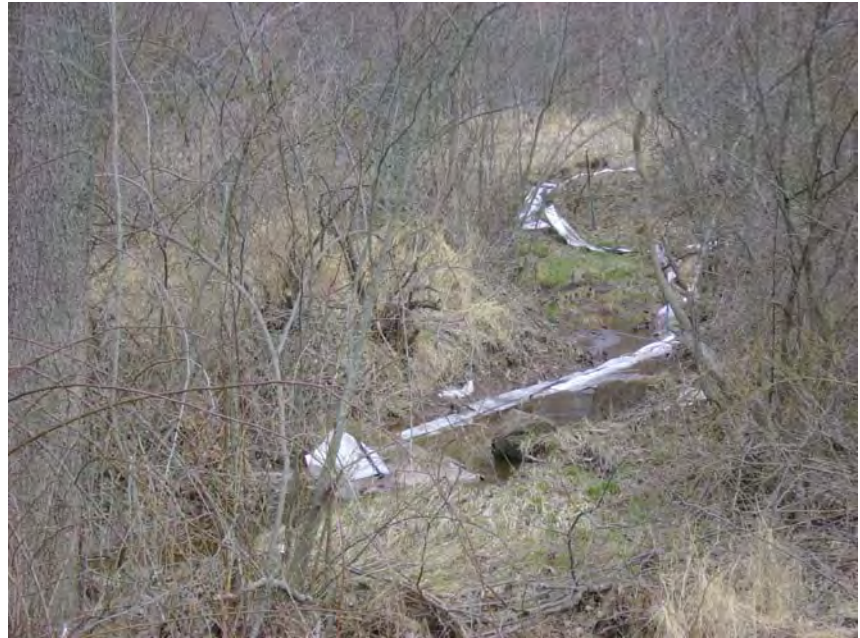
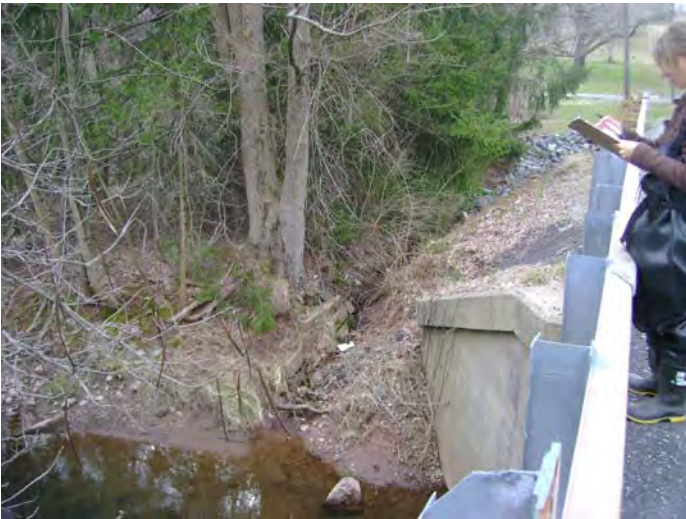
# Reach A – Sidney Rd Bridge

**Home heating oil spill in February appears resolved, and booms should be removed.**

**Large tree by bridge overpass may need removal.**

**Trash can needed to address debris left by fisherman.**

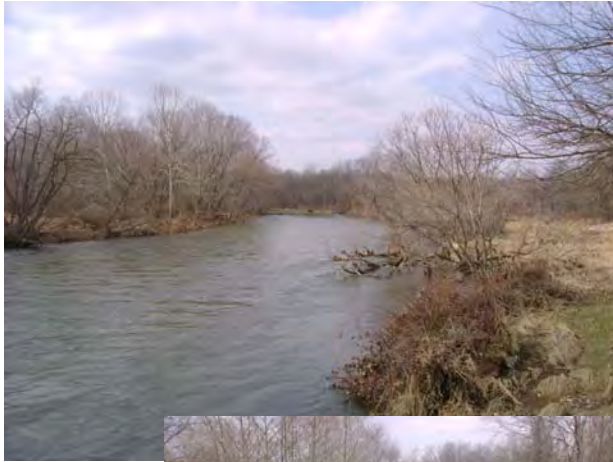
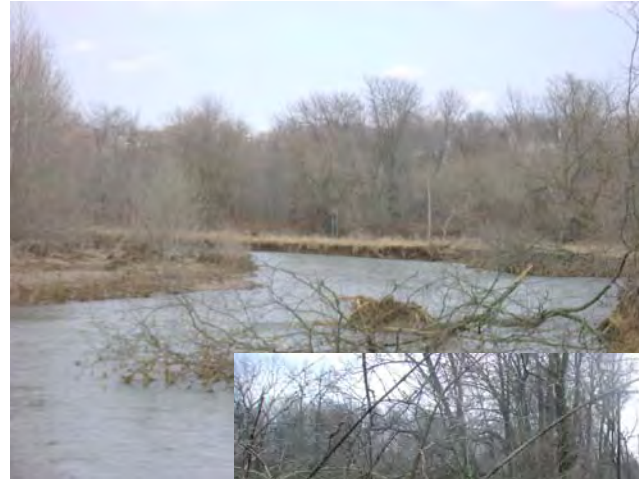
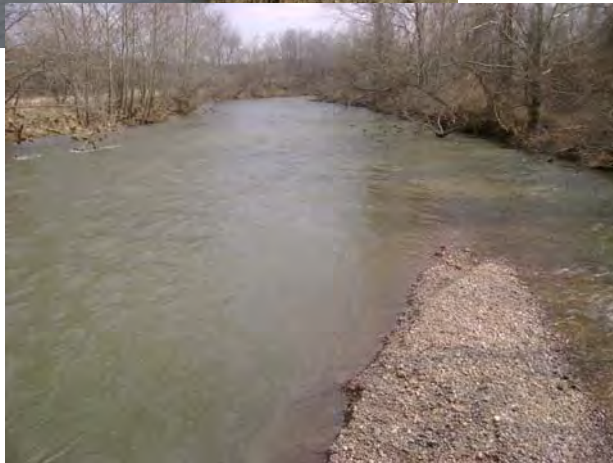
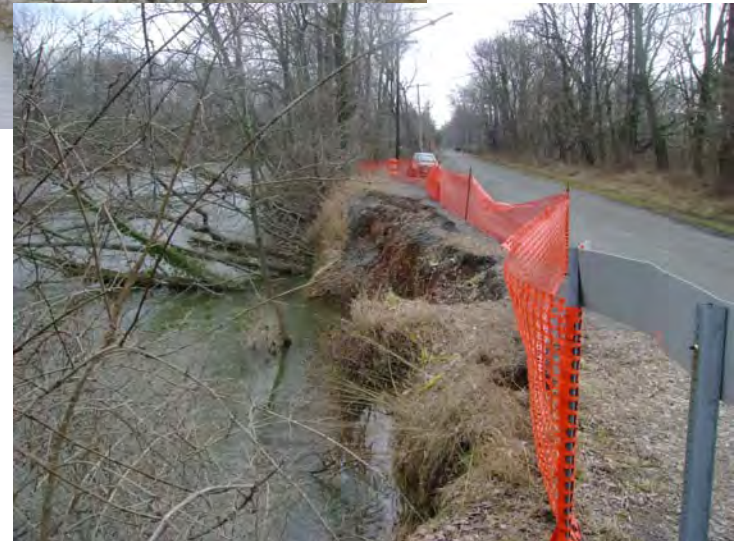
# Downstream of Sidney Brook South Branch of Raritan River

**High flows cause sediment deposition and eroded stream banks near Hampton Rd .**

**Hampton Road being eroded and undermined by high storm flows.**

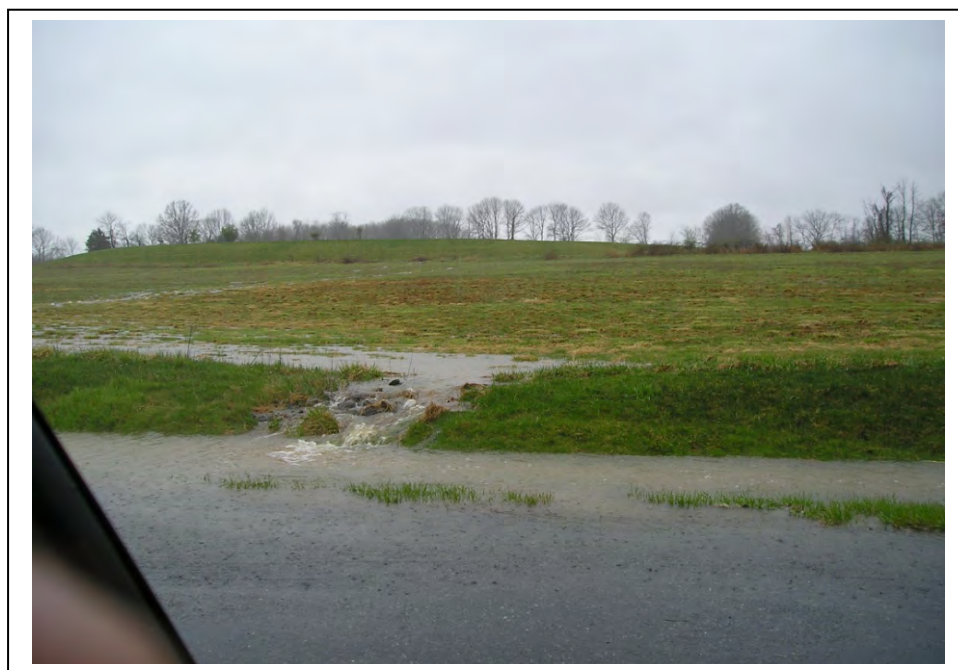
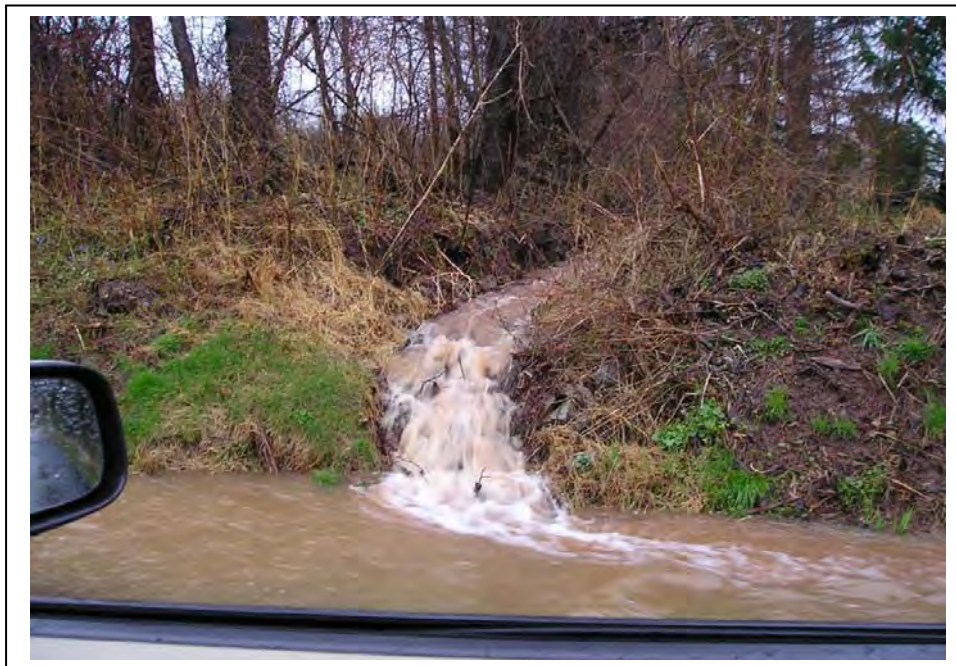
<b>Project Name: Sanctuary Stormwater Pond Modification</b> Rank: Tied-2 Priority: High Map ID: 4	<b>Location/Ownership:</b> Perryville Road, Block 27 Lot 12, potential drainage easement
<b>1. Identified Concerns</b> <ul style="list-style-type: none"> <li>• Sediment loading to the pond caused by erosion and poor stormwater management practices upstream</li> <li>• Downstream of the pond major erosion caused by inadequate detention and poor channel geometry</li> <li>• Flooding frequent downstream</li> </ul>	
<b>2. Mitigation Solutions</b> <ul style="list-style-type: none"> <li>• The best option would be a reconfiguration of the basin to an infiltration design or a bioretention design or secondarily to a detention design</li> <li>• The spillway, if the basin remains in the current configuration, must be reworked to discharge into the channel at a reduced angle to decrease erosive forces</li> <li>• Secondly, the apron must incorporate a higher degree of roughness and flow dissipating features to decrease discharge velocity</li> </ul>

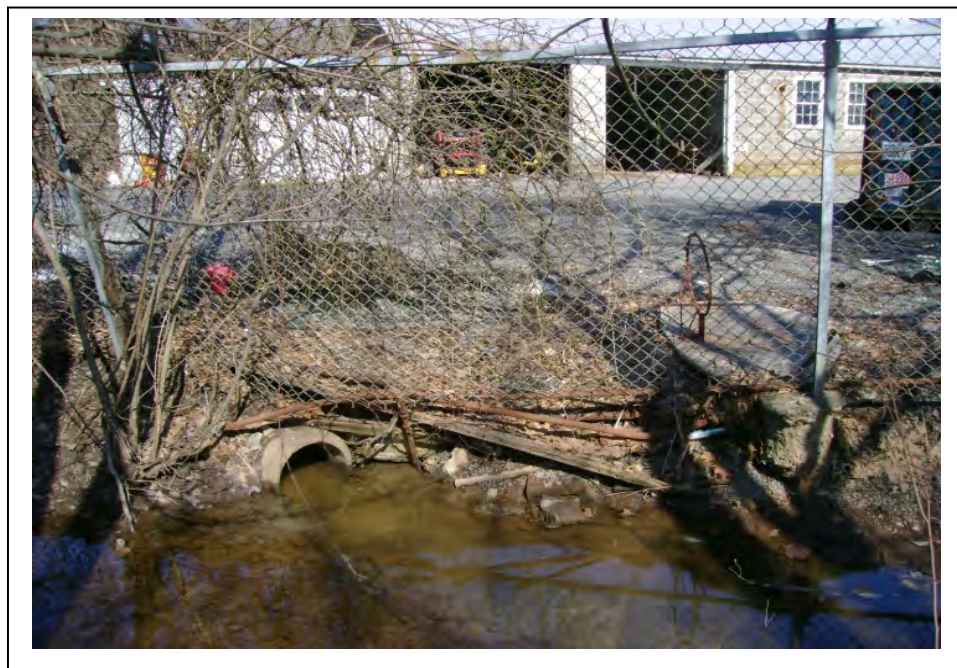
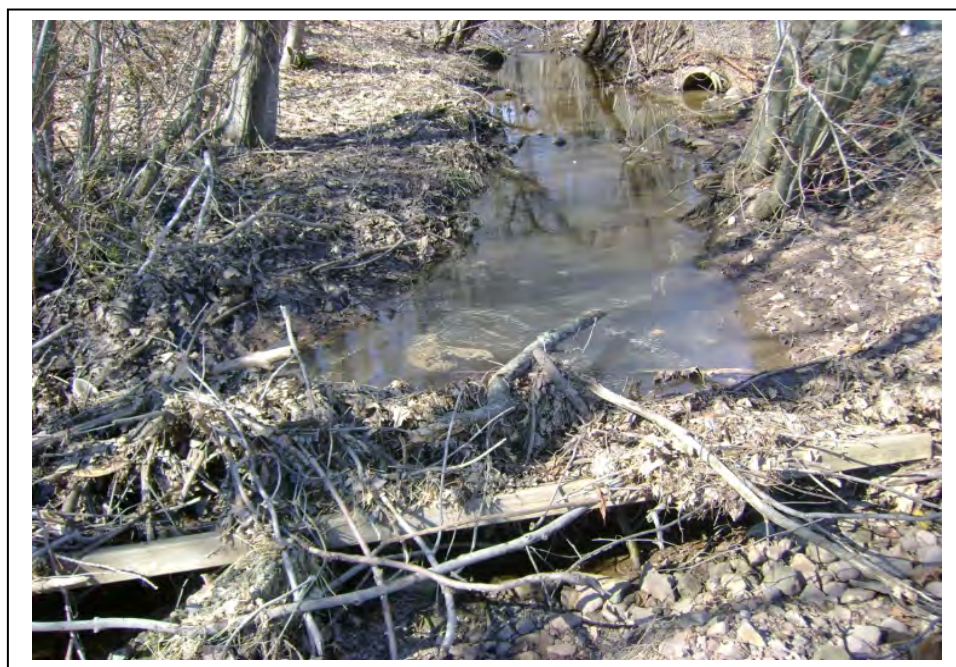
<b>Project Name: Main Street Obstruction Removal and Bank Stabilization</b> Rank: Tied-2 Priority: High Map ID: 11		<b>Location/Ownership:</b> Main Street, Block 21 Lot 19
<b>1. Identified Concerns</b> <ul style="list-style-type: none"><li>• Incised stream banks through area exacerbated by lack of riparian vegetation</li><li>• Old concrete dam causes flooding in the area</li><li>• The dam also acts as a barrier to fish passage and contributes to stream warming through unnecessary impoundment of the creek</li></ul>		
<b>2. Mitigation Solutions</b> <ul style="list-style-type: none"><li>• Dam removal</li><li>• Installation of a grade control device, likely a cross vane or engineered rock riffle to connect the stream beds across the hydraulic jump</li><li>• Implementation of a no-mow zone at a minimum or bank plantings to stabilize the reach</li></ul>		
<b>3. Benefits</b> <ul style="list-style-type: none"><li>• Removal of the dam will result in improved hydraulics in the area with a greatly reduced chance of localized flooding</li><li>• Improved hydraulics will lead to increased oxygenation of the reach with turbulent flow and decreased temperature both benefitting macroinvertebrate utilization of the reach</li><li>• Allows for unimpeded fish passage</li><li>• The use of either grade control will create favorable habitat for aquatic biota</li><li>• Bank planting will increase bank stability and shading</li></ul>

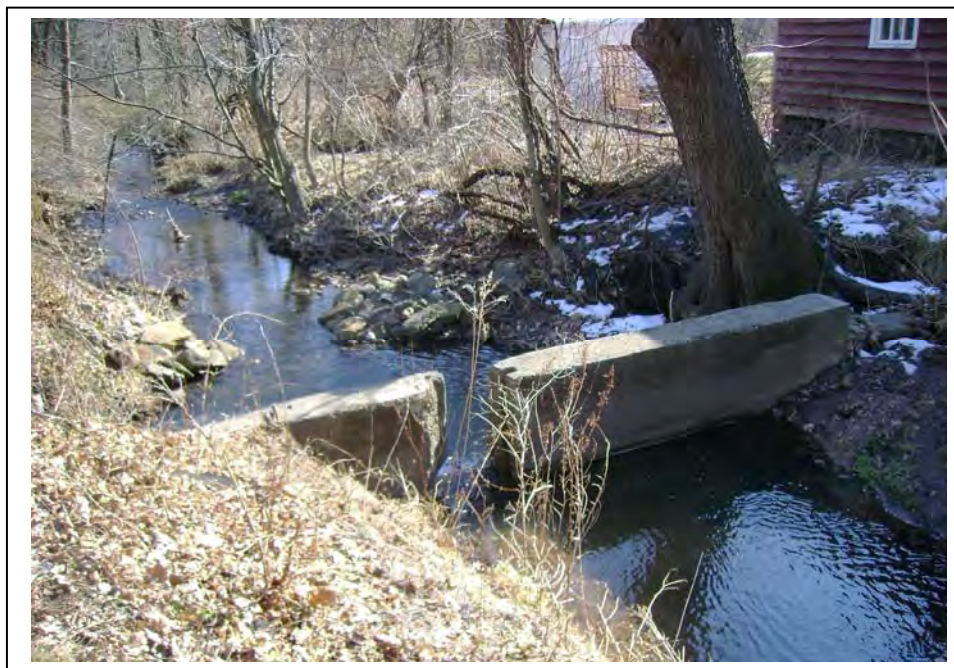
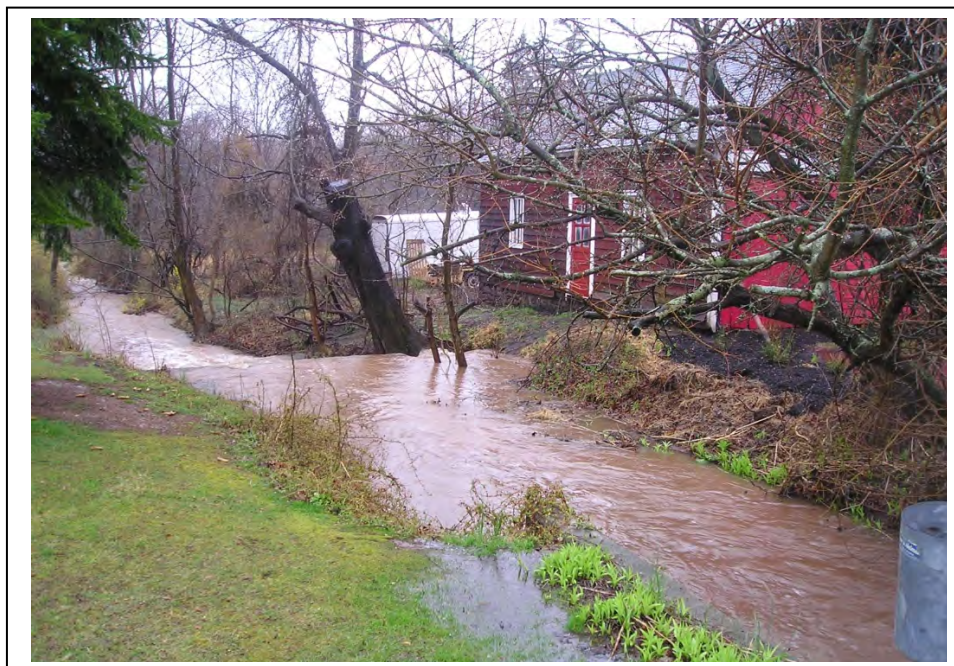
<b>Project Name: Sodres Farm Stormwater Management and Bank Stabilization</b> Rank: Tied-2 Priority: High Map ID: 15	<b>Location/Ownership:</b> Block 25 Lot 37, private ownership
<b>1. Identified Concerns</b> <ul style="list-style-type: none"> <li>• Extreme erosion and bank incision</li> <li>• <i>E. coli</i> loading to the stream from livestock and waterfowl</li> <li>• NPS loading from agricultural fields</li> <li>• Excessive erosion caused by poor riparian buffer in adjacent lands and excessive runoff from Cooks Cross Road upstream</li> </ul>	
<b>2. Mitigation Solutions</b> <ul style="list-style-type: none"> <li>• Bank stabilization including bank grading followed by riparian planting</li> <li>• Installation of vegetated filter strips parallel to contours and grassed waterways perpendicular to grade</li> <li>• Improved stormwater management of roadways upstream</li> <li>• Agricultural BMPs such as nutrient and manure management</li> </ul>

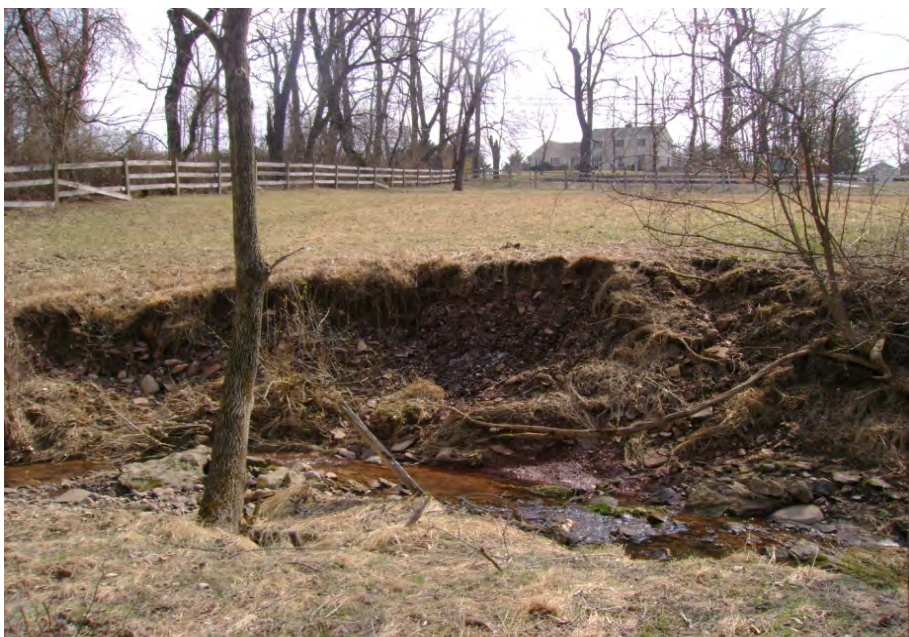
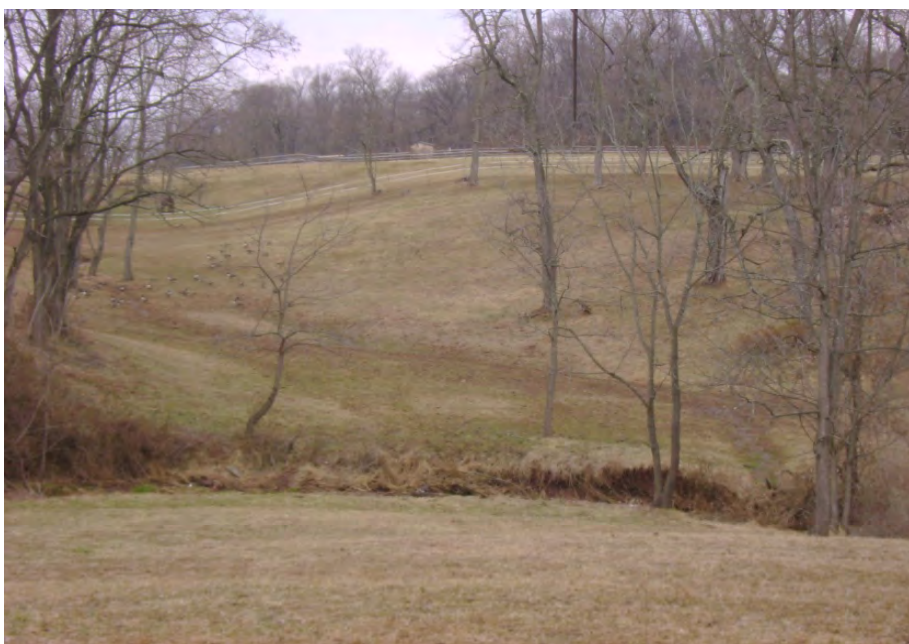
<b>Project Name: Race Street Tributary Restoration</b> Rank: 3 Priority: High Map ID: 12	<b>Location/Ownership:</b> Race Street, Block 25 Lot 2
<b>1. Identified Concerns</b> <ul style="list-style-type: none"> <li>Stream channel is completely degraded</li> <li>Extreme erosion, mass wasting, movement of very large particles</li> <li>Oxbow formation where stream is changing pattern and moving</li> <li>Culvert under is Race Street is severely scoured</li> </ul>	
<b>2. Mitigation Solutions</b> <ul style="list-style-type: none"> <li>Control must be initiated upstream to limit the source generation of stormwater and better control structures to reduce velocity</li> <li>Many sections will need drastic reworking, but work will also be limited by steep grades and forested sections</li> <li>At risk infrastructure, such as the culvert, will need to be armored using gabions</li> <li>Grade control structures will be needed to limit headcut migration and to orient primary flow vectors in the center of the channel</li> </ul>

<b>3. Benefits</b> <ul style="list-style-type: none"> <li>The main goal for work in this section will be to simply maintain the stream in the same course</li> <li>Bank stability will be aided through the use of hard armoring to absorb hydraulic impacts</li> <li>Armoring will reduce the generation of solids which are transported to Jutland Lake</li> <li>Infrastructure will be maintained</li> </ul>	
<b>4. Implementation Concerns</b> <ul style="list-style-type: none"> <li>The severity of the degradation, presence of trees, and steep slopes will make this a difficult implementation</li> </ul>	
<b>5. Task Description</b> <ul style="list-style-type: none"> <li>Bank stabilization (2000 ft)</li> <li>Gabion installation</li> <li>Grade control installation</li> </ul>	<b>Projected Costs</b> <ul style="list-style-type: none"> <li>\$100,000</li> <li>\$30,000</li> <li>\$50,000</li> </ul>

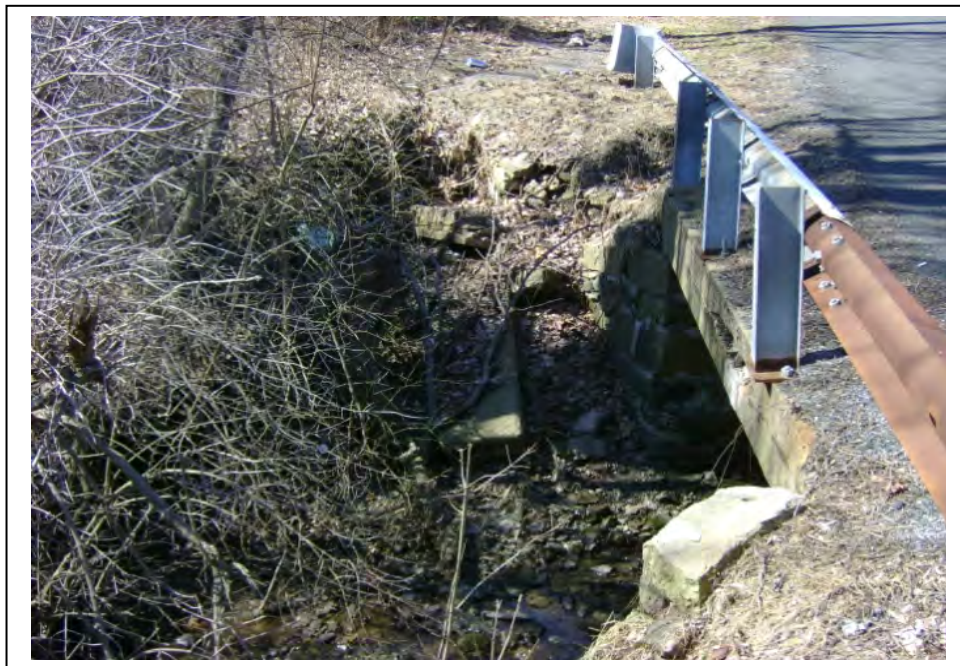
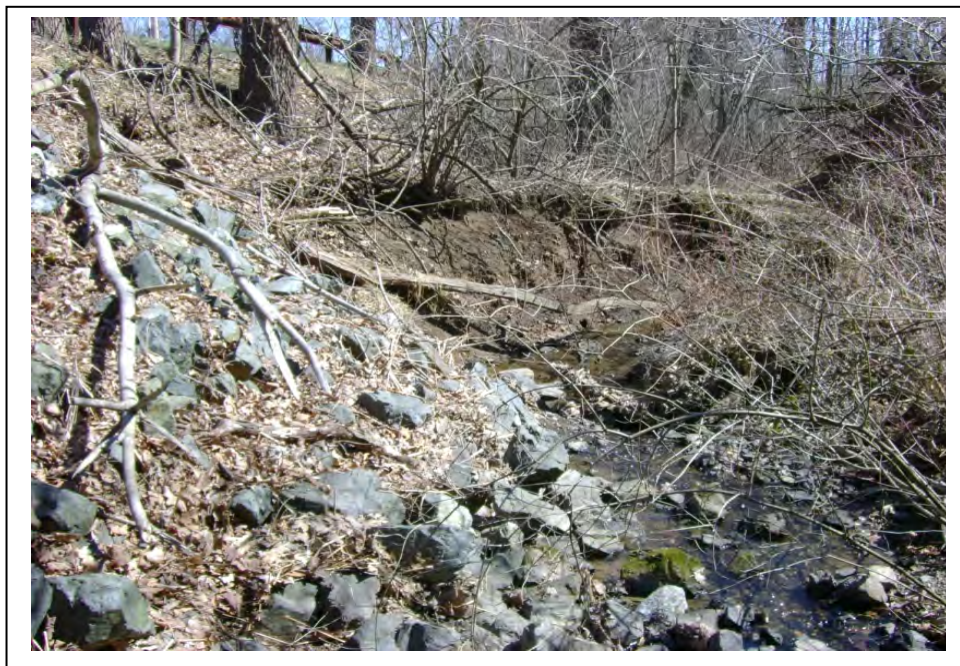
<b>Project Name: High View Court Bank Stabilization</b> Rank: Tied-4 Priority: Medium Map ID: 3		<b>Location/Ownership:</b> Cooks Cross Road near High View Court, Block 27 Lot 3.02, potential drainage easement
<b>1. Identified Concerns</b> <ul style="list-style-type: none"><li>• Major bank instability characterized by sloughing and mass wasting</li><li>• Sediment deposition</li><li>• Lack of riparian vegetation</li><li>• Eight stormsewer outfalls in the vicinity</li></ul>		
<b>2. Mitigation Solutions</b> <ul style="list-style-type: none"><li>• The major effort should focus first on the restoration of the stream banks</li><li>• Planting with shrubs and trees will be needed to stabilize the banks probably after grading; rip-rap and toe protection likely needed at certain locations</li><li>• If possible a regional bioretention basin should be created to receive and detain stormwater from the various basins prior to discharge to the stream</li><li>• If a bioretention basin is not feasible stormwater should be routed via vegetated swales of either dry or wet design</li></ul>

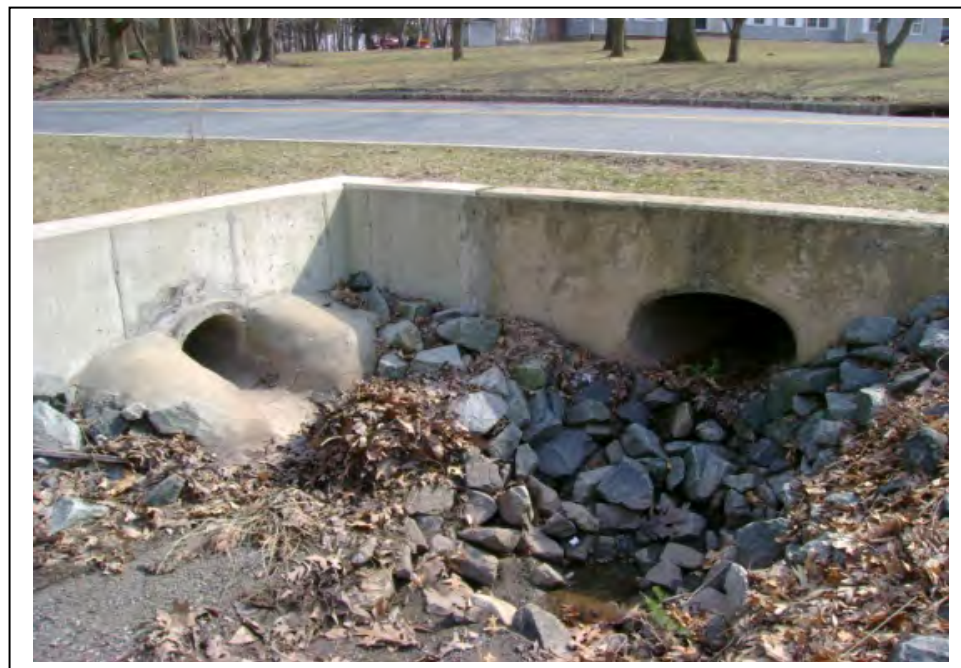
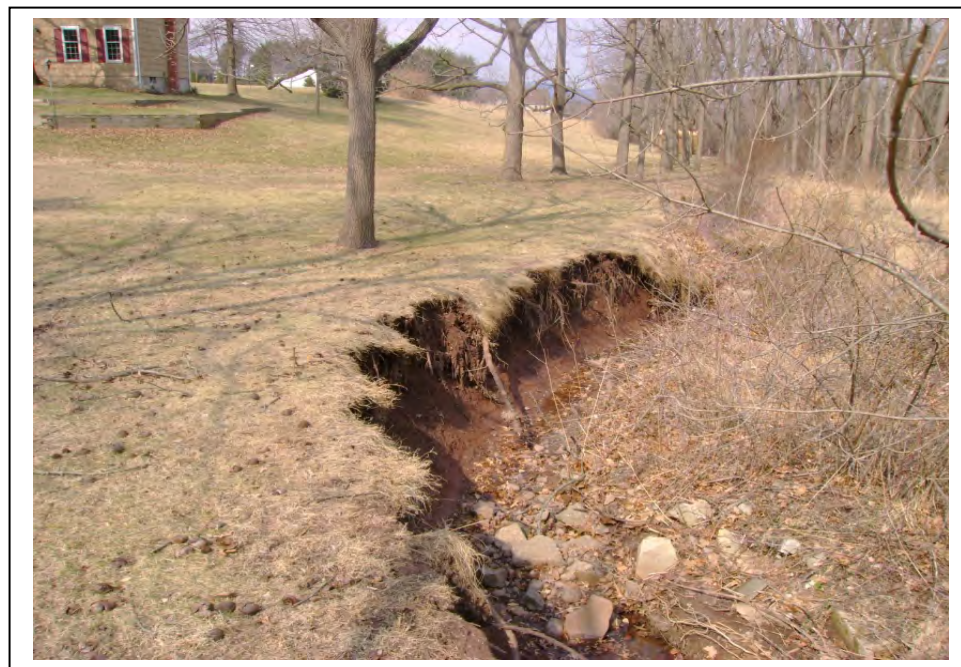
<b>Project Name: Union Township Elementary School Stormwater Improvements</b> Rank: Tied-4 Priority: Medium Map ID: 8	<b>Location/Ownership:</b> Union Township Elementary School, Block 21 Lot 1
<b>1. Identified Concerns</b> <ul style="list-style-type: none"> <li>• Insufficient drainage and drainage treatment throughout campus</li> <li>• Basin discharge to sensitive wetlands</li> </ul>	
<b>2. Mitigation Solutions</b> <ul style="list-style-type: none"> <li>• A variety of solutions can be employed at this site</li> <li>• All swales should be converted to vegetated swales to limit the formation of rills; at a minimum this may simply require no-mow zones</li> <li>• The corner of the parking lot would be an ideal location to install a rain garden</li> <li>• The basin should be converted to a bioretention system through the addition of plants to accelerate the natural processes of wetland species colonization</li> </ul>

<b>3. Benefits</b> <ul style="list-style-type: none"> <li>• These solutions will provide increased treatment of stormwater, including solids removal in excess of 80%</li> <li>• Stormwater volume will be decreased in part through evapotranspiration</li> <li>• Plantings will stabilize the features and produce less erosion</li> <li>• Rain gardens and bioretention systems also have an educational benefit and can be used as a demonstration project for both the students and the community</li> </ul>	
<b>4. Implementation Concerns</b> <ul style="list-style-type: none"> <li>• An ideal site for relatively low intensity solutions.</li> </ul>	
<b>5. Task Description</b> <ul style="list-style-type: none"> <li>• Conversion to vegetated swales</li> <li>• Rain garden installation</li> <li>• Conversion to bioretention basin</li> </ul>	<b>Projected Costs</b> <ul style="list-style-type: none"> <li>• \$10,000</li> <li>• \$10,000</li> <li>• \$30,000</li> </ul>

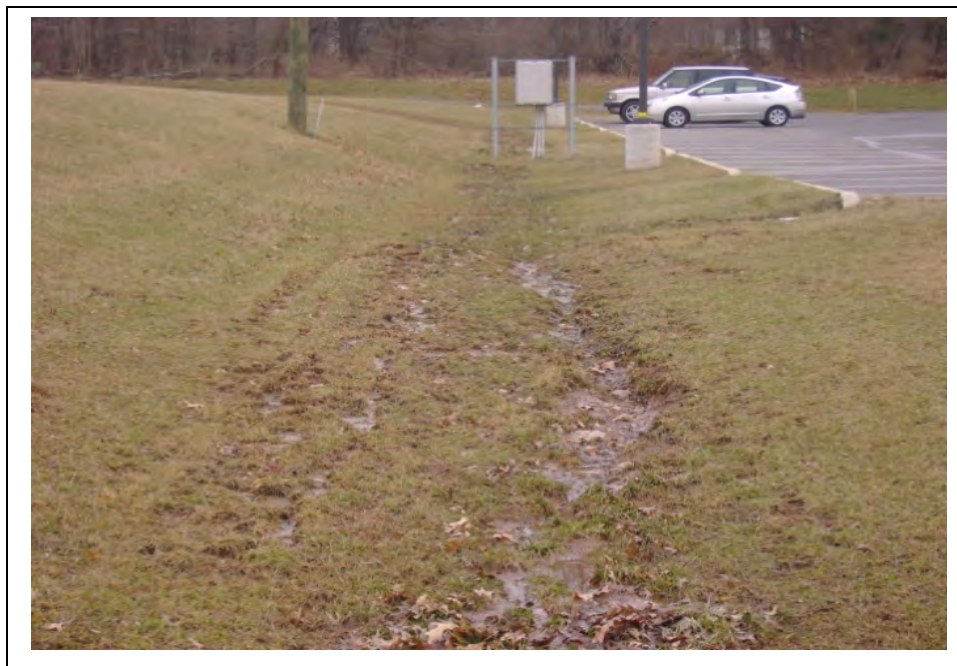
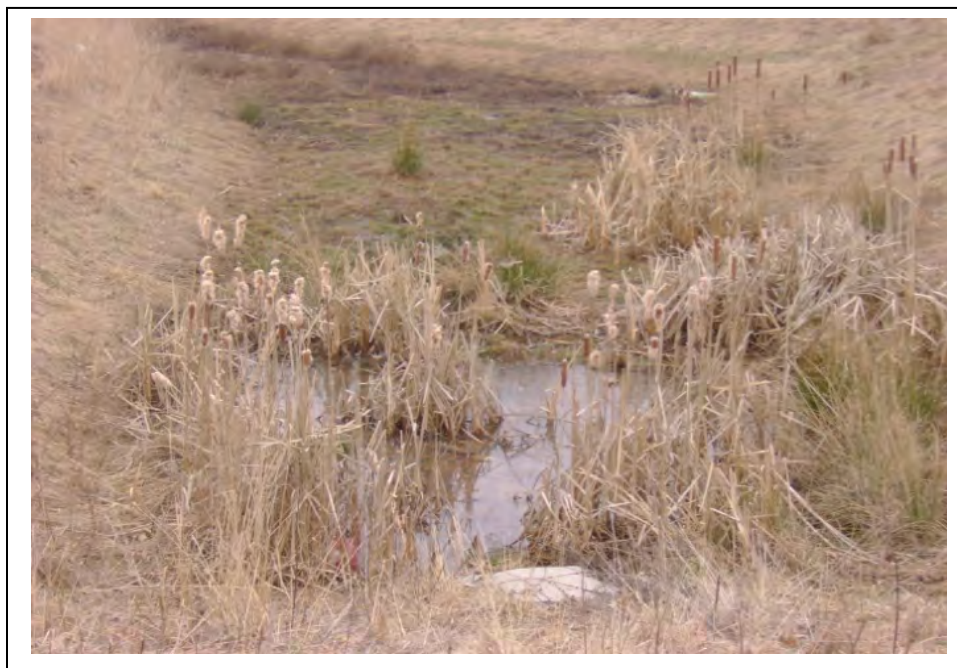
<b>Project Name: Wood Hollow Road Detention Basin Upgrade</b> Rank: Tied-4 Priority: Medium Map ID: 14	<b>Location/Ownership:</b> Cooks Cross Road, Block 30 Lot 1.02, potential drainage easement
<b>1. Identified Concerns</b> <ul style="list-style-type: none"> <li>• Insufficient detention</li> <li>• Downstream flooding and erosion of roadside swale and adjacent properties</li> <li>• Older style basin with low-flow channel and inadequate treatment of first-flush</li> </ul>	
<b>2. Mitigation Solutions</b> <ul style="list-style-type: none"> <li>• Modify basin by adding plantings and removing low-flow channel</li> <li>• Modify orifice to increase retention period</li> <li>• Reconfigure outlet swale</li> <li>• Regrade roadside swale</li> </ul>	
<b>3. Benefits</b> <ul style="list-style-type: none"> <li>• Increased retention period will yield improved capture of solids and phosphorus</li> <li>• Increased retention will also decrease discharge velocities and minimize erosion and flooding downstream</li> <li>• Vegetative component will increase NPS removal efficacy, limit maintenance, and decrease total volume through evapotranspiration and maintain lower temperatures in the basin</li> <li>• Regrading the roadside swale will limit generation of eroded solids in the swale and provide better channel geometry to improve conveyance</li> </ul>

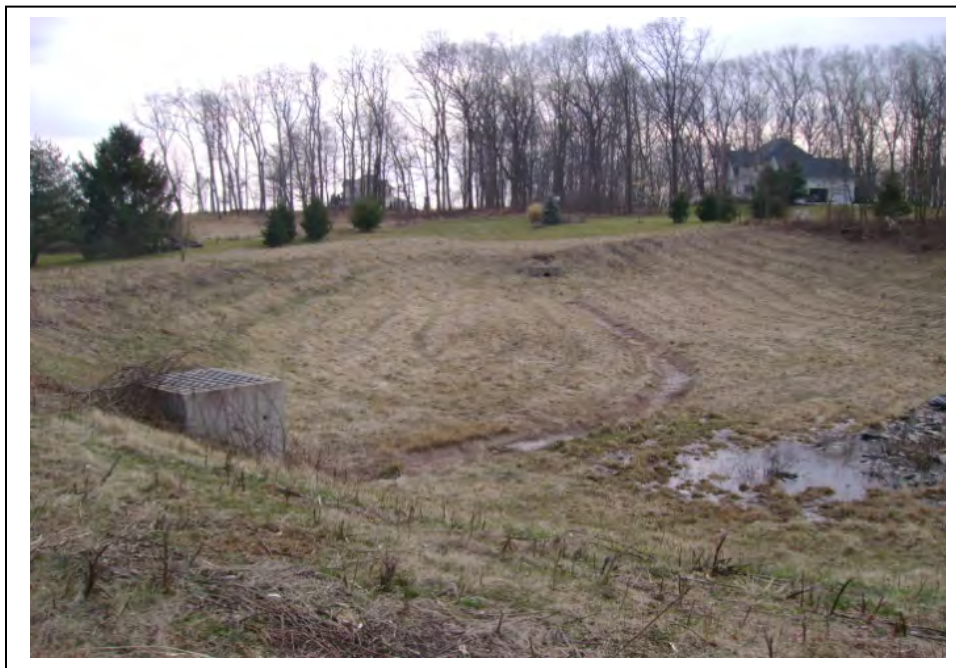
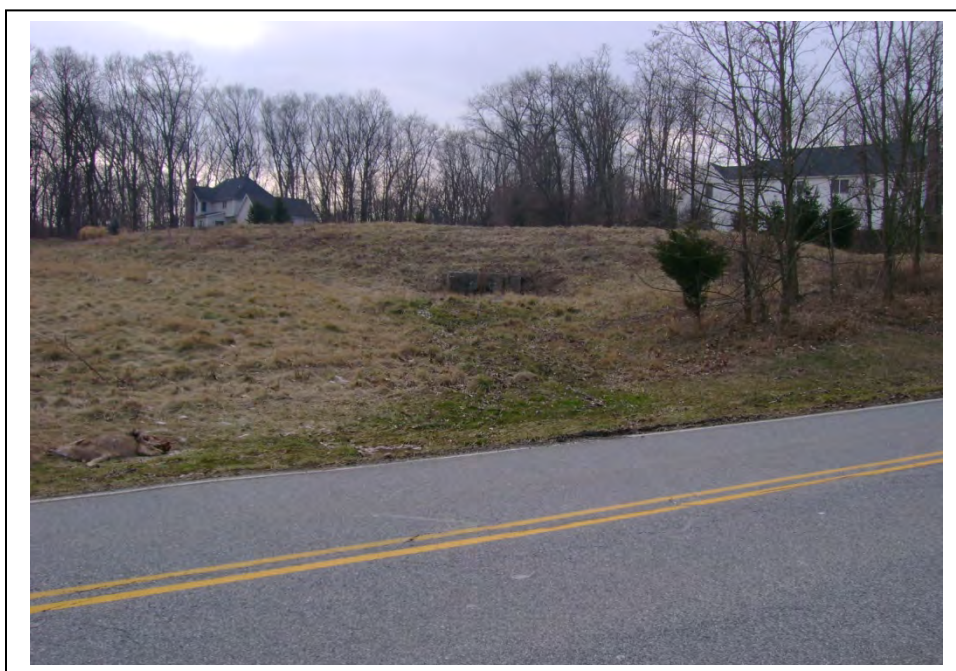
<b>Project Name: Wolf Farm Basin Maintenance and Buffer Restoration</b> Rank: Tied-5 Priority: Medium Map ID: 9	<b>Location/Ownership:</b> Stonebridge Road, Block 21 Lot 29.12
<b>1. Identified Concerns</b> <ul style="list-style-type: none"><li>• Lack of outfall maintenance manifested in erosion, sedimentation, and invasive species colonization</li><li>• Basin is showing high level of sedimentation</li><li>• Lack of any buffer upstream is leading to channel incision, solids mobilization, and direct sunlight on the stream contributing to warming</li></ul>	
<b>2. Mitigation Solutions</b> <ul style="list-style-type: none"><li>• Riparian bank plantings should be used to increase bank stability and shading</li><li>• Basin should be dredged to maintain solids capture efficacy</li></ul>	
<b>3. Benefits</b> <ul style="list-style-type: none"><li>• The addition of bank plantings will be extremely beneficial in limiting further erosion in this reach as well as reducing flood velocity as well as the uptake of nutrients and the filtering of solids</li><li>• Riparian vegetation will also limit warming in this section by providing shade</li><li>• The dredging of the basin is a required periodic maintenance item that needs to be conducted to maintain high solids capture rate near 80%; the in-filling and establishment of cattails is evidence of high solids capture efficiency, but also of lax maintenance</li></ul>

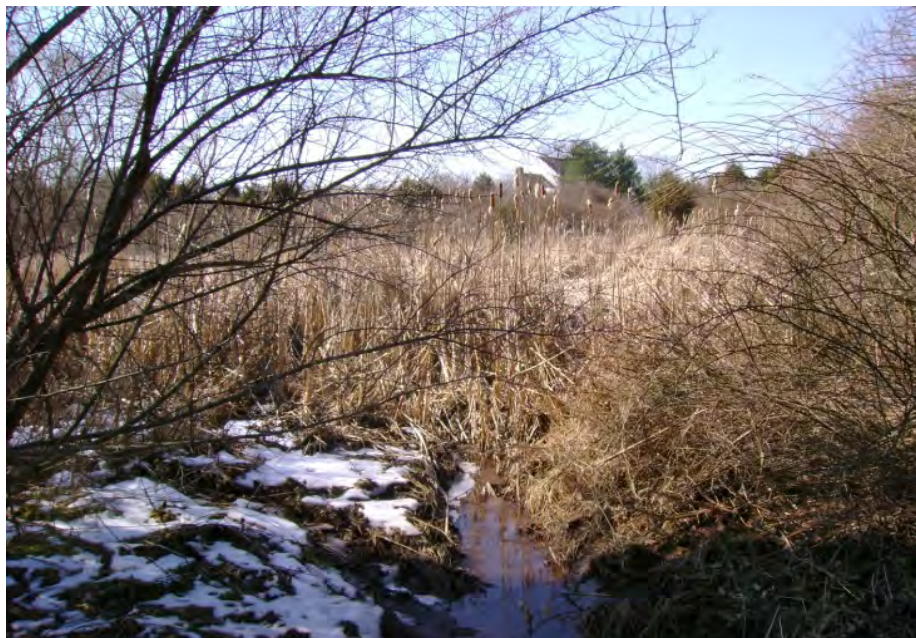
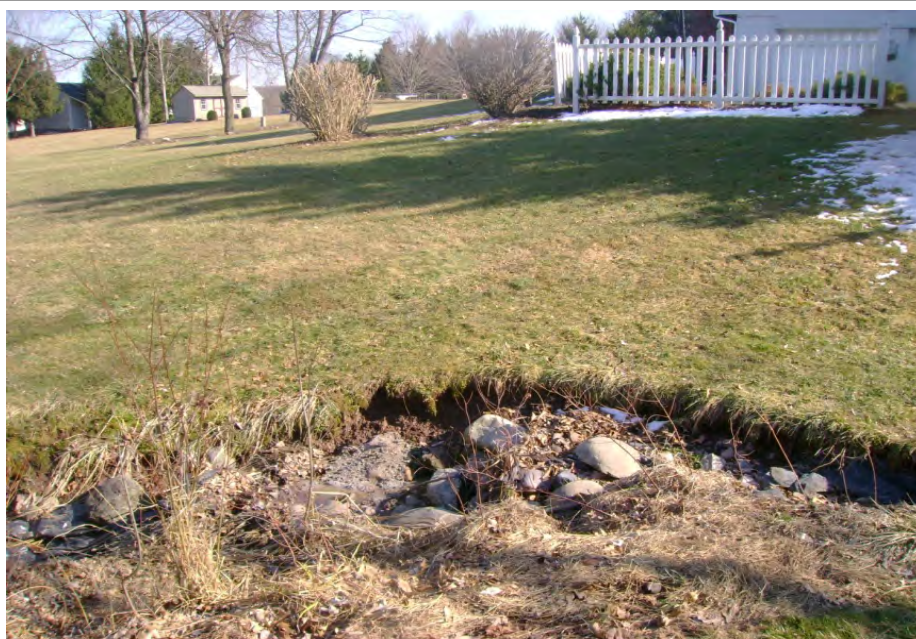
<b>Project Name: Midvale Road Development Stormwater Management</b> Rank: Tied-5 Priority: Medium Map ID: 13	<b>Location/Ownership:</b> Race Street, Block 22.02
<b>1. Identified Concerns</b> <ul style="list-style-type: none"> <li>Excessive stormwater generation</li> <li>Source of generation is varied but includes large amount of impervious surface from roads, roofs, driveways, and compacted lawn as well as steep slopes</li> <li>Inadequate stormwater infrastructure</li> <li>Detention basin is probably by-passed by much of the runoff</li> <li>Extreme channel erosion downstream</li> <li>NPS generation from fertilizers, pets, and other sources</li> </ul>	
<b>2. Mitigation Solutions</b> <ul style="list-style-type: none"> <li>The basin must be reconfigured to remove the low flow channel, increase detention, or switch to an infiltration design to drastically reduce volume</li> <li>All homes should install dry wells or rain barrels to limit roof runoff</li> <li>Cultural BMPs, such as limiting irrigation, need to be implemented community wide</li> <li>Grass needs to be maintained at longer lengths to curb volume</li> <li>Vegetated filter strips should be installed to reduce sheet flow velocity and reduce pollutant loads</li> <li>Pervious pavement should be considered for driveways</li> </ul>

<b>3. Benefits</b> <ul style="list-style-type: none"> <li>The benefits will largely be realized downstream</li> <li>Bank stability will increase if runoff is significantly reduced</li> <li>Vegetated filter strips will minimize <i>E. coli</i> loading from pet waste and capture fertilizers and other solids</li> <li>Stream pattern can be maintained without major channel migration</li> </ul>	
<b>4. Implementation Concerns</b> <ul style="list-style-type: none"> <li>A relatively straightforward implementation project although the modification of basin aesthetics may be problematic to surround homeowners</li> </ul>	
<b>5. Task Description</b> <ul style="list-style-type: none"> <li>Basin retrofits</li> <li>Rain barrel installation</li> <li>Vegetated filter strip installation</li> <li>Pervious pavement installation</li> </ul>	<b>Projected Costs</b> <ul style="list-style-type: none"> <li>\$25,000</li> <li>\$300 per home</li> <li>\$30,000</li> <li>\$10 per square foot</li> </ul>

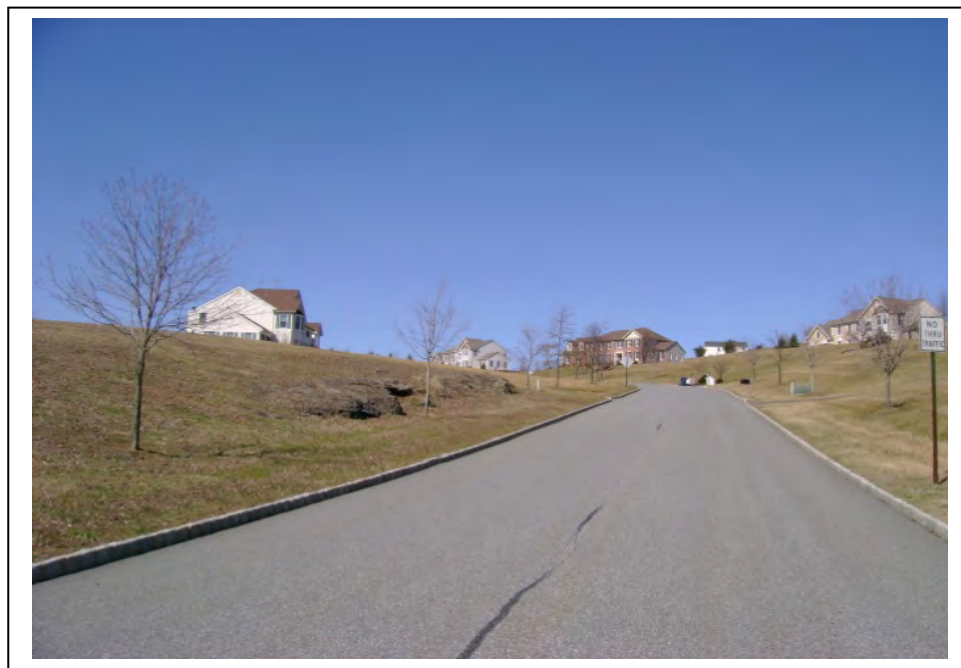
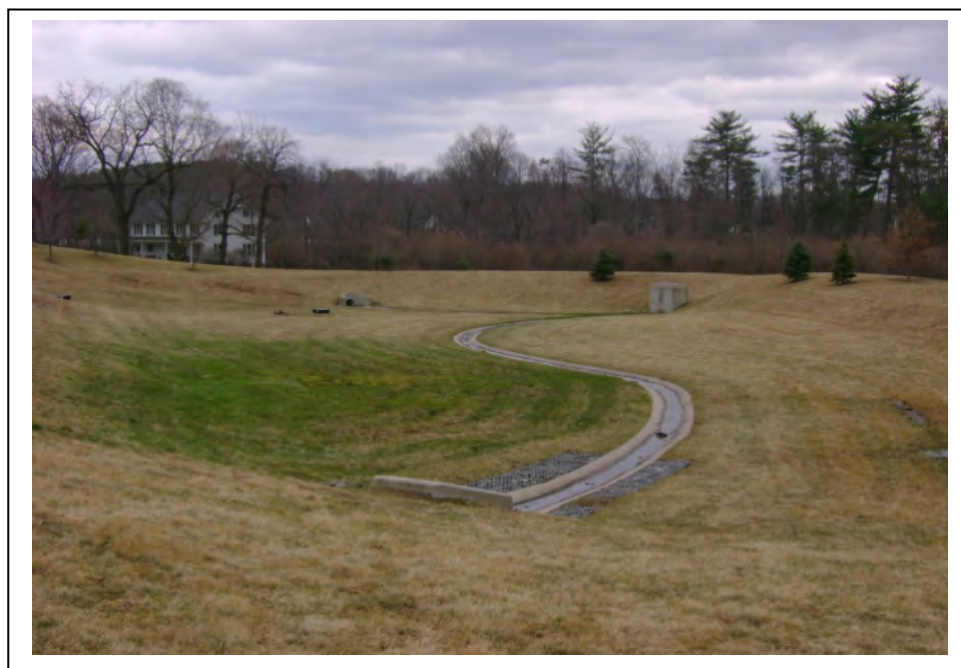
<b>Project Name: Race Street Flooding Alleviation</b> Rank: Tied-5 Priority: Medium Map ID: 18	<b>Location/Ownership:</b> Race Street, Block 25 Lot 11
<b>1. Identified Concerns</b> <ul style="list-style-type: none"><li>• Frequent flooding of roadway</li><li>• Formation of transverse gravel bars in mid-channel and other sedimentation</li><li>• Reduced buffer quality</li><li>• Minor erosion</li></ul>	
<b>2. Mitigation Solutions</b> <ul style="list-style-type: none"><li>• Limited channel cleaning to remove excessive accumulations of solids</li><li>• Riparian buffer planting to increase bank stability</li><li>• Roadway or bridge modification to promote drainage in floodway</li></ul>	
<b>3. Benefits</b> <ul style="list-style-type: none"><li>• Channel cleaning to remove accumulated gravel bars and other fine sediments that impede flow; avoid channel widening or deepening of the original channel to maintain floodplain connectivity</li><li>• Limited riparian plantings will stabilize the banks and provide shading; because this area is publically accessible for angling channel access must be maintained</li><li>• Bridge or roadway modification should raise bridge or install culverts on the floodplain to promote flow across floodplain and alleviate temporary impoundment behind the bridge; maintaining floodplain access will limit erosion in the channel</li></ul>

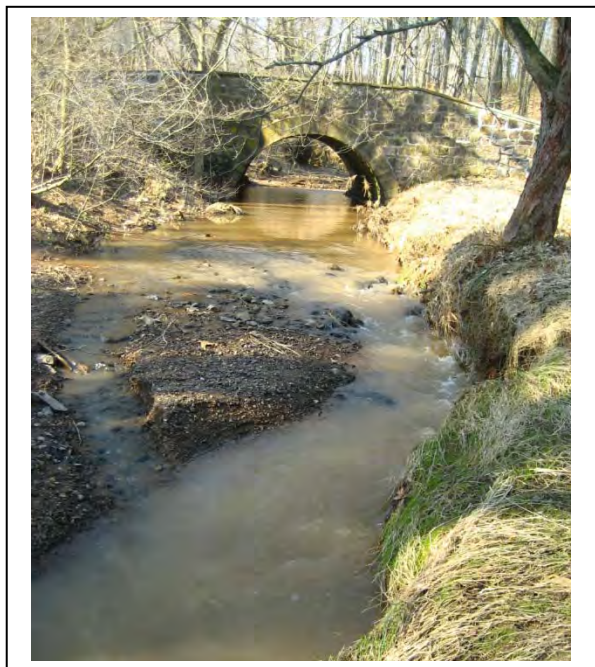
<b>Project Name: Rt. 513 Public Access Improvements</b> Rank: Tied-5 Priority: Medium Map ID: 19		<b>Location/Ownership:</b> Race Street, Franklin Township, Block 3 Lot 1
<b>1. Identified Concerns</b> <ul style="list-style-type: none"><li>• Unimproved access and facilities</li><li>• Invasive species colonization</li></ul>		
<b>2. Mitigation Solutions</b> <ul style="list-style-type: none"><li>• Invasive species removal followed by replacement with native vegetation</li><li>• Access and use improvements including trail maintenance and provision of garbage cans</li></ul>		
<b>3. Benefits</b> <ul style="list-style-type: none"><li>• As one of the few publically accessible areas on the stream improvements to access would increase utilization consistent with use designations</li><li>• Removal of invasive vegetation will improve access and enhanced native vegetation will provide shoreline stability and improved habitat quality</li></ul>

<b>4. Implementation Concerns</b> <ul style="list-style-type: none"><li>• No concerns for this site.</li></ul>		
<b>5. Task Description</b> <ul style="list-style-type: none"><li>• Invasive species removal</li><li>• Riparian bank plantings</li><li>• Site improvements</li></ul>		<b>Projected Costs</b> <ul style="list-style-type: none"><li>• \$12,000</li><li>• \$8,000</li><li>• \$1,000</li></ul>
