# **THE SIDNEY BROOK WATERSHED PROTECTION PLAN**

HUC-14 02030105020070 Raritan River South Branch (River Road to  
Spruce Run)

**Princeton Hydro, LLC  
1108 Old York Road  
Suite 1, Post Office Box 720  
Ringoes, NJ 08551  
908-237-5660**

**June 2010  
Revised December 2011  
Revised May 2012**

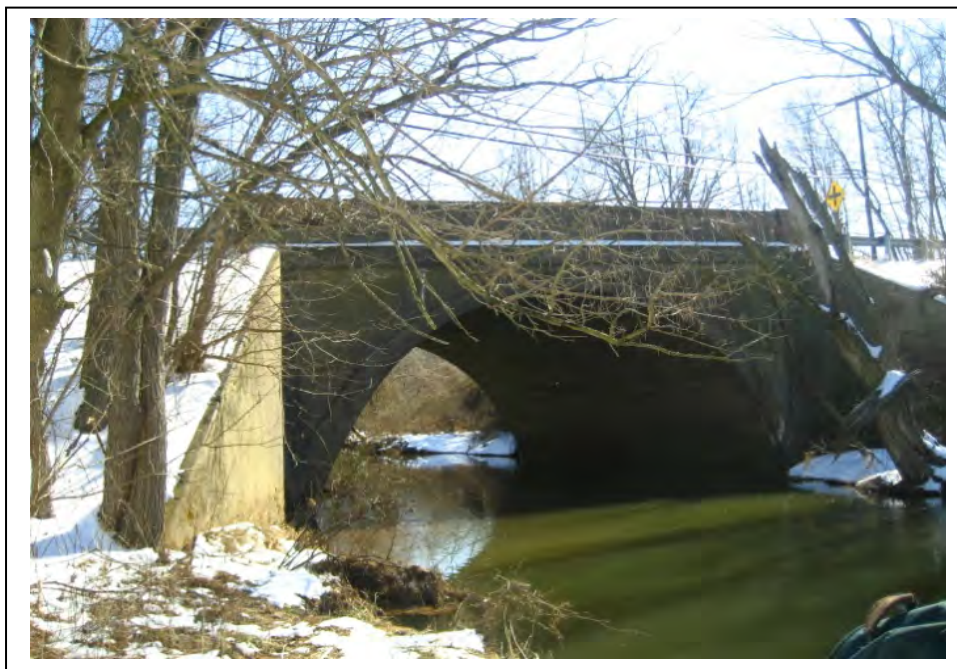
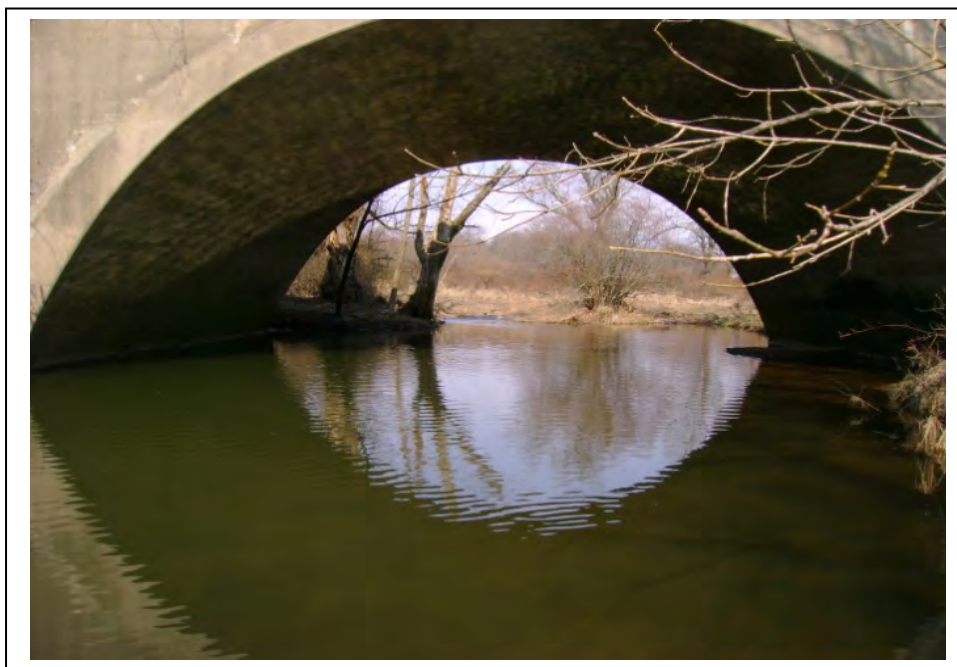
<b>Project Name: Cooks Cross Road Runoff Management</b> Rank: Tied-6 Priority: Low Map ID: 1	<b>Location/Ownership:</b> Cooks Cross Road near Woods Road, Block 28 Lot 25, potential drainage easement
<b>1. Identified Concerns</b> <ul style="list-style-type: none"> <li>Excessive stormwater velocity causing bank incision and sedimentation</li> <li>Downstream ponds affected by extreme turbidity during storm events</li> </ul>	
<b>2. Mitigation Solutions</b> <ul style="list-style-type: none"> <li>Regrade and modify road drainage swales and inlets</li> <li>Installation of a large MTD to capture road grit and eroded material from swales</li> <li>Construct a bioretention basin at the toe of slope to slow velocity and capture solids</li> <li>Consider linking these solutions</li> <li>Regular maintenance of the roadside drainage features and any constructed BMP is required</li> </ul>	
<b>3. Benefits</b> <ul style="list-style-type: none"> <li>While the catchment at this location is small, less than 3.5 acres, steep slopes in this area exacerbate erosion and swales serve as the major loaders of solids</li> <li>Total anticipated solids load in this catchment combining road grit and eroded channel materials is approximately 15,000 lbs annually</li> <li>At 80% removal provided by either an MTD or bioretention basin, or in series, up to 12,000 lbs of solids could be captured</li> <li>Efficacy of the system would only be maintained under regular maintenance</li> </ul>

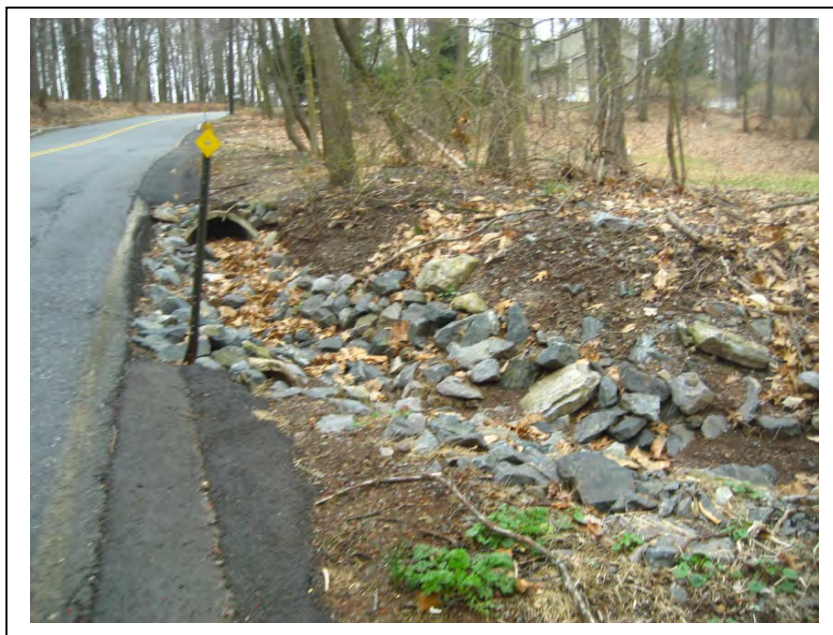
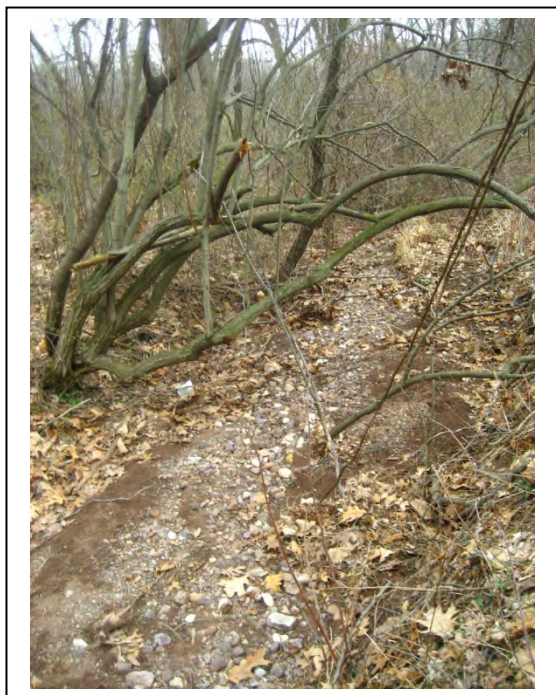
<b>Project Name: Kenneth Place Detention Basin Outlet Repair</b> Rank: Tied-6 Priority: Low Map ID: 7	<b>Location/Ownership:</b> Kenneth Place, Block 28 Lot 13
<b>1. Identified Concerns</b> <ul style="list-style-type: none"> <li>• Outfall from detention basin is causing significant erosion in the channel through a tussock sedge wetland</li> <li>• Mowing encroaches on this wetland which may be potential habitat for T&amp;E species</li> </ul>	
<b>2. Mitigation Solutions</b> <ul style="list-style-type: none"> <li>• Repair outlet erosion by extending apron and laying rip-rap or convert to a vegetated swale</li> <li>• Channel should be slightly raised to allow the water to flood the wetland</li> <li>• Basin may be retrofitted to lower stage and provide more detention and increase detention period by resizing orifice</li> <li>• Provide a no-mow zone adjacent to the wetland</li> </ul>	
<b>3. Benefits</b> <ul style="list-style-type: none"> <li>• Modifying or retrofitting the outlet structure will decrease discharge velocity and limit erosion</li> <li>• Stabilizing the channel preferably through planting will limit erosion and provide roughness to further reduce velocity and limit deposition of sediment in the wetland</li> <li>• More regular flooding of the wetland will provide more natural hydrology</li> <li>• No-mow buffer will protect the wetland edge and provide a degree of water treatment</li> </ul>

<b>4. Implementation Concerns</b> <ul style="list-style-type: none"> <li>• Permitting may be difficult because of the wetlands and potential T&amp;E species issues.</li> </ul>	
<b>5. Task Description</b> <ul style="list-style-type: none"> <li>• Rip-rap installation/conversion to vegetated swale</li> <li>• Basin retrofits</li> </ul>	<b>Projected Costs</b> <ul style="list-style-type: none"> <li>• \$20,000</li> <li>• \$15,000</li> </ul>

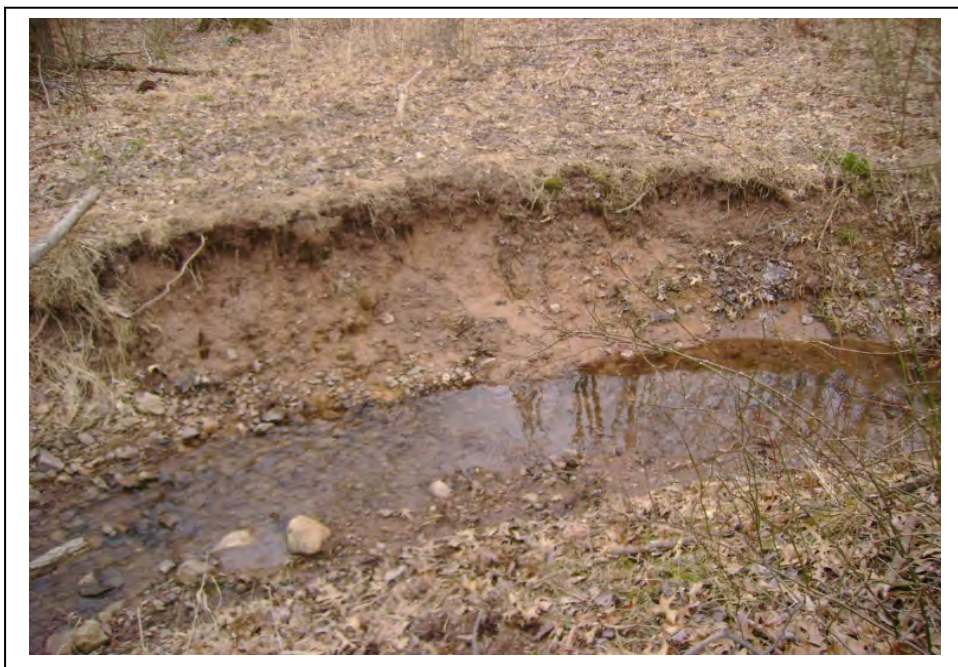
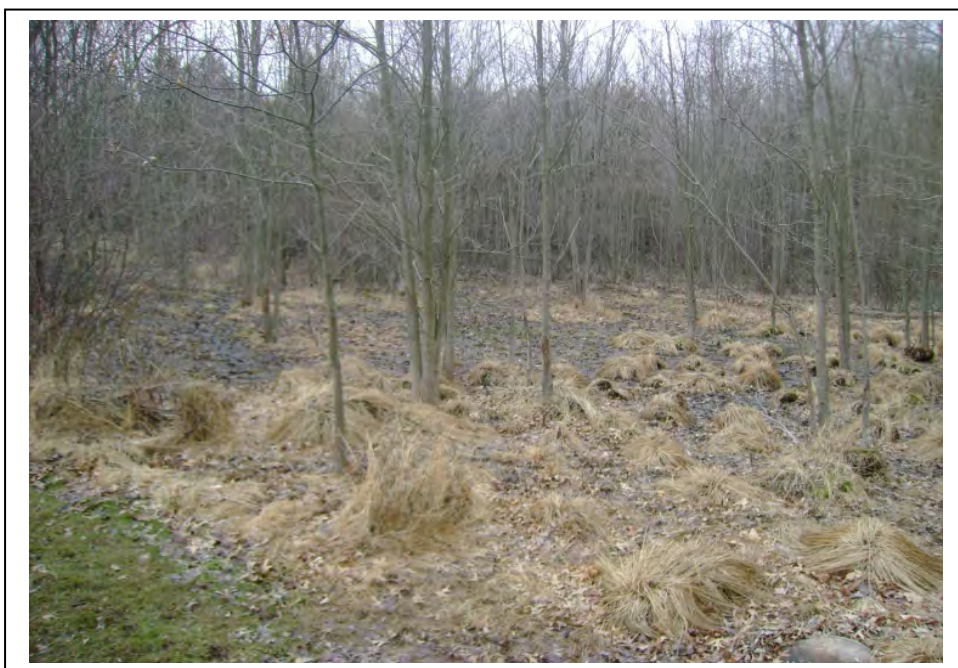
<b>Project Name: Peaceful Valley Orchards Agricultural BMPs</b> Rank: Tied-6 Priority: Low Map ID: 16	<b>Location/Ownership:</b> Block 25 Lot 35, private ownership
<b>1. Identified Concerns</b> <ul style="list-style-type: none"> <li>• General soil erosion in agricultural lands</li> <li>• Streambank erosion</li> <li>• NPS loading from agricultural fields</li> <li>• Excessive turbidity of farm pond</li> <li>• Outfall from road runoff is conveyed across agricultural lands and farm access lane</li> </ul>	
<b>2. Mitigation Solutions</b> <ul style="list-style-type: none"> <li>• Utilize vegetated swales to convey runoff</li> <li>• Improve buffers on existing drainage features</li> <li>• Install an improved agricultural stream crossing on the intermittent channel</li> <li>• Continued use of agricultural BMPs such as residue management on fields</li> </ul>	
<b>3. Benefits</b> <ul style="list-style-type: none"> <li>• The use of vegetated swales captures many different pollutants, including nutrients, solids, and bacteria, and will limit erosion in the swale itself and points downstream</li> <li>• Improving buffer width on existing drainage features will further add channel stability and limit the quantity of NPS pollutants discharged to the channel</li> <li>• Adding an improved agricultural crossing on the access lane will significantly decrease localized erosion of the lane and limit solids loading to the swale</li> <li>• Agricultural BMPs such as residue management, maintaining at least 30% ground coverage with crop residue, can decreased erosion of topsoil by up to 90% significantly reducing solids loading to the creek and maintaining organic rich soils in fields thus maintaining crop yields and decreasing the need for chemical fertilizers</li> </ul>

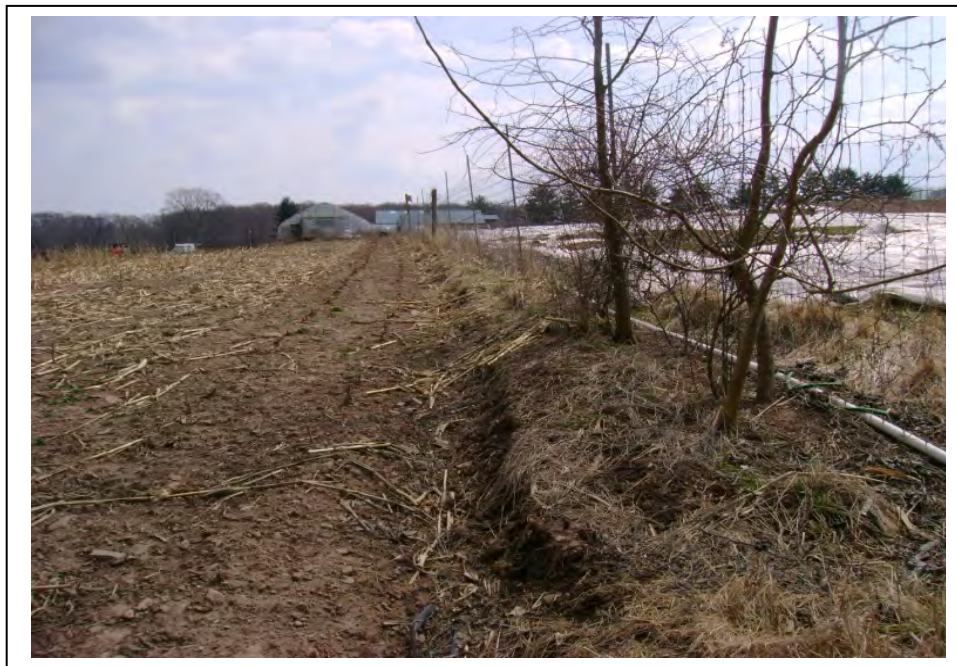
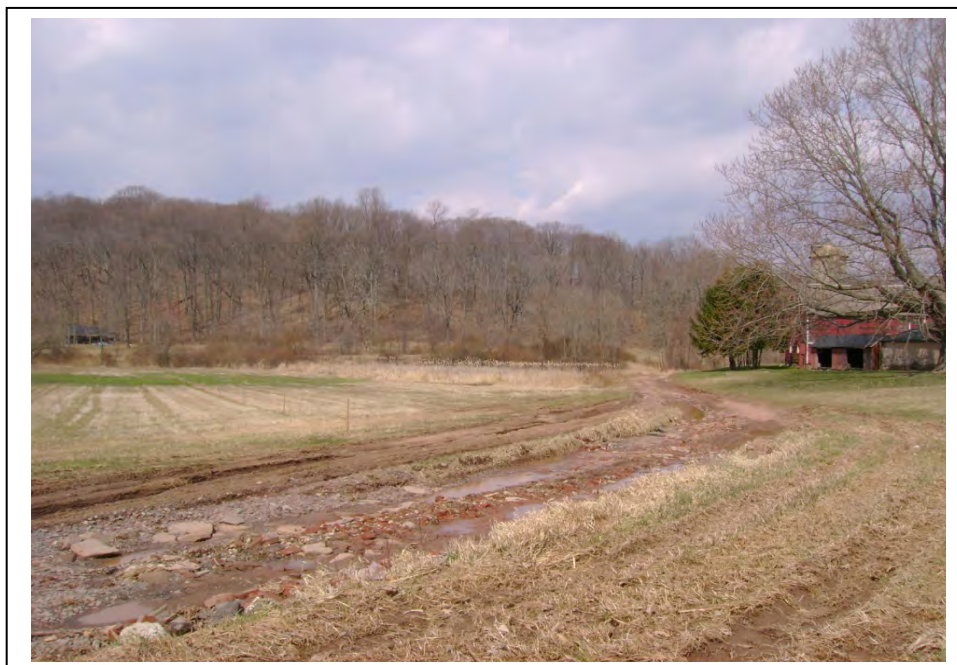
<b>Project Name: Bank Stabilization upstream of Race Street near Hilltop Lane</b> Rank: Tied-7   Priority: Low   Map ID: 17		<b>Location/Ownership:</b> Race Street and Hilltop Lane, Block 25 Lot 11	
<b>1. Identified Concerns</b> <ul style="list-style-type: none"><li>• Significant bank erosion downstream of culvert under train tracks</li><li>• Formation of transverse gravel bars in mid-channel and other sedimentation</li><li>• High turbidity during stormflows indicative of TSS loading</li><li>• Some scour noted around culvert</li></ul>			
<b>2. Mitigation Solutions</b> <ul style="list-style-type: none"><li>• Limited channel cleaning to remove excessive accumulations of solids</li><li>• Classic location for installation of flow deflection devices, such as J-hooks, to minimize erosive forces on the stream bank</li><li>• Augment existing woody vegetation on stream banks with shrubs</li><li>• Inspection of infrastructure</li></ul>

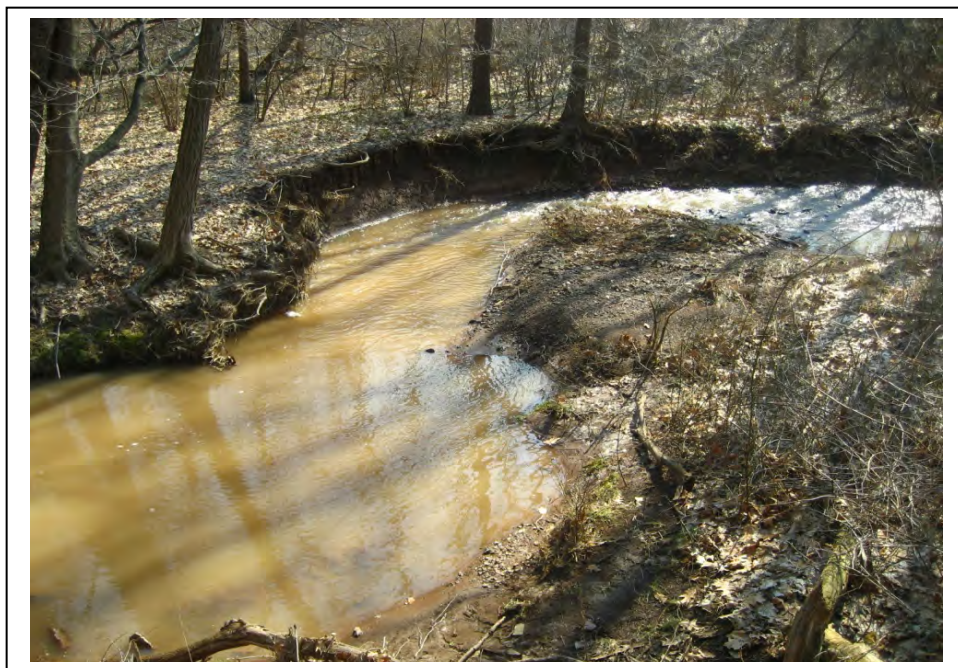
<b>Project Name: Sidney Road Bank Stabilization</b> Rank: Tied-7 Priority: Low Map ID: 20	<b>Location/Ownership:</b> Sidney Road, Block 200 Lot 2.X
<b>1. Identified Concerns</b> <ul style="list-style-type: none"><li>• Minor buffer encroachment and fine solids accumulation</li><li>• Limited erosion around bridge</li></ul>	
<b>2. Mitigation Solutions</b> <ul style="list-style-type: none"><li>• No-mow zone instituted on south bank with some plantings</li><li>• Possible armoring with rip-rap or gabions near bridge</li></ul>	
<b>3. Benefits</b> <ul style="list-style-type: none"><li>• Improved bank stability by plantings to limit erosion and reduce solids</li><li>• Decreased thermal impact</li><li>• Decreased erosion around bridge to protect infrastructure</li></ul>	
<b>4. Implementation Concerns</b> <ul style="list-style-type: none"><li>• Landowner buy-in a concern.</li></ul>	
<b>5. Task Description</b> <ul style="list-style-type: none"><li>• Plantings</li><li>• Gabion installation</li></ul>	<b>Projected Costs</b> <ul style="list-style-type: none"><li>• \$2,000</li><li>• \$60,000</li></ul>

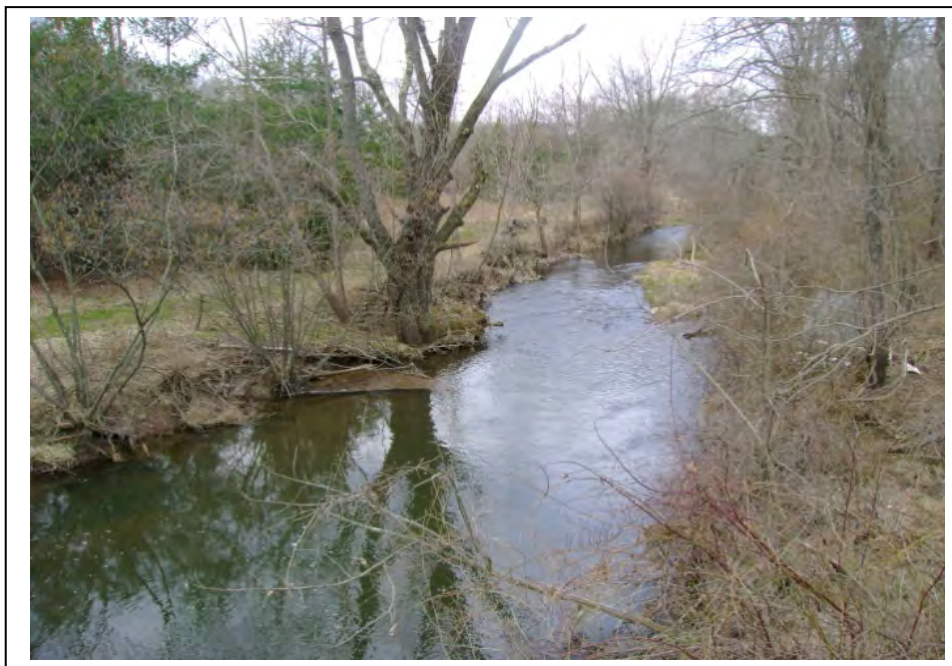
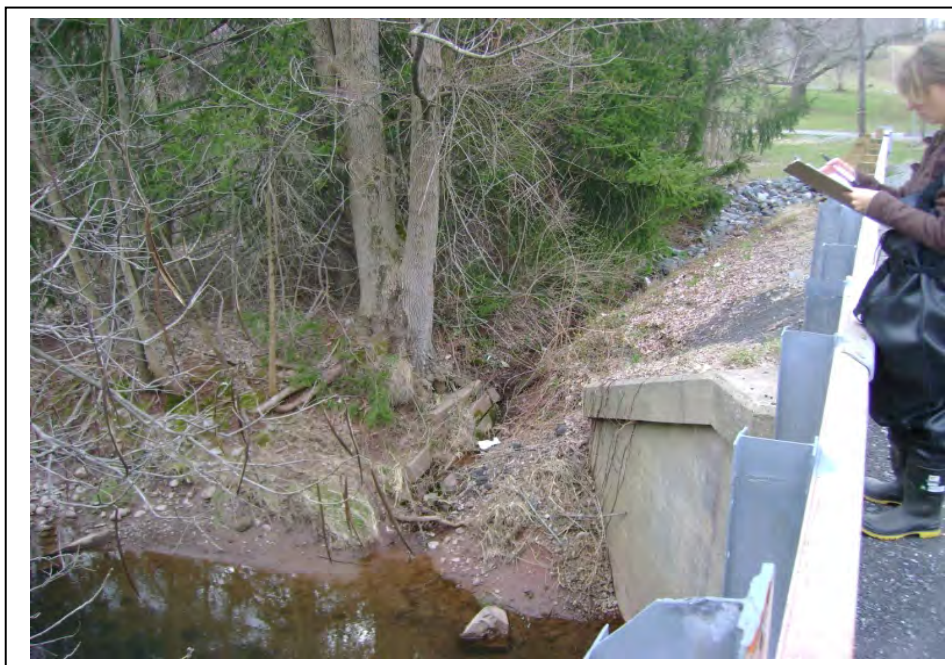
<b>Project Name: Lakeshore Aquascaping</b>  Rank: Tied-8 Priority: Low Map ID: 2	<b>Location/Ownership:</b> A general measure for ponds and lakes throughout the watershed, including Jutland Lake and the four identified ponds on reach I
<b>1. Identified Concerns</b> <ul style="list-style-type: none"> <li>• Bank instability</li> <li>• Unmitigated delivery of solids and nutrients in runoff</li> <li>• Increased temperatures including discharged waters to stream</li> <li>• Waterfowl access and pollutant loading</li> </ul>	
<b>2. Mitigation Solutions</b> <ul style="list-style-type: none"> <li>• At a minimum establish a narrow no-mow zone around all lakeshores to limit goose access and provide filtration</li> <li>• Where acceptable establish multi-tiered planting or aquascaping plan including shallow emergents, herbaceous plants, and shrubs</li> <li>• Creative solutions can be used to maintain access and view including zig-zag paths through the plantings</li> </ul>

<b>3. Benefits</b> <ul style="list-style-type: none"> <li>• The establishment of plants will foremost serve to mechanically filter runoff capturing much of the solids load as well as nutrients that contribute to infilling and algae blooms thereby reducing these issues with TP removal rates from runoff as high as 30%</li> <li>• Limits access for waterfowl such as geese; each goose kept off the lake decreases TP loading up to 0.5 lbs per year</li> <li>• In a lake setting planting may have a limited effect on decreasing temperatures, but still contributes positively</li> <li>• Increased value as wildlife habitat, especially important for species that rely on shrub or marsh habitats, such as Red-Winged Blackbird or Willow Flycatcher</li> </ul>	
<b>4. Implementation Concerns</b> <ul style="list-style-type: none"> <li>• Landowner buy-in a concern. While this is a low-rated project, it is also very easily implemented at minimum cost and thus should receive higher attention</li> </ul>

<b>5. Task Description</b> <ul style="list-style-type: none"> <li>• Shoreline aquascaping</li> </ul>	<b>Projected Costs</b> <ul style="list-style-type: none"> <li>• \$2,000 to \$20,000</li> </ul>

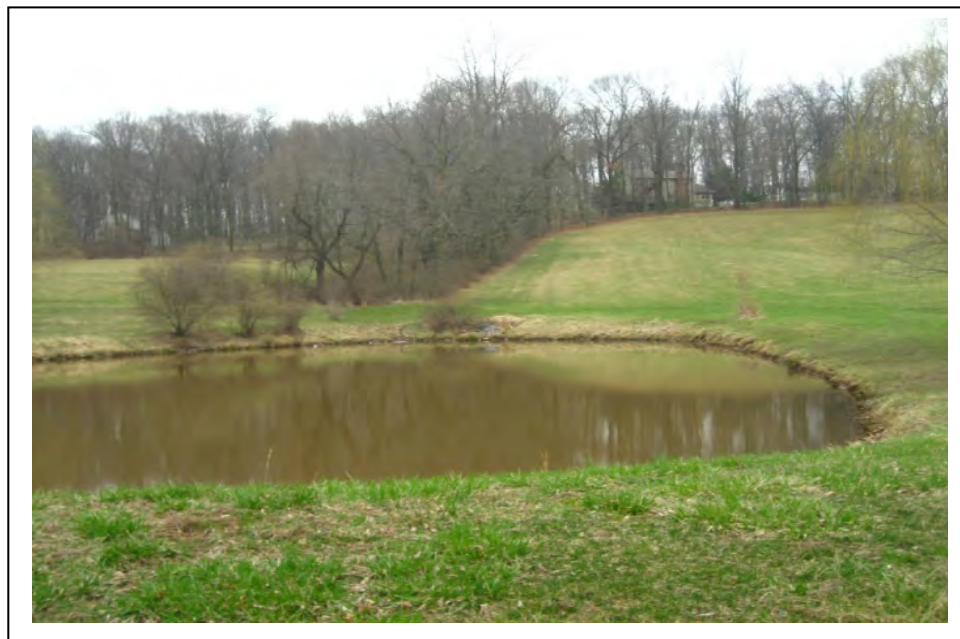
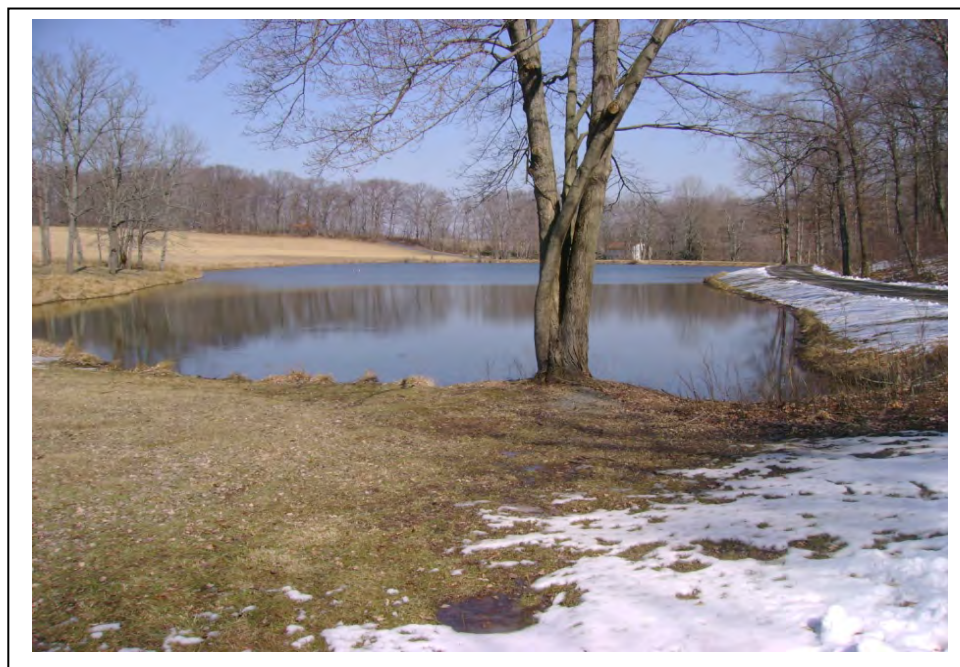
<b>Project Name: Perryville Road Crossing Bank Restoration</b> Rank: Tied-8 Priority: Low Map ID: 6	<b>Location/Ownership:</b> Perryville Road, Block 25 Lot 31
<b>1. Identified Concerns</b> <ul style="list-style-type: none"> <li>Stream is incising near the road crossing</li> <li>Lack of riparian vegetation upstream exacerbates problem</li> </ul>	
<b>2. Mitigation Solutions</b> <ul style="list-style-type: none"> <li>Bank stabilization activities beginning with invasive vegetation removal followed by riparian planting</li> <li>To minimize impacts to the adjacent forest grading activities and other disturbances should be limited</li> <li>Bends should receive toe protection in the form of root wads or boulder toe</li> <li>Upstream portions should focus on improving existing woody vegetation with the addition of woody shrubs</li> </ul>	
<b>3. Benefits</b> <ul style="list-style-type: none"> <li>Initiating a planting plan focused on willows, dogwoods, and similar species will provide additional stability in this reach and limit in-channel erosion</li> <li>Increased roughness along banks and in floodplain will reduce flood velocity further decreasing erosion</li> <li>Vegetation community will be improved by the removal of invasive and replacement of natives providing increased shading, higher nutrient removal capacity, and better habitat value</li> <li>Forested buffers are capable of providing up to 70% removal of solids in stormwater</li> </ul>

<b>4. Implementation Concerns</b> <ul style="list-style-type: none"> <li>Landowner buy-in a concern as well as the sensitivity of adjacent forest and wetland.</li> </ul>	
<b>5. Task Description</b> <ul style="list-style-type: none"> <li>Invasive vegetation removal and replanting</li> <li>Toe protection installation</li> </ul>	<b>Projected Costs</b> <ul style="list-style-type: none"> <li>\$15,000</li> <li>\$25,000</li> </ul>

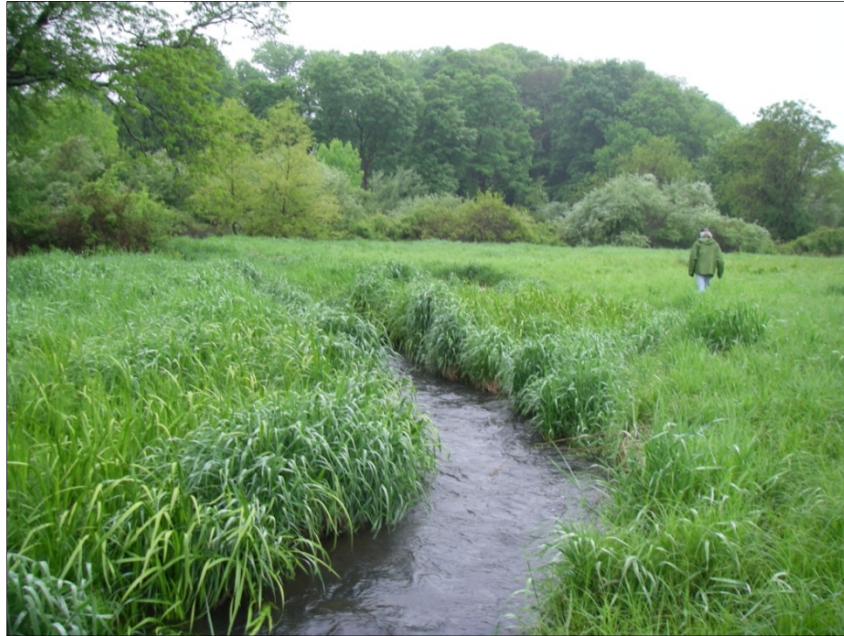
Figure 29. Buffer Site 69

**Existing Conditions:** There is very little canopy cover above the stream at this site. The stream banks are vegetated with grasses and the shrub layer is dominated by invasive species like multiflora rose and autumn olive. There is some fine material in the stream bed indicating some erosion and exposed banks in some areas. This site would be improved with the addition of several trees that have a high saturation tolerance due to the frequently wet conditions. The trees would provide canopy cover to help reduce temperature, stabilize the banks, crowd out the increasing amount of invasive species, and add plant material to the food web of the stream. Willows along the bank will help to stabilize areas exhibiting erosion.

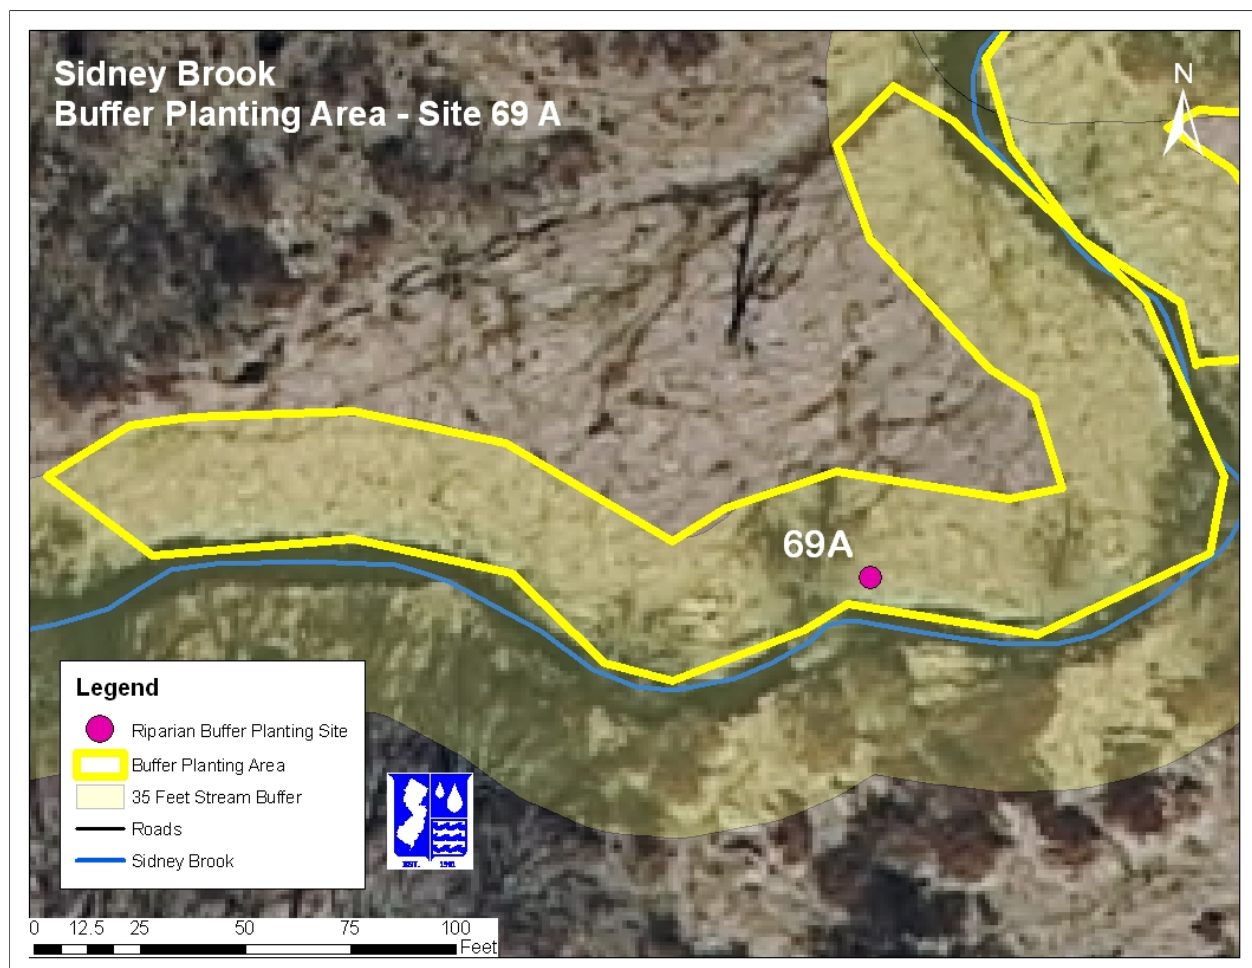
**Figure 31. Buffer Site 69A**

**69A:** This segment is the furthest upstream of this site. It is approximately 0.28 acres in size. A total of 86 plants will be needed to adequately buffer this area to achieve a density of at least 200 plants per acre, taking into account the willow and dogwood stakes will be planted in clusters.

Table 2. Plant Cost Estimate for Buffer Site 69A				
Plant Species	Number of Plants	Container Size	Approximate Cost/Unit	Approximate Total Cost
<i>Salix nigra</i> , Willow	30	stakes	\$2.00	\$60.00
<i>Cornus sericea</i> , Redosier Dogwood	30	stakes	\$2.00	\$60.00
<i>Betula nigra</i> , River Birch	6	#3	\$16.25	\$97.50
<i>Quercus bicolor</i> , Swamp White Oak	5	#2	\$12.00	\$60.00
<i>Quercus palustris</i> , Pin Oak	5	#3	\$16.25	\$97.50
<i>Chamaecyparis thyoides</i> , Atlantic White Cedar	5	#3	\$16.25	\$97.50
<i>Acer saccharinum</i> , Silver Maple	5	#2	\$12.00	\$60.00
<b>TOTALS</b>	<b>86</b>			<b>\$532.50</b>

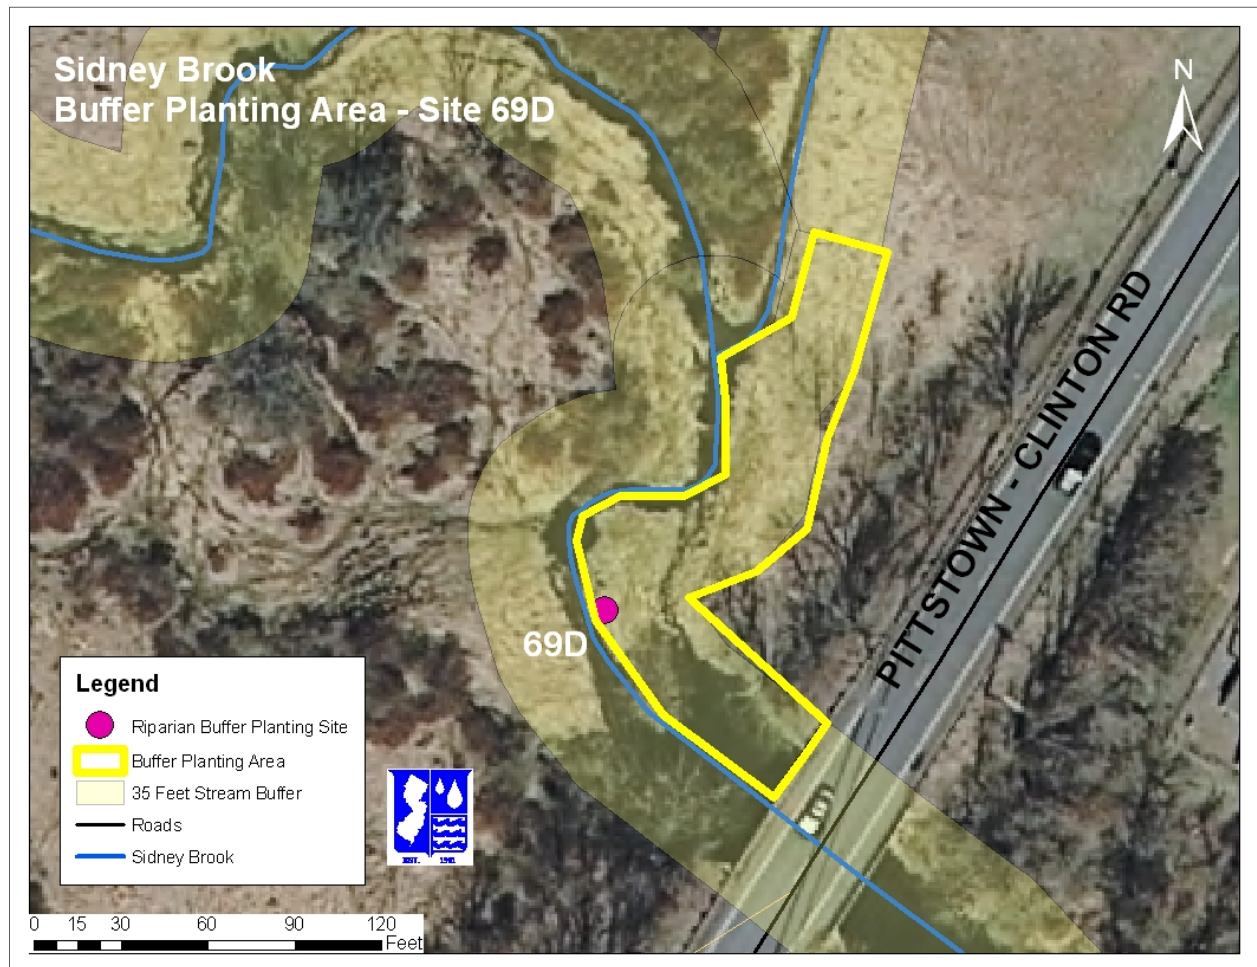
**Figure 33. Buffer Site 69D**

**69D:** This site is furthest downstream and closest to the road. The area for this site is just under 0.2 acres. Approximately 60 plants will be needed for this site.

<b>Table 5. Plant Cost Estimate for Buffer Site 69D</b>				
<b>Plant Species</b>	<b>Number of Plants</b>	<b>Container Size</b>	<b>Approximate Cost/Unit</b>	<b>Approximate Total Cost</b>
<i>Salix nigra</i> , Willow	40	stakes	\$2.00	\$80.00
<i>Betula nigra</i> , River Birch	5	#3	\$16.25	\$81.25
<i>Quercus bicolor</i> , Swamp White Oak	5	#2	\$12.00	\$60.00
<i>Quercus palustris</i> , Pin Oak	5	#3	\$16.25	\$81.25
<i>Chamaecyparis thyoides</i> , Atlantic White Cedar	5	#3	\$16.25	\$81.25
<b>TOTALS</b>	<b>60</b>			<b>\$383.75</b>

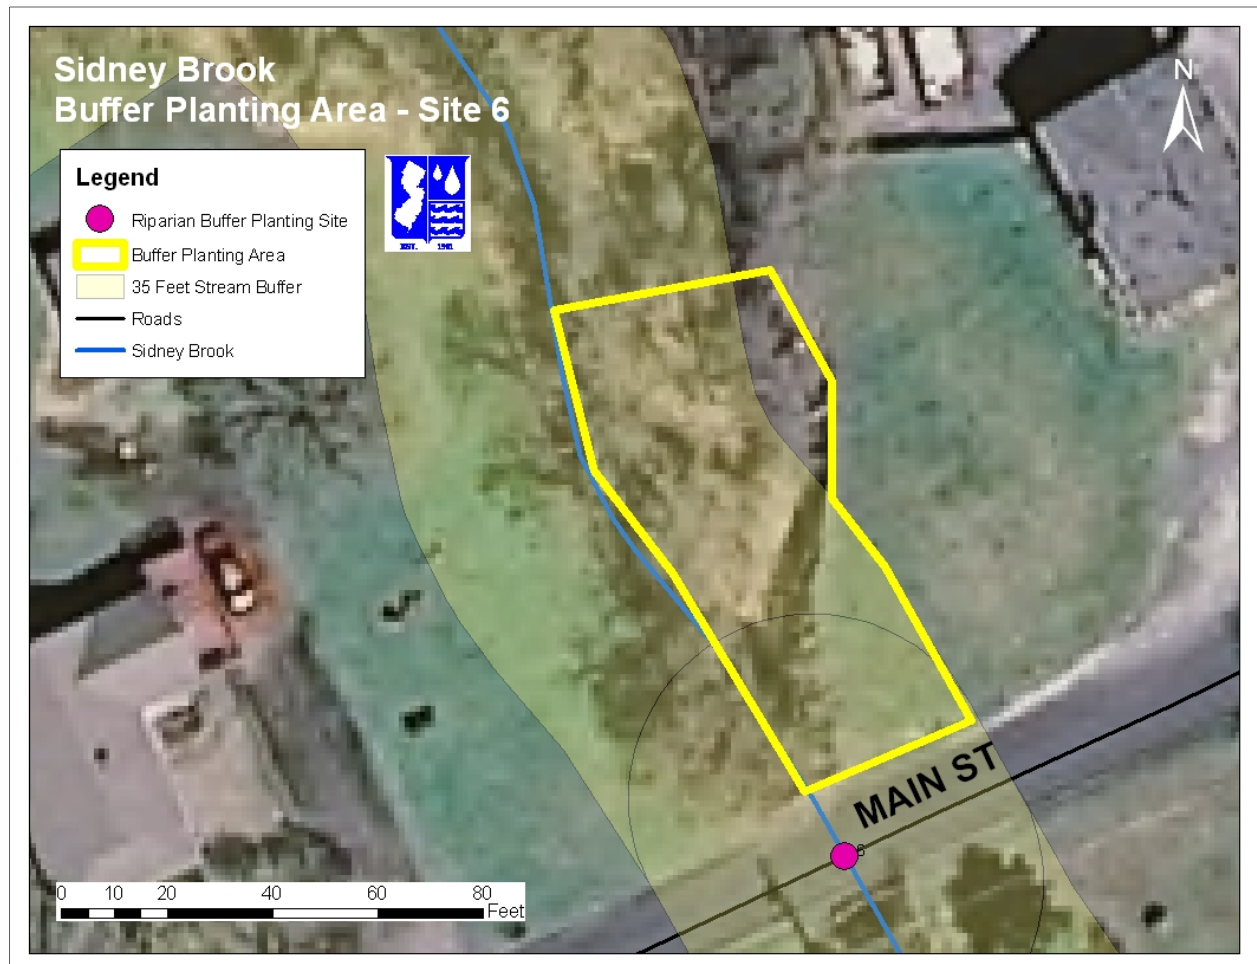
**Figure 34. Buffer Site 6**

**Site 6:** This buffer site is located on public property next to the historic municipal building on Main Street in Union Township, New Jersey. Upstream from this site is a residential area as well as some small farm operations.

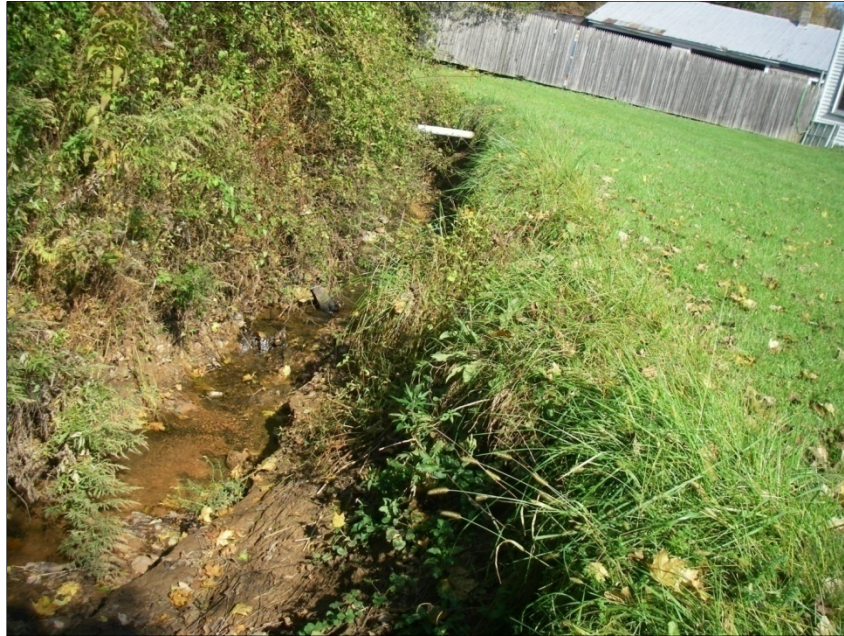
Figure 35. Buffer Site 6

**Existing Conditions:** The buffer planting area is approximately 0.10 acres in size and there is just over 100 feet of stream length. This site offers a highly visible opportunity to demonstrate how stream buffers can be implemented. There is severe erosion at this site. The left bank is incised and is approximately five feet above the stream. Fortifying this bank with some plant material will help to reduce erosion and bank failure, although a structural bank stabilization design may be needed to significantly improve conditions.

**Soil Conditions:** The dominant soil type at this buffer site is Landsdowne silt loam. This soil has somewhat poor drainage.

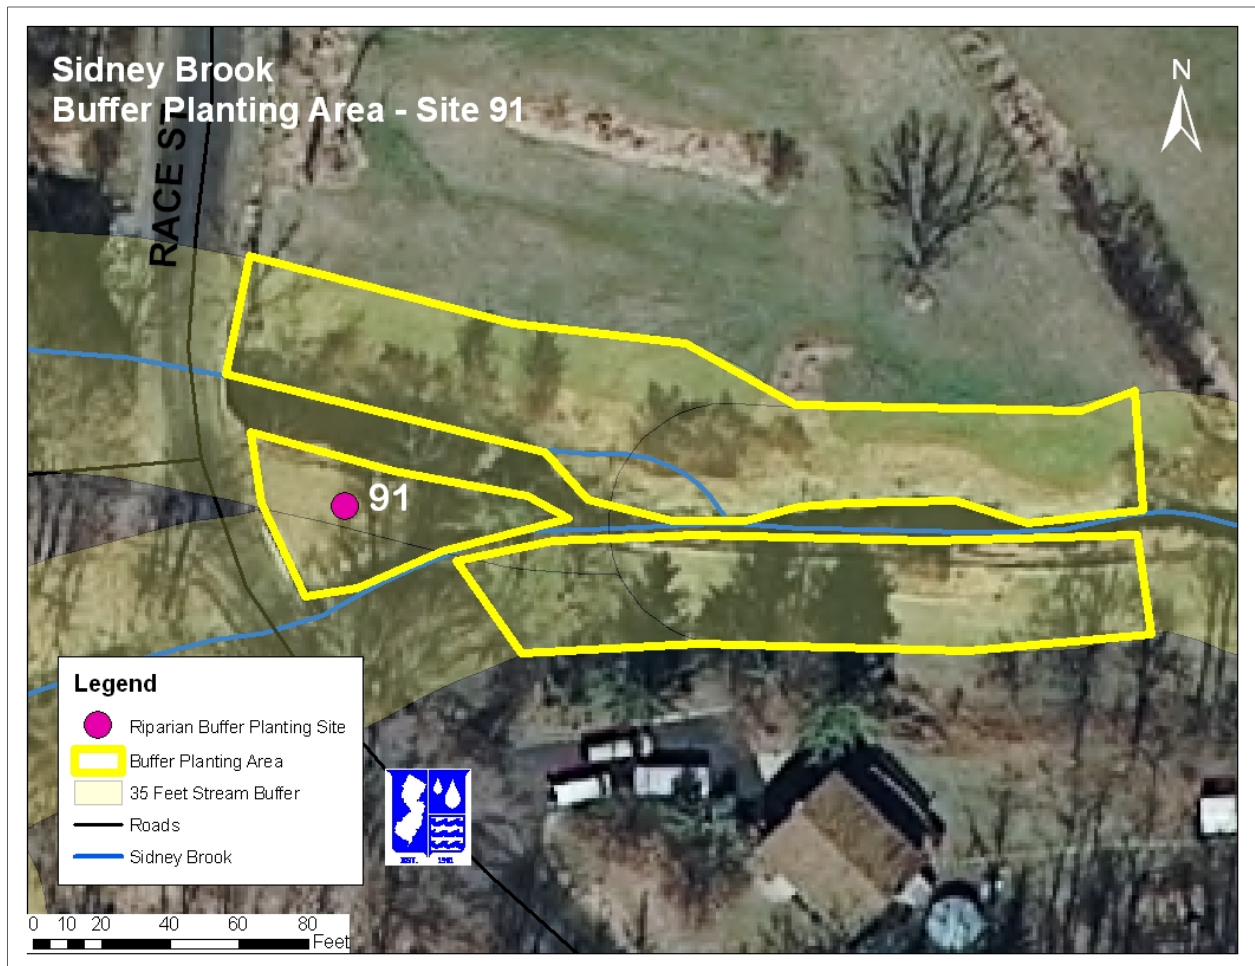
Figure 36. Buffer Site 91

**Site 91:** This buffer site is located along Race Street near the intersection with Hilltop Lane in Union Township, New Jersey. It is located on private property and homeowner approval would be necessary before moving forward with this site. This site is just upstream from buffer site 69A-D.

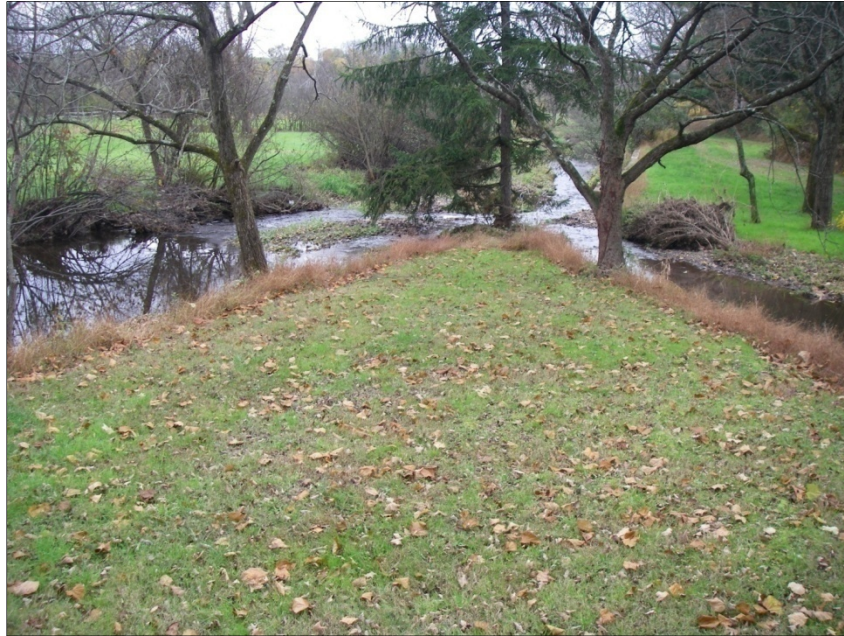
Figure 37. Buffer Site 91

**Existing Conditions:** This buffer site is located at a confluence of a tributary and the main stem of the Sidney Brook. This site lacks a significant canopy and much of the riparian area is mowed lawn. By implementing a riparian buffer at this site, a canopy will provide shade and cool the water, shrubs and trees will stabilize the banks, and mowing needs will be reduced. This buffer site is 0.42 acres in size and includes 360 feet of stream length.

**Soil Conditions:** Rowland silt loam is the predominant soil at this buffer site. This area is susceptible to water saturation and will be a major factor in selecting plants for the buffer.

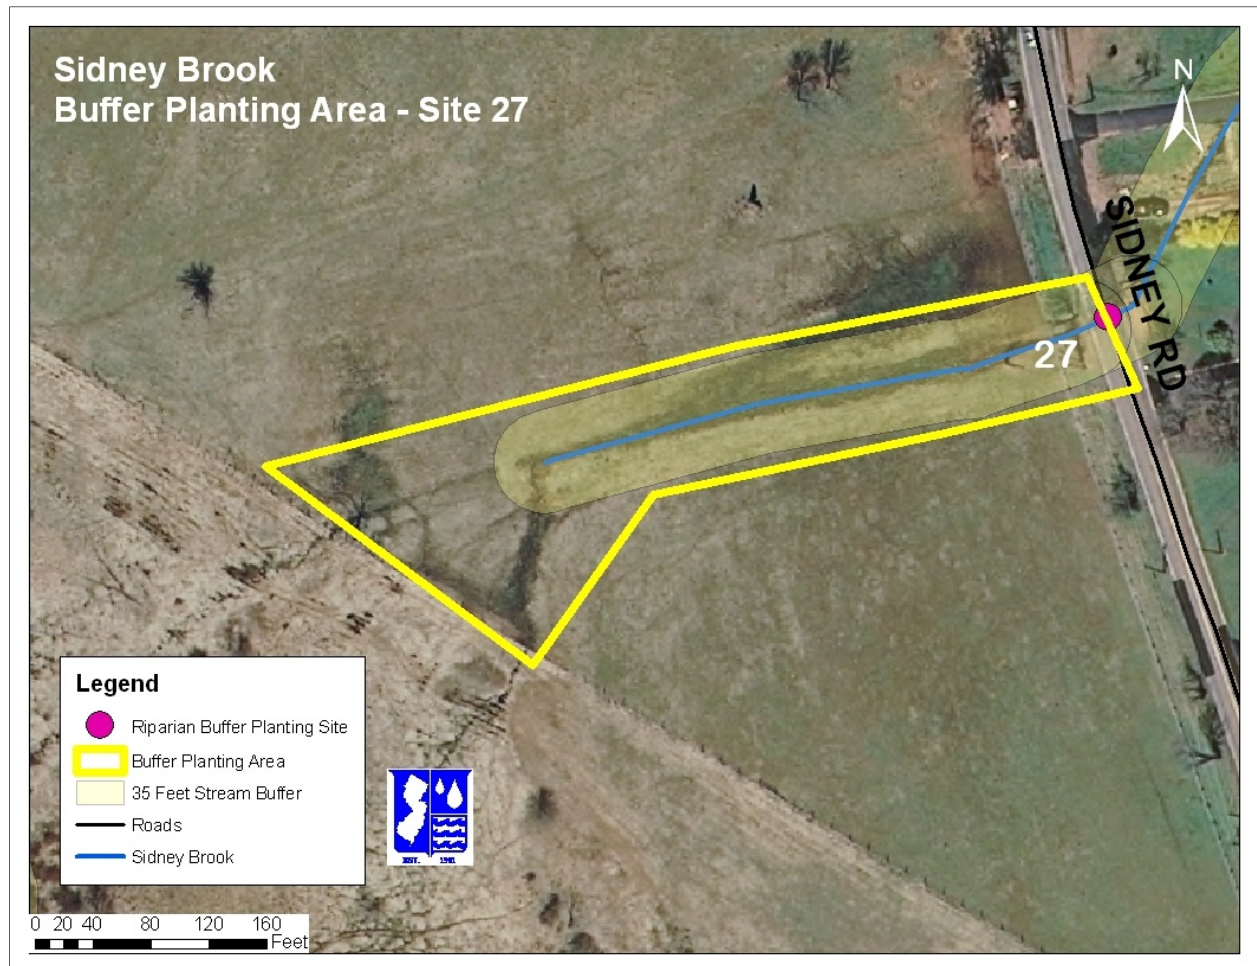
**Figure 38. Buffer Site 27**

**Site 27:** Located on Sidney Road in Franklin Township, New Jersey, this buffer site is a swale through a pasture on a preserved farm that drains stormwater from Sidney Road and the northeastern section of the watershed. After flowing through the pasture, the swale reaches a wet area where there is a gas pipeline.

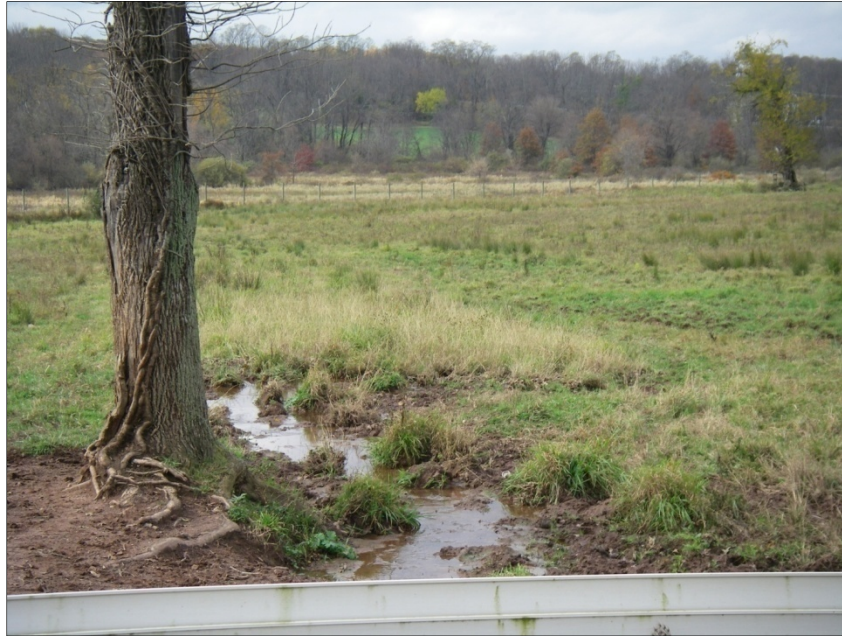
Figure 39. Buffer Site 27

**Existing Conditions:** This site is exhibiting some heavy erosion from stormwater as well as from heavy animal use. The section of the swale closest to the road is experiencing the most degradation since this area absorbs most of the force from stormwater. The water source this site provides, as well as the shade of one of the few trees in the pasture makes this site attractive to the cattle. There is also a pile of feed adjacent to this site, an indication of supplemental feeding. With a buffer of approximately 35 feet wide on each side of the swale, the total area is 1.25 acres.

**Soil Conditions:** The major soil type at this site is Rowland Silt Loam. This soil type is commonly found in flood plains and is frequently flooded.

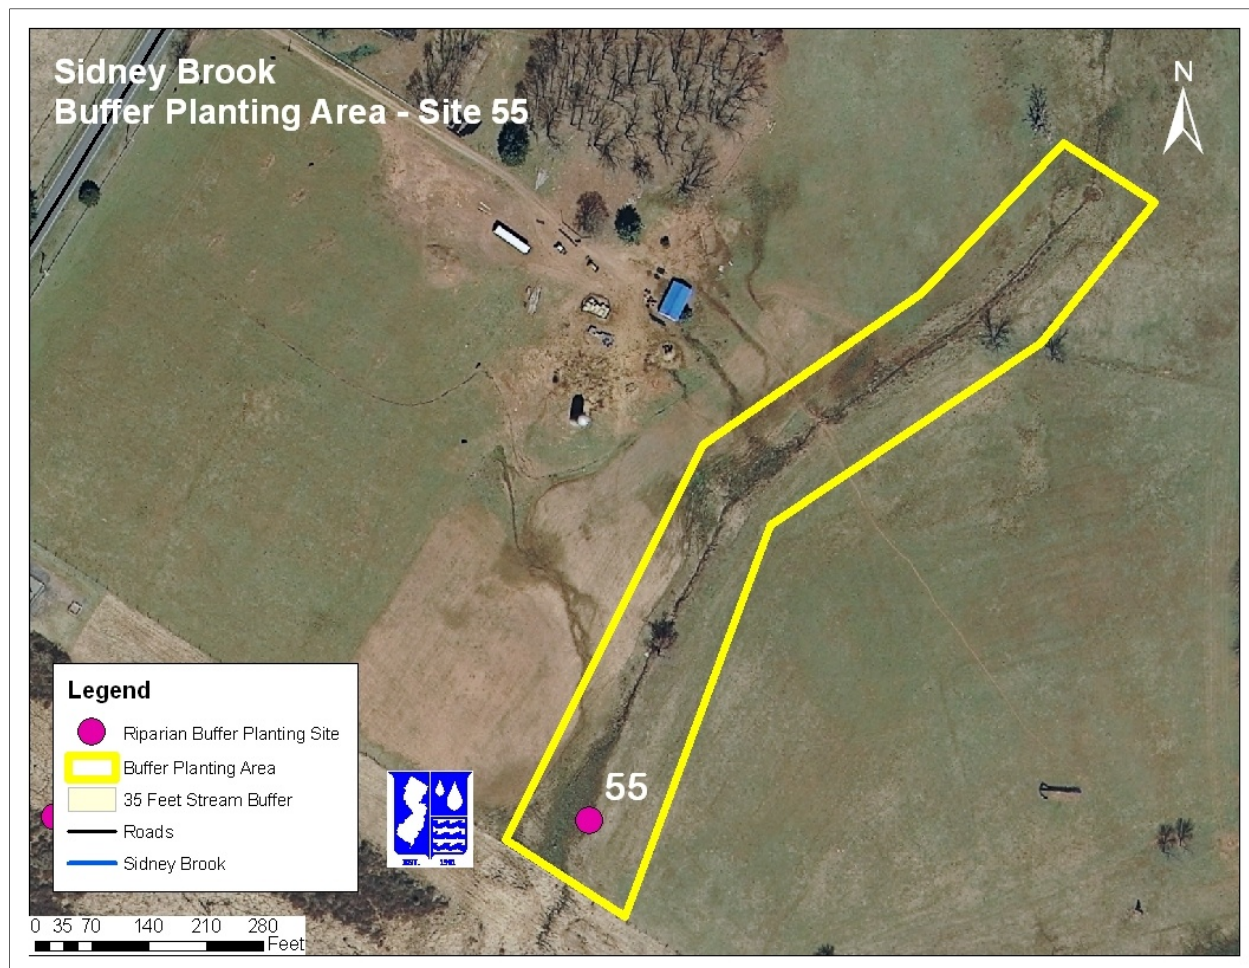
**Figure 40. Buffer Site 55**

**Site 55:** This buffer site is a drainage swale in a pasture on a preserved farm located on Sidney Road in Franklin Township, New Jersey. It drains runoff from the upper sections of the pasture and from the hard and compacted surfaces surrounding the barn area. It drains to a wetland area where a gas line runs along the southern border of the parcel.

**Existing Conditions:** This swale is an excellent opportunity for buffer implementation. The swale is vegetated, but it is grazed regularly by cattle. Livestock can compact as well as loosen soil that can easily be eroded when there is little vegetation. The steepness of the swale also contributes to the erosive power of stormwater flowing through the swale. By using a buffer guideline of at least 35 feet, this buffer totals 3.7 acres in size.

**Soil Conditions:** The soil in the area of this buffer is primarily made up of Pattenburg gravelly loam. The estimated grade on this site ranges from two to twelve percent.
