Stakeholders Meeting May 27, 2010

The Importance Of Functioning Soils In Low Impact Development Practices

David Friedman, District Director
Ocean County Soil Conservation District

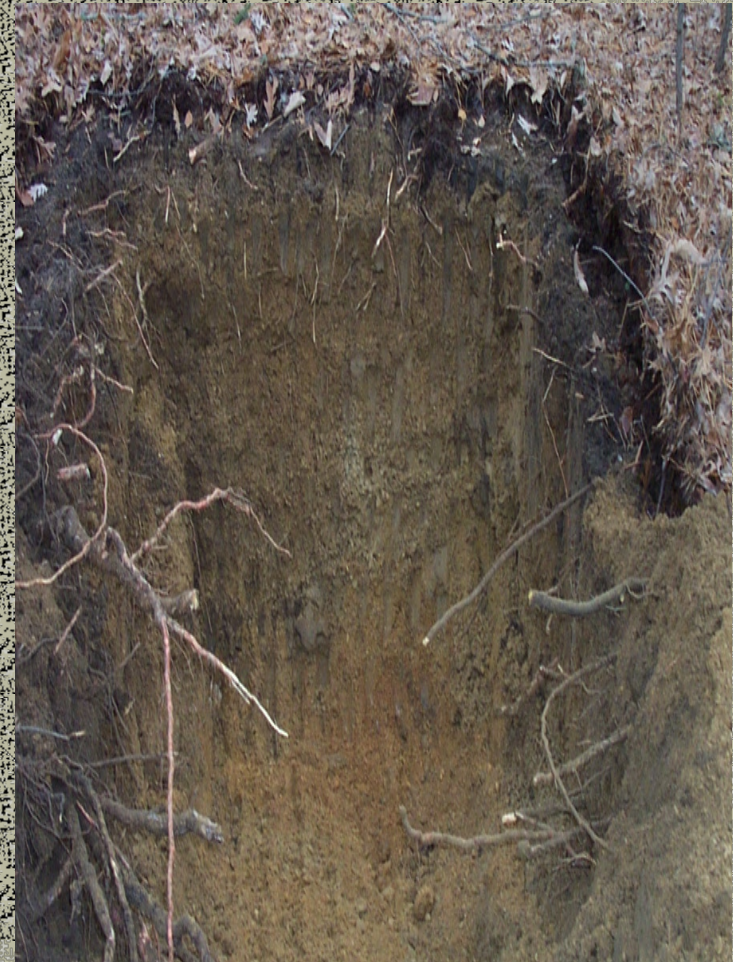
Water Movement in Soils

In natural forested soils water moves rapidly downward through root channels and large pores. US Forest Service report confirms little to no runoff from forest-covered soils.

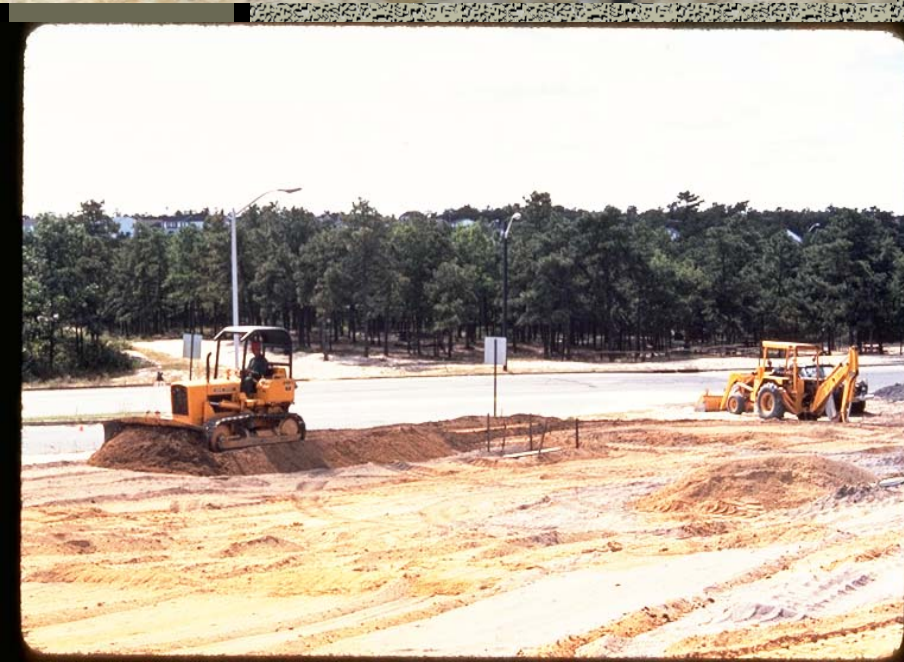
Impact of Soil Disturbance During Construction on Bulk Density and Infiltration in Ocean County, NJ , OCSCD and USDA-NRCS 2001

There is general agreement in the shape and relative trends of the data from both the lab and *in-situ* tests. As soil bulk density increases to 1.65 g/cm³, the infiltration rate decreases rapidly. When the bulk density increases above 1.65 g/cm³, infiltration rate declines slowly, approaching zero. Unless the soil surface becomes crusted or covered with an impermeable surface such as concrete, this permeability becomes the limiting factor for infiltration into the soil profile. Thus the permeability measurements were used to develop the following technique to estimate infiltration rates of densities not specifically measured. For example, using the formula from the *in-situ* data above [Permeability = (42198)(Bulk Density)^{-21.255}] it can be estimated that soil with a bulk density of less than 1.75 g/cm³ would be expected to have an infiltration rate of greater than 0.3 in/hr.

The following graphs summarize the sites sampled in Ocean County. Graph 1 shows the distribution of bulk density with depth in the sites sampled. In the graded condition, the soil is more dense in all layers, especially just below the topsoil that was applied after most grading activities and loosened during seedbed preparation. Graph 2 relates permeability rate to bulk density for the specific layers sampled in Table 1.

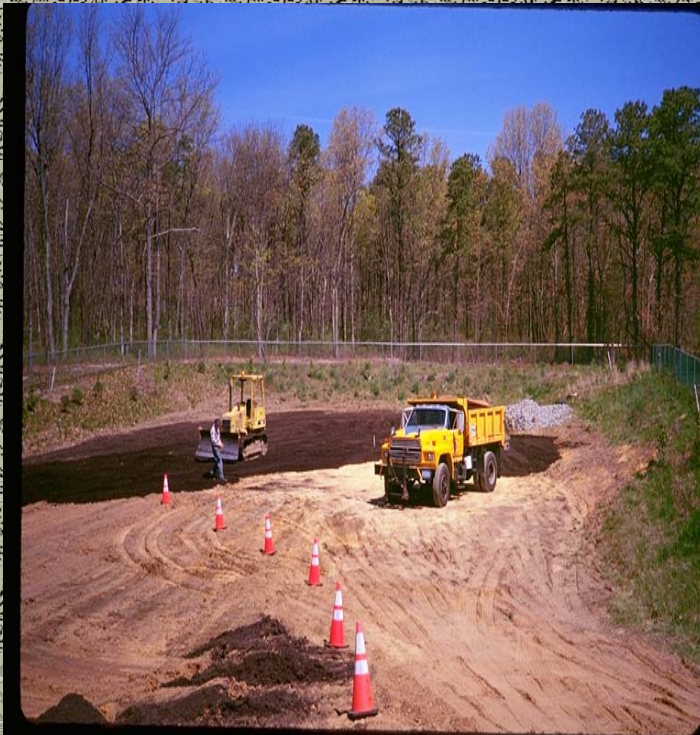
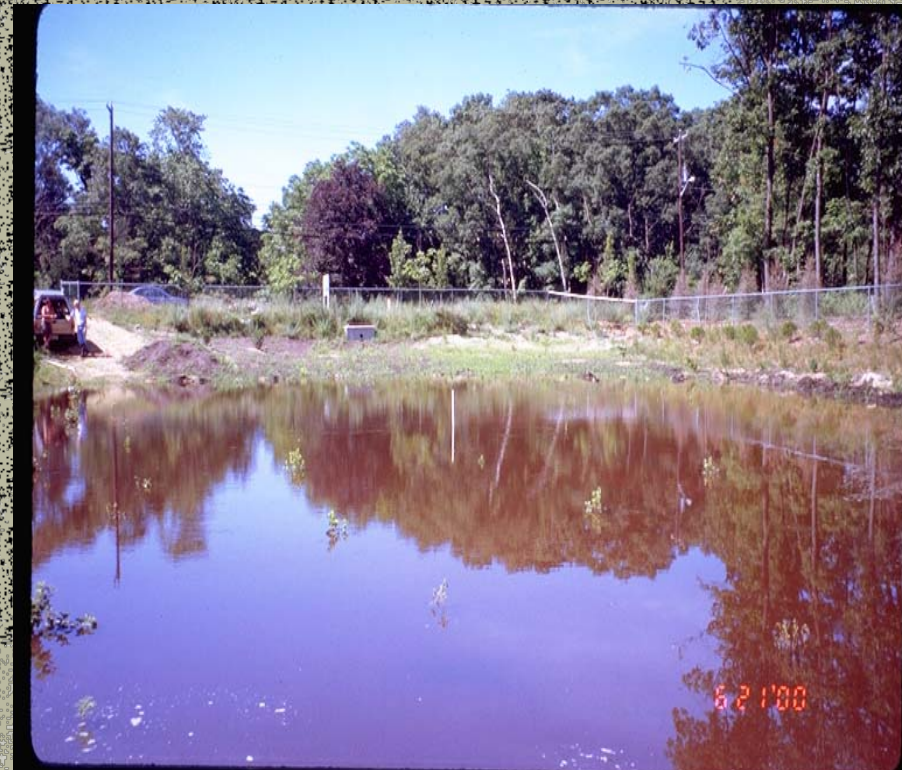
Division Street Basins

(Restoration of these basins is not a beautification project. Restoration, by definition is about restoring structure and function when the original function of the system has been degraded or lost. Soil restoration was undertaken because the physical, chemical, and biological properties had been impaired.)

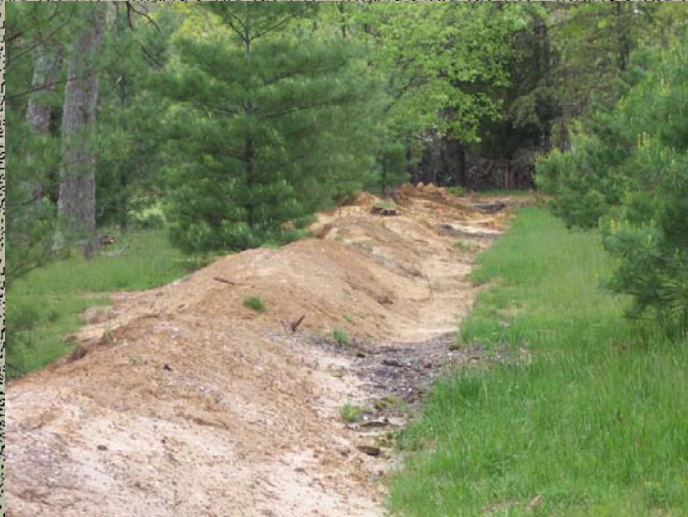
Incorporation of organic matter is key to drought resistant soil and sustaining infiltration.

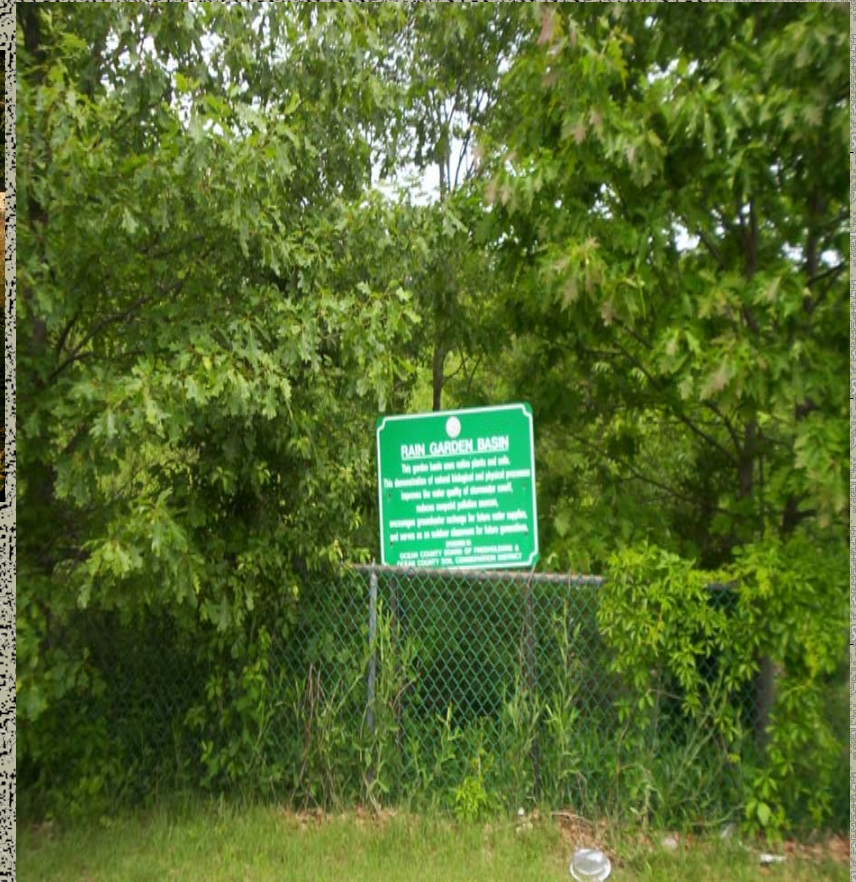
Due to Poor Soil Health Many Basins Do NOT Treat Water - They Simply Convey Runoff

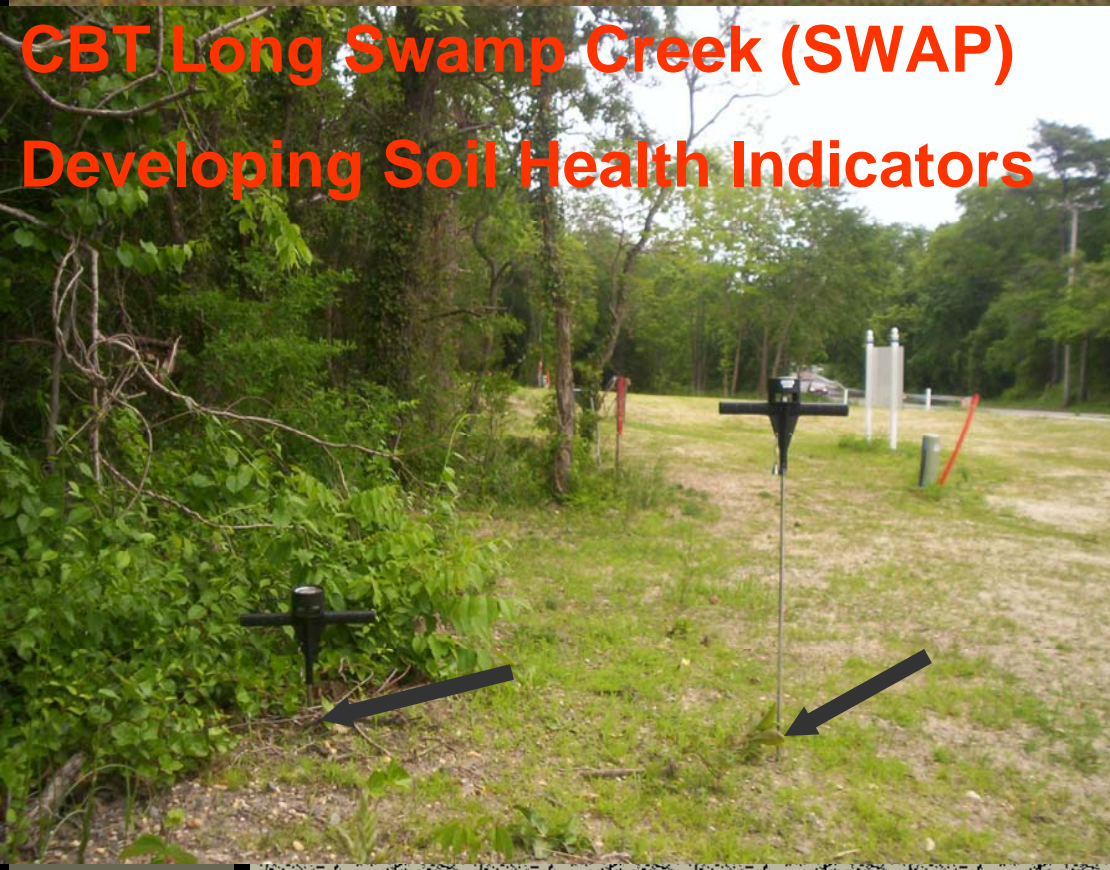
- Training citizens to use tools and soil indicators to help evaluate soil conditions.
- Note the penetrometer (left) in woods and penetrometer (right) about six (6) ft into disturbed area.

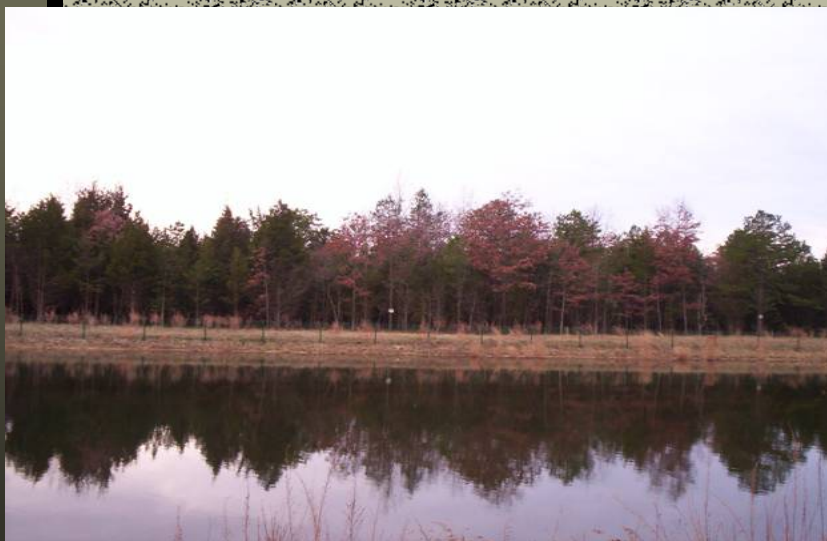
- Basin ponding water for several years due to poor soil structure. OCSCD installed a monitoring well confirming the natural water table 9 ft. below surface.

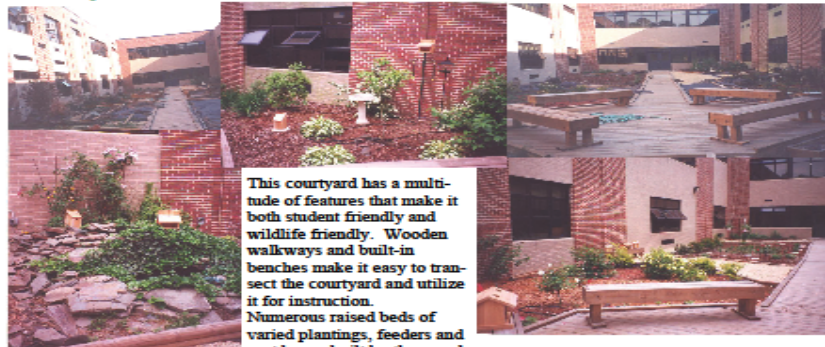
This courtyard has a multitude of features that make it both student friendly and wildlife friendly. Wooden walkways and built-in benches make it easy to transect the courtyard and utilize it for instruction. Numerous raised beds of varied plantings, feeders and nest boxes built by the wood shop students, and a small pond, provide food, water & shelter for wildlife.

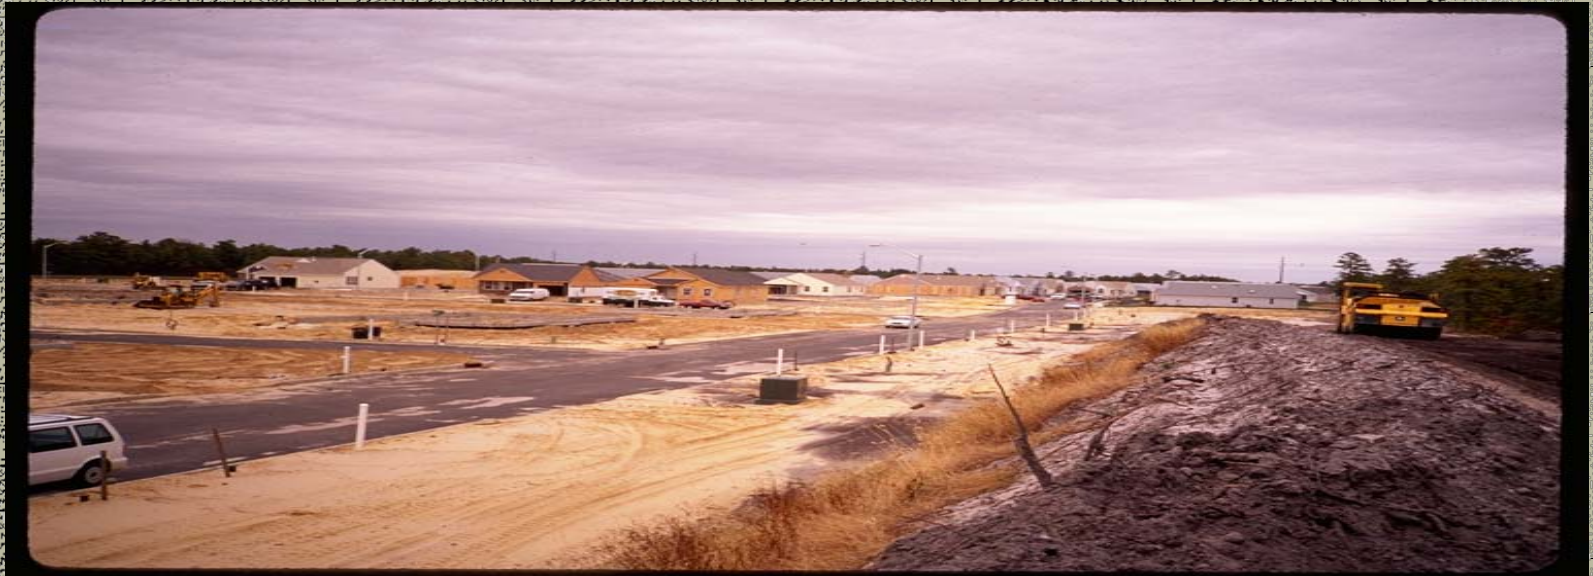
King County Construction Guidelines for Stormwater Management

- King County, Washington State adopted design, construction/field inspection guidelines (*King County Surface Water Design Manual*) to sustain infiltration and protect water resources. County guidelines require restoration of soil functions including soil amendment specifications to sustain soil health for long term function of lawns and BMPs. Further information [www. BuildingSoil.org](http://www.BuildingSoil.org)
www.seattle.gov/util/NaturalSystems/
