Wreck Pond

Monmouth County, NJ

Baseline Conditions Report

Prepared in support of the
U.S. Army Corps of Engineers New York District
Wreck Pond Coastal Storm Risk Management Feasibility Study

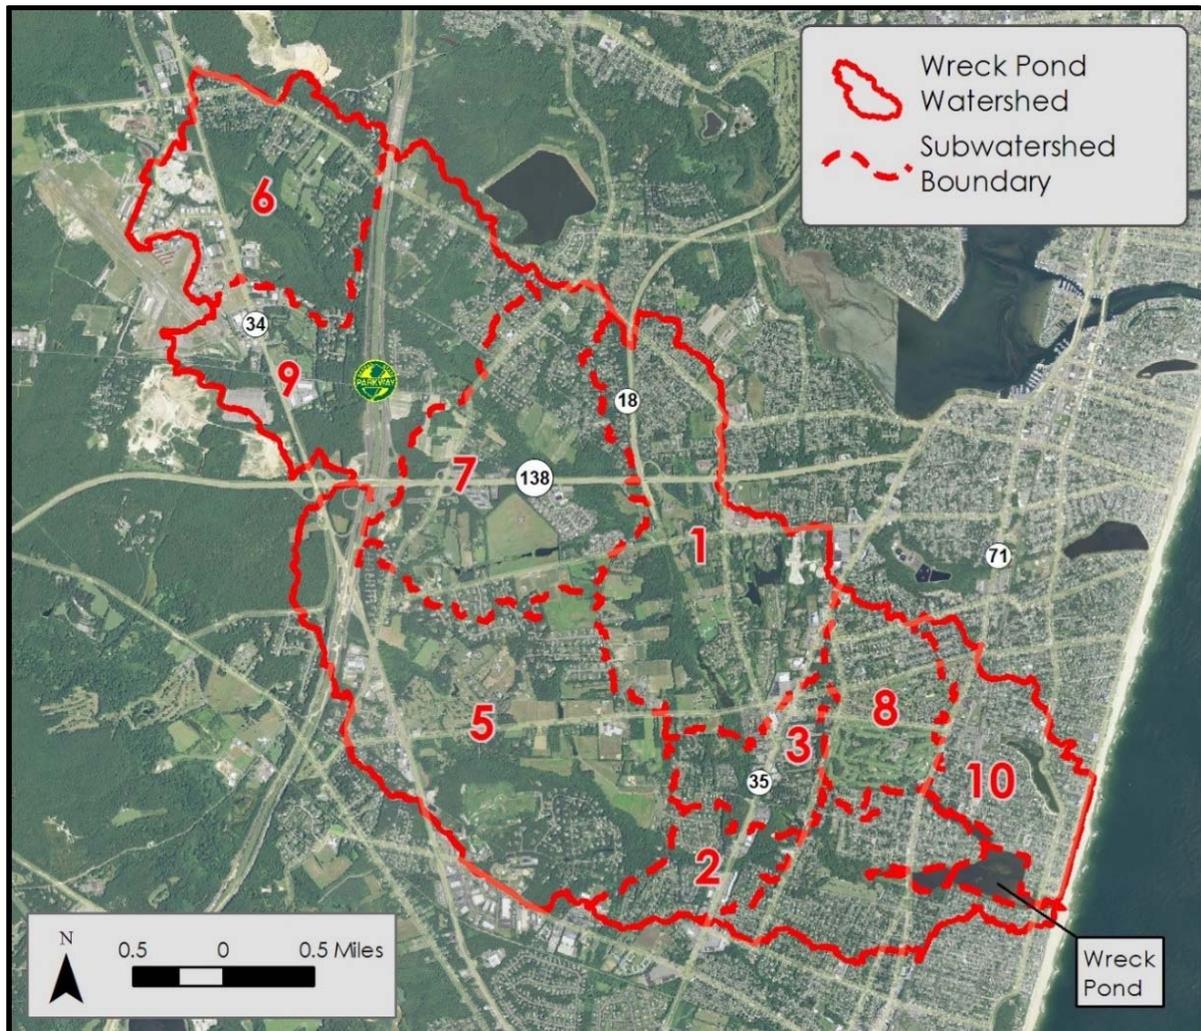
Wreck Pond is a tidally-influenced pond located on the coast of the Atlantic Ocean. The Wreck Pond Brook watershed includes 8,174 acres in southern Monmouth County. The watershed is approximately 12.8 square miles, with its headwaters located in Wall Township, flowing east-southeast to discharge into Wreck Pond. Major tributaries to Wreck Pond within the study area include Wreck Pond Brook and Black Creek. The western boundary of the watershed is in Wall Township and extends east-southeast to Wreck Pond on the border of the Boroughs of Spring Lake and Sea Girt. The watershed also includes lands in the Borough of Spring Lake Heights and Wall Township. The major tributaries are Hannabrand Brook, Wreck Pond Brook, Hurley's Pond Brook, and Black Creek (Figure 2).

Figure 2: Wreck Pond watershed and sub-watersheds.

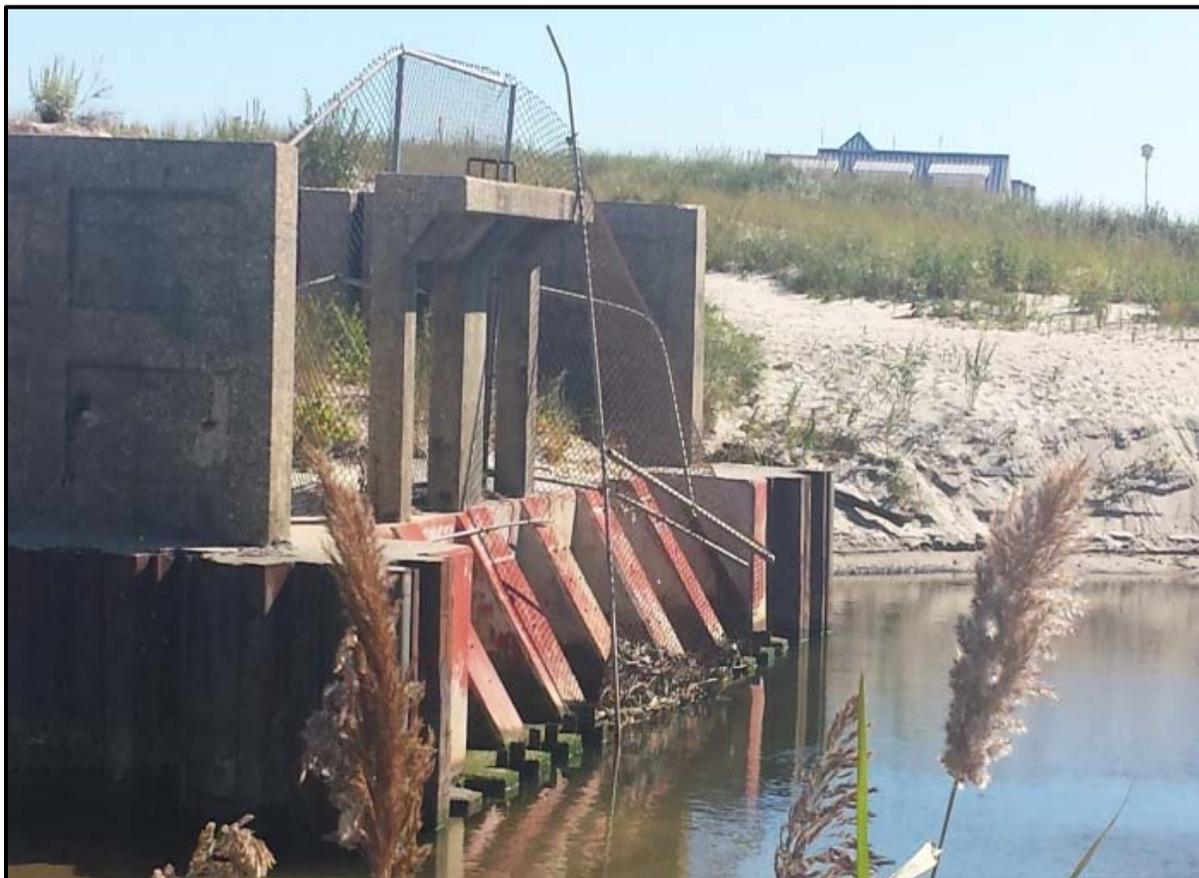
Tidal influence of Wreck Pond is via a connection to the Atlantic Ocean through a 795-foot long and 7-foot diameter outfall. The western reaches of the pond are less saline than the eastern portions. A 7-foot diameter outlet pipe provides tidal exchange between the Atlantic Ocean and Wreck Pond (Figure 3 and Figure 4). The end of the outfall pipe is 600 feet offshore. The outlet also provides some flood risk reduction by controlling peak tides concurrent with peak flow from the watershed. It consists of two main structural parts: 1) the actual outfall culvert which is a 795 foot long, 7-foot diameter concrete pipe, and 2) the pond side outfall structure, which consists of sheet pile across the channel and sluice gates with weirs. This large concrete structure has six ports of varying dimensions and invert elevations which collect flow from the pond and discharge to a large chamber which is connected to the 7-foot diameter outfall pipe.

Figure 3: Wreck Pond outfall structure on September 9, 2013.

The outfall structure was damaged by Hurricane Sandy in October 2012. Between September 2013 and 2014, the outfall structure was reconstructed. Sluice gates and a second outfall were added to control the flow exchange between the pond and the ocean.

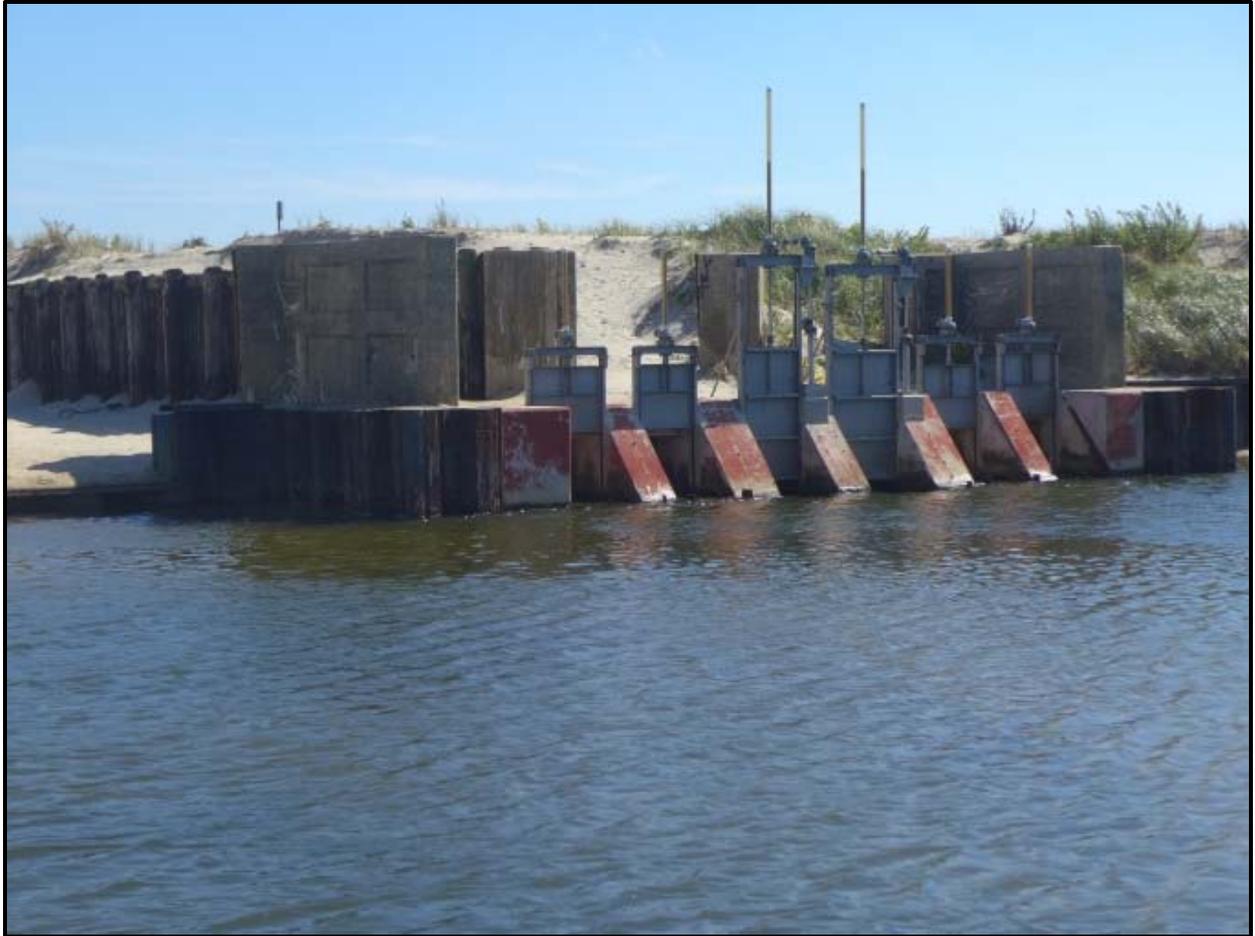
Figure 4: Wreck Pond outfall structure on September 27, 2014.

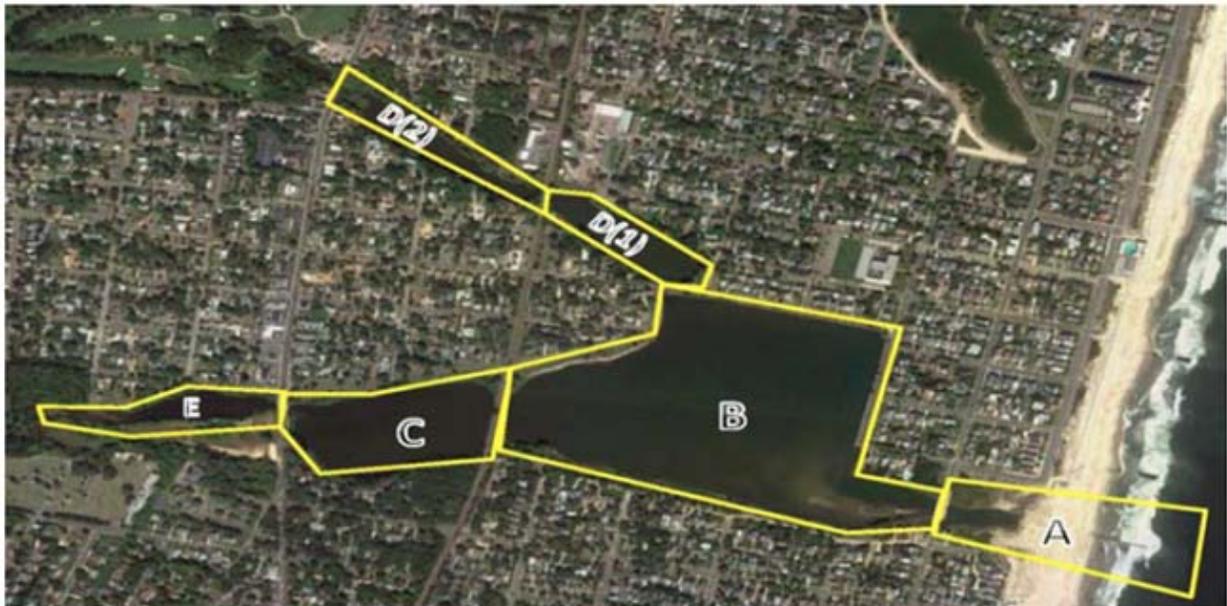
To tie in the land survey to the bathymetric survey to be completed, automated water elevation data collectors were installed in each of the subject pond sections. The bathymetric survey was conducted over a period of 5 days (June 16 through 20, 2014). Due to shallowness of the pond, an echo-sounder was not used. Instead, a 10-foot calibrated pole was utilized. A pole graduated every 0.2 feet (US Survey feet) with red marks on pole, and yellow marks at every 1-foot interval was used to penetrate the sediment. To provide horizontal control a Trimble GPS data-logger was used. The calibrated rod was lowered into the water until it reached the top of the sediment (TOS). Depth in feet was observed and recorded within the GPS unit. The pole was pushed into sediment to point of refusal at the estimated bottom of the unconsolidated sediment (BOS). Depth in feet was observed and recorded on the data logger.

Figure 9: Survey study reaches.

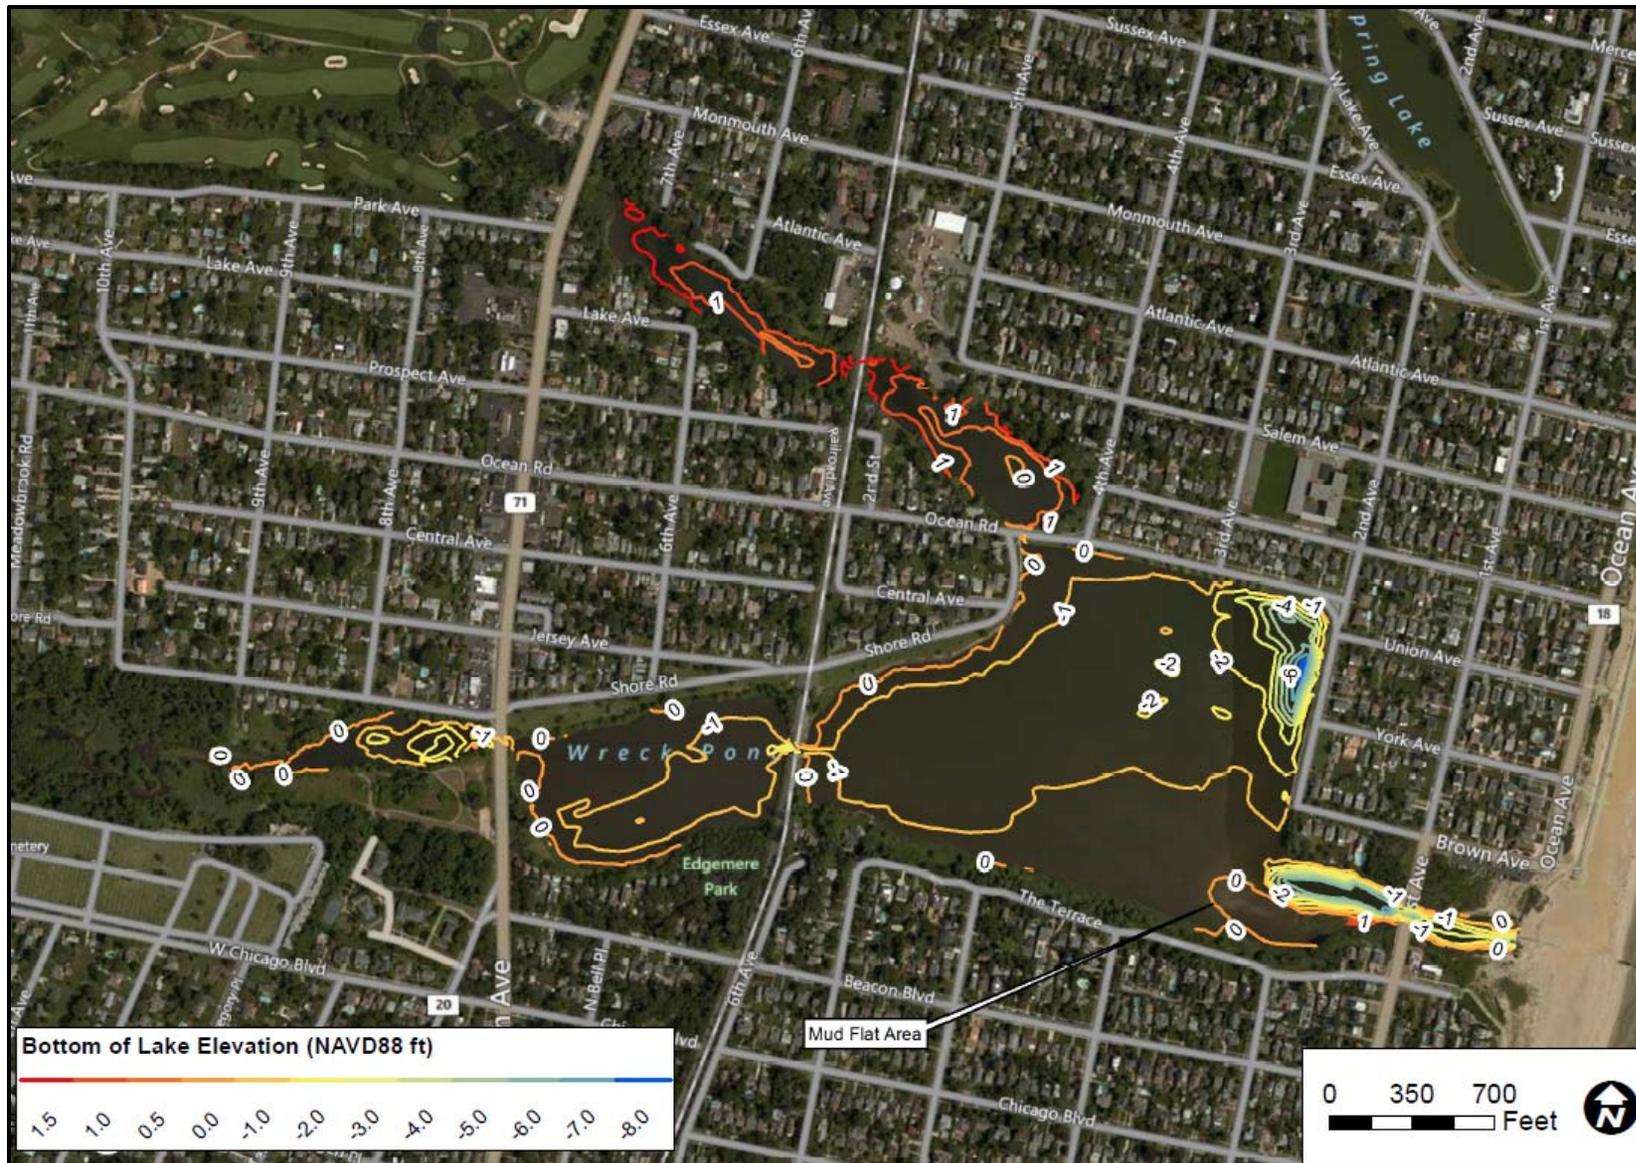
As shown in the bathymetric survey map (Figure 10), Wreck Pond and the smaller open water areas up Wreck Pond Brook and Black Creek are consistently very shallow, with depths at one or two feet. The only deep spots are at the extreme east edge of Wreck Pond (approximately 8 feet) and in the channel leading to the inlet to the ocean (7 feet).

Figure 10: Bathymetry of Wreck Pond.

Following the completion of the bathymetric survey, the GPS data and timestamps were calibrated with the water level data collectors and the spot elevations collected were then converted to the land survey datum (NAVD88). Following the completion of processing the raw field data, GIS was used to develop bathymetric data, including volume of sediment, average thickness and elevation contours of top of sediment and estimated bottom of sediment. A summary of the bathymetric survey statistics can be found in Table 1.

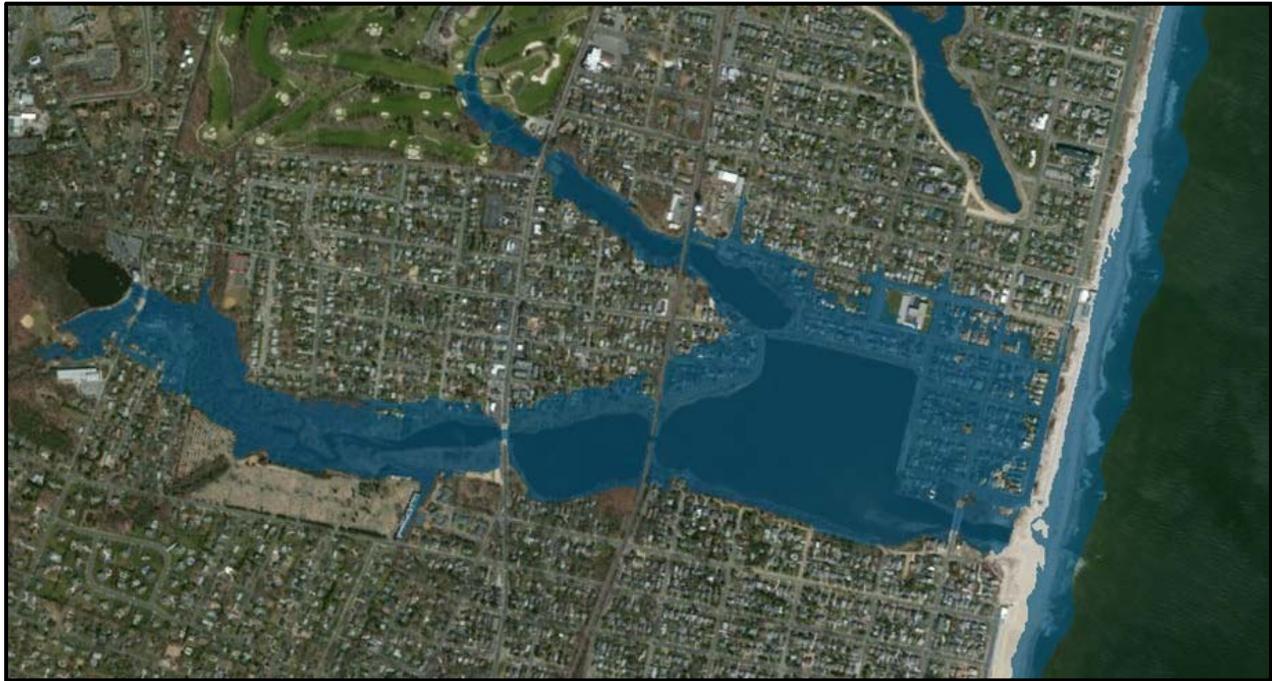
Hurricane Sandy was the most recent coastal storm that affected the area. It inundated the study area with approximately 6 feet of surge (10.9-foot NAVD88 recording at the Shark River National Oceanic and Atmospheric Administration [NOAA] gage). The surge generally extended to the north and west of the pond and Wreck Pond Brook (Figure 14). The storm had a return period between 100 and 200 years at Spring Lake. The outfall structure was damaged and the dune was breached by the storm, which exacerbated flooding in the area. The December 1992 nor'easter also severely flooded the area, with almost \$800,000 (1992 value) in damages sustained by homeowners.

Figure 14: Extent of Hurricane Sandy flooding (FEMA MOTF Model, accessed March 2015).

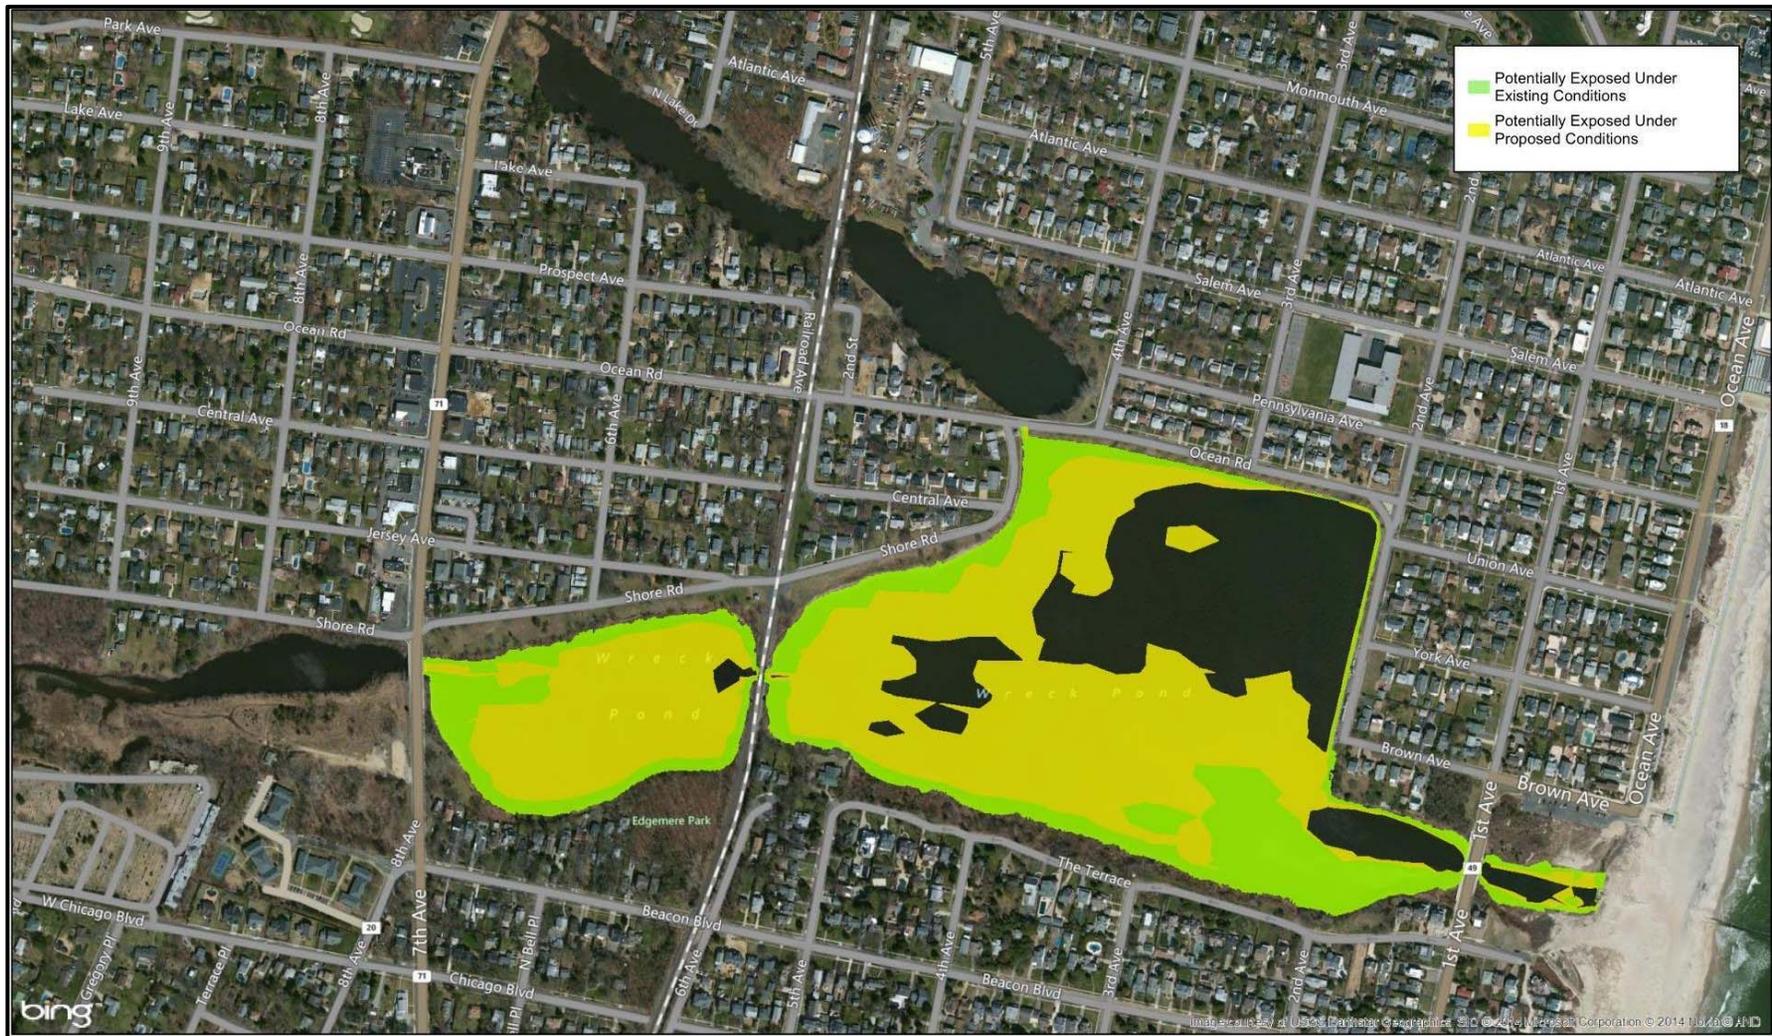
Figure 18: Potential exposed area.
