WRECK POND BROOK WATERSHED REGIONAL STORMWATER MANAGEMENT PLAN

BOOK 1: Watershed Characterization

**Prepared by
Wreck Pond Brook Watershed Technical Advisory Committee**

Lead Planning Agency: Monmouth County Planning Board

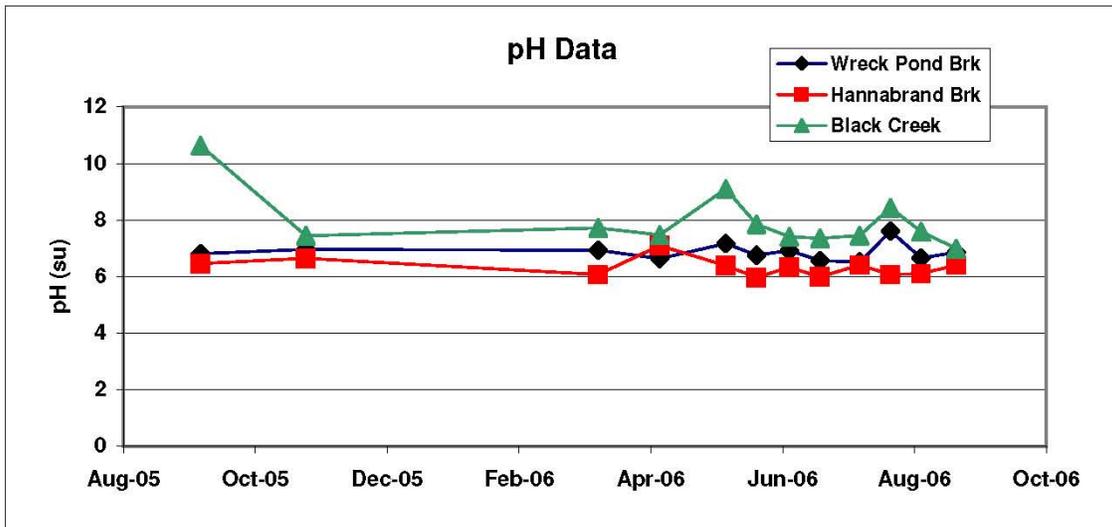
Figure 23: Spring Lake Wreck Pond Environmental Study
Tributary Analyses

Units	n	Mean	Med	Std Dev	Max	Min	75th Perc	25th Perc
pH	su	12	6.86	6.83	0.30	7.60	6.51	6.94	6.65
Temperature	°C	12	21.9	23.5	6.5	30.3	7.4	25.4	18.7
Dissolved Oxygen	mg/l	12	8.82	8.94	1.06	10.15	6.50	9.53	8.43
Specific Conductance	mg/l	12	0.22	0.22	0.02	0.26	0.19	0.23	0.21
Field Turbidity	ntu	12	7.50	6.50	4.19	18.00	4.00	9.00	4.00
Water Level	ft	12	0.86	0.87	0.11	1.00	0.68	0.96	0.76
Calcium Hardness	mg/l	12	20	20	3	24	14	21	19
Magnesium Hardness	mg/l	12	11	12	2	13	8	12	11
Total Hardness	mg/l	12	31	32	4	37	22	33	30
Calcium	mg/l	12	7.84	7.95	1.01	9.57	5.59	8.36	7.44
Iron	mg/l	12	1.137	1.160	0.297	1.570	0.713	1.348	0.923
Magnesium	mg/l	12	2.80	2.88	0.35	3.17	2.01	3.04	2.72
Manganese	mg/l	12	0.046	0.043	0.013	0.067	0.030	0.056	0.037
Chloride	mg/l	12	45.2	43.2	5.5	58.7	38.1	46.4	42.8
Alkalinity	mg/l	12	10.36	10.30	2.57	14.80	4.60	11.50	9.73
Total Dissolved Solids	mg/l	12	148	146	16	180	131	153	136
Total Suspended Solids	mg/l	12	3.9	3.7	1.4	7.7	2.0	4.2	3.2
