SUMMARY OF HURRICANE FLOYD IN THE DELAWARE RIVER BASIN SEPTEMBER 1999

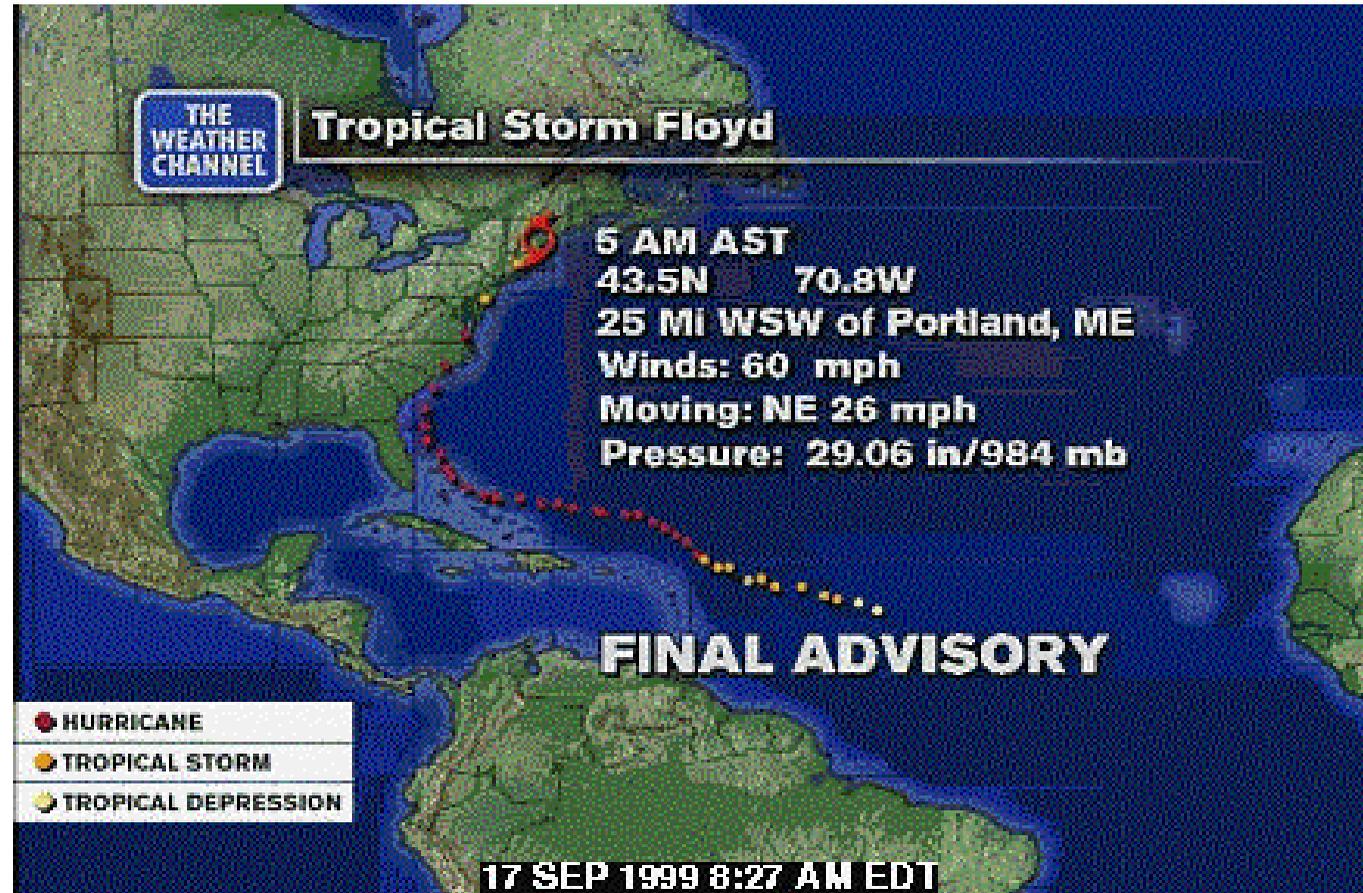
Rainfall from Hurricane Floyd began impacting the Delaware River Basin during the early morning of Thursday, September 16, 1999. This Weather Channel map shows the track of Floyd.

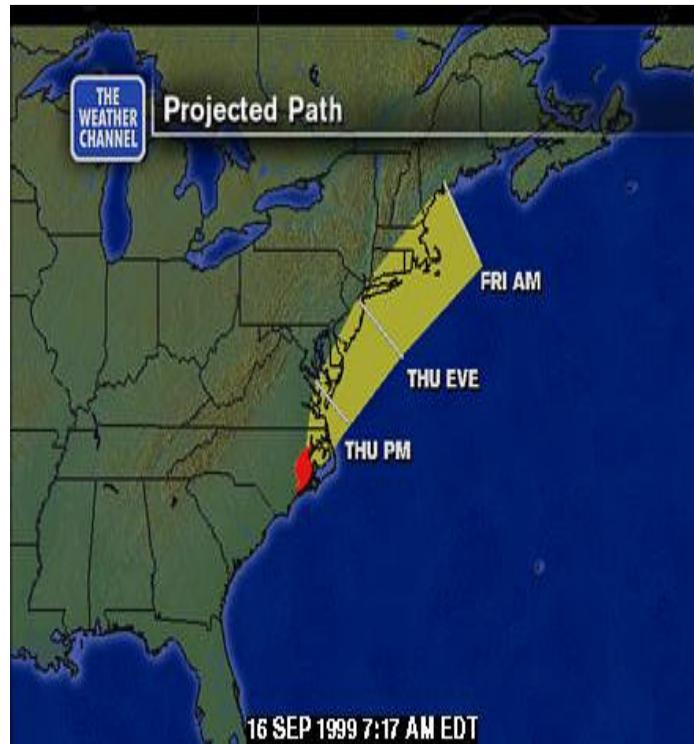
Maps from theWeather Channel

The timing of Floyd's move up the eastern seaboard coincided with the arrival of a cold front in the mid-Atlantic states and triggered heavy rainfall across the Delaware River Basin. The heaviest rain occurred in the southern half of the basin, where 6-to-10 inches of rain fell over an 18-hour period.

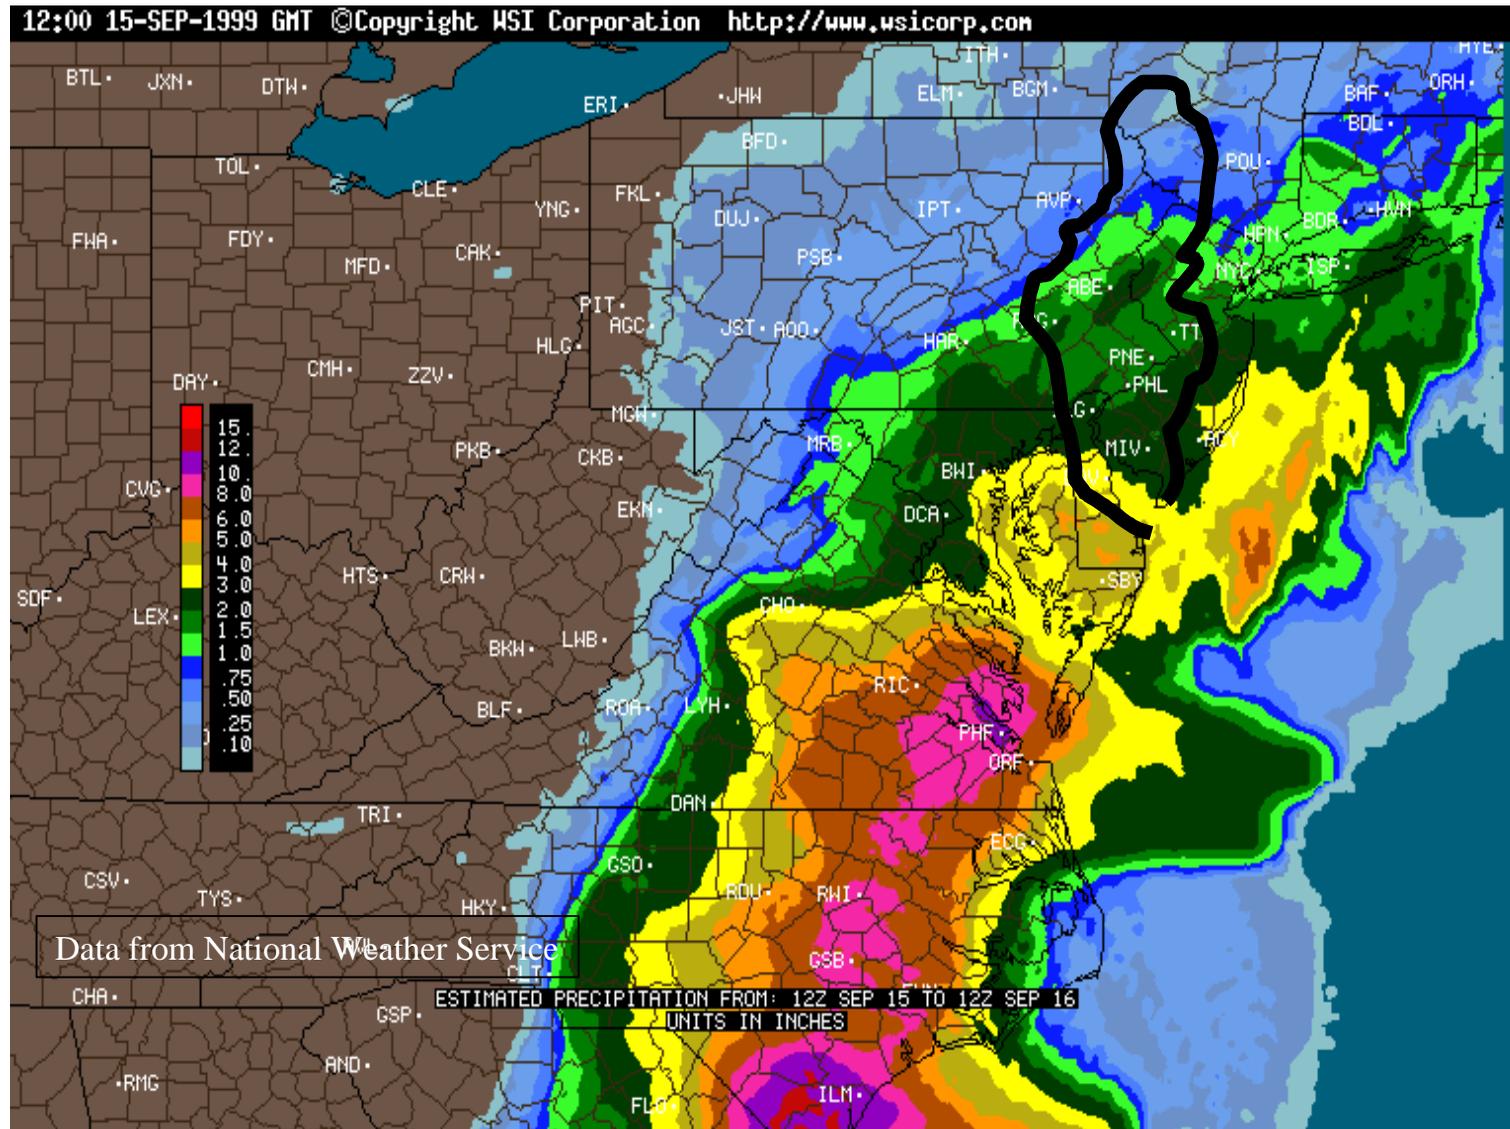
The map below, supplied by Intellicast, shows precipitation estimates through 7 a.m. on Thursday, September 16.

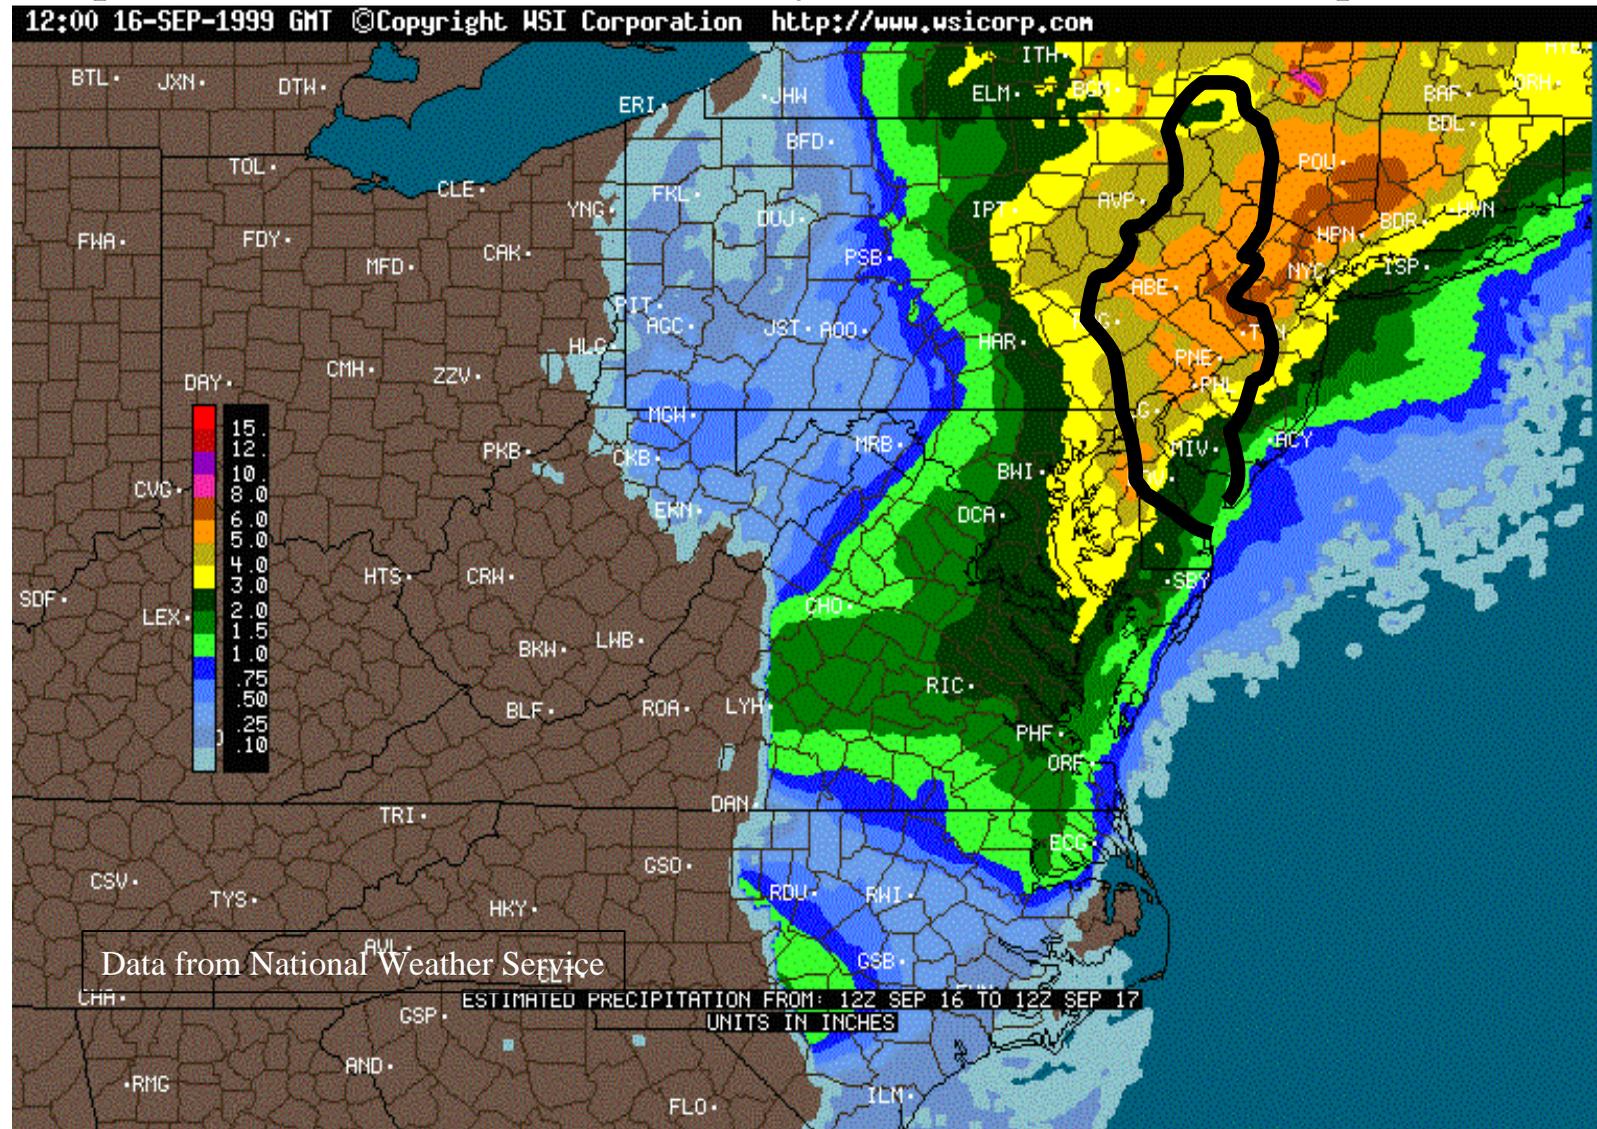
This Intellicast supplied map shows subsequent precipitation through 7 a.m. on September 17. Total rainfall from Floyd is the sum of the two maps.

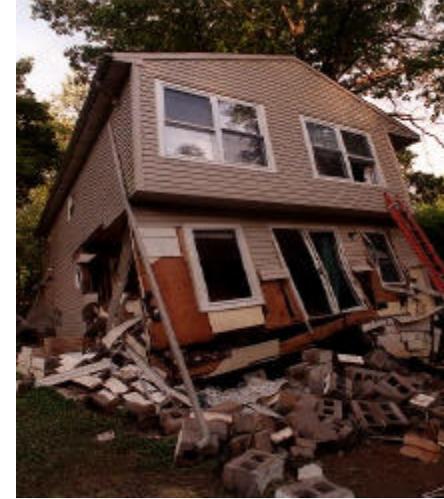
House in Langhorne, Pa. lifted off foundation
Photo by M. Vicar (Bucks County Courier Times)

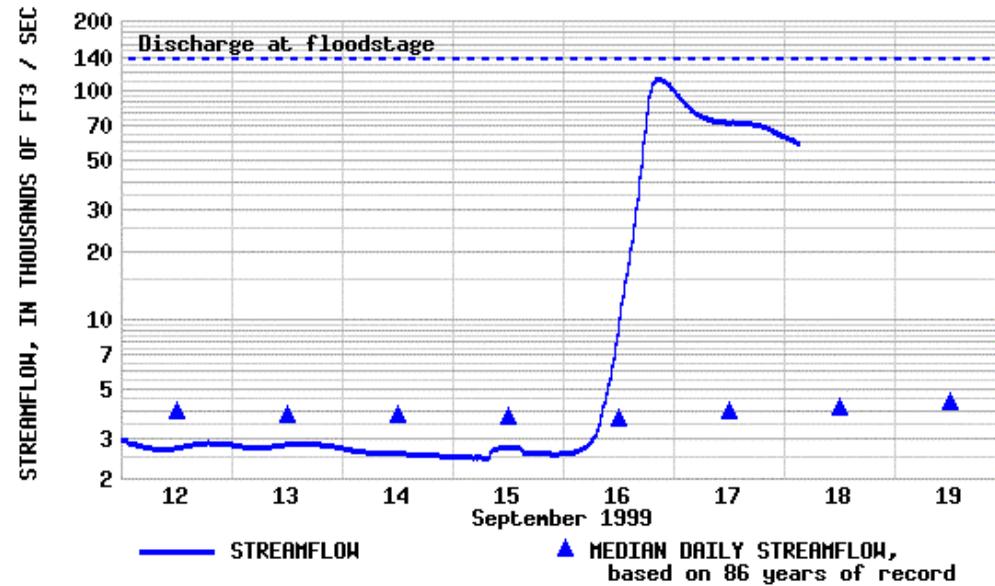
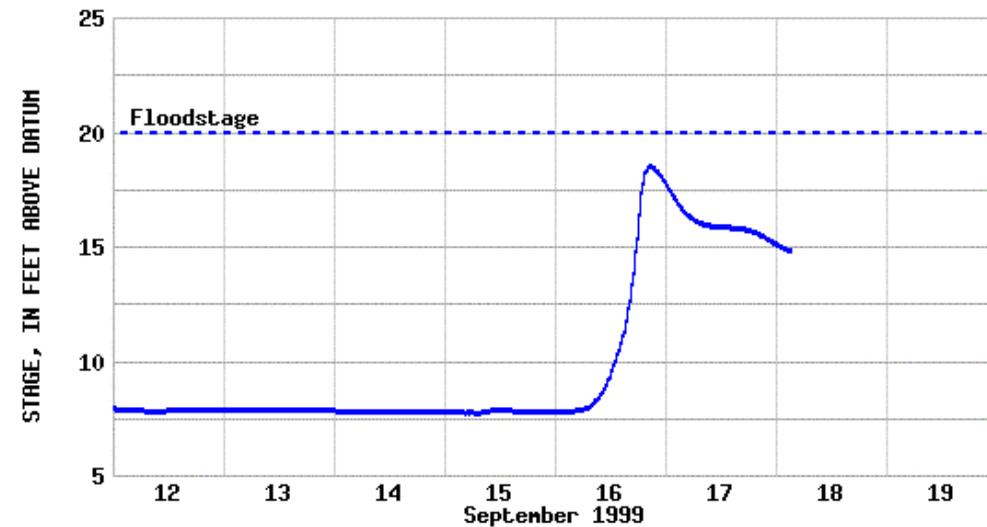
The **Delaware River** at Trenton experienced one of its fastest increases in stage, rising 11 feet in about 8 hours. Flood waters were about a foot and a half deep along River Road in Bucks County. Some rainfall totals along the main stem Delaware were as follows:

Trenton	7.5 inches
Belvidere	8.9 inches
Montague	7.2 inches
Riegelsville	8.5 inches
New Hope	9.1 inches
Philadelphia	7.0 inches

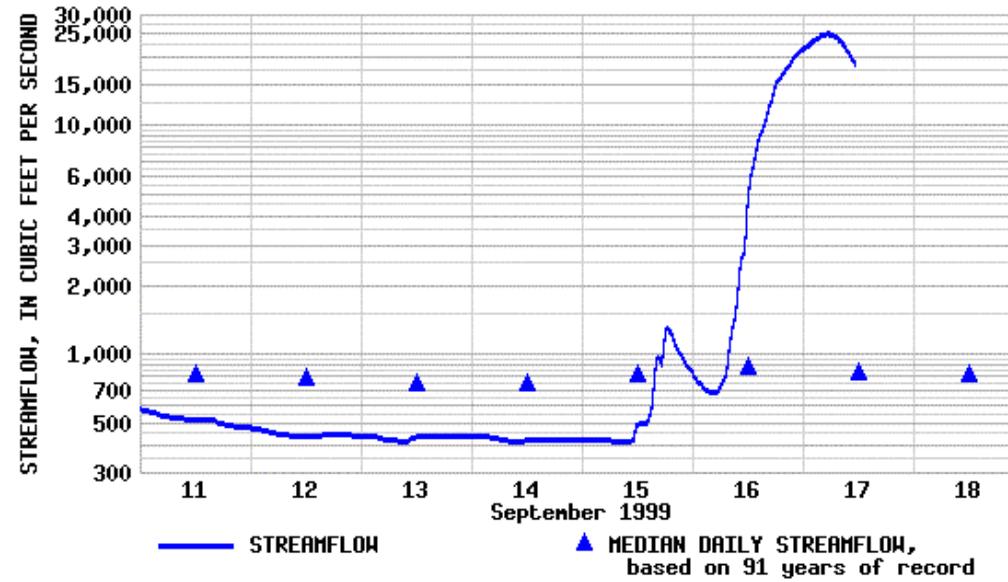
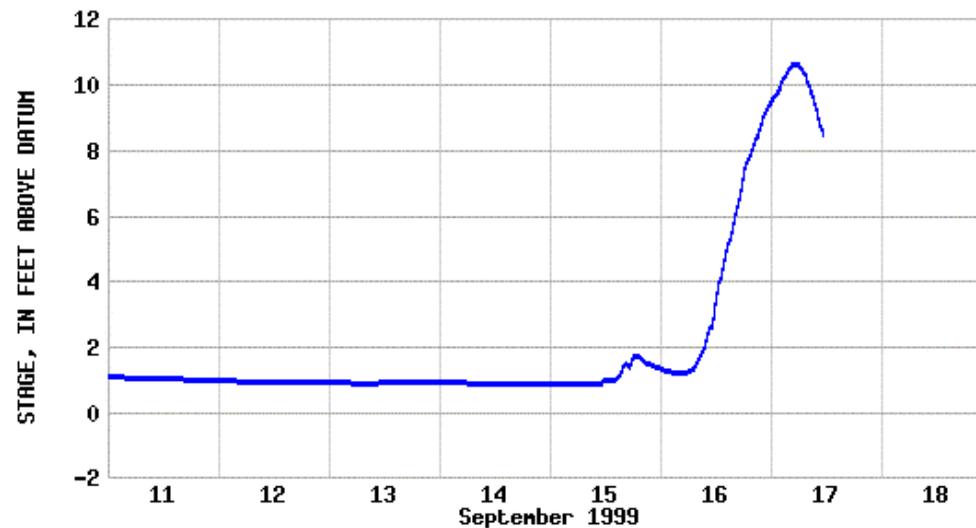
The **Lehigh River** at Bethlehem did not reach its flood stage of 16 feet. Further upstream at Walnutport, the Lehigh rose to its flood stage of 8 feet, then receded. Some rainfall totals in the Lehigh Basin are shown below.

F.E. Walter Dam	6.1 inches
Lehighton	6.4 inches
Beltzville Lake	3.8 inches
Walnutport	6.2 inches
Allentown	7.6 inches
Tobyhanna	6.9 inches

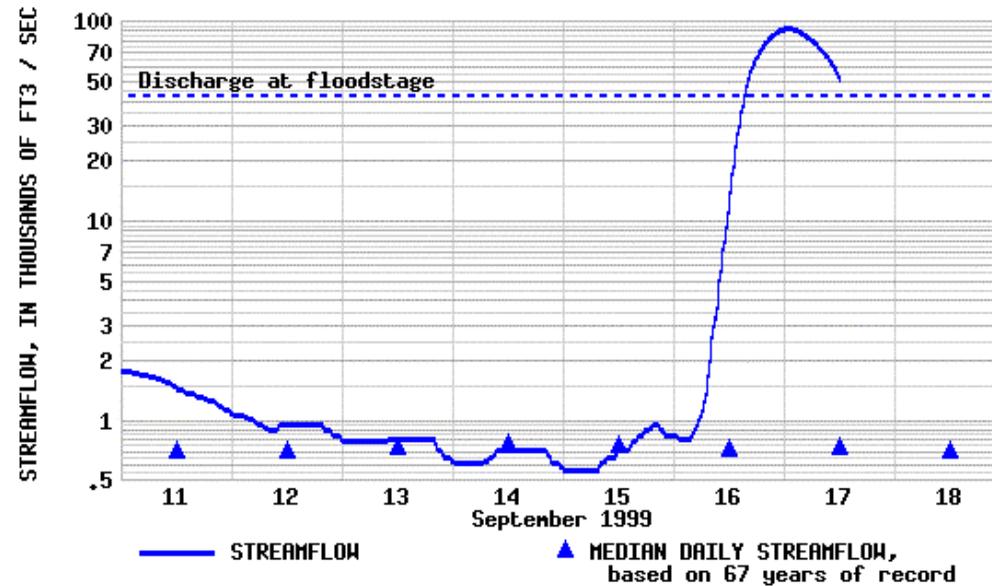
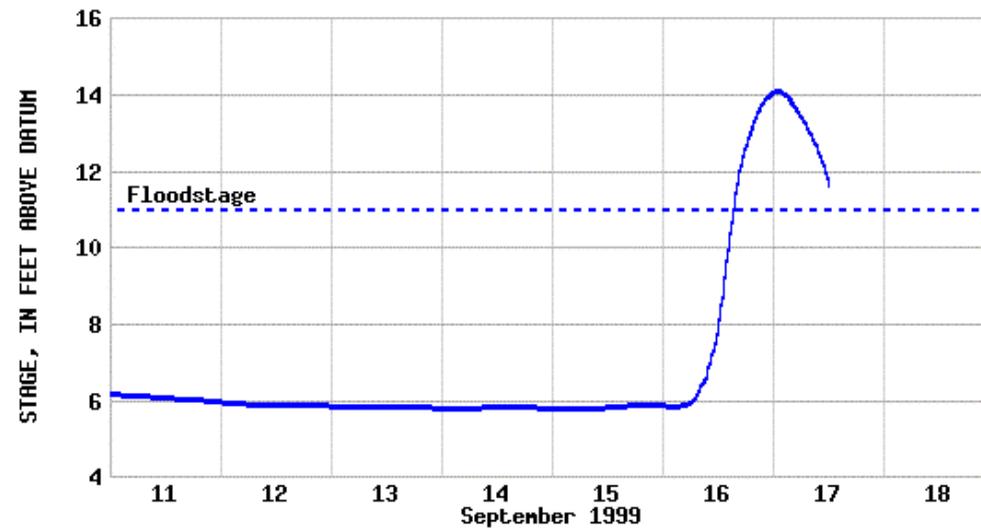
The **Schuylkill River** at Philadelphia exceeded its flood stage by over 3 feet. Serious flooding occurred along the Schuylkill and its tributaries. Parts of Manyunk and Venice Island were submerged. The following are some rainfall totals in the Schuylkill River Watershed.

Tamaqua	6.5 inches
Hamburg	5.2 inches
Blue Marsh Dam	6.3 inches
Reading	6.9 inches
Valley Forge	10.0 inches
Pottstown	6.3 inches

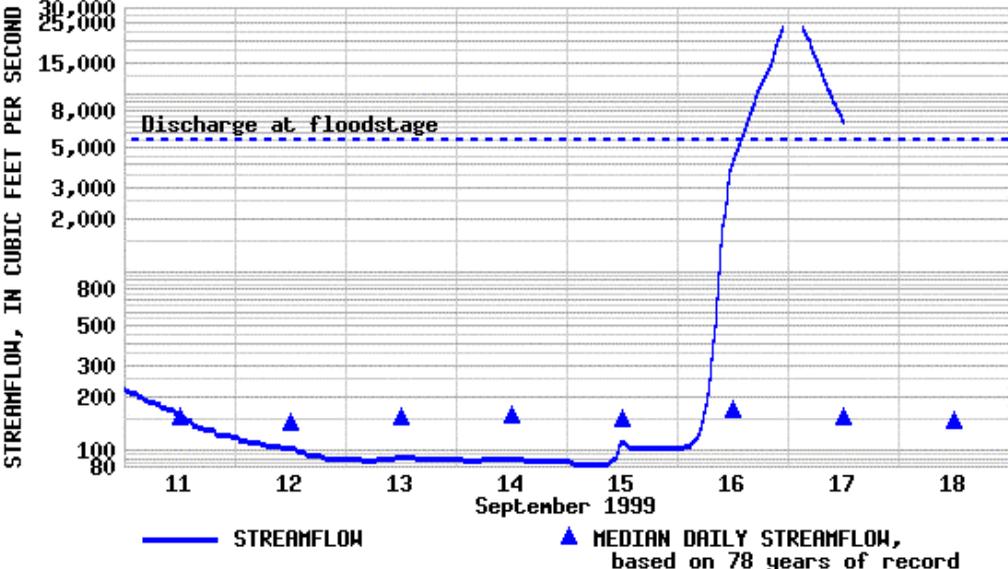
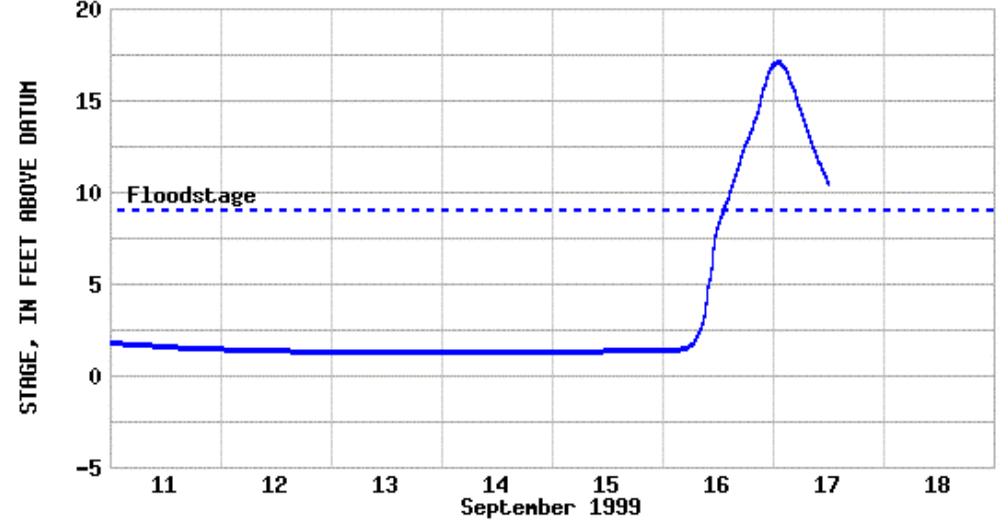
The **Brandywine Creek** at Chadds Ford exceeded its flood stage by 8 feet. Rainfall totals in the Christina/Brandywine Watersheds are shown below.

Glenmore	6.9 inches
Newark	8.7 inches
Wilmington	8.3 inches
Honey Brook	5.5 inches
