ExxonMobil Lail Property
East Greenwich Township and Borough of
Paulsboro, Gloucester County, New Jersey

Site History

- 30,000 Cubic Yards of Aluminosilicate Material (ASM) Deposited in 1950's
- 1985 Investigation of Buried Drums
- 1995 Mobil Signed MOA for Cleanup
- 2001 Mobil Signed MOA for ASM
- 2005 ExxonMobil Signed ACO for Remediation of ASM and PCB Residuals
- 2008 ExxonMobil Implements Remedial Actions (RA)

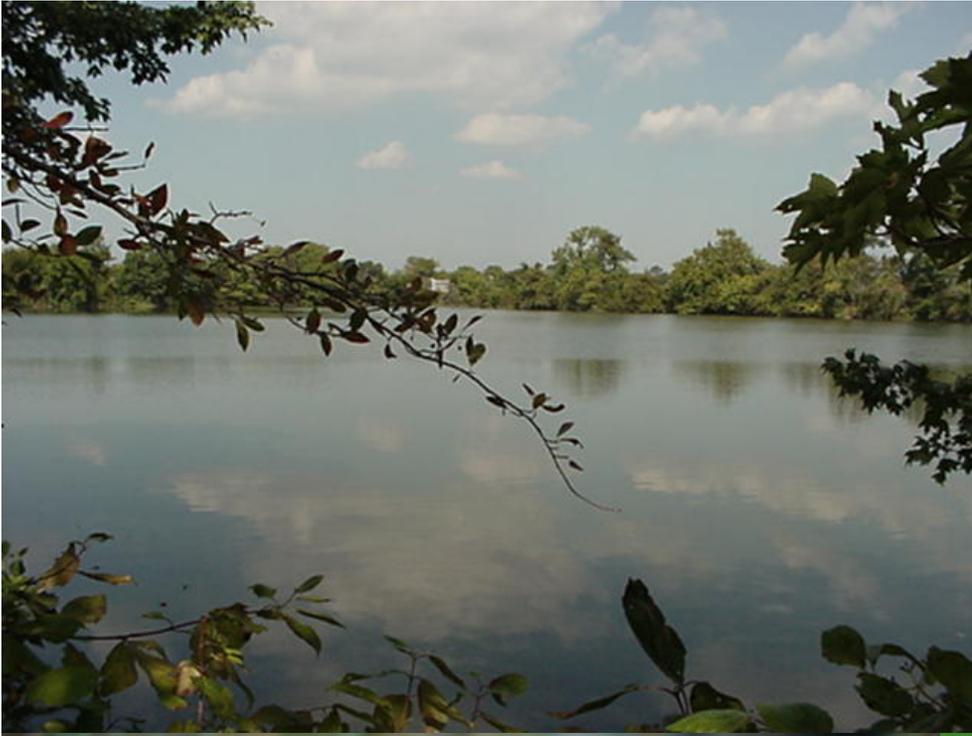
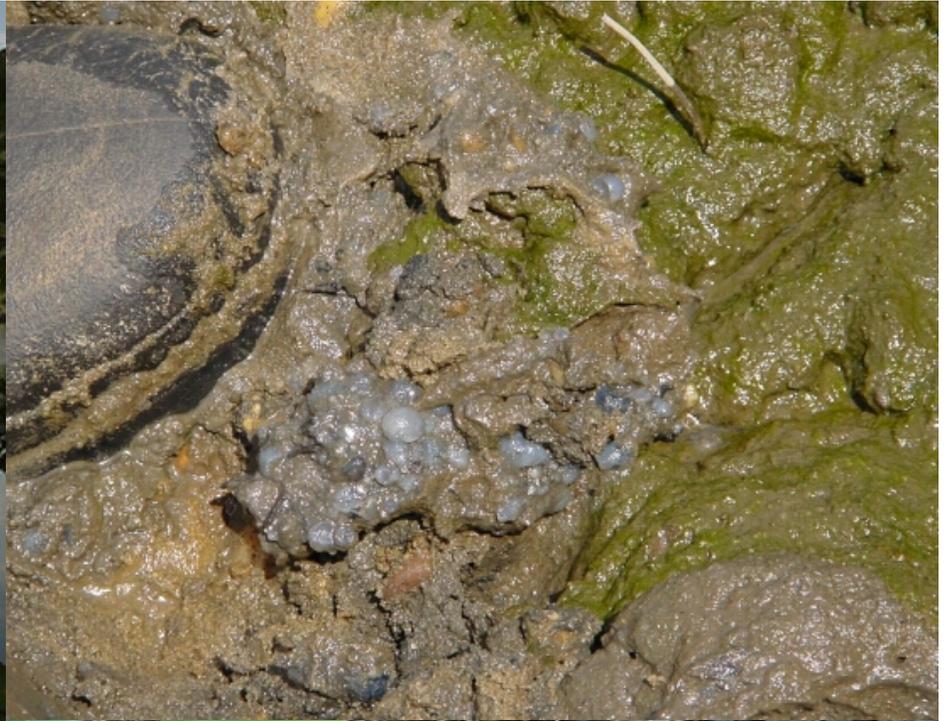
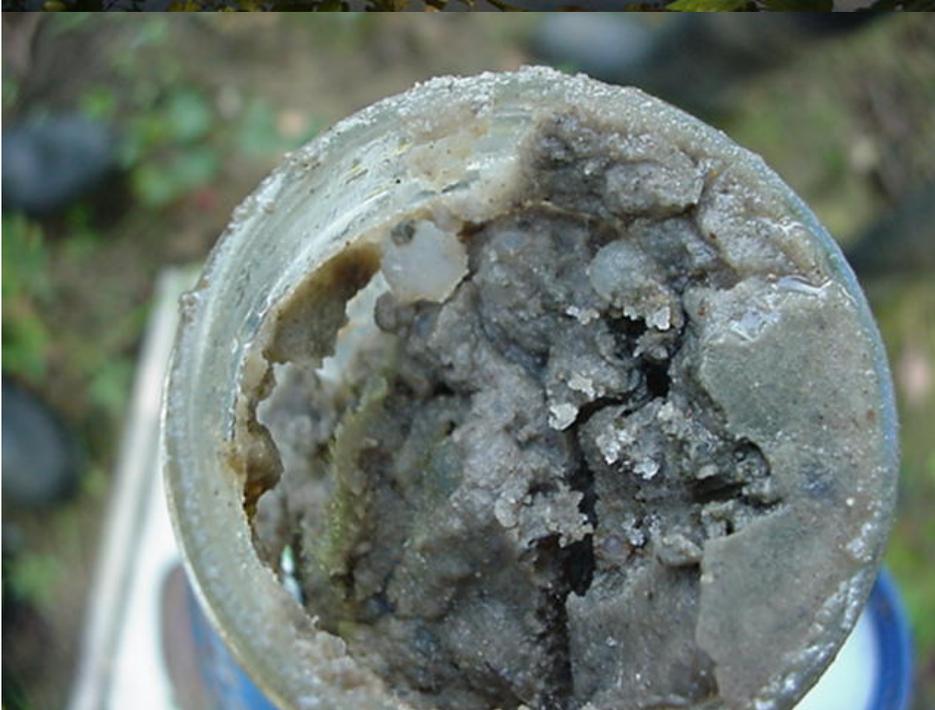
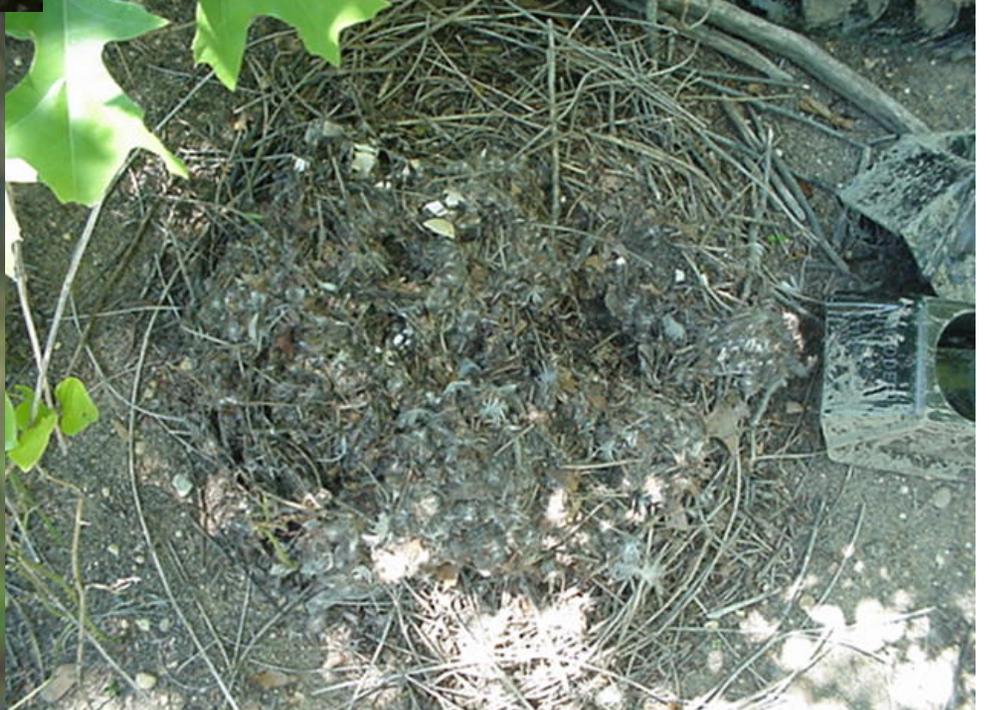
Site Photographs

- Slide 11 shows (clockwise) Site at high tide, ASM Beads in Sediment , Waterfowl Nest, ASM Beads collected from Subsurface

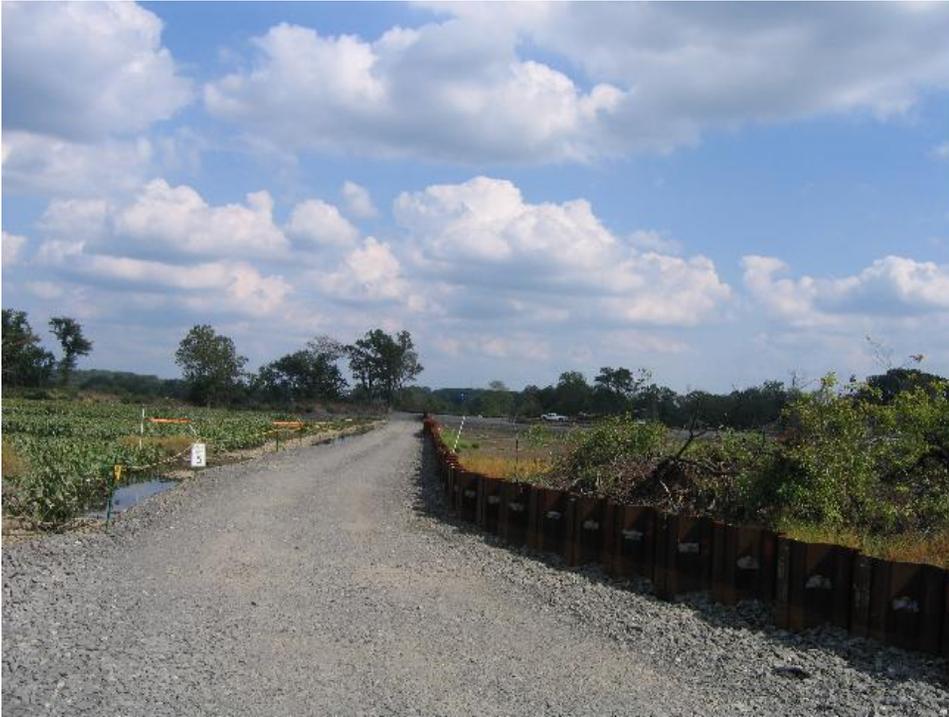
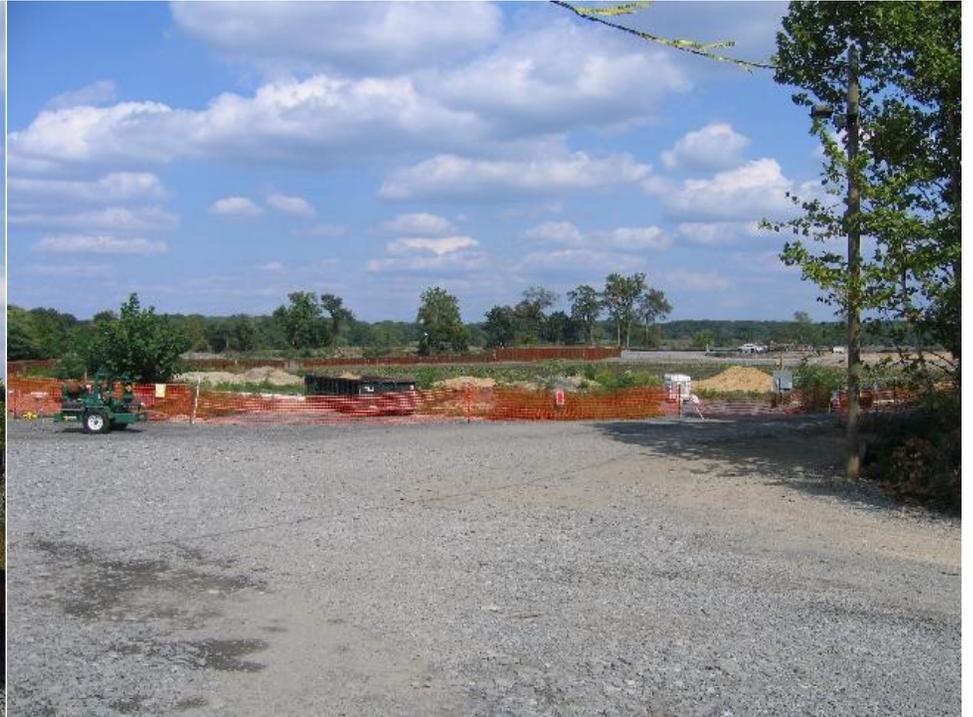
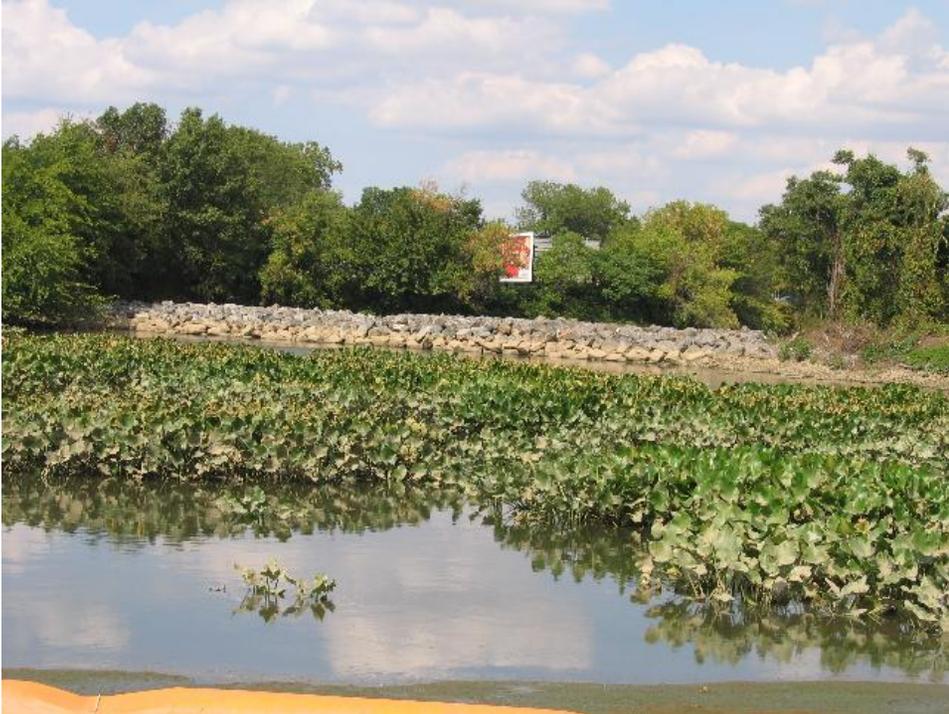
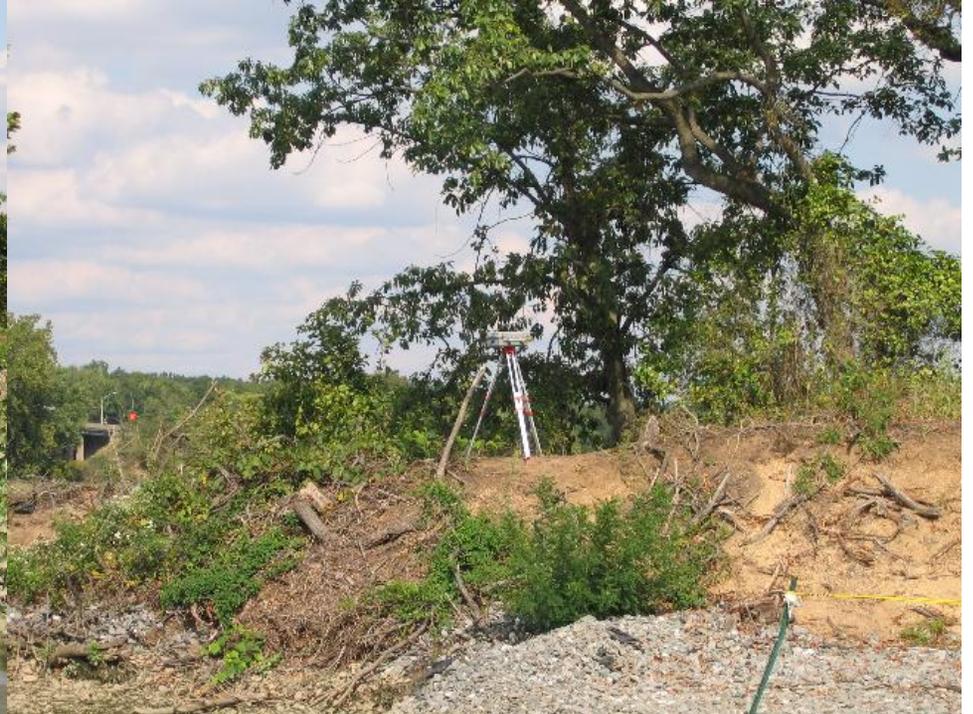
Site Photographs

- Slide 14 shows (clockwise) Construction Road (top two photos) , Air Monitoring Station, Stone Berm to reduce tidal influence
- Slide 15 Shows (clockwise) Truck being detarped for loading, Truck being loaded , Wastewater Treatment Plant, Truck being decontaminated
- Slide 16 shows various views of dewatered sediments being removed
- Slide 17 shows various views of site during construction
- Slide 18 shows Raccoon Tracks and Carp and Killifish in surface water

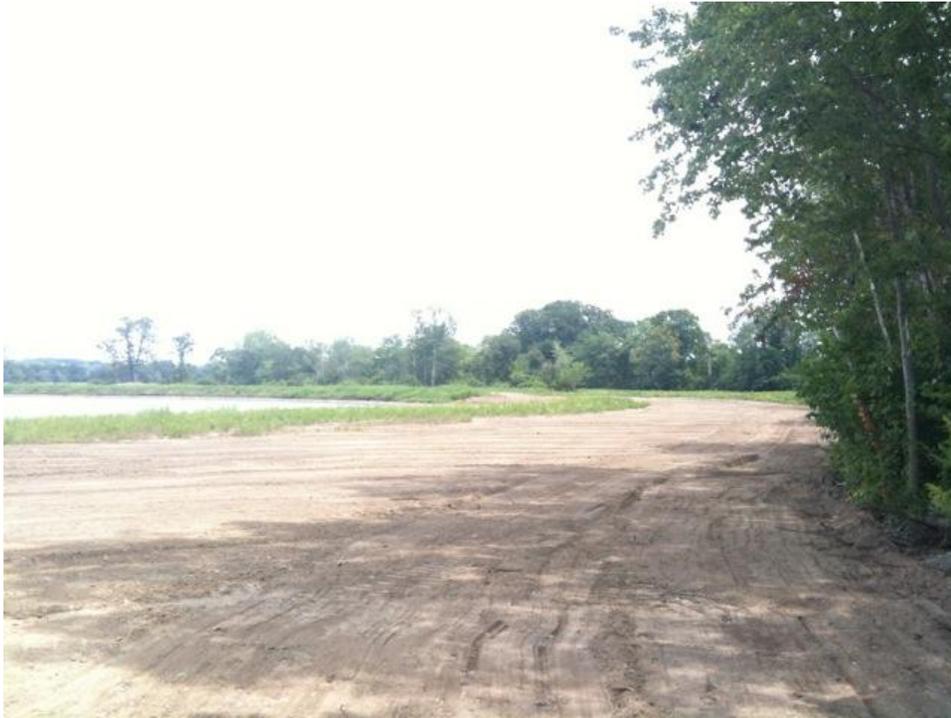
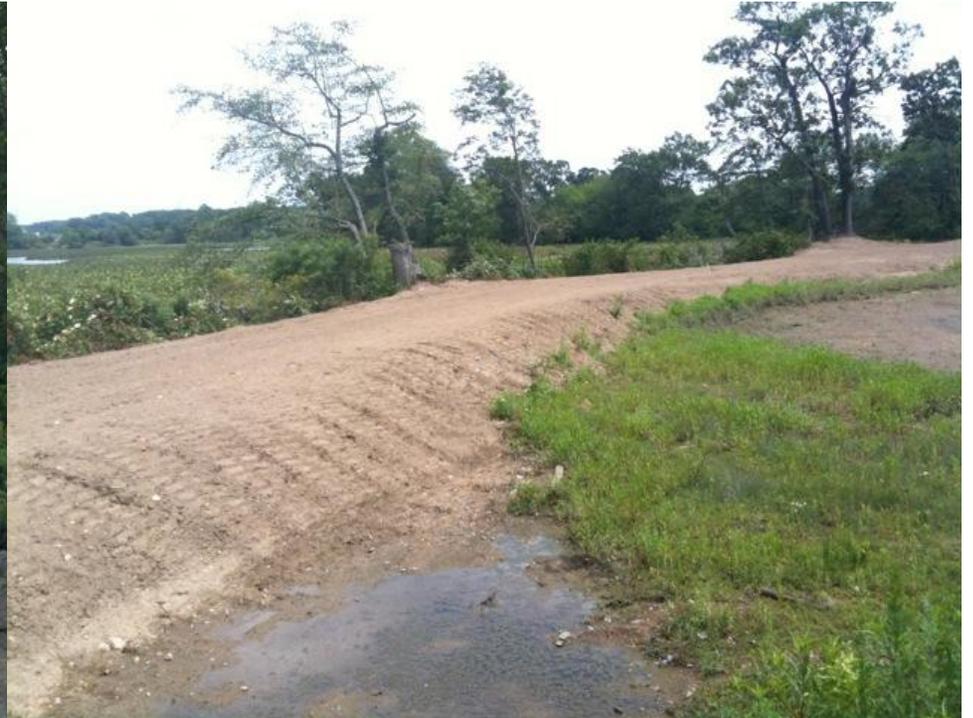
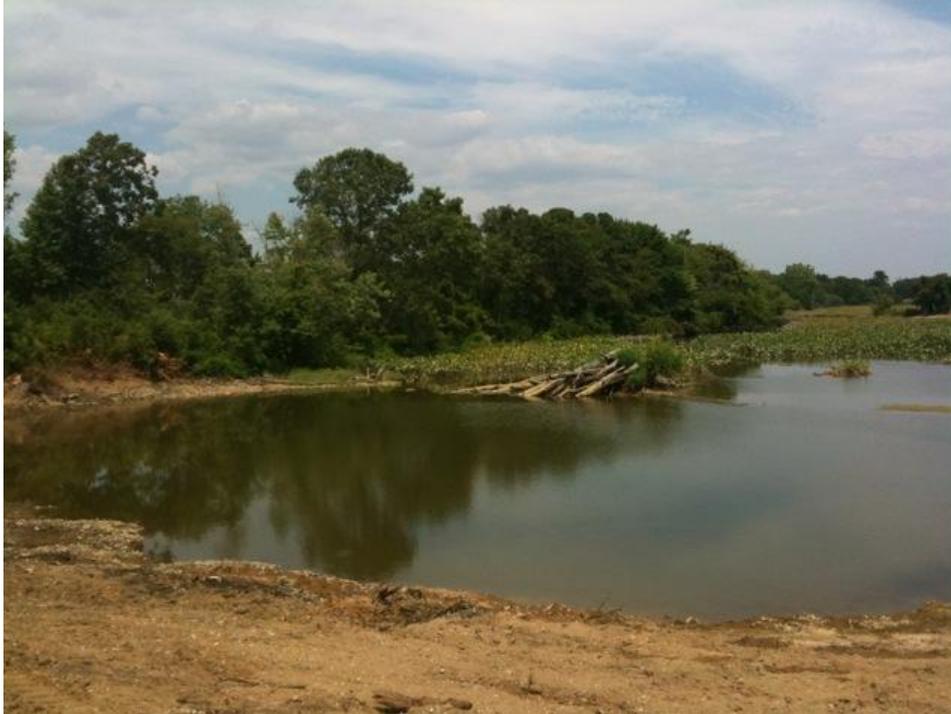
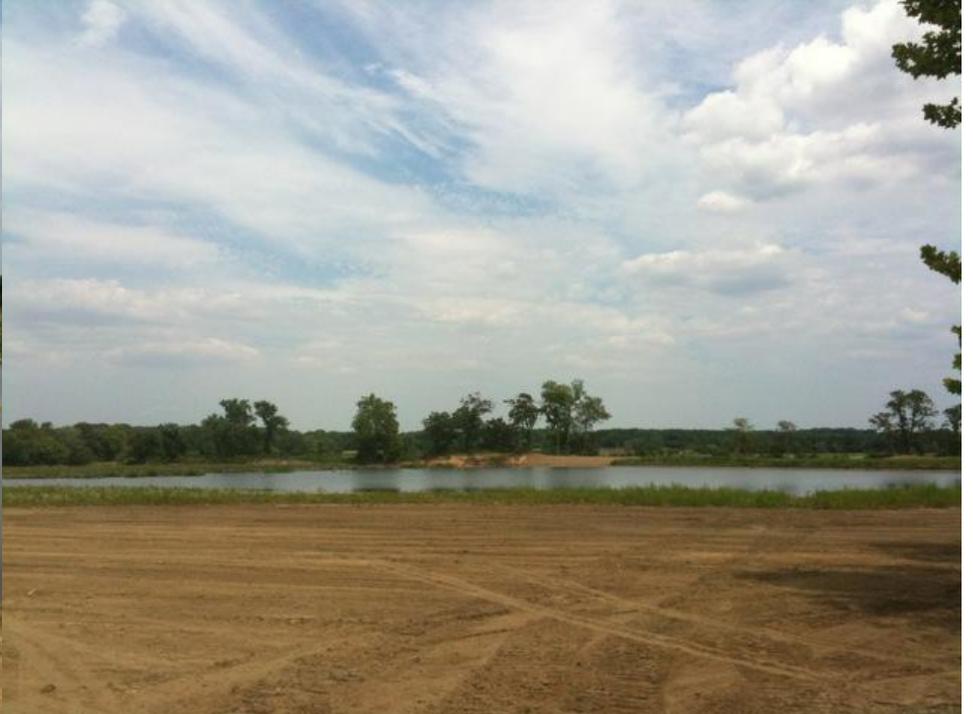
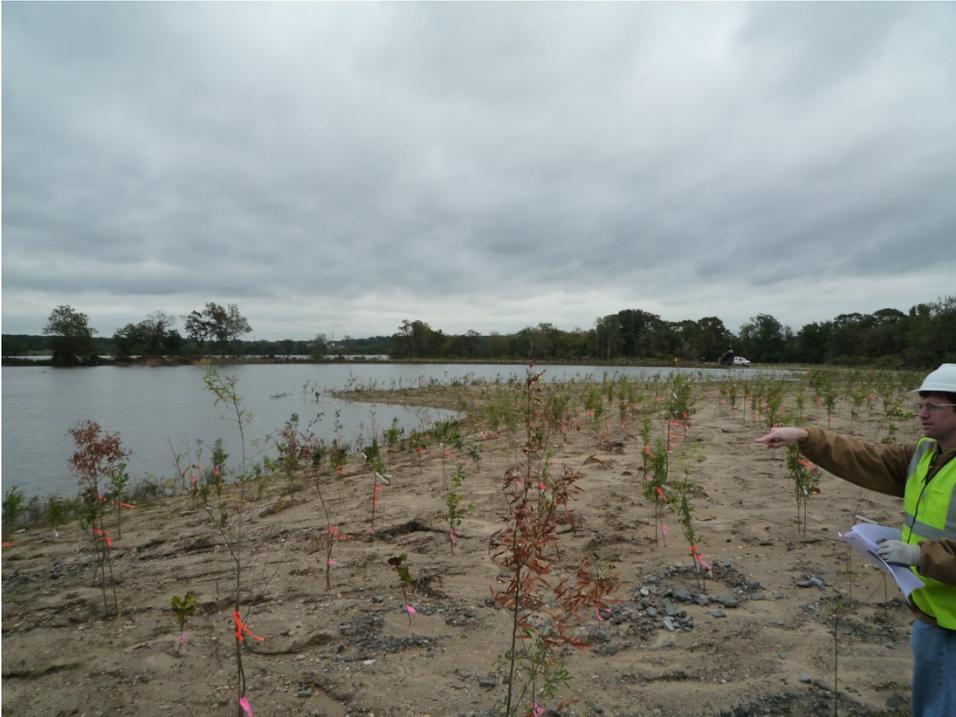
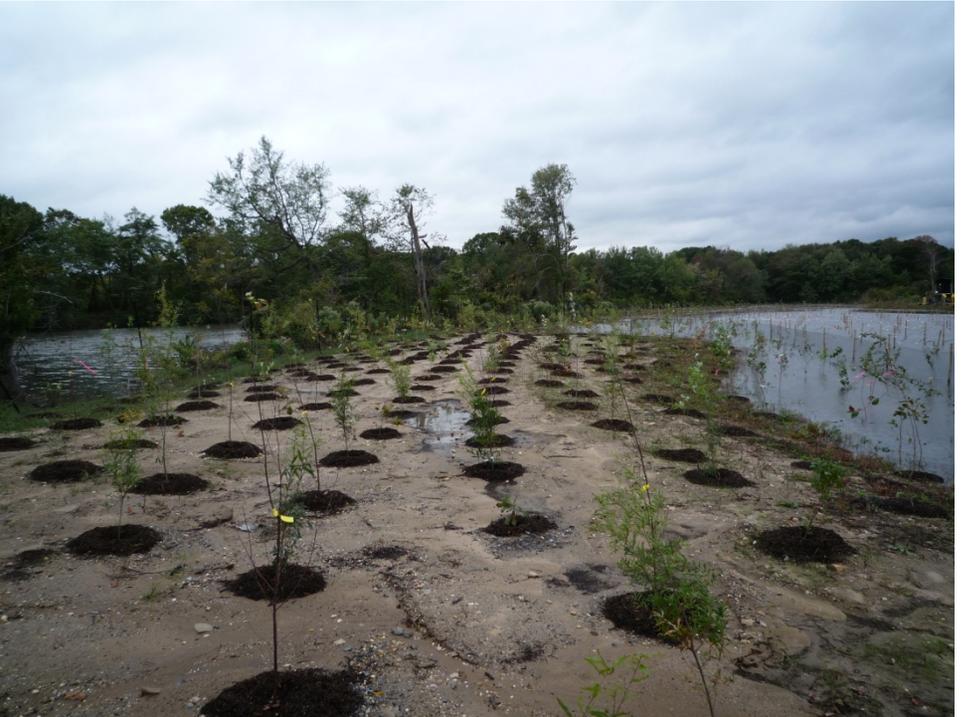
Post RA Results

- Slide 25 shows various views of post RA restoration
- Slide 26 shows various views of post RA planting
