Hydrilla Management for Protection of the Delaware & Raritan Canal

**Senior Watershed Protection Specialist
New Jersey Water Supply Authority**

May 24, 2018

DRBC Regulated Flow
Advisory Committee

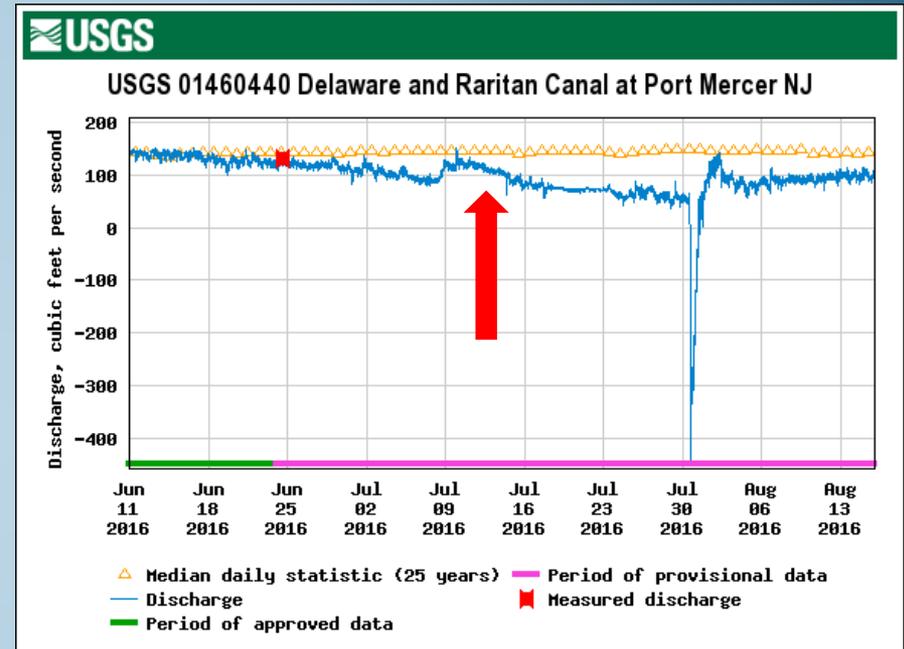
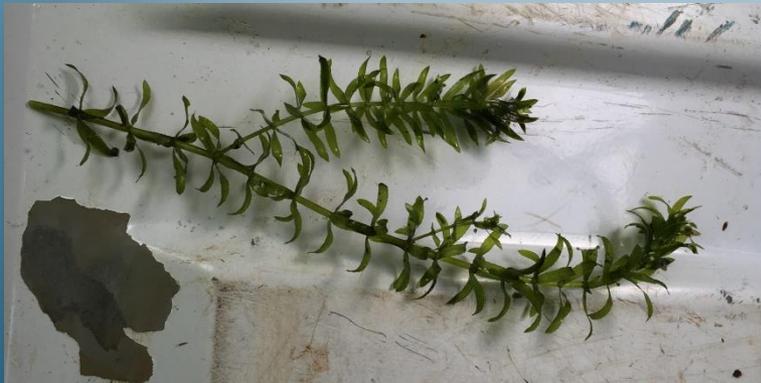
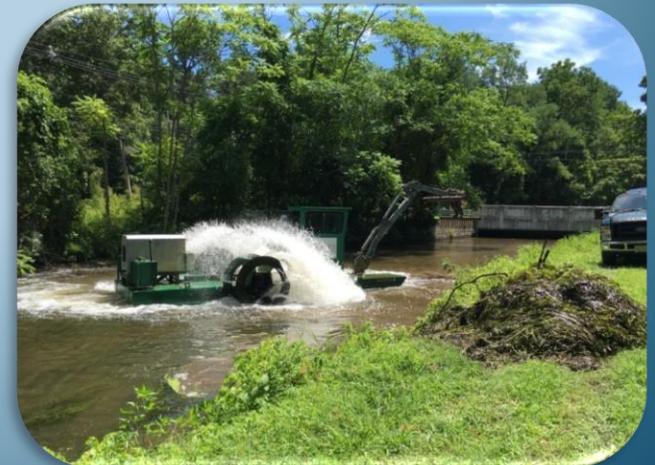
2016 Detection & Response

- Water flow restriction due to excessive plant growth
- Canal water level below intake
- Hydro-raking: July-August

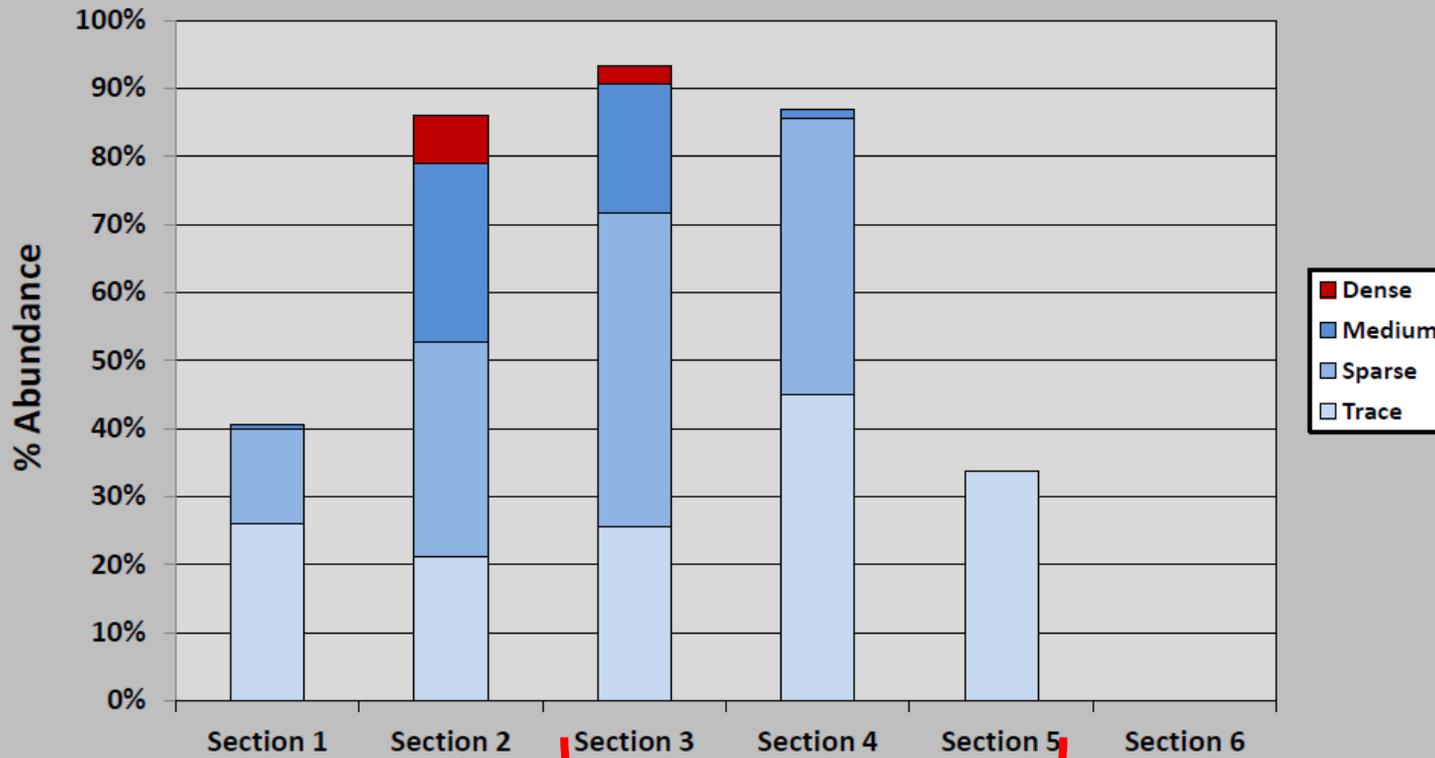
Hydrilla (*Hydrilla verticillata*)
Percent Abundance by Section
D&R Canal

Hydro-raked prior to survey

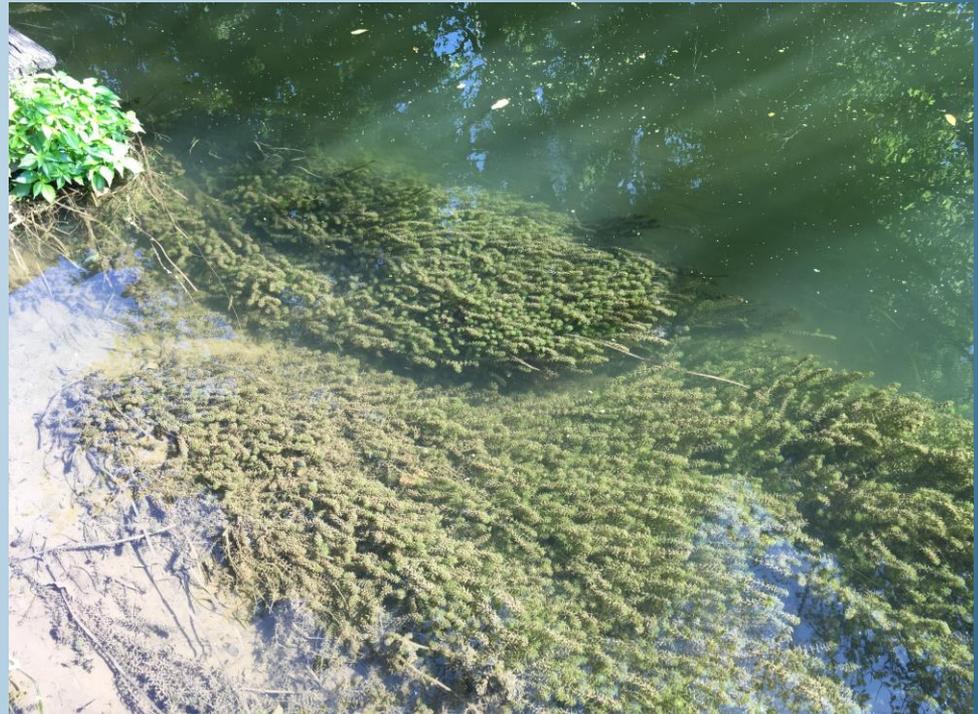
D&R Canal at Scudders Falls September 2016

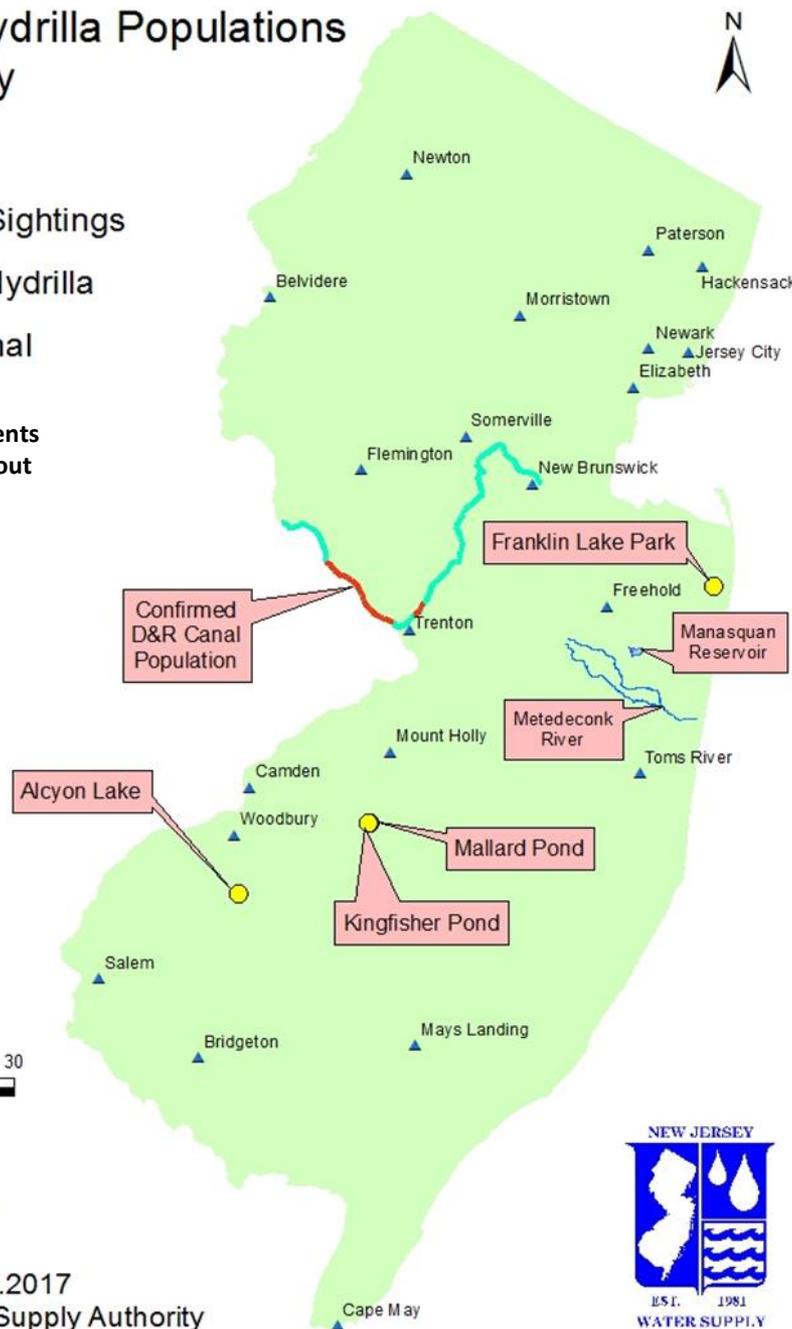
Confirmed Hydrilla Populations in New Jersey

- ▲ Towns
- Hydrilla Sightings
- Rooted Hydrilla
- D&R Canal

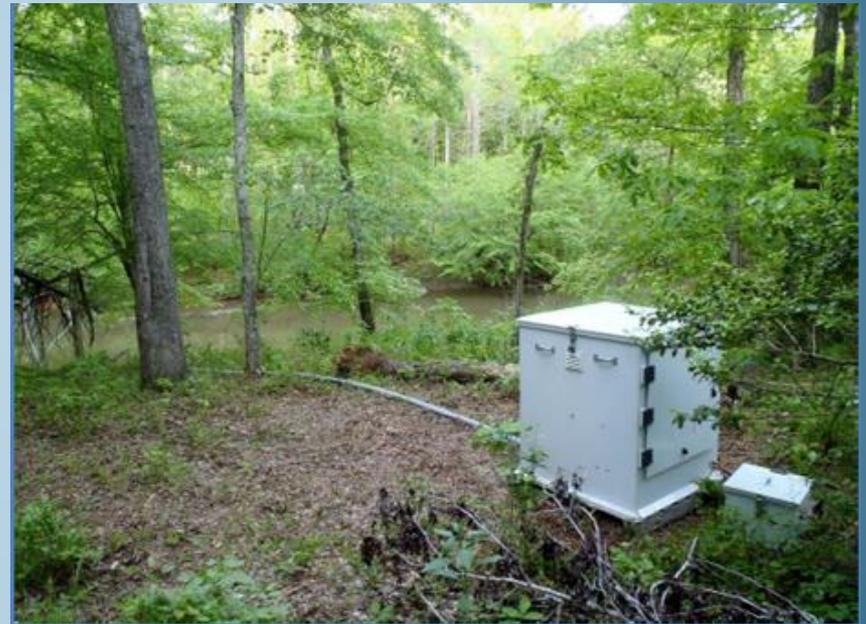
Injection unit

Eno River, NC
Photos: Mark Heilman, SePRO

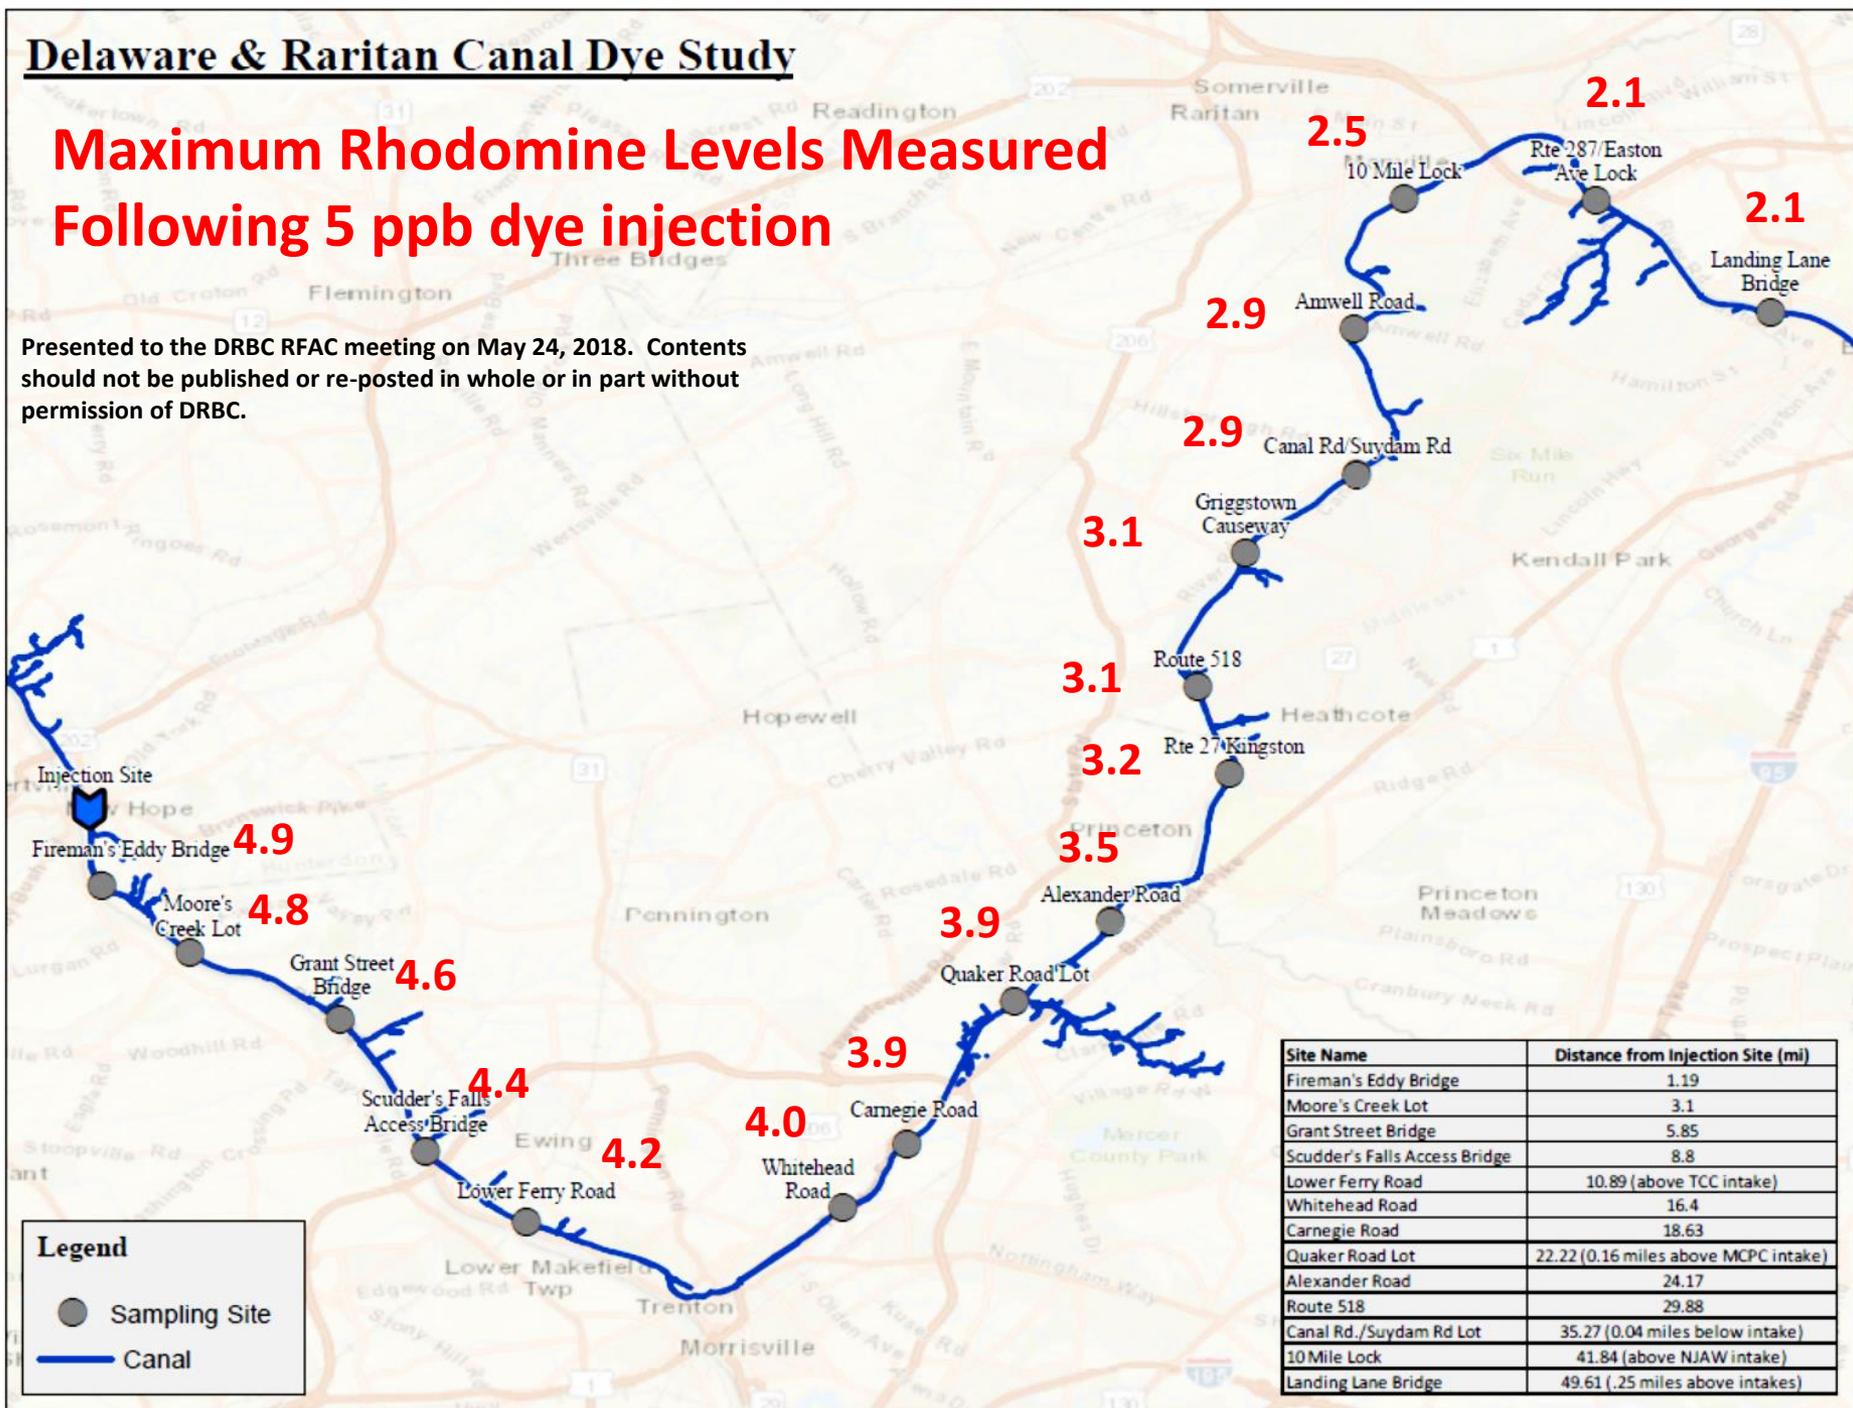
Delaware & Raritan Canal Dye Study

Maximum Rhodomine Levels Measured Following 5 ppb dye injection

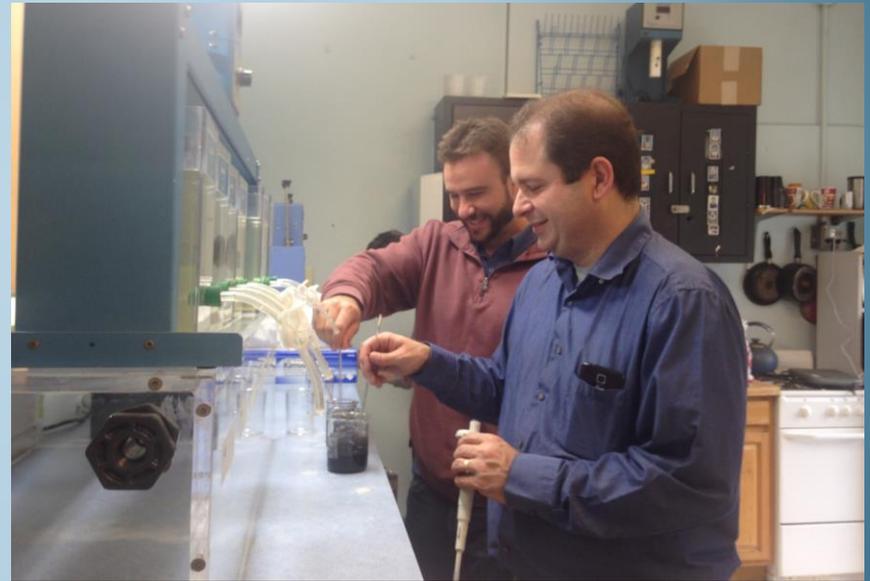
Benchtop simulations

- Canal water with fluridone
- Simulated each treatment plant process
- Samples collected and analyzed for fluridone concentration
- Carbon very effective at removing fluridone

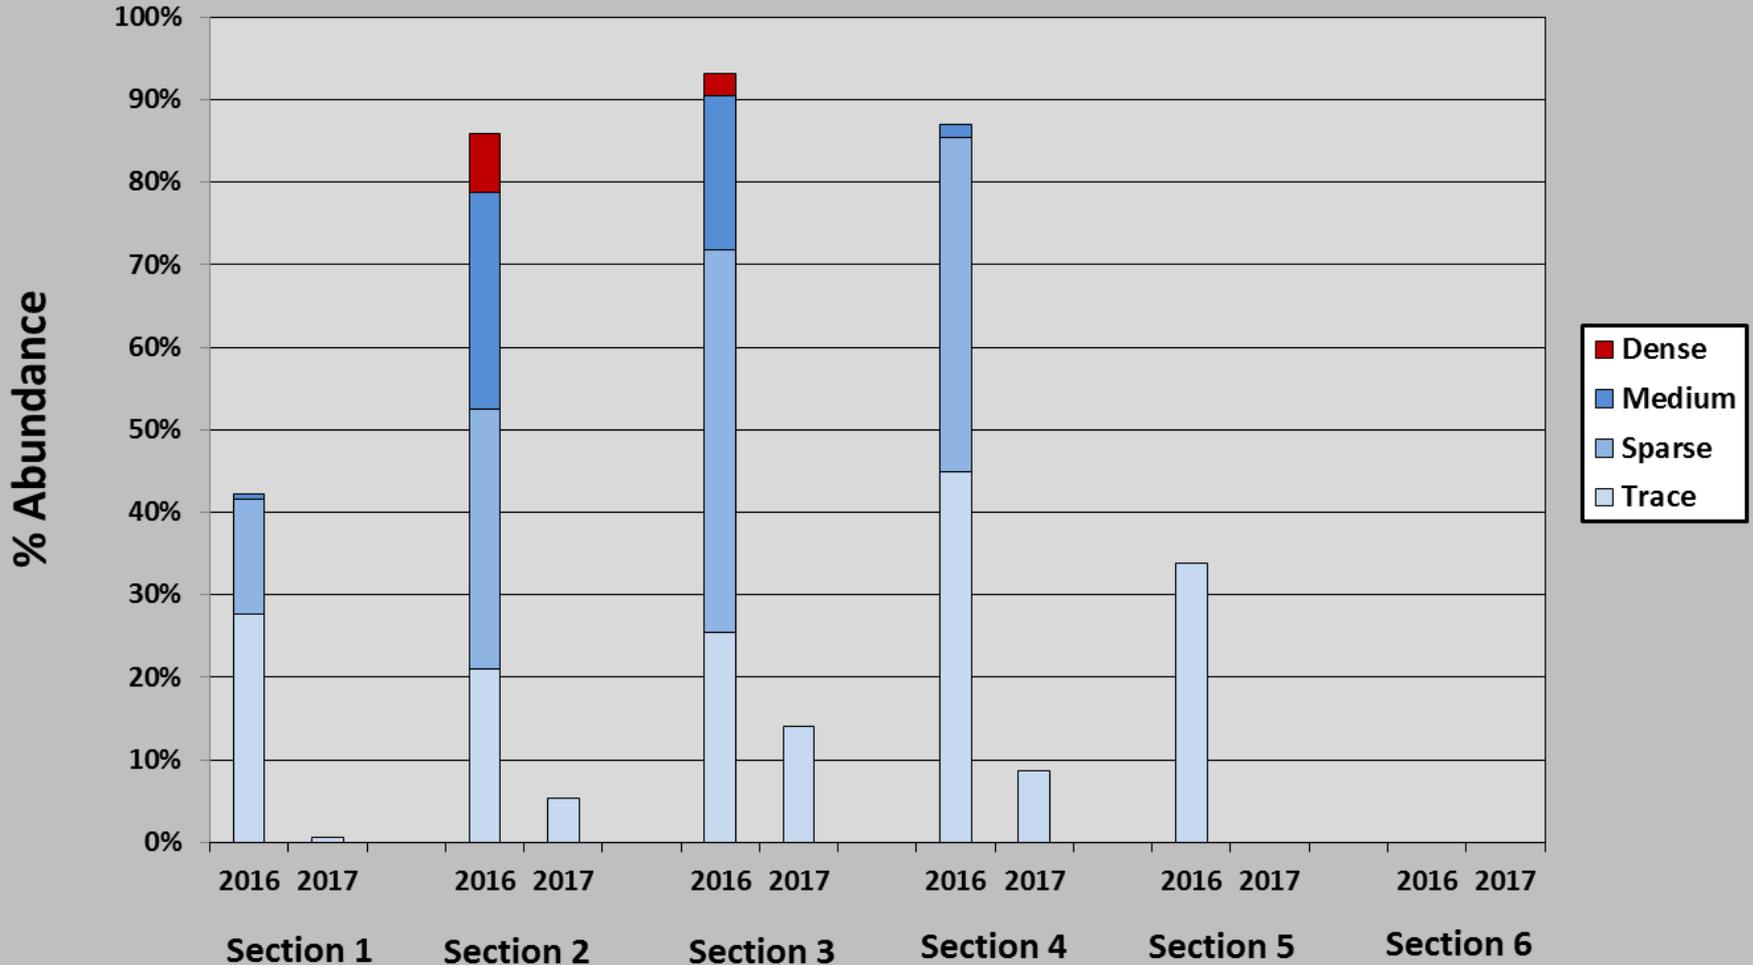
Hydrilla (*Hydrilla verticillata*)
2016 vs 2017 Percent Abundance by Section
D&R Canal

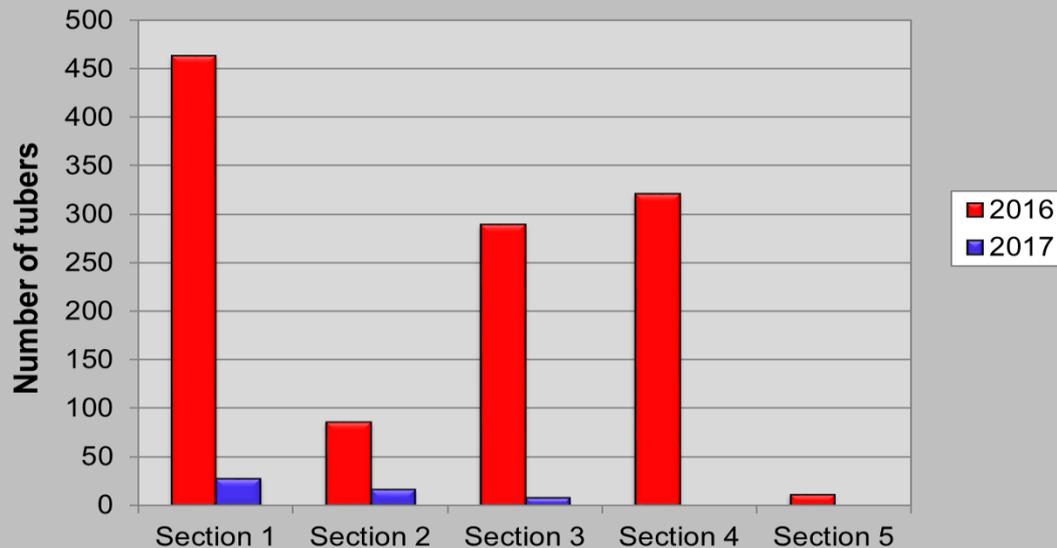
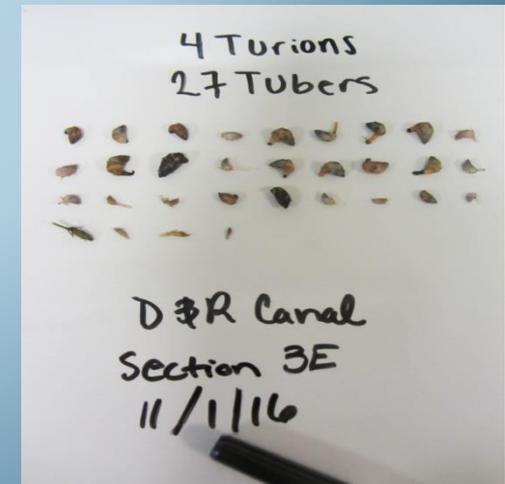
**2016 vs. 2017
Number of Hydrilla Tubers**

Tuber Sampling Stations	2016 (tubers/ m ²)	2017 (tubers/ m ²)	% Change
DR-1	462.8	26.5	94.27
DR-2	85.6	15.2	82.24
DR-3	288.9	7.6	97.36
DR-4	320.4	0	100.00
DR-5	10.7	0	100.00

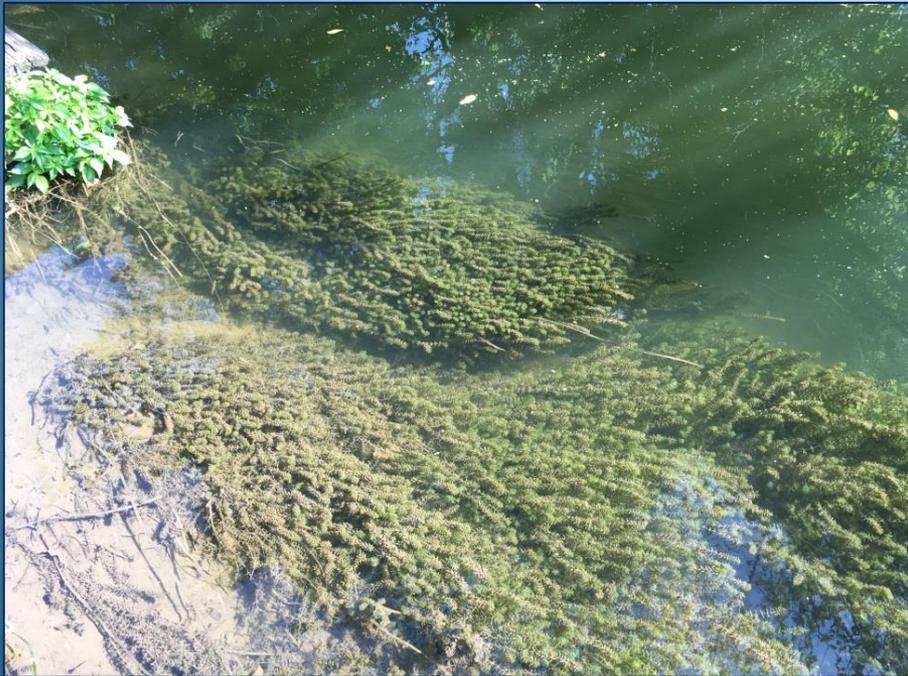
September 8, 2016

Hydrilla at Scudders Falls
