HIGH FLOW MANAGEMENT OBJECTIVES FOR NEW JERSEY NON-COASTAL WATERS

**A Study of the Delaware, Saddle, Whippany, and
Musconetcong Rivers and Flat Brook**

**Delaware River Basin Commission
West Trenton, NJ**

August 2000

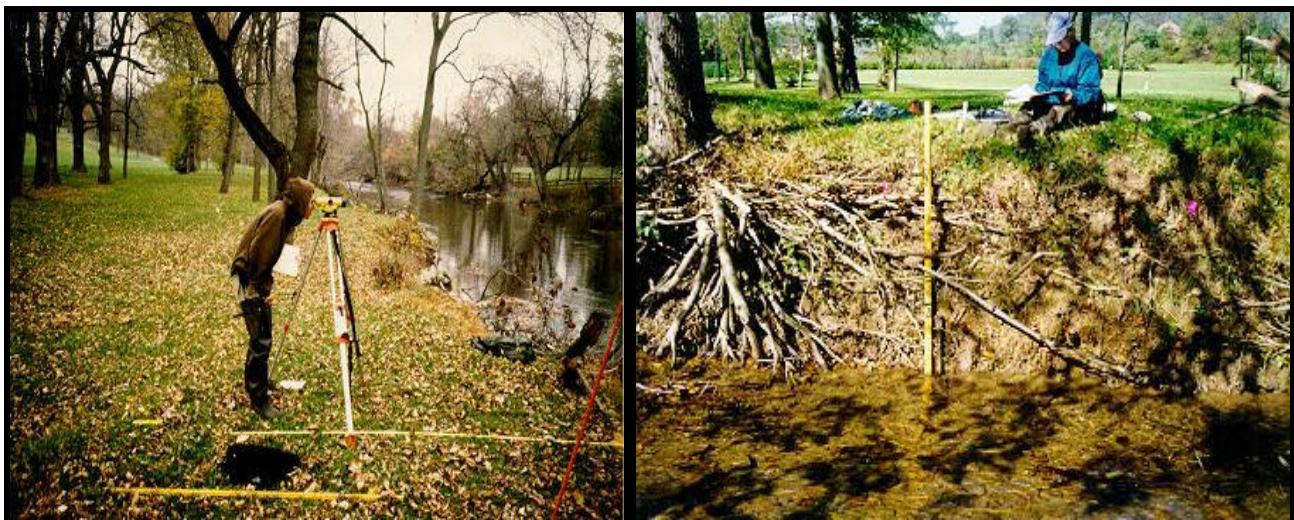
Musconetcong River field workers (clockwise from top left): Doug Jerolmack surveys at a cross-section; Pamela V'Combe takes notes by a scoured stream bank; Judith Strong records measurements at a cross section; and Ms. V'Combe measures channel characteristics next to a leaning tree.
