# NJ FACE INVESTIGATION REPORT

FACE 01-NJ-092

## **Machine Operator Killed In Masonry Block Palletizing Machine**

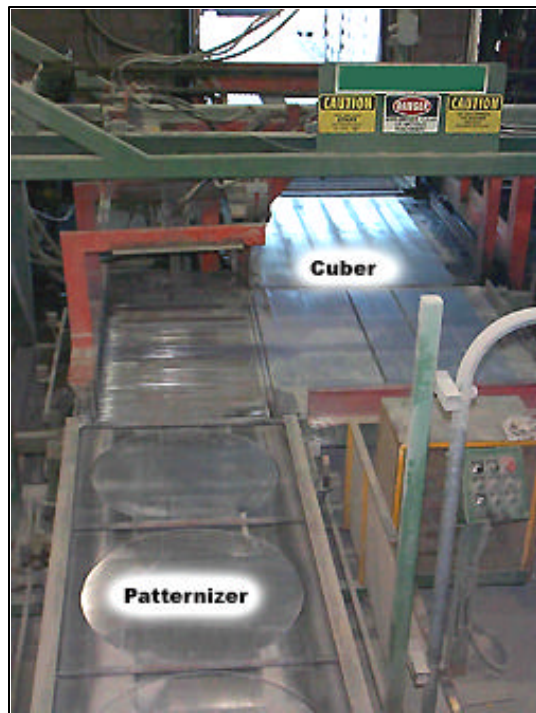
**Photo 1**

The incident occurred on Wednesday, August 8, 2001, at 10:03 in the morning. The victim started his shift overseeing the machines in the block-making room. After being released from the molds, the newly-made blocks were conveyed to the patternizer. This was a series of turntables that rotated the blocks, allowing them to form an interlocking pattern when pushed together. The arranged blocks were then directed into a cuber, which gripped the tier of blocks and stacked them onto a pallet.

**Block patternizing/cubing machine**

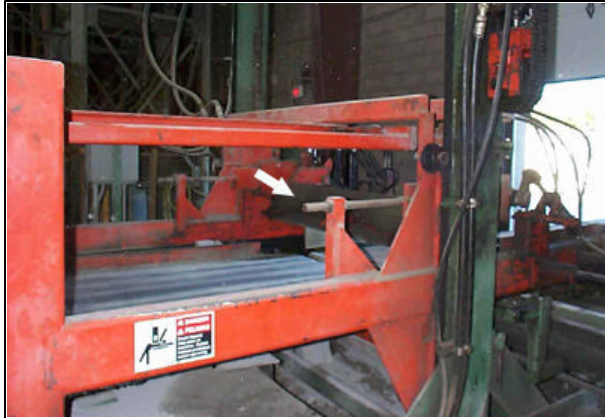
**Photo 2**

A second employee was working nearby in the same room, but their duties and the noise from the process left the two men to work mostly on their own. There were no witnesses to the incident. At about 10:00 a.m., the victim went to clear a jam in the cuber. He apparently stood on a frame member and leaned into the cuber to re-arrange the blocks with a hooked metal rod. As the machine cycled, the victim's head became caught between the moving arm and a large stationary bolt securing a frame member. The coworker heard the victim yell and looked over to see him fall by the side of the machine. He went to help the victim, who had severe head injuries. Plant personnel called 911 for the police and

**Cubing machine showing stationary bolt**

**Discussion:** In this case, the victim leaned into the operating machine in an apparent effort to unjam it. It is recommended that a written safety program be developed that includes a plan for training supervisors and workers in the safe operation of the machines before they are allowed to use or maintain the equipment. Training should include standard operating procedures and safety practices for each piece of equipment. Close supervision and periodic retraining should be required to ensure that

**Discussion:** The company did not have an effective lockout/tagout program at the plant at the time of the incident. Such a program would require employees to shut down and lock out the power supplies to any machines before maintenance or repairs are done. An effective program would include thorough employee training in lockout/tagout procedures and strict enforcement of the program. A lockout/tagout program may be required under the Federal OSHA Standard 29 CFR 1910.147.

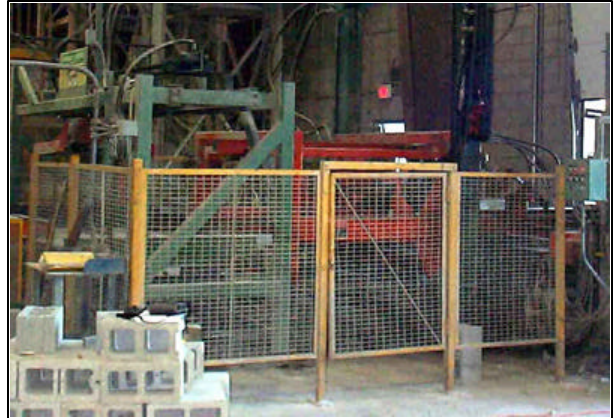
**Photo 3**

**Fenced-in machine guard around machines**

The Federal OSHA investigation noted that employees were trained to shut down the machine before attempting to rearrange the blocks with the hook. OSHA also noted that the machine was equipped with a freestanding fence to guard the machine, and that the fence may not have been properly positioned at the time of the incident. The Medical Examiner's investigation report noted that the frame edge where the victim apparently stood on the machine was worn, as if it was stood on frequently. The M.E. investigator reported that a co-worker confirmed this to be true. The plant manager reported that since the incident the fence had been permanently secured to the floor and that interlock devices had been ordered that would shut down the machine when a worker opened the fence entrance to the area.

**Discussion:** The machine was guarded by a fence with an interlocked gate to prevent personnel from getting close to the operating machine. OSHA reports that this fence was not properly installed at the time of the incident. It is extremely important that all machine guards are kept in place at all times and that safety interlocks are in operating order. The company has permanently installed the fence and interlock after the incident.
