# NJ FACE INVESTIGATION REPORT

FACE 02-NJ-003

## **Industrial Metals Recovery Worker Killed in Explosion**

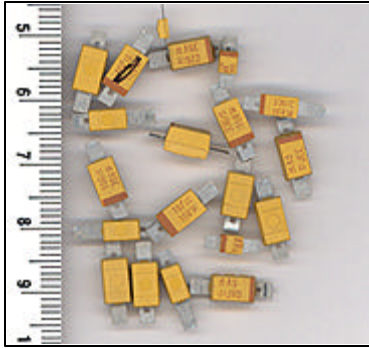
**Photo 1**  
**Tantalum Capacitors**

companies. This incident occurred in the tantalum recovery process. Tantalum is a hard, ductile metal with dielectric properties that is used in the manufacture of small electronic capacitors. Tantalum is rare and difficult to purify, so recovery of the metal from scrap electronic parts is an important source of the metal to manufacturers. In the company's

process, rejected tantalum capacitors and other tantalum parts such as fine ductile wires are received from overseas manufacturers for processing. Company representatives stated during the FACE interview that the capacitors were supplied only by known sources. The capacitors involved in this incident were small, the largest measuring approximately seven by four millimeters (see Photo 1). Each capacitor consisted of a small anode of pressed tantalum powder coated with manganese dioxide. The anode is coated again with layers of carbon and silver, and then covered with a heavy epoxy casing. A three millimeter lead extends from each end of the capacitor for connection into the circuit.

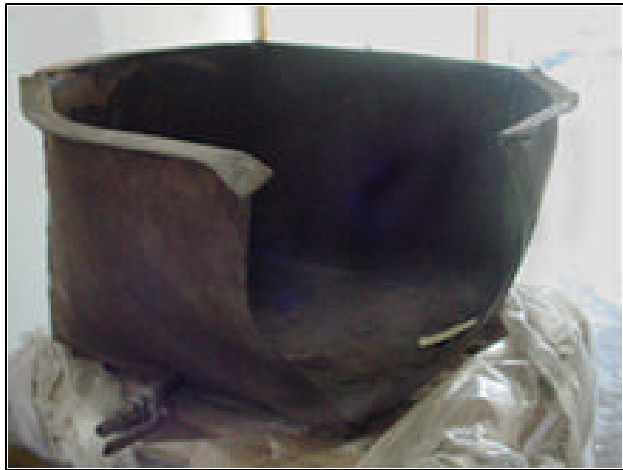
**Photo 2**  
**Acid Tank Involved in Incident**

The tantalum recovery process was done in the plant's acid room #2, a large room measuring 60 feet long, 15 feet wide, and 14 feet high. The acid room contained four acid tanks for use with two different types of acid. Ventilation hoods were mounted above the tanks and a sump system was used for disposal of the used acids. The acid tank involved in the incident was a 50-gallon, stainless steel tank measuring two feet by two feet by two feet (Photo 2). The tank was outfitted with a flat, stainless steel cover with four holes (Photo 3). Four stainless steel baskets (Photo 4) were positioned in the tank, one directly under each hole. A worker scooped the capacitor anodes through the lid into the baskets until each basket was filled, usually with about 150 pounds of material. The tank was filled with an acid solution and heated to a prescribed temperature until 11:00 p.m. when a timer shut down the heating element. When the morning shift workers arrived, the anodes were removed from the tank, rinsed with water, and transferred to a second acid solution. This process was repeated until all the impurities were removed. The tantalum was then dried, packed in containers, and sold.

The company had recently begun reusing part of the acid. Each steel acid tank had a drain valve at the bottom front panel of the tank. Workers connected a hose from the drain of a full tank of used acid to the drain of an empty neighboring tank. Both drains were opened, and the acid was gravity fed into the empty tank until the volumes in both tanks were equalized. The workers then drained one tank into the acid sump and topped off the second tank with fresh acid, leaving it with approximately 50% used acid. The process continued as outlined above.

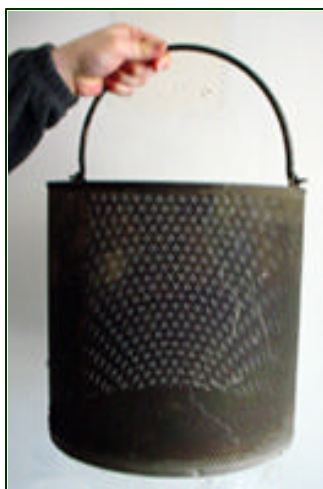
**Photo 4**  
**Stainless Steel  
Basket**

- Eight hundred pounds of material were added to the acid tank, which was 200 pounds more than the amount usually added. This increased the amount of organic material in the acid by 33%, while potentially reducing the amount of acid in the tank by displacement. In addition, this extra material presumably caused the open stainless steel baskets to overflow, depositing material on the bottom of the tank. This material was susceptible to shock as the heavy steel baskets were removed from the tank.

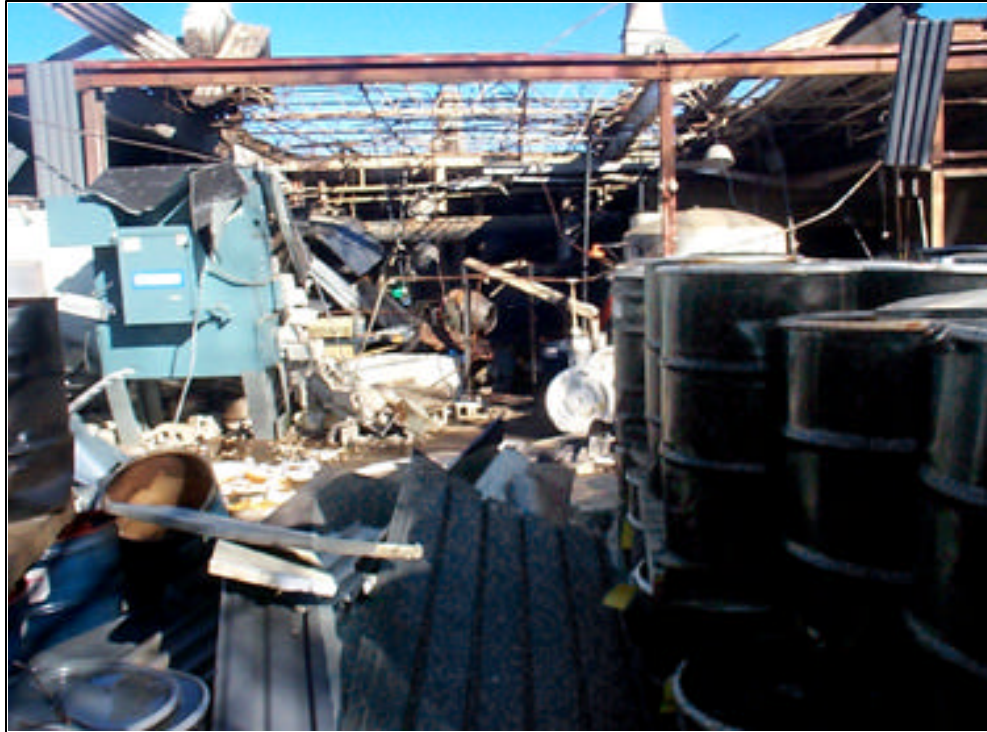
**Photo 5**  
**Acid Room Shortly After the Explosion**

The first police units arrived within a minute of the first 911 call and found that a large section of the roof had been blown off the building (Photo 5). Due to the nature of the emergency and the recent terrorist attacks of September 11, 2001, the police treated this as a potential terrorist attack and requested backup from EMS, fire department, bomb squad, and state and county hazmat units. Federal OSHA also sent several investigators to the scene. The area was secured, several small fires were extinguished, and the badly injured worker was evacuated by helicopter to a NJ Level 1 trauma center and later transferred to the burn unit of a major Pennsylvania hospital. Several other plant workers were treated for injuries and smoke inhalation, as were employees at a neighboring Public Works facility who were evaluated for possible chemical exposure. A chemical decontamination area was established and many of the employees on the scene were decontaminated due to possible acid exposure. The victim, who was killed instantly, suffered multiple injuries including traumatic amputation of his arms. He was pronounced dead at the scene at 4:30 p.m. The police cleared the scene at 5:17 p.m.

Police: The police did a thorough room-to-room examination of the site soon after the explosion. An examination of the acid room found cigarette butts on the floor and numerous butts in the acid tanks. A bomb squad detective hypothesized that the explosion might have been caused by a fuel-air explosion, possibly from hydrogen formed by the acid process. However, they did note the obvious explosive damage to the acid tank.

Federal OSHA: The initial OSHA investigation found residual explosive nitrated compounds using a portable test kit at the scene. More definitive tests were done by the OSHA analytical lab in Salt Lake City. The OSHA chromatography test results determined the cause of the explosion to be due to the creation of picric acid formed from the reaction of acid and organic compounds. Picric acid is shock sensitive and OSHA concluded that it detonated as the tank was being emptied.

**Discussion:** The major cause of this incident was the creation of picric acid due to the mixture of organic compounds and acid, partly a result of a process change in which the company switched acids to obtain a cleaner product. The change was overseen by the company technical director, a PhD inorganic chemist. Although qualified in his field, he was apparently not aware of the dangers of mixing these organic compounds. NJ FACE recommends that all major changes to any chemical process should be preceded by extensive research and consultation with qualified experts, such as an organic chemist experienced in industrial processes. It was noted following the investigation that the company has totally redesigned the tantalum process using different, safer procedures and chemicals.
