NJ FACE INVESTIGATION REPORT

FACE 04-NJ-034

Rofer Killed After Falling From a Ladder Lowered From a School Roof

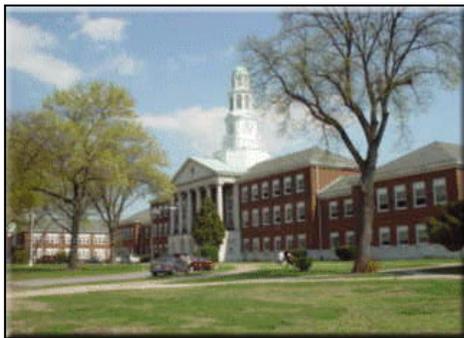
Photo 1
Front of School
(website photograph)

The incident occurred outside a large high school located in an urban area. Approximately 2,300 students were enrolled in grades 9 through 12 at this school. The high school building was a 72-year-old, three-story, brick central structure with a sloped roof (Photo 1). Over time, additional

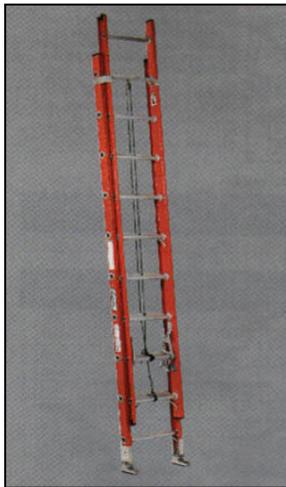
Photo 2
Identical Ladder
(Manufacturer's Photo)

found and carried a 28-foot, two-section fiberglass extension ladder to his worksite (Photo 2). A school surveillance camera just below his worksite recorded the ladder as the victim lowered it from the roof of the building. The victim apparently lowered the ladder to get back down to the ground, or to possibly work on the roof from a different angle. After placing and adjusting the ladder, the victim climbed onto it. Apparently, the fly-lock mechanism that locks the ladder sections together was not properly set, causing it to slip when the victim placed his weight on the ladder. The top section of the ladder slid down several rungs until it hit the ground, causing the victim to fall from the ladder. The police report stated that the sliding ladder was seen in the video, although the camera angle was such that the victim's fall was not seen. As he fell, the victim's head struck a piece of angle iron which protruded about 18 inches from the building, before landing on the concrete sidewalk below (Photos 3 & 4).

Discussion: While viewing the OSHA photographs of the incident, NJ FACE investigators noted that the ladder the victim was using was improperly labeled as 32 feet in length. The photographs also suggest that the rope used to raise the top ladder section may not have been properly mounted to the ladder. NJ FACE recommends an equipment inspection and maintenance program to ensure that ladders and other construction equipment are properly maintained and removed from service when found to be defective.

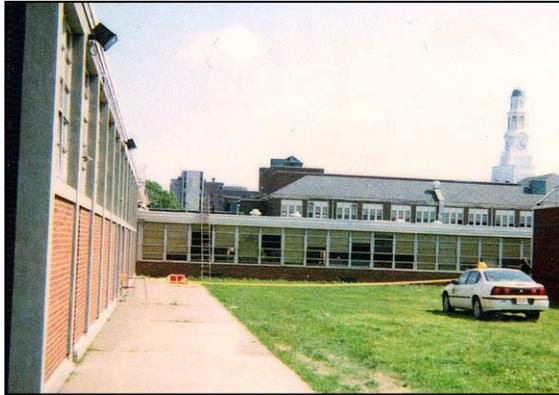
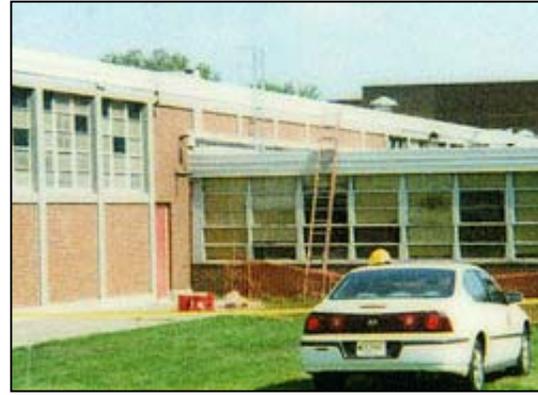
Photos 3 & 4

**Incident Site, victim landed near box on sidewalk.
Ladder was originally raised near the doorway on the left.**
