INVESTIGATION REPORT

FACE 04-NJ-074

Maintenance Supervisor Crushed Under a Falling Gantry Crane

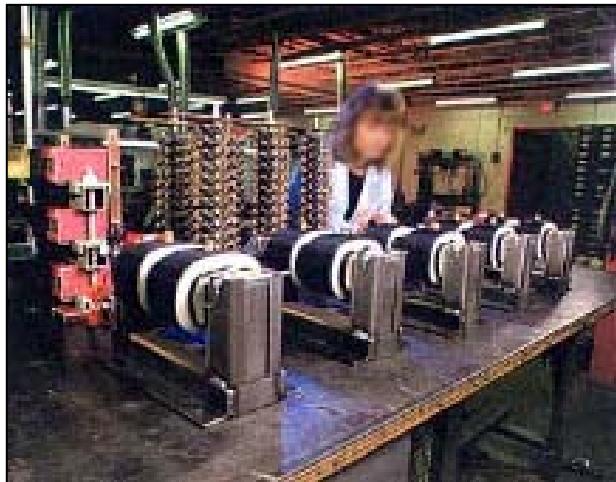
The victim's employer was a large electrical transformer manufacturing company. The company was housed in a 75,000 square-foot, single-story industrial building located in a suburban industrial area. The industrial transformers were individually manufactured to order, and ranged in size from "utility pole" transformers to much larger transformers that weighed thousands of pounds. These transformers were generally made by first making a steel "core" out of steel plates. Electrical wires were wrapped around the core to create the primary winding, which is the winding first energized by electricity. A secondary winding of wire was also wrapped around the steel core, next to the primary winding. The electromagnetic field created by the primary winding travels along the core and induces an electrical current in the secondary

winding. This induced voltage is determined by the ratio of the number of wire wraps of the two windings. Once the transformer is made, the core and windings may be sealed with a coating and baked in a curing oven. It is then mounted in a heavy metal case, which may be filled with oil to help cool the unit. The completed transformer is then tested before being shipped to the customer.

Photo 1
Transformer manufacturing
(Company website photo)

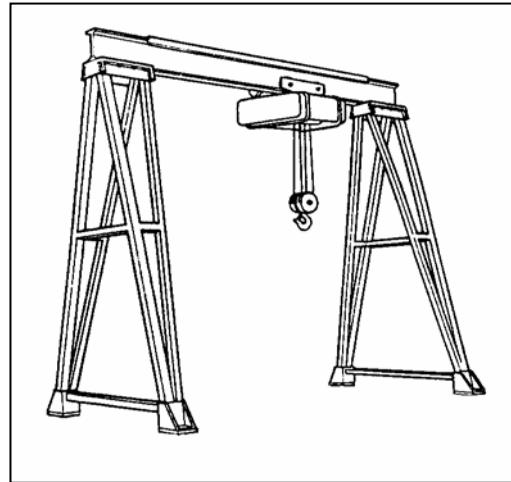
Illustration 1
Typical gantry crane
(Unidentified website graphic)

Much of the work at the plant was done manually, including the handling and stacking of hundreds of steel plates to make the cores. Due to the weight of the materials and products, the plant utilized a number of small gantry cranes to move these materials at the workstations. The gantry crane involved in the incident was made up of an electric hoist that moved along the length of a horizontal steel I-beam. Steel posts supported the ends of the I-beam, with each post terminating in an A-frame mounting that was secured to the concrete floor. The crane used an electric hoist with a 1,000-pound rating that was operated with a pendulum controller. The crane's dimensions were 10 feet high by 28 feet long, with a 62-inch base. The OSHA Compliance Officer calculated that the crane weighed 1,058 pounds, and the hoist weighed 150 pounds.

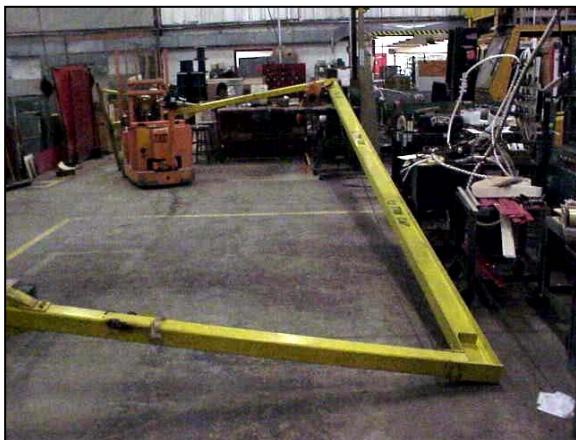
The incident occurred on Tuesday, August 24, 2004. After arriving for work in the morning, the victim met with his maintenance worker, who was to operate the forklift truck. A young laborer who had worked at the plant for six weeks was assigned to assist them. Under the victim's direction, they planned to move the crane with a forklift and a wheeled dolly. First, they secured the 150-pound hoist with beam clamps to prevent it from moving on the I-beam. After unbolting the crane from the floor, they used a small, walk-behind forklift to raise one end of the crane. This was done by positioning the forks between the crane's A-frame, using pieces of 4-by-4 inch wood blocks (cribbing) to fill the space between the forks and the frame. Once raised, the frame was lowered onto an industrial wheeled dolly, and the forklift was removed. The crew then took the forklift to the other end of the crane, planning to lift it in the same manner. As the crew was placing the cribbing into the crane's A-frame, the plant's safety manager stopped the operation to make a correction to the blocks in order to make them more stable. The crew immediately made the change, and lifted the end of the crane up about five inches with the forklift. At 10:20 a.m., the forklift (which was positioned in the inside of the crane under the horizontal beam) was moved forward, and the victim and laborer stood at either side of the A-frame supported by the dolly. As the forklift slowly started to make a turn to the left, the crane became unbalanced on the forks and started to tip to the right. The victim moved in and tried to grab the steel support at his end, apparently in an attempt to right the crane or to keep it from striking the laborer who was helping him. His effort failed, and the crane continued to topple over, striking the victim across his back. The other two workers were under the falling crane, which passed over their heads as it fell. The laborer received minor injuries when the crane caught and ripped his pants, the forklift operator was not injured.

The production supervisor and several other employees went to the victim, who was pinned in a squatting position under the frame of the crane. They manually lifted the crane off the victim, who was unconscious. They placed him on the floor as another employee came over to give first aid. The production supervisor gave an order to call 911, and to get the first aid kit, oxygen unit, and automatic external defibrillator (AED). CPR was started after they lost his pulse. EMS arrived and transported the victim to the local hospital where he was pronounced dead at 11:01 a.m.

Photo 2
Collapsed gantry crane
(Company photo)

Recommendation #1: Employers should service cranes and other equipment as per manufacturers' directions.

Discussion: In this case, it appears that a number of improvisations and shortcuts were used to move this crane. These include not disassembling the unit, not removing the hoist, and using the forklift and dolly to move the crane in one piece. NJ FACE recommends following the manufacturers instructions for safely servicing and moving the cranes. If the directions are not available or clear, the manufacturer should be called for advice.

Recommendation #2: Employees should be kept at a safe position and distance from hazardous operations.

Discussion: All three employees were working directly under the crane, exposing them all to a deadly hazard. All unnecessary employees should be kept at a safe distance from these types of hazardous operations.

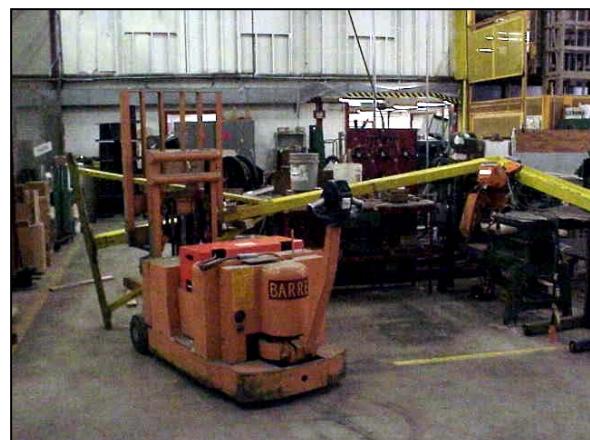
Photo 3
Forklift & A-frame
(Company photo)
