NJ FACE INVESTIGATION REPORT

FACE 05-NJ-007

Three Hispanic Acetylene Manufacturing Plant Workers Killed in Explosion

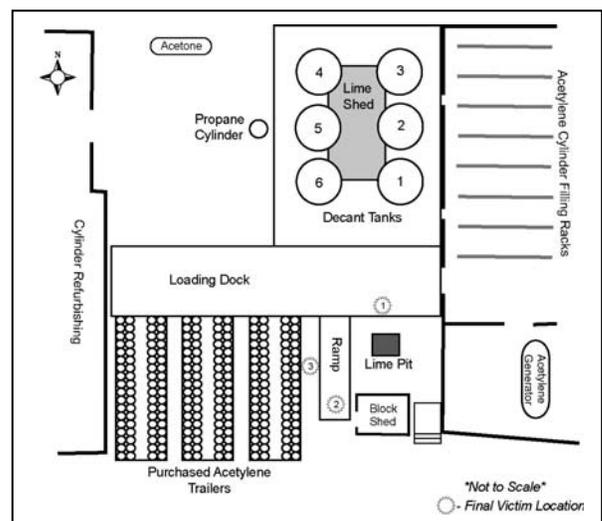
Graphic 1
Area of photograph detail
Overview of the incident site
Recreated & modified CSB graphic

The victims' employer was an acetylene generating and bottling plant located in a zoned urban industrial area. The facility consisted of four areas: the main plant building which held the acetylene generator, bottle filling room, business offices, and employee areas. To the west of the plant was the decant tank area, which consisted of six 10,000 gallon water tanks and a small wooden shed (lime shed) which housed the pump and associated piping for delivering decant water to the acetylene generator. The lime shed also contained a space heater to prevent the pipes and equipment from freezing. The loading dock area was located in front of the main plant and decant tanks. At the time of the incident, this area was occupied by three large truck trailers holding bulk bottles of acetylene the company had purchased for repacking. Finally, a cylinder refurbishing building was located to the west of the decant tanks and loading dock.

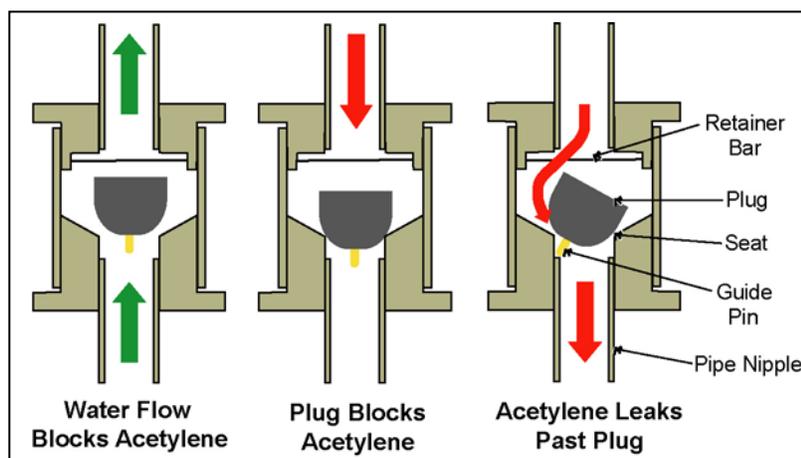
Graphic 2
Diagram of failed check valve

the lime shed remained drained and open. As the reaction proceeded, the heat generated caused the automatic water valve to open. The only device to prevent acetylene gas from traveling back through the water line was a “gumdrop” check valve. This valve contained a rubber-coated plug which closed off when gravity or a back flow of gas causes the plug to fall into the seat at the bottom of the valve, sealing the pipe off. (See Graphic 2). The extended stem of the valve stopper apparently caught on an interior edge of the pipe, causing it to remain open. The acetylene gas passed through this valve and past the other open valves, gauges, and other devices in the path to the lime shed. The gas exited through the open drain valve in the lime shed.

Left- Plug open with water flowing. Water blocks gas backflow.

Center- Plug properly seated, gas flow is blocked.

Right- Plug failure. Pin hangs on pipe nipple, gas flows past plug.

- Maintain check valves in good working order by establishing maintenance schedules and inspections.
- Provide a more reliable check valve for the back flow of acetylene at the generator. (The current design allows a 20 % failure rate).

Discussion: The water pipes at this plant were prone to freezing, requiring that they be routinely drained in very cold weather. There was only one automatic safety valve to prevent the acetylene from backflowing out of the generator, and this valve failed. NJ FACE recommends that the entire process be reviewed to ensure that all process pipes are properly placed and protected against the elements and other physical hazards, such as being struck by vehicles. Critical safety valves should be equipped with a redundant system to ensure against the failure of a single valve.

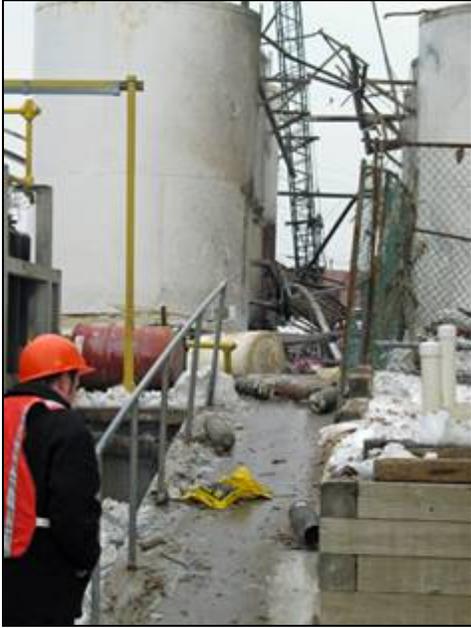
Photo 2
Incident site, facing north
NJFACE Photo

of the blast was so severe that it drove wood splinters into nearby cinderblock and cracked a cinderblock wall on a neighboring building 57 feet away. It was determined through the type and extent of the blast damage and other physical evidence that the explosion was caused by acetylene and not propane from the heater. The gas apparently ignited when it contacted the heating surface of the propane heater in the lime shed. Federal OSHA issued 43 citations to the company after the incident, including 39 serious and four unclassified violations. Many of the citations dealt with violations of the OSHA Process Safety Standard, 29 CFR 1910.119.
