# NJ FACE INVESTIGATION REPORT

FACE 05-NJ-090

## **School Crossing Guard Struck and Killed by a Sport Utility Vehicle**

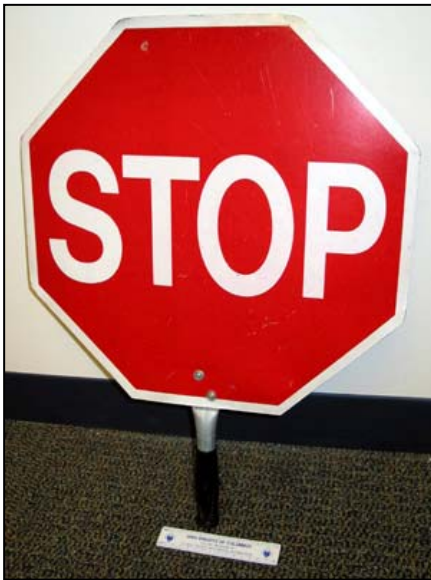
**Photo 1**  
**Stop-sign paddle used  
by the victim**

**Discussion:** This incident occurred during a dark, rainy morning where the visibility on the road was limited. The victim was wearing a bright orange raincoat which did not have any reflective material on it, nor was her hand-held stop sign reflective, which would make it difficult for a motorist to see her. To prevent future incidents, NJ FACE recommends that police departments provide retroreflective safety gear for the crossing guards, and ensure that it is worn

(retroreflective material sends light directly back to where it came from, regardless of the angle of the light source). This should include all outerwear (raincoats, jackets, and vests) and hand-held signs.

**Discussion:** The equipment provided to and worn by the crossing guards did not meet the requirements outlined in Part 7 of the 2003 Manual on Uniform Traffic Control Devices (MUTCD), *Traffic Controls for School Areas*. Published by the Federal Highway Administration, the MUTCD is the national standard on traffic control on public roads. The standard requires that adult crossing guards and student patrols wear retroreflective clothing that conforms to the American National Standards Institute (ANSI) 107-1999 Class 2 for adult crossing guards, and Class 1 for student patrols. The standard also requires retroreflective or illuminated stop-sign paddles.

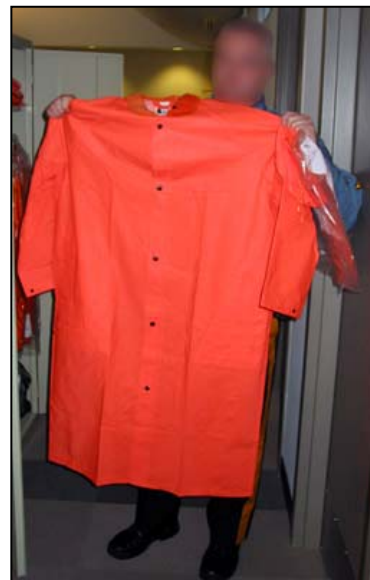
**Photo 2**  
**Raincoat identical to the  
one worn by the victim**

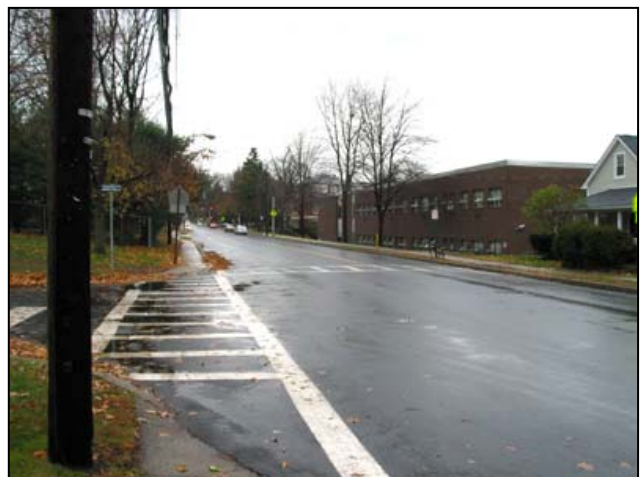
**Photo 4**  
**Photo of intersection facing north**

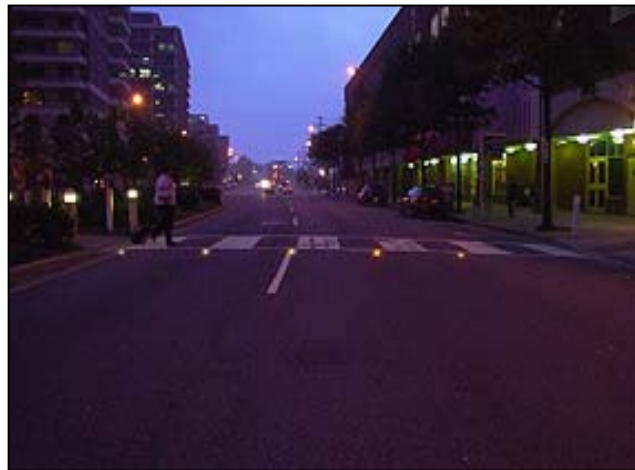
**Photo 5**  
**Example of in-road lighting system**  
*USDOT Website Photo*

**Discussion:** This incident occurred early in the morning during poor weather, limiting the visibility of the drivers. Although the MUTDC standards are comprehensive in setting up school crossings, it may be helpful to consider additional measures to increase visibility and/or slow down traffic approaching crossing guard posts. A recently developed device is an in-road lighting system, which uses permanent in-

road warning lights along the borders of the crosswalk. The flashing lights could be used whenever the crossing guard is on duty, or activated by the crossing guard during each individual crossing. Traffic speed may also be limited by installing speed bumps or humps near the posts. This may be especially useful in residential streets where slower speed limits are posted. The use of radar speed-indicating boards may also help drivers to slow down by alerting them of
