# NJ FACE INVESTIGATION REPORT

FACE 08-NJ-003

## **A 60-Year-Old Hispanic Maintenance Worker Killed when a Pressure Vessel Exploded; Eight Others Injured**

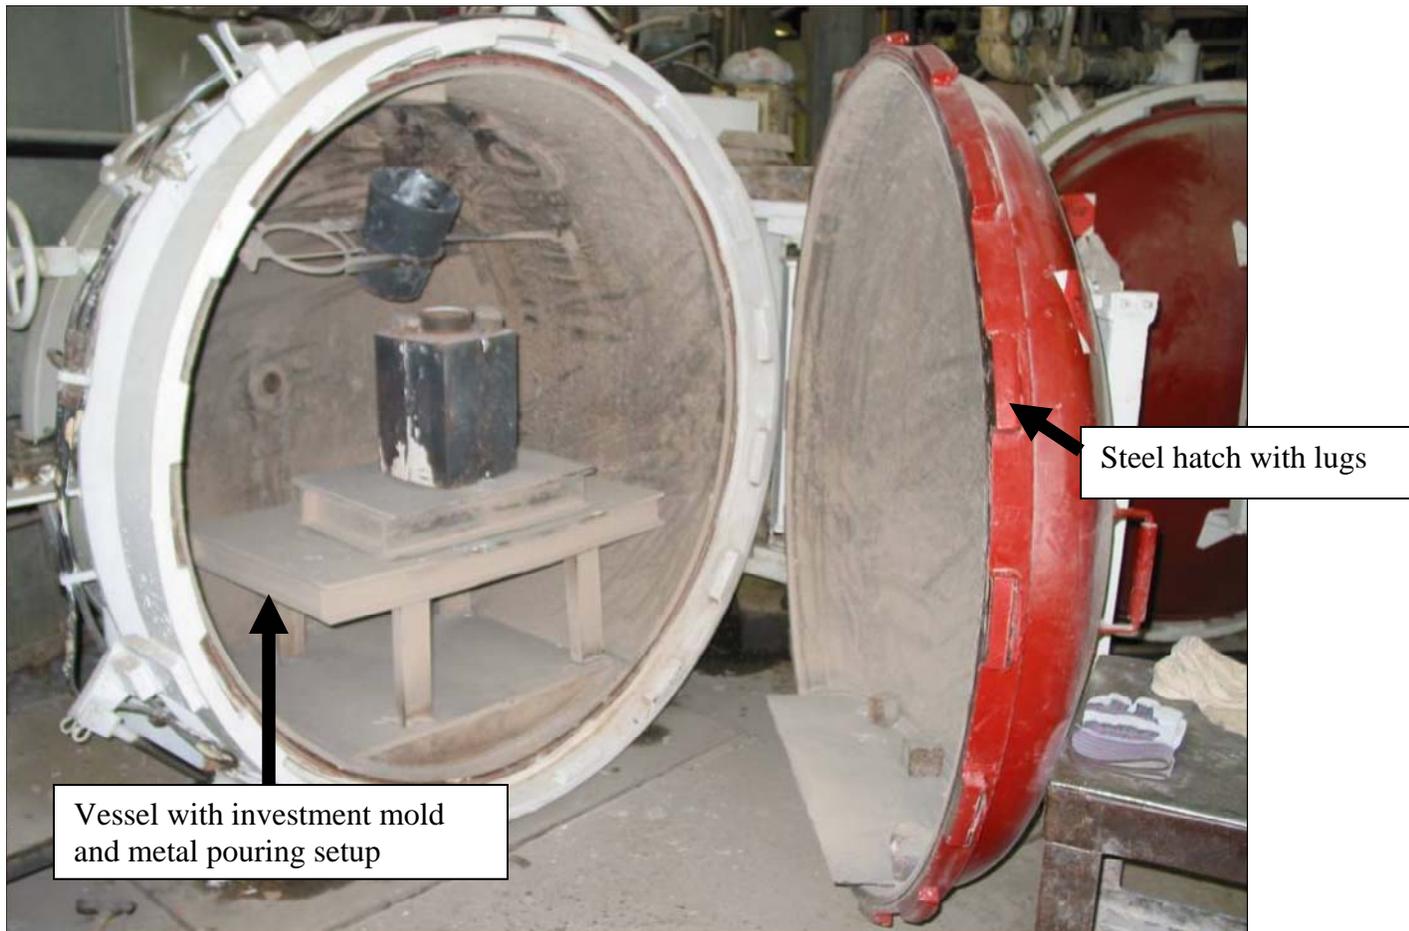
Figure 1: Vessel # 1, which is newer but almost identical to Vessel #3

The incident occurred at a small-scale foundry in an urban area of New Jersey. The vessel that the victim was working with at the time of his death was one of three similar units with a hinged access hatch in the front with metal lugs (teeth) and a large O-ring (see Figure 1). The two similar, newer units were adjacent to the vessel that exploded, and were in operation at the time of the incident.

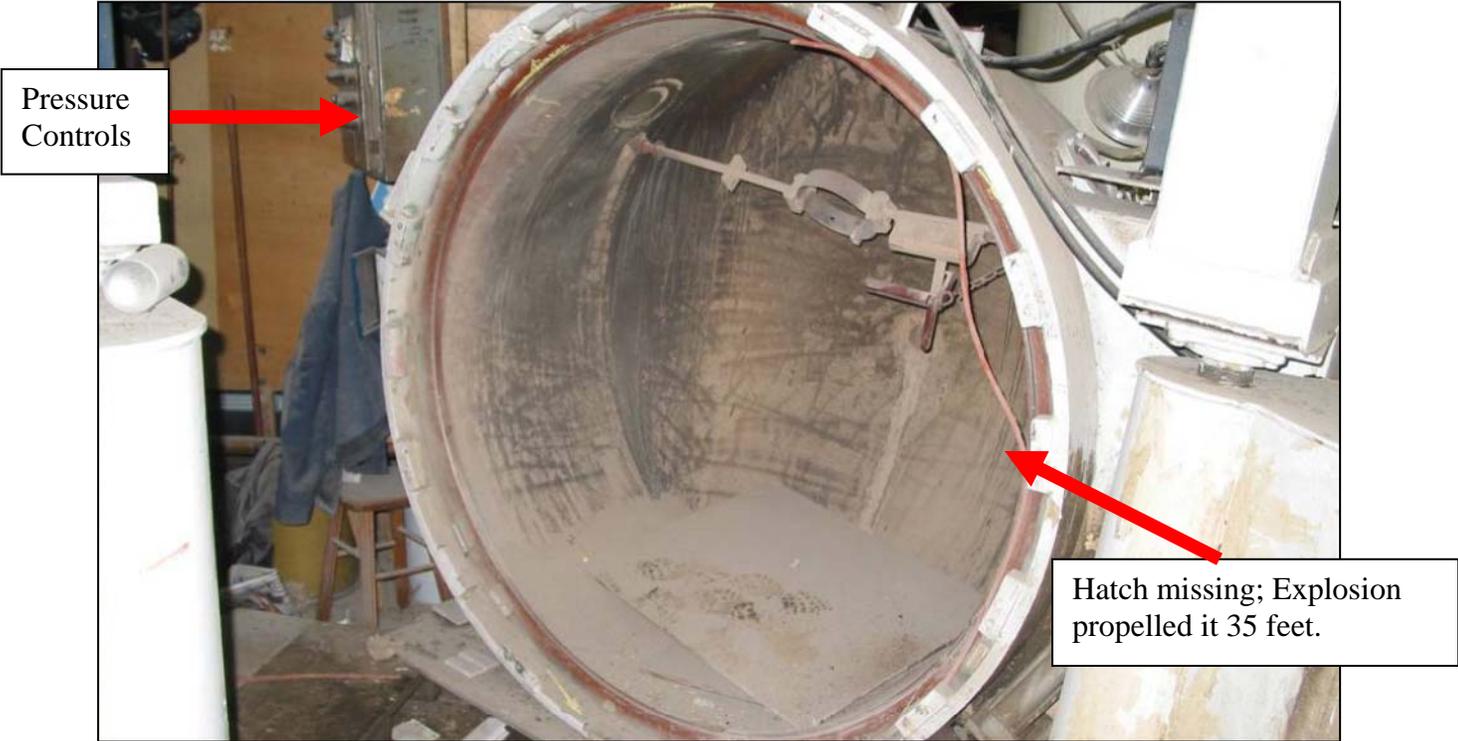
Figure 2: Vessel #3

On the day of the incident, the vessel that exploded (vessel #3) was offline. The company had been having trouble with leaks from the O-ring gasket that creates the seal around the circumference of the hatch. The metal teeth on the hatch that engage with lugs on the vessel also had a history of cracks and breaks, and many had to be welded or replaced. In addition, the pressure relief valve on this unit was clogged and not working properly. In an effort to put the vessel back online, a new O-ring gasket was installed and tested. Two workers were involved in this process; one to work the pressure controls (on the side of the vessel, see Figure 2), and a second worker (the decedent) to stand in front of the unit to listen for leaks. The first worker began increasing the pressure until approximately 80 pounds per square inch (psi) when the decedent heard a "hiss," indicating a leak. Their initial reaction was to shut down the machine, but a process

was attempted that had been successful in the past, which was to increase the pressure further, and force the gasket into place. Worker #1 then increased the pressure to approximately 112 psi, and the vessel exploded. The decedent, who was standing in front of the vessel, was struck by the hatch, thrown approximately 38 feet, and killed instantly. The hatch was propelled 35 feet. Worker #1 sustained injuries, and eight other workers in the immediate vicinity sustained injuries from shrapnel and/or the force of the explosion. Although the maximum allowable pressure of the unit was rated at 100 psi, the American Society of Mechanical Engineers (ASME), Section VII UG-125, permits this to be exceeded by three percent. At the time of the explosion, the maximum rated pressure was exceeded by eight percent.

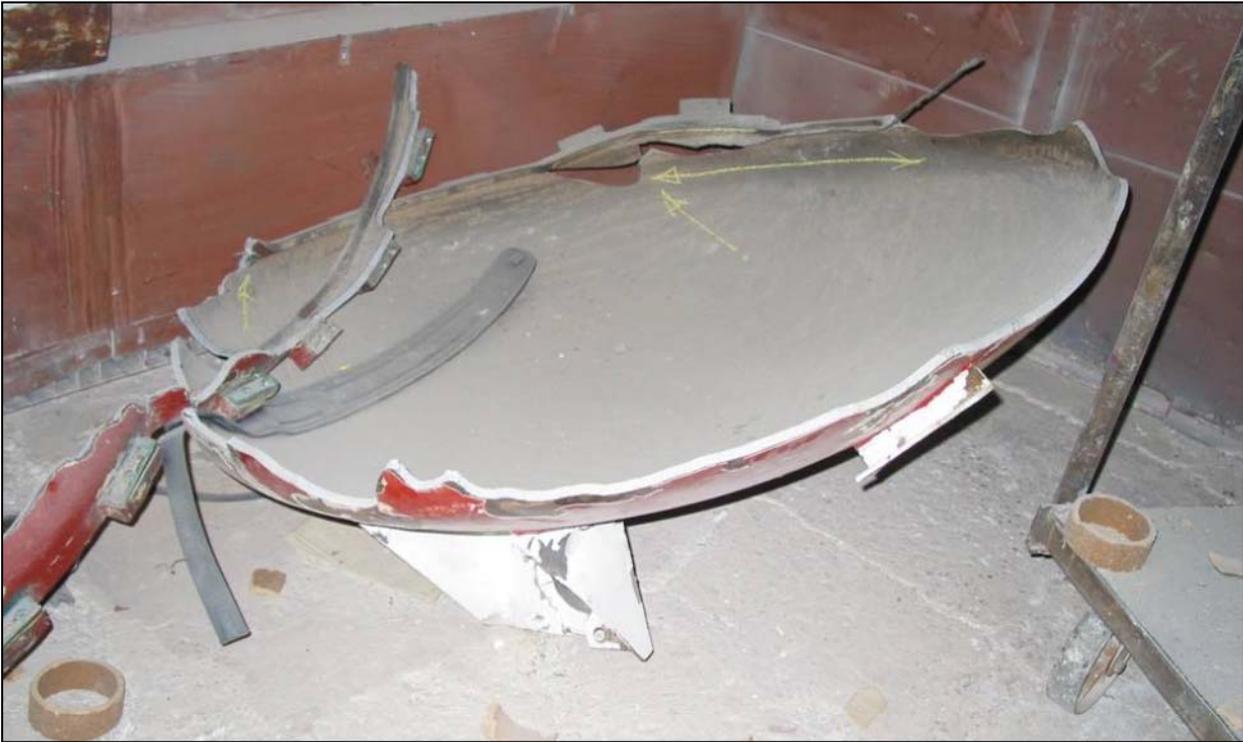
Figure 3. Broken Hatch

**Discussion:** Several factors likely contributed to the explosion of the pressure vessel. First, the vessel ruptured due to overpressurization. In an attempt to correct a leak, the workers pressurized the vessel to 112 psi, which is greater than 3% of the maximum allowable working pressure of the unit (100 psi). Second, it was discovered that the pressure relief valves were clogged with aluminum production material and were inoperative. According to the American petroleum Institute (API) 510, 8<sup>th</sup> Edition, Addendum #4, August 2003, Sections 6 and 7, all pressure vessels and pressure-relieving devices shall be inspected at specific intervals to ensure vessel integrity. Third, repairs and welds were performed on the vessel by a worker who was not certified by the American Society of Mechanical Engineers (ASME), or the National Board.
