NJ FACE INVESTIGATION REPORT

FACE 11-NJ-020

52-Year-Old Public Employee Dies After Being Crushed between Dumpster and Rails of Roll-Off Truck

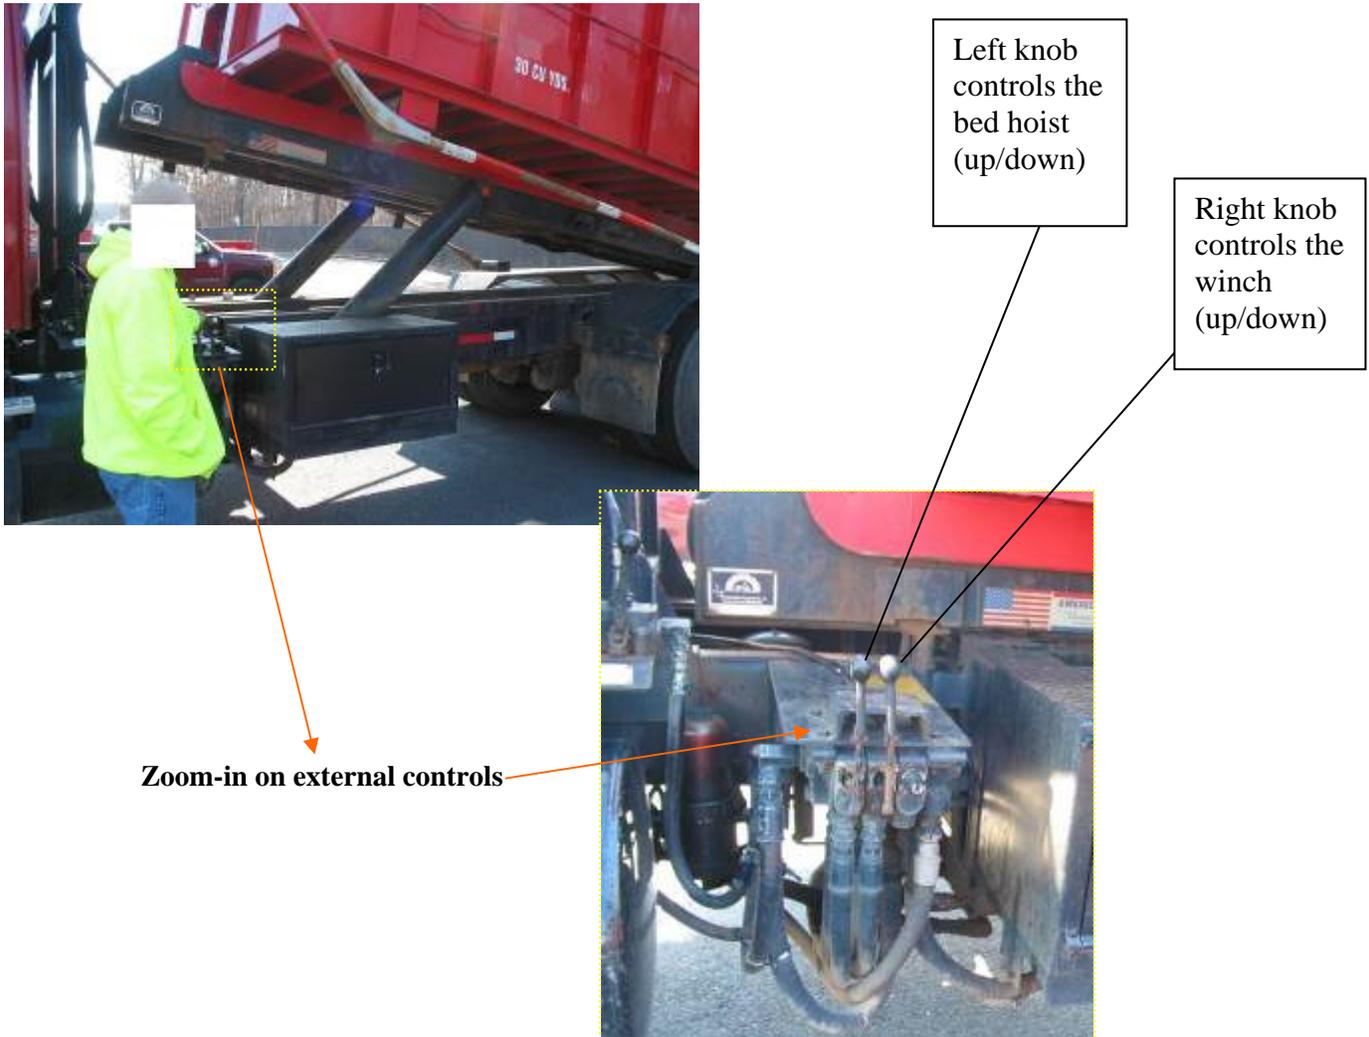
There are two locations for the controls that raise and lower the truck bed and operate the winch. The controls that are most commonly utilized are located in the truck cab. There are also auxiliary controls located outside of the cab, just beside the fuel tank (see Figure 1). Both controls work in a similar manner. The controls consist of two levers—the right lever operates the winch (the cable line that pulls the roll-off dumpster up the rails or allows the roll-off dumpster to go down the rails). The left lever operates the hoist that raises and lowers the bed rails that the roll-off dumpster sits upon.

FIGURE 1: Worker demonstrating the use of the external roll off controls, including the movement of the winch and the bed.

Recommendation #1: Roll-off truck operators should only use external hydraulic controls when absolutely necessary and if so, with extra caution. If an operator is not intending on utilizing external controls and is exiting the cab, the Power Take-Off (PTO) should be disengaged.

According to the employer, the external controls to raise and lower the roll-off should only be used if there are significant visibility issues or alignment difficulties with the truck rails as the roll-off dumpster is pulled back onto the truck. NJ FACE recommends that the external hydraulic controls only be used if absolutely necessary, used with extreme caution (perhaps with the use of an additional employee as a spotter). When not in use, the PTO should be disengaged. In addition, the operator should assure that all persons in the area be aware that the dumpster is being raised or lowered. Another related recommendation is to equip the roll-off truck with an external video camera and monitor in the cab to monitor worker activity in the area and the position of the roll-off dumpster. This would allow the worker to remain in the cab at all times while operating the hydraulic controls for the roll-off.

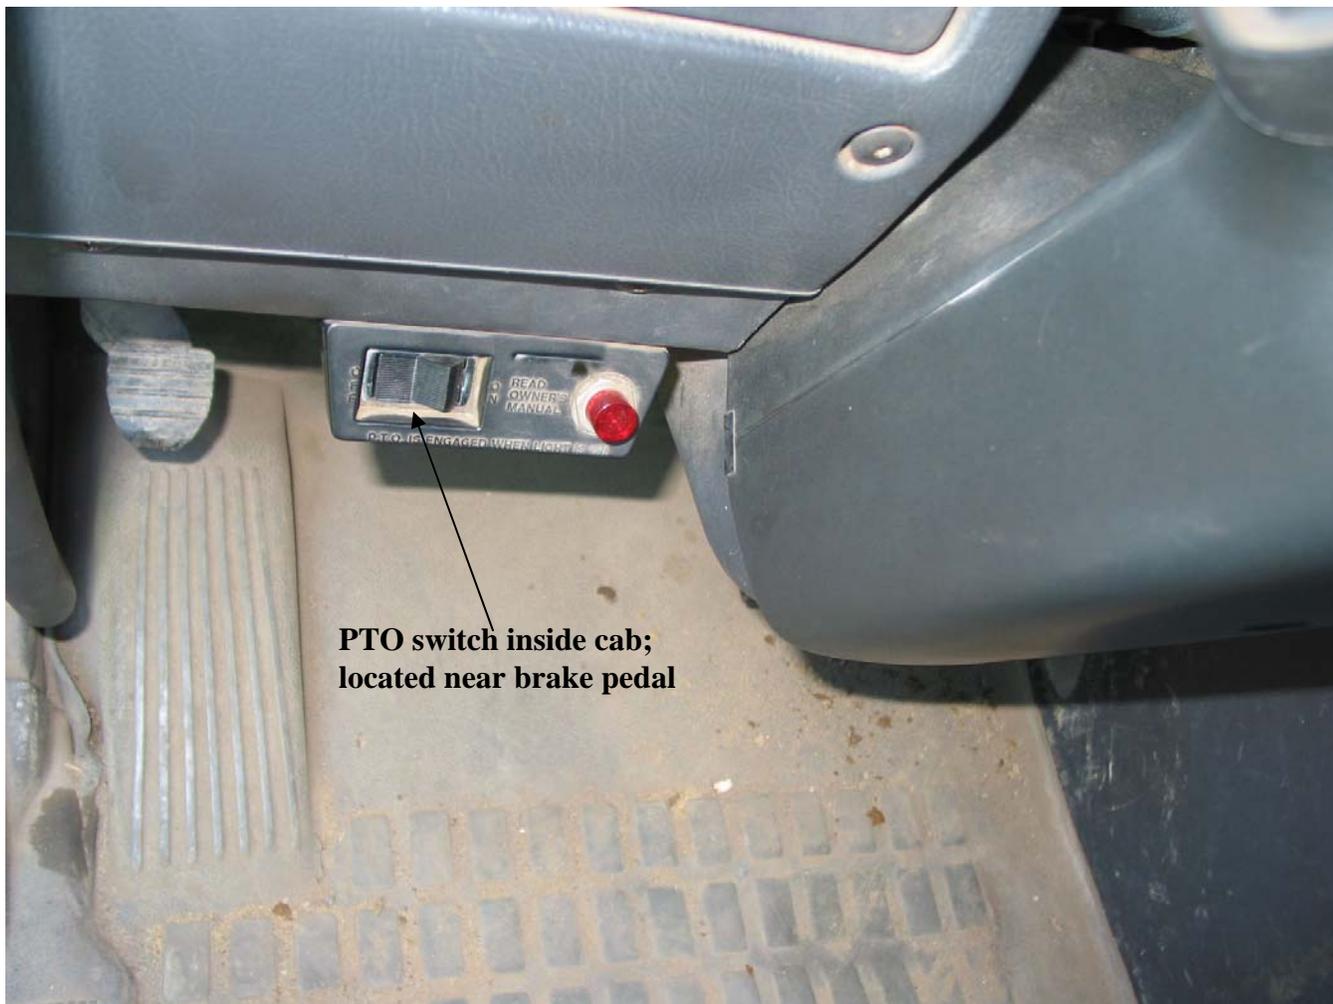
In order for either of the control systems to work, the Power Take-Off (or PTO) switch must be in the “on” position (See Figure 2.). The PTO switch controls the hydraulic mechanism of the truck. When the PTO is “on” the hydraulics can operate. Conversely, when the PTO is “off” the operator can neither raise/lower the bed, nor power the winch.

FIGURE 2: Power Takeoff Switch (PTO) located inside the cab.

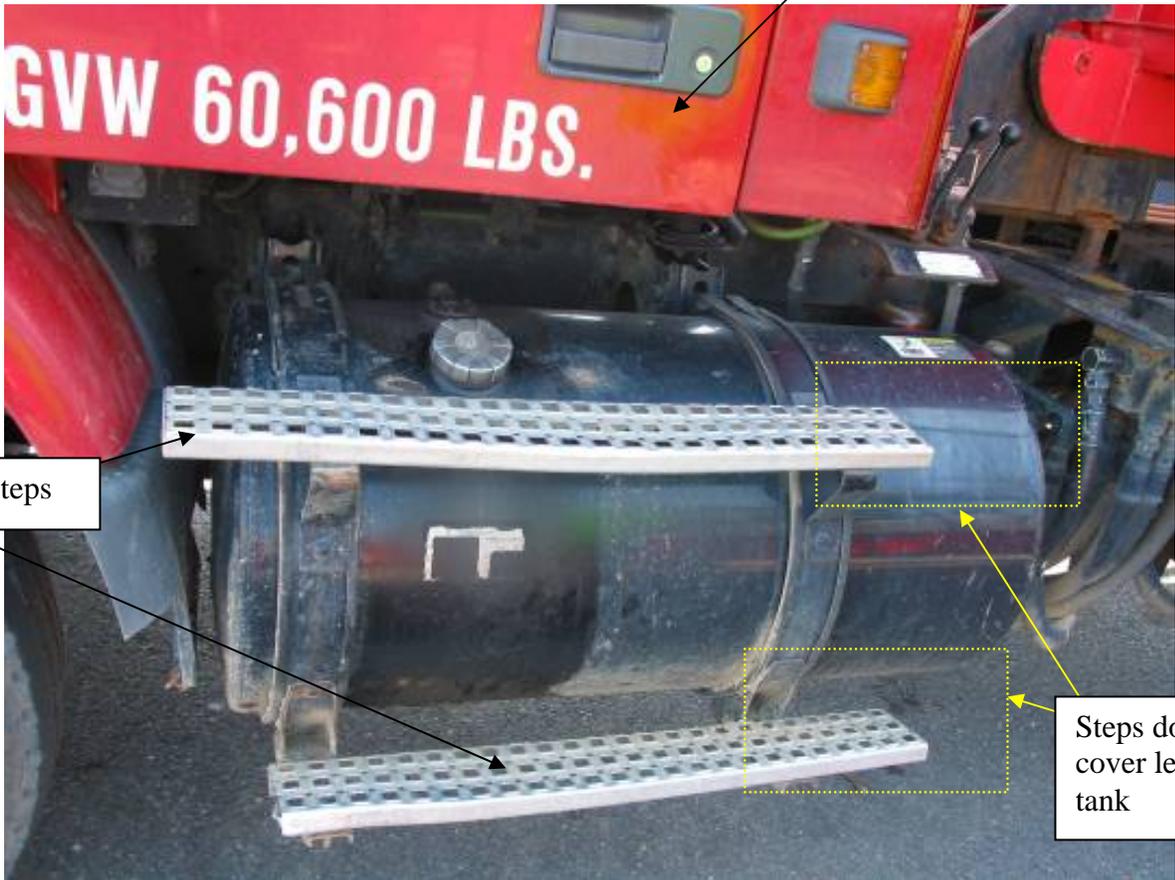
3a

FIGURE 3a-b. 3a. Door and step to truck cab; 3b. Close up of gas tank.

Cab door

Cab steps

Steps do not fully cover length of fuel tank

The heavy cab door had a broken hinge, such that it would swing without stopping in either direction and the interior door handle was broken. NJ FACE recommends that all parts of the truck should comply with 49 CFR 393.203, PART 393—PARTS AND ACCESSORIES NECESSARY FOR SAFE OPERATION *Subpart J—Frames, Cab and Body Components, Wheels, Steering, and Suspension Systems* § 393.203; *Cab and body components*. It was also noted that there was a mark on the gas tank from a foot slip. In addition, the steps that lead up to the cab (see Figure 3) did not cover the length of the gasoline tank. NJ FACE recommends that the grated platform steps extend over the tank. According to another operator, the victim also occasionally used another truck that had a step that extended the extent of the gasoline tank.

Recommendation #2: All parts and equipment on the roll-off truck should meet appropriate specifications as specified in 49CFR 393.203.

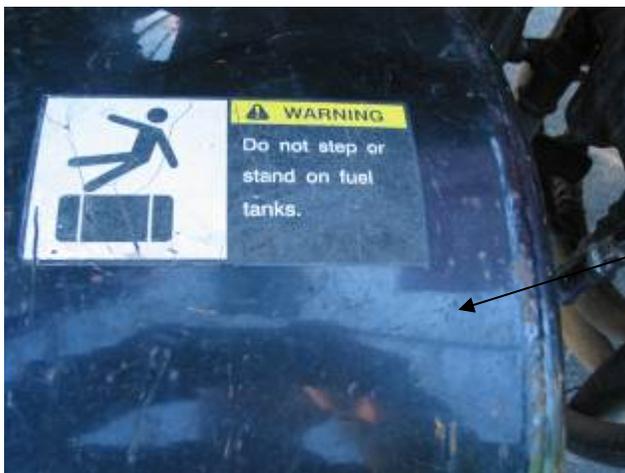
3b

Close up view of gas tank, with warning label

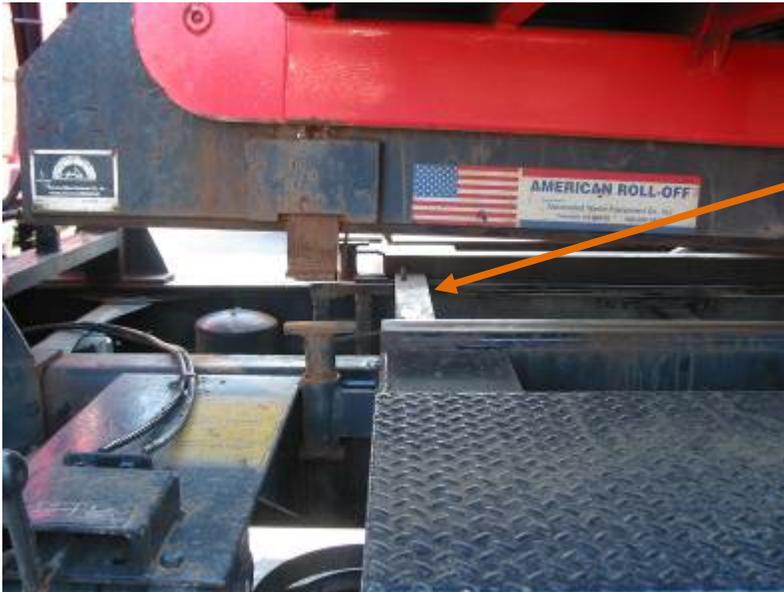
On the day of the incident, the victim was working alone and had unloaded a 25 cubic yard roll-off dumpster that was full of leaves and debris. The victim was found crushed between the bottom of the roll-off dumpster and the bed of the truck (see Figure 3.) A co-worker found him sometime later and notified the employer who called 9-1-1. The victim was pronounced dead on the scene.

Note that there were no witnesses to the incident, and how the victim became entrapped or why he was outside the cab with the PTO switch on cannot be determined. When the victim was found, he was lying on his stomach (prone), bent at the waist with his legs extended straight out about one foot off the ground. His head was pinned between the roll-off dumpster and the rails of the truck. The container was not in a fully down position. According to other operators, there was absolutely no reason for any worker to be between the bed and the container, at any time.

FIGURE 4. The location where the victim was found on the day of the incident.

Victim was found between the rails and the dumpster
