NJ FACE INVESTIGATION REPORT

FACE 12-NJ-021

Laborer Killed after being Struck by a Slab of Concrete that had been Lifted

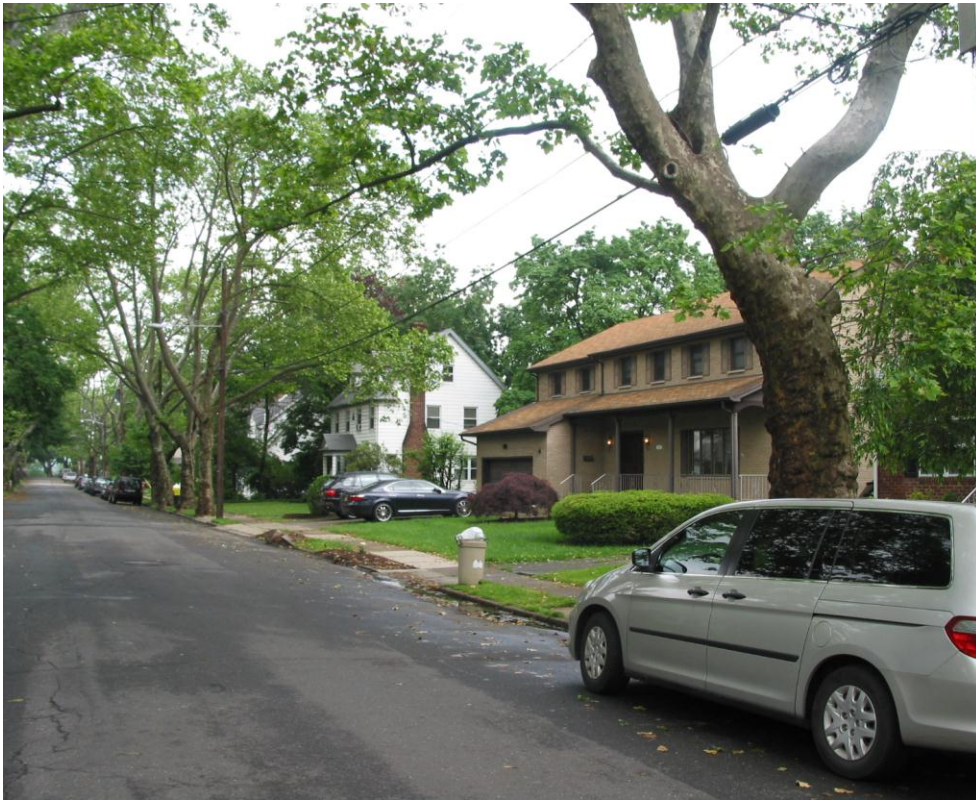
The incident occurred on a clear, calm spring day (approximately 66°F at the time of the incident, wind speed up to about seven mph), with no significant precipitation recorded. The incident site was a sidewalk in a heavily treed residential neighborhood in northern NJ (Figure 1). The area had experienced a snowstorm approximately six months earlier which caused trees to be uprooted, damaging sidewalks. A homeowner hired the small landscaping and construction company (less than five employees), that the victim worked for, to fix a sidewalk that had sustained damage.

FIGURE 1. Incident site, a heavily treed residential neighborhood in NJ.

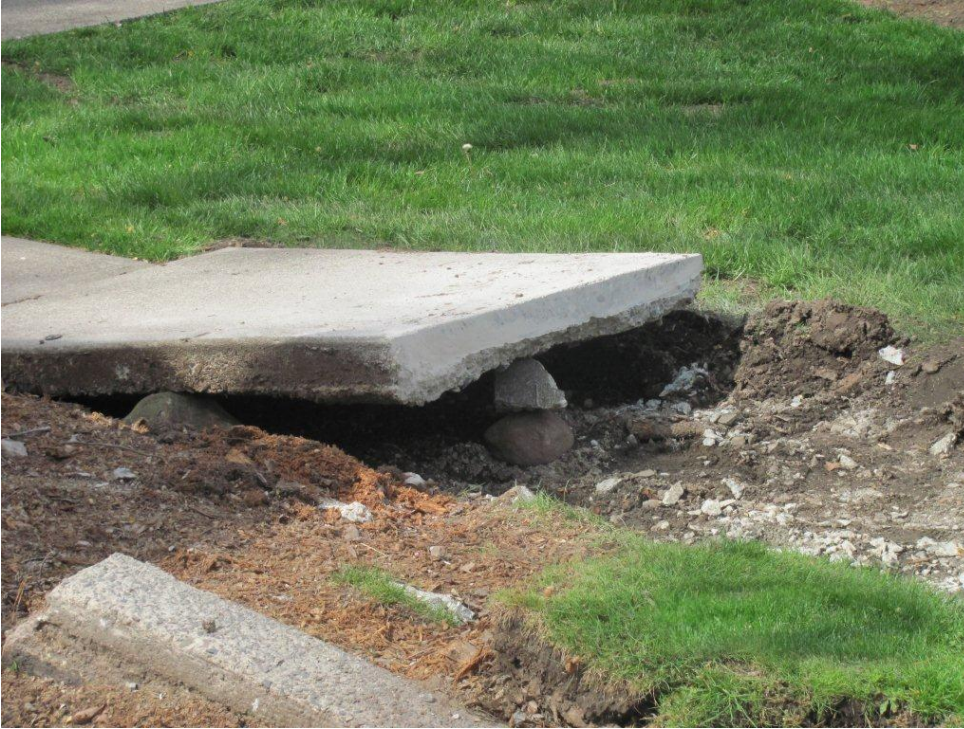
On the day of the incident, the victim and three co-workers arrived at the work site in the morning. The assigned task was to lift the sidewalk slabs and re-grade the soil underneath (rather than breaking up and replacing the concrete). In order to lift a slab, the four-worker crew would pry it up slightly (using a pry bar) and place large stones underneath to hold it in place (Figure 2). The crew would then connect a 40-foot-long chain to the bucket hook of a skid-steer loader and wrap the other end around the slab, connecting it to itself with a 2" pelican hook (Figures 3 and 4). The chained slab would then be lifted via the skid-steer loader and moved away, allowing the ground underneath the slab to be properly graded.

FIGURE 2: Sidewalk slab propped-up by stones.

If the method utilized during this incident continues to be used, NJ FACE makes the following additional recommendations: 1) use wood or small cement blocks in good condition to prop-up the slab; 2) ensure that the chain and hooks can handle the approximate load of the slab; 3) employ tag lines when moving the slab to keep workers clear of the hazard; 4) take extra care when using a skid-steer loader to lift and move heavy objects (according to onsite interviews, the skid-steer loader made “jerky” movements and it was difficult to move the slab smoothly).

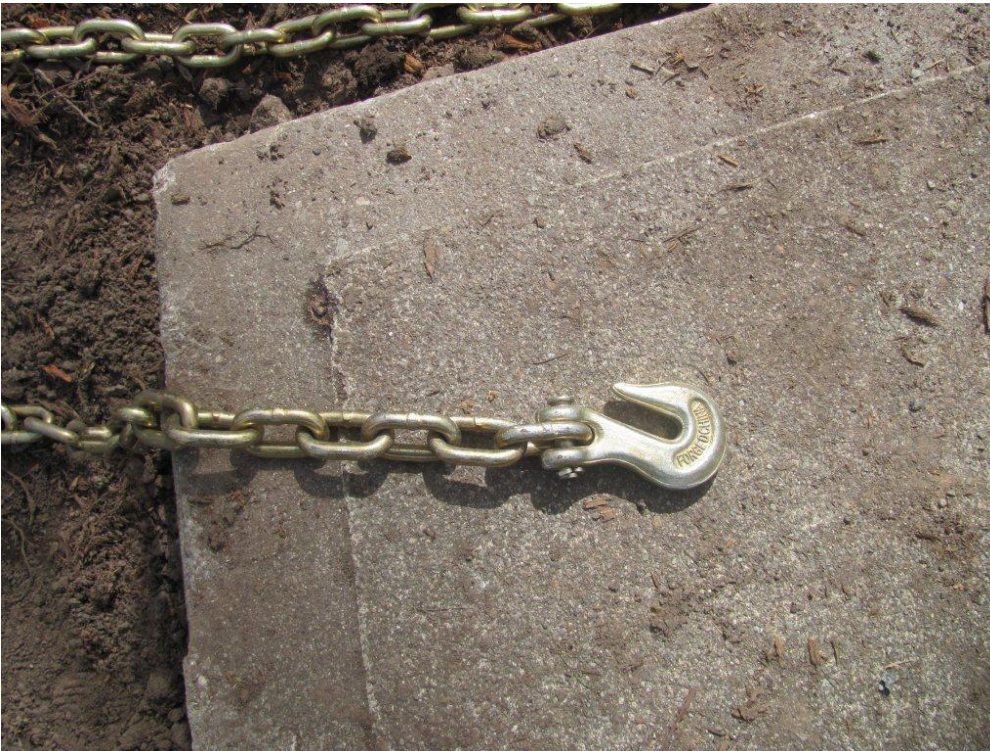
The slab that was lifted at the time of the incident was approximately 58" long x 48" wide x 5" deep, and weighed approximately 1200 lbs (assuming 150 lbs/cubic foot¹). According to the crew, the slab was unstable, so three workers (including the victim) helped walk the slab away by holding it at three different places, guiding it, and keeping it balanced. The slab was then placed on the ground and the

FIGURE 3. Chain with two-inch pelican hook used to lift the slab.

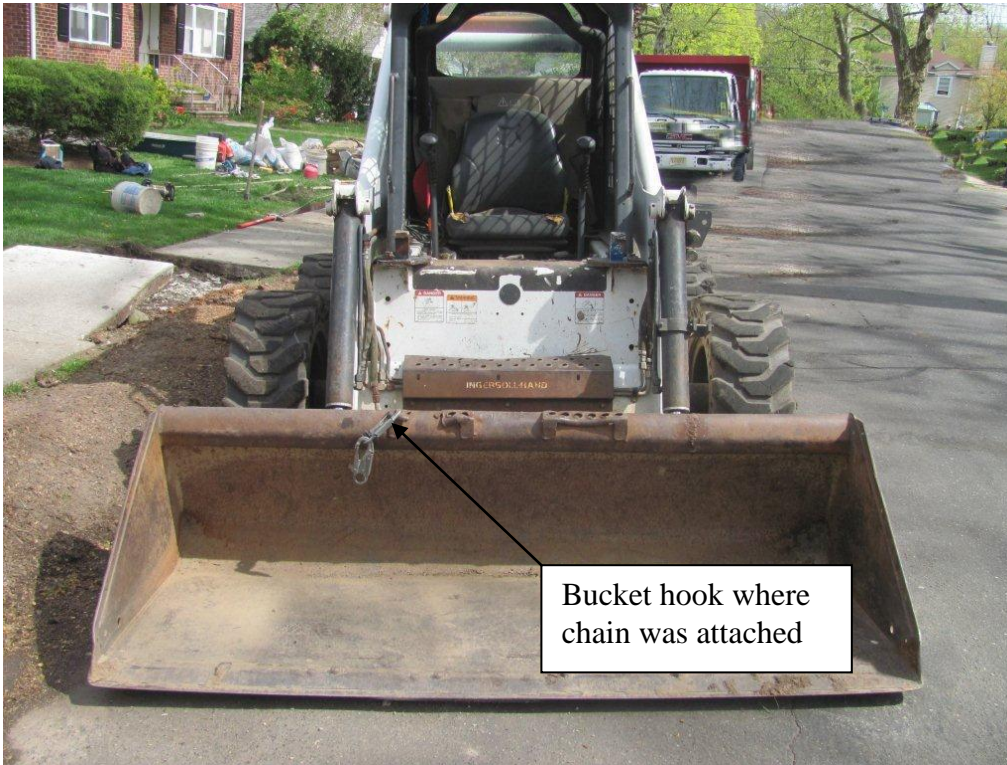
crew began to re-grade the soil. When finished, the slab was being walked back into place by the victim and lowered. During this time, for an unknown reason the victim knelt down, perhaps to fix part of the re-grade, and asked the skid-steer operator to raise the slab back up. As the slab was lifted, it swung and hit him in the head. The victim sustained blunt force trauma injuries, including a fractured skull. The victim died minutes after the injury. A crewman called 9-1-1 and the police arrived on the scene immediately.

FIGURE 4. Skid-steer loader; note bucket hook where chain was connected.

Many safer alternatives exist for re-grading the ground beneath concrete slabs. The important commonality between them is that the slab is never suspended off the ground. One alternative is to raise the concrete by cutting/jacking and filling (also known as slabjacking or mudjacking). This process is accomplished by drilling small holes into the concrete (or lifting the concrete using specialized jacks or pry bars) then pressure injecting (or hand-filling) material underneath the slab to fill the gaps, leveling the concrete.²⁻³ Another method is to pry the concrete up and place metal rollers between wood boards underneath; the slab can then carefully rolled away, the soil re-graded, and the slab rolled back into place.⁴
