NJ FACE INVESTIGATION REPORT

FACE 13-NJ-059

May 21, 2015

Batch Maker Dies after Toxic Exposure to Toluene Vapor

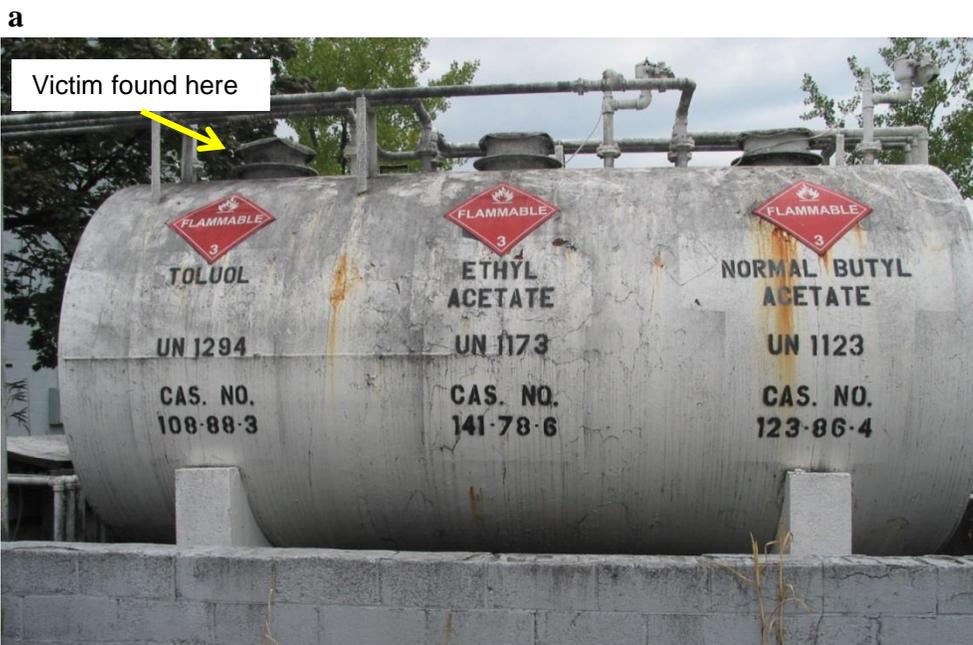
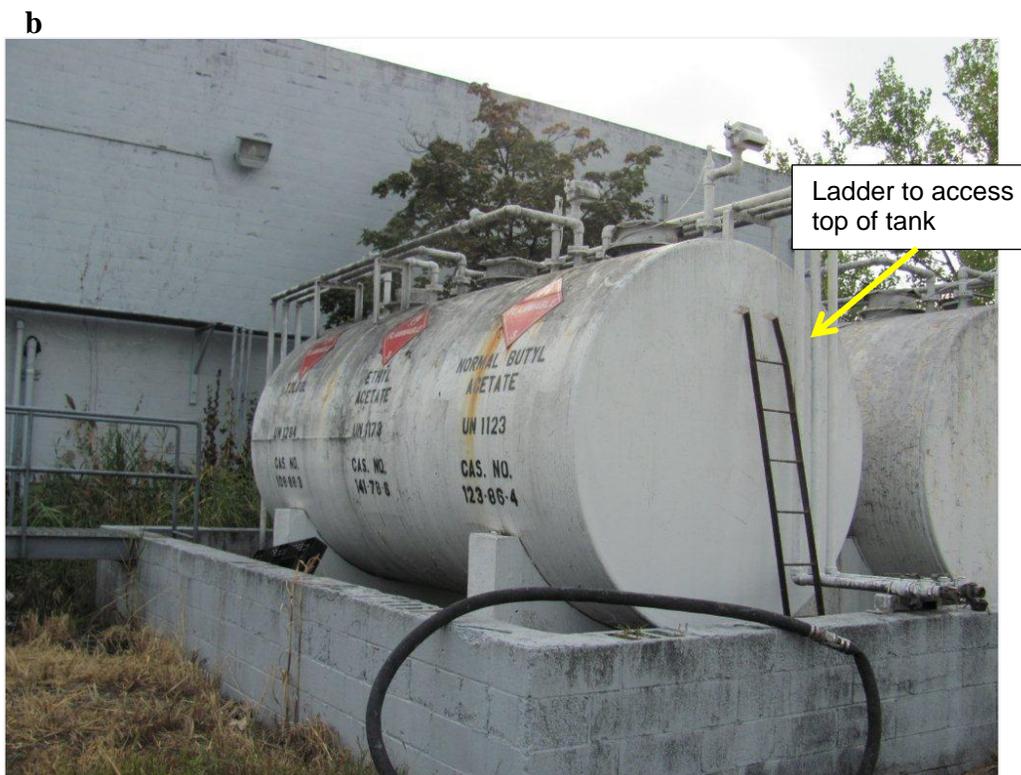
The incident occurred on an extremely hot summer day (approximately 95° F at the time of the incident, wind speed up to about 12 mph), with no significant precipitation recorded. The incident site was located in the backyard of a manufacturing plant in northern NJ. The company manufactures varnishes, lacquers, enamels and other coatings. A total of 12 nonunion workers are employed on site. The incident occurred on the top of a 37-year-old, 6,000-gallon above-ground storage tank, separated into three 2,000 gallon sections used for storage of toluene, ethyl acetate, and butyl acetate (Figure 1). The cylindrical tank was 16 feet (192 inches) in length by eight feet (96 inches) in depth. The tank access was an 18-inch diameter access port, 12 inches in height (Figure 2). The total distance from the tip of the port to the bottom of the tank was nine feet (108 inches).

FIGURE 1: Incident site, above-ground storage tank with three 2,000-gallon sections (a. side view; b. front view).

NJ FACE recommends developing a method of determining the volume of the liquid in the tank without entry. This can be accomplished in many ways, including retrofitting the tank with a small, sealed window for external view, fixing or replacing the volume gauges, or the creation of a permanent system that would indicate the remaining volume without the need for manual gauging. If an alternative method cannot be developed, the employer must comply with OSHA's confined space entry standard (CFR 29, 1910.146).

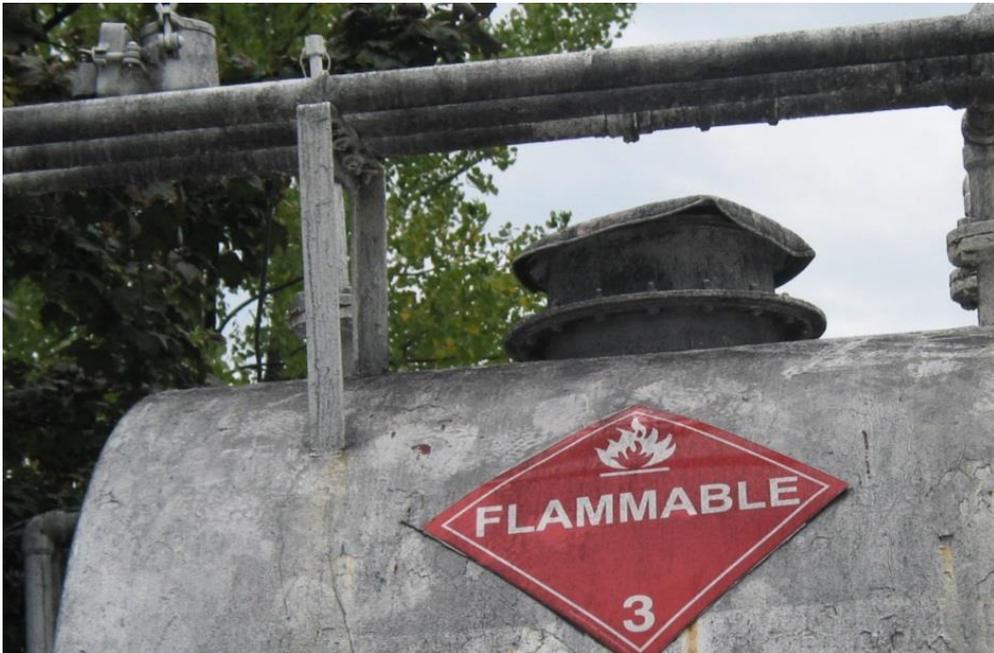
FIGURE 2. View of access port on top of tank.

Discussion: According to 1910.146(b), entry into a confined space is *considered to have occurred as soon as any part of the entrant's body breaks the plane of an opening into the space.*¹ As such, the job task of opening the hatch and inserting the stick into the tank is considered a confined space entry. The victim and the coworker would open the access port and lower the stick down to the bottom of the tank. Since the stick was eighty-four inches long, and the distance from the top of the hatch to the bottom of the tank was nine feet, the workers had to reach two feet into the tank in order to obtain an accurate volume measurement.

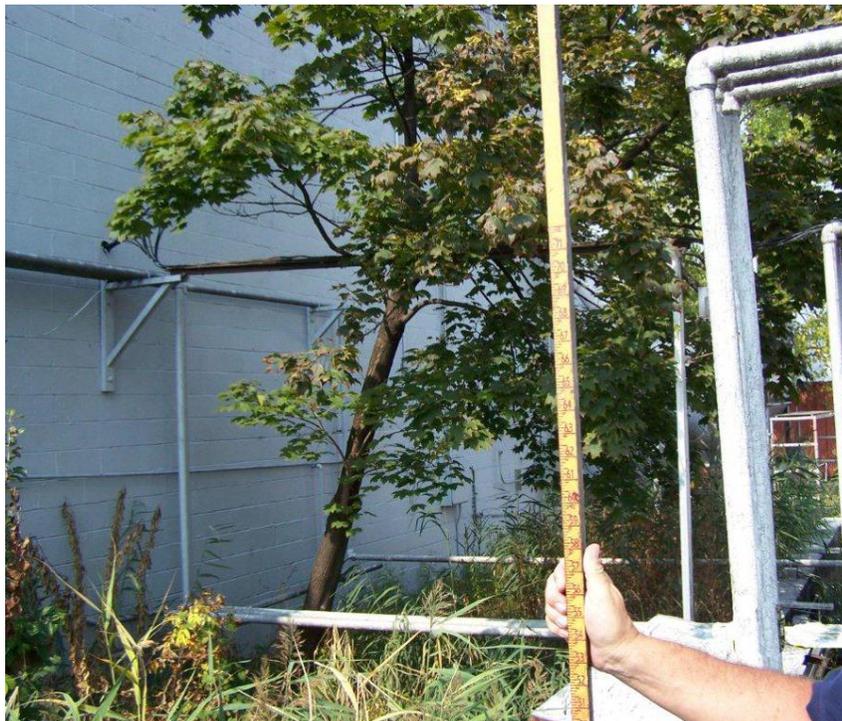
Two batch makers were trained by the plant manager to measure the volume of liquid in each section by using an 84-inch-tall wooden measuring stick (Figure 3). Measurements were taken either daily or every other day in order to determine if additional solvent needed to be ordered. The tank-level gauges were not functioning, and volume measurements had been conducted manually for approximately the past 30 years.

FIGURE 3. Eighty-four-inch-long wooden measuring stick used to manually gauge the volume of the remaining liquid in the tank.
