NJ FOIS INVESTIGATION REPORT

FOIS 16-NJ-07

Crossing Guard Killed in Crosswalk After Being Struck by Vehicle

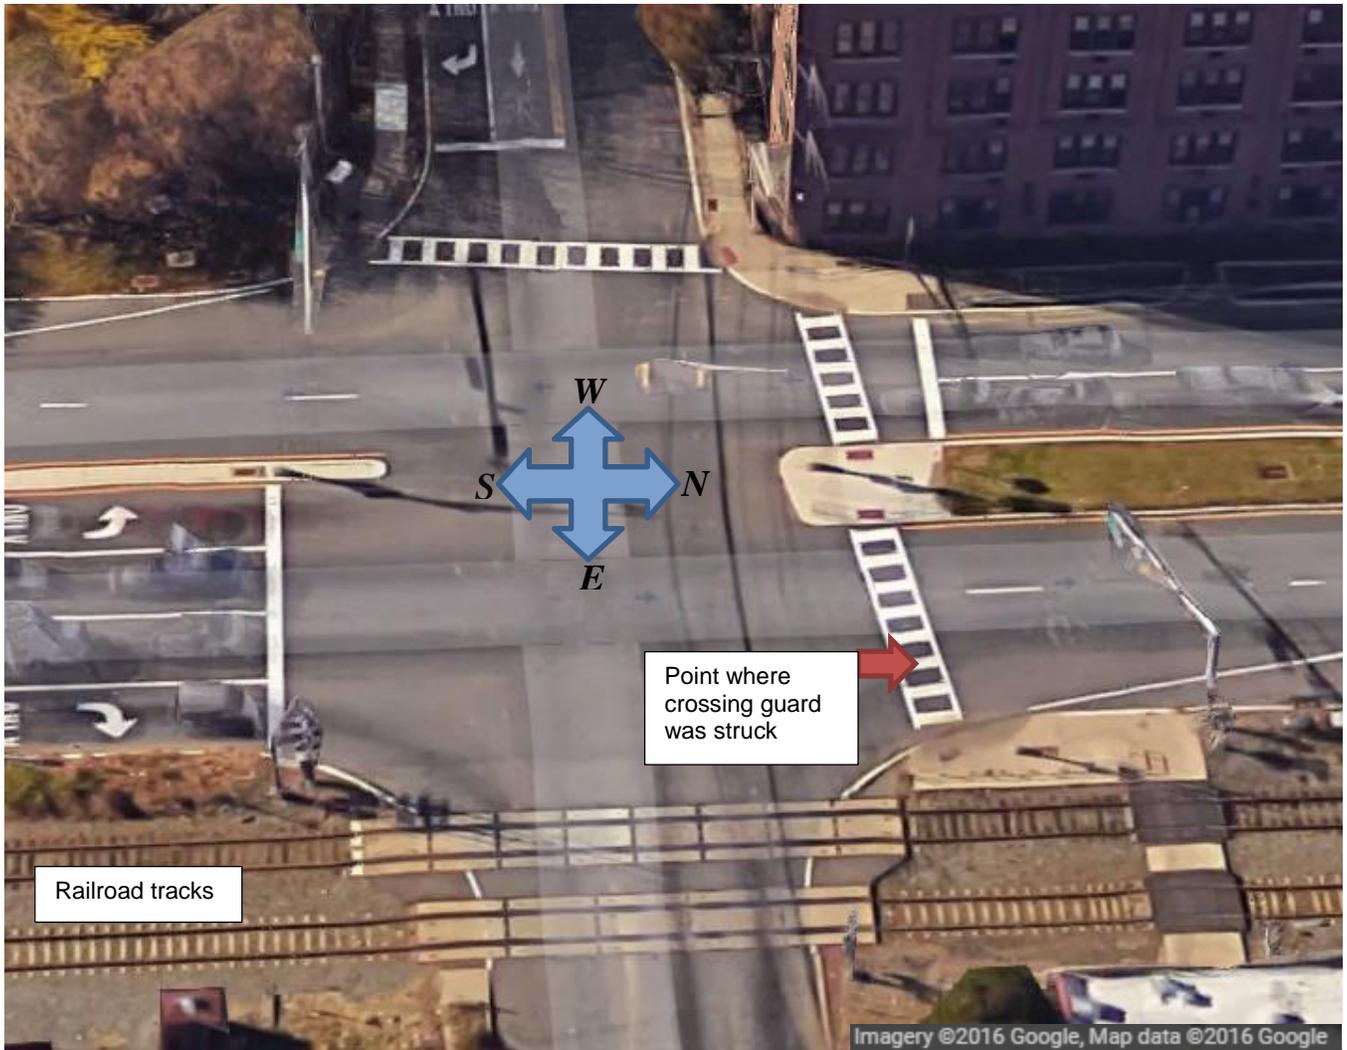
FIGURE 1: Incident scene; four-way, intersection in central NJ.

The incident occurred at approximately 3:20pm on a clear, dry spring day (79° F at the time of the incident, maximum wind speed about 3.5 miles per hour, and no recorded precipitation). The incident site was a heavily-trafficked, four-way lighted intersection in central NJ (Figure 1). In the north and southbound direction, the intersection consisted of a divided highway with two lanes on each side with a speed limit of 40 miles per hour. East and westbound was a local road with a speed limit of 25 miles per hour. On the east-most side of the intersection there was a crosswalk. The crosswalk was regularly used by pedestrians including residents of a large apartment complex (on to walk to a shopping center located on the northbound side. Between the shopping center and the intersection was a rail line (at-grade; traveling north and south) which had its own designated crossing point (Figures 2 and 3). The train passes the intersection approximately every 15 minutes on weekdays between 6:00 a.m. and 10:00 p.m., and until after midnight on the weekend. Although there were several pedestrian crossing signals, the complexity of the intersection (train tracks, divided highway, multiple speed limits) and the high

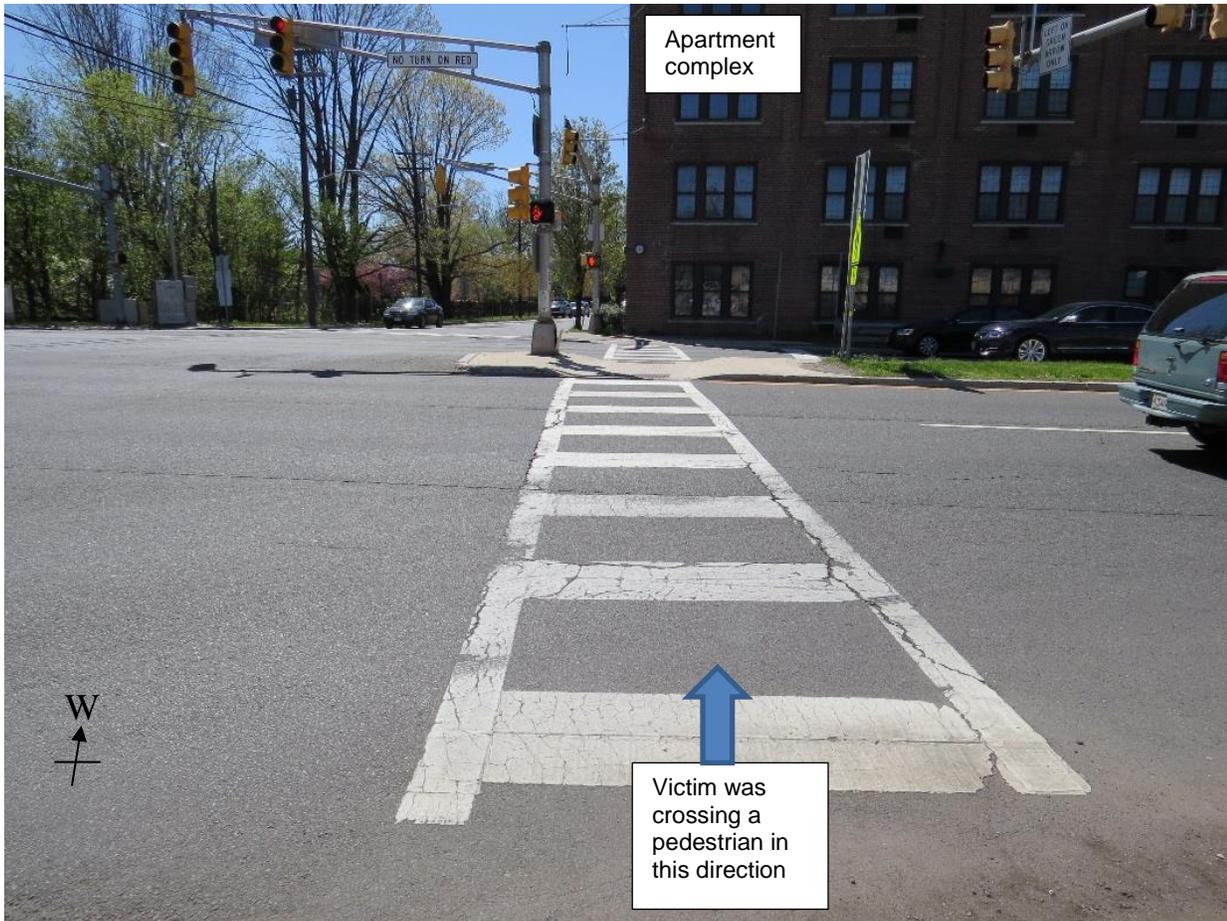
FIGURE 2. Incident scene; street view.

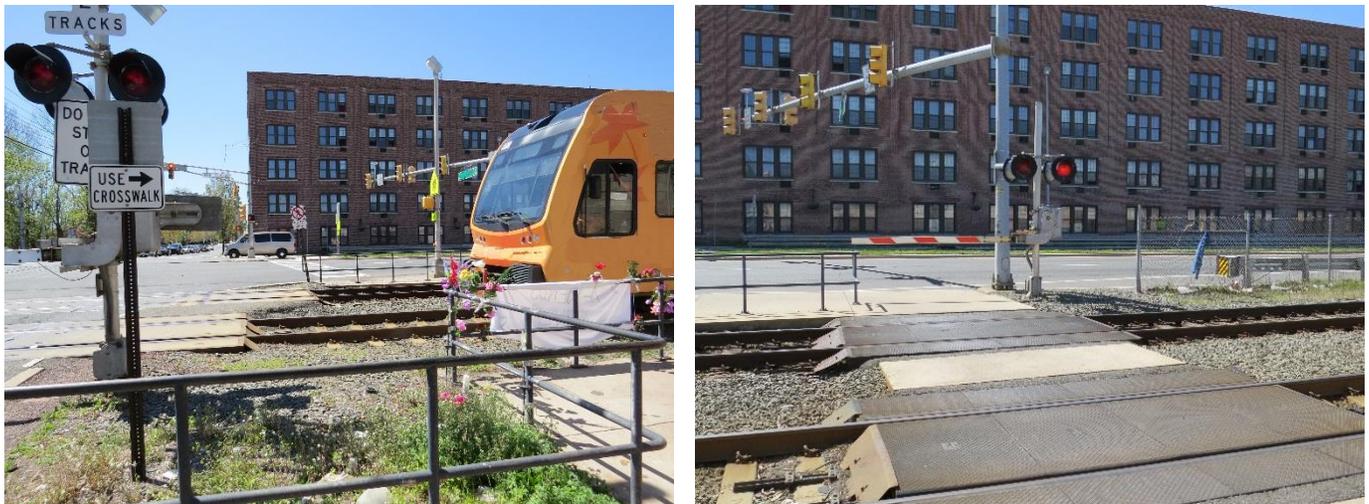
FIGURE 3. View of train and the area designated for pedestrians to cross the tracks.

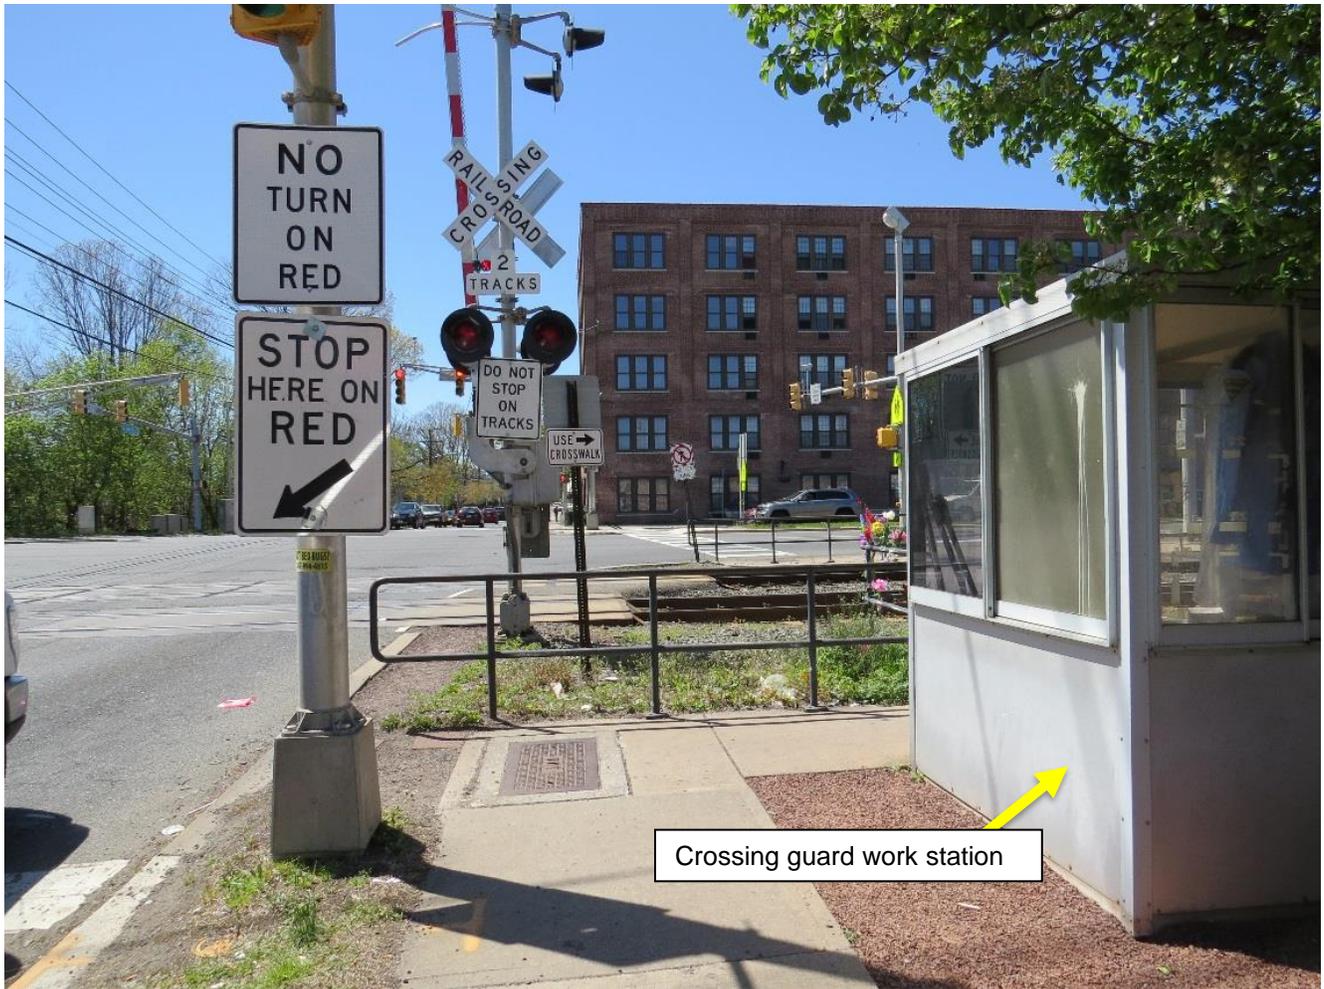
FIGURE 4. Crossing guard workstation (located on east-side of intersection, adjacent to rail line).

The crossing guards had a small workstation between the shopping center and the rail line (Figure 4), and worked in shifts to cover the work day. The crossing guards rotated between three, six-hour shifts, 7:00 a.m. to 7:00 p.m., six days a week. The victim was assigned the second shift on weekdays, beginning at 1:00 p.m. According to an interview with one of the other crossing guards for that intersection, they crossed pedestrians approximately 50 times per day. The guards wore high visibility, retro-reflective safety vests, and were equipped with stop paddles.

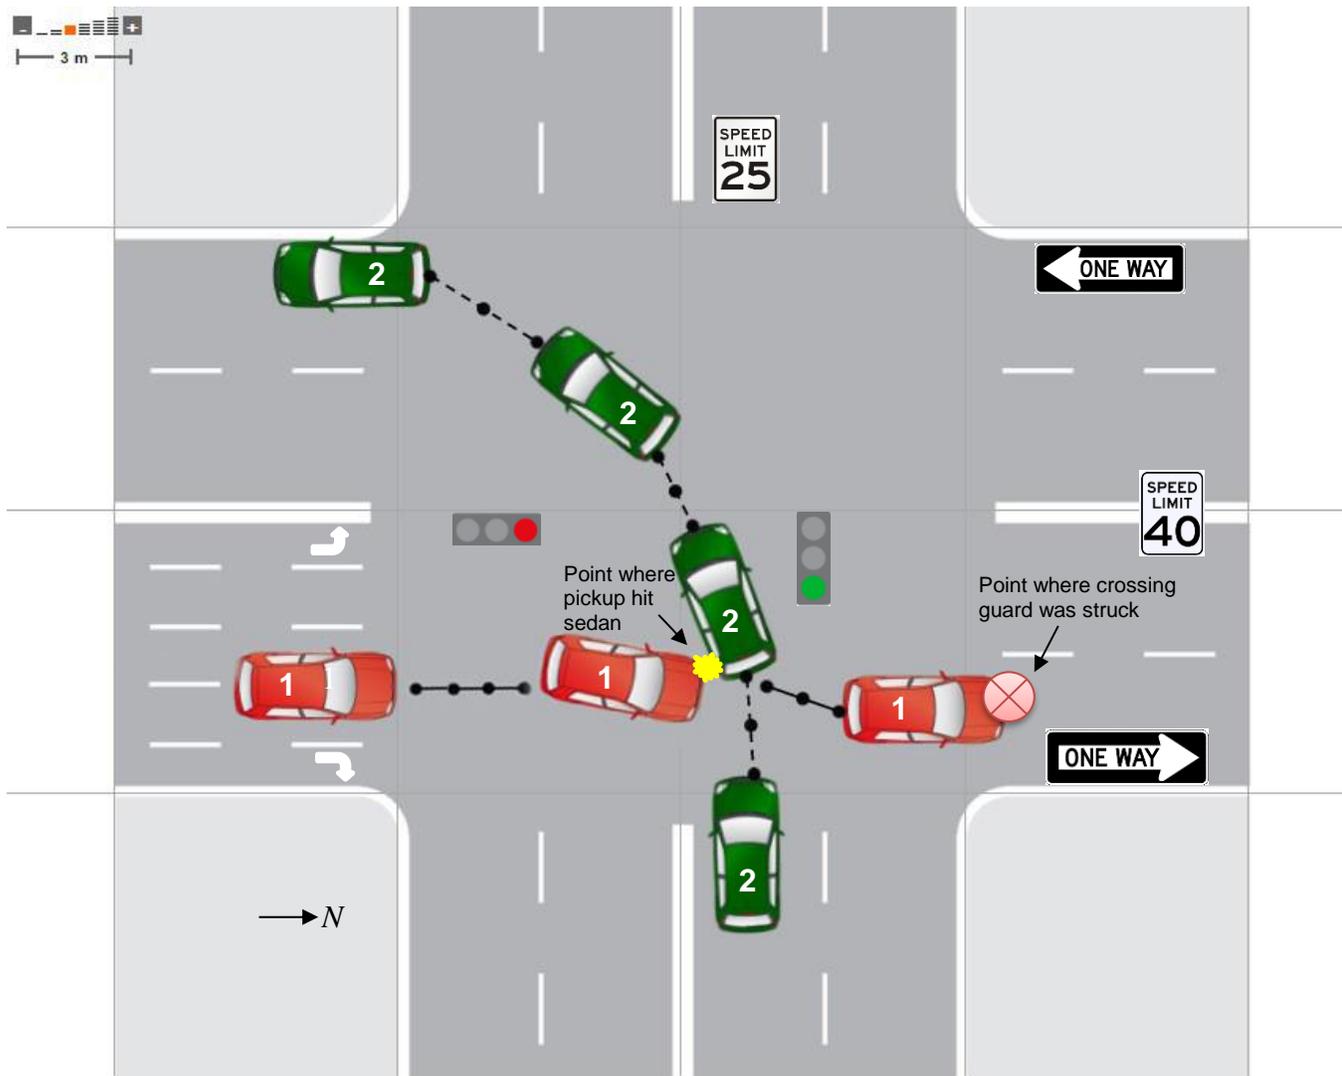
FIGURE 5. Re-creation of incident (not to scale).*

- 1 = Pick-up truck that struck the crossing guard
- 2 = Sedan making a left turn that was hit by vehicle #1

On the day of the incident, the victim was crossing a pedestrian westbound towards the apartment complex, when a small pickup truck traveling northbound entered the intersection against the red light. At this time, a sedan that had been stopped at the eastside light began to turn left onto the southbound road. The pickup truck hit the driver's side rear bumper of the sedan and then proceeded forward, striking the crossing guard who was still in the intersection (Figure 5). A witness called 9-1-1, and the victim was pronounced dead at the scene as a result of massive multiple traumatic injuries.

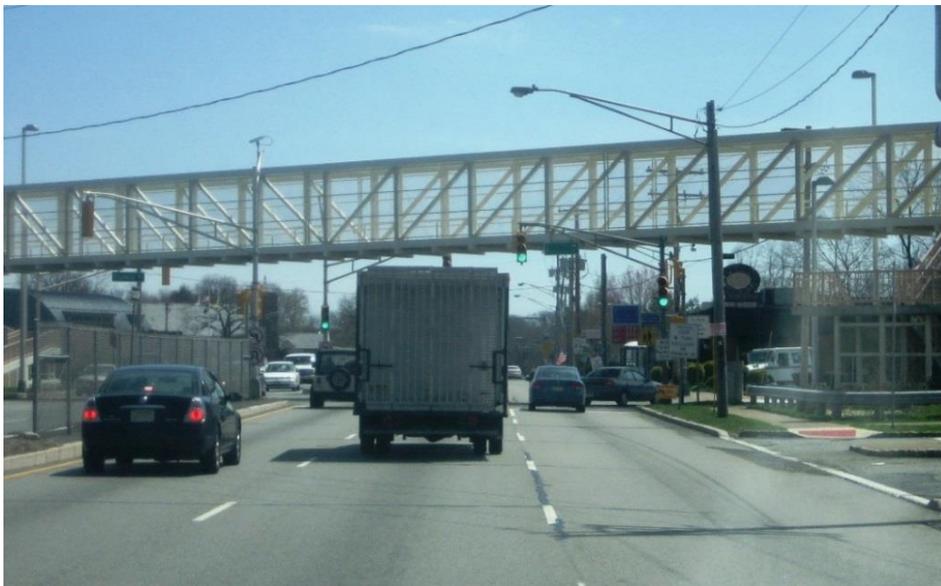
FIGURE 6. Example of pedestrian walking bridge over busy intersection in NJ (adapted from NJDOT⁴).

Recommendation #2: In an intersection with high speed and multiple complicating factors, a skyway or underpass for pedestrians should be considered.

Discussion: The intersection in which the incident took place involved the following factors: heavy pedestrian volume; an at-grade train line through the intersection; and a separate designated area to cross the train line several feet away from the crosswalk. NJ FOIS recommends constructing a pedestrian walking bridge (Figure 6) or an underpass that would both serve the community for convenience and safety, and would eliminate the need for a crossing guard post. Both would need to comply with guidelines set forth in the Americans with Disabilities Act (ADA), specifically Chapter 4, Section 405 of the 2010 Standards, including both the Title II regulations at 28 CFR 35.151; and the 2004 ADAAG (ADA Accessibility Guidelines) at 36 CFR part 1191, appendices B and D.³

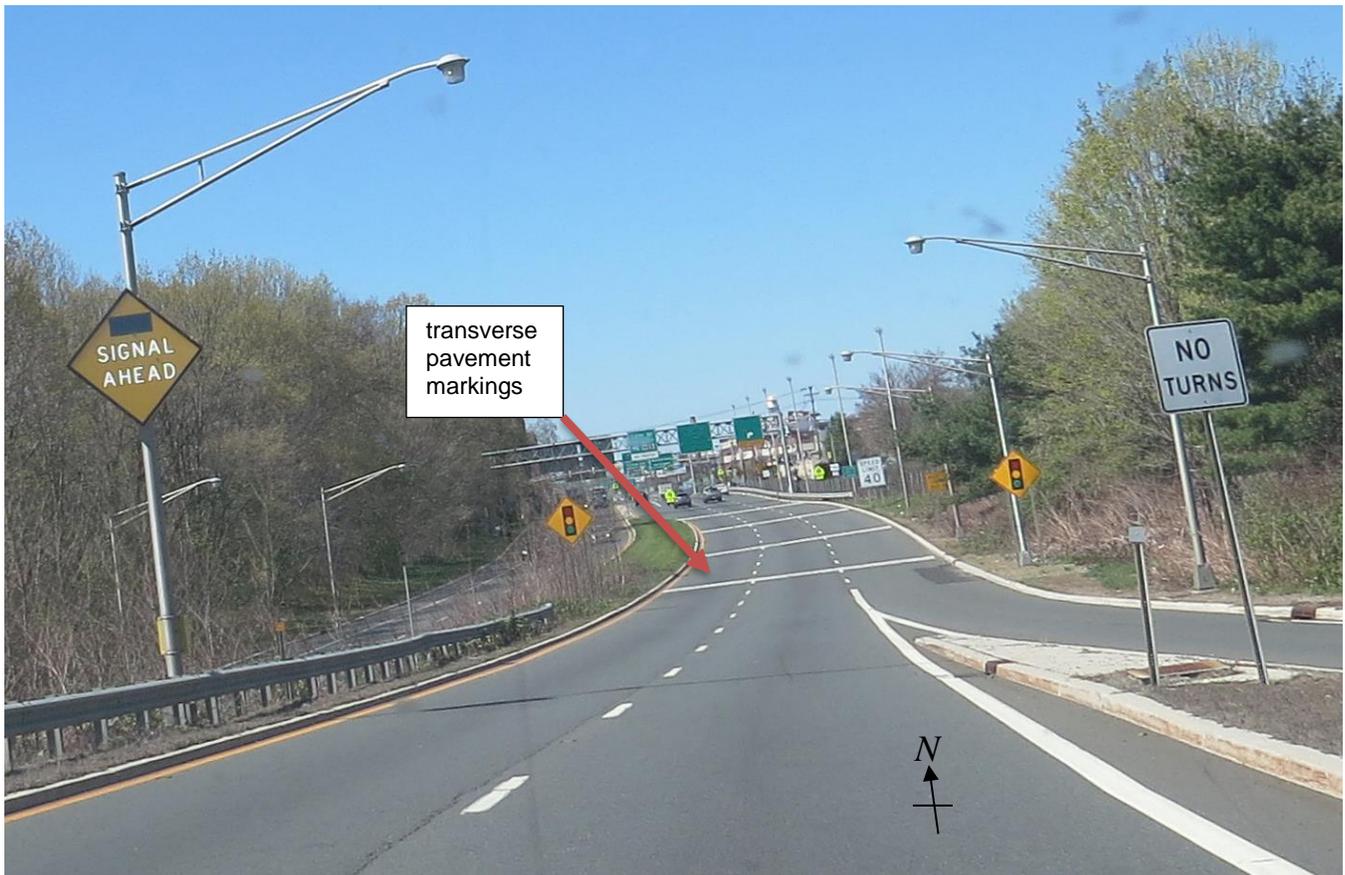
FIGURE 7. View from car approaching the intersection. Note signage and transverse pavement markings.

Discussion: As noted above, the speed limit for the road that approaches from the south is 40 mph. NJ FOIS staff drove through the intersection from this direction and observed that there was a downhill slope shortly before the light, and several signs to notify drivers of the approaching intersection (Figure 7). Just after the signs there was a set of transverse pavement markings--a type of rumble strip consisting of lines or bars that are perpendicular to the path of travel and placed across the road.⁵ Neither the signs nor the pavement markings seemed to effectively slow traffic. NJ FOIS recommends that pavement grooves (milled rumble strips) be installed in both directions approaching the intersection (Figure 8).

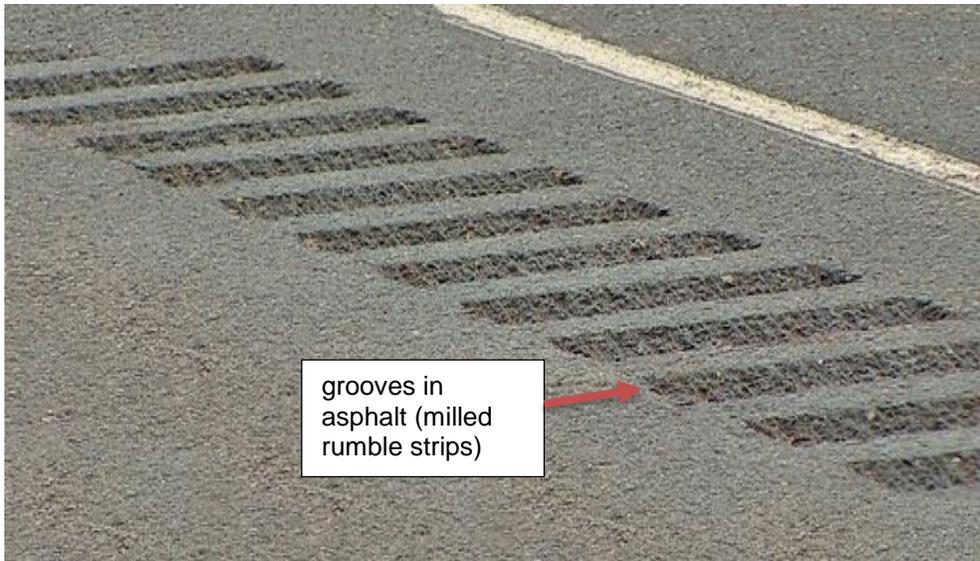
FIGURE 8. Example of milled asphalt grooves (rumble strips).*
