# F.A.C.E. INVESTIGATION REPORT

FACE #97-NJ-045-01  
Maintenance Contractor Killed After Falling From A  
Ladder

SUBJECT: Face Investigation #97-NJ-045-01  
Maintenance Contractor Dies After Falling From A Ladder

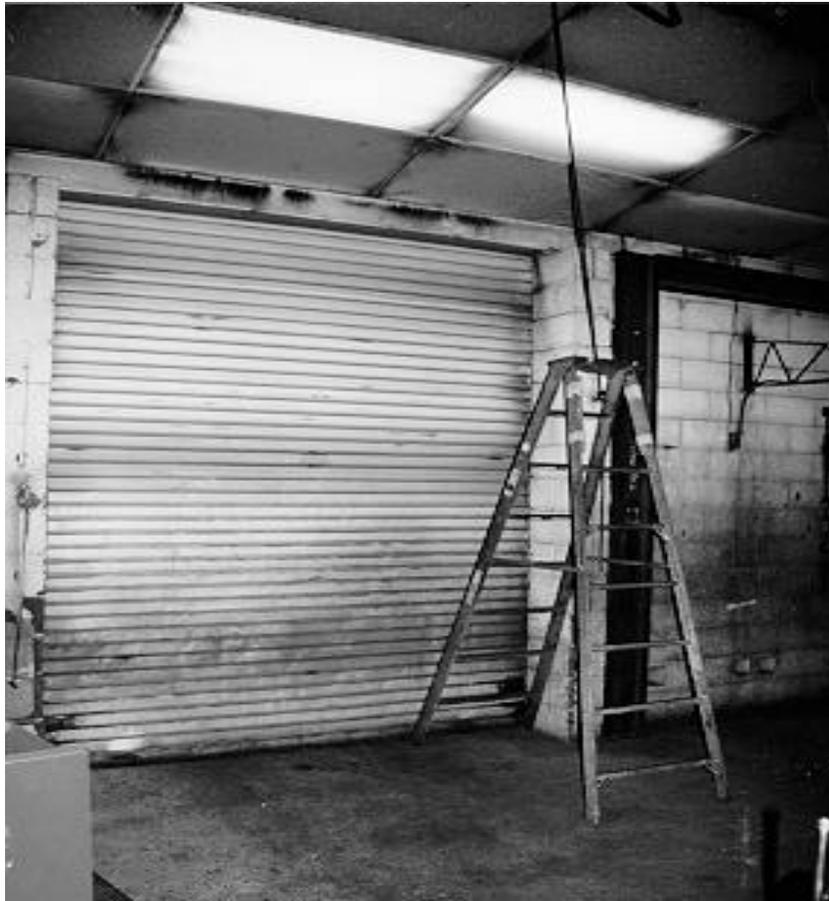
**Photo 1**

It is not known what caused the victim to fall from the ladder. The 277 volt light fixture was energized, suggesting the possibility of an electric shock. An examination of the fixture by the company service manager did not find any wires disconnected. One worker stated that the victim usually took the lights off line by disconnecting the power cable, which he may have been looking for since he was moving the ceiling tile and had not yet used any tools. It was also noted that the ladder wobbled slightly.

Ladder Positioned Under Ceiling Light Fixture

Discussion: It is not known why the victim fell from the ladder, although the slight instability of the ladder may have been a factor in this incident. To prevent future incidents, contractors should ensure that all ladders and other work platforms are stable before using them. Companies that loan equipment to contractors should ensure that all ladders and work platforms conform to OSHA standards (see recommendation #3).
