# Preventing Worker Injuries and Deaths as a Result of the Use of Leaf Collection Vacuuming Equipment

## Public Employee Alert # 28 Safety & Health Bulletin ATTENTION: All Public Employers

February 2004

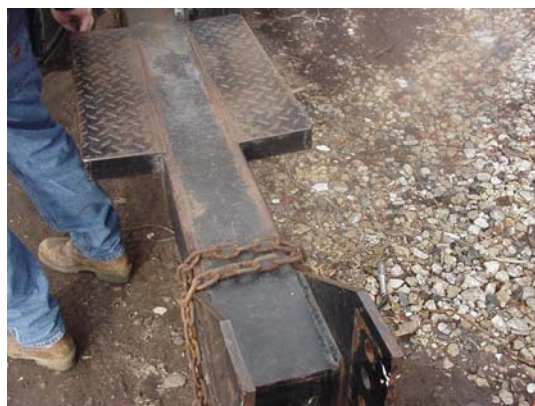
In November of 2003, a municipal public works employee was killed when he was run over by the wheels of a portable leaf collection vacuum trailer. The victim was riding on the yoke of the portable leaf vacuum as the driver was turning onto a side street. The vacuum hose swung loose, hitting several parked cars. The tow driver felt a "thump" and brought the vehicle to a stop. After stopping the truck, the driver found the victim who had been run over by the rear wheels of the vacuum. It is believed that the victim was attempting to retrieve and secure the swinging vacuum hose, lost his footing and fell from the yoke. Upon inspection of the municipal public works department, another similar type of leaf collection vacuum was discovered that was missing the warning labels which instructed individuals not to ride on the yoke of the trailer. Additionally, diamond plate had been welded onto the yoke of the trailer. It is presumed that the diamond plate had been welded onto the yoke to provide better footing for an individual to ride on it. The employer stated that they were unaware of these violations and upon being made aware by the inspector immediately took steps to abate the violations by adding the appropriate warning labels to the yoke and removing the diamond plate.

**Improperly Modified Yoke**

- Follow all manufacturer's recommendations for the safe operation of leaf vacuuming equipment.
- Make no modifications to any equipment, unless authorized by the manufacturer.
- Make sure that warning labels are not removed or altered. Contact the manufacturer to obtain replacement labels.
- Enforce all safe operating practices, such as keeping vacuum operators in clear view at all times.
- Provide employees with and ensure the use of all personal protective equipment recommended by the manufacturer.
- Thoroughly train all new employees prior to allowing them to operate any piece of equipment.
- Due to the extended time frames over which many communities perform leaf collection, reinforce safety training at regular intervals.
