PHASE I ENVIRONMENTAL SITE ASSESSMENT REPORT FINAL

Reference: R0255-00 WO#2 (GBRC-Solar PPA)
Green Brook Regional Center
275 Greenbrook Road
Green Brook Township, NJ 08812

August 26, 2024

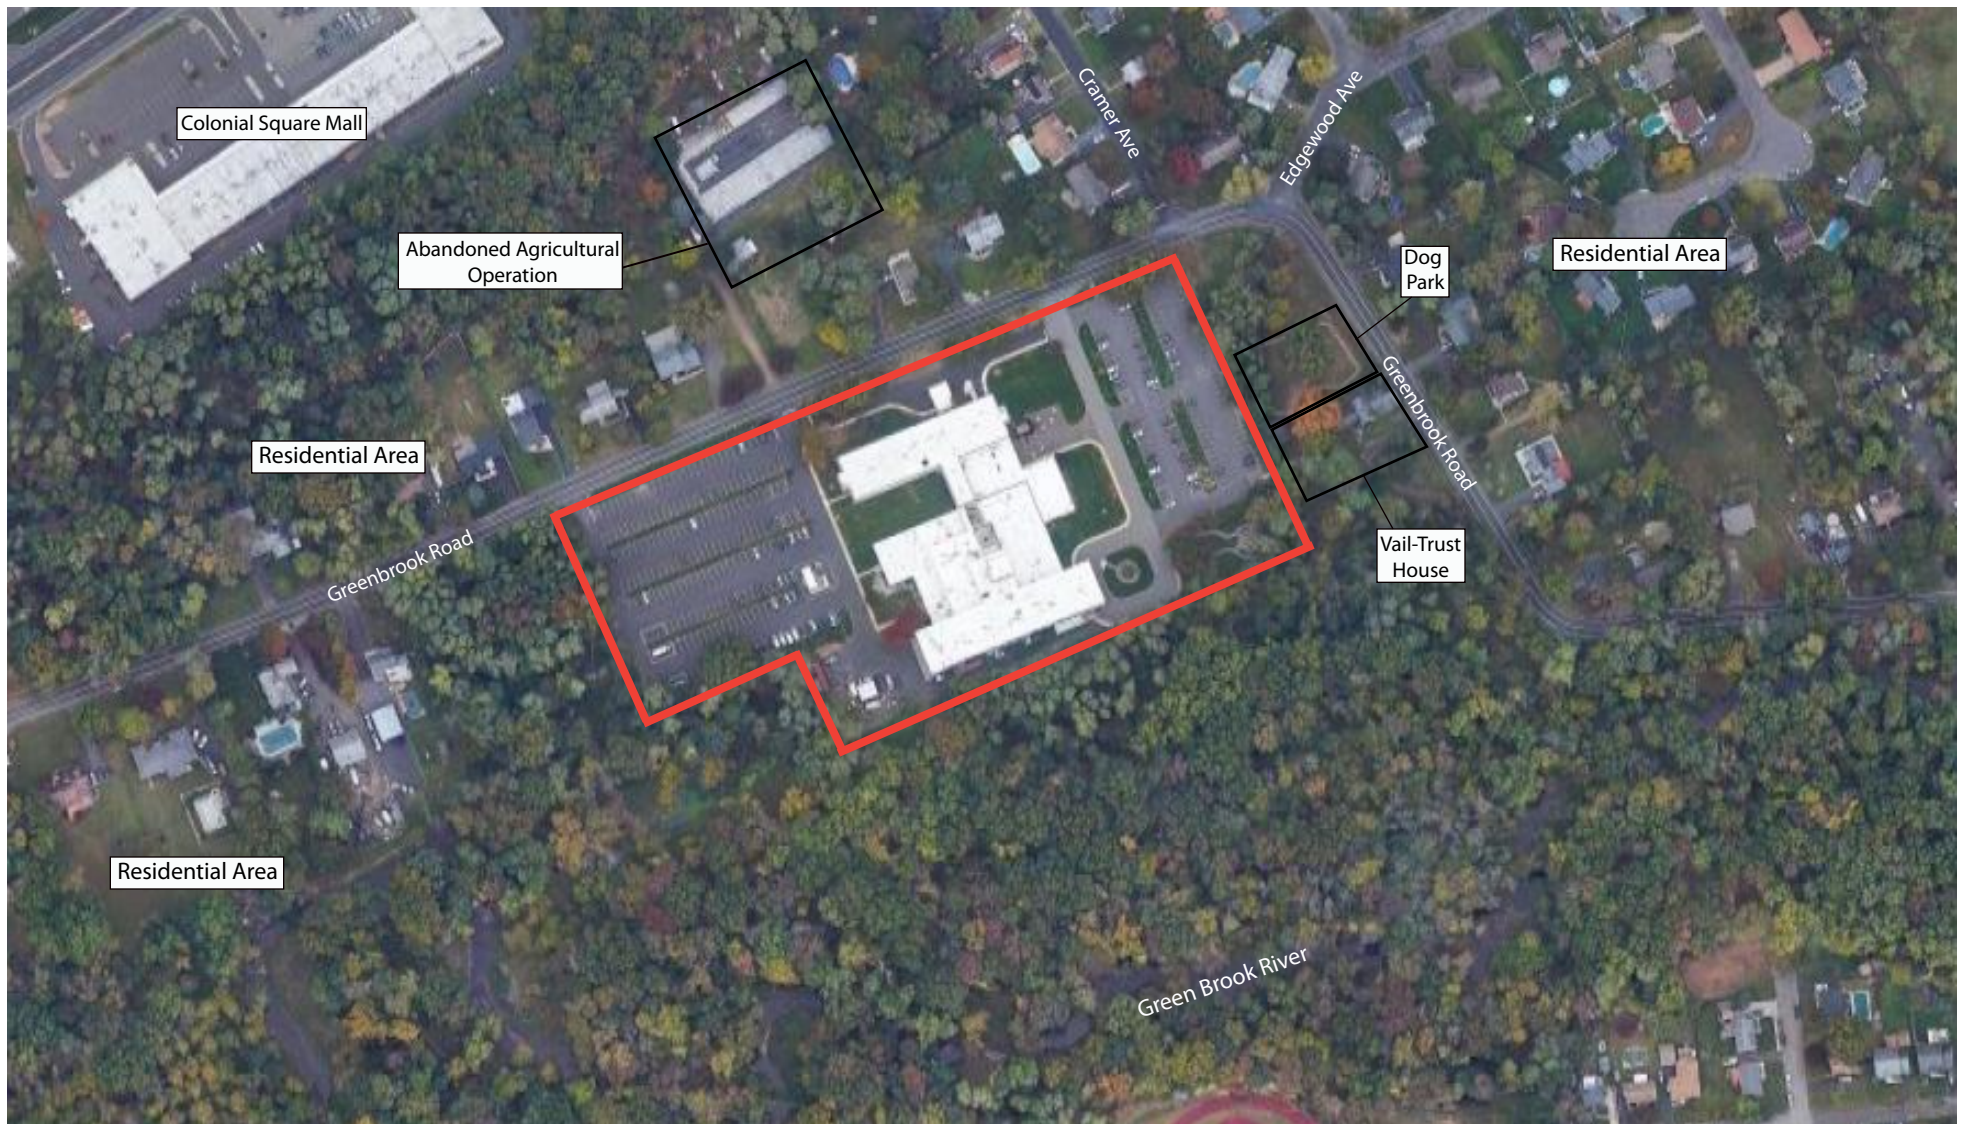
A Subject Property Location Map created from the United States Geological Survey (USGS) 7.5-minute Quadrangle, Plainfield, NJ (2023) is presented in Figure 1, a Site Plan with surrounding property is presented as Figure 2, and Detailed Site Plan is presented in Figure 3.
