GREENWOOD LAKE WATERSHED IMPLEMENTATION PLAN

WEST MILFORD TOWNSHIP, PASSAIC COUNTY, NEW JERSEY

JANUARY 2020

PRINCETON HYDRO, LLC
1108 OLD YORK ROAD, SUITE 1
P.O. BOX 720
RINGOES, NJ 08551
908-235-5660

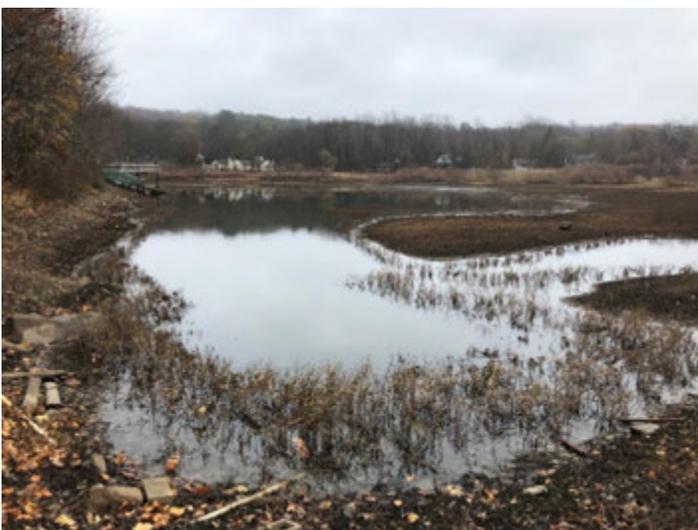
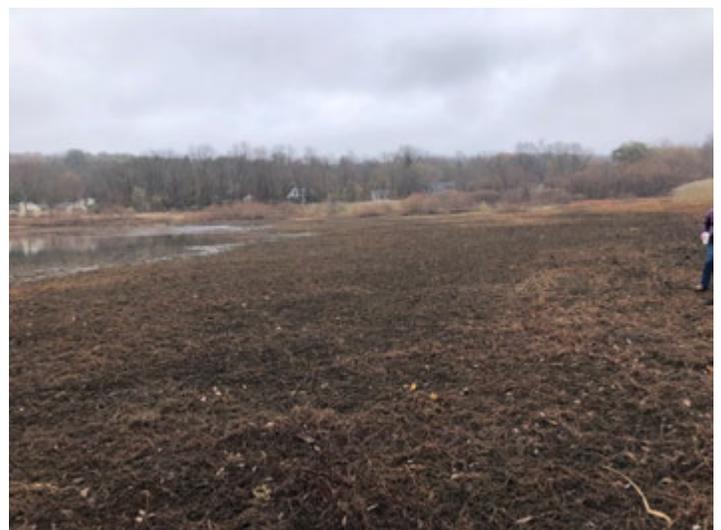
In addition to converting the site into a functional wetland BMP, the stabilization of the discharge channel and removal of the spillway and/or portion of the earthen embankment would be necessary to provide a connection of the channels. An additional benefit to the project is that it would deregulate the dam. While such a project has the potential to address a substantial portion of the phosphorus load entering Greenwood Lake, a considerable amount of planning, design work and public education would be required for its successful implementation.

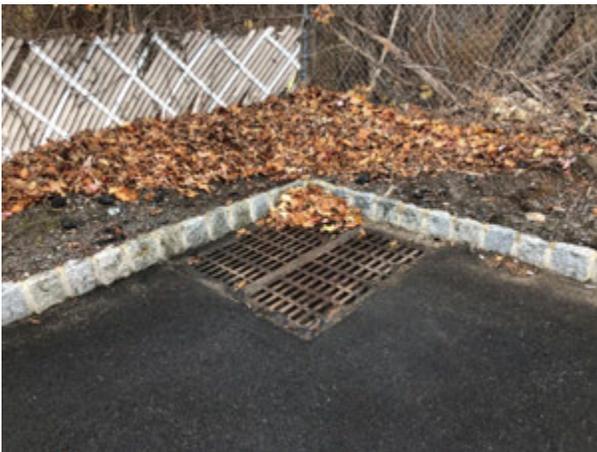
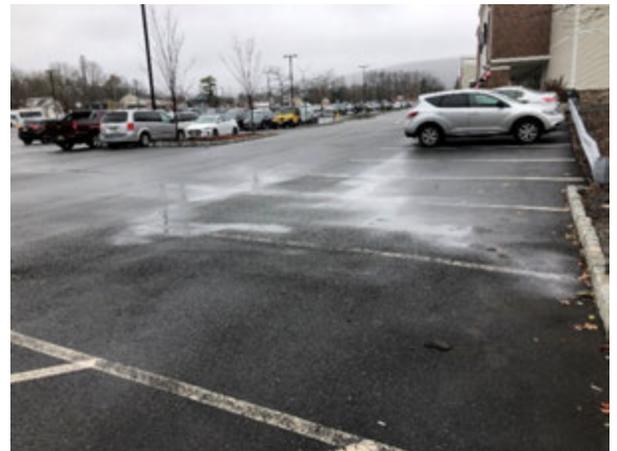
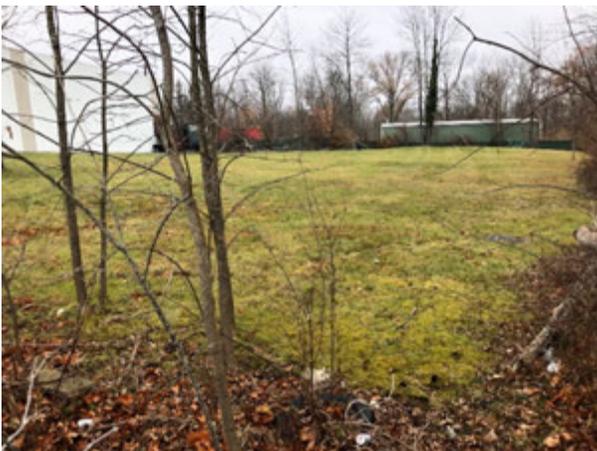
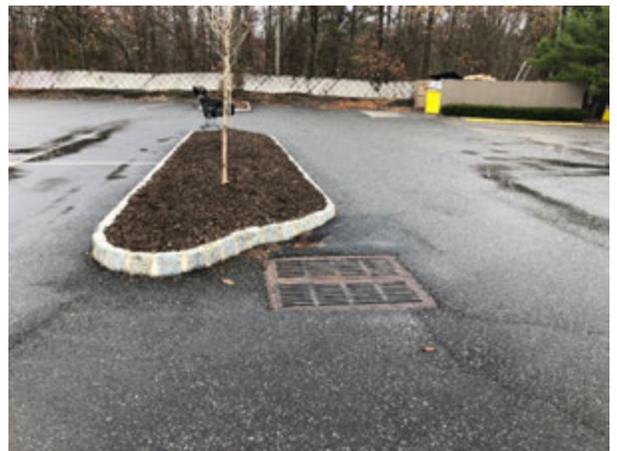
SITE 2: SHOP-RITE PARKING LOT (ACROSS FROM WEST MILFORD LAKE DAM)

There are other catch basins and storm drains around the parking lot that could also be retrofit with smaller MTDs and/or Filterra tree boxes.

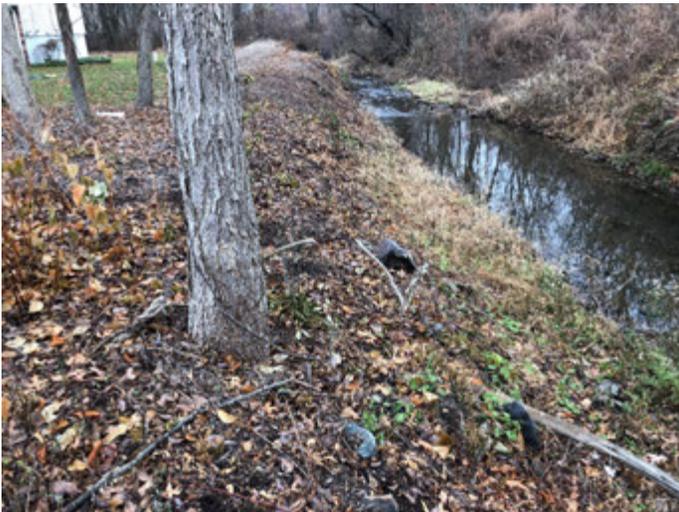
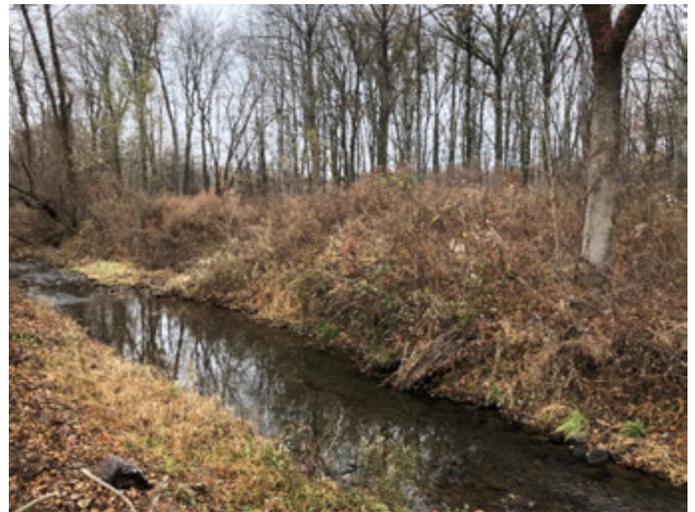
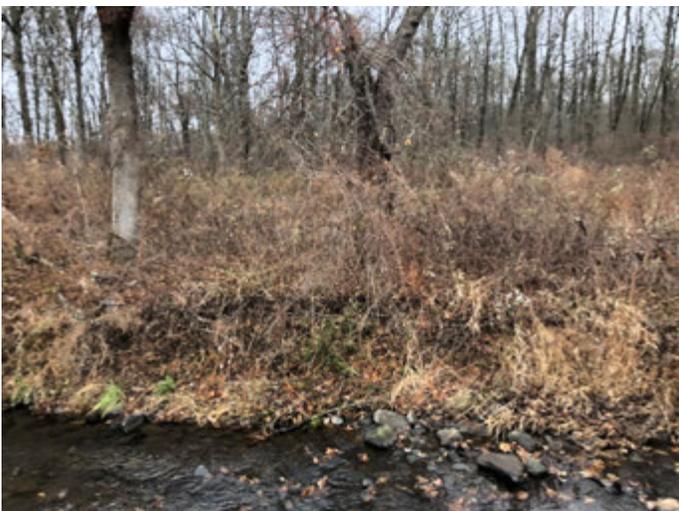
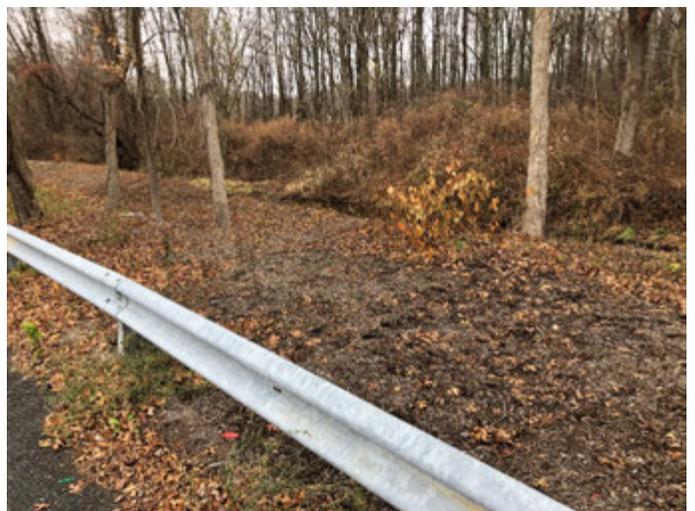
SITE 3: TRIBUTARY AT THE END OF ADELAIDE TERRACE

The streambank on the opposite side could be stabilized to include floodplain benches in addition to toe protection. This streambank can be graded back to a gentler slope, allowing for more flood storage during periods of heavy precipitation and could act as a wetland storage area, filtering nutrients and other pollutants.

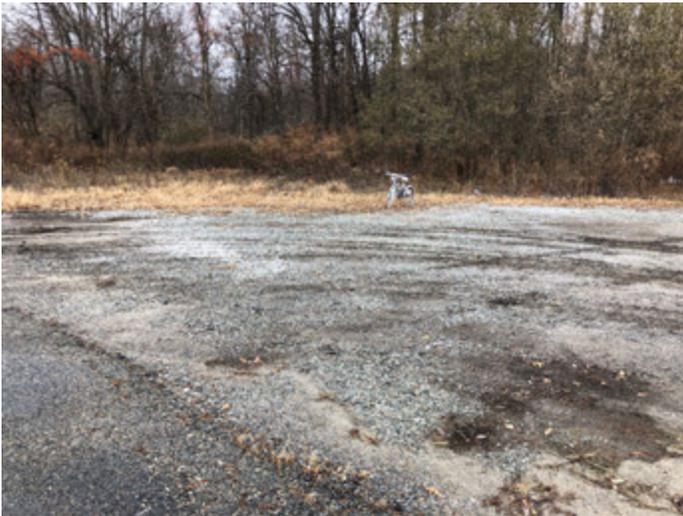
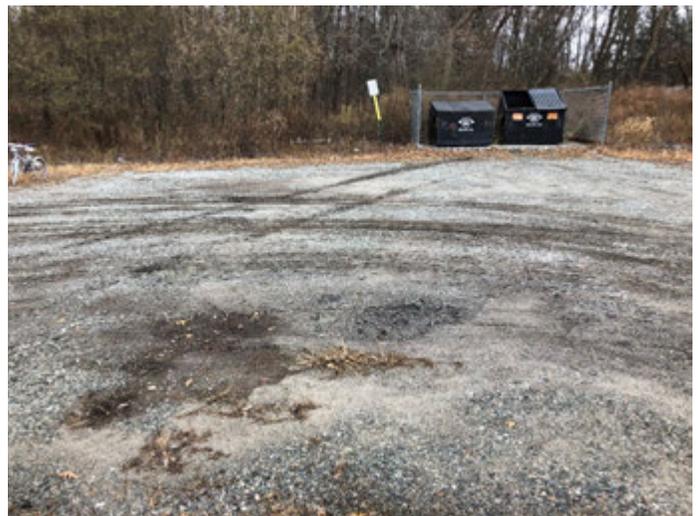
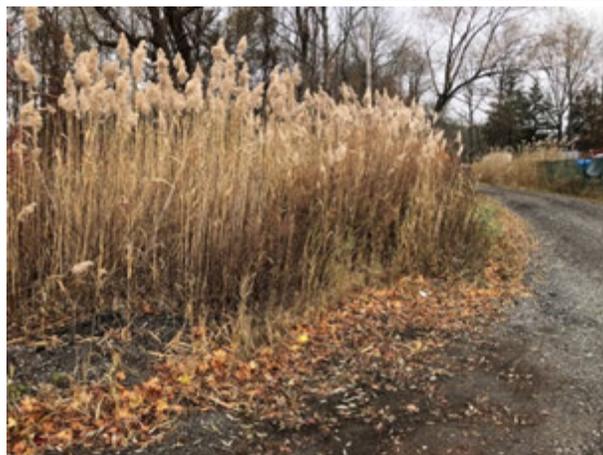
SITE 4: REAR PARKING LOT ON NEW JERSEY AVENUE

The rear parking lot behind the small strip of stores on the corner of New Jersey Avenue and Union Valley Road is located directly next to Belcher Creek and is almost entirely made of loose gravel. The rear half of the parking lot was not being utilized during the two site visits that Princeton Hydro made to this site and appears to be unfinished due to the curbing within the vegetation. There is a lack of a riparian buffer between the parking lot and Belcher Creek and there is a large patch of the invasive *Phragmites australis* (phragmites) near the back corner of the parking lot where pollution from trash and other debris is extensive.

Estimated Costs: The estimated cost of the design and implementation of the extended filter strip is approximately \$203,500 and the rain garden is approximately \$105,500.

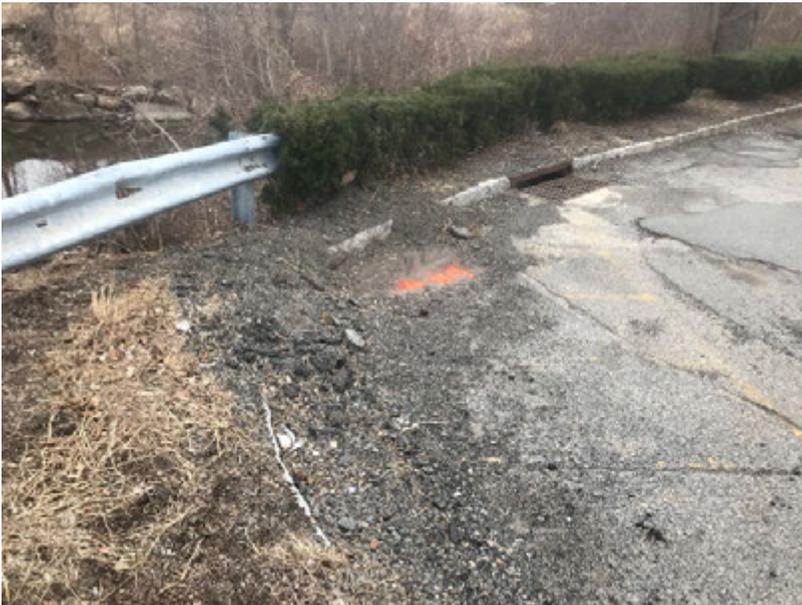
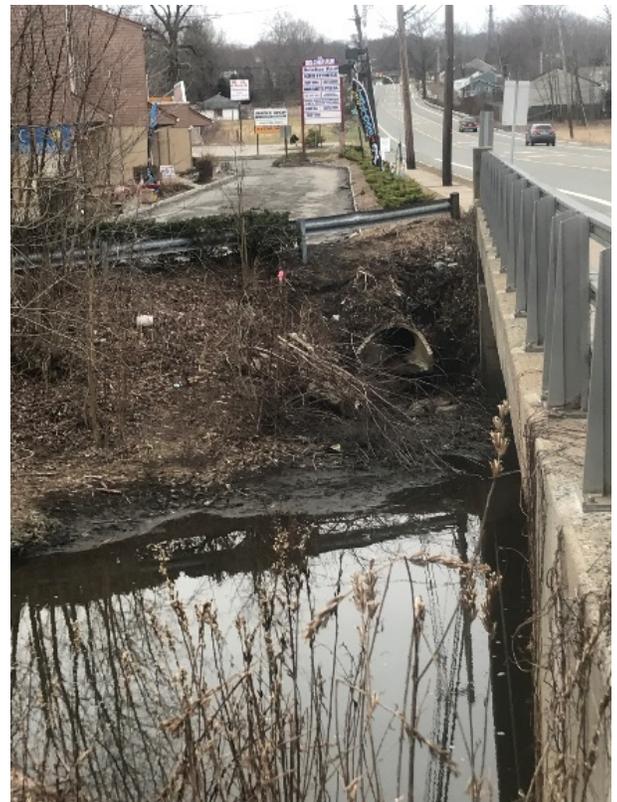
Recommended Measures: All of the sediment/road grit should be cleared out of the parking lot before any further work is done to this site. This location appears to be the primary point where snow would be pushed and would benefit from a curb to stop the plows from pushing snow and sediment right to the bank of the creek as well as minor adjustment to the pavement grades so grit could accumulate in a location/system that is more maintainable. These improvements would be further beneficial if installed with nutrient separating baffle box MTD along the existing pipe at the end of the parking lot that drains directly into Belcher Creek. Additionally, the streambank in the vicinity of the pipe discharge should be stabilized to prevent future erosion. Bank stabilization methods could include the planting of vegetation where the slope allows and through the installation of rip-rap to prevent further bank scour.

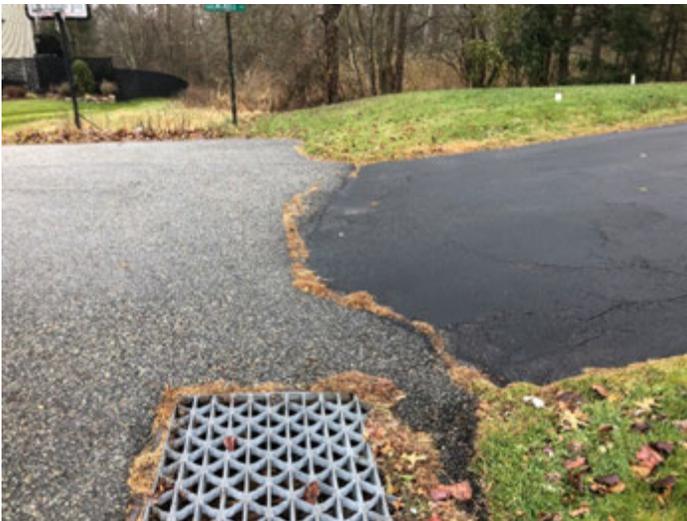
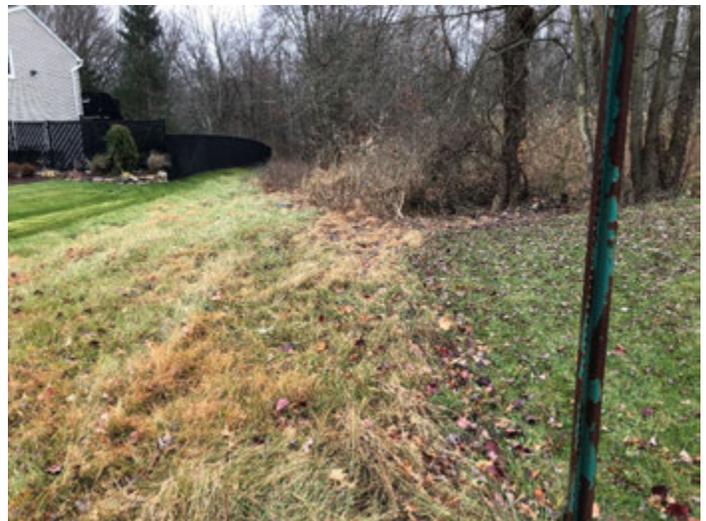
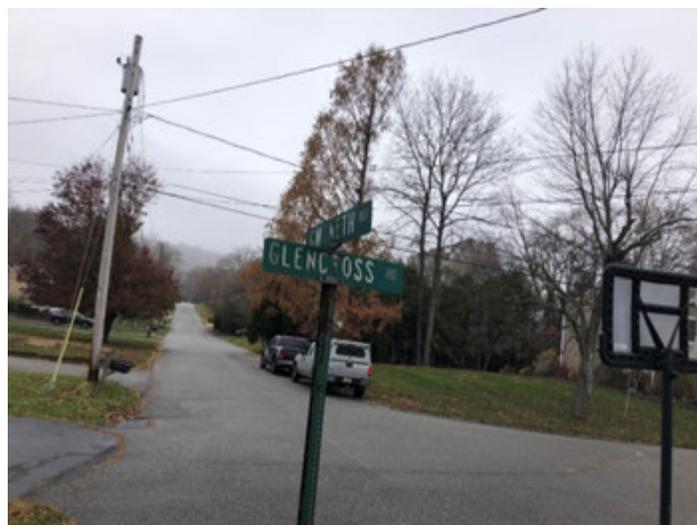
SITE 8: GWYNETH ROAD AND GLENCROSS ROAD

Recommended Measures: This site is an ideal candidate for the installation of an MTD that discharges into a vegetative filter strip, allowing for the further treatment of stormwater. The nutrient separating baffle box should be installed in the pavement between the inlet and the grassed buffer as this is the most down gradient catch basin to the discharge point and would therefore treat the largest quantity of stormwater from this community. Additionally, the discharge pipe could be daylighted closer to the edge of pavement and converted into a vegetated buffer or swale.

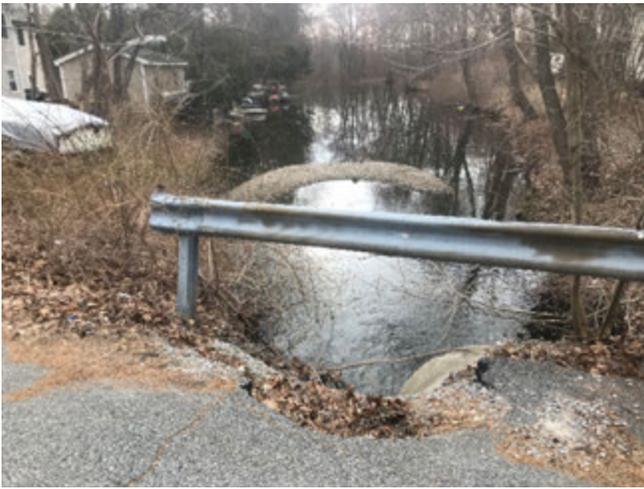
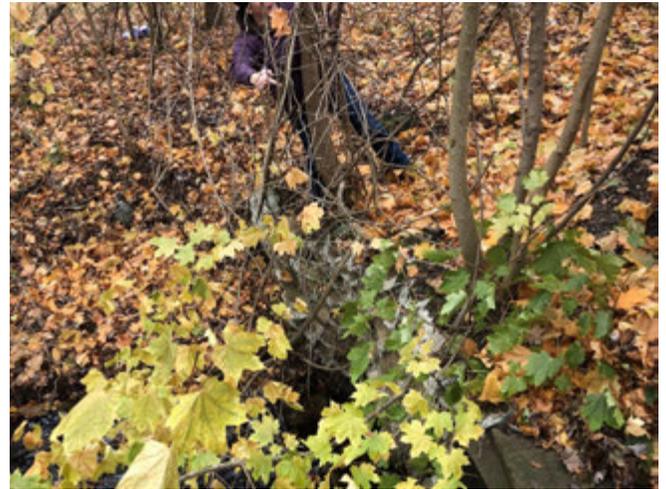
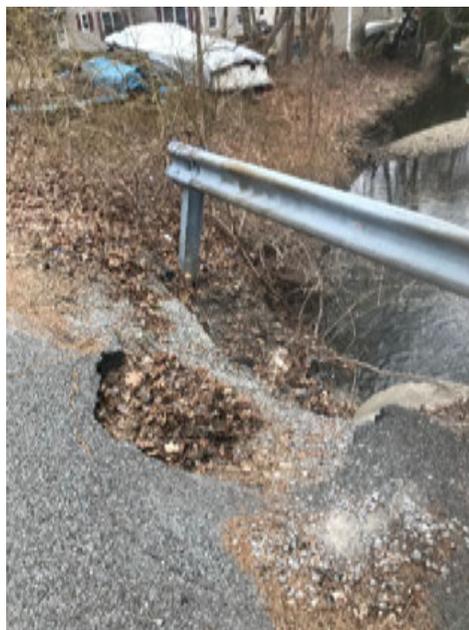
SITE 9: HEADWALL OF BELCHER CREEK AT GLENCROSS ROAD

The downstream side of Glencross Road at the Belcher Creek stream crossing is actively eroding from runoff and is creating a sediment bar just downstream in the channel to Belcher Creek. There are currently sandbags installed as a method to control the erosion and stabilize the area. The erosion of the bank is creating a sizeable hole in the road that is already a safety concern and will only get worse if not addressed. While this site is not a huge priority for nutrient reductions, the eroding road should be addressed as a safety concern.

Estimated Costs: The estimated cost of the design and installation of a headwall is approximately \$115,000.

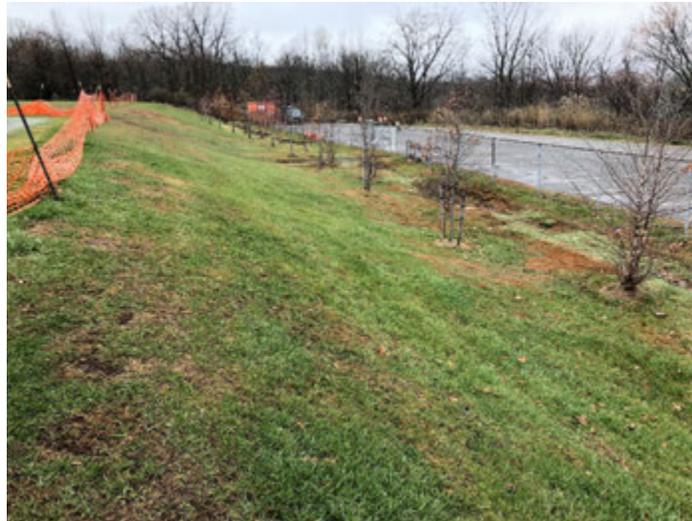
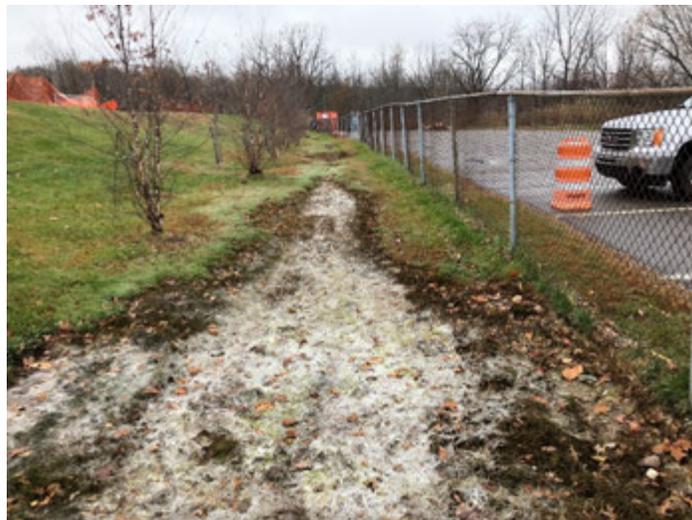
Recommended Measures: This site would be an ideal candidate for replacing the current “swale” with a bioretention swale that would capture, treat/filter, and convey the stormwater in a much more efficient manner. The bioretention swale would greatly reduce nutrient loads that drain to Morestown Brook and eventually Belcher Creek and Greenwood Lake. This site would also be a great location to incorporate educational material on a sign highlighting the importance of stormwater management because of all the foot traffic associated with the athletic fields and bike course. The slope from the athletic fields should be vegetated with meadow or similar lower maintenance vegetation with specified paths from the parking lot to the facilities.

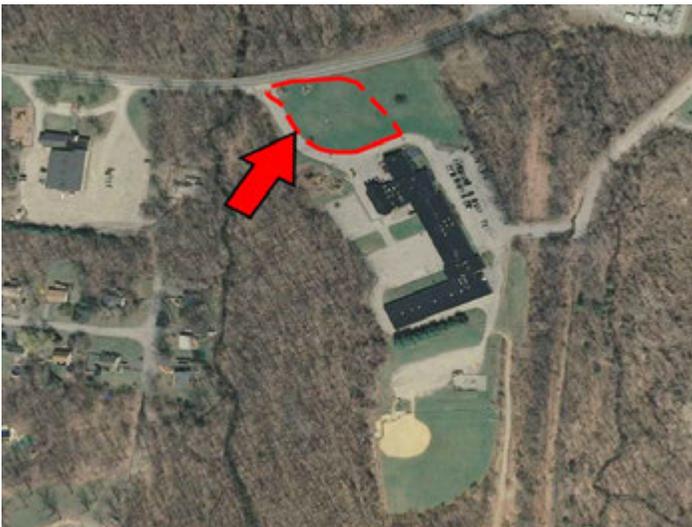
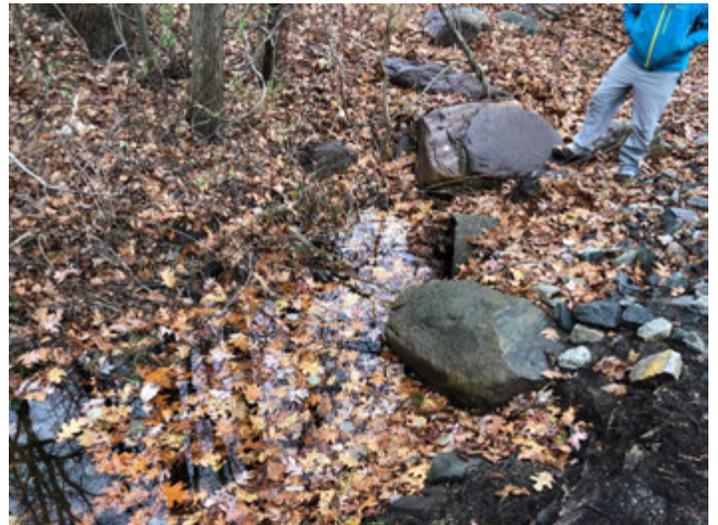
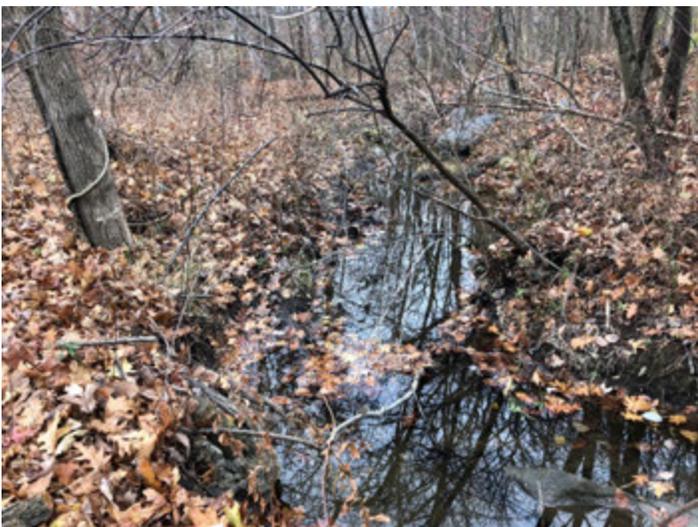
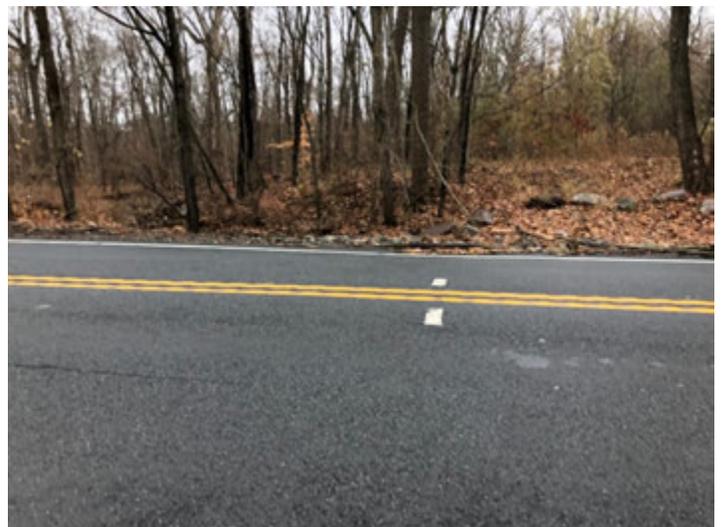
SITE 11: MARSHALL HILL ELEMENTARY SCHOOL AND ROAD

Recommended Measures: The Marshall Hill Road and Marshall Hill School project would involve a series of activities including the enlargement of a culvert, the diversion of stormwater and vegetated conveyance, and some additional streambank stabilization work. In addition, a rain garden / biofiltration system would be installed in front of Marshall Hill School. The rain garden / biofiltration system would include some signage and would be used for educational purposes as well.

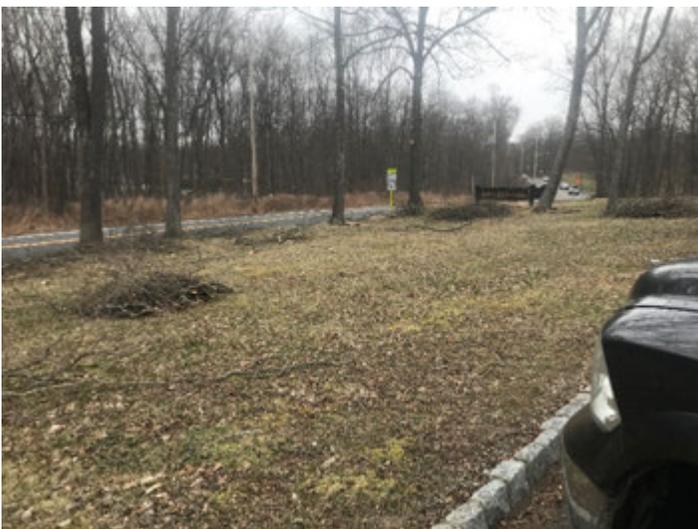
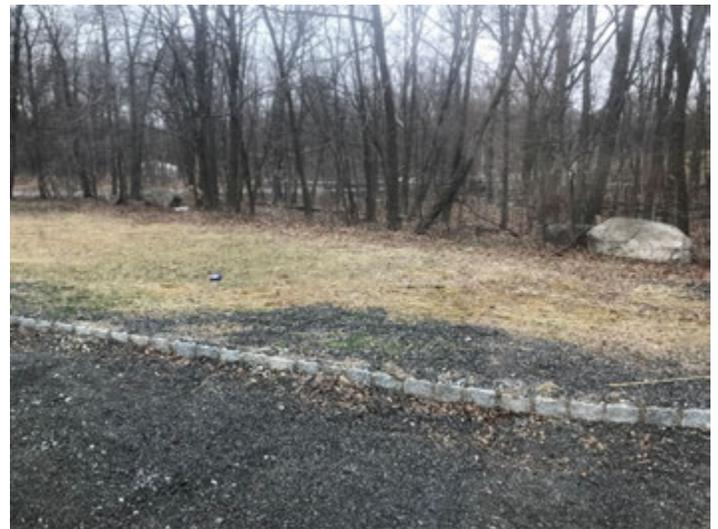
SITE 12: ALMOND BRANCH CHURCH

2. The second recommendation at this site and the focus of the demonstration project would be the installation of pervious and/or vegetated pavers in the gravel section of the parking lot. This would eliminate the loose gravel that is accumulating along the side of the parking lot where Morestown Brook is located and would allow for most of the runoff in the parking lot to be filtered by the soil and vegetation instead of carrying pollutants into Morestown Brook. As part of the demonstration project, multiple types of pervious/porous/grass pavers could be implemented in different parts of the parking lot.

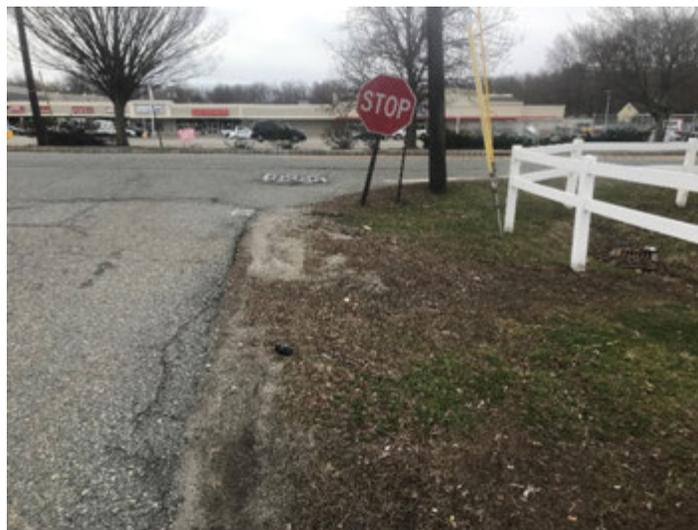
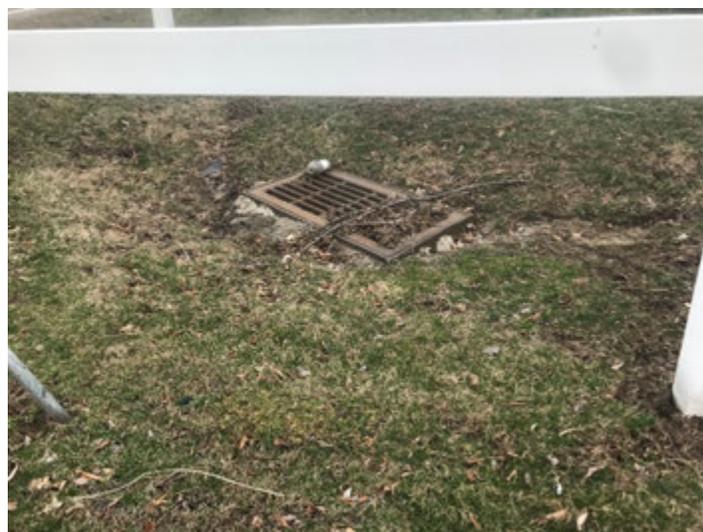
Recommended Measures: The catch basin in the grassy area on the corner of Union Valley Road and Elm Street is an ideal candidate for the installation of a rain garden. The rain garden would receive runoff from both Union Valley Road and Elm Street and would reduce the discharge rate of stormwater by allowing the water to infiltrate into the soil, and the plants would utilize some of the available nutrients.

Estimated Costs: The estimated cost of the design and installation of a rain garden on the corner of Union Valley Road and Elm street would be approximately \$176,300.

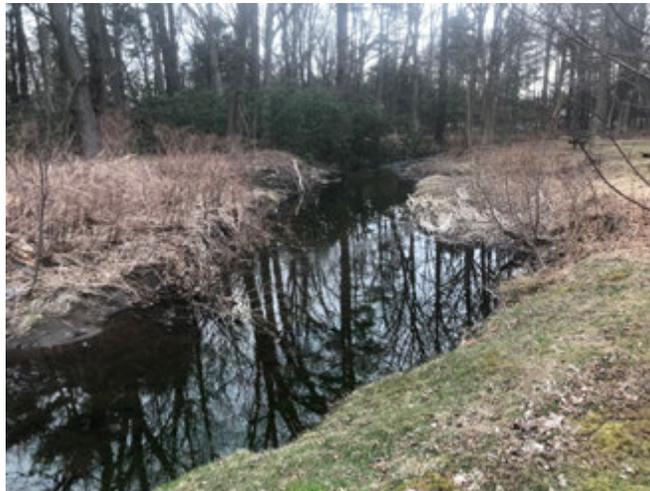
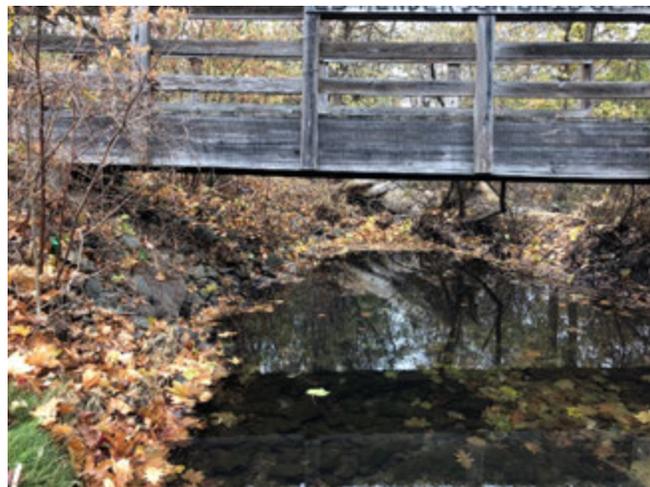
SUB-WATERSHED J

Cooley Brook passes across the back of the Elks Lodge property right before it empties into Green Brook. The streambanks appeared to be in relatively good condition, although the right bank lacked a sufficient vegetative buffer between the stream and the Elks Lodge property. Minor erosion is occurring under the foot bridge that is causing a widening of the stream here. There is also a downed tree just upstream of the foot bridge that is likely causing head cut erosion on the streambed.

Recommended Measures: The first recommended measure at this site is to enhance the riparian buffer between the stream and Elks Lodge from a grass to meadow buffer to help intercept stormwater and reduce the nutrient loads. The downed tree in the stream should also be removed to allow for the natural flow of water under the bridge.

Estimated Costs: The estimated cost for the enhancement of the riparian buffer and the removal of the downed tree is approximately \$75,000.

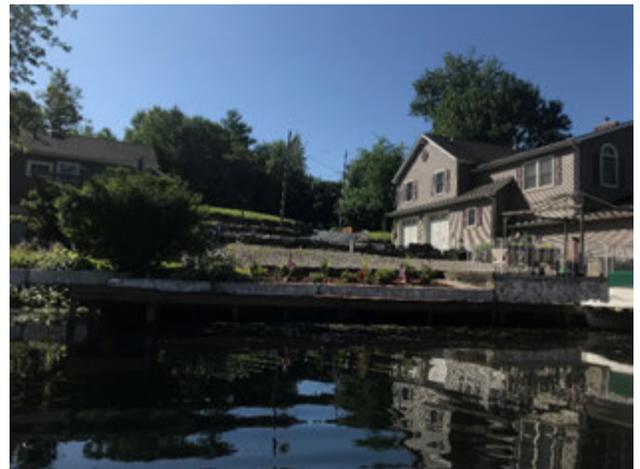
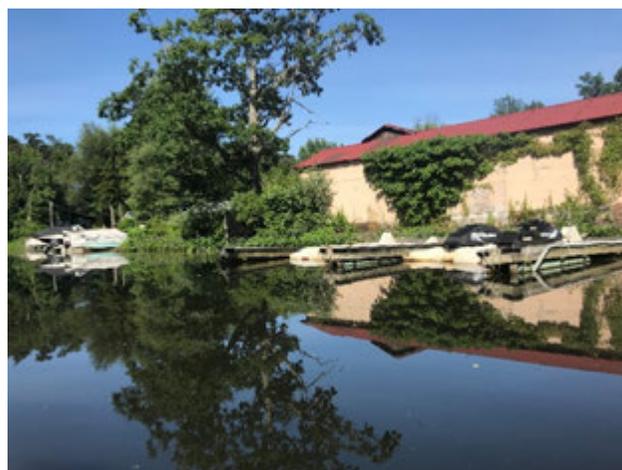
Recommended Measures: A vegetative riparian buffer in this location would provide multiple benefits, including the prevention of potential shoreline erosion in areas without a bulkhead and increased filtration of nutrients from residential stormwater runoff. The right bank should be prioritized for a riparian buffer. Additionally, the placement of a floating wetland island in this section of the creek would sequester nutrients before the water empties into Greenwood Lake and would provide habitat and protection from the sun for fish and other aquatic organisms. There appear to be a few locations along either shoreline where a floating wetland island could be tucked in off the main channel, protecting the island during periods of heavy flow. The floating wetland island would have to be placed in a protective location and tied to the shoreline for protection.

Estimated Costs: The estimated costs for the riparian buffer and a floating wetland island is estimated to cost between \$11,400 - \$15,400.

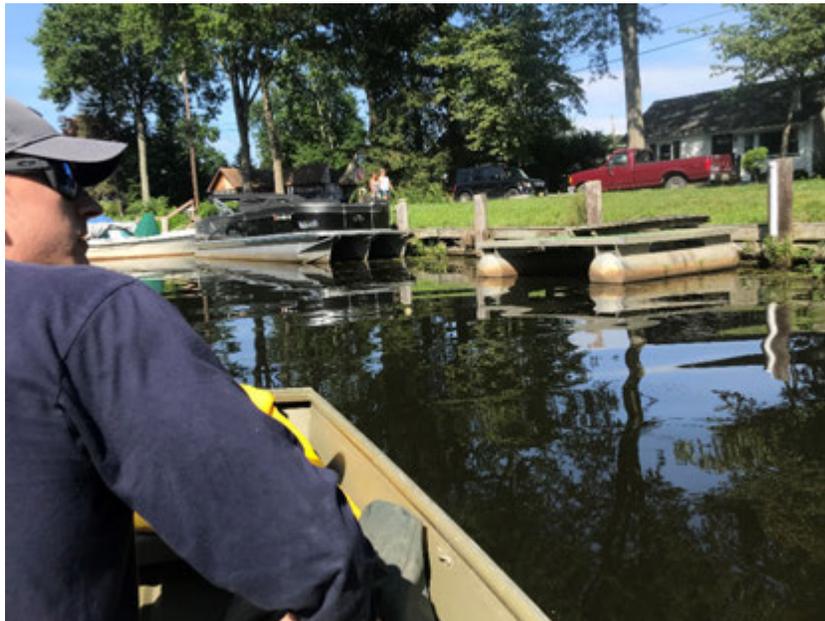
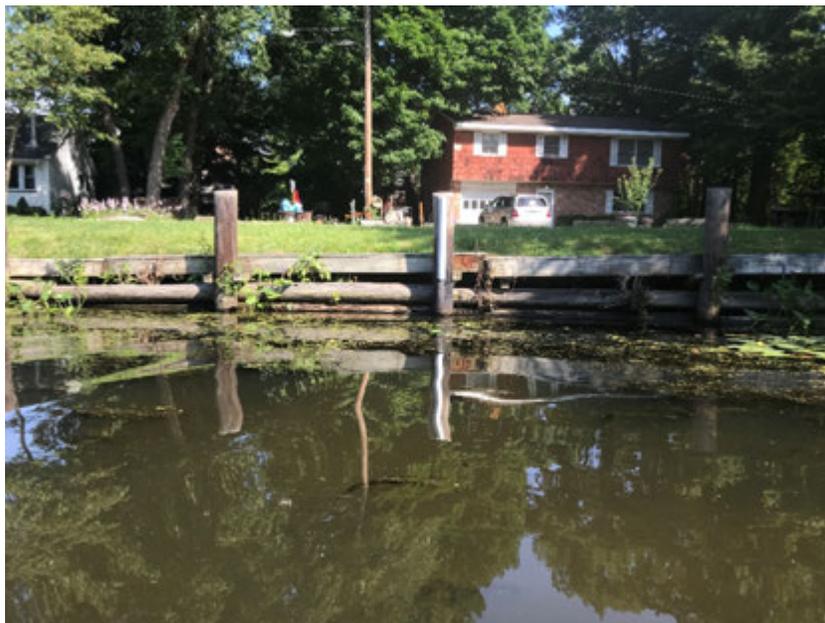
SITE 18: (B-3: BELCHER CREEK ALONG BEAVER AVENUE)

The left Bank of Belcher Creek runs parallel to Beaver Avenue, and the creek is only separated from the road by a few feet of mowed grass. The shoreline here lacks any type of vegetative buffer that would act as a nutrient filter for any stormwater that drains from Beaver Avenue. This side of the creek also lacks adequate canopy cover which leads to increased surface water temperatures.

Estimated Costs: The estimated costs for the riparian buffer is approximately \$3,600 - \$13,500.

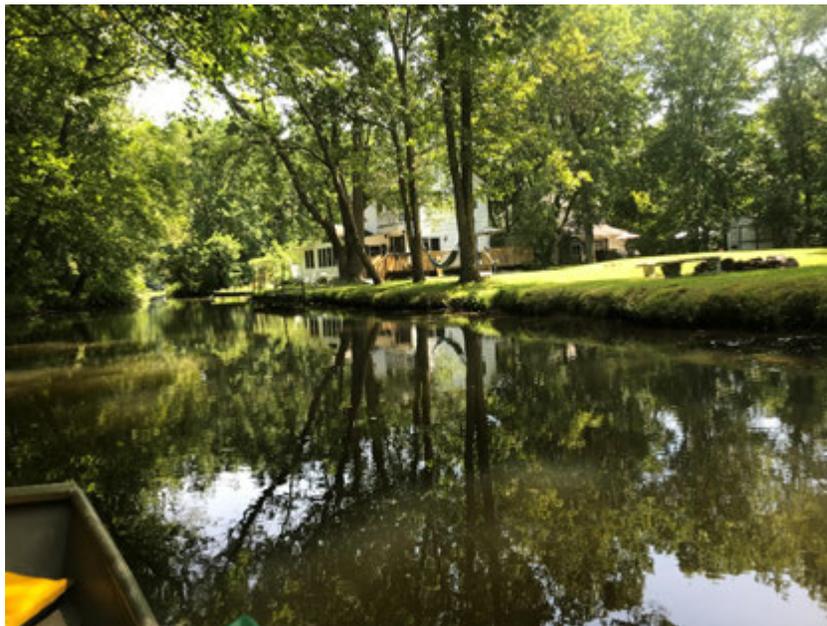
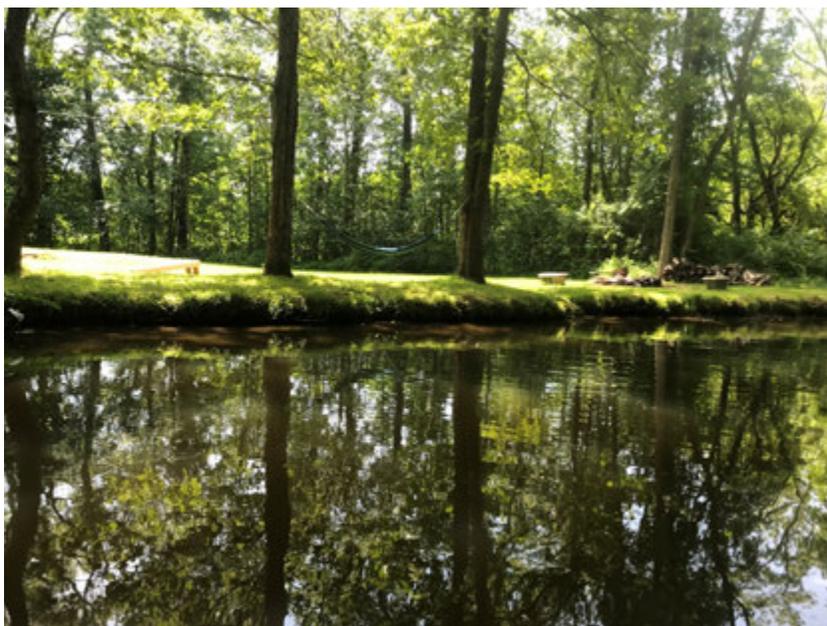
Recommended Measures: A vegetative riparian buffer in this location would provide multiple benefits, including the prevention of potential shoreline erosion and increased filtration of nutrients from stormwater runoff that originates on the residential property.

Estimated Costs: The estimated costs for the riparian buffer is approximately \$1,200 - \$4,500.

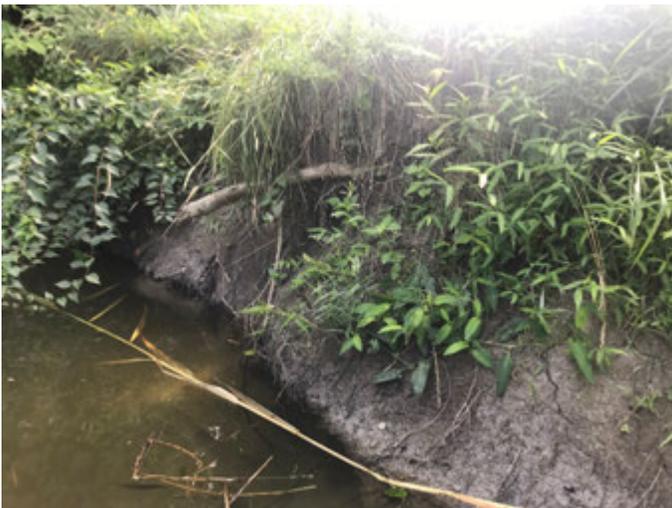
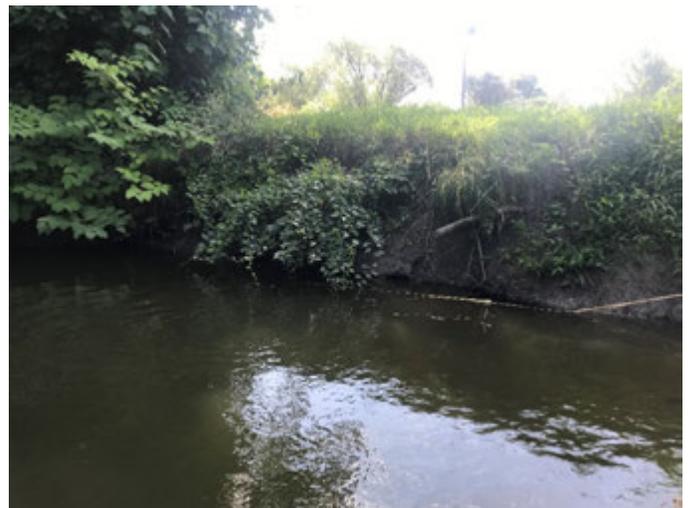
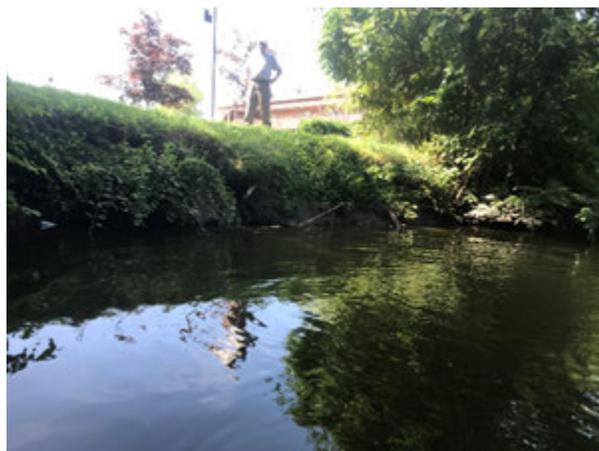
SITE 20: (B-6: RIGHT BANK ALONG PARKING LOT DOWNSTREAM OF UNION VALLEY ROAD)

The right bank of Belcher Creek along the parking lot referenced in Site 4 is the site most in need of restoration measures, as determined during the field assessment on 16 July 2019. Extensive erosion, including undercutting and bank scour, was observed along the right bank. Sediment deposition was observed in Belcher Creek downstream from this site. In addition to the erosion, the right streambank lacks an adequate riparian buffer. The gravel parking lot referenced in site 4 likely washes into Belcher Creek during storm events due to the lack of vegetation.

Recommended Measures: The right bank of this stream is an ideal candidate for bank stabilization to help address the erosion and sedimentation that is occurring. The streambank should be regraded to a gentler slope to allow for floodplain connectivity; the streambank is currently very steep. Re-grading the streambank would also help prevent flooding that is reported to occur in the adjacent parking lot. Once re-graded, the streambank toe can be further stabilized with riprap or another stabilization method that will allow the bank to absorb the impact of the stormwater without eroding. Additionally, a vegetative buffer would further enhance this site by acting as a nutrient filter for stormwater runoff and by stabilizing the streambank from further erosion.

Estimated Costs: The estimated cost for the streambank stabilization and riparian buffer enhancement is approximately \$7,500 – \$33,300.

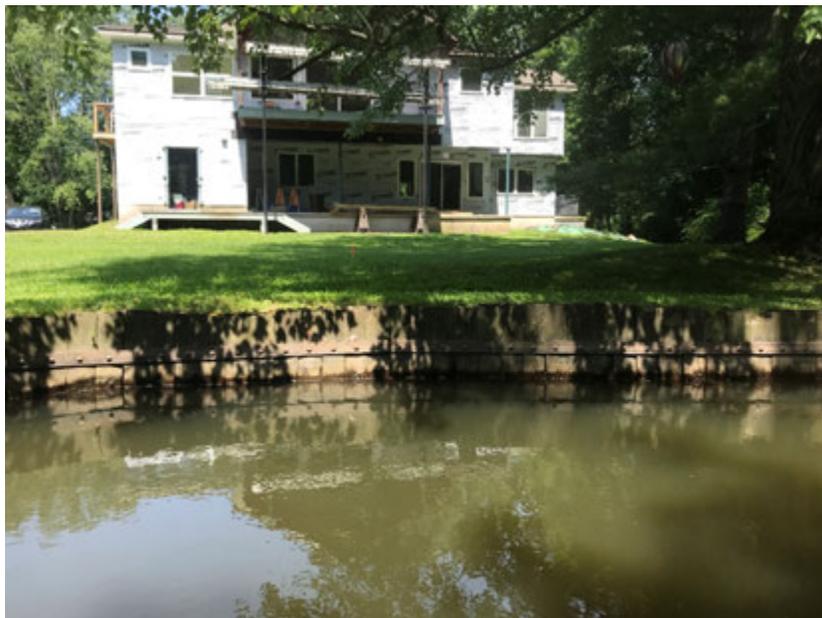
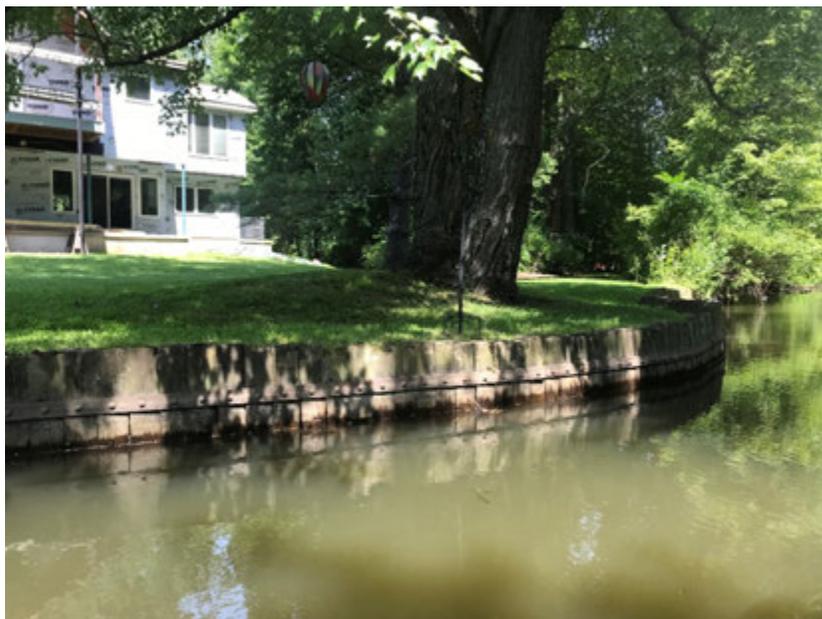
SITE 21: (B-9: RESIDENTIAL SHORELINE NEAR WINDSOR ROAD)

The left bank of Belcher Creek runs parallel to a residential shoreline just downstream of Windsor Road. The shoreline here lacks an adequate riparian buffer that would act as a nutrient filter from any residential stormwater runoff.

Estimated Costs: The estimated costs for the riparian buffer is approximately \$1,200 - \$4,500.

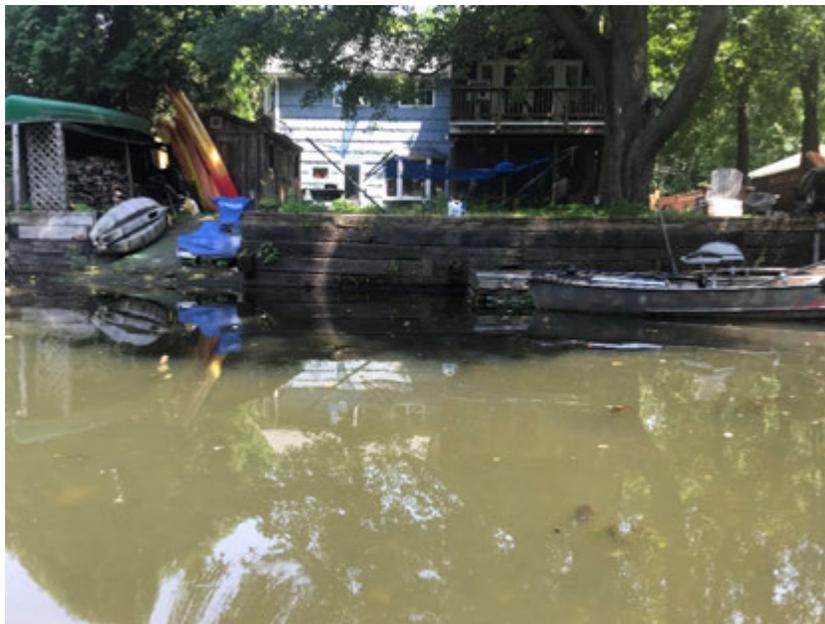
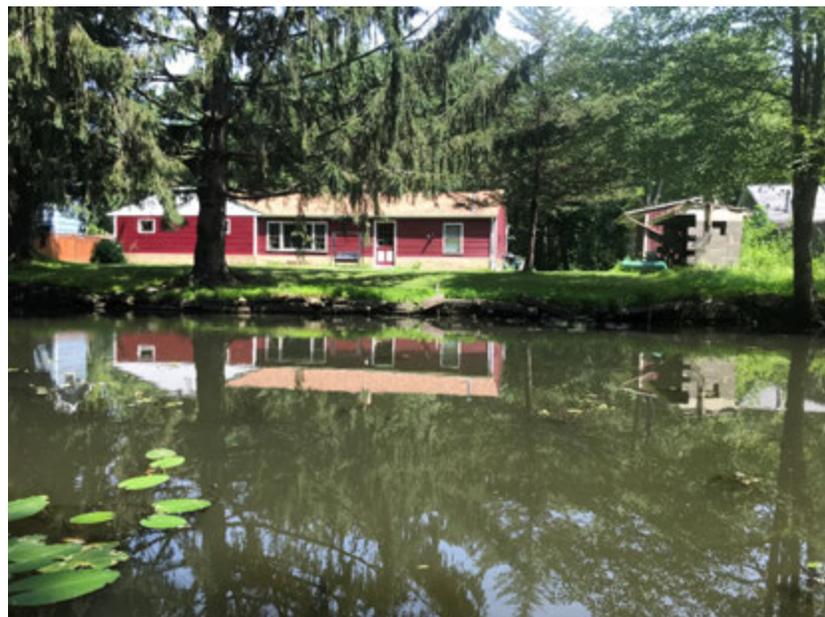
SITE 22: (B-10: BELCHER CREEK PARALLEL TO EDGE CUMB ROAD)

There is a side channel of Belcher Creek that runs for approximately 375 feet from Glencross Road to the main channel of the creek. This is the same section of the creek that has a large sediment bar from erosion from Glencross Road that was referenced in site 9. The creek channel is surrounded by residential properties on both sides that lack adequate riparian buffers for the majority of the channel.

Estimated Costs: The estimated costs for the riparian buffer is approximately \$1,800 - \$6,750.

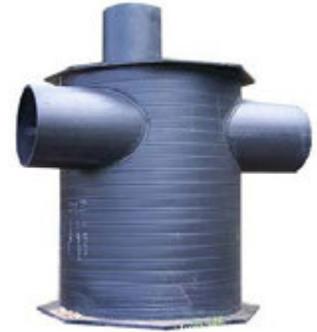
Ascribed Pollutant Removal Efficiencies:

- TSS reduction: 50%
- Total phosphorus removal rate: No data
- Total nitrogen removal rate: No data

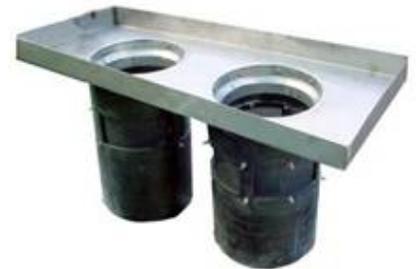
AQUA-GUARDIAN

Total phosphorus removal rate: No data

Total nitrogen removal rate: No data

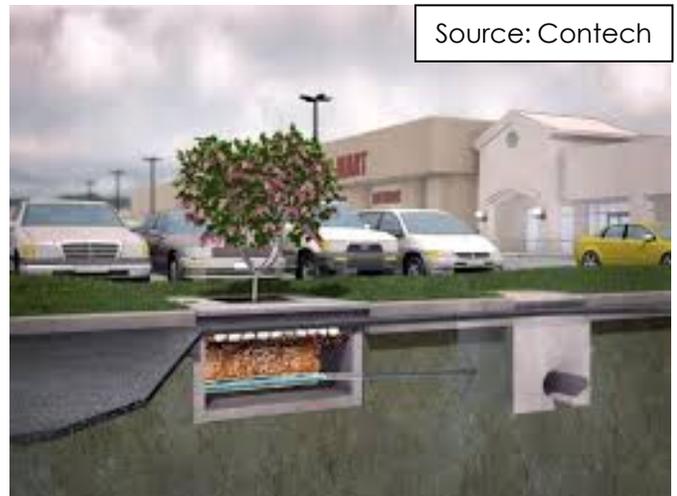
FILTERRA BIORETENTION SYSTEM

Total phosphorus removal rate: 70%

Total nitrogen removal rate: 40%
