# **GREENWOOD LAKE WATERSHED IMPLEMENTATION PLAN**

**WEST MILFORD TOWNSHIP, PASSAIC COUNTY, NEW JERSEY**

**JANUARY 2020**

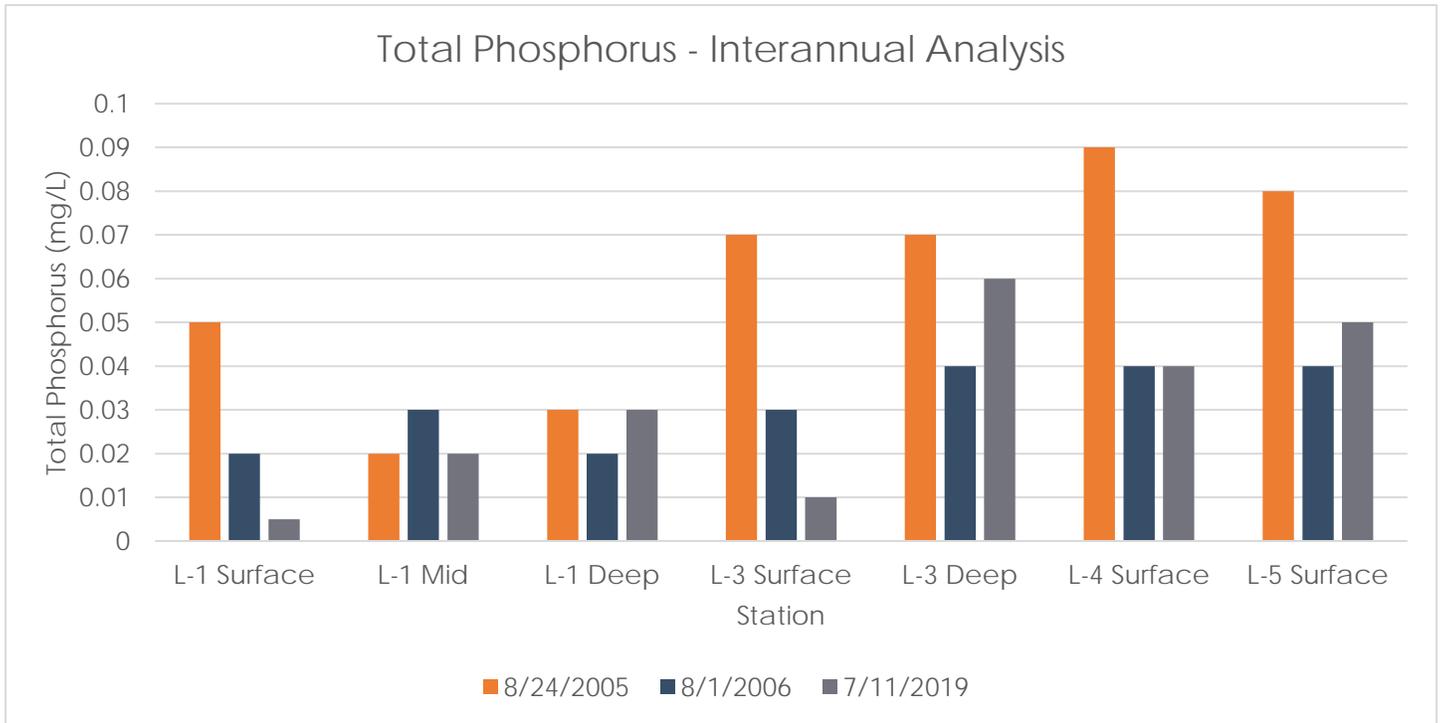
Figure 1: Total phosphorus concentrations in Greenwood Lake from 2005, 2006, and 2019.

2. A TMDL was established for TP in the New Jersey end of Greenwood Lake. TP concentrations in the surface waters of Greenwood Lake varied between non-detectable concentrations and 0.05 mg/L. TP concentrations contravened the TMDL upper limits during both the May and July sampling events. Deep water concentrations consistently exceeded the TMDL target during the 2019 season. Extremely elevated TP was noted in the deep waters of L1 due to extended periods of anoxia causing internal loading of P.

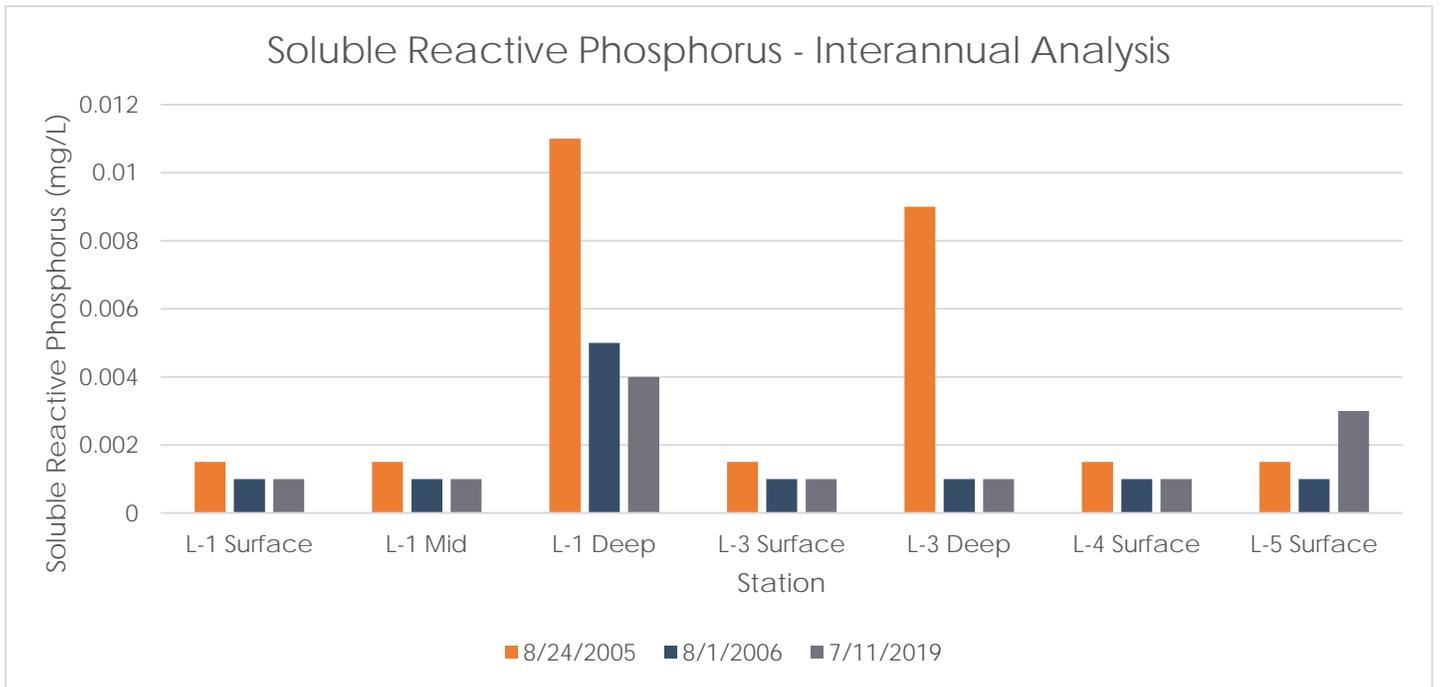
Figure 2: Soluble reactive phosphorus concentrations in Greenwood Lake from 2005, 2006, and 2019

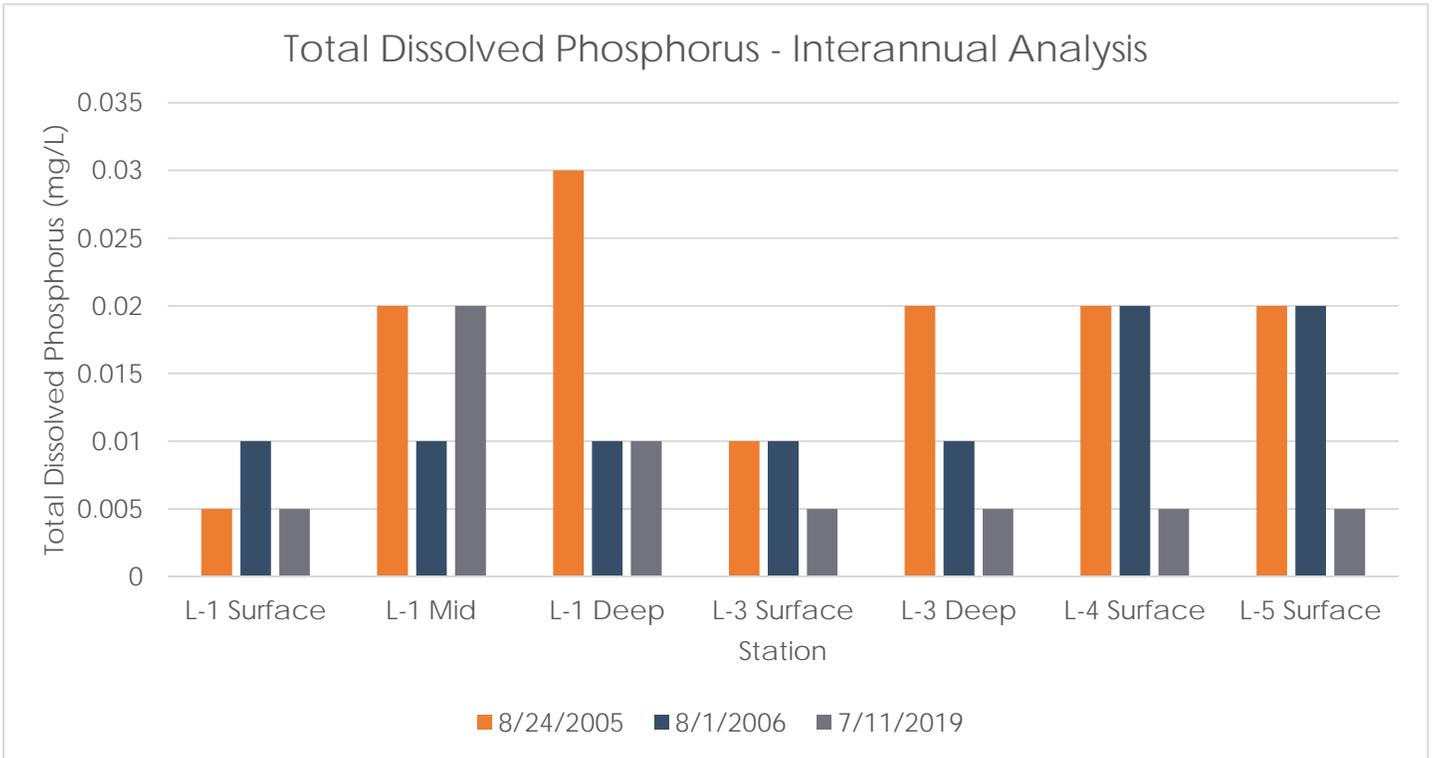
**Figure 3: Total dissolved phosphorus in Greenwood Lake in 2005, 2006, and 2019.**

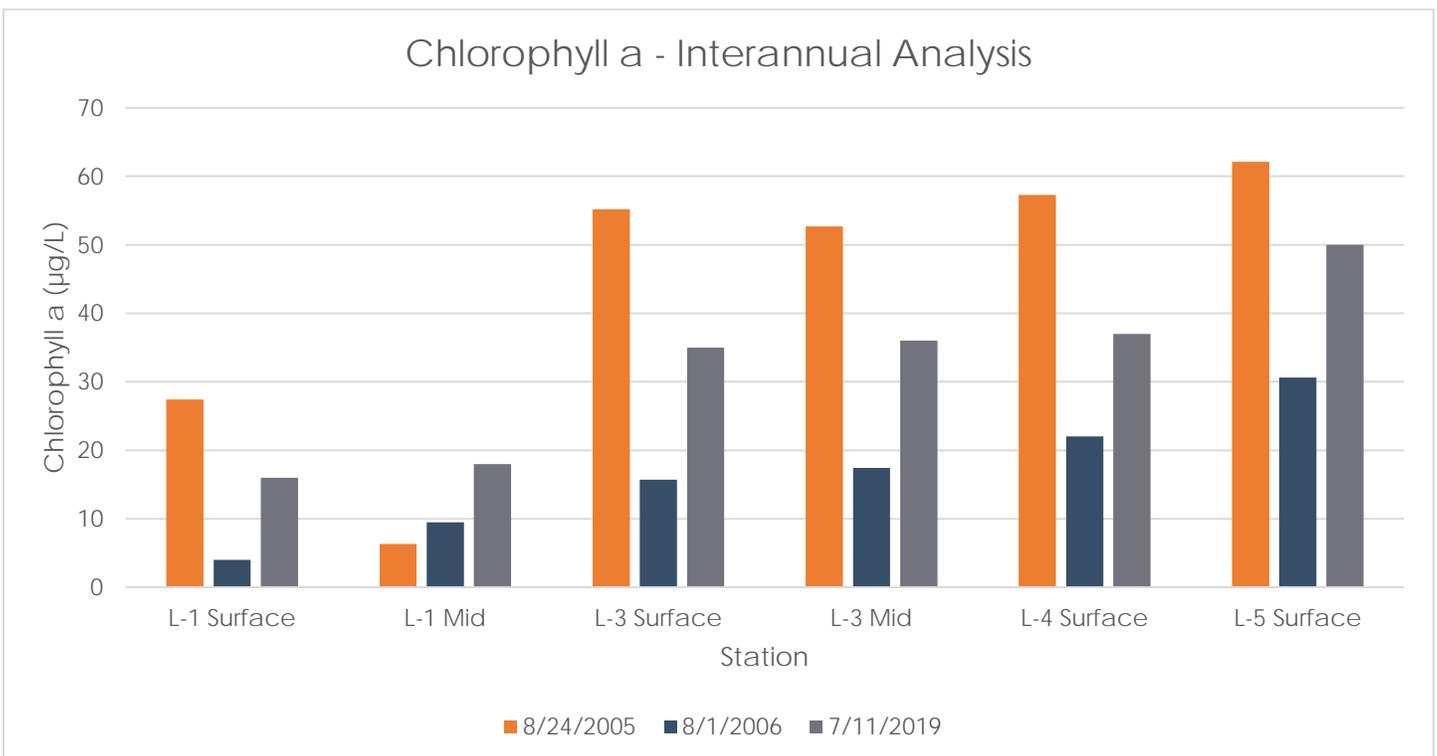
**Figure 4: Chlorophyll a concentrations in Greenwood Lake in 2005, 2006, and 2019.**

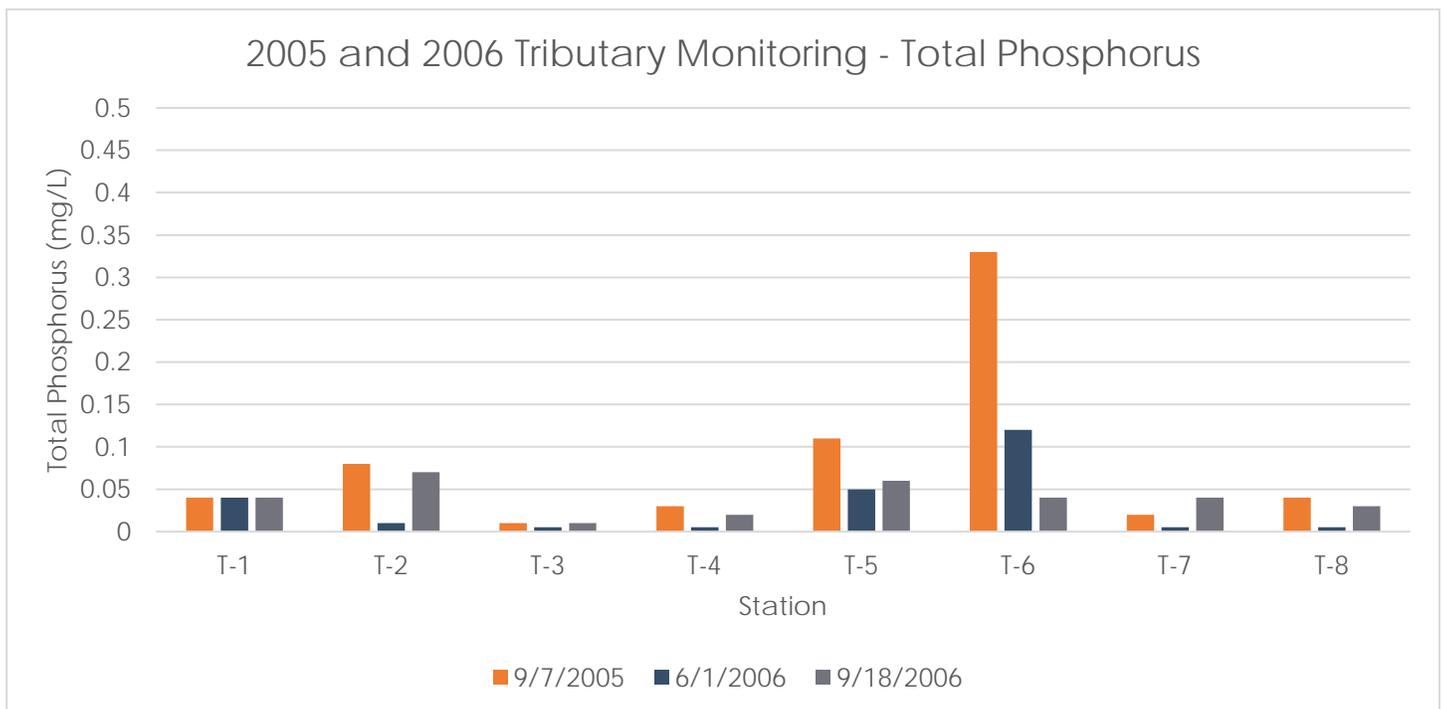
**Figure 5: Total phosphorus concentrations in tributaries of Greenwood Lake on 7 September 2005, 1 June 2006, and 18 September 2006.**

In addition to lake monitoring throughout the 2019 season, Princeton Hydro conducted sampling of various tributaries of Greenwood Lake (Appendix A at the end of the full water quality report). The purpose of this sampling was to determine sources of nutrient loading throughout the watershed in order to locate areas which may be prioritized for management efforts. Similar to the in-lake sampling, the tributary sampling in 2019 was conducted at the same sites that were sampled during the 2005 – 2006 season. Locations of all tributary sampling sites can be found in Appendices A and B at the end of the full water quality report. The tributaries were all sampled and analyzed for TP, and the results are presented in Figure 5 for 2005 – 2006 and Figure 6 for 2019.

Overall, nutrient loading in the various tributaries followed similar trends in 2019 to those observed in 2005 – 2006. For example, T-6 had the highest nutrient concentrations during both time periods, although the July and September sampling events in 2019 were much higher than those observed in 2005 – 2006; TP concentrations reached a maximum of 1.8 mg/L on 11 July 2019. Sampling site T-5 had the second highest TP concentrations during both time periods, although the July event was again much higher in 2019. All other tributaries were much lower in TP concentrations than T-5 and T-6 during both time periods, with nutrient concentrations varying between 0.005 mg/L – 0.1 mg/L. All other tributaries did not necessarily exhibit a reduction in TP concentrations between the time periods, and in many locations were often slightly higher in 2019. TP concentrations in all tributaries besides T-5 and T-6 were slightly elevated at times, although never exceeded the New Jersey Surface Water Quality Standard of 0.1 mg/L for TP in streams. It is clear that tributary locations T-5 and T-6, located at the outlet from the former West Milford Lake at Marshall Hill Road and Morestown Brook at Marshall Hill Road, respectively, are significant sources of TP loading to Greenwood Lake and are ideal locations for the implementation of BMPs.

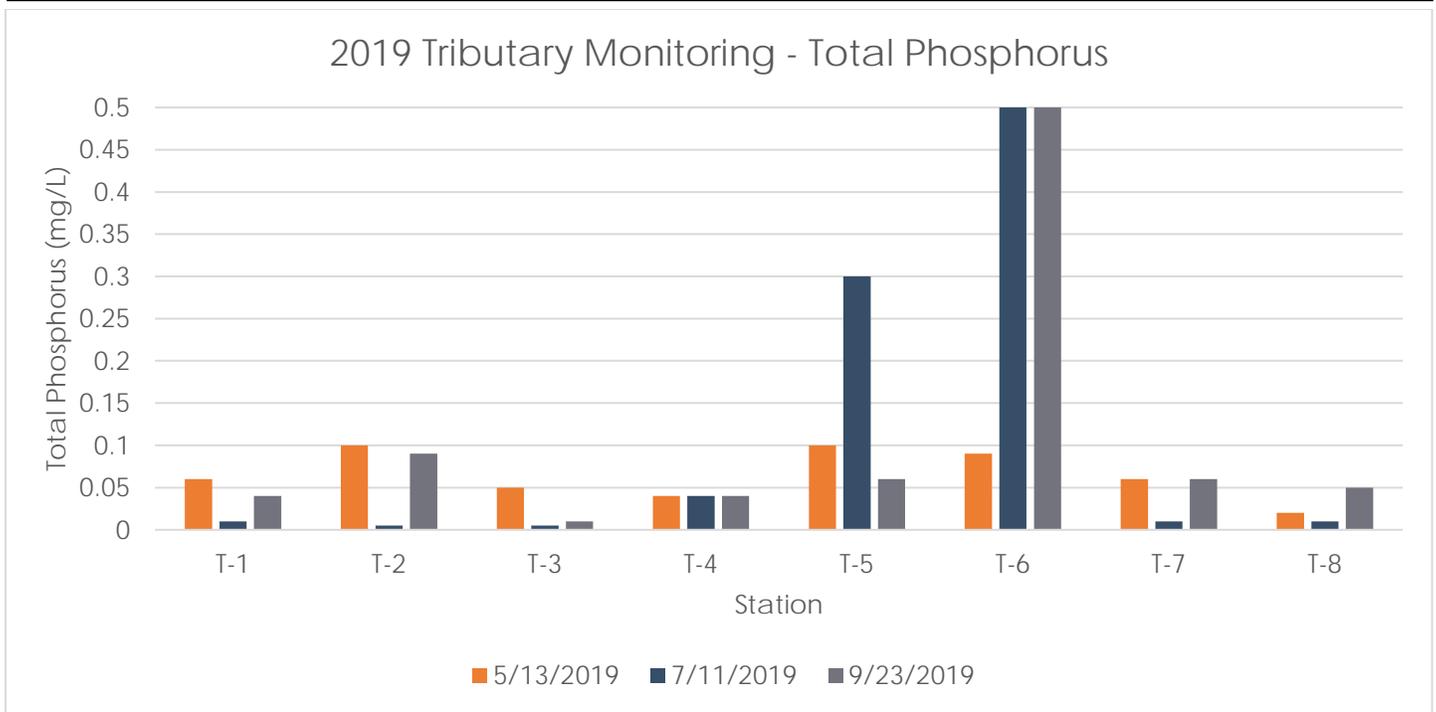
Figure 6: Total phosphorus concentrations in tributaries of Greenwood Lake on 13 May 2019, 11 July 2019, and 23 September 2019.

\*Note that the actual values for 11 July 2019 and 23 September 2019 are 1.8 mg/L and 0.89 mg/L, respectively. The x-axis stops at 0.5 mg/L so all other values can be visually represented.

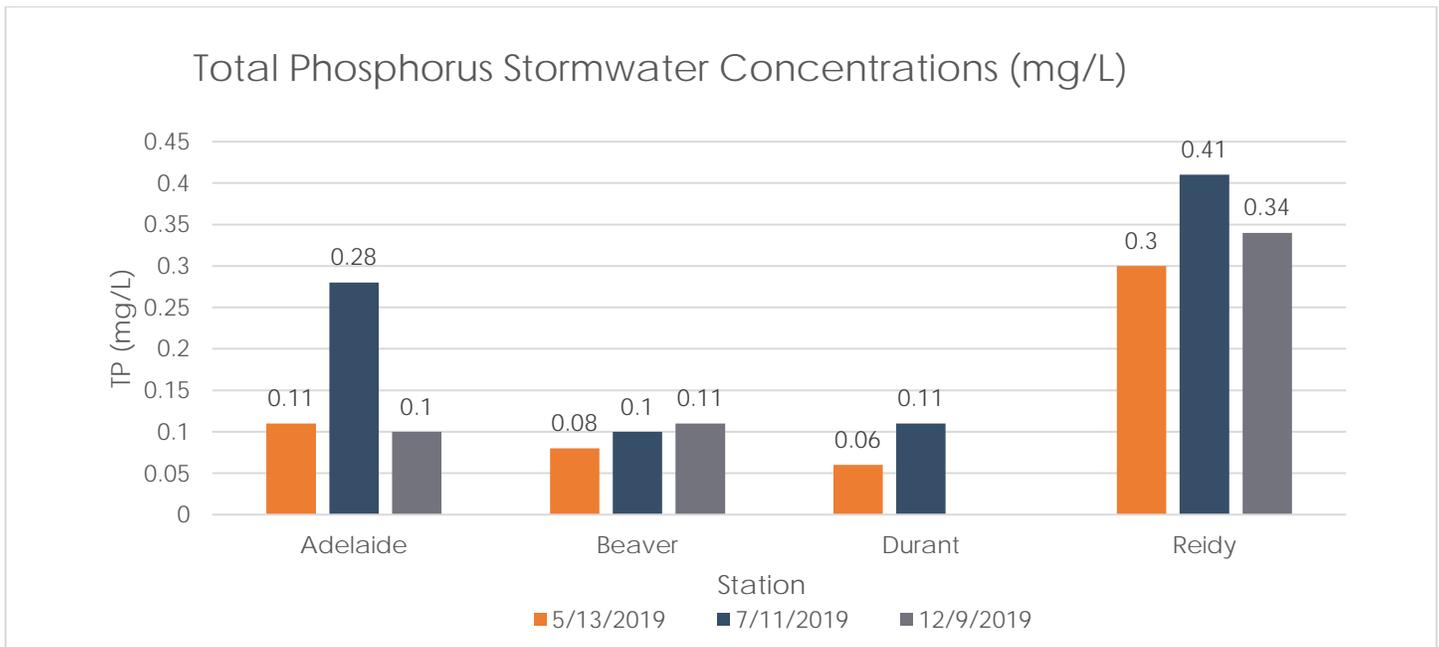
**Figure 7: TP concentrations at all stormwater sampling sites on 13 May 2019, 11 July 2019, and 9 December 2019.**

Stormwater samples at Beaver Avenue were taken directly from the outflow pipe of the nutrient separating baffle box at Belcher Creek. TP and TSS concentrations were similar to those at Adelaide Terrace, although concentrations during the July sampling event were not elevated to the degree that was observed at Adelaide Terrace. TP concentrations ranged from 0.08 mg/L – 0.11 mg/L and TSS concentrations ranged from 1.0 mg/L – 9.0 mg/L. Similar to what was observed at Adelaide Terrace, TSS removals in the MTD appear to be great and while TP concentrations were not extremely elevated, this site would remove more phosphorus if the MTD were coupled with green infrastructure. It is not always possible to incorporate green infrastructure, as was the case with the Adelaide Terrace and Beaver Avenue MTDs but will be incorporated wherever possible moving forward.

Durant Road were the lowest of the four sites. TP concentrations ranged from 0.06 mg/L – 0.11 mg/L and TSS concentrations from 3.0 mg/L – 4.0 mg/L. The reason for the reduction in TP concentration relative to the other sites is likely due to the extra treatment that the stormwater receives when passing through the filter strip. In addition to the lower nutrient concentrations, the filter strip also reduces the quantity of stormwater that enters Belcher Creek via surface flow due to the associated infiltrative properties, further lowering the nutrient load. As such, this set of BMPs appears to be the most effective of the four sites that were sampled and will be considered for future implementation wherever applicable.

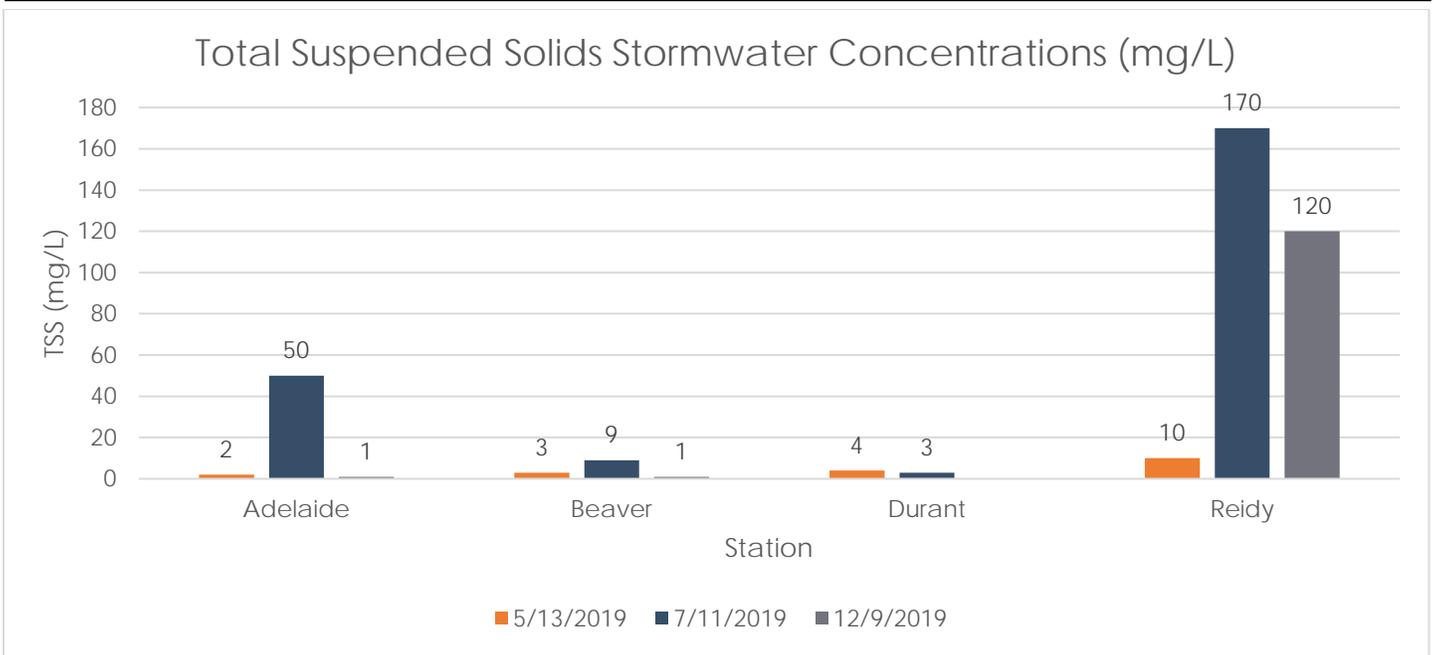
**Figure 8: TSS concentrations at all stormwater sampling sites on 13 May 2019, 11 July 2019, and 9 December 2019.**

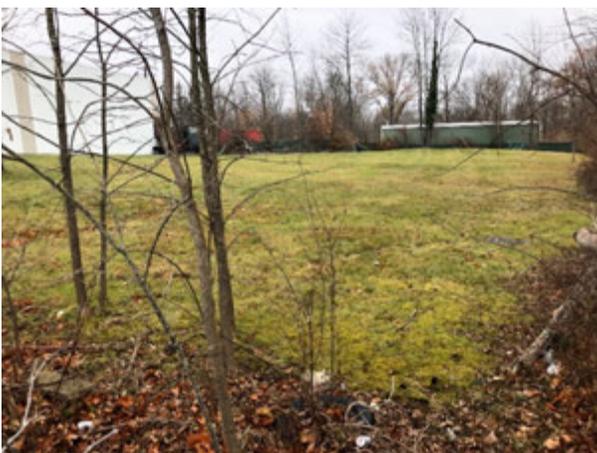
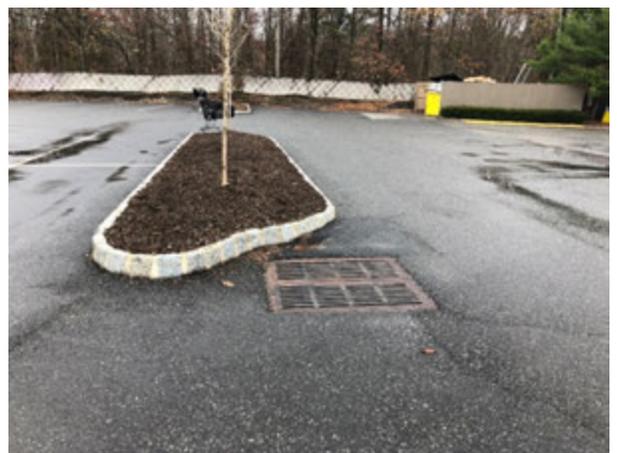
There are other catch basins and storm drains around the parking lot that could also be retrofit with smaller MTDs and/or Filterra tree boxes.

**Estimated Costs:** The estimated cost of the design and installation of a nutrient separating baffle box and the bioretention system is approximately \$406,300. The estimated cost of the design and installation of a Filterra is approximately \$130,000 per unit.

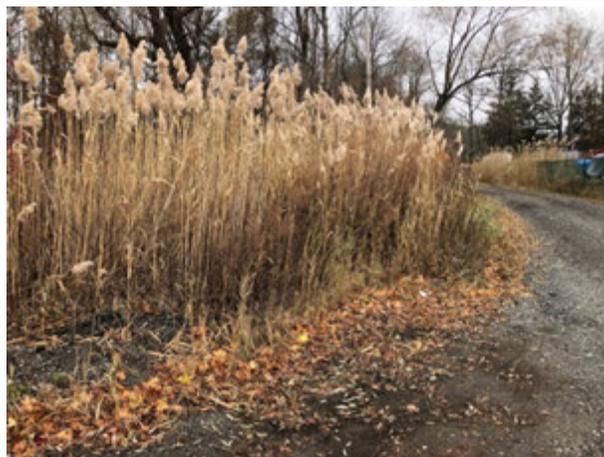
## SITE 4: REAR PARKING LOT ON NEW JERSEY AVENUE

The rear parking lot behind the small strip of stores on the corner of New Jersey Avenue and Union Valley Road is located directly next to Belcher Creek and is almost entirely made of loose gravel. The rear half of the parking lot was not being utilized during the two site visits that Princeton Hydro made to this site and appears to be unfinished due to the curbing within the vegetation. There is a lack of a riparian buffer between the parking lot and Belcher Creek and there is a large patch of the invasive *Phragmites australis* (phragmites) near the back corner of the parking lot where pollution from trash and other debris is extensive.

The patch of phragmites in the back corner of the parking lot should also be removed and replaced with native vegetation that would function as a rain garden. The installation of the rain garden could possibly require some minor modifications to deepen the depression but would work to further reduce the nutrient load into Belcher Creek.

**Estimated Costs:** The estimated cost of the design and implementation of the extended filter strip is approximately \$203,500 and the rain garden is approximately \$105,500.

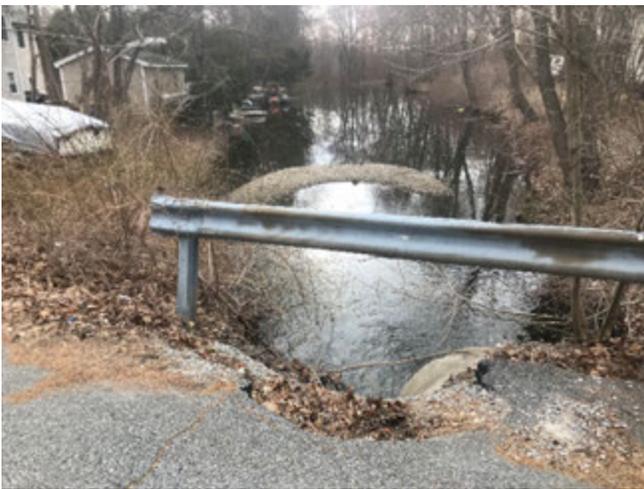
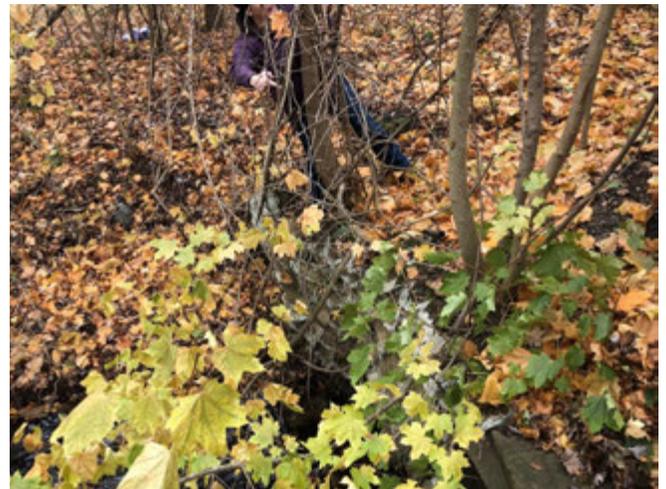
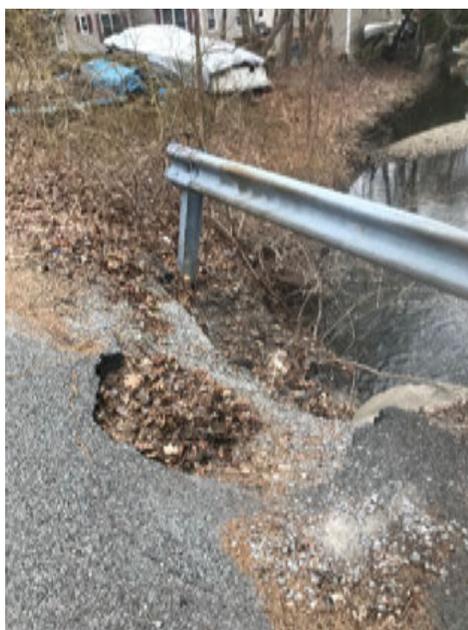
## SITE 9: HEADWALL OF BELCHER CREEK AT GLENCROSS ROAD

The downstream side of Glencross Road at the Belcher Creek stream crossing is actively eroding from runoff and is creating a sediment bar just downstream in the channel to Belcher Creek. There are currently sandbags installed as a method to control the erosion and stabilize the area. The erosion of the bank is creating a sizeable hole in the road that is already a safety concern and will only get worse if not addressed. While this site is not a huge priority for nutrient reductions, the eroding road should be addressed as a safety concern.

**Recommended Measures:** This site would benefit from the construction of a headwall along Glencross Road to prevent the future erosion into Belcher Creek.

**Estimated Costs:** The estimated cost of the design and installation of a headwall is approximately \$115,000.

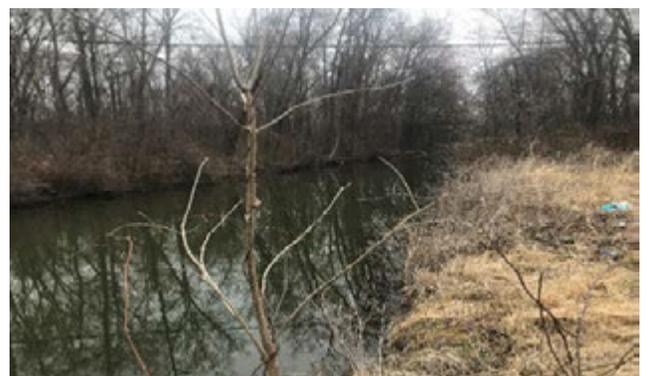
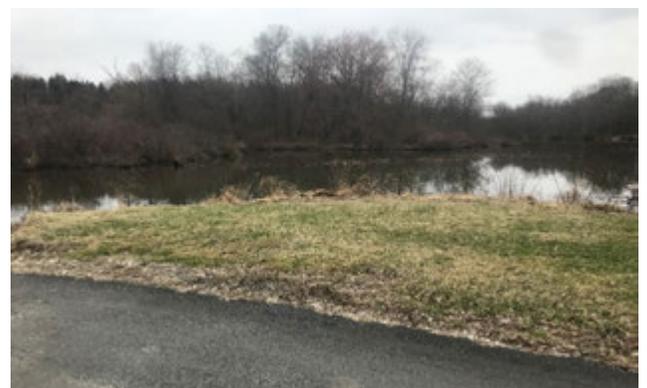
**Recommended Measures:** This community as well as Belcher Creek and Greenwood Lake would benefit from becoming a sewerred community. The sewerred would be not be connected to the other sewerred sections of West Milford Township but instead have its own community treatment system located to the south of the community. The proposed system is anticipated to connect to the existing watertight septic tanks at each residence, flow via gravity pipes to the mains in each of the streets, a lift or pump station near the intersection of Sophie and Wallisch Avenues. The pump station would discharge to a treatment facility and ultimately be discharged via land application. It has also been suggested that this community might be well served by being connected to an existing plant like Birch Hill.

**Estimated Costs:** The estimated cost for the design and implementation of a community wastewater treatment system in the open green space is approximately \$5.6 million. Connection to an existing plant has not yet been estimated.

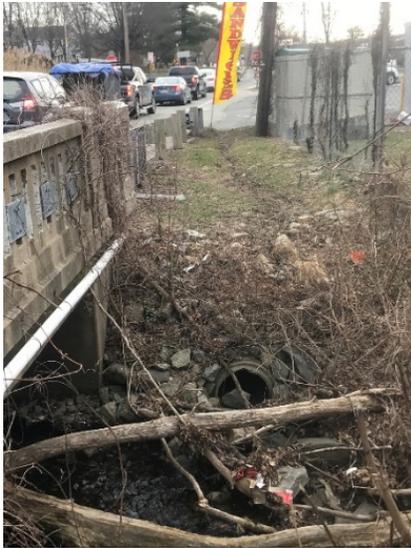
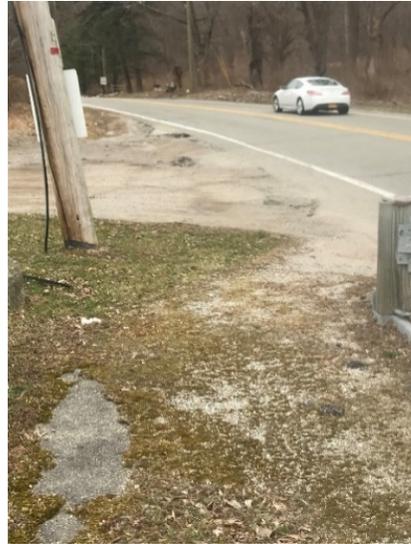
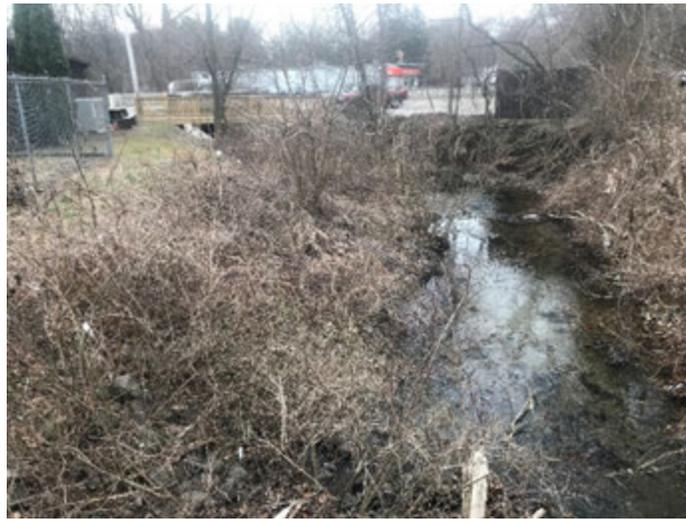
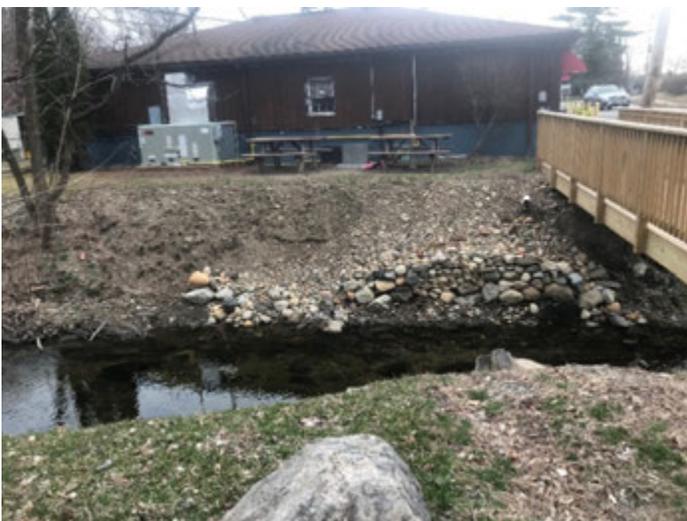
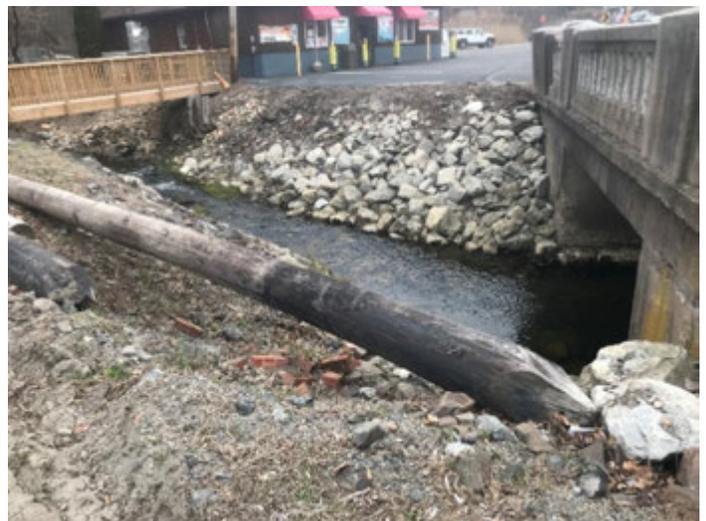
**Recommended Measures:** This site is an ideal candidate for bioengineered streambank stabilization from Warwick Turnpike to Union Valley Road and on both streambanks. This could include boulder toe with vegetated soil wraps. This will require regrading of the slopes and excavation in order for proper placement of the stabilization measures. The increased vegetative cover along the streambanks will better hold the soil in place and the installation of boulder toe protection with vegetation will prevent future erosion. In addition to the stream, the drainage path between Warwick Turnpike and Cooley Brook could also be addressed to prevent the future erosion and to assist in nutrient removal from stormwater runoff. This work could consist of bioengineered stream bank with stabilized conveyance systems on both sides of the stream. It may be possible to replace the outflow pipe that drains water from Warwick Turnpike along the left bank of Cooley Stream with vegetated conveyance system that would aid in nutrient removal, but further investigations would be required.

Pictures can be found on the following page.

**Estimated Costs:** The estimated cost for the design and implementation of road to road bioengineered streambank stabilization is approximately \$570,000.

The estimated cost for the design and implementation the bioengineered bank stabilization with vegetated conveyance systems is approximately \$150,000.

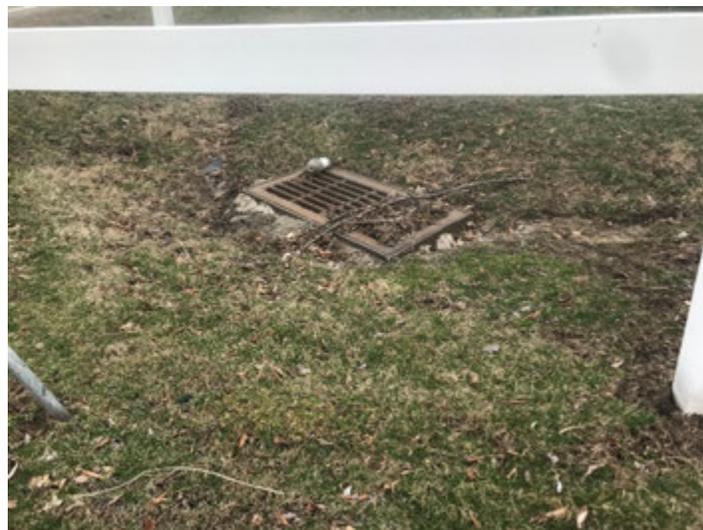
## SITE 15: OUR LADY QUEEN OF PEACE CHURCH

Our Lady Queen of Peace church is located on the corner of Union Valley Road and Elm Street. There is a catch basin located in a small depression on the grassy area of this corner. The concrete structure of the catch basin appeared to be in poor condition during the site visit and organic debris was built up on top of the grate. There are no curbs or swales on the adjacent road, and the grass area between the road and catch basin was also showing signs of erosion and sedimentation.

**Recommended Measures:** The catch basin in the grassy area on the corner of Union Valley Road and Elm Street is an ideal candidate for the installation of a rain garden. The rain garden would receive runoff from both Union Valley Road and Elm Street and would reduce the discharge rate of stormwater by allowing the water to infiltrate into the soil, and the plants would utilize some of the available nutrients.

**Estimated Costs:** The estimated cost of the design and installation of a rain garden on the corner of Union Valley Road and Elm street would be approximately \$176,300.

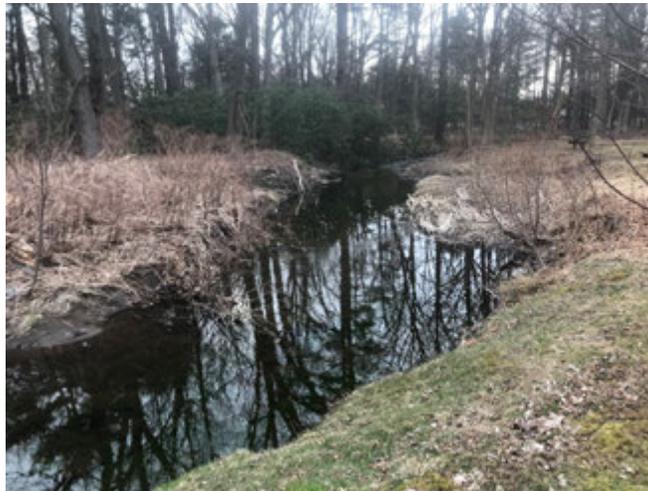
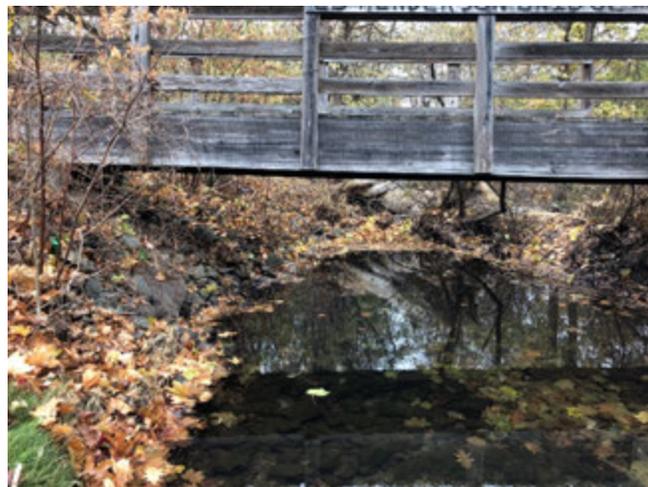
Cooley Brook passes across the back of the Elks Lodge property right before it empties into Green Brook. The streambanks appeared to be in relatively good condition, although the right bank lacked a sufficient vegetative buffer between the stream and the Elks Lodge property. Minor erosion is occurring under the foot bridge that is causing a widening of the stream here. There is also a downed tree just upstream of the foot bridge that is likely causing head cut erosion on the streambed.

**Recommended Measures:** The first recommended measure at this site is to enhance the riparian buffer between the stream and Elks Lodge from a grass to meadow buffer to help intercept stormwater and reduce the nutrient loads. The downed tree in the stream should also be removed to allow for the natural flow of water under the bridge.

**Estimated Costs:** The estimated cost for the enhancement of the riparian buffer and the removal of the downed tree is approximately \$75,000.

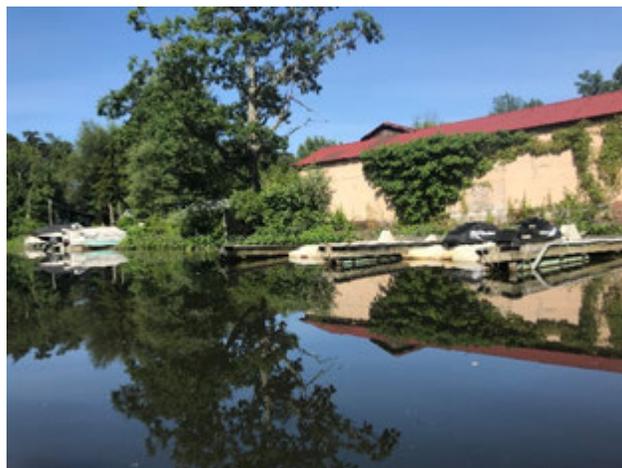
**Recommended Measures:** A vegetative riparian buffer in this location would provide multiple benefits, including the prevention of potential shoreline erosion in areas without a bulkhead and increased filtration of nutrients from residential stormwater runoff. The right bank should be prioritized for a riparian buffer. Additionally, the placement of a floating wetland island in this section of the creek would sequester nutrients before the water empties into Greenwood Lake and would provide habitat and protection from the sun for fish and other aquatic organisms. There appear to be a few locations along either shoreline where a floating wetland island could be tucked in off the main channel, protecting the island during periods of heavy flow. The floating wetland island would have to be placed in a protective location and tied to the shoreline for protection.

**Estimated Costs:** The estimated costs for the riparian buffer and a floating wetland island is estimated to cost between \$11,400 - \$15,400.
