**CAMP MEETING AVENUE OVER  
TRENTON LINE (CSX)  
STRUCTURE NO. 1850-160  
MONTGOMERY TOWNSHIP, SOMERSET COUNTY  
PRELIMINARY DESIGN SUBMSISION REPORT**

**BRIDGE REHABILITATION REPORT AND  
SHPO DOCUMENTATION**

**PRELIMINARY DESIGN SUBMISSION REPORT  
BRIDGE REHABILITATION REPORT AND SHPO DOCUMENTATION**

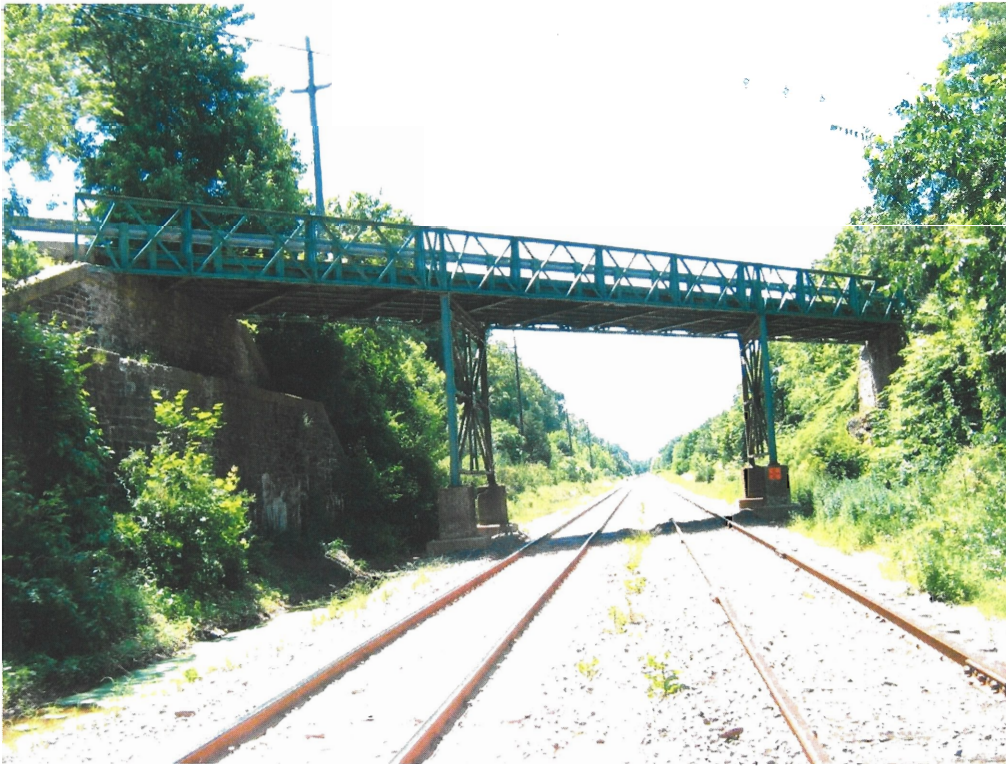
**PHOTO- 1****DESCRIPTION:**

Bridge Elevation,  
looking south.

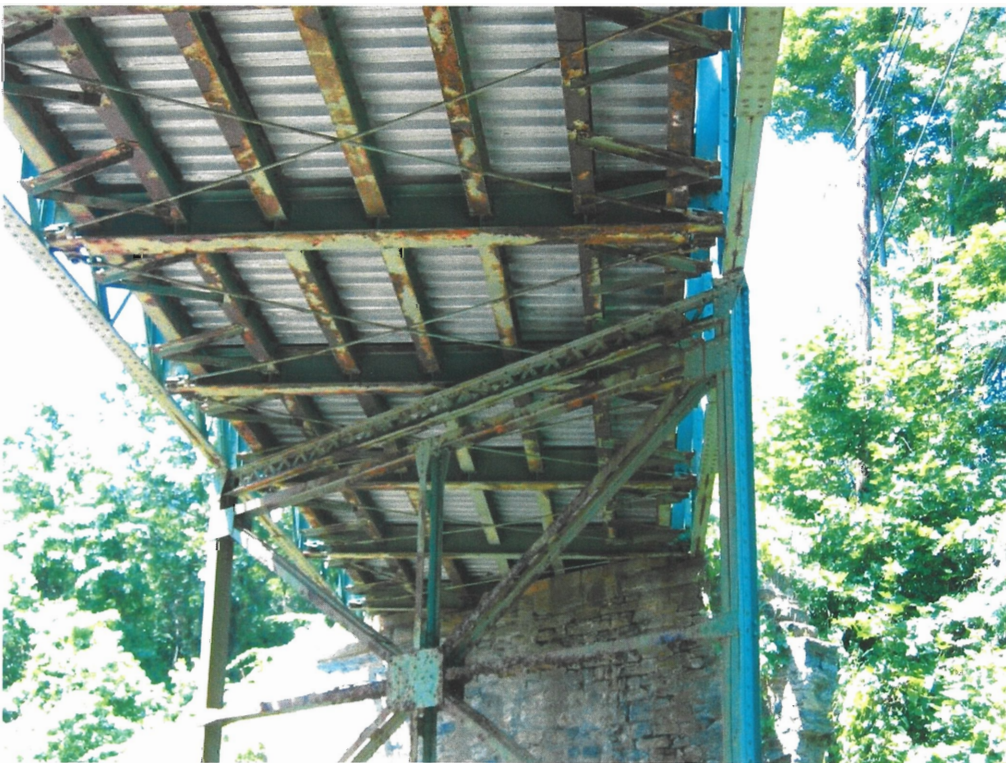
**PHOTO- 2****DESCRIPTION:**

General underdeck  
view, looking west.

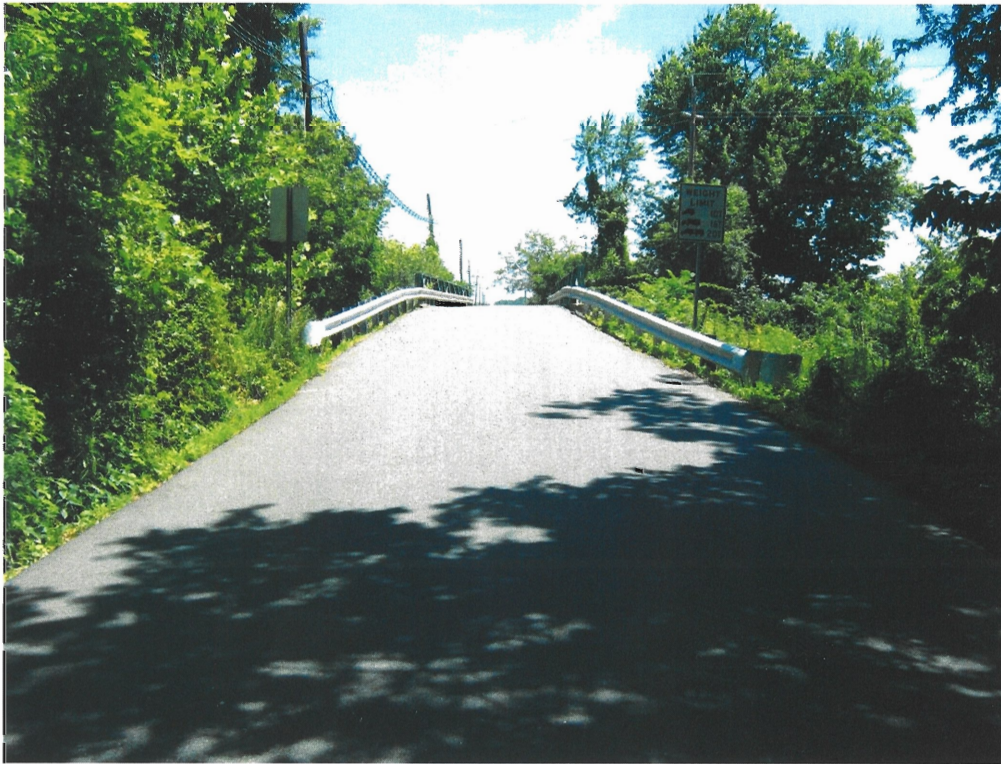
**PHOTO- 3**

DESCRIPTION:  
Bridge Approach,  
looking east.

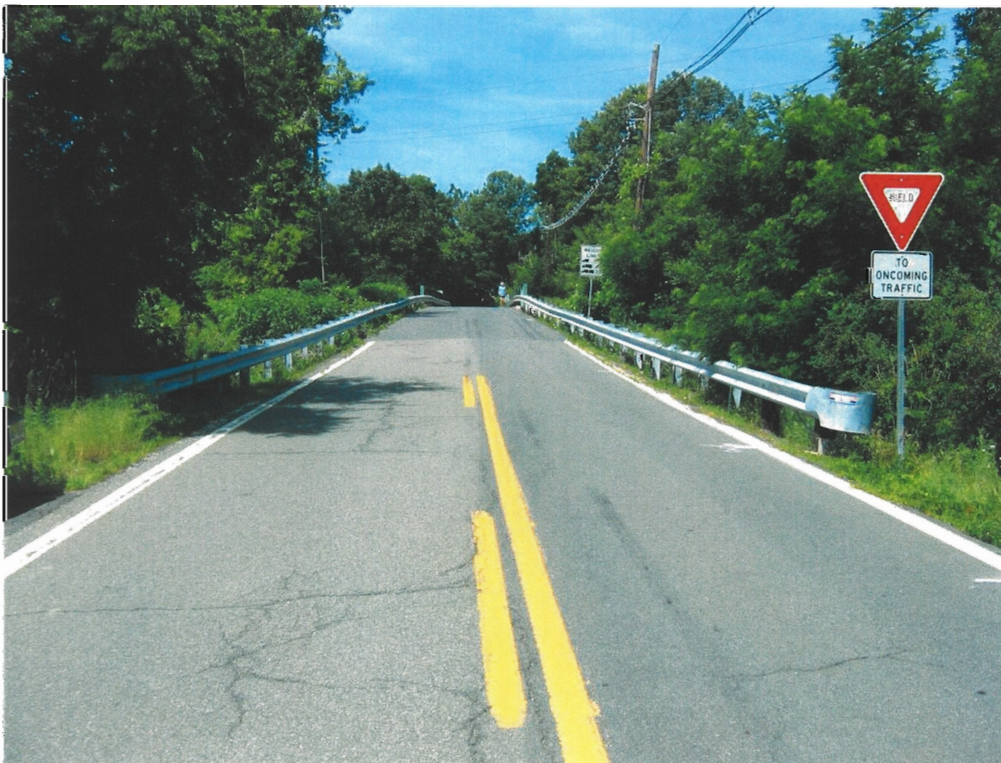
**PHOTO- 4**

DESCRIPTION:  
Bridge Approach,  
looking west.

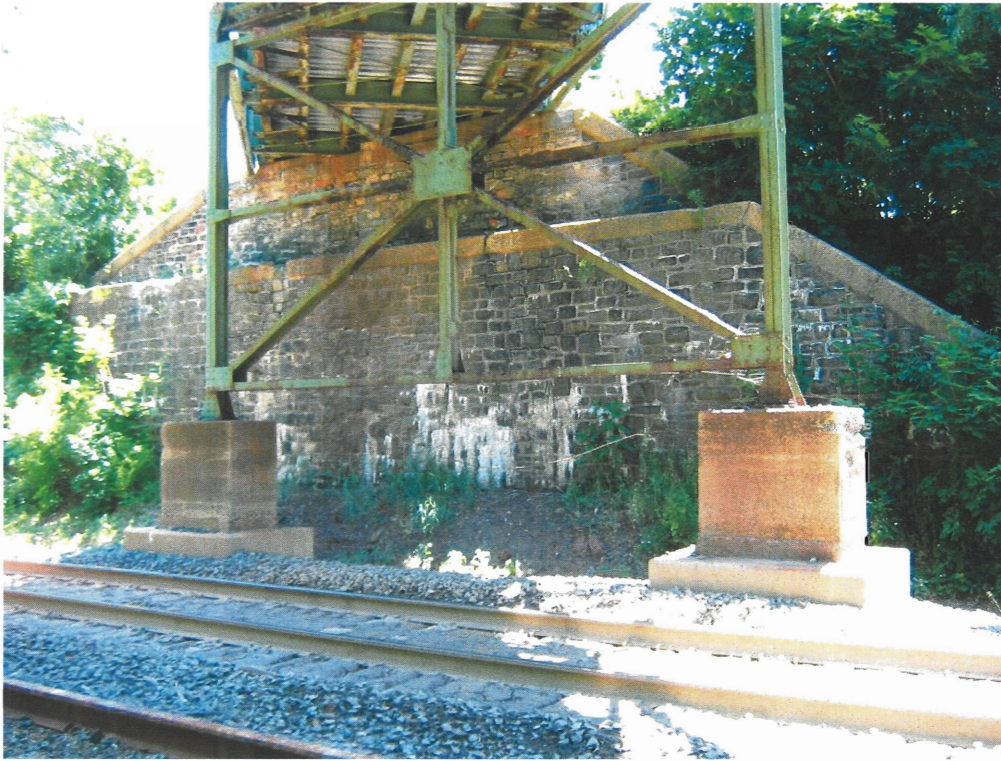
**PHOTO- 5**

DESCRIPTION:  
East Abutment and  
Bent, looking east.

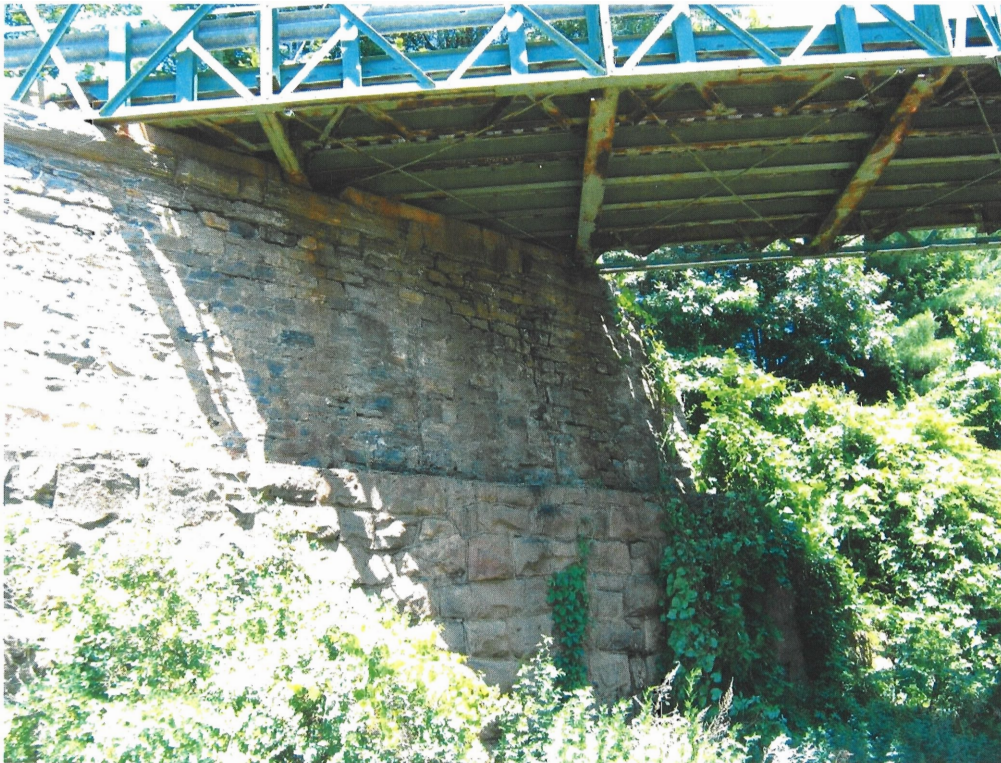
**PHOTO- 6**

DESCRIPTION:  
West Abutment

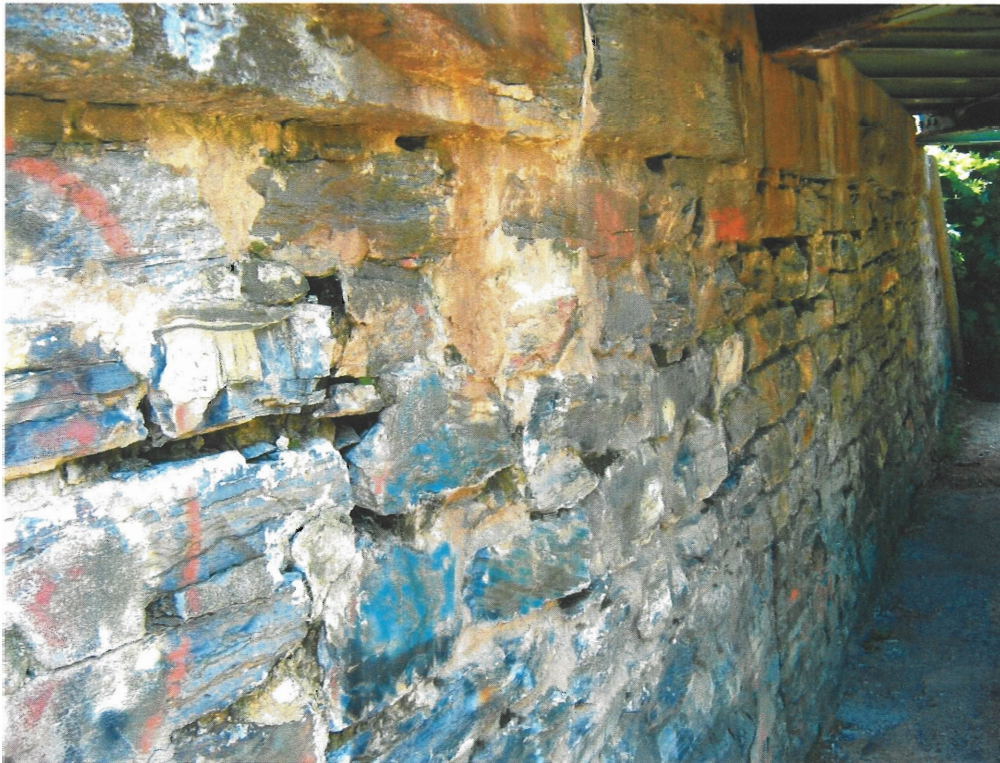
**PHOTO- 7****DESCRIPTION:**

Findings from previous inspection reports also indicate that the deck was in serious condition due to the extensive section loss of the load bearing steel members, impact damages, medium to large cracks and loss of pointing in the masonry of abutments.

East Abutment:  
Loss of mortar,  
cracked and settled  
masonry stones,  
especially under truss  
supports.

It is recommended to replace the Camp Meeting Avenue Bridge in its entirety with a single span structure on the same alignment. The roadway traffic will be detoured and a detour plan developed, but the railroad traffic under the bridge will be maintained and protected during reconstruction.

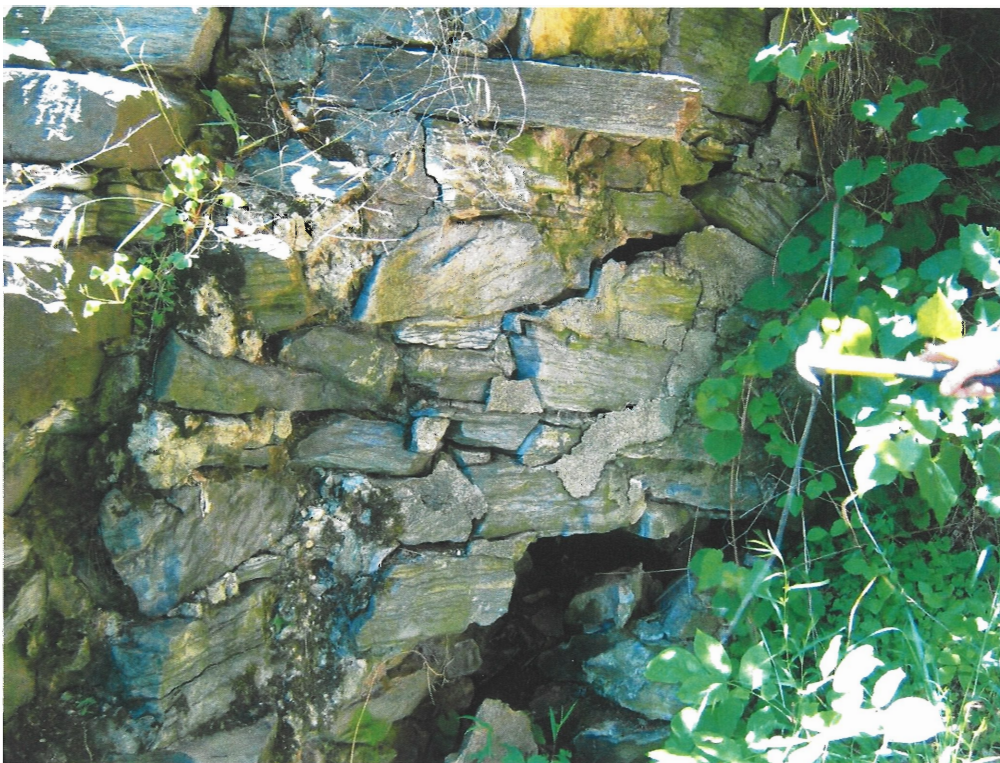
**PHOTO- 8****DESCRIPTION:**

Northwest Wingwall:  
Loss of mortar and  
cracks in the masonry  
with loose stones.

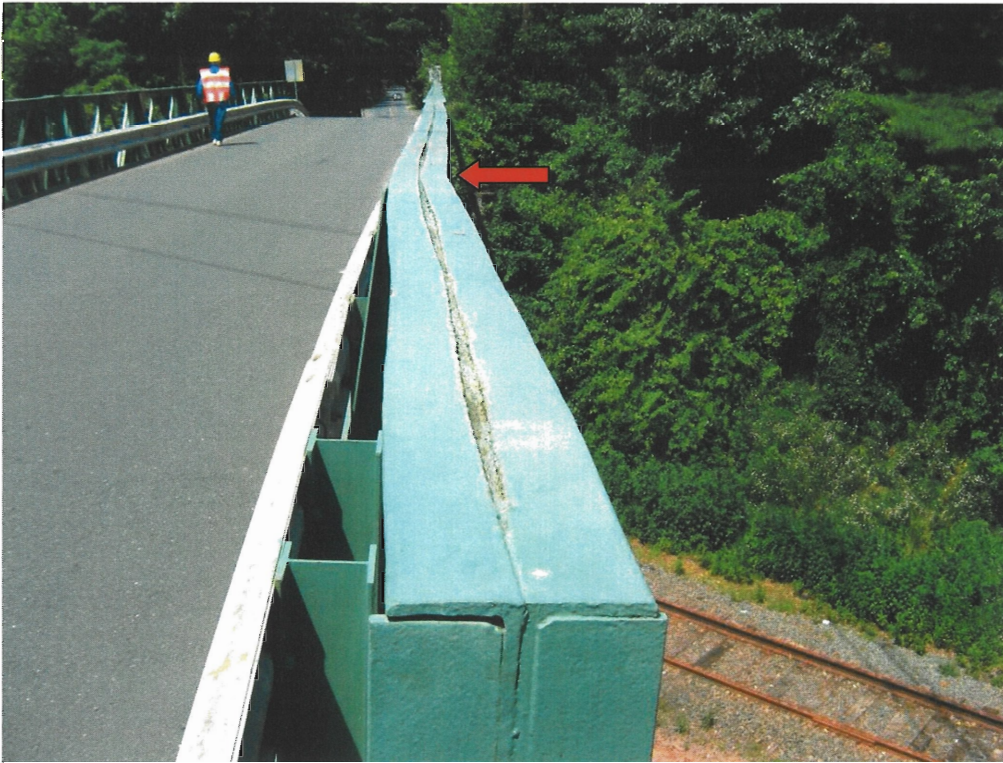
**PHOTO- 9****DESCRIPTION:**

North Fascia Truss:  
Looking west.

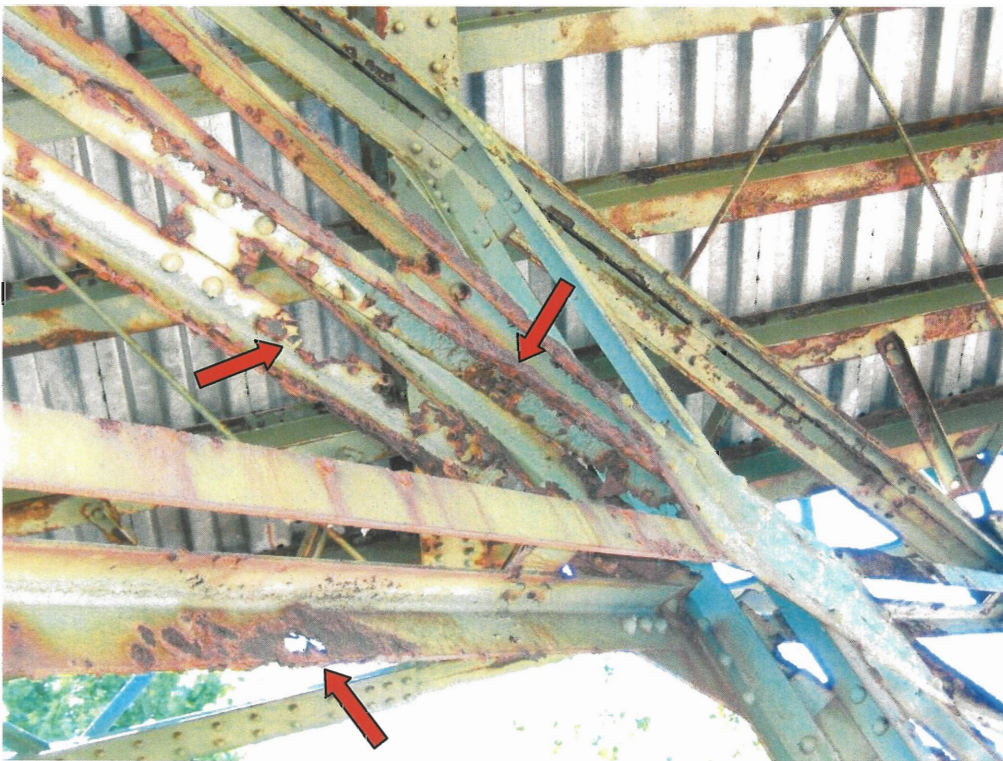
**PHOTO- 10****DESCRIPTION:**

The steel built-up bent type piers are supported on concrete pedestals. These piers have substandard lateral clearance from the railroad tracks and exhibit extensive section loss and impact damages.

General condition of  
Bent members,  
excessive rust and  
loss of section.

The proposed structure will locate the abutments between the existing pier bents and abutments. The pier bents will be removed, however removing the abutments might be expensive and it is considered unnecessary, except for the top portion as necessary for roadway construction and grading. Constructing a new full height abutment might require foundations that most likely would conflict with existing footings and compromise stability of the existing abutments.
