## **APPENDIX II**

### **Record Plans for Rt. 29**

New Jersey  
State Highway Department  
**GENERAL PROPERTY PARCEL MAP**  
ROUTE 29A (1927) SECTION 4  
ROUTE 29 (1953)  
From one mile north of Byram to Kingwood Station  
Showing Existing Right of Way  
& Parcels To Be Acquired In The  
Township of Kingwood County of Hunterdon  
May 1953

STATE OF NEW JERSEY  
HIGHWAY DEPARTMENT  
PLANS OF  
ROUTE 29A (1927) SECTION 5A  
ROUTE 29 (1953)  
From Raven Rock to one mile north of Byram  
PARTIAL GRADING  
Delaware and Kingwood Townships Hunterdon County  
Scales as Indicated December 1953

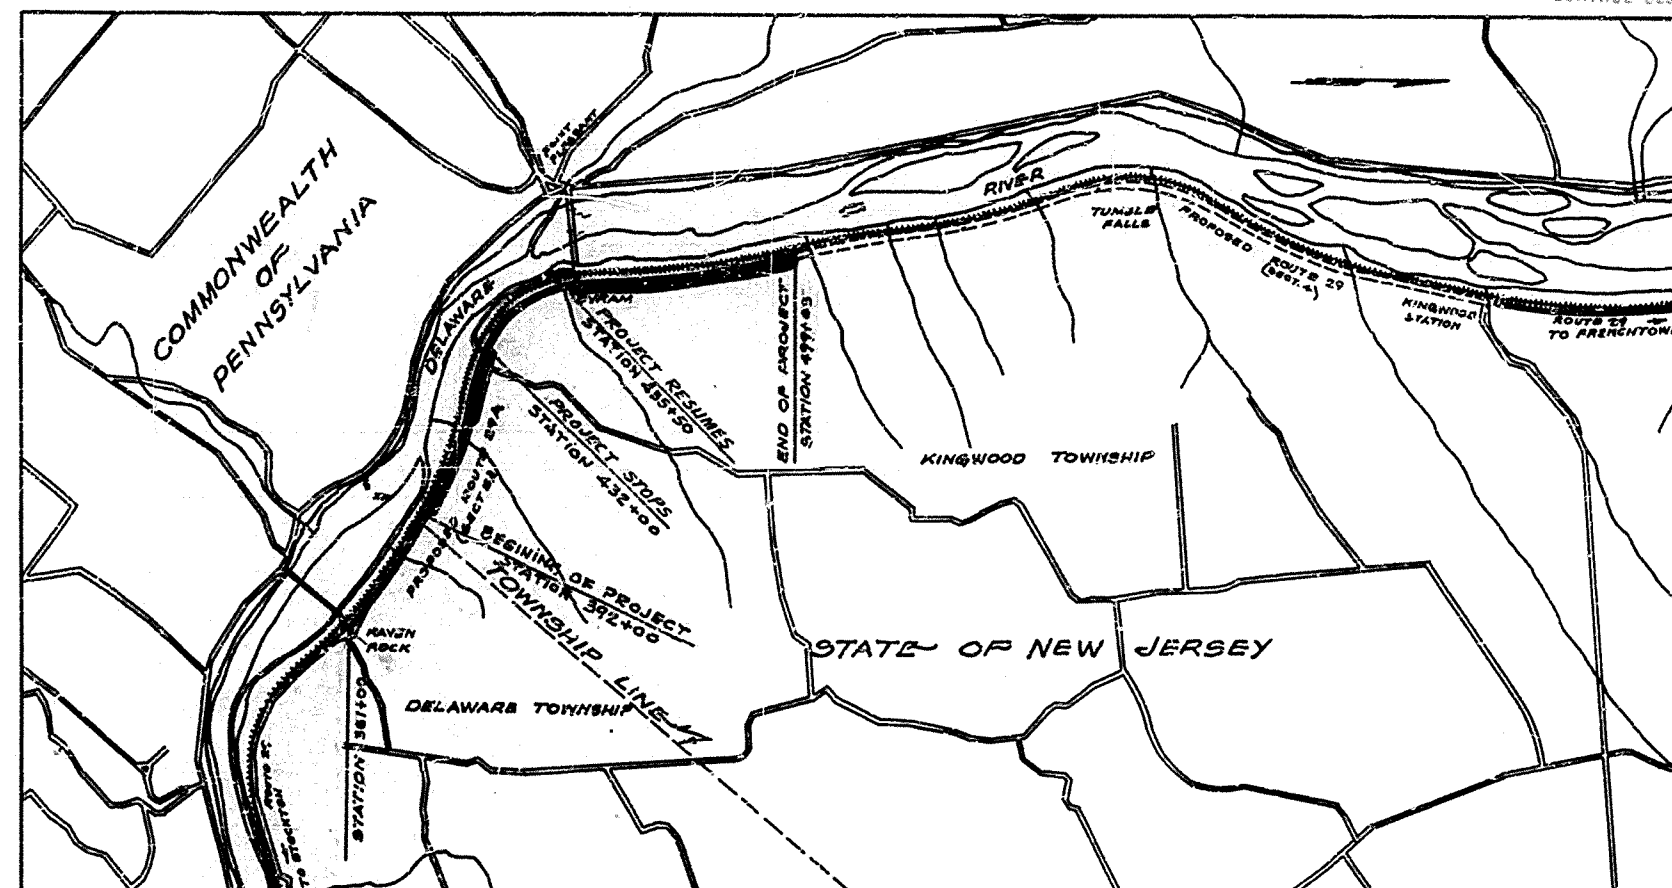
LAYOUT & KEY MAP

SCALE - 1" =  $\frac{1}{2}$  MILE

LENGTH OF PROJECT - 8,413 Lin. Ft. - 1.593 Miles

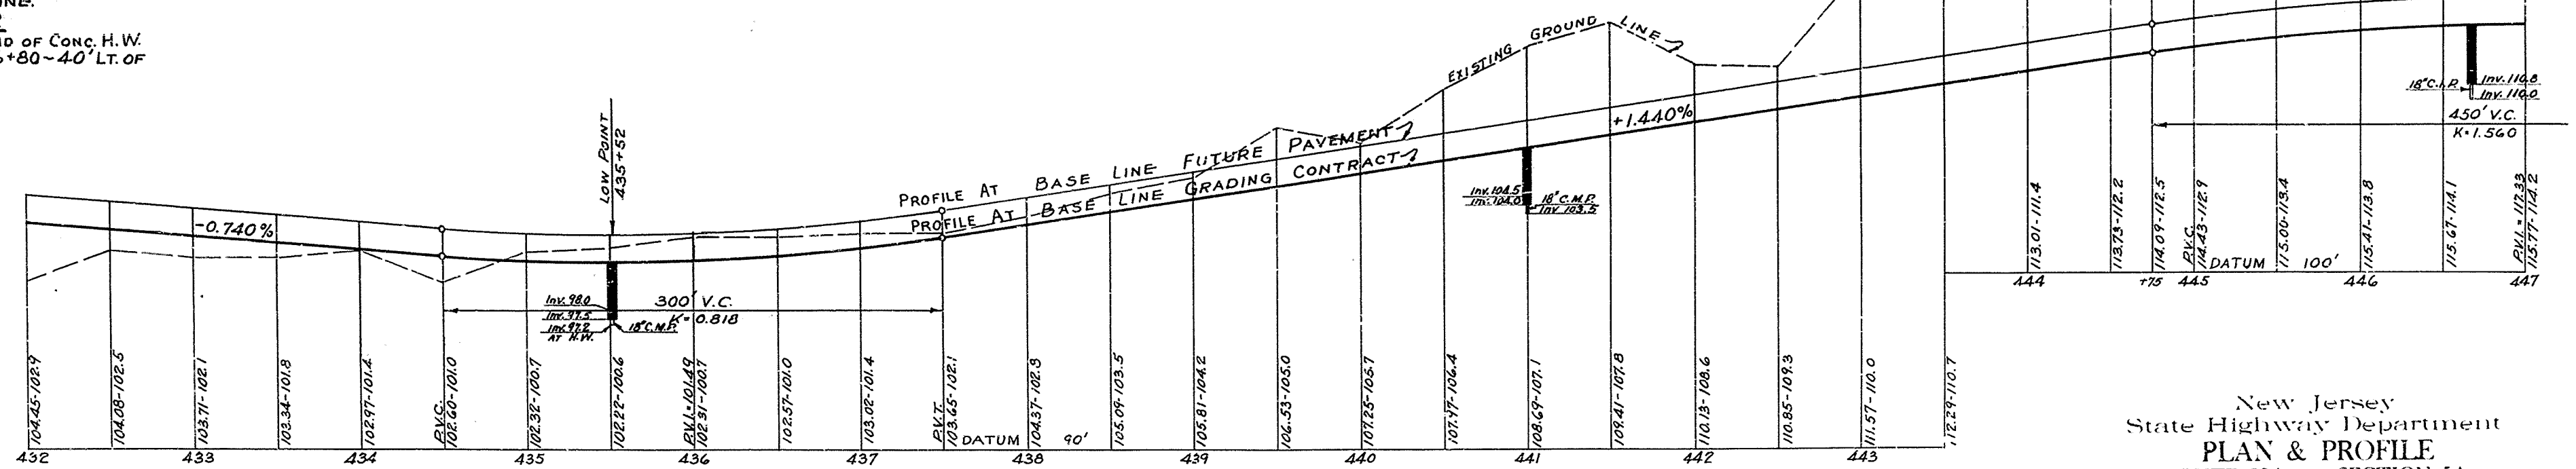
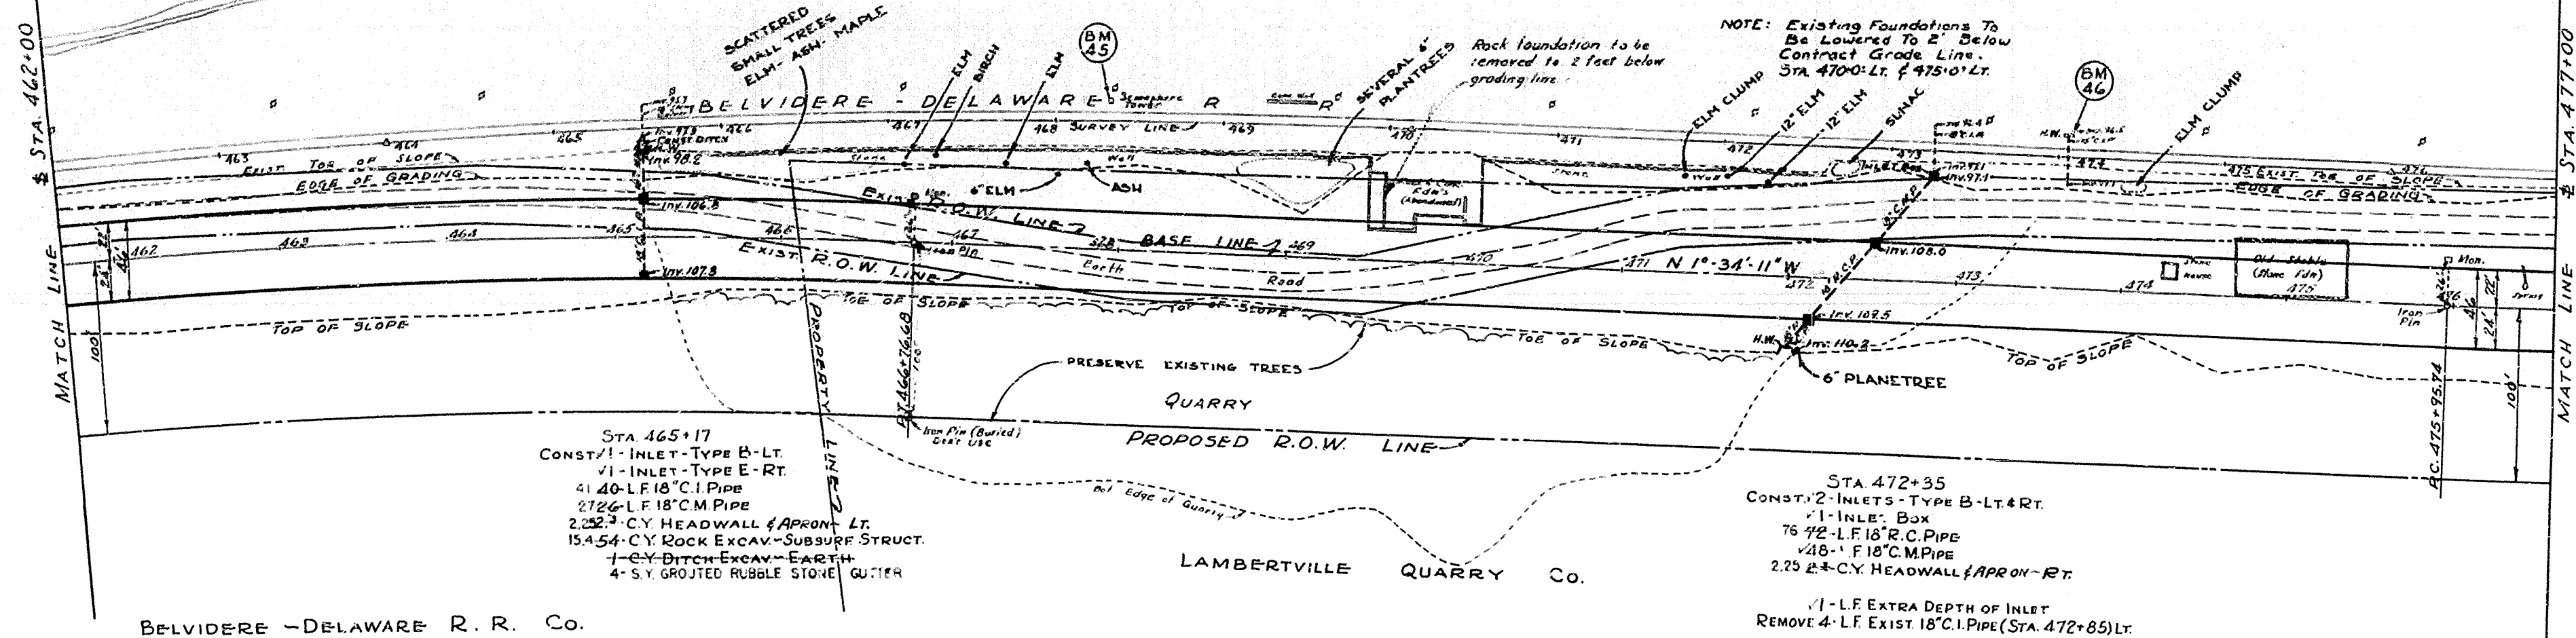
New Jersey  
State Highway Department  
**PLAN & PROFILE**  
ROUTE 29A (1927) SECTION 5A  
ROUTE 29 (1953)  
From Raven Rock to one mile north of Byram  
PARTIAL GRADING  
Scales as Indicated

**CURVE DATA**  
 $\Delta = 10^\circ 58' 19''$   
 $R = 4,000.00'$   
 $T = 364.17'$   
 $L = 765.99'$   
 $D = 1^\circ 25' 57''$

**CURVE DATA**  
 $\Delta = 9^\circ 48' 53''$   
 $R = 6,000.00'$   
 $T = 515.16'$   
 $L = 1,027.80'$   
 $D = 0^\circ 57' 18''$

PLAN SCALE - 1" = 50'

FOR CROSS-SECTIONS  
SEE SHEETS 23, 24, 25 & 26

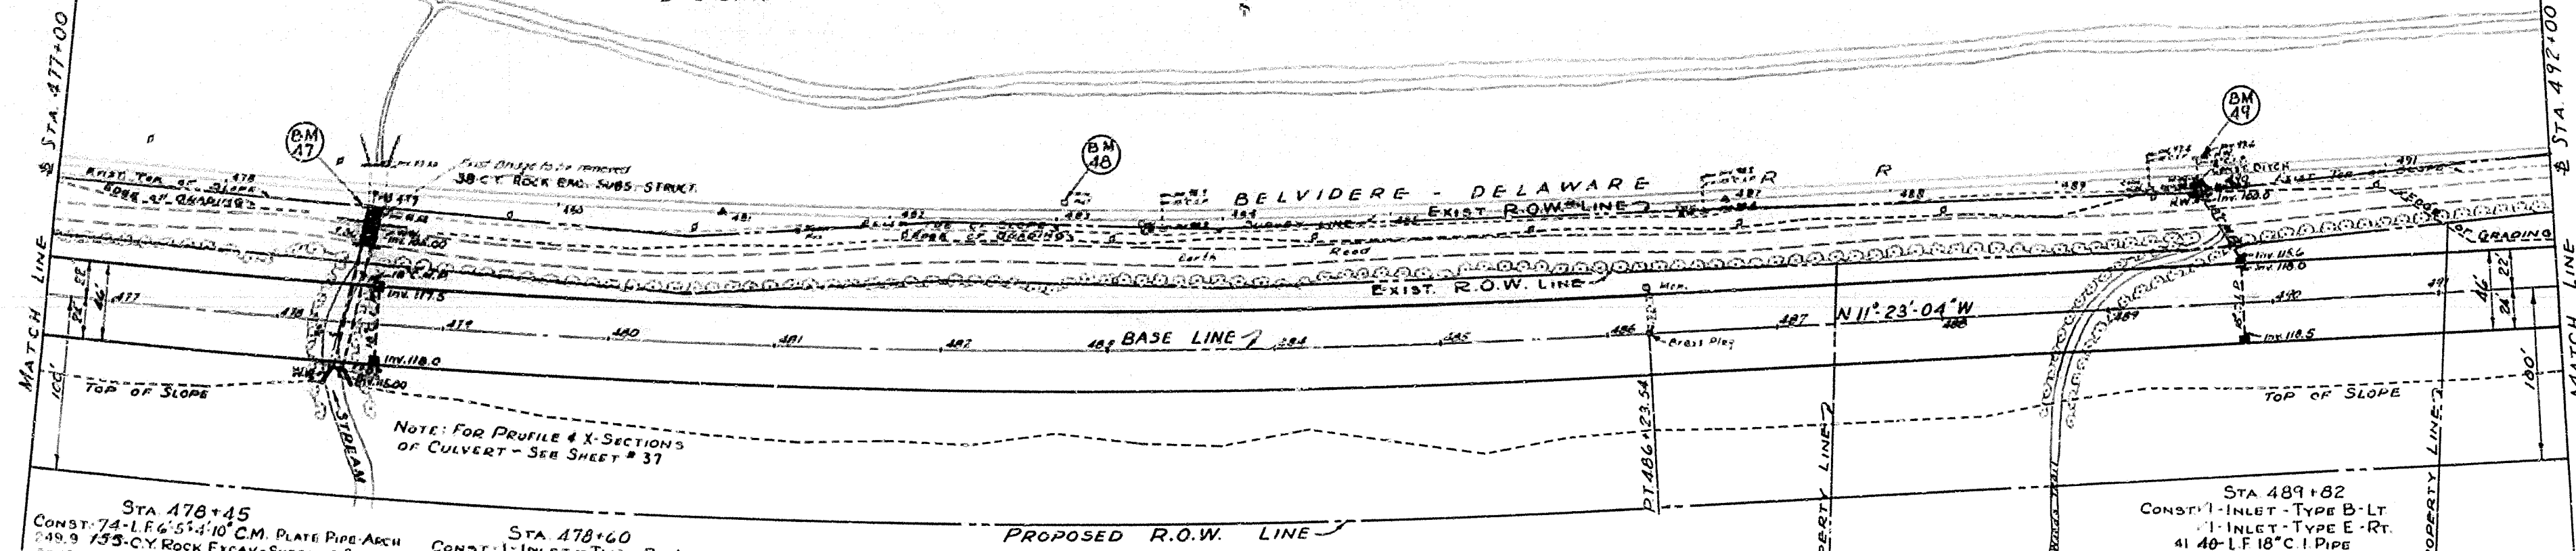
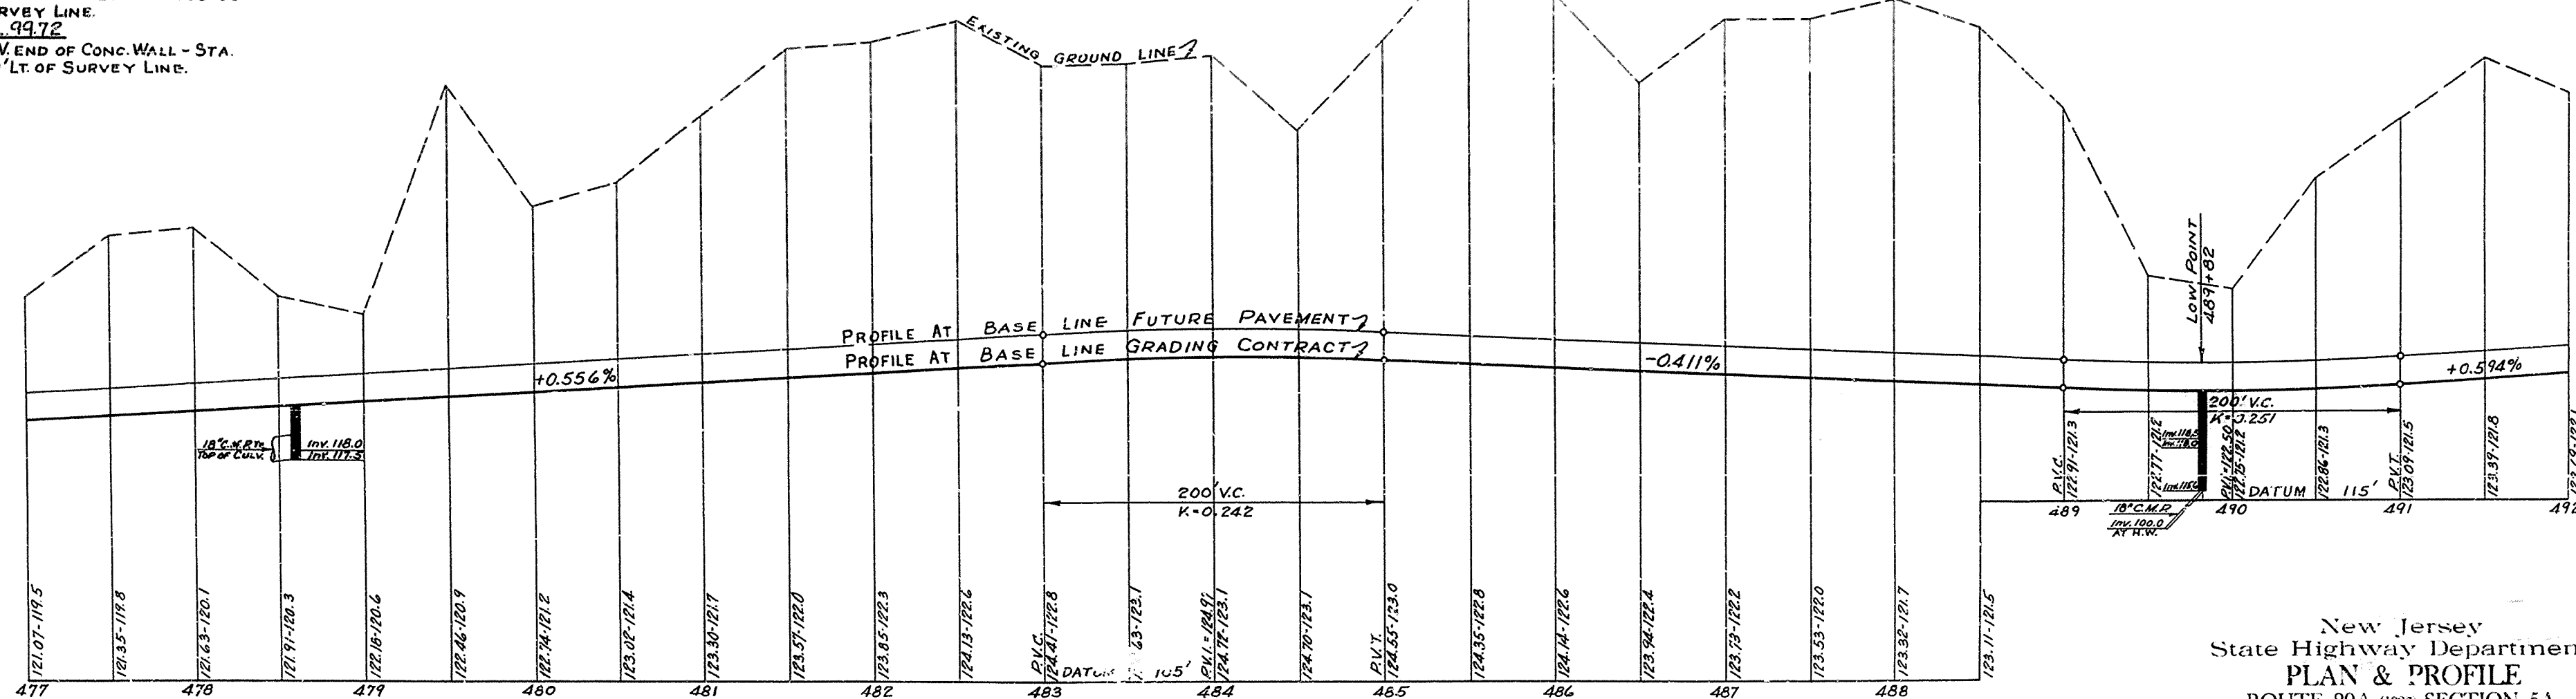
New Jersey  
 State Highway Department  
**PLAN & PROFILE**  
 ROUTE 29A (1927) SECTION 5A  
 ROUTE 29 (1953)  
 From Raven Rock to one mile north of Byram  
 PARTIAL GRADING  
 Scales as Indicated

**CURVE DATA**  
 $\Delta = 9^\circ 48' 53''$   
 $R = 6,000.00'$   
 $T = 515.16'$   
 $L = 1027.80'$   
 $D = 0^\circ 37' 18''$

**STA 478+45**  
 CONST. 74'-L.F. 5'-10" C.M. PLATE PIPE-ARCH  
 249.9 C.Y. ROCK EXCAV. - SUBSURF. STRUCT.  
 59.12 47'-25" C.Y. HEADWALL - LT. & RT.  
 105 C.Y. CHANNEL EXCAV.  
 242 47'-5" GROUTED RUBBLE STONE GUTTER  
 73 C.Y. DITCH EXCAVATION - ROCK

**STA 478+60**  
 CONST. 1'-INLET - TYPE B - LT.  
 1'-INLET - TYPE E - RT.  
 41 40'-L.F. 18" C.I. PIPE  
 15 18'-L.F. 18" C.M. PIPE (INCL. 1-90° ELBOW)  
 156 22 C.Y. ROCK EXCAV. - SUBSURF. STRUCT.

FOR CROSS-SECTIONS  
 SEE SHEETS # 26, 27, 28, 29 & 30

PROFILE SCALE: HOR. 1"=50'  
 VERT. 1"=5'

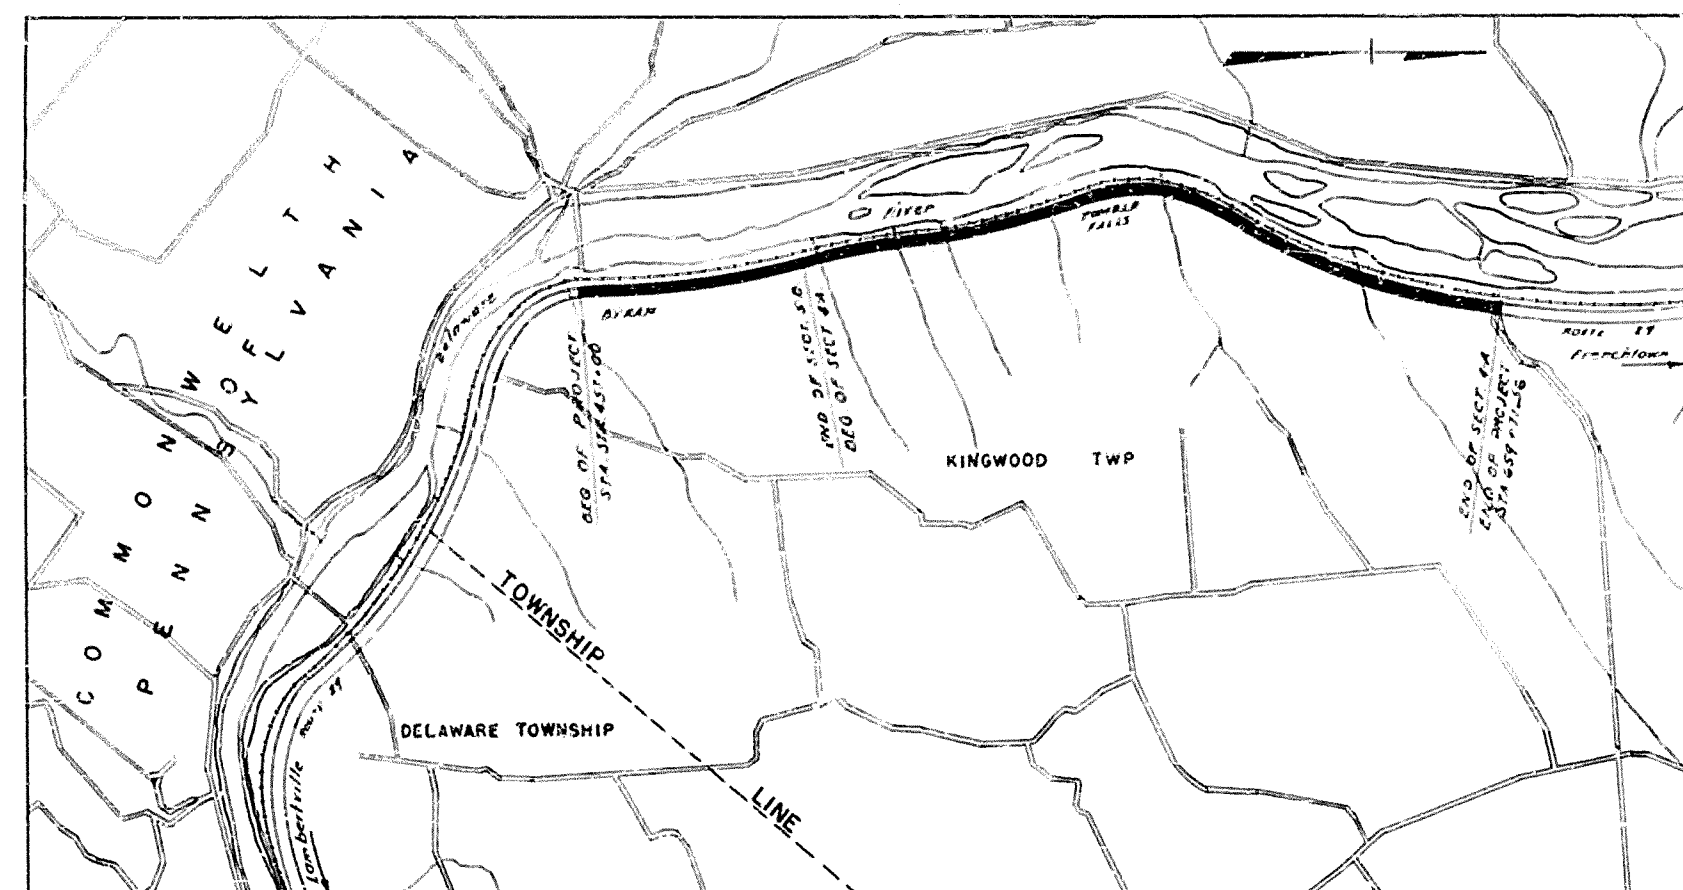
KEYMAP

SCALE 1" = 1/2 MILE

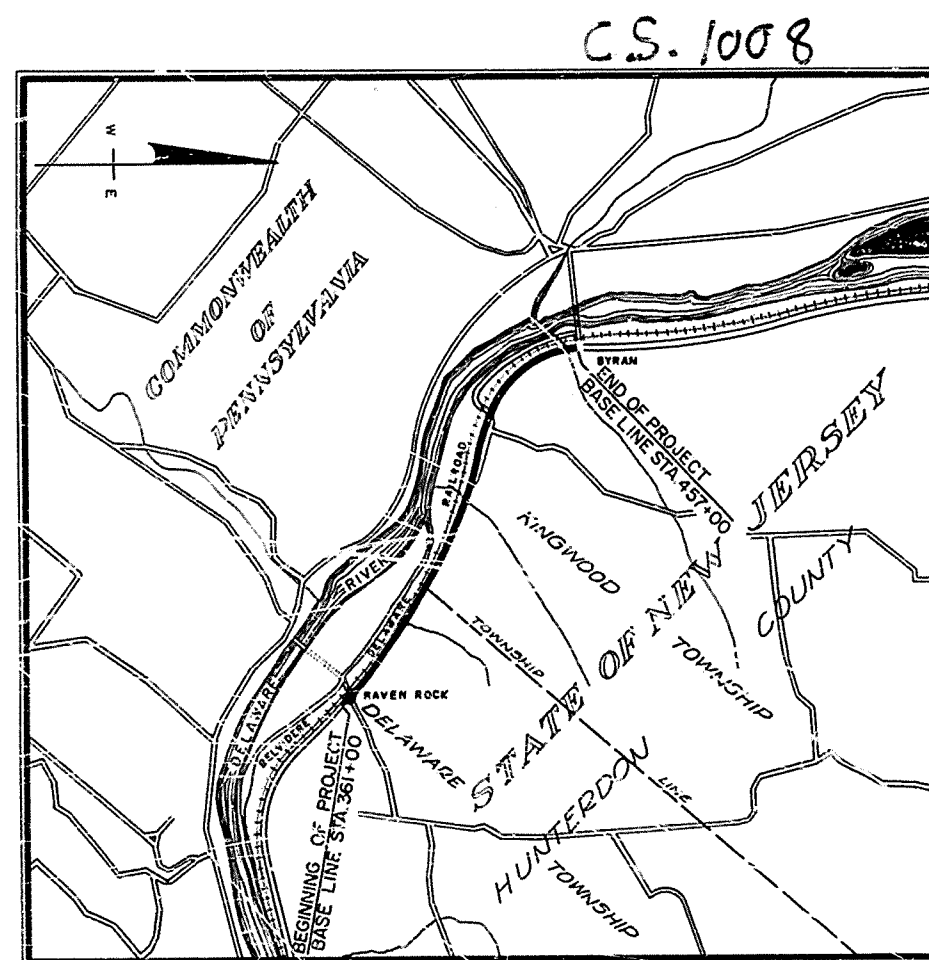
## KEY MAP

SCALE 2" = 1 MILE
