Evaluation of Corrosion Inhibitors

FINAL REPORT

1. Report No. FHWA-NJ-2003-005	2. Government Accession No.	3. Recipient's Catalog No.	
4. Title and Subtitle Evaluation of Corrosion Inhibitors		5. Report Date December 2002

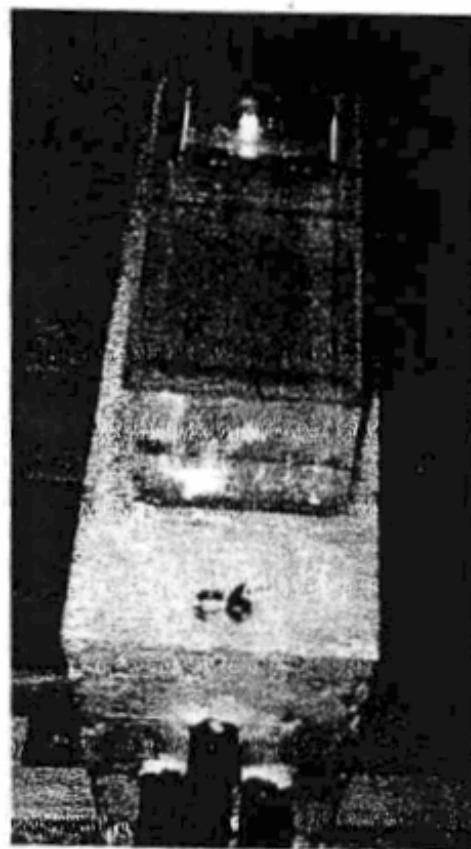
Fig. 3.22: View of Plexiglas Dam

The minidecks were prepared for accelerated corrosion tests after 90 days. Silicon caulk was then used to fix $\frac{1}{4}$ in. thick Plexiglas dams to the top of each sample in the center. The Plexiglas dam can be seen in Fig. 3.22. Concrete sealing epoxy was used to seal all four sides and the top of the sample except for the area enclosed by the dam. The samples were placed on sturdy racks supported on $\frac{1}{2}$ in. strips of wood. The Minideck designation is listed on Table 3.7.

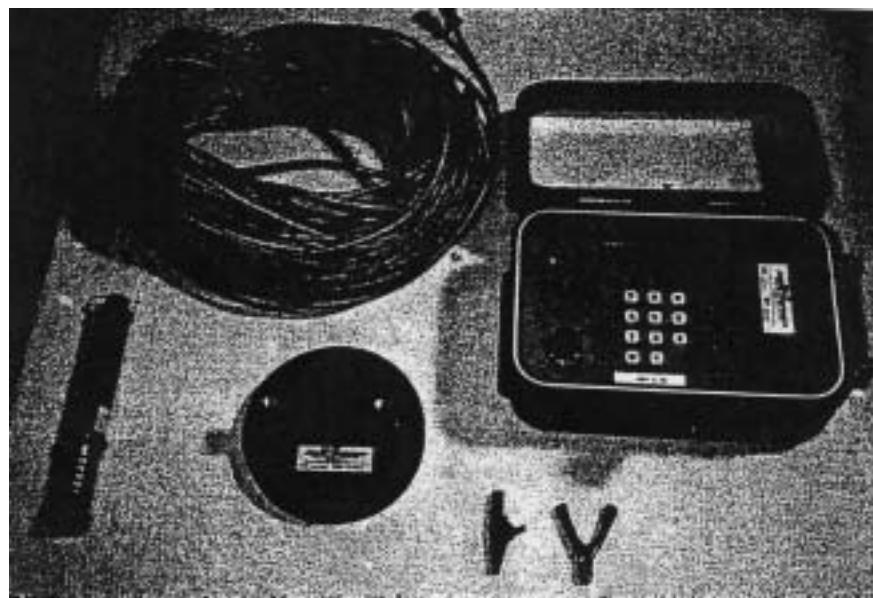
Fig.A.1: Components of the GECOR 6 Corrosion Rate Meter
