# EFFECTIVENESS OF BUS BULBS FOR BUS STOPS

FINAL REPORT

JANUARY, 2005

Dr. Janice Daniel and Prof. Walter Konon  
National Center for Transportation and Industrial Productivity  
New Jersey Institute of Technology

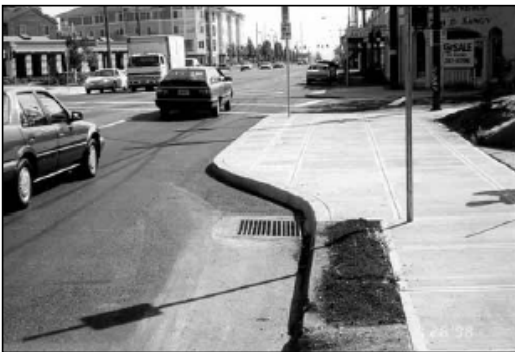
**Figure 1. Example of Bus Bulb**  
(Source: TCRP 65).

Some of the advantages cited for the use of bulbs as a bus stop zone include that bus bulbs: (1) remove fewer parking spaces than the traditional curb-side bus stop; (2) decreases the walking distance for pedestrians crossing the roadway; (3) provides additional sidewalk area for bus patrons to wait; and (4) results in minimal delay for the bus. When a bus stops at a bus bulb, the bus remains in the travel lane, rather than weaving into and out of the curb lane as is typical of curbside bus stops. Removing this weaving has the potential of reducing conflicts between buses and other vehicles on the roadway as the bus does not have to merge back into the traffic stream after stopping at the bus stop.

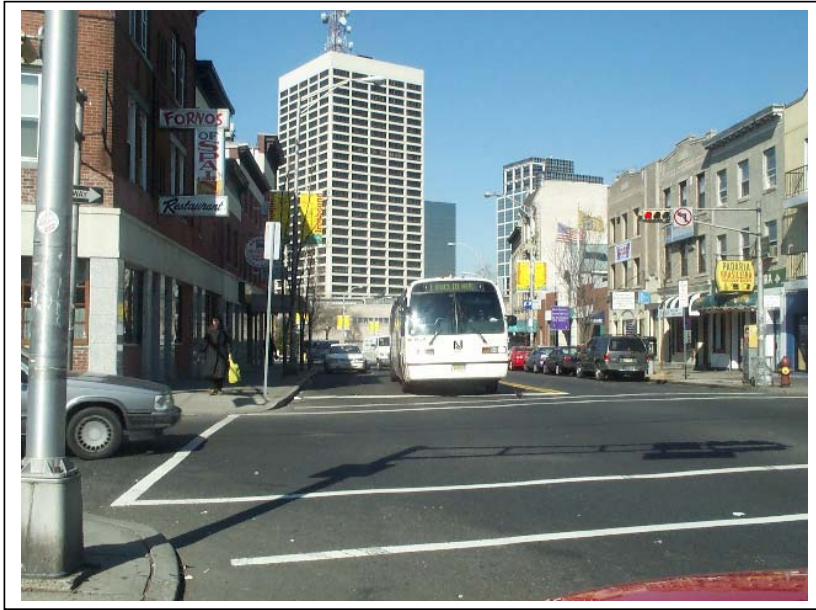
**Figure 6. Ferry Street, Newark.**

Ferry Street is a two-lane municipal roadway located in the City of Newark (see Figure 6). This location was identified as a potential location for installing bus bulbs through a recommendation from NJ TRANSIT and also through a meeting with the Traffic Engineer for the City of Newark, Bahman Izadmehr. Ferry Street is a two-lane, two-way roadway with parking on both sides of the roadway. The street is located in the historic Ironbound District of Newark with several restaurants and businesses located on the roadway. On-street parking is limited within the area and, as a result, the area is plagued with parking violations of patrons in the bus zones. The volumes on the roadway are high during the peak hour, with sufficient pedestrian and bus volumes to warrant a bus bulb on this street.

Based on the criteria provided in *TCRP 65*, bus bulbs should not be placed on roadways with two travel lanes. This location is still recommended for bus bulb installation, however, because site visits showed that at present, bus drivers do not pull into the bus stop, causing bus patrons to enter the roadway while loading the bus. It is

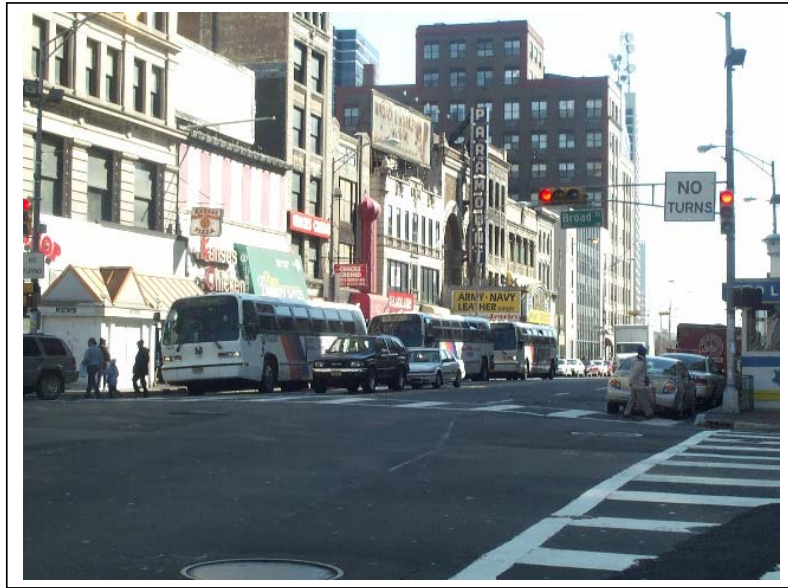
**Figure 7. Broad Street, Newark.**

Broad Street is a major roadway within the City of Newark (see Figure 7). The roadway is designated as an urban principal arterial with between four to six travel lanes provided. Volumes on this roadway are one of the highest for local roadways providing both access to businesses located on the roadway and providing mobility through Newark and to adjacent communities. The roadway also is a heavy transit corridor with over 20 bus routes using Broad Street. Broad Street intersects with several major roadways including Interstate 280, Route 21 (McCarter Highway), Route 510 (Market Street), and Route 508 (Central Avenue).

On the initial site visits, the intersection of Broad Street and Market Street was identified as a potential location for including a bus bulb. This location was seen to have very high volume of bus patrons with limited sidewalk area. The site visits also showed that at this location there is no on-street parking with a bus lane operating during the AM and PM peak hours on both Broad Street and Market Street. This location was recommended as a location for installing a bus bulb by the City of Newark Traffic Engineer. However, the presence of a bus lane and no-parking would make this location infeasible as a potential location for installing a bus bulb.

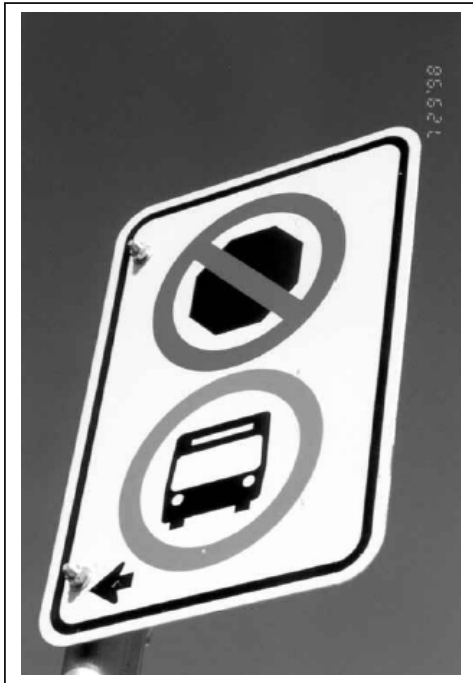
**Figure 14. No Parking Sign**  
(Source: TCRP 65).

Bus bulbs are a self-enforcing no-parking design. They discourage motorists from temporarily parking in the bus stop zone because of the traffic blockage that would be caused by the illegal parked vehicle. Bus bulbs must be clearly marked with signs and paint along the curb over the entire bus stop zone. Figures 14, 15, 16, and 17 are examples of signage that should be used at bus bulbs. The use of bollards at nearside and midblock bulb locations needs to be considered where there is a "No Parking During Snow Emergencies" policy on the subject street.

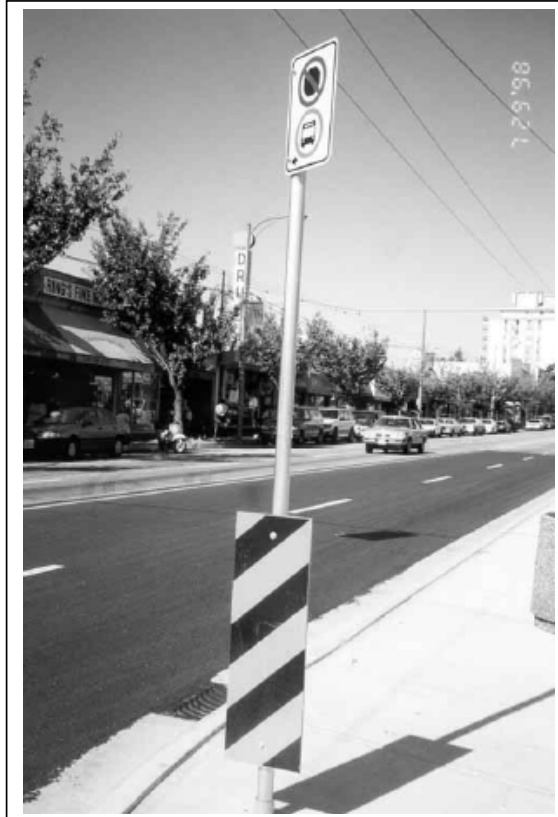
**Figure 15. Traffic Control Sign** (Source:  
TCRP 65).

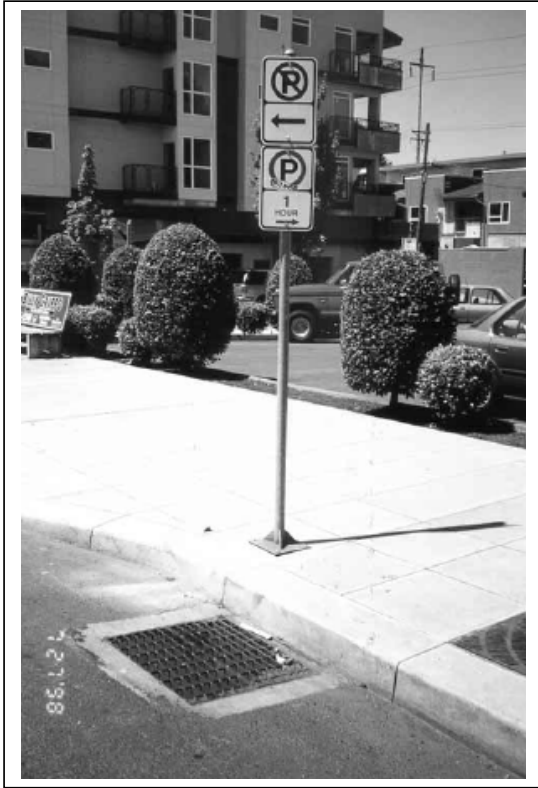
**Figure 16. No Parking Sign**  
(Source: TCRP 65).

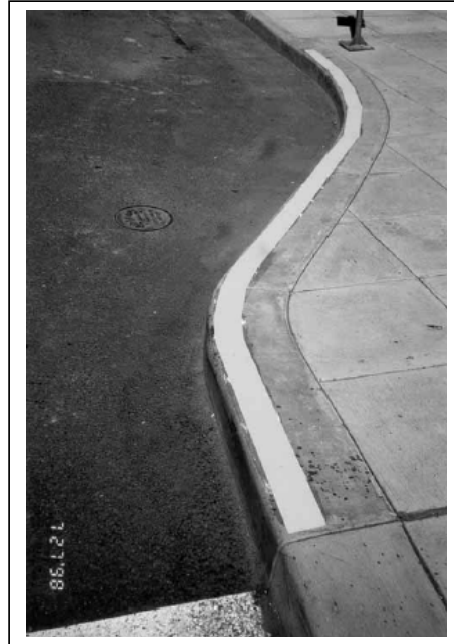
**Figure 17. No Parking Tape**  
(Source: TCRP 65).
