Stormwater System Monitoring and Evaluation

FINAL REPORT

December 2013

Dept. of Civil & Environmental Engineering &
Center for Advanced Infrastructure and Transportation
Rutgers, The State University of New Jersey

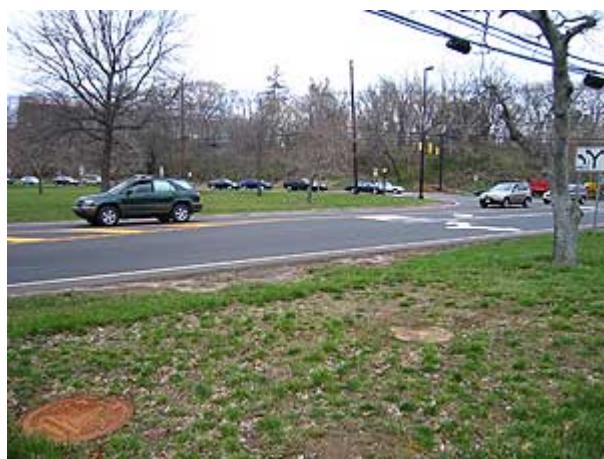
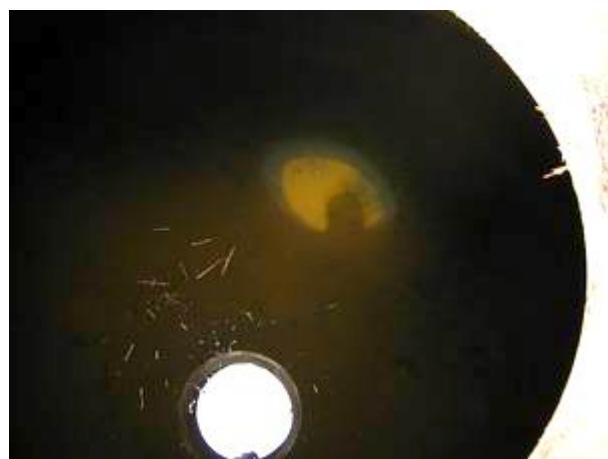
RU01-01 (2008-02-01)

Remarks:
Each manhole cover is fixed with 4 bolts.
The Vortechs is located along the side of Landing lane.
0.05 ft sediment accumulation in the grit chamber.
Water in grit chamber was clear. The bottom was visible.

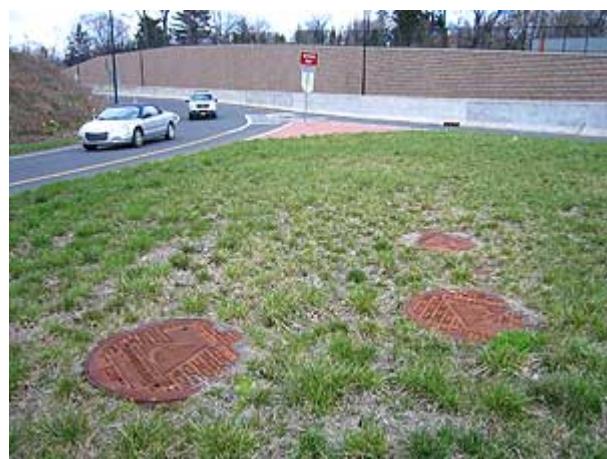
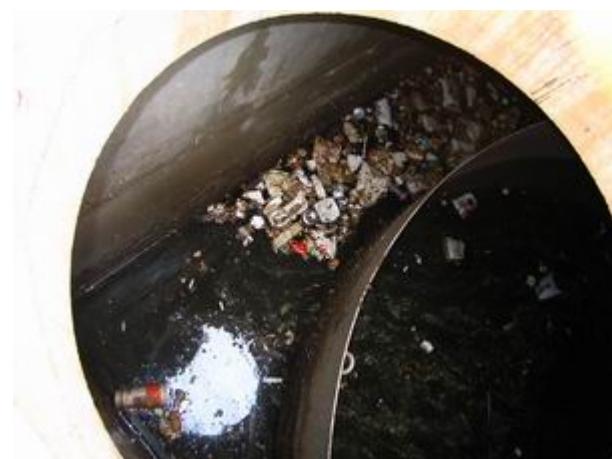
RU01-02 (2008-02-01)

Sediment was found in the center of the floatables chamber.

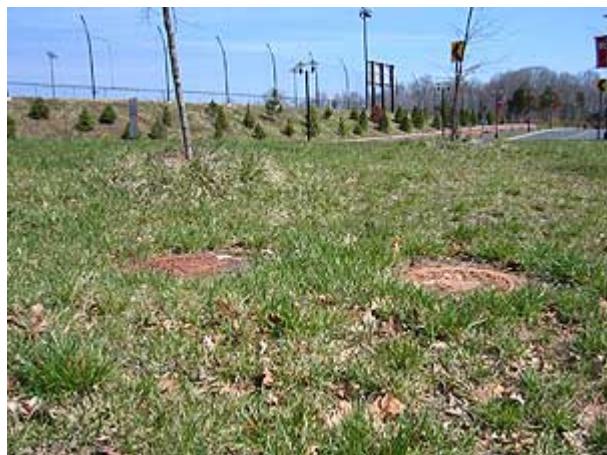
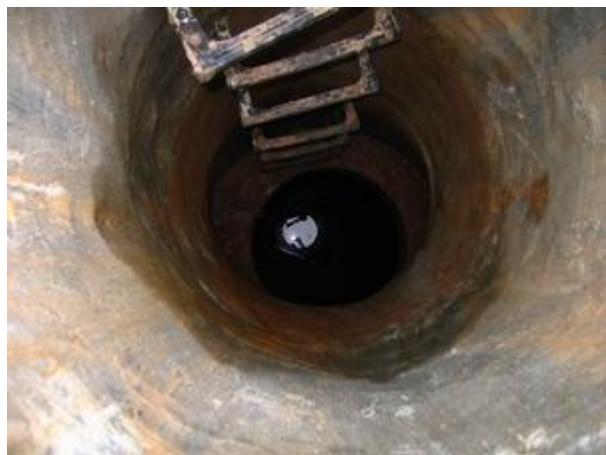
RU01-03 (2008-02-26)

Sediment above water surface in quarter of the grit chamber area near inlet.

2.5ft sediment accumulation in the grit chamber (16.9-14.4).

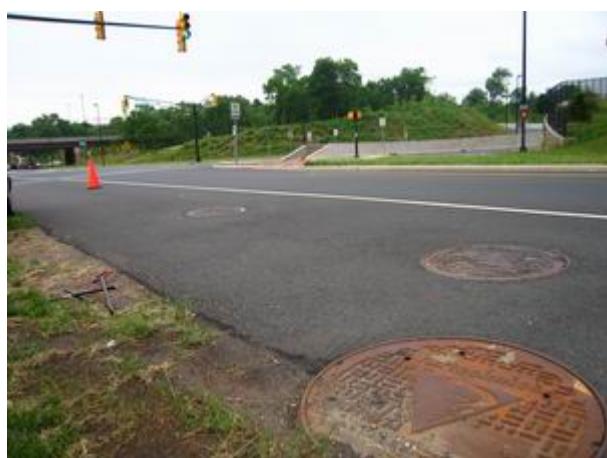
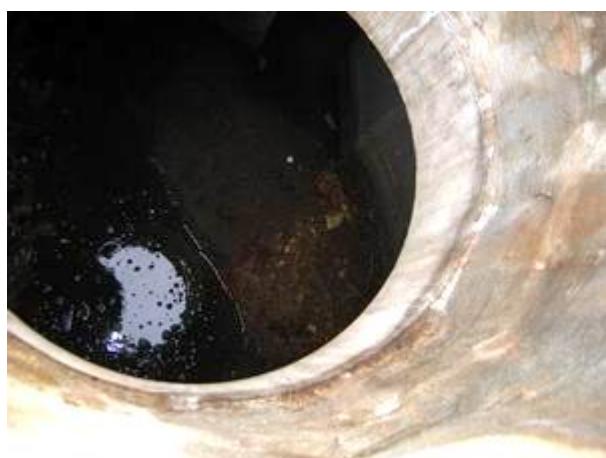
RU01-04 (2008-01-11)

However, the outflow water could be observed from an adjacent chamber.

One cover for inflow diversion chamber between River Road and Vortechs.

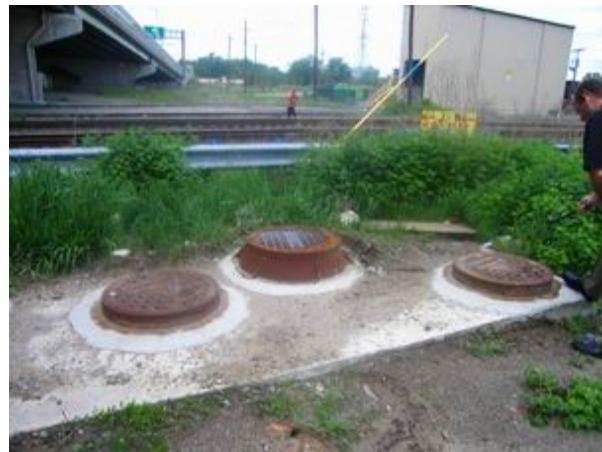
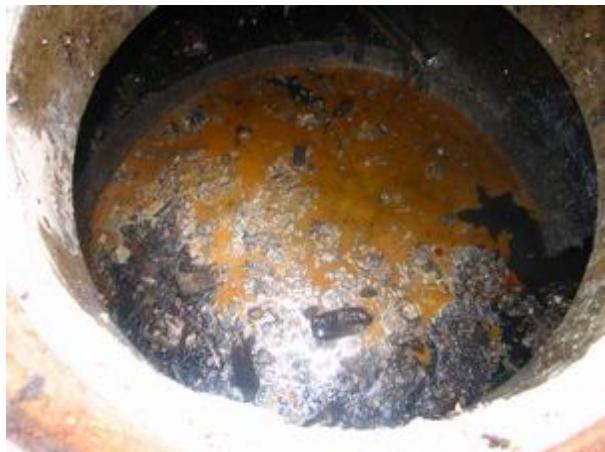
RU06-01 (2008-02-28)

1.7 ft sediment accumulation in the grit chamber ($7.3-5.6=1.7$)A 0.7 ft layer of sediments was found in the floatables chamber ($7.6-6.9=0.7$)A 0.8 ft layer of sediments was found in the outlet chamber ($7.8-7.0=0.8$)

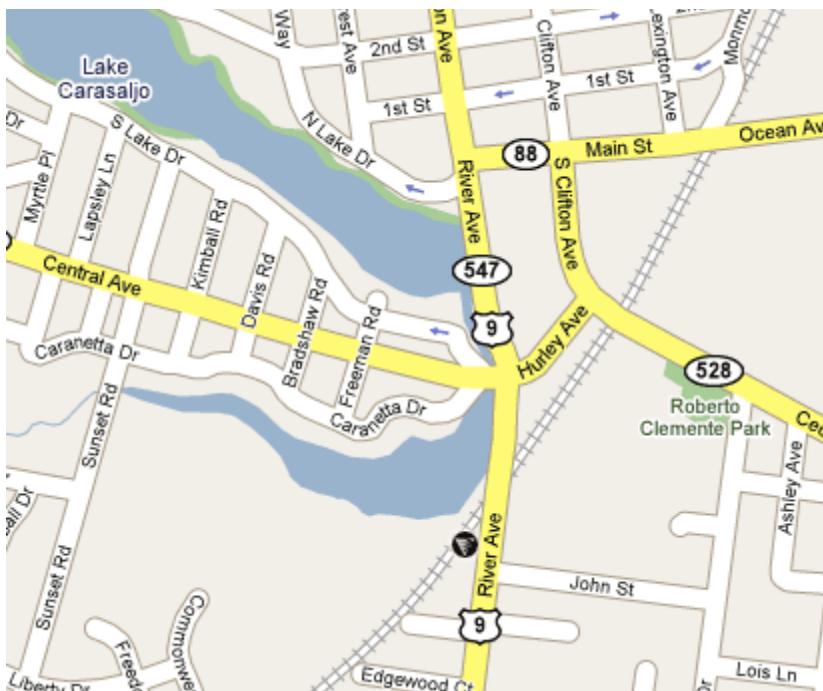
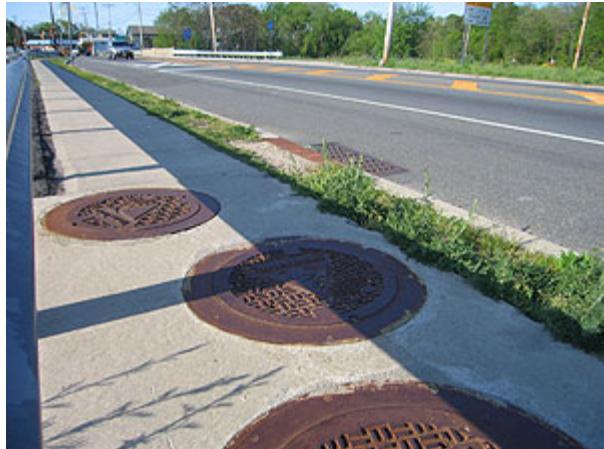
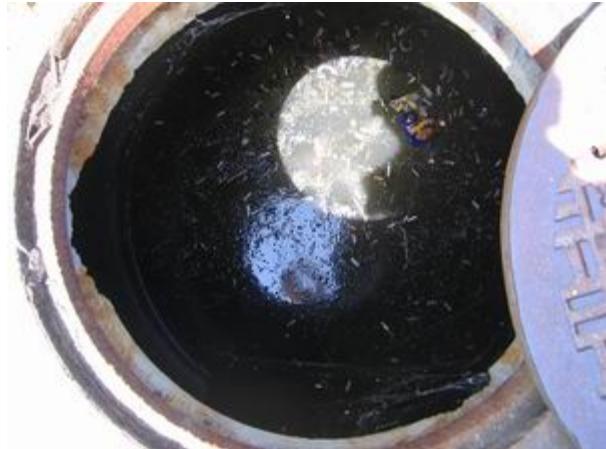
RU09-01 (2007-12-19)

The grit chamber and the floatables chamber were mostly covered by floating litter (such as cigarette butts).

Outlet level was almost the same as Lake Carasaljo level.

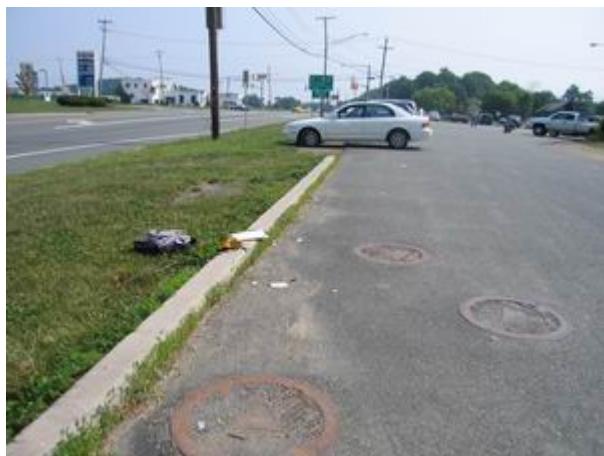
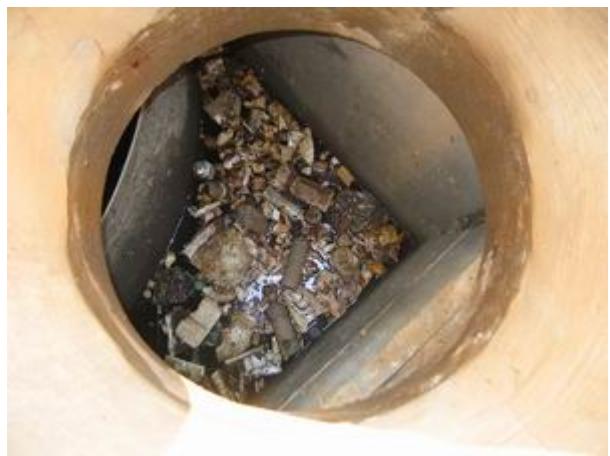
RU16-01 (2008-02-07)

Remarks:
The Vortechs is installed in parking lot.
2.1 ft sediment accumulation in the grit chamber (9.8-7.7=2.1)
Water surface of the floatables chamber was mostly covered by floating litter.
A 0.3 ft layer of sediments was found in the floatables chamber (9.8-9.5=0.3).

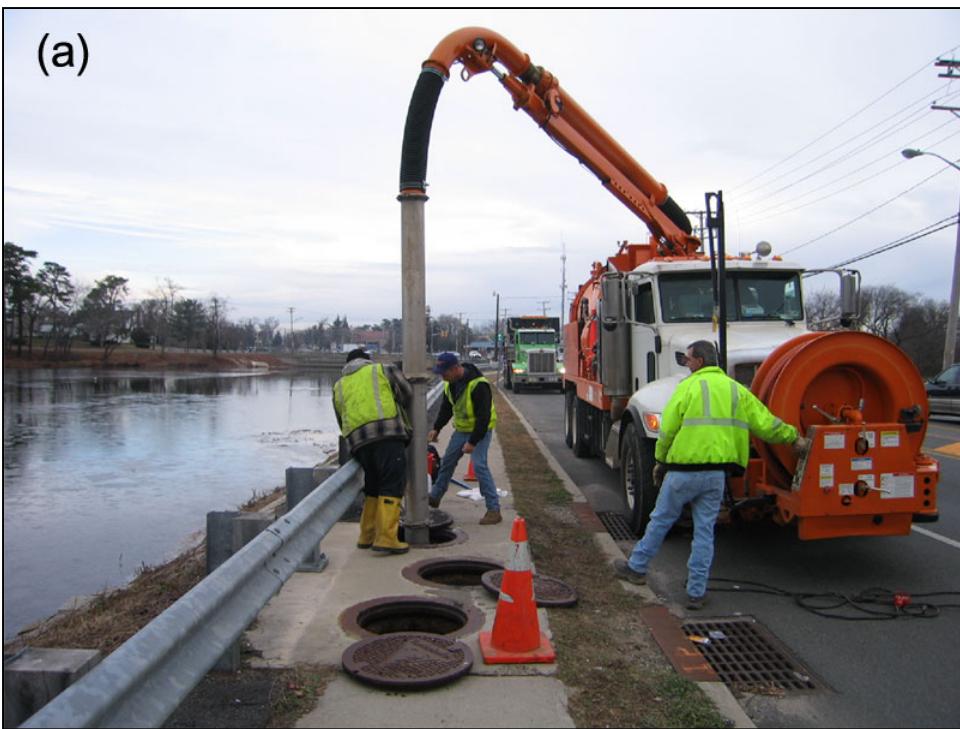
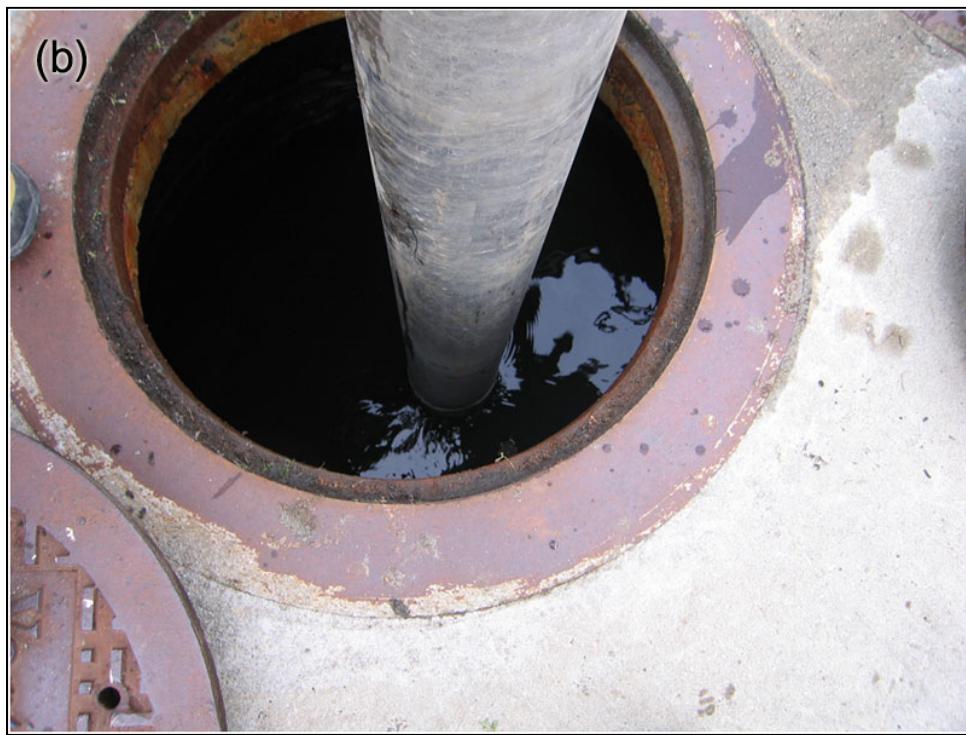
Figure 5. The cleanout of the Vortechs system: (a) Cleaning out the Vortechs unit with vacuum truck, (b) Pumping out water first and then pumping out solids (Typically)

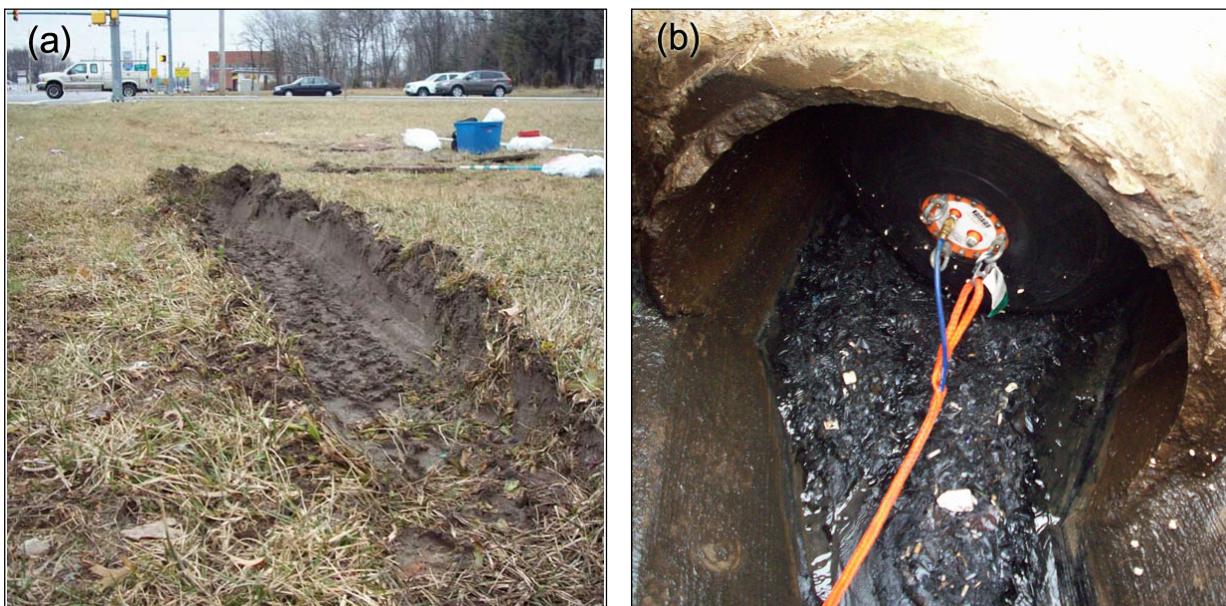
RU14-01: Cleanout operation failed twice. First, the ground was too soft to support the vacuum truck (02/09/2008). Second, water was flowing from inlet due to small size plug-in (04/17/2008). Operation was completed with proper plug-in size (42"). (Date: 05/08/2008)

Figure 6. Encountered problems while cleanout at RU14-01 site: (a) Soft ground might not support the vacuum truck after a rainy day. Operation was completed on a dry day, (b) Water was flowing from inlet pipe which size is 42-inch. Operation was completed with a pneumatic pipe plug

Although a dry day was chosen for clean up, previous rain events caused inflow from inlet or backflow from outlet. An air compressor, pipe plugs and sand bags were used to prevent inflow or backflow during vacuum procedures.

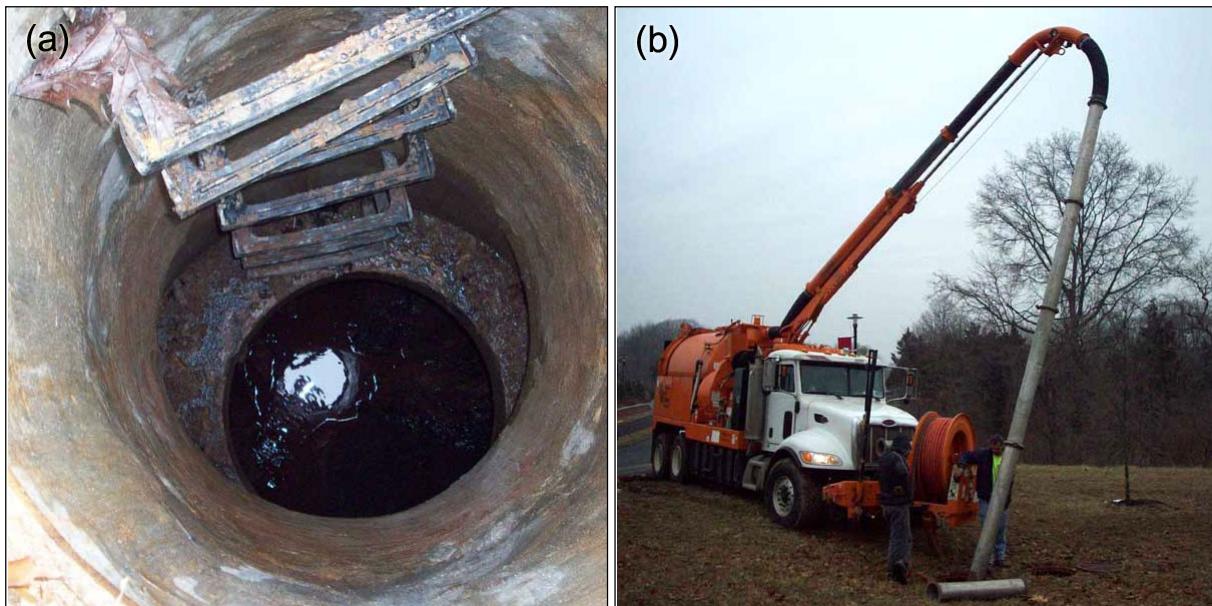
Some devices, for design reasons, were placed deep underground. The truck used assembled pipe sections to reach the bottom for vacuuming, however, could not reach the edge of the device. The pipes had a limited sweep angle due to the relatively small hole diameter and depth of device. The combination of high pressure water jetting attached to a vacuum truck is recommended to allow for a more thorough cleaning of the device. If the jetting apparatus is not available, it is possible to send a laborer down into the device with a portable power washer or tool to clean the edges of the chamber. However, it is imperative that precautions are taken to ensure the safety of personnel. This includes, but is not limited to: (1) harness system to allow for emergency egress from device, (2) protective clothing, (3) noxious gas detector, etc.

Figure 7. The cleanout of the Vortechs unit buried deep underground: (a) The depth of the Vortechs unit in Piscataway, NJ. is 17-feet below grade, (b) Cleaning out the deep underground device with assembled vacuum tubes

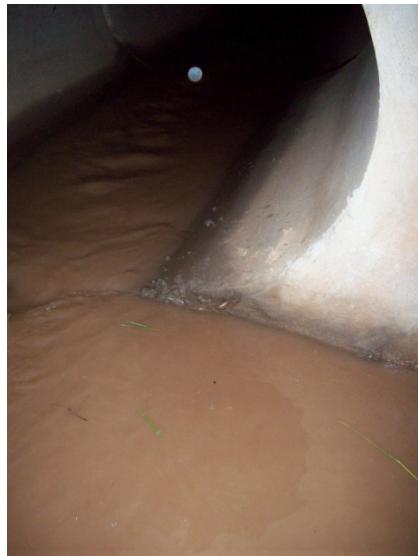
A field observation was conducted on June 5, 2009 shortly after a small rainfall. The runoff was observed to enter the main storm sewer line (Figure 26), but the flow continued along the main storm sewer (Figure 27), without entering the treatment device (Figure 28).

**Figure 26. Inflow to diversion chamber
(Point A in DC 1 in Figure 25)**

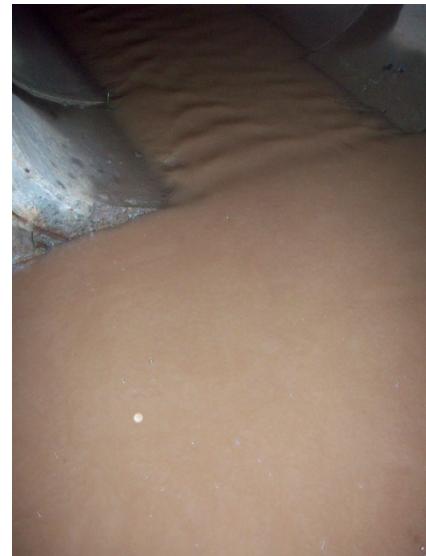
**Figure 27. Outflow from diversion
chamber
(Point C in DC 1 in Figure 25)**

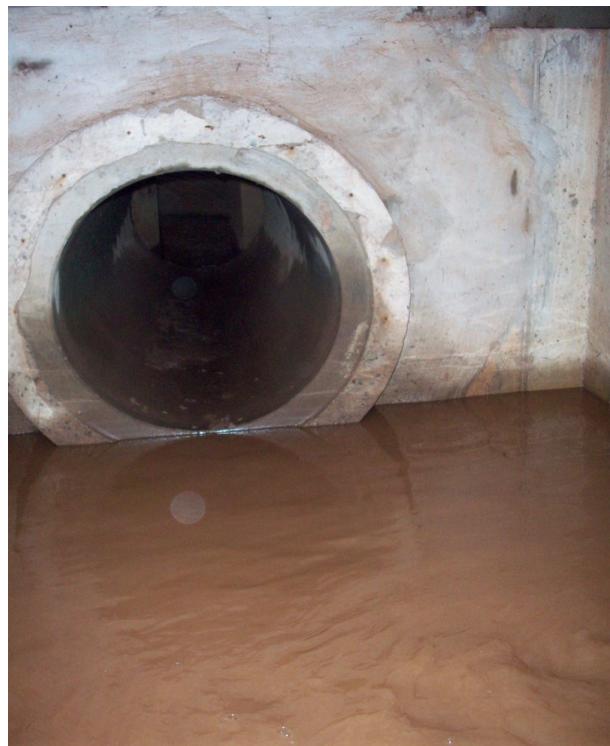
The difference between expected and observed results is due to an incorrectly constructed diversion chamber. The stormwater runoff is not being diverted to the installed Vortechs stormwater treatment device, thus is not receiving treatment. The runoff produced by small frequent rainfalls or early part of large infrequent rainfalls should have been diverted to the treatment device, since this part of the runoff contains

Water level in the diversion chamber was observed to be below invert of the diverting/inlet pipe (Figure 28). Water depth in the diversion chamber was approximately eight inches. In a correct installation, inflow to the treatment device would occur before outflow from the diversion chamber. But in this incorrect installation, inflow to the treatment device did not occur (Figure 28) even after outflow from the diversion chamber occurred (Figure 27).

**Figure 28. No flow from diversion chamber to treatment device
(Point B in DC 1 in Figure 25).**

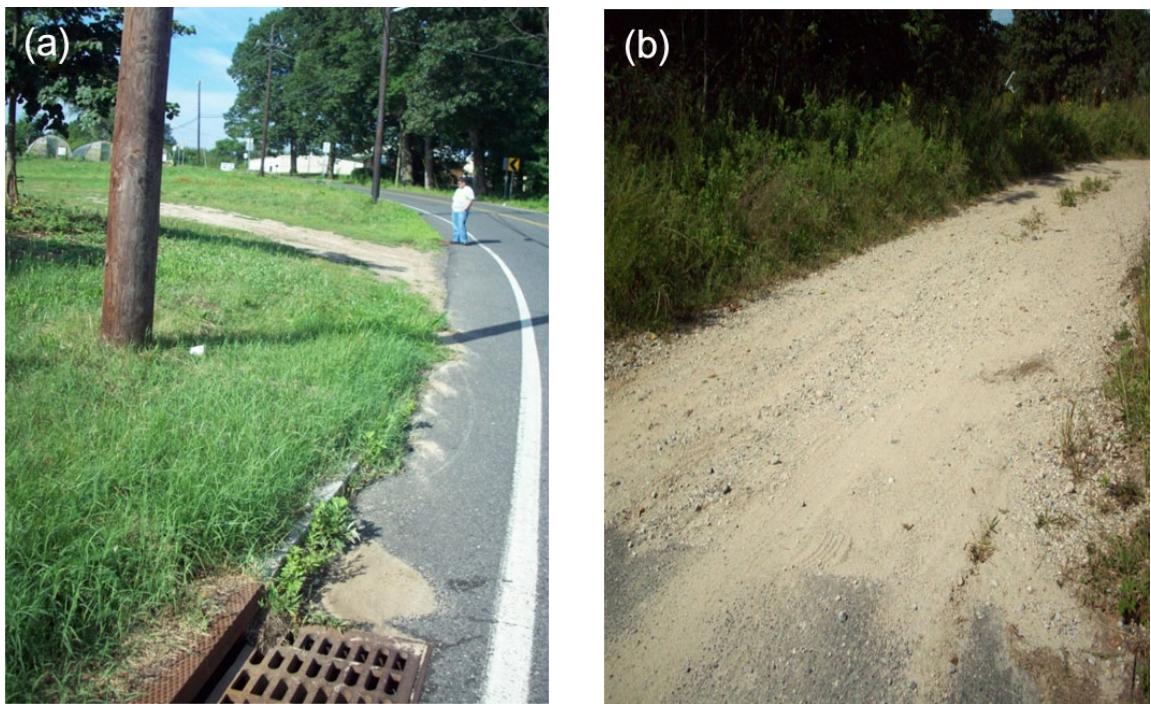
It was noticed that a driveway comprised mostly of sand was eroded from a nearby farm and the sand was washing into the network. Not only eroded sand, but also a large amount of deposited sand was at the driveway of the construction area. Sand was seen deposited outside of the effluent culvert and inside the drainage manholes (Figure 29). Also, the RU07-01 site has steep roads and the slope of pipe connected to the device is 0.04, which is the highest in our research. Eroded sand from the farm, deposited sand from construction activity, heavy rain events (51.16 inches between September 25th 2008 and September 24th 2009), and steep roads were responsible for unusually high increases of accumulated sediment.

Figure 29. Eroded sand into network: (a) Sand was eroded from the driveway to the farm, (b) Sand was eroded from the driveway to the construction area

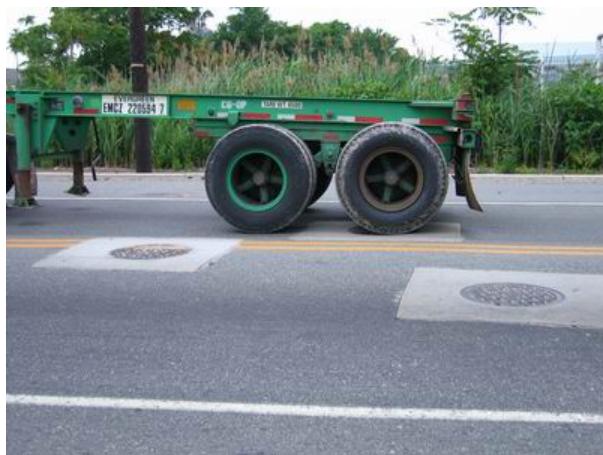
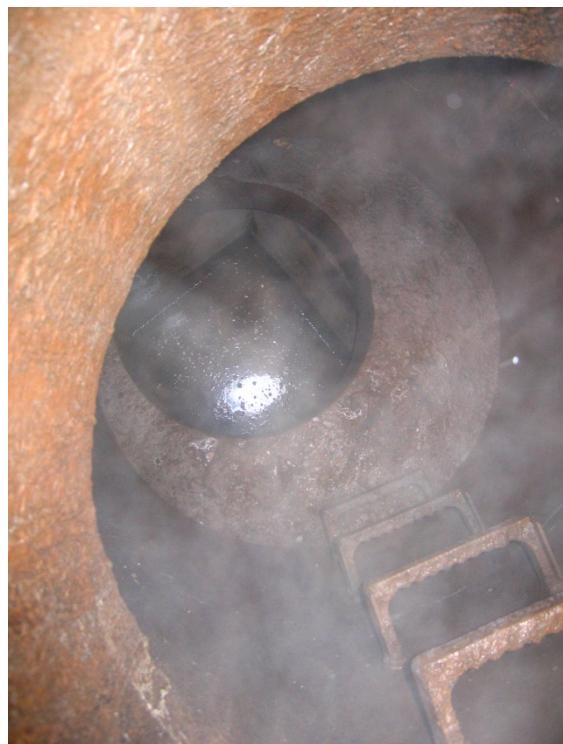
Rutgers ID: **RU 03-02**Date 2007-06-26 Time 14:00

Vortechs was installed deep underground

Overflow and backflow problems

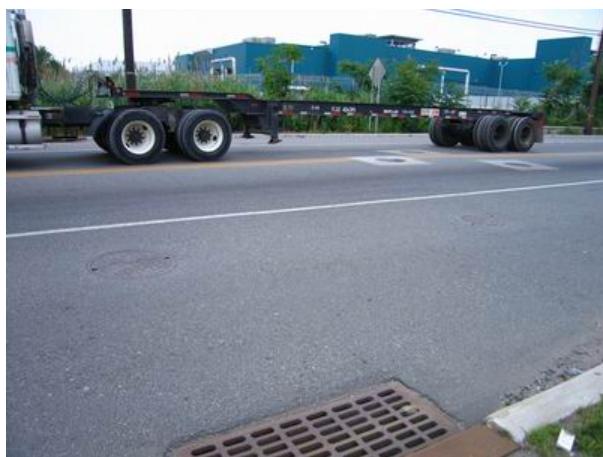
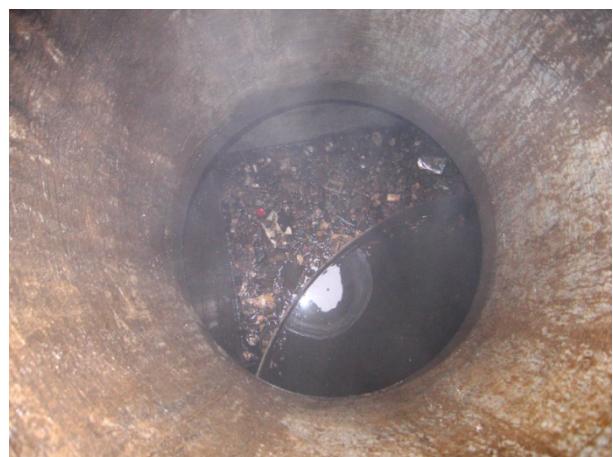
Rutgers ID: **RU 03-03**Date 2007-06-26 Time 14:00

The Vortechs manholes are located in the center of the road

Overflow and backflow problems

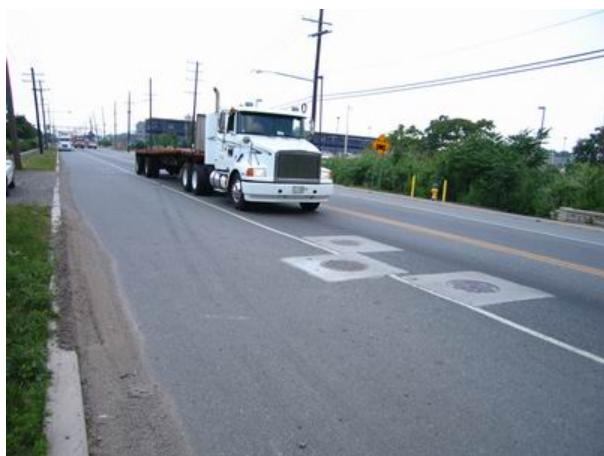
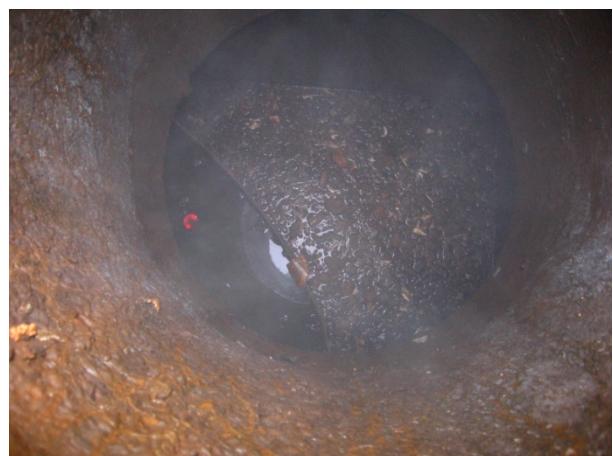
Rutgers ID: **RU 03-04**Date 2007-06-26 Time 14:00

Water surface of floatables chamber are mostly covered by floating litter.

Oil in outlet chamber

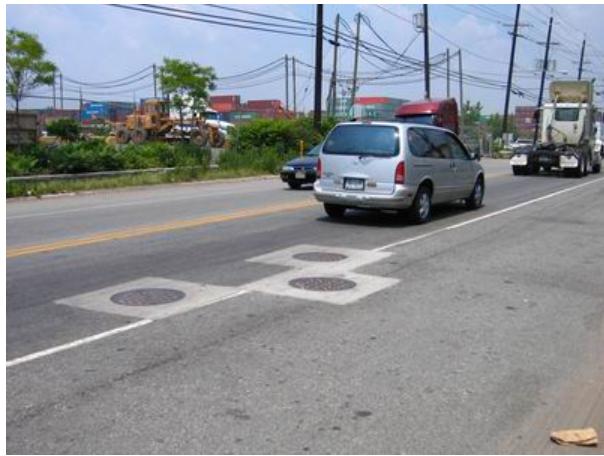
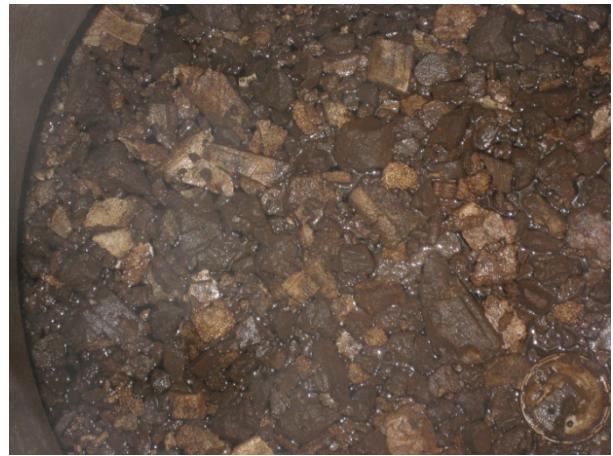
Rutgers ID: **RU 03-05**Date 2007-06-26 Time 14:00

Water surfaces of both grit chamber and floatables chamber are mostly covered by

floating litter (such as Styrofoam).
Oil in outlet chamber

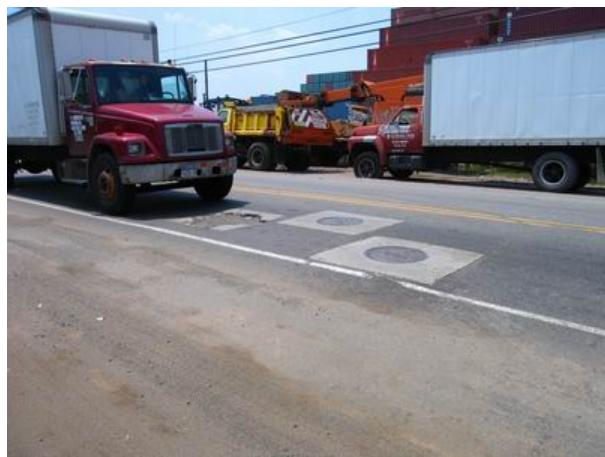
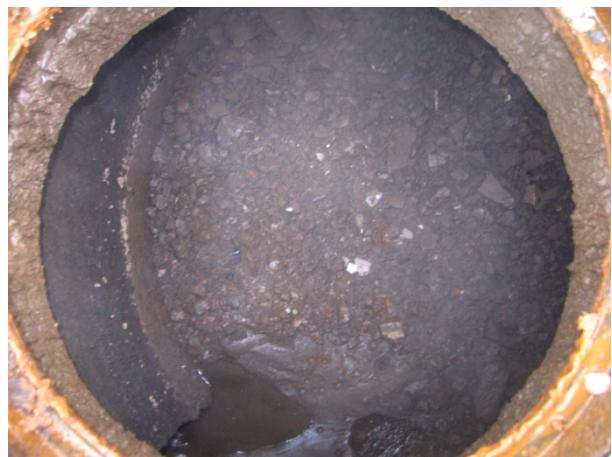
Styrofoam) and oil.
Oil in outlet chamber

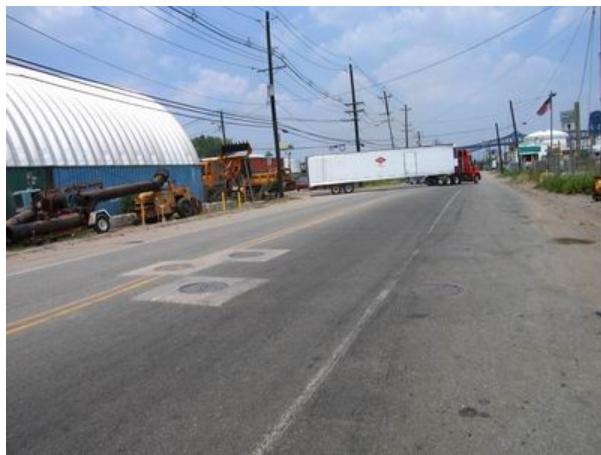
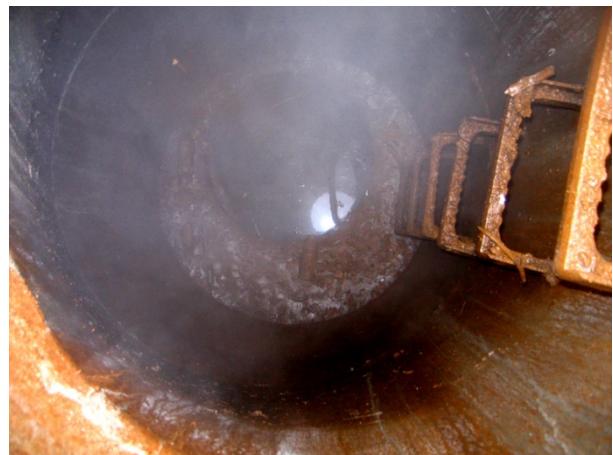
Rutgers ID: **RU 03-07**Date 2007-06-26 Time 14:00

Overflow and backflow problems

Oil in outlet chamber

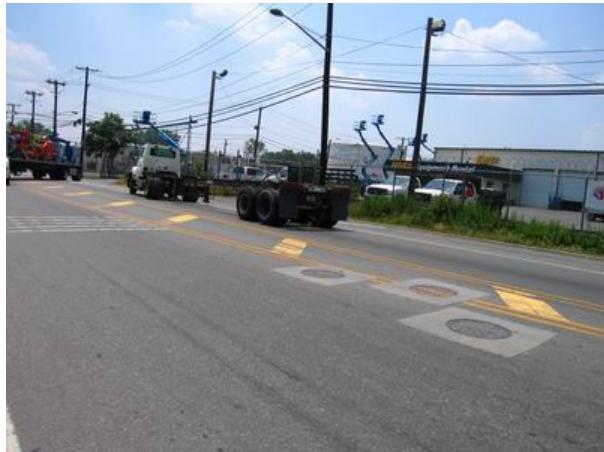
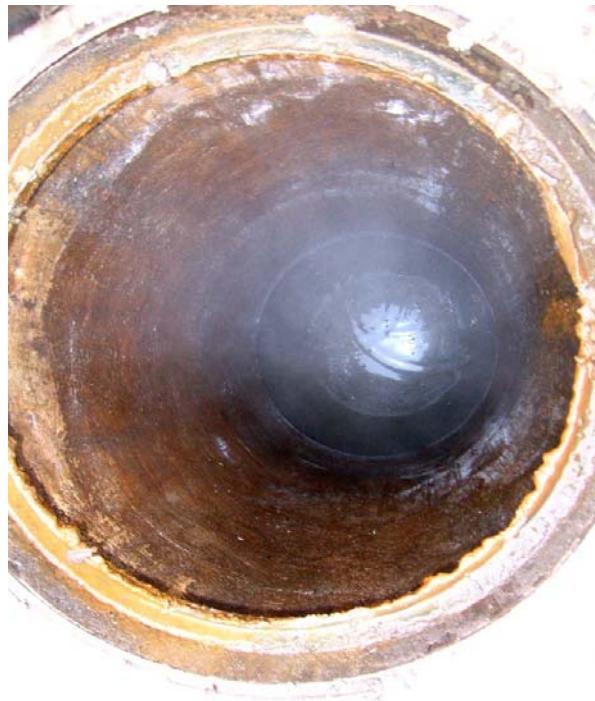
Rutgers ID: **RU 03-08**

Overflow and backflow problems

Oil in outlet chamber

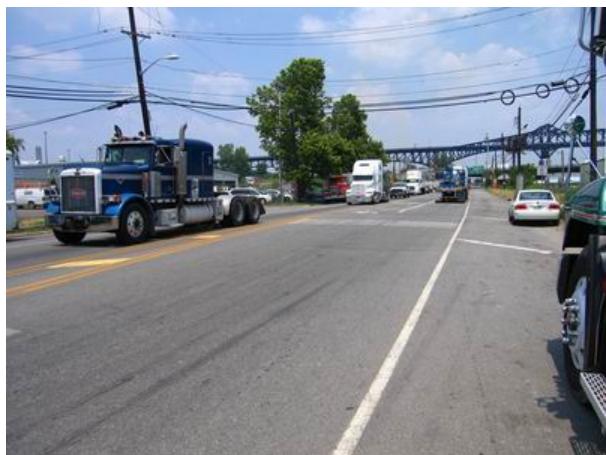
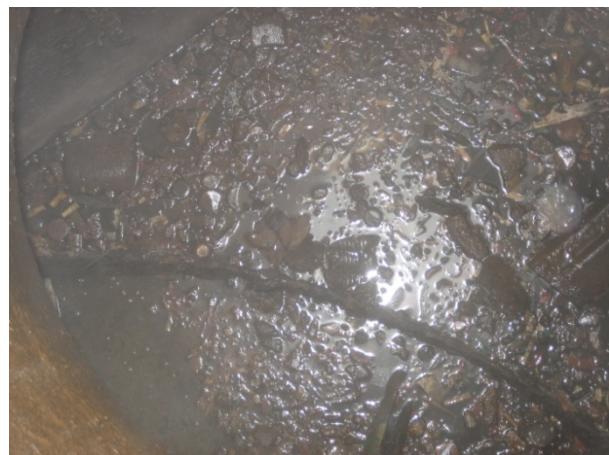
Rutgers ID: **RU 04-01**Date 2007-05-04 Time 14:00

Water surface of floatables chamber is mostly covered by floating litter.

Oil in outlet chamber

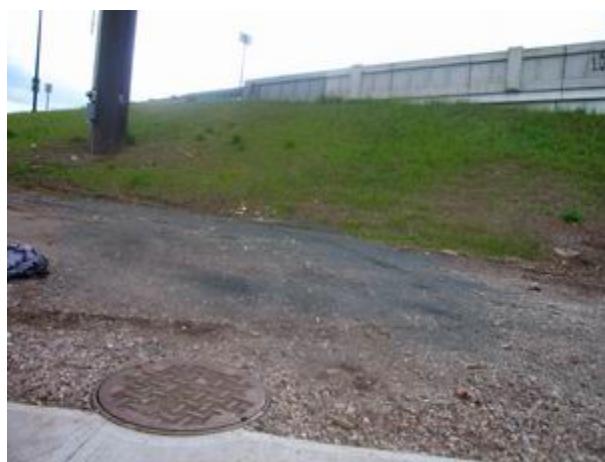
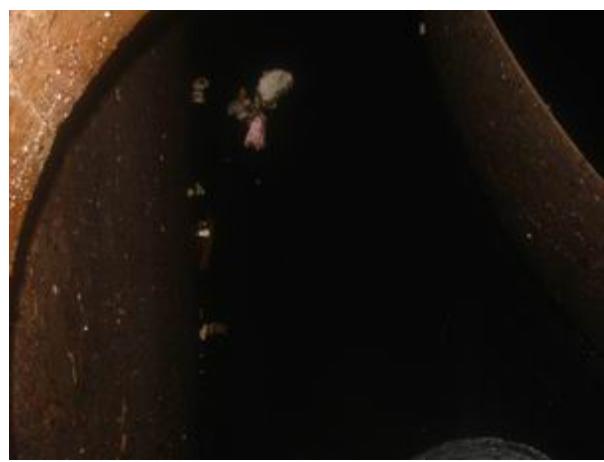
The manhole covers are not identified with the Vortechs logotype.

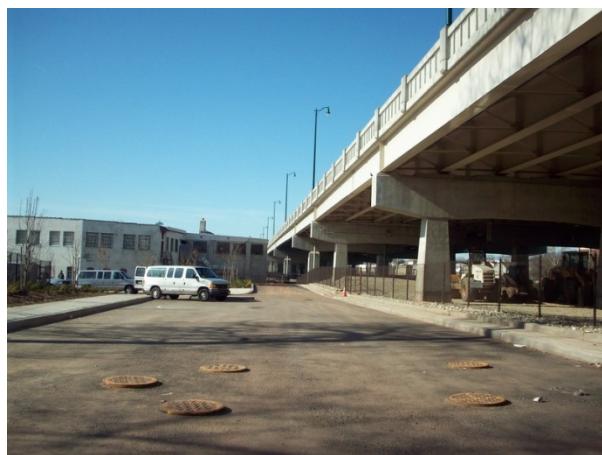
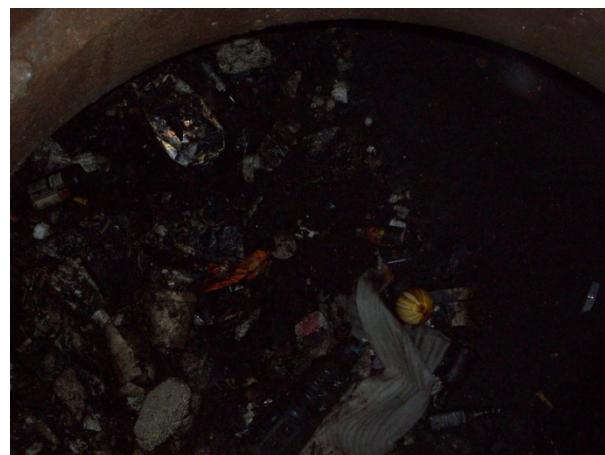
Rutgers ID: **RU 04-04**Date 2009-03-30 Time 11:00

Remarks:

The Vortechs is located between Rt.1&9 and Spring St.
 1.0 ft sediment accumulation in the grit chamber (11.6-10.6=1.0)

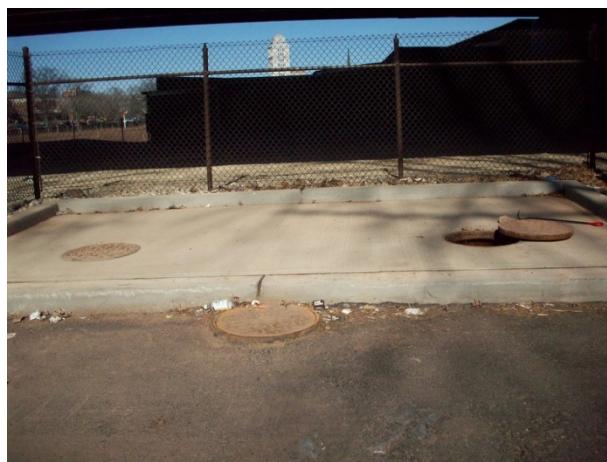
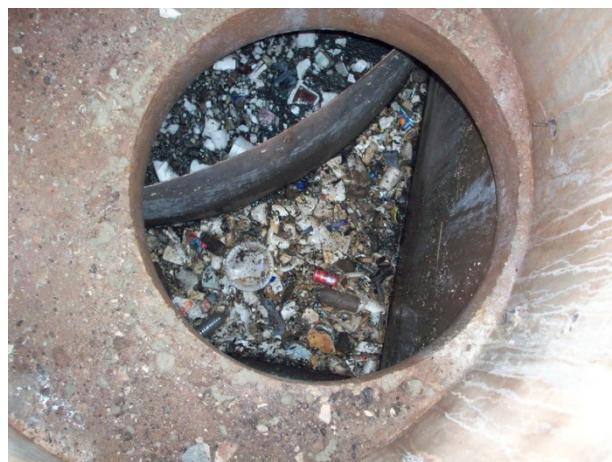
Rutgers ID: **RU 05-01**Date 2007-05-10 Time 11:40

Remarks:

The Vortechs is located between Rt.1&9 and Spring St.
 1.1 ft sediment accumulation in the grit chamber (12.6-11.5=1.1)

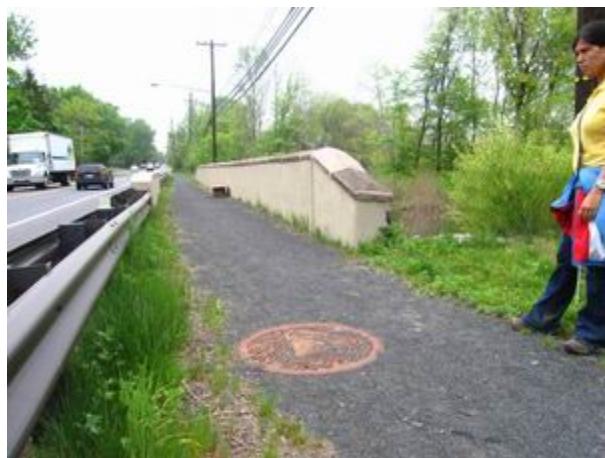
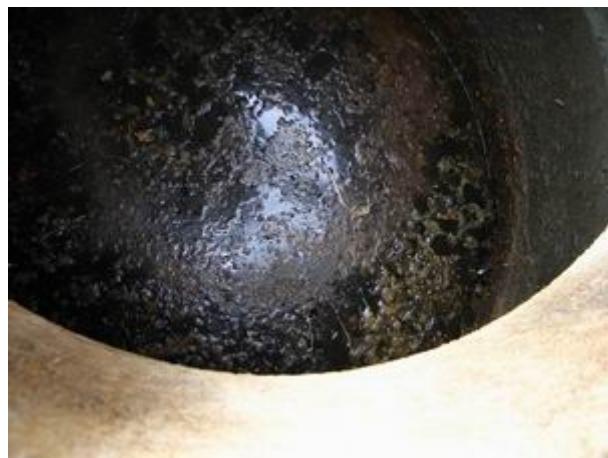
Rutgers ID: **RU 05-02**Date 2007-05-10 Time 11:40

The floatables chamber was not accessible since there were only two covers and none above the floatables chamber.

In the outlet chamber, The depth of water was 4.32ft (4.5-8.82ft)

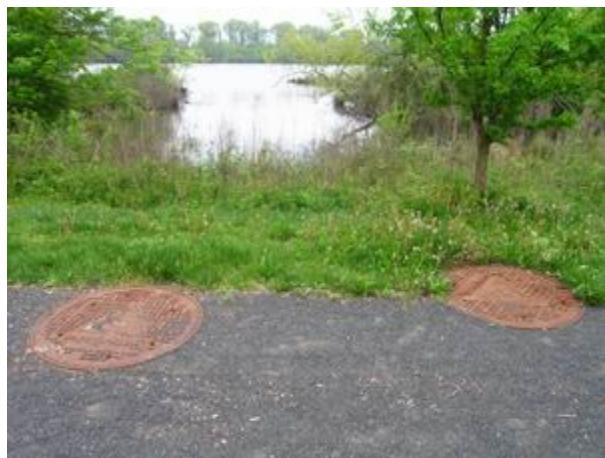
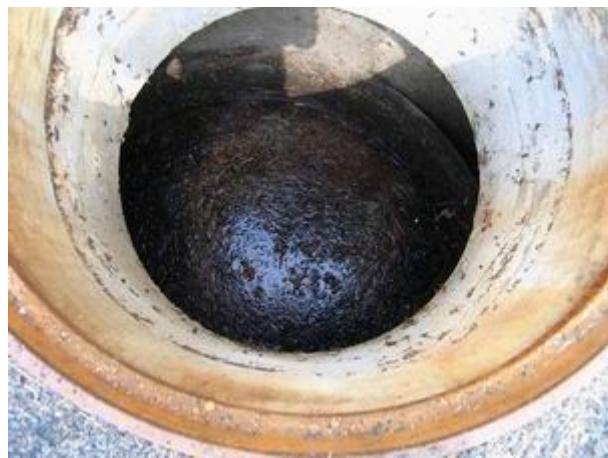
Rutgers ID: **RU 08-01**Date 2007-05-20 Time 14:40

Remarks:
Located at Harry's Brook bridge
It had rained the day before the site visit:
The floatables chamber was not accessible since there were only two covers and none above the floatables chamber.
In the outlet chamber, the depth of water is 4.0ft (3.4-7.4ft) and the depth of sediment is 0.7ft (7.4-8.1ft).

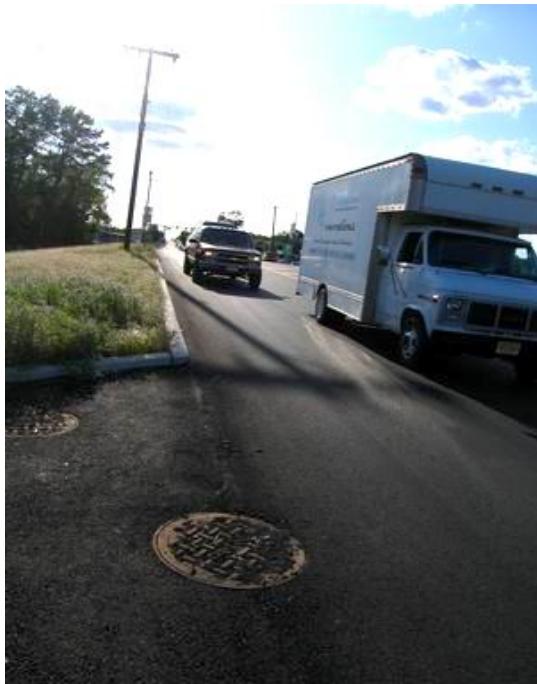
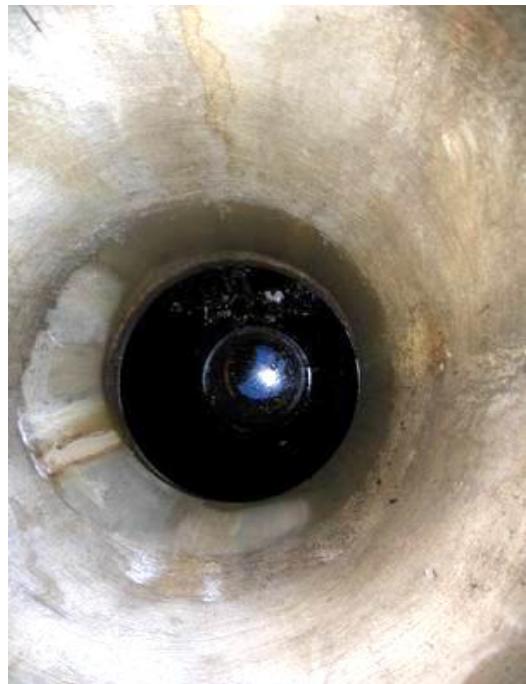
Rutgers ID: **RU 09-02**Date 2007-05-13 Time 13:30

The bottom of the Vortechs System could not be reached with the measurement tool since the device is installed **deep underground**.

Manhole cover above floatables chamber is located on the Rt73. It is difficult to open without blocking traffic.

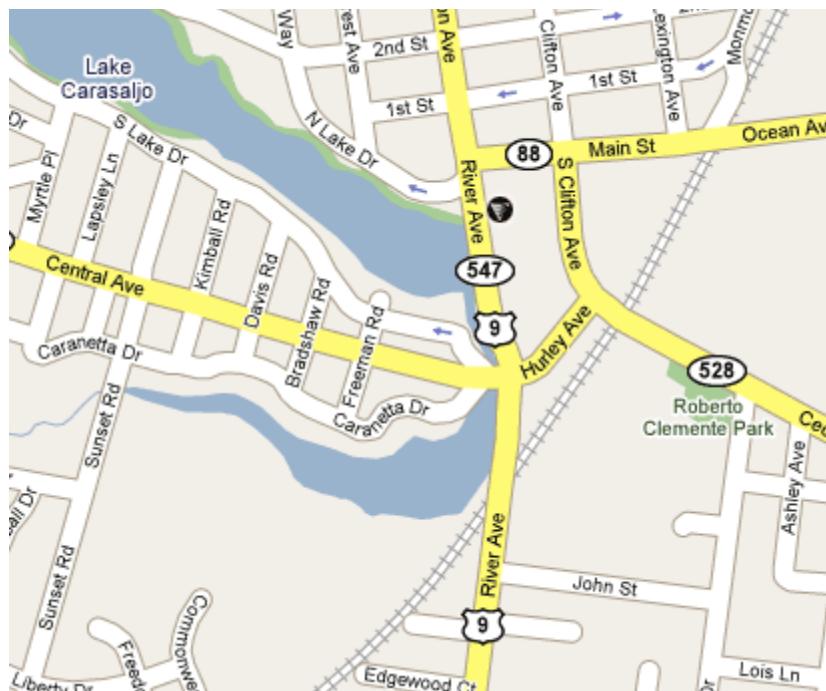
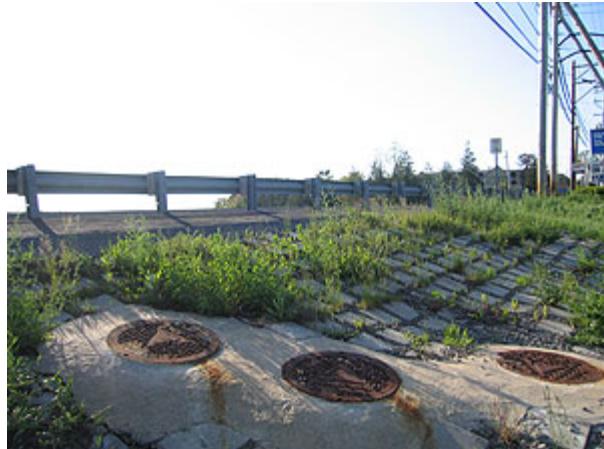
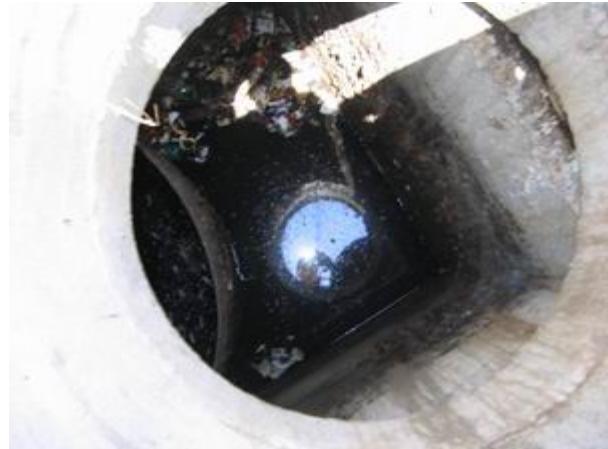
Rutgers ID: **RU 10-01**Date 2007-05-28Time 11:30

A lot of small gravels around covers

The grit chamber and the floatables chamber were mostly covered by floating litter
(Such as cigarette butts).

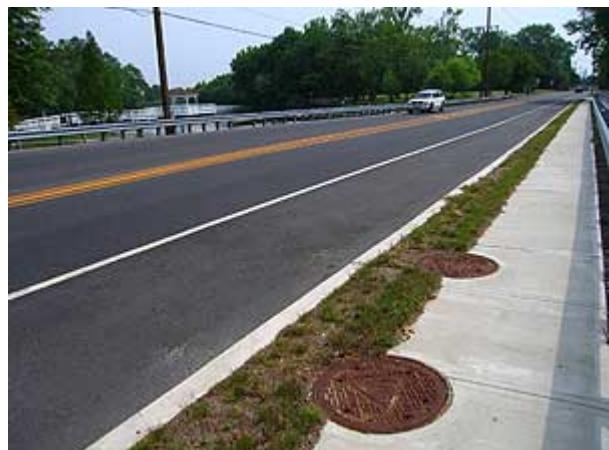
Rutgers ID: **RU 10-02**Date 2007-05-28 Time 11:30

The first visiting day (05/28/07) was a holiday (Memorial day)

The floatables chamber was not accessible since there were only two covers and none above the floatables chamber.

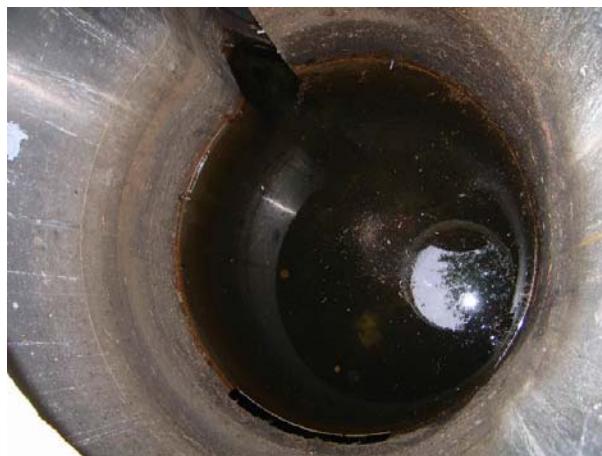
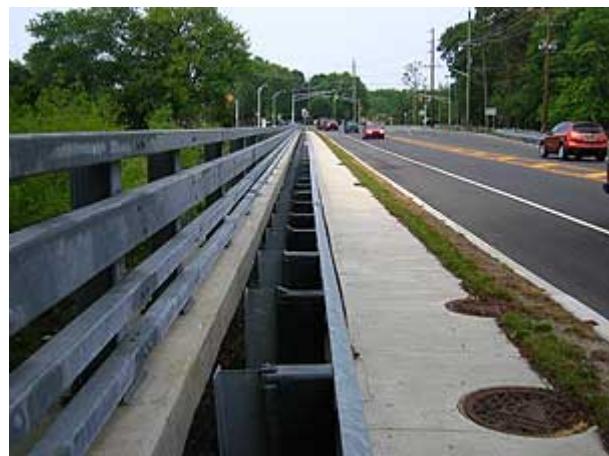
The floatables chamber was not accessible since there were only two covers and none above the floatables chamber.

The contaminated outlet flow is accumulated in front of the outlet mouth. Surrounded lake vegetables impede flow through lake

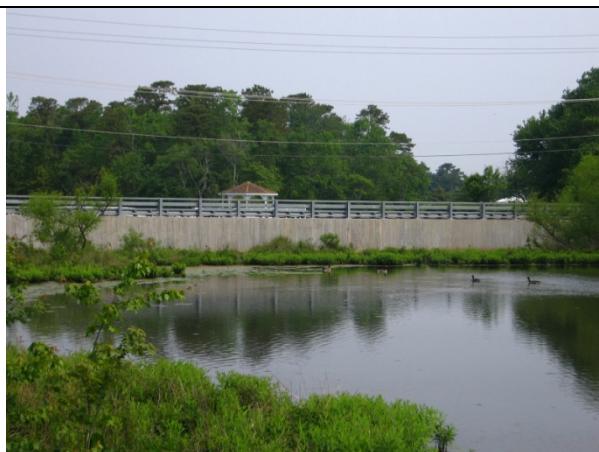
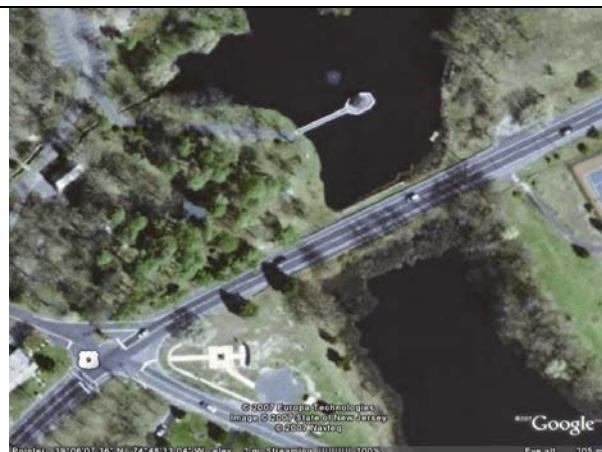
Rutgers ID: **RU 11-01**

Grit Chamber	Water S. Reading <u>4.2 ft</u>	Sediment Surface Reading			Bot Reading <u>8.2</u>
		1 (center)	2 (in between)	3 (side)	
Float. Chamber	Floatables Top Surface Reading			Fl. Bott. Su. R	Bot Reading <u>8.1</u>
	1 (center)	2 (in between)	3 (side)	N/A

Remarks:
Vortechs manholes are located on a **construction site**.
The Vortechs is located along the side of Randolph Ave and is about 30ft away from Rt.1&9.
There are two other manhole covers between the Vortechs device and the road.
Water surfaces of both grit (swirl) chamber and floatables chamber were mostly covered by floating litter (such as Styrofoam). One layer of floatables only and thickness difficult to measure.

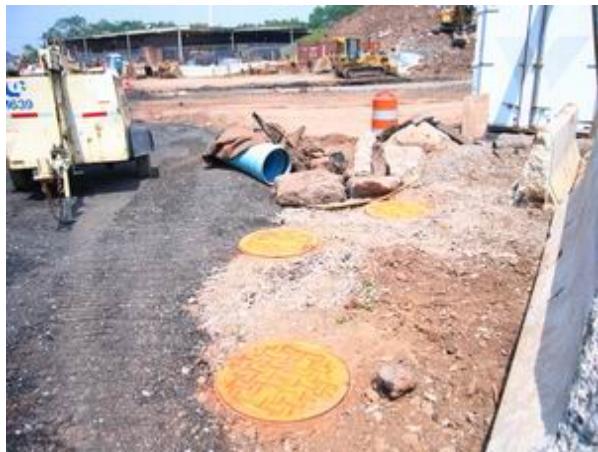
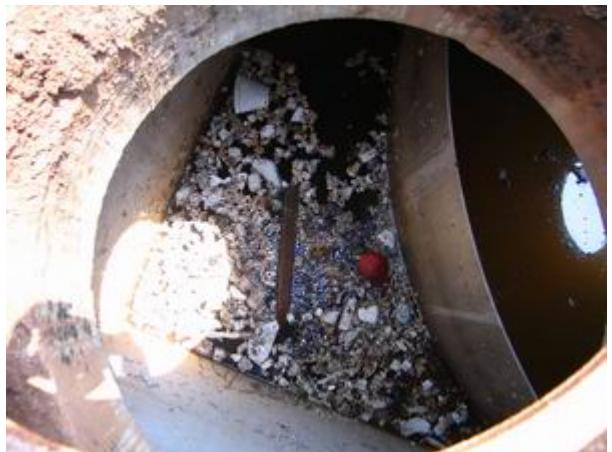
Rutgers ID: **RU 11-02**Date 2007-06-08 Time 14:00

There are two other manhole covers between the Vortechs device and the road.

Water surface of both grit (swirl) chamber and floatables chamber was about half covered by floating litter. One layer of floatables only and thickness difficult to measure.
