Stormwater System Monitoring and Evaluation

FINAL REPORT

December 2013

Dept. of Civil & Environmental Engineering &
Center for Advanced Infrastructure and Transportation
Rutgers, The State University of New Jersey

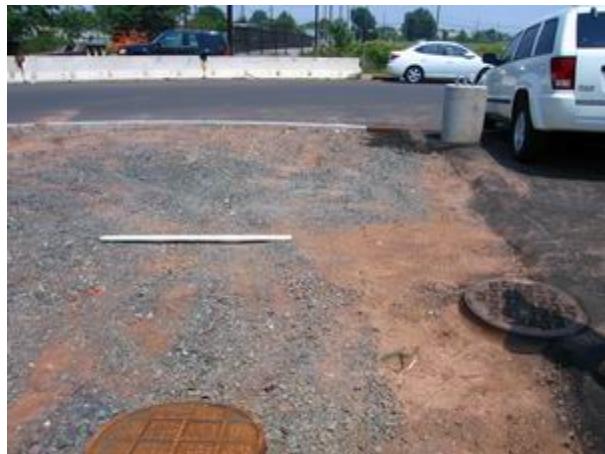
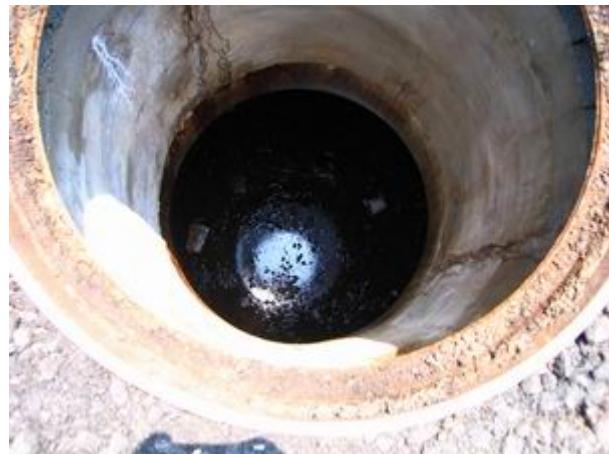
Rutgers ID: **RU 12-01**Date 2007-06-08Time 15:30

Remarks:

- Vortechs system manholes are located on the road and shoulder.

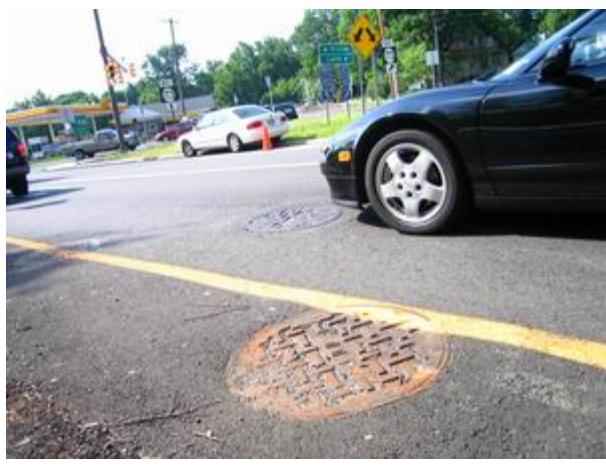
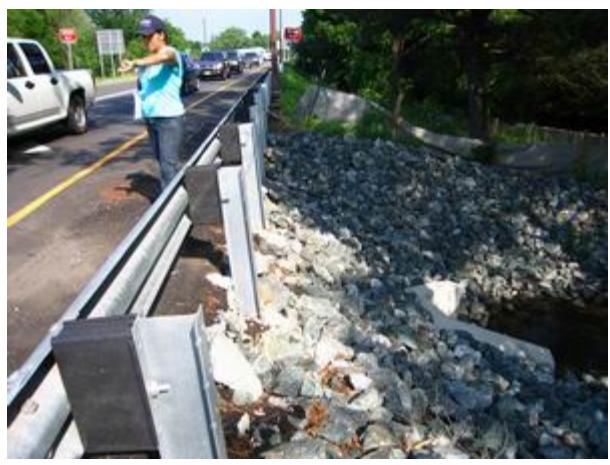
Rutgers ID: **RU 13-01**Date 2007-06-12Time 13:00

- Vortechs manholes are located on a **construction site**.
- This Vortechs is installed recently. : 2006-12-08.

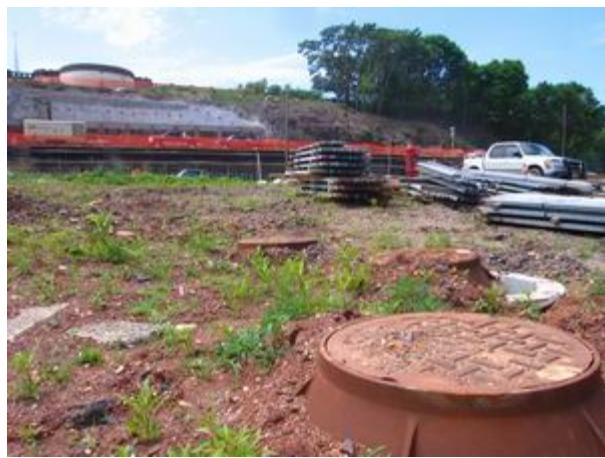
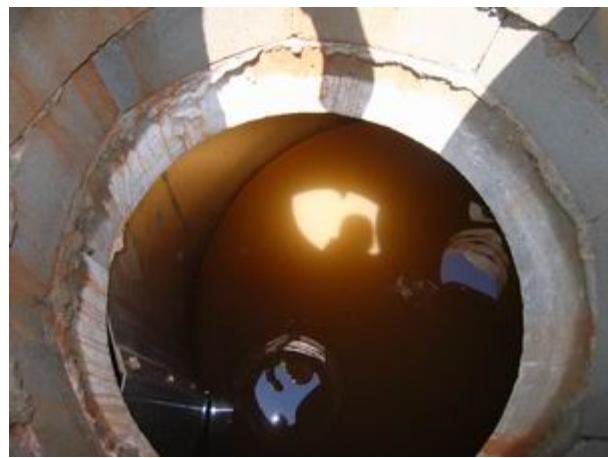
Rutgers ID: **RU 13-02**Date 2007-06-12Time 13:00

- Vortechs manholes are located on a **construction site**.
- This Vortechs is installed recently. : 2006-12-08.

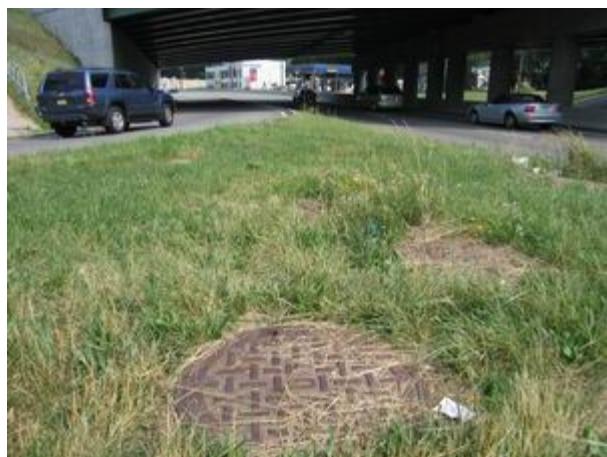
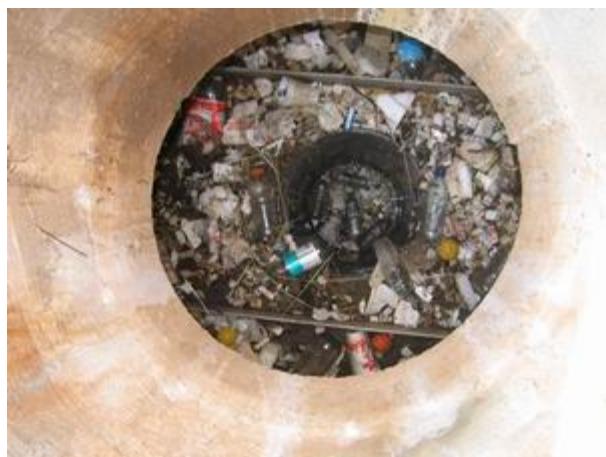
Rutgers ID: **RU 16-02**Date 2008-12-07 Time 14:00

A 2.1 ft layer of sediments was found in the floatables chamber (6.3-8.4ft).

- The Vortechs manholes are located in the center of the road
- Agriculture residential

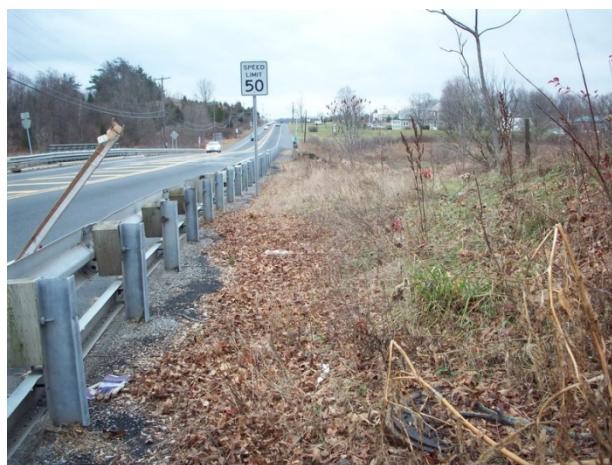
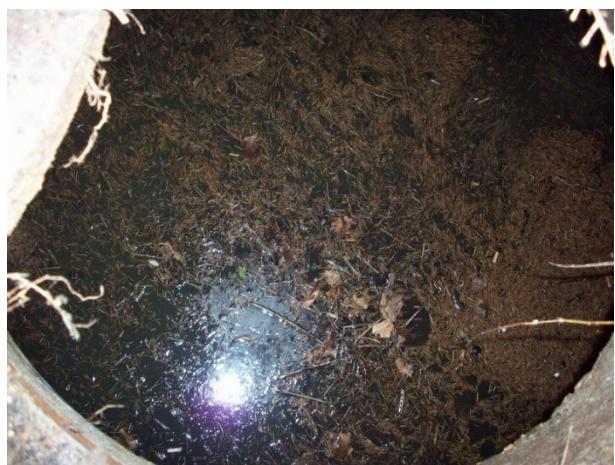
The floatables chamber was not accessible since there was no cover above it.

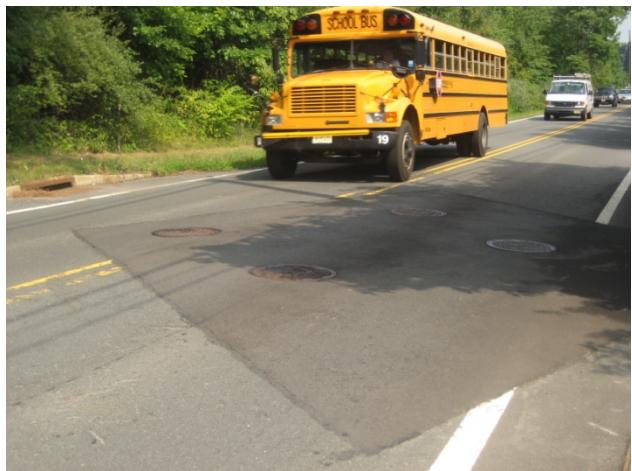
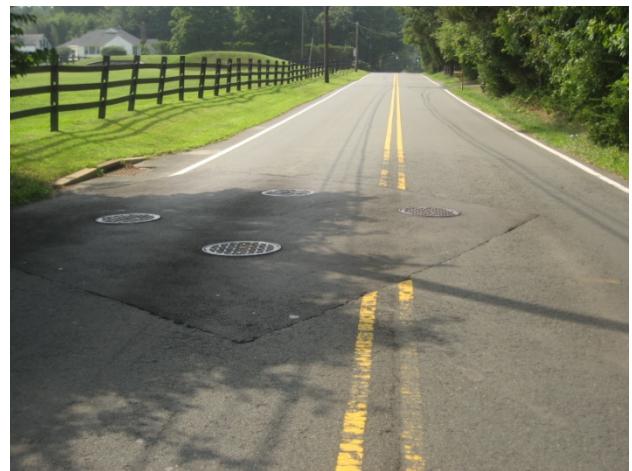
Rutgers ID: **RU 17-02**Date 2007-08-09Time 7:30

- The floatables chamber was not accessible since there were only two covers and none above the floatables chamber.
- Agriculture residential
- Two diversion chambers for inlet and outlet have each cover
