SAFETY AND ACCESSIBILITY OF DYNAMIC MESSAGE SIGNS (DMS)

FINAL REPORT

August 2014

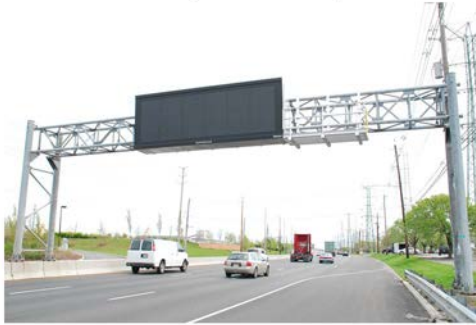
Figure 1. Span Structure (Edison, NJ)

The accessibility of DMSs is influenced by the sign support structure. New Jersey uses four types of overhead DMS support structures including: span, cantilever, butterfly and ground mounted. These structures typically consist of steel tubular posts (or columns) combined with space trusses which support the DMS. Figures 1, 2, 3, and 4 show examples of span, cantilever, butterfly and ground mounted DMS types, respectively, used in New Jersey. A span support extends over the roadway with supports on both sides of the roadway. A cantilever DMS extends over the travel lanes and has a support on only one side of the roadway. A butterfly consists of a single vertical steel post and one or two pairs of horizontal steel tubes. Ground mounted DMSs are the front access DMSs mounted on two posts with a 7' minimum clearance under the bottom of the sign.

Route 1 NB,1203221,MP 30.90

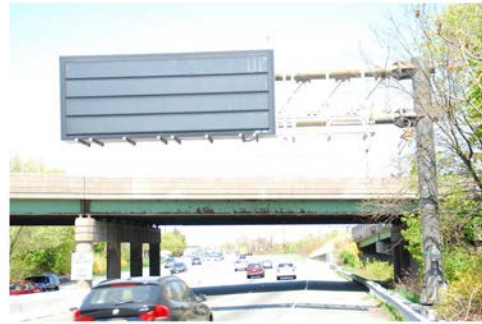
Figure 2. Cantilever Sign Structure (Woodbridge, NJ)

Route 17 NB,0212203,MP 6.71

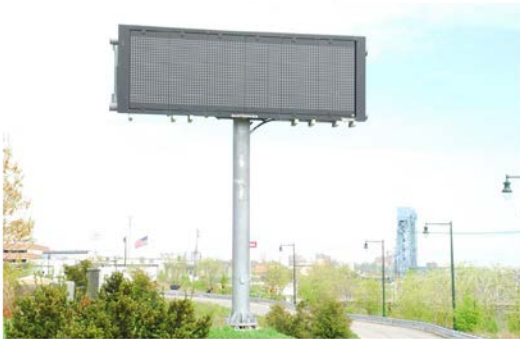
Figure 3. Butterfly Sign Structure (Newark, NJ)

Route 21 NB,3157,MM:2.8

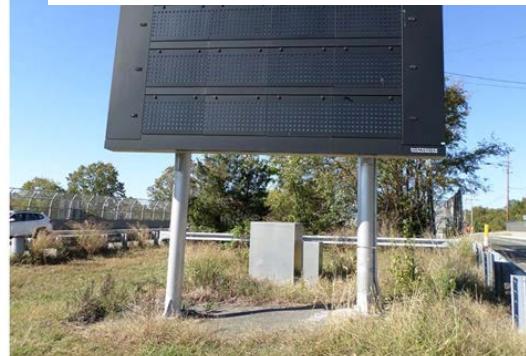
Figure 4. Ground Mounted Structure (Wall, NJ)

Route 138 WB, MP 2

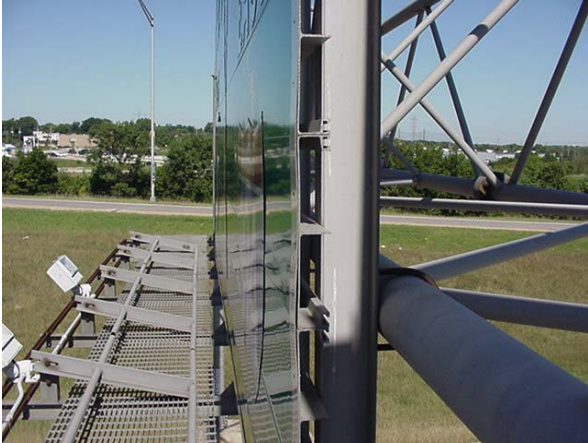
Catwalks or walkways are important features in assessing the accessibility to the DMS. Figures 5 and 6 show two views of catwalks for static overhead signs. The figures show components of the catwalk that impact safety including the use of grates, presence of a handrail and safety chains. Figure 5 shows the catwalk with safety rails in a collapsed position. This type of collapsible safety rail is also used with DMSs in New Jersey. Figure 6 shows the safety rails in an upright position.

Figure 5. Catwalk with Safety Rails in Collapsed Position (Source: WSDOT, Structure Inspection Manual Part 4)

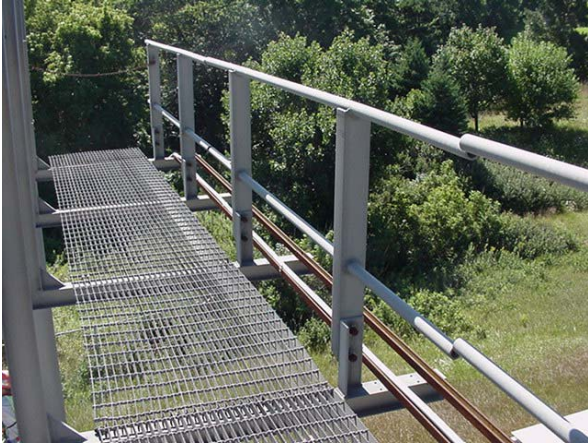
Figure 6. Catwalk with Safety Rails in Upright Position (Source: WSDOT, Structure Inspection Manual Part 4)

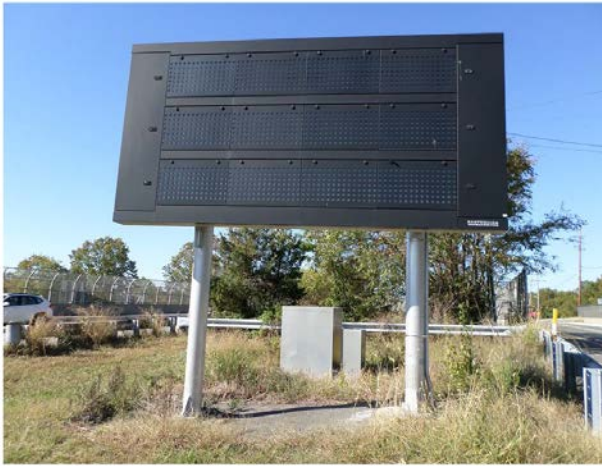
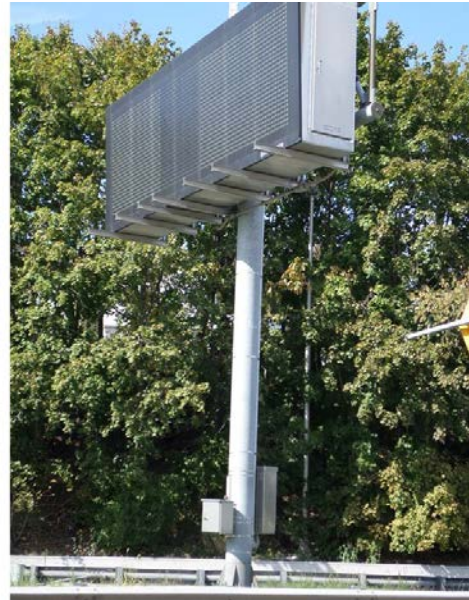
Figure 7. Examples of Ground Mounted and Butterfly DMS

In New Jersey, ground mounted and butterfly type DMSs are typically not provided with a catwalk. Figure 7 shows a typical ground mounted and butterfly DMS support. As shown in Table 4, 19 DMSs are butterfly and 49 DMSs are ground mounted. Applying

Ground Mounted DMS
ID 138 Route 138 WB, MP 2

Butterfly DMS
ID 31 Route 17 NB, MP 8.4

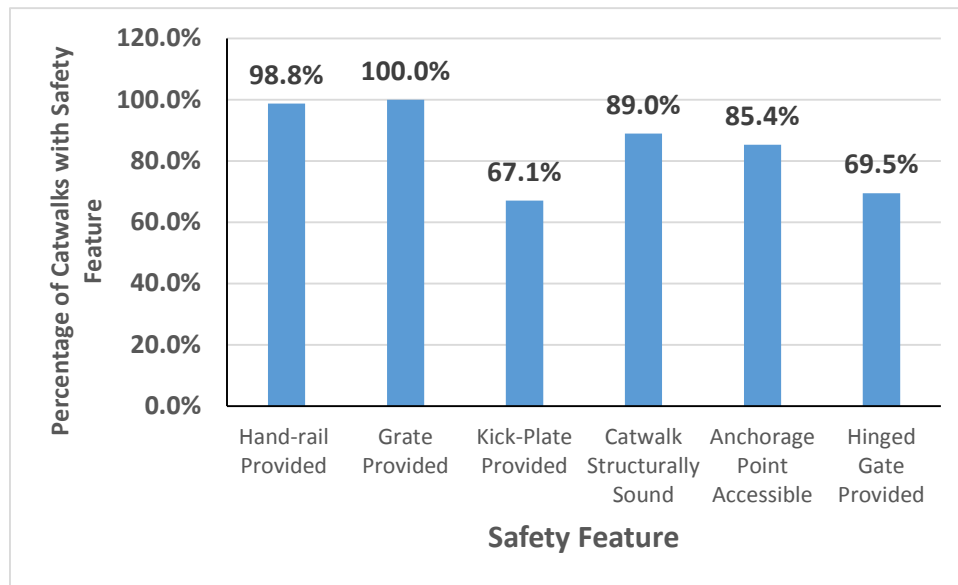
Figure 8. Presence of Catwalk Safety Features at DMSs

provided with a handrail (98.8%) and 100 percent are provided with a grate. The safety feature most missing from the catwalks are kickplates, with 67 percent of the catwalks having this feature, and a hinged gate, with 69.5% of catwalks with this feature.

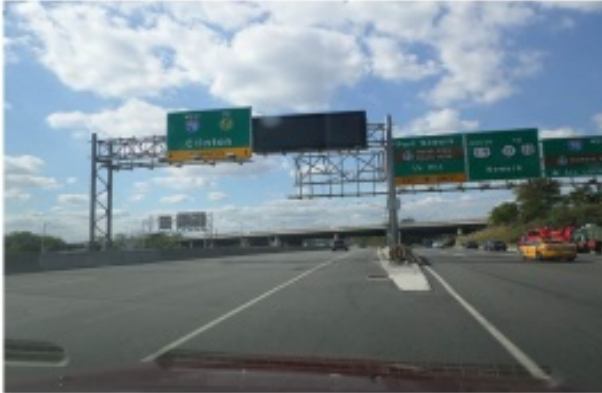
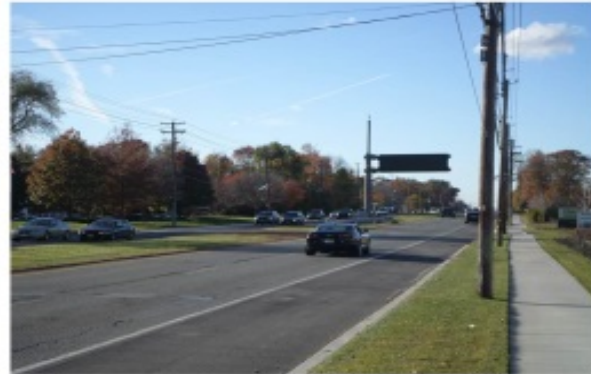
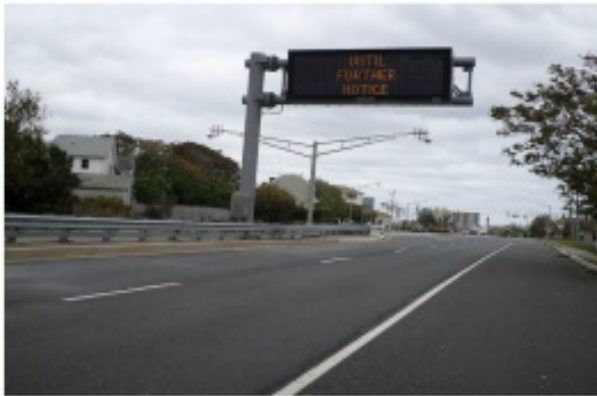
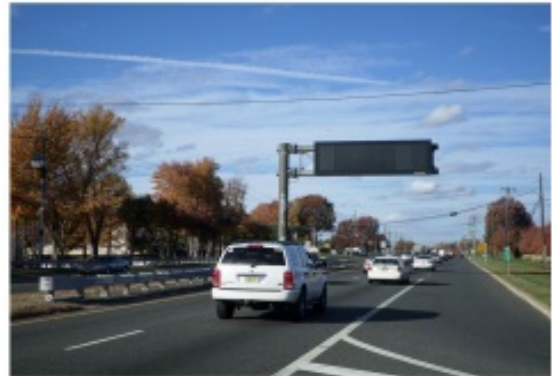
ID 116, Route 78 WB, MP 58.4

ID 93, Route 70 WB, MP 6.6

ID 59, Route 36 NB, MP 6.15

ID 98, Route 73 NB, MP 22.98

Installation of catwalks is also recommended at some DMS locations where the existing sign support would not adequately support the catwalk. At these locations it is recommended not only that the catwalk be installed, but also that the sign support be replaced to accommodate the catwalk. These locations include the following:

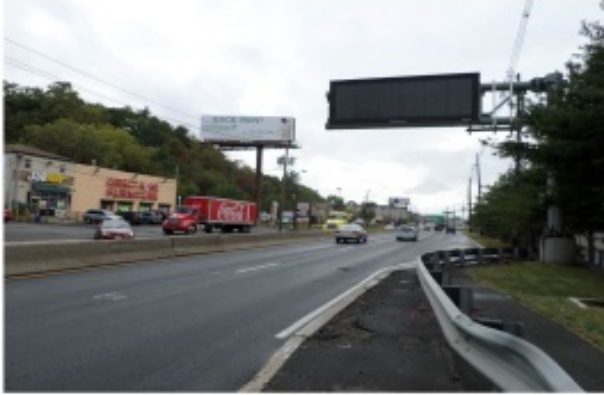
ID 15, Route 1 SB, MP 56.3

1	2	2	No hand-rail, kickplate, anchorage point or hinged gate provided. Replace catwalk with a catwalk meeting minimum standards.

At some DMS locations, the minimum standards for catwalks are partially met. If more than one of the safety features identified in the minimum standard is not met, it is recommended that these catwalks be replaced with catwalks that meet the minimum standards. These locations include the following:

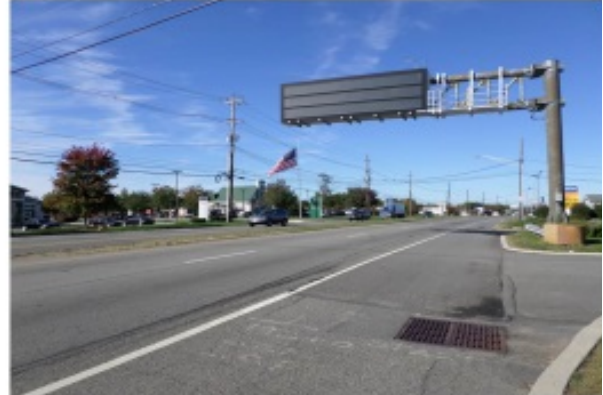
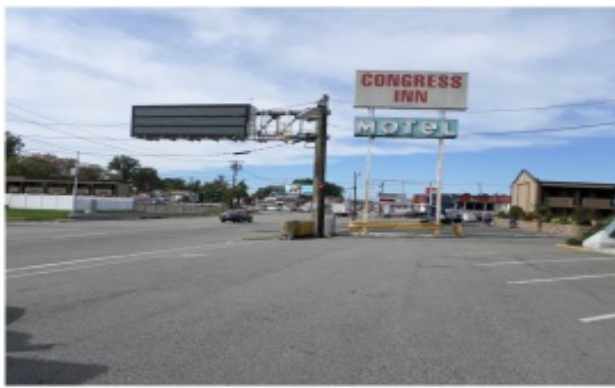
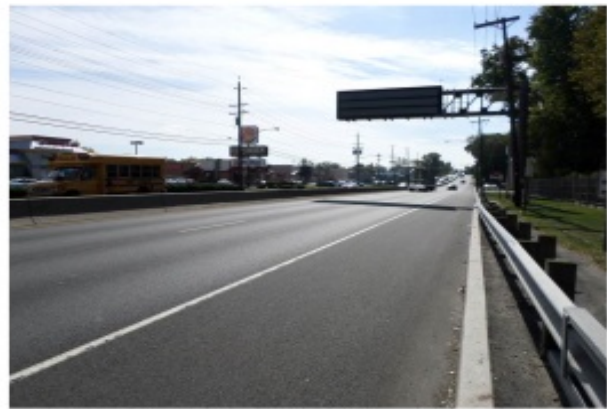
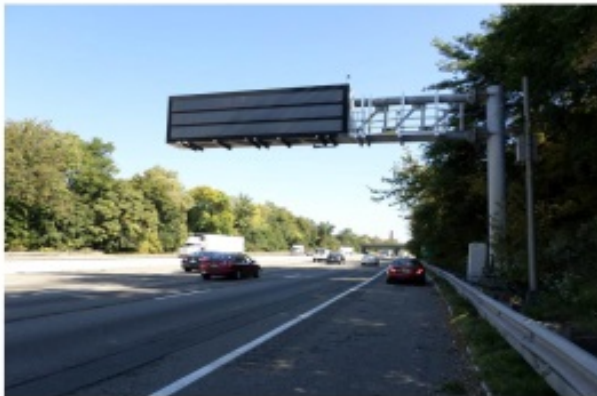
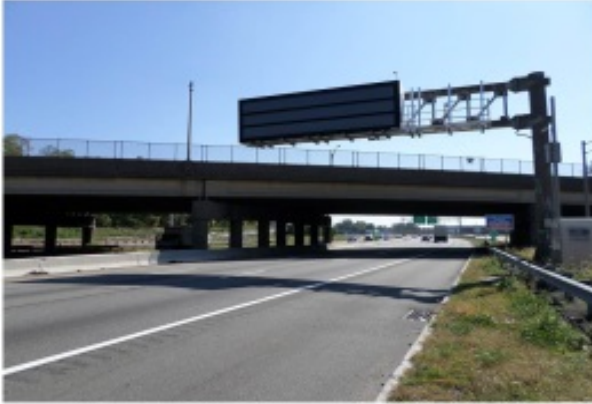
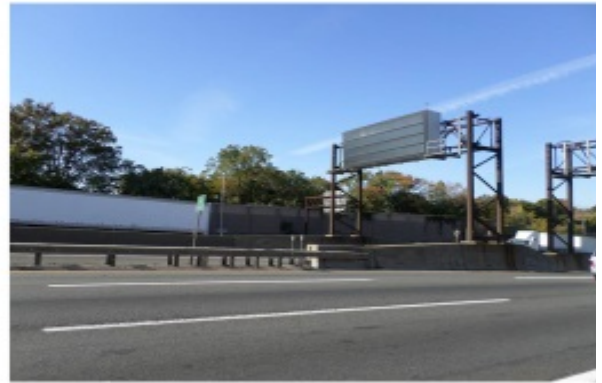
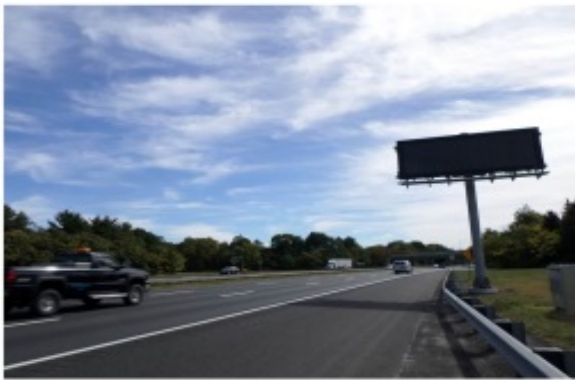
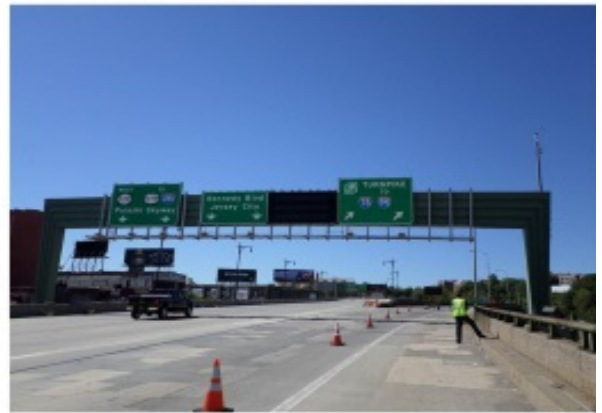
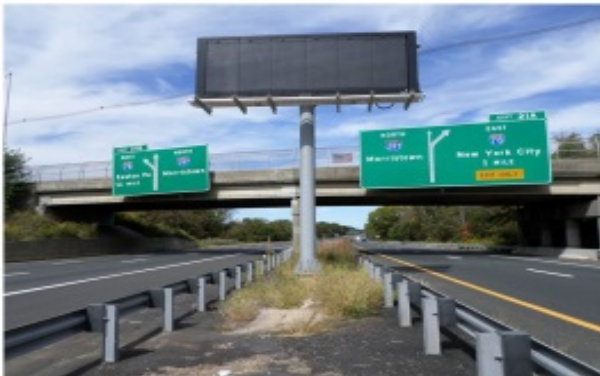
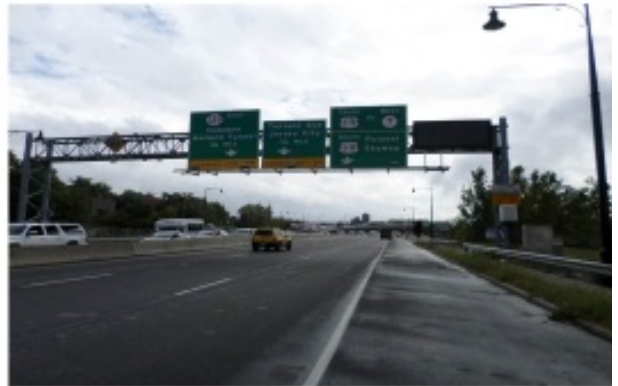
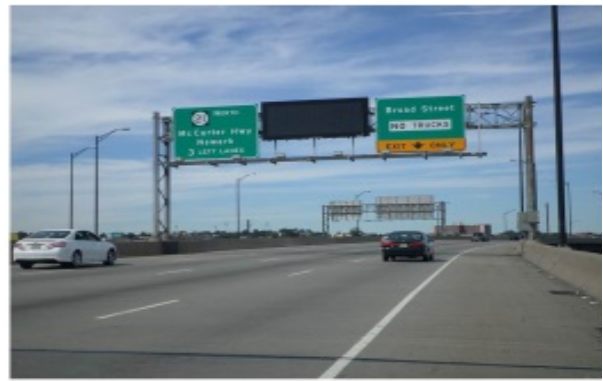
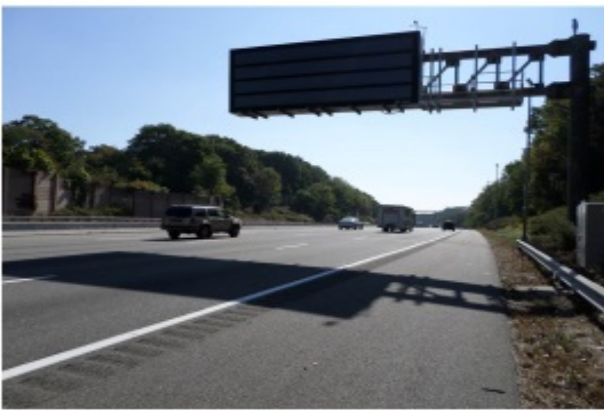
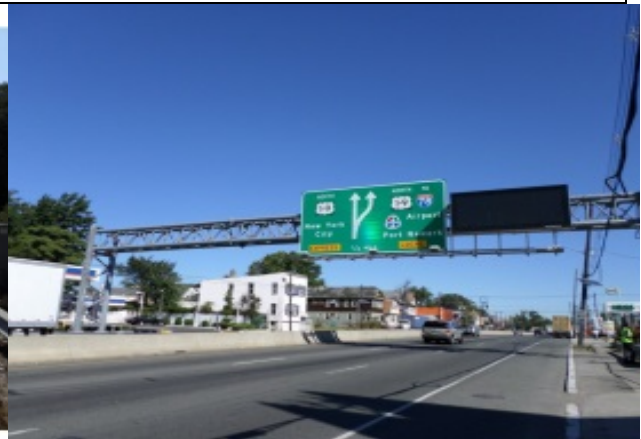
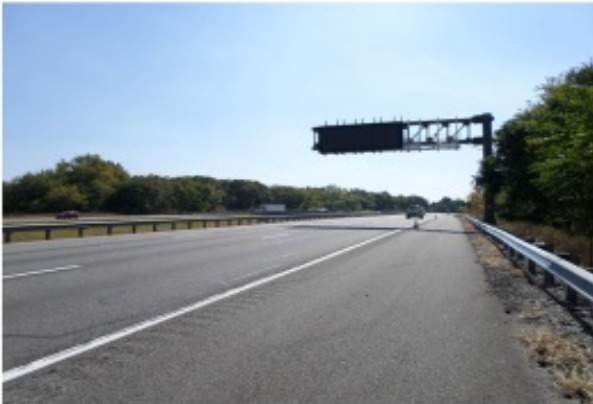
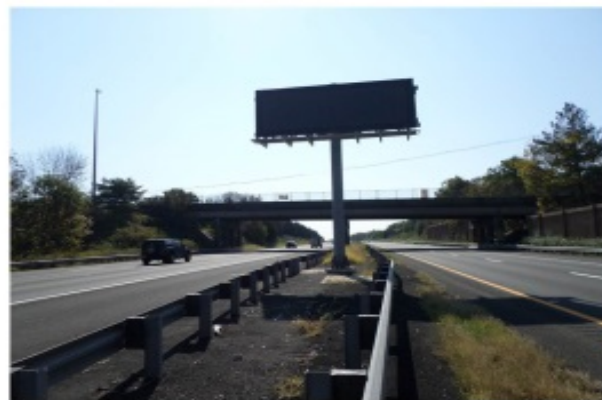
ID 79, Route 46 WB, MP 50.2

ID 85, Route 46 WB, MP 69.4

ID 32, Route 17 SB, MP 11.1

ID 126, Route 80 EB, MP 57.5

ID 127, Route 80 EB, MP 59

ID 136, Route 95 SB, MP 75.2

ID 160, Route 287 SB, MP 13.64

ID 139, Route 139 WB, MP 1.37

ID 162, Route 287 NB, MP 20.14

ID 11, Route 1 NB, MP 48.2

ID 39, Route 21 NB, MP 0.4

ID 120, Route 80 EB, MP 40.8

ID 8, Route 1 NB, MP 45.5

ID 123, Route 80 WB, MP 48.5

ID 161, Route 287 SB, MP 20.1

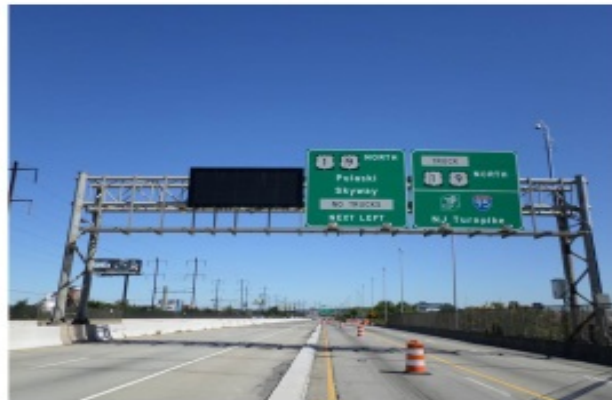
ID 12, Route 1 NB, MP 50.73

1	2	2	No kickplate, anchorage point or hinged gate. Replace catwalk with a catwalk meeting minimum standards.
ID 13, Route 1 NB, MP 53.8

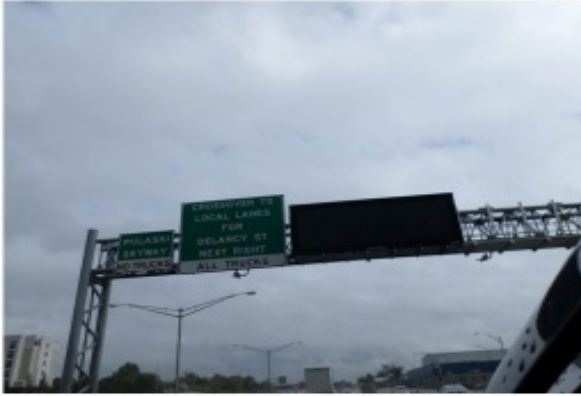
1	2	2	No kickplate or hinged gate provided. Replace catwalk with a catwalk meeting minimum standards.
ID 12, Route 1 NB, MP 50.73

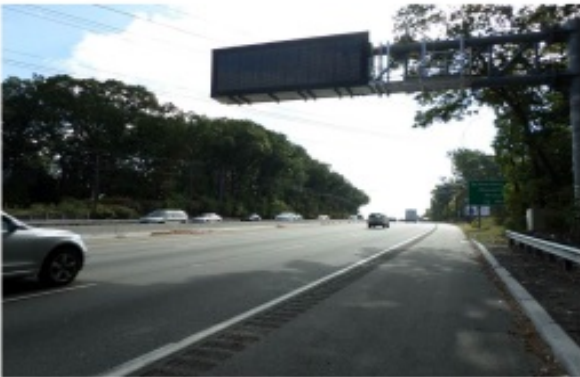
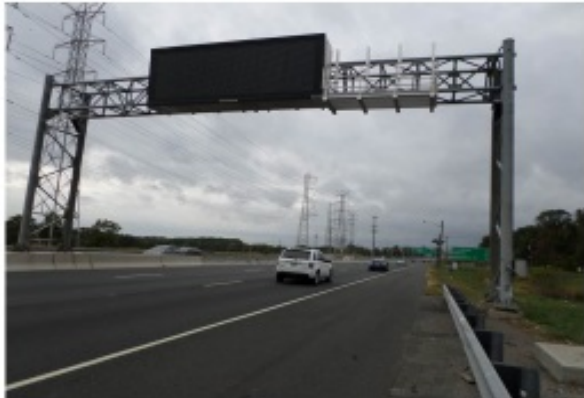
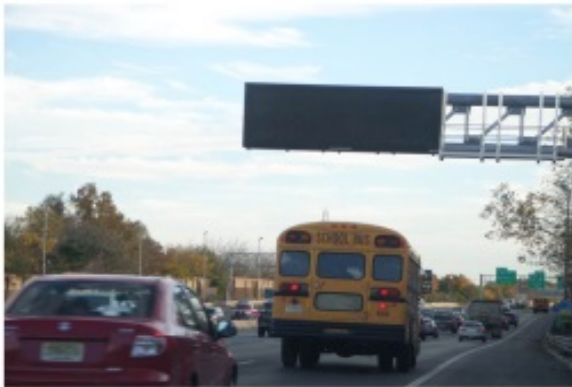
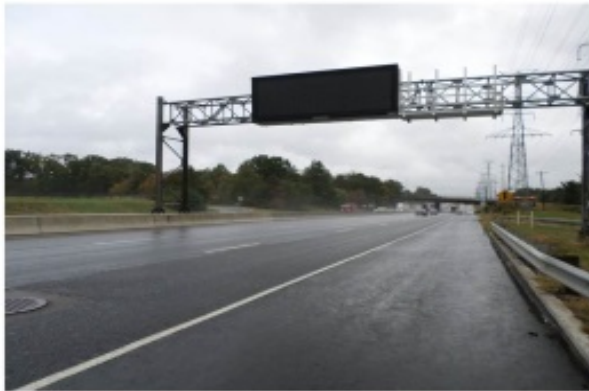
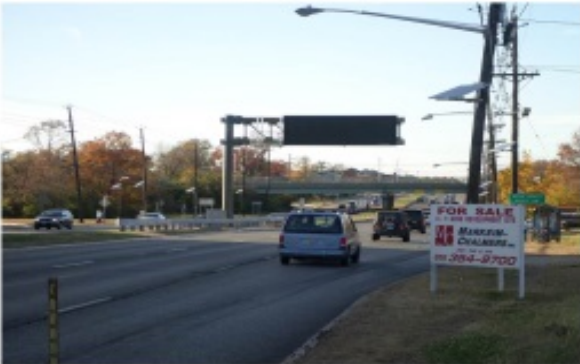
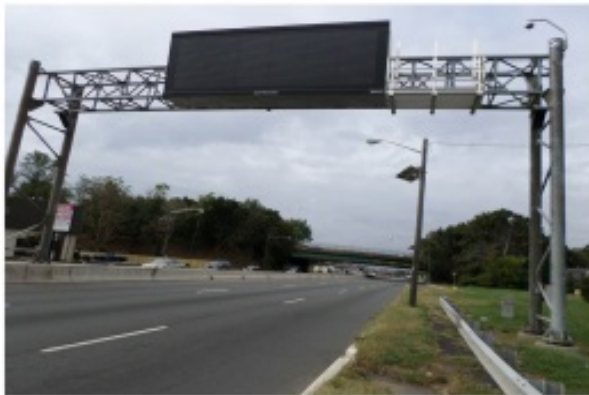
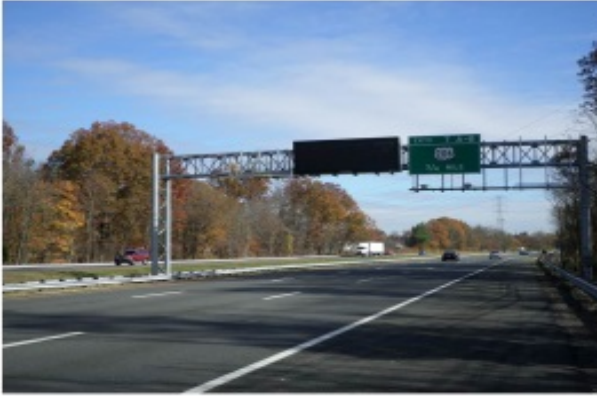
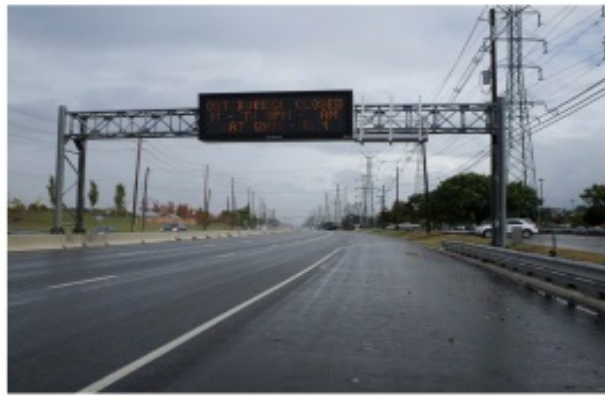
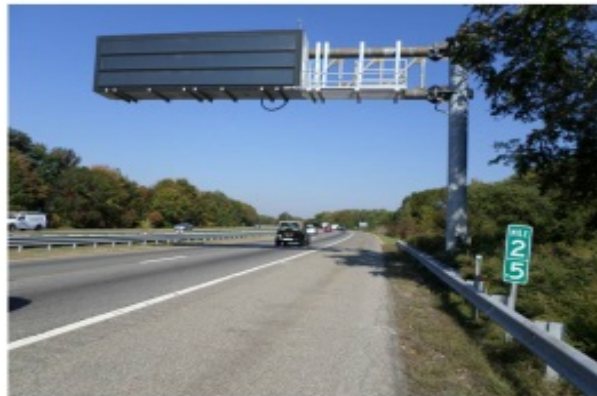
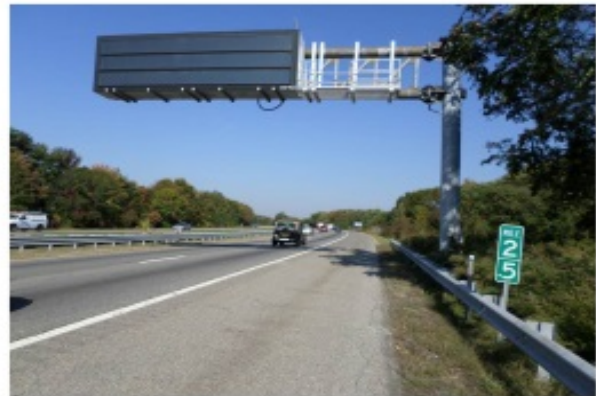
kickplate was not observed during the inspection and therefore the DMS partially met the minimum standards for catwalks. At these locations, it is recommended that a verification be performed to determine whether the kickplate is present and, if needed, the catwalk be modified to meet minimum standards. These locations include the following:

<p>ID 17, Route 3 EB, MP 2</p>	<p>ID 3, Route 1 SB, MP 26.1</p>

<p>ID 103, Route 76 SB, MP 1.56</p>	<p>ID 4, Route 1 NB, MP 26.2</p>

<p>ID 92, Route 70 WB, MP 1.19</p>	<p>ID 5, Route 1 SB, MP 28.5</p>

ID 134, Route 95 NB, MP 6.3

ID 6, Route 1 NB, MP 31

ID 149, Route 280 WB, MP 2.5

ID 151, Route 280 EB, MP 12.6

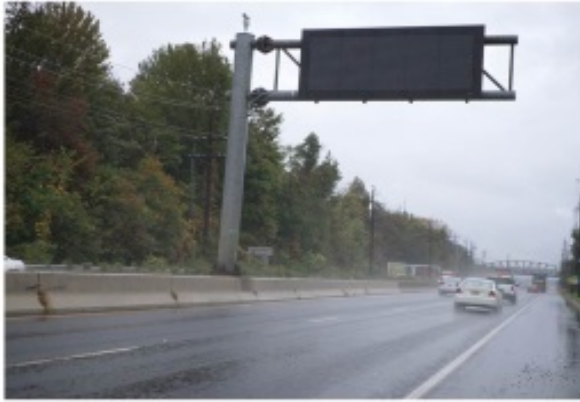
ID 1, Route 1 NB, MP 6.2

0	2	2	This is a front-access DMS with no catwalk. No catwalk recommended.
ID 2, Route 1 SB, MP 8.7

At some DMS locations, access to the DMS is provided through a front panel and no catwalk currently exists. At these locations, catwalks are not recommended and access to the DMS continue to be provided through the use of a bucket truck. These locations include the following:

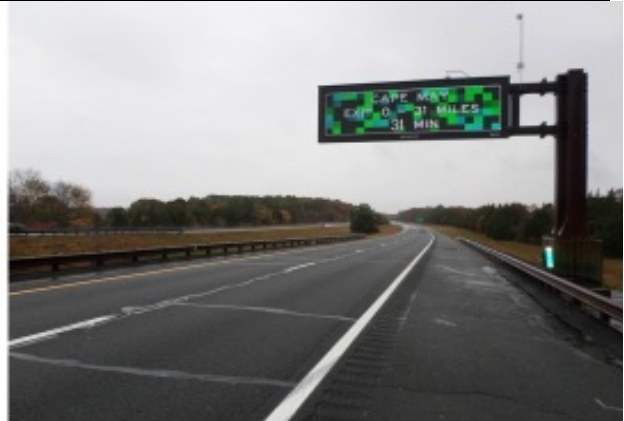
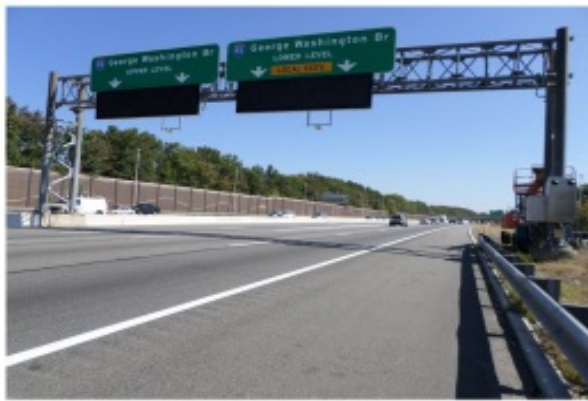
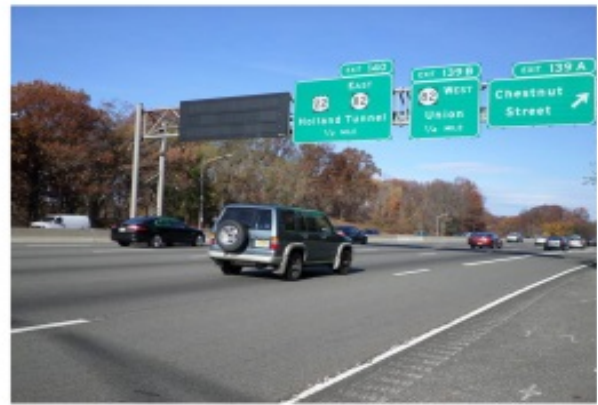
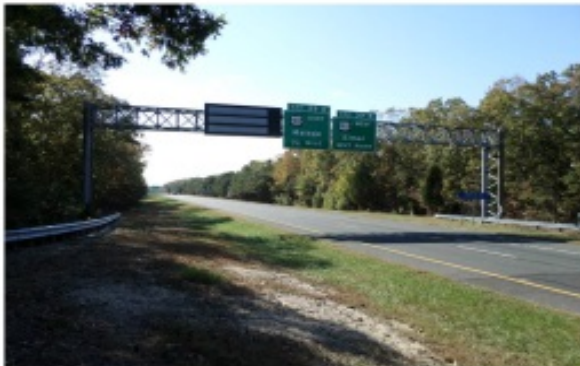
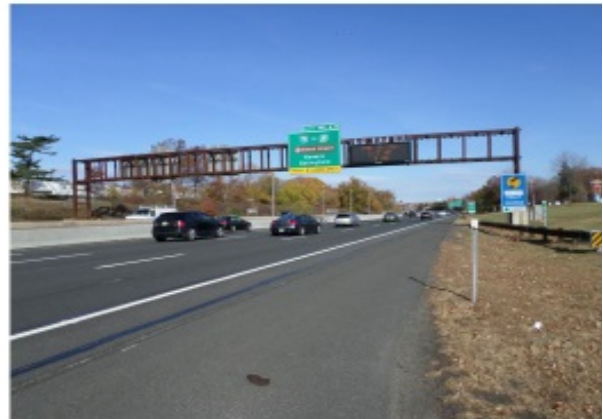
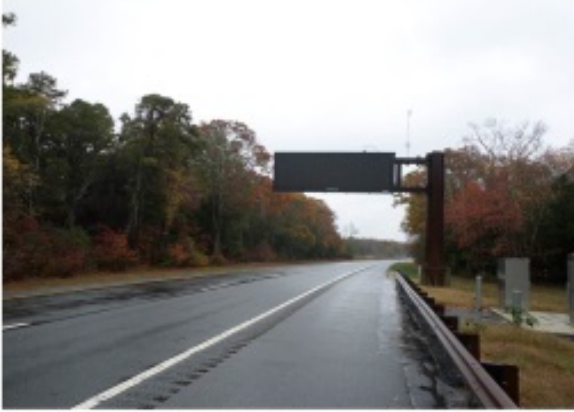
ID 188, Route 444 SB, MP 31.4

ID 130, Route 80 EB, MP 63.8

ID 189, Route 444 NB, MP 141.5

ID 88, Route 55 SB, MP 39.96

ID 190, Route 444 NB, MP 142.2

ID 187, Route 444 NB, MP 23.9

Catwalk Not Recommended

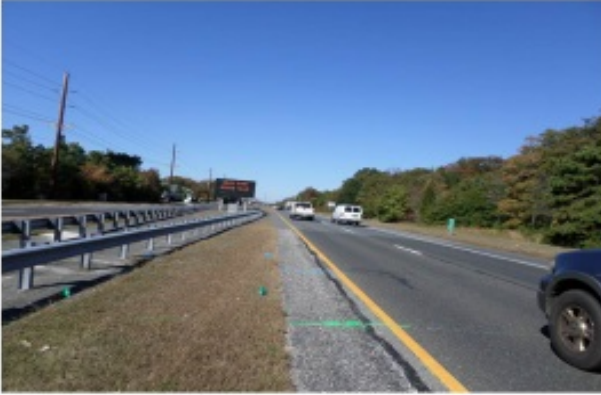
ID 97, Route 72 WB, MP 24.95

At some DMS locations, no hard surface is available for maintenance personnel to park the vehicle. Without a hard surface, weather related conditions can impact accessibility to the DMS. At these locations, a parking pad is recommended for installation. These locations include the following:

Install Parking Pad

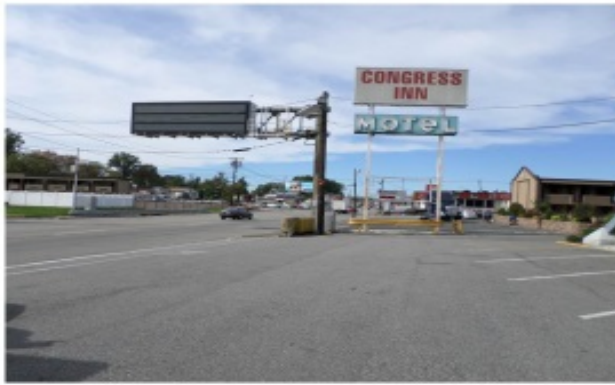
ID 85, Route 46 WB, MP 69.4

These recommendations identify locations where the minimum standards for utility lines are not met. At these locations, the recommendations indicate utility lines adjacent to the DMS. The recommendations do not explicitly state that the utility lines should be relocated as the vertical and horizontal distances between the DMS and the utility lines were estimated. These locations are as follows:

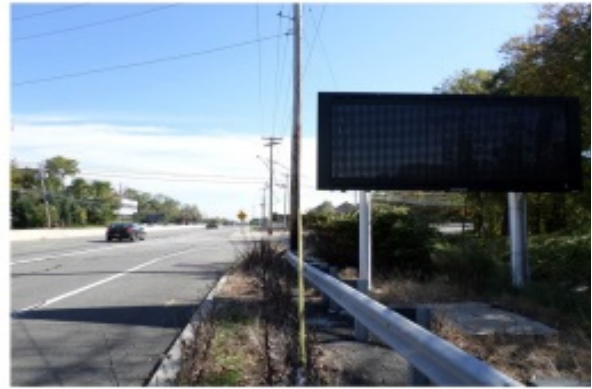
Location	DMS	Rating			Recommendation
		Catwalk	Access	Utility Line	
ID 28, Route 10 EB, MP 10.68	 	3	1	0	No safe access by ladder. Utility line is adjacent to DMS. Requires use of bucket truck to access sign.
ID 29, Route 10 WB, MP 10.71	 	3	1	0	No safe access by ladder; Utility line is adjacent to DMS. Requires use of bucket truck to access sign.
ID 30, Route 17 NB, MP 6.7	 	2	2	2	No modification required.
ID 31, Route 17 NB, MP 8.4	 	3	2	2	No modification required.
ID 32, Route 17 SB, MP 11.1	 	1	2	0	No kickplate, anchorage point or hinged gate provided. Utility line adjacent to DMS. Replace catwalk with a catwalk meeting minimum standards.
