Hazardous Waste Screening Technical Environmental Study

March 2006

**I-295/I-76/ROUTE 42 DIRECT CONNECTION
 BELLMAWR, GLOUCESTER CITY AND MT. EPHRAIM
 CAMDEN COUNTY**

HAZARDOUS WASTE SCREENING TECHNICAL ENVIRONMENTAL STUDY

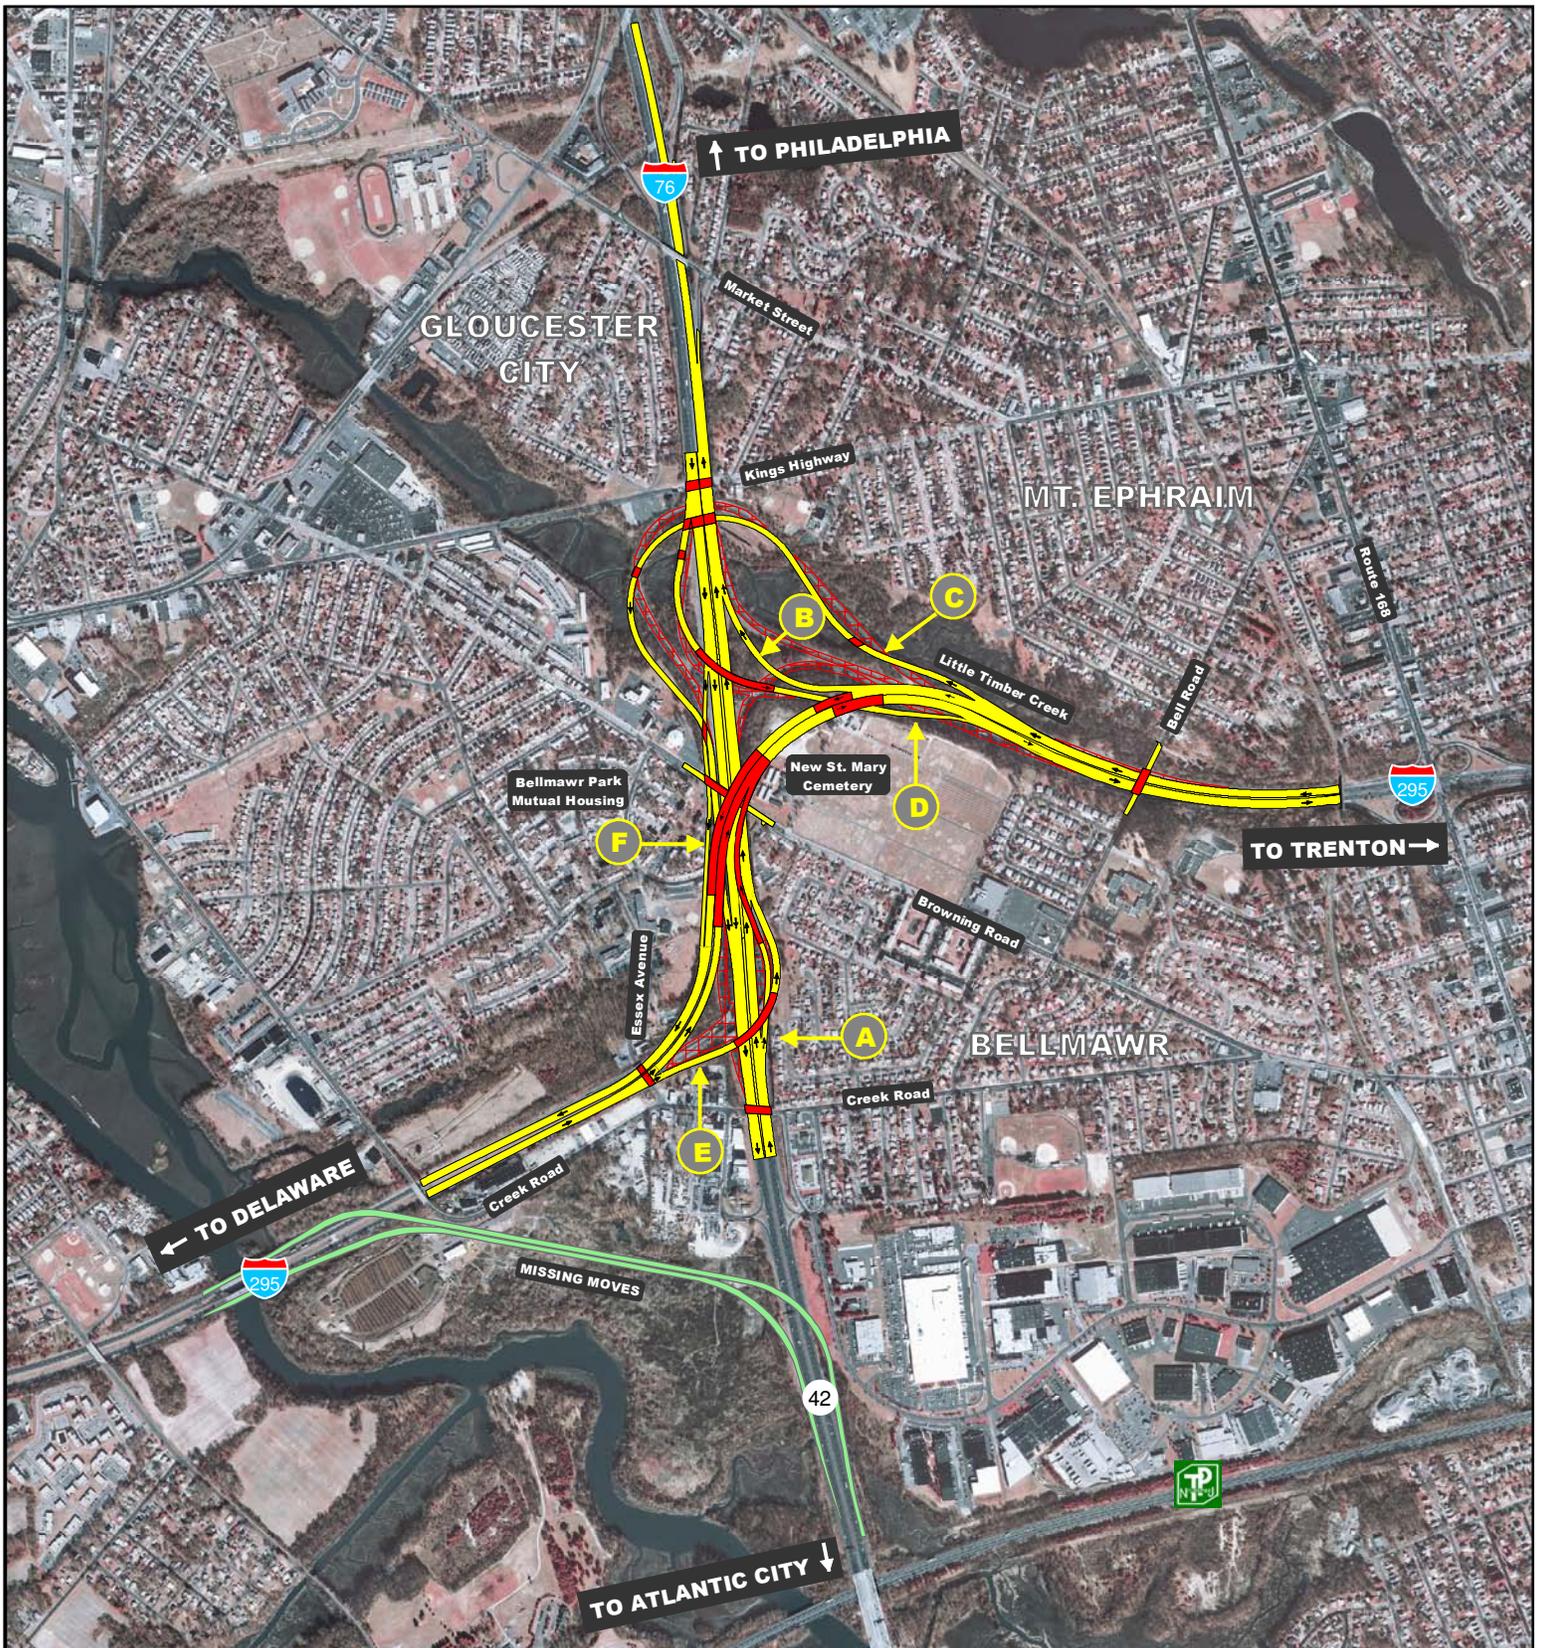
Alternative D1, shown in Figure 4, is almost identical to Alternative D. The primary difference is the configuration of Ramps B and C. Ramp C exits I-295 southbound from the tangent section of I-295 southbound. Ramp B exits from the right approximately 1,000' later. Ramp B is on a new alignment south of its present location, but ties into I-76 at a similar location. Ramp C generally follows (within 150'±) the existing Ramp C alignment (Al Jo's Curve) and passes under I-76 and Ramp F before merging with Route 42 southbound. The substandard radius on the existing Ramp C is replaced with a larger radius. Ramp D follows the same alignment as in Alternative D.

- Northbound and Southbound I-295 are side-by-side
- I-295 crosses over Route 42/I-76 on a viaduct on a skew
- I-295 on viaduct over Ramp C and Browning Road
- Ramp D on viaduct over I-76/Route 42 and under I-295
- Two lane ramps except for Ramp F
- Removes express/local lanes on I-76 Westbound
- I-295 Posted Speed Limit: 55 mph (Design Speed: 60 mph)
- Ramp Speed Limits: 40 mph (Design Speed: 45 mph)

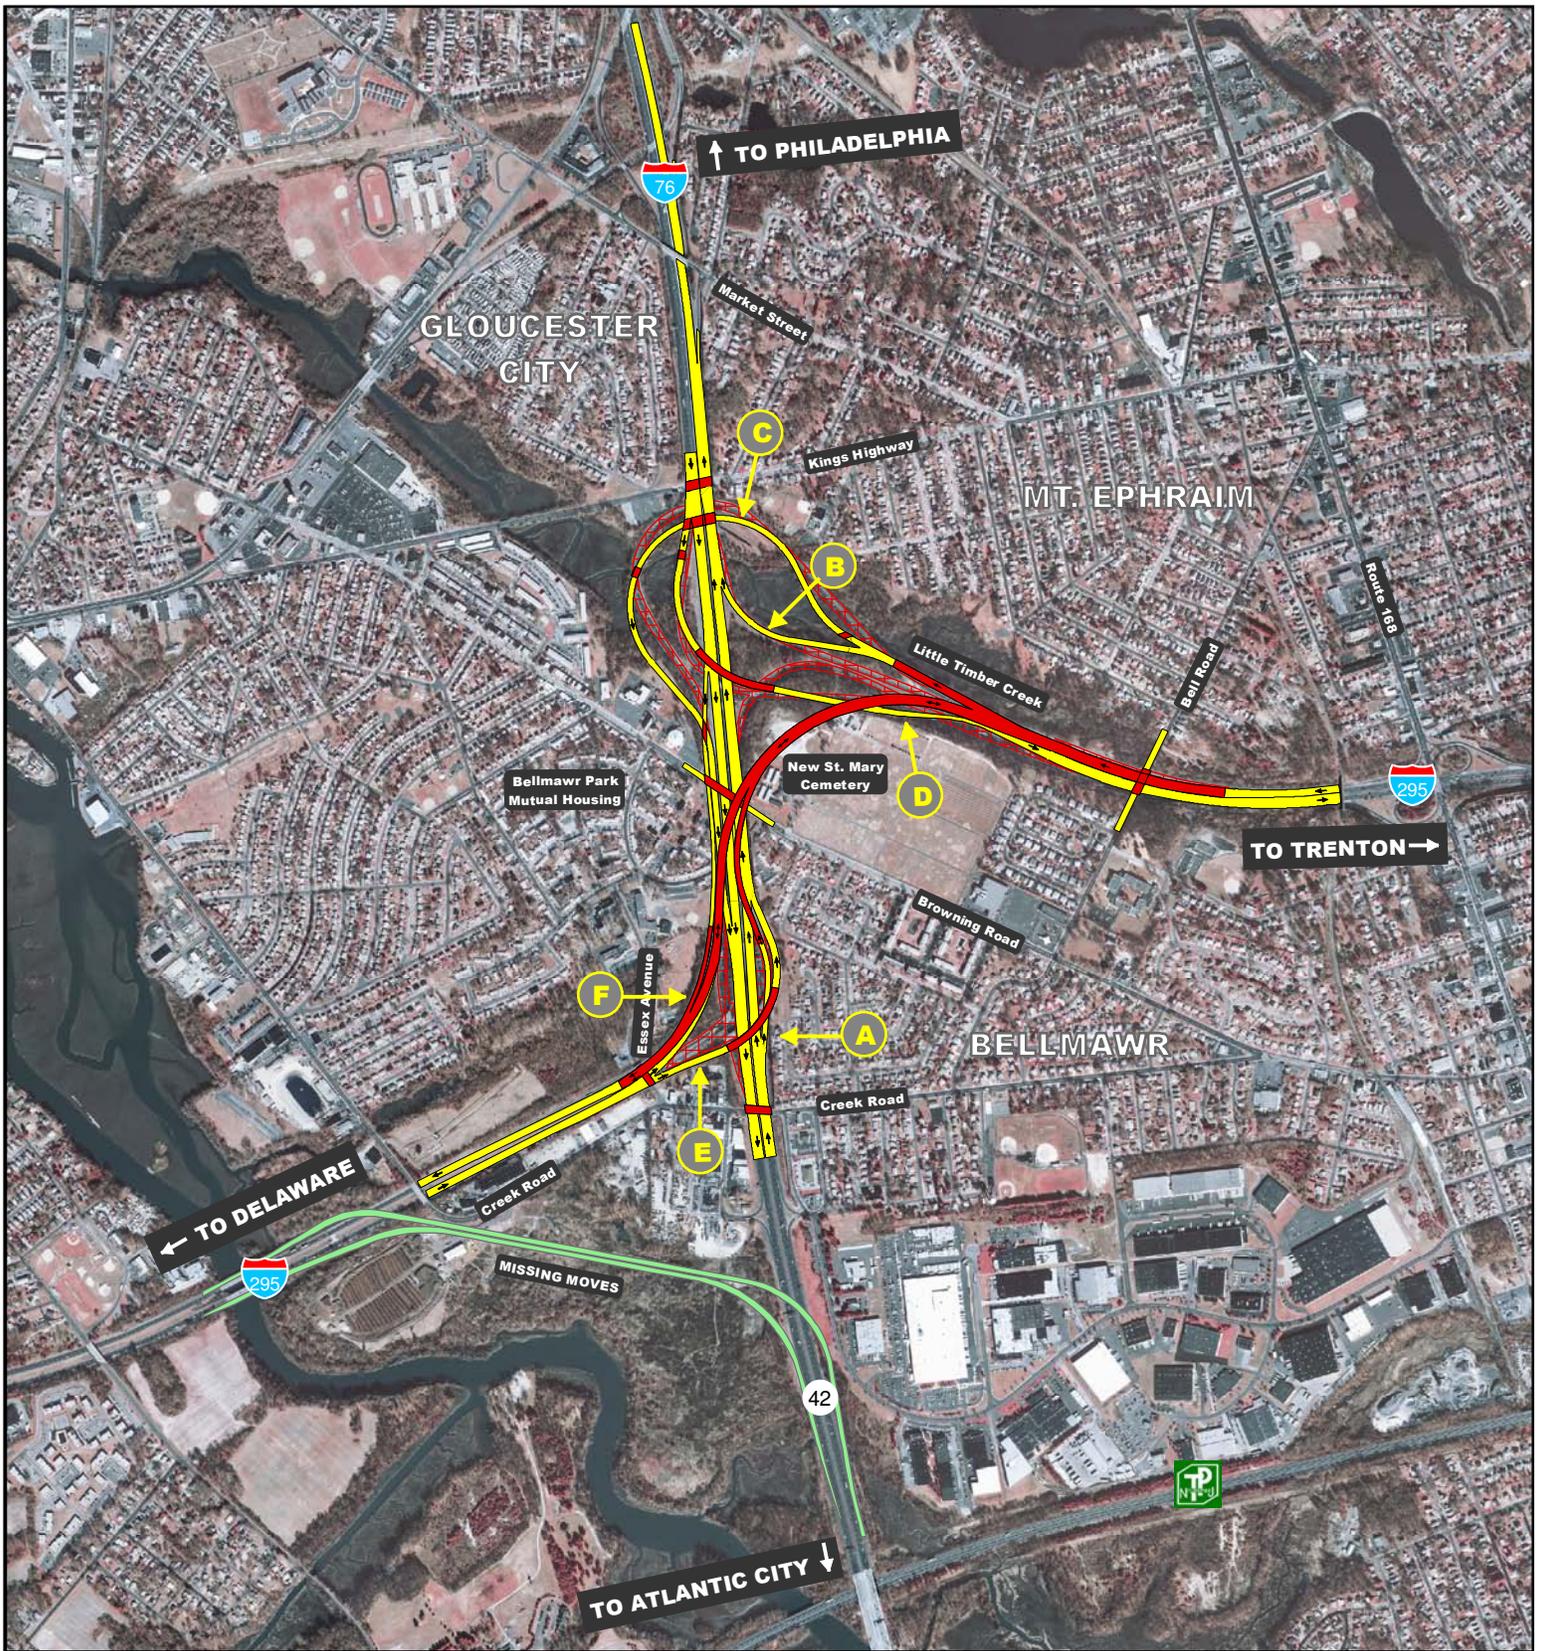
I-295 / I-76/ ROUTE 42
 Direct Connection
 Camden County
 Figure 6
 Alternative H1

Alternative H1, shown in Figure 6, is almost identical to Alternative G2. The primary difference is the configuration of Ramps B and C. Ramps B and C exit from I-295 from the right. Ramp C generally follows (within 150'±) the existing Ramp C alignment (Al Jo's Curve) and passes under I-76 and Ramp F before merging with Route 42 southbound. The substandard radius on the existing Ramp C is replaced with a larger radius. Ramp B splits from Ramp C to meet I-76 northbound.

Vehicles on northbound Route 42 whose destination is I-295 northbound, exit on Ramp A, which would be separated from, but parallel with, Route 42. This ramp configuration, in conjunction with the new I-295 mainline alignment, eliminates the current substandard weaving condition with Ramp E at this location. Ramp A then crosses under Ramp E before joining the depressed I-295 alignment north of Browning Road.

Ramp B provides the movement from southbound I-295 to northbound I-76. Ramp C provides the movement from southbound I-295 to southbound Route 42. Ramp C exits I-295 from the right and Ramp B exits from the right approximately 1,000' further. Ramp B follows a similar path but to the south of its existing location to meet I-76 northbound. Ramp C crosses over Ramps B and D, and I-76. Then Ramp C passes over Browning Road and I-295 to connect with Route 42 north of the Creek Road Bridge.

Ramp D is the move from I-76 southbound to I-295 northbound. Ramp D exits I-76 in much the same way that it does now. The Ramp D alignment crosses over I-76, under Ramp C, and over I-295 before merging with I-295 northbound south of Bell Road.

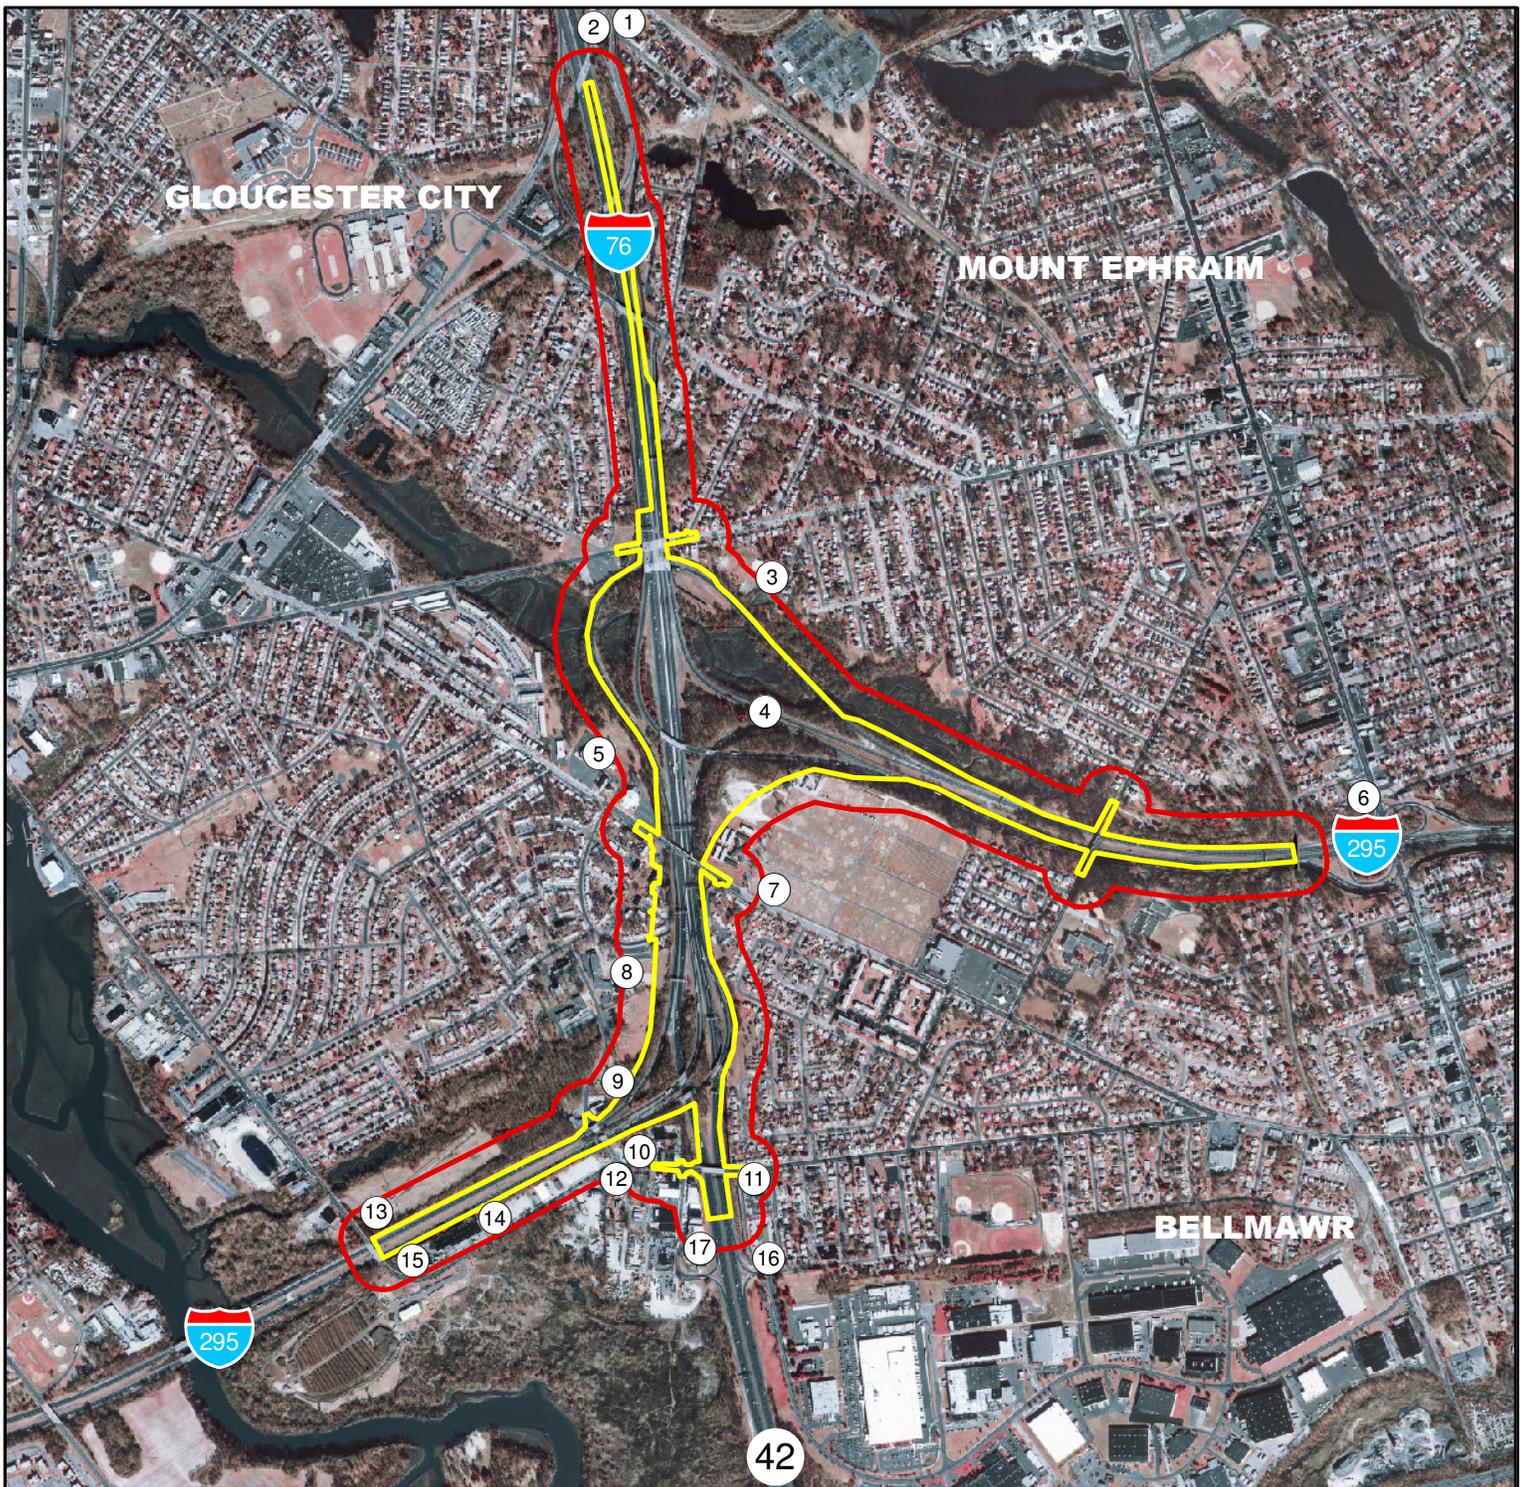
Figure 8

1. Block 261, adjacent to Lots 1 & 4; Vacant Lot
2. Block 260; I-76 ROW
3. Block 123.01, Lot 3.03; Mt. Ephraim Sewage Plant & Garage
4. Area of Ramp C at I-295, MP 27
5. Block 50.02, Lot 1.01; Annunciation Regional School
6. Block 122, Lots 1, 2.01, 2.02 & 3.01; Exxon Service Station
7. Block 50, Lot 1.01; New St. Mary's Cemetery
8. Block 49, Lot 3; Bellmawr Park Elementary School
9. Block 56, Lots 1-7; Bill Seas Towing
10. Block 57, Lots 1.01 & 9; Ana Labs
11. Block 70, Lots 1,2,3 & 4; Mobil Service Station
12. Block 58, Lots 1,2,3 & 4; B&G Tool & Die Company
13. Block 49, Lot 4; Infinity Broadcasting
14. Block 49.05, Lot 6; LEIDKA
15. Block 49.05, Lot 2.01; Bellmawr Truck Repair
16. Block 70, Lot 6.02; Sunoco Service Station
17. Block 67, Lot 7; Quality Patterns Inc. / Oxygen Support Systems

Areas of Environmental Concern
Alternative D

A reconnaissance of the study area was performed on April 25, 2005. Previous visits were conducted in 2002. During this site reconnaissance, the information presented in the EDR[®] report was evaluated and existing environmental conditions were assessed. As summarized in Table 2 below, 17 potential AOCs were identified in the study corridor and are shown in Figures 8-12 for each of the alternatives.

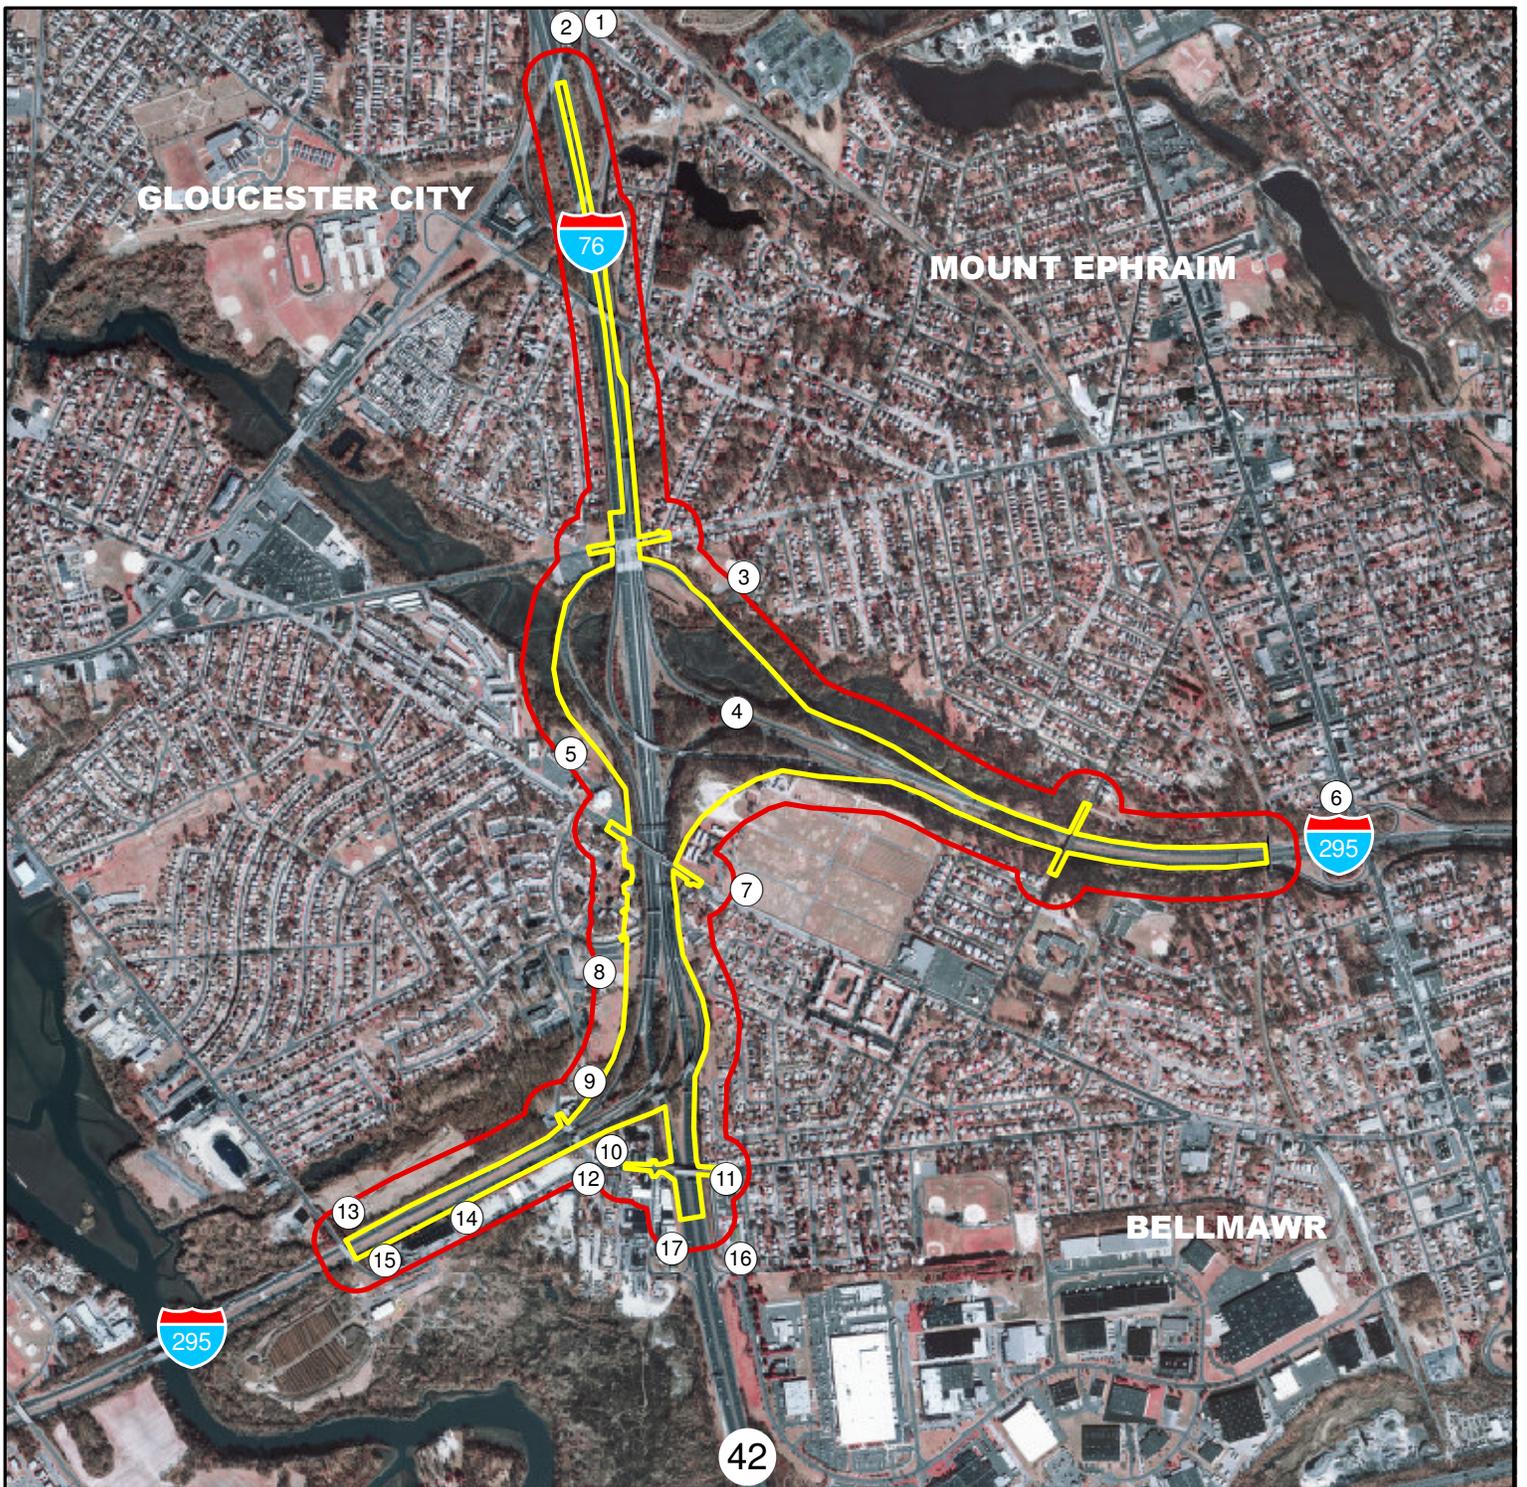
Figure 9
Areas of Environmental Concern
Alternative D1

1. Block 261, adjacent to Lots 1 & 4; Vacant Lot
2. Block 260; I-76 ROW
3. Block 123.01, Lot 3.03; Mt. Ephraim Sewage Plant & Garage
4. Area of Ramp C at I-295, MP 27
5. Block 50.02, Lot 1.01; Annunciation Regional School
6. Block 122, Lots 1, 2.01, 2.02 & 3.01; Exxon Service Station
7. Block 50, Lot 1.01; New St. Mary's Cemetery
8. Block 49, Lot 3; Bellmawr Park Elementary School
9. Block 56, Lots 1-7; Bill Seas Towing
10. Block 57, Lots 1.01 & 9; Ana Labs
11. Block 70, Lots 1,2,3 & 4; Mobil Service Station
12. Block 58, Lots 1,2,3 & 4; B&G Tool & Die Company
13. Block 49, Lot 4; Infinity Broadcasting
14. Block 49.05, Lot 6; LEIDKA
15. Block 49.05, Lot 2.01; Bellmawr Truck Repair
16. Block 70, Lot 6.02; Sunoco Service Station
17. Block 67, Lot 7; Quality Patterns Inc. / Oxygen Support Systems

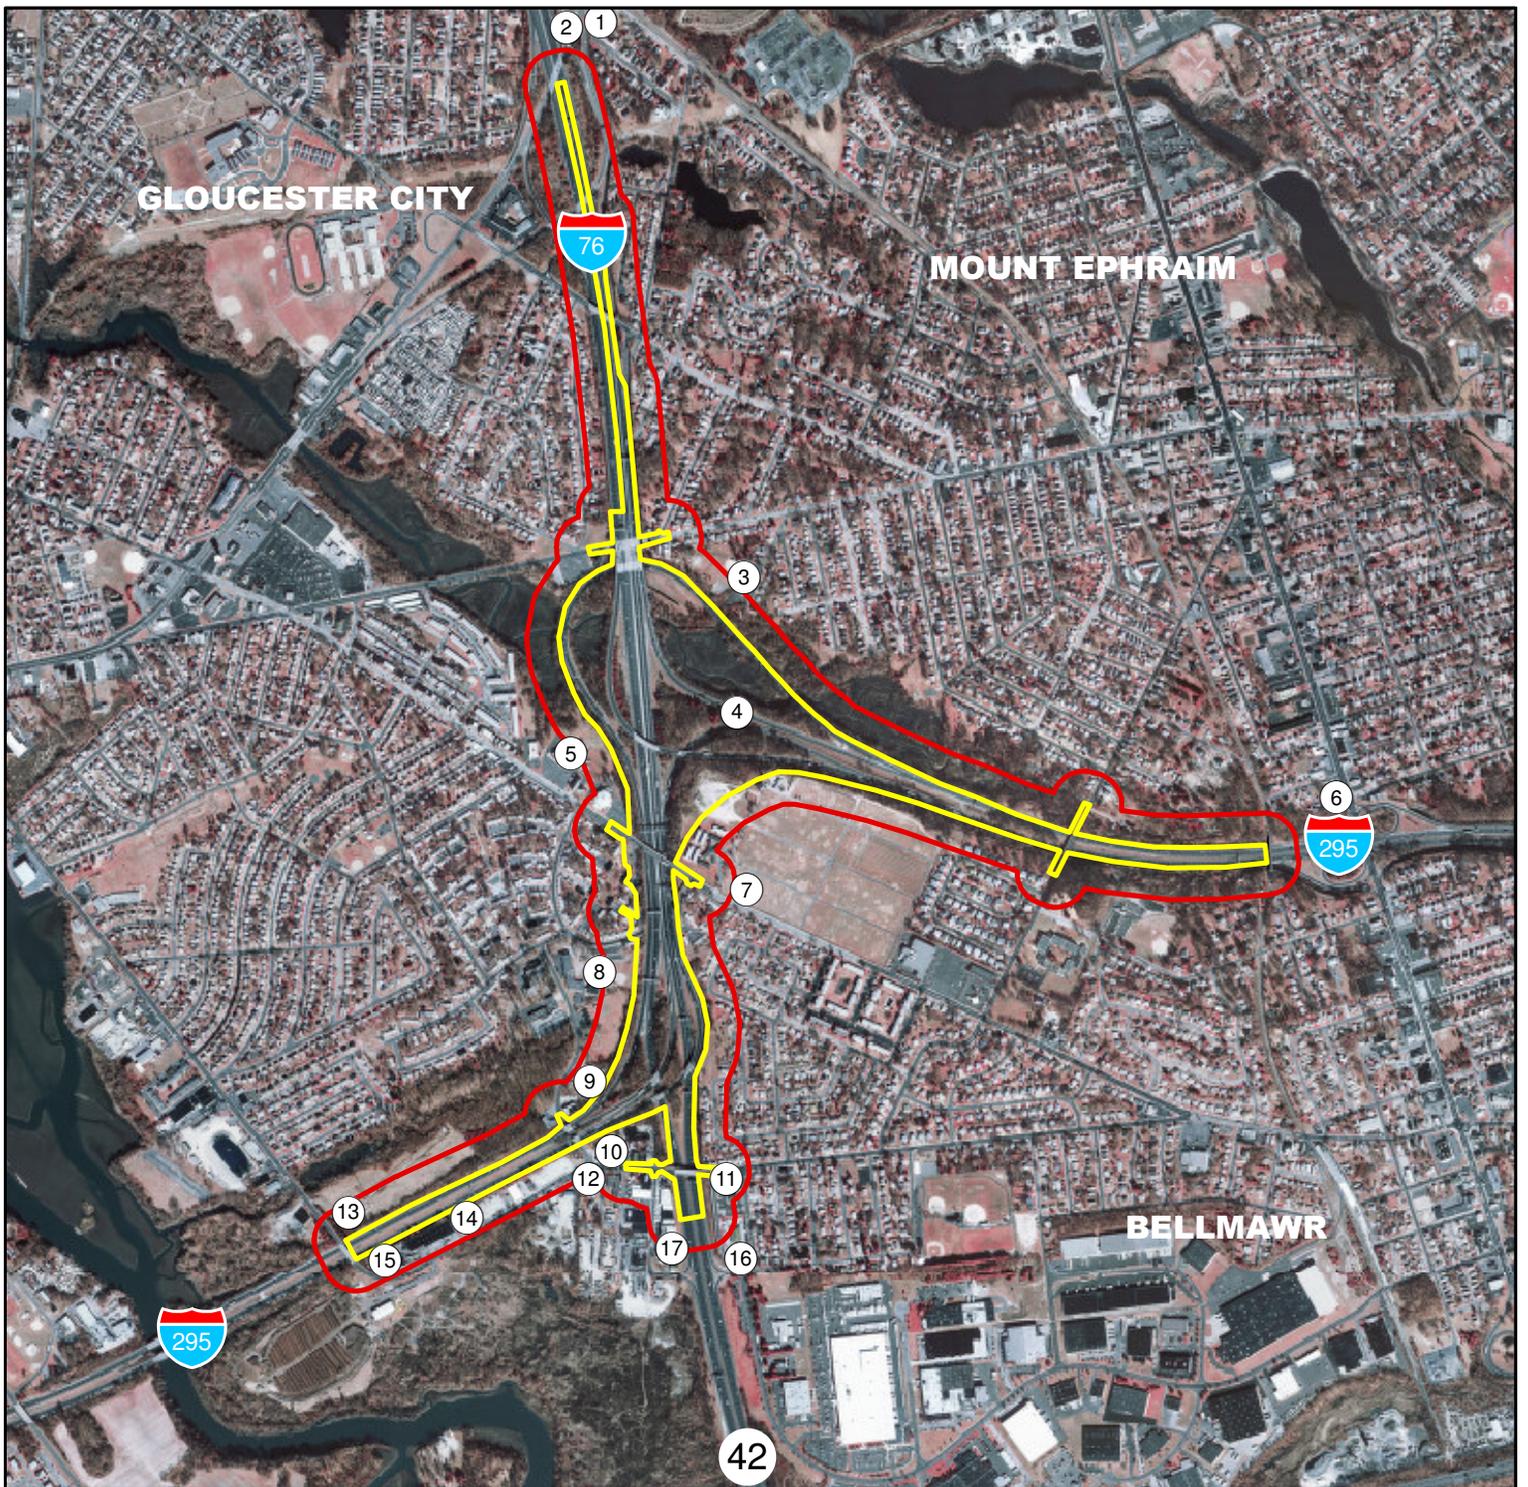
Figure 10

1. Block 261, adjacent to Lots 1 & 4; Vacant Lot
2. Block 260; I-76 ROW
3. Block 123.01, Lot 3.03; Mt. Ephraim Sewage Plant & Garage
4. Area of Ramp C at I-295, MP 27
5. Block 50.02, Lot 1.01; Annunciation Regional School
6. Block 122, Lots 1, 2.01, 2.02 & 3.01; Exxon Service Station
7. Block 50, Lot 1.01; New St. Mary's Cemetery
8. Block 49, Lot 3; Bellmawr Park Elementary School
9. Block 56, Lots 1-7; Bill Seas Towing
10. Block 57, Lots 1.01 & 9; Ana Labs
11. Block 70, Lots 1,2,3 & 4; Mobil Service Station
12. Block 58, Lots 1,2,3 & 4; B&G Tool & Die Company
13. Block 49, Lot 4; Infinity Broadcasting
14. Block 49.05, Lot 6; LEIDKA
15. Block 49.05, Lot 2.01; Bellmawr Truck Repair
16. Block 70, Lot 6.02; Sunoco Service Station
17. Block 67, Lot 7; Quality Patterns Inc. / Oxygen Support Systems

Areas of Environmental Concern
Alternative G2

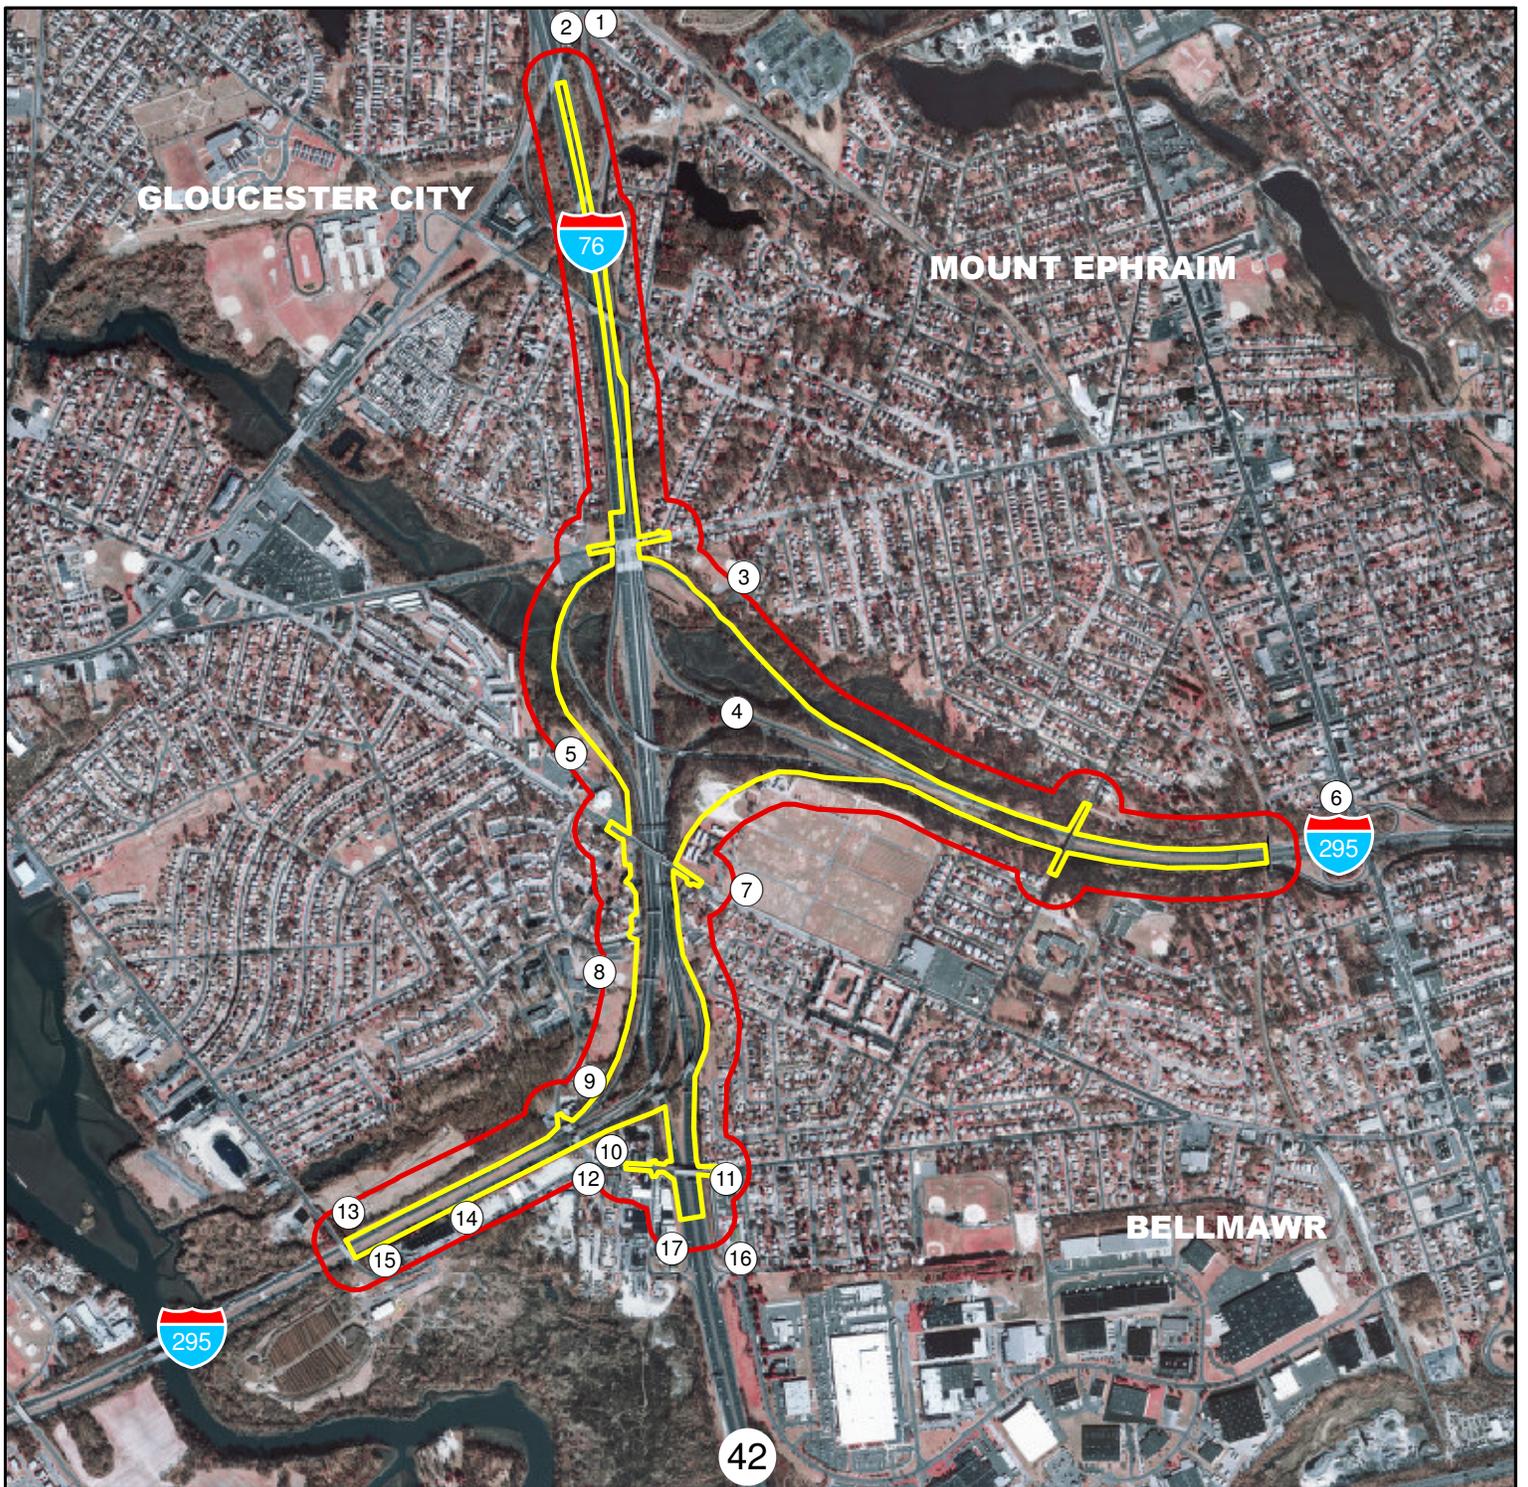
Figure 11
Areas of Environmental Concern
Alternative H1

1. Block 261, adjacent to Lots 1 & 4; Vacant Lot
2. Block 260; I-76 ROW
3. Block 123.01, Lot 3.03; Mt. Ephraim Sewage Plant & Garage
4. Area of Ramp C at I-295, MP 27
5. Block 50.02, Lot 1.01; Annunciation Regional School
6. Block 122, Lots 1, 2.01, 2.02 & 3.01; Exxon Service Station
7. Block 50, Lot 1.01; New St. Mary's Cemetery
8. Block 49, Lot 3; Bellmawr Park Elementary School
9. Block 56, Lots 1-7; Bill Seas Towing
10. Block 57, Lots 1.01 & 9; Ana Labs
11. Block 70, Lots 1,2,3 & 4; Mobil Service Station
12. Block 58, Lots 1,2,3 & 4; B&G Tool & Die Company
13. Block 49, Lot 4; Infinity Broadcasting
14. Block 49.05, Lot 6; LEIDKA
15. Block 49.05, Lot 2.01; Bellmawr Truck Repair
16. Block 70, Lot 6.02; Sunoco Service Station
17. Block 67, Lot 7; Quality Patterns Inc. / Oxygen Support Systems

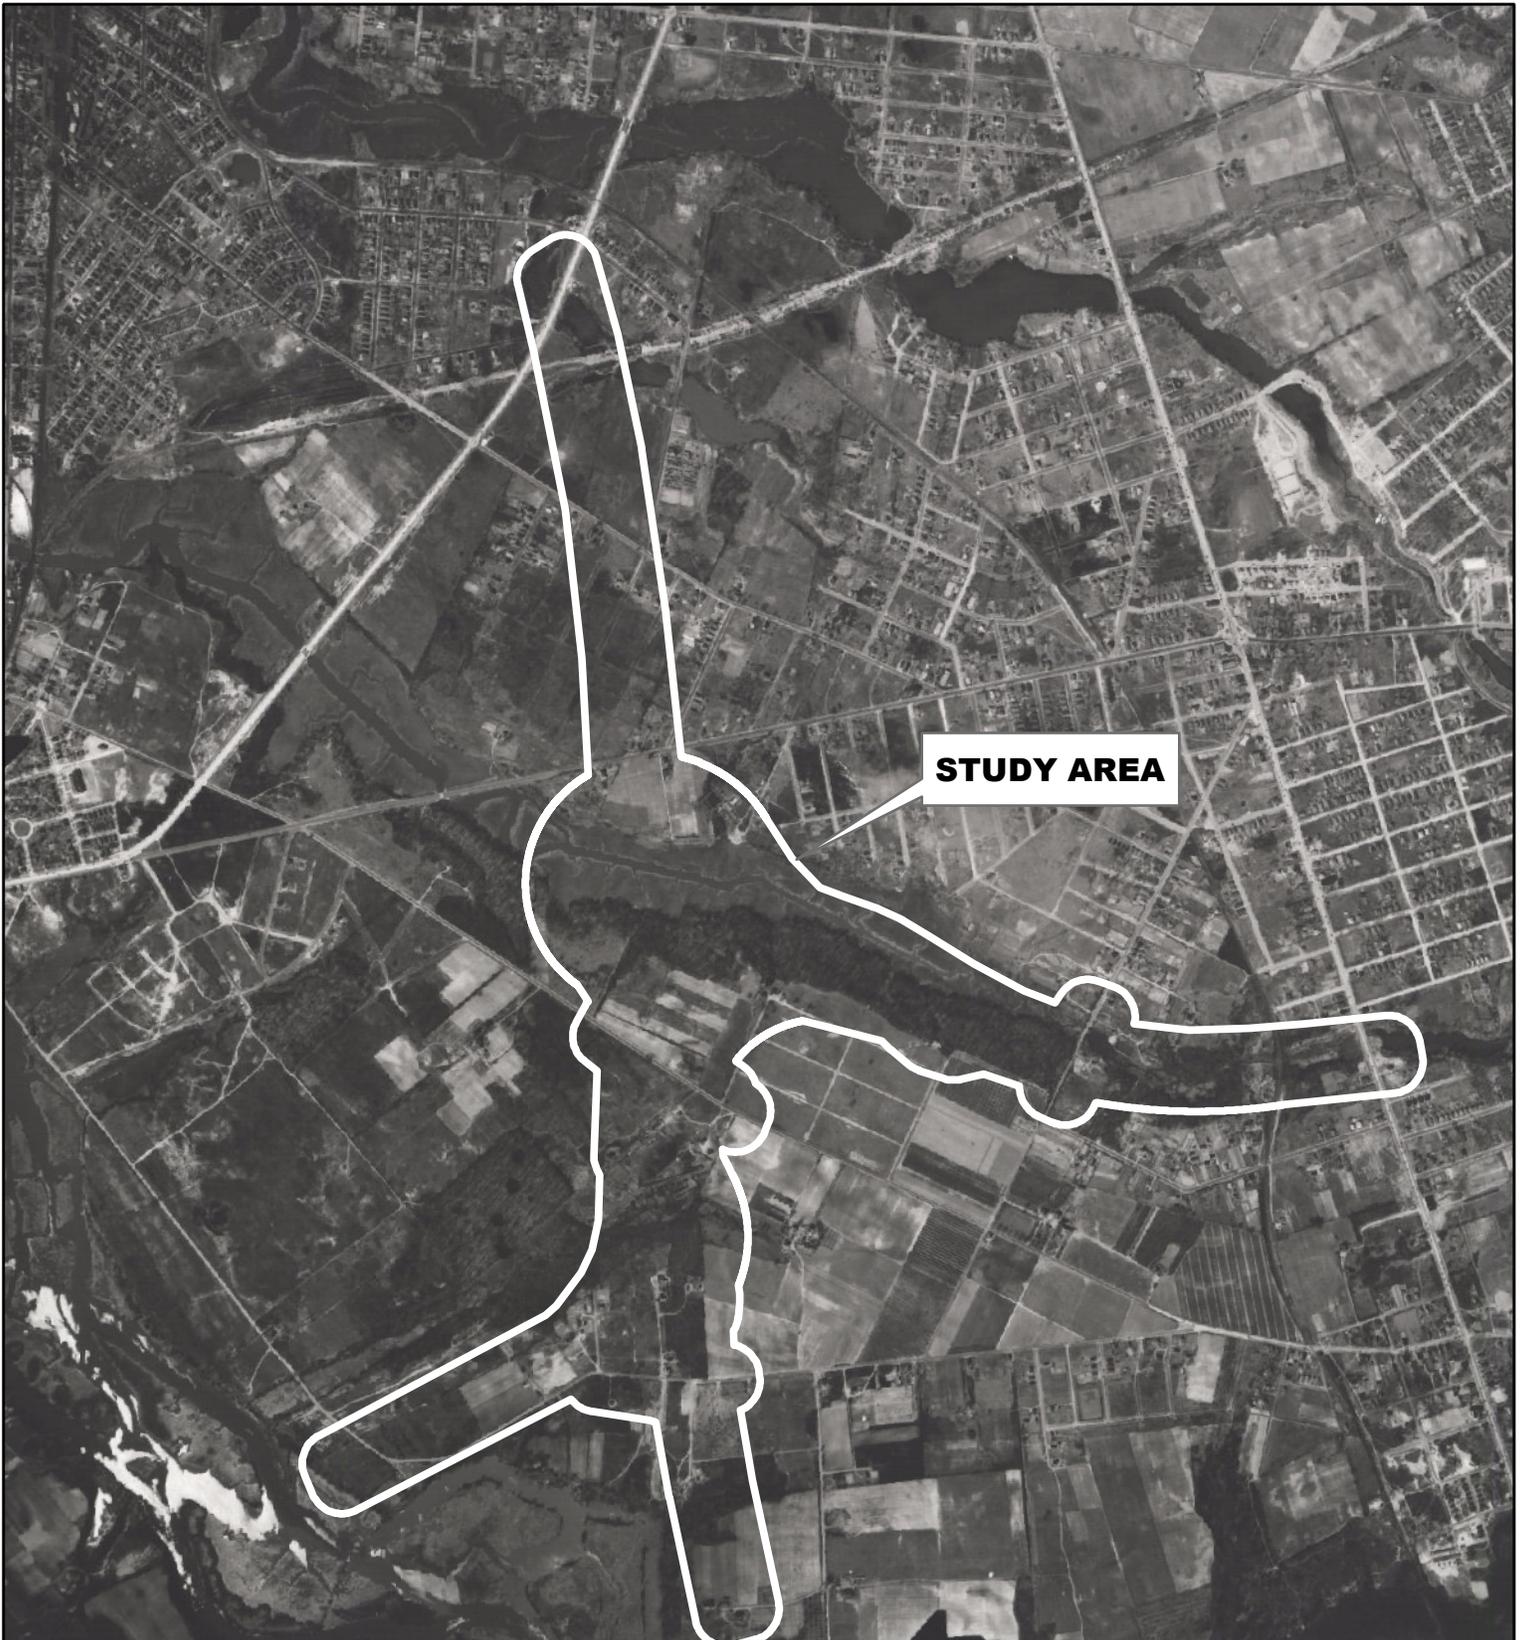
Figure C1

Historical Aerial Photograph - 1940

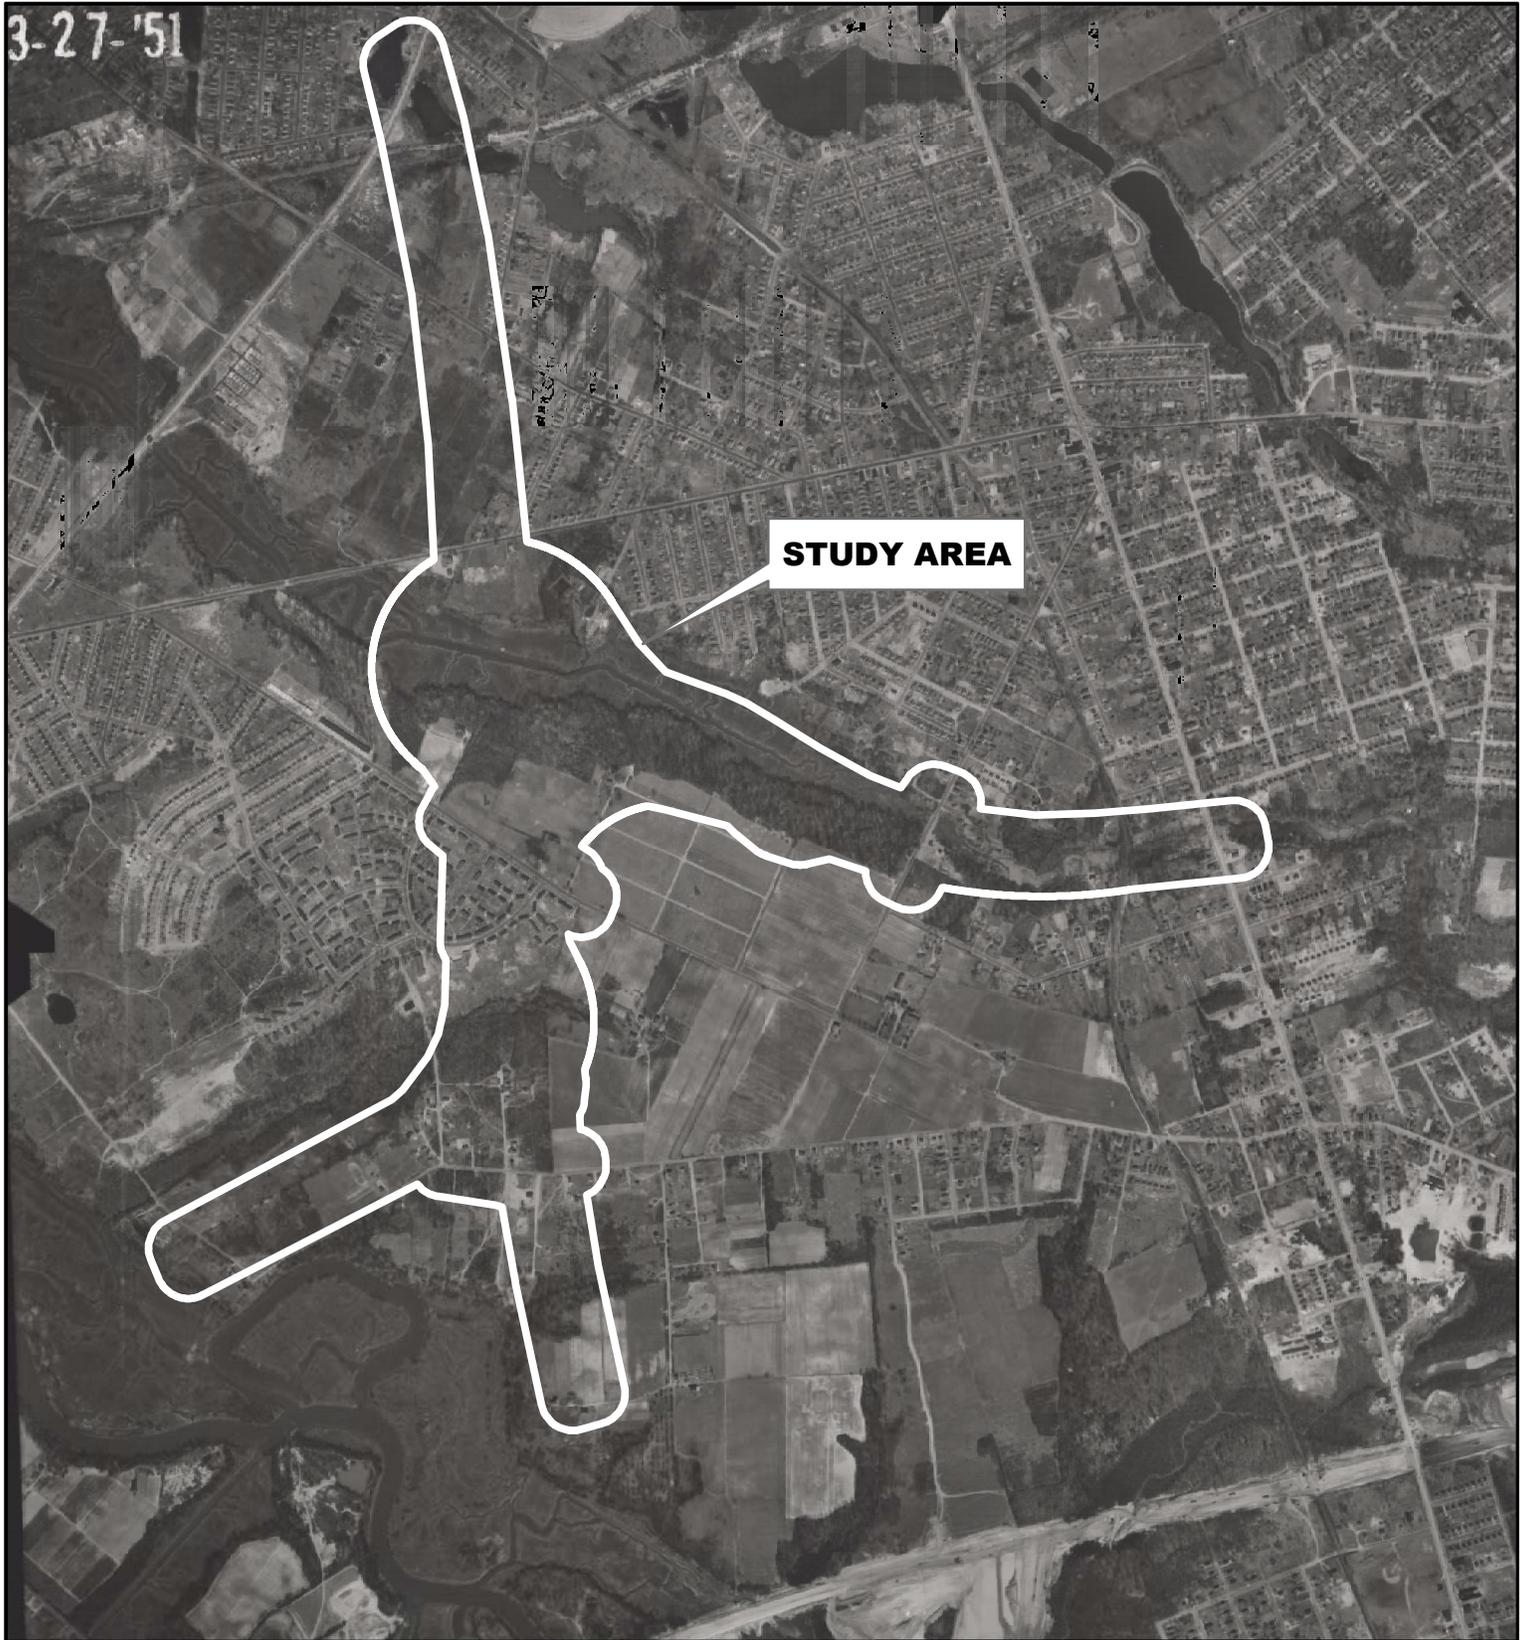
Figure C2

Historical Aerial Photograph - 1951
