Hazardous Waste Screening Technical Environmental Study

March 2006

**I-295/I-76/ROUTE 42 DIRECT CONNECTION
 BELLMAWR, GLOUCESTER CITY AND MT. EPHRAIM
 CAMDEN COUNTY**

HAZARDOUS WASTE SCREENING TECHNICAL ENVIRONMENTAL STUDY

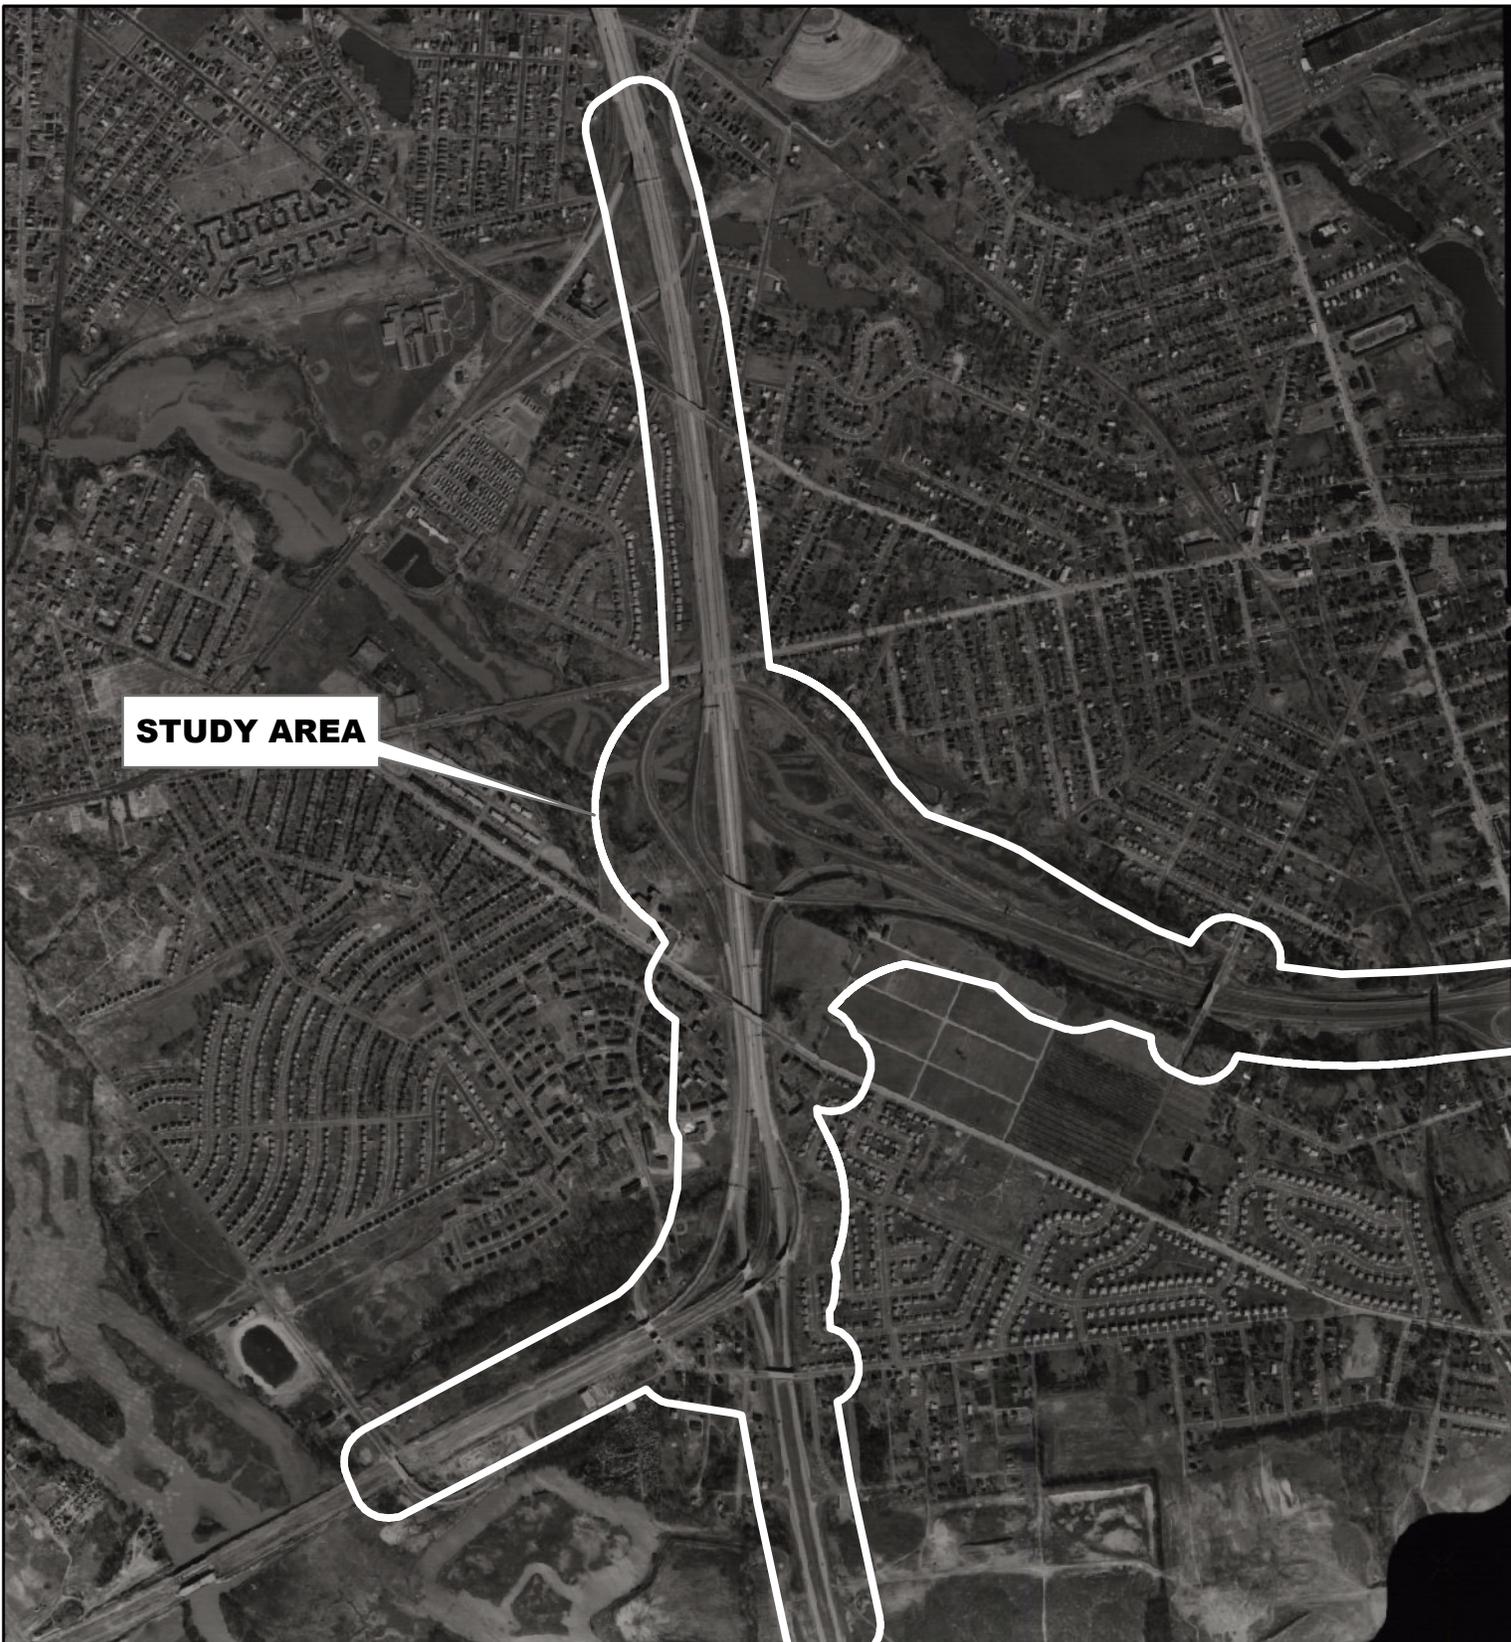
Figure C3

Historical Aerial Photograph - 1962

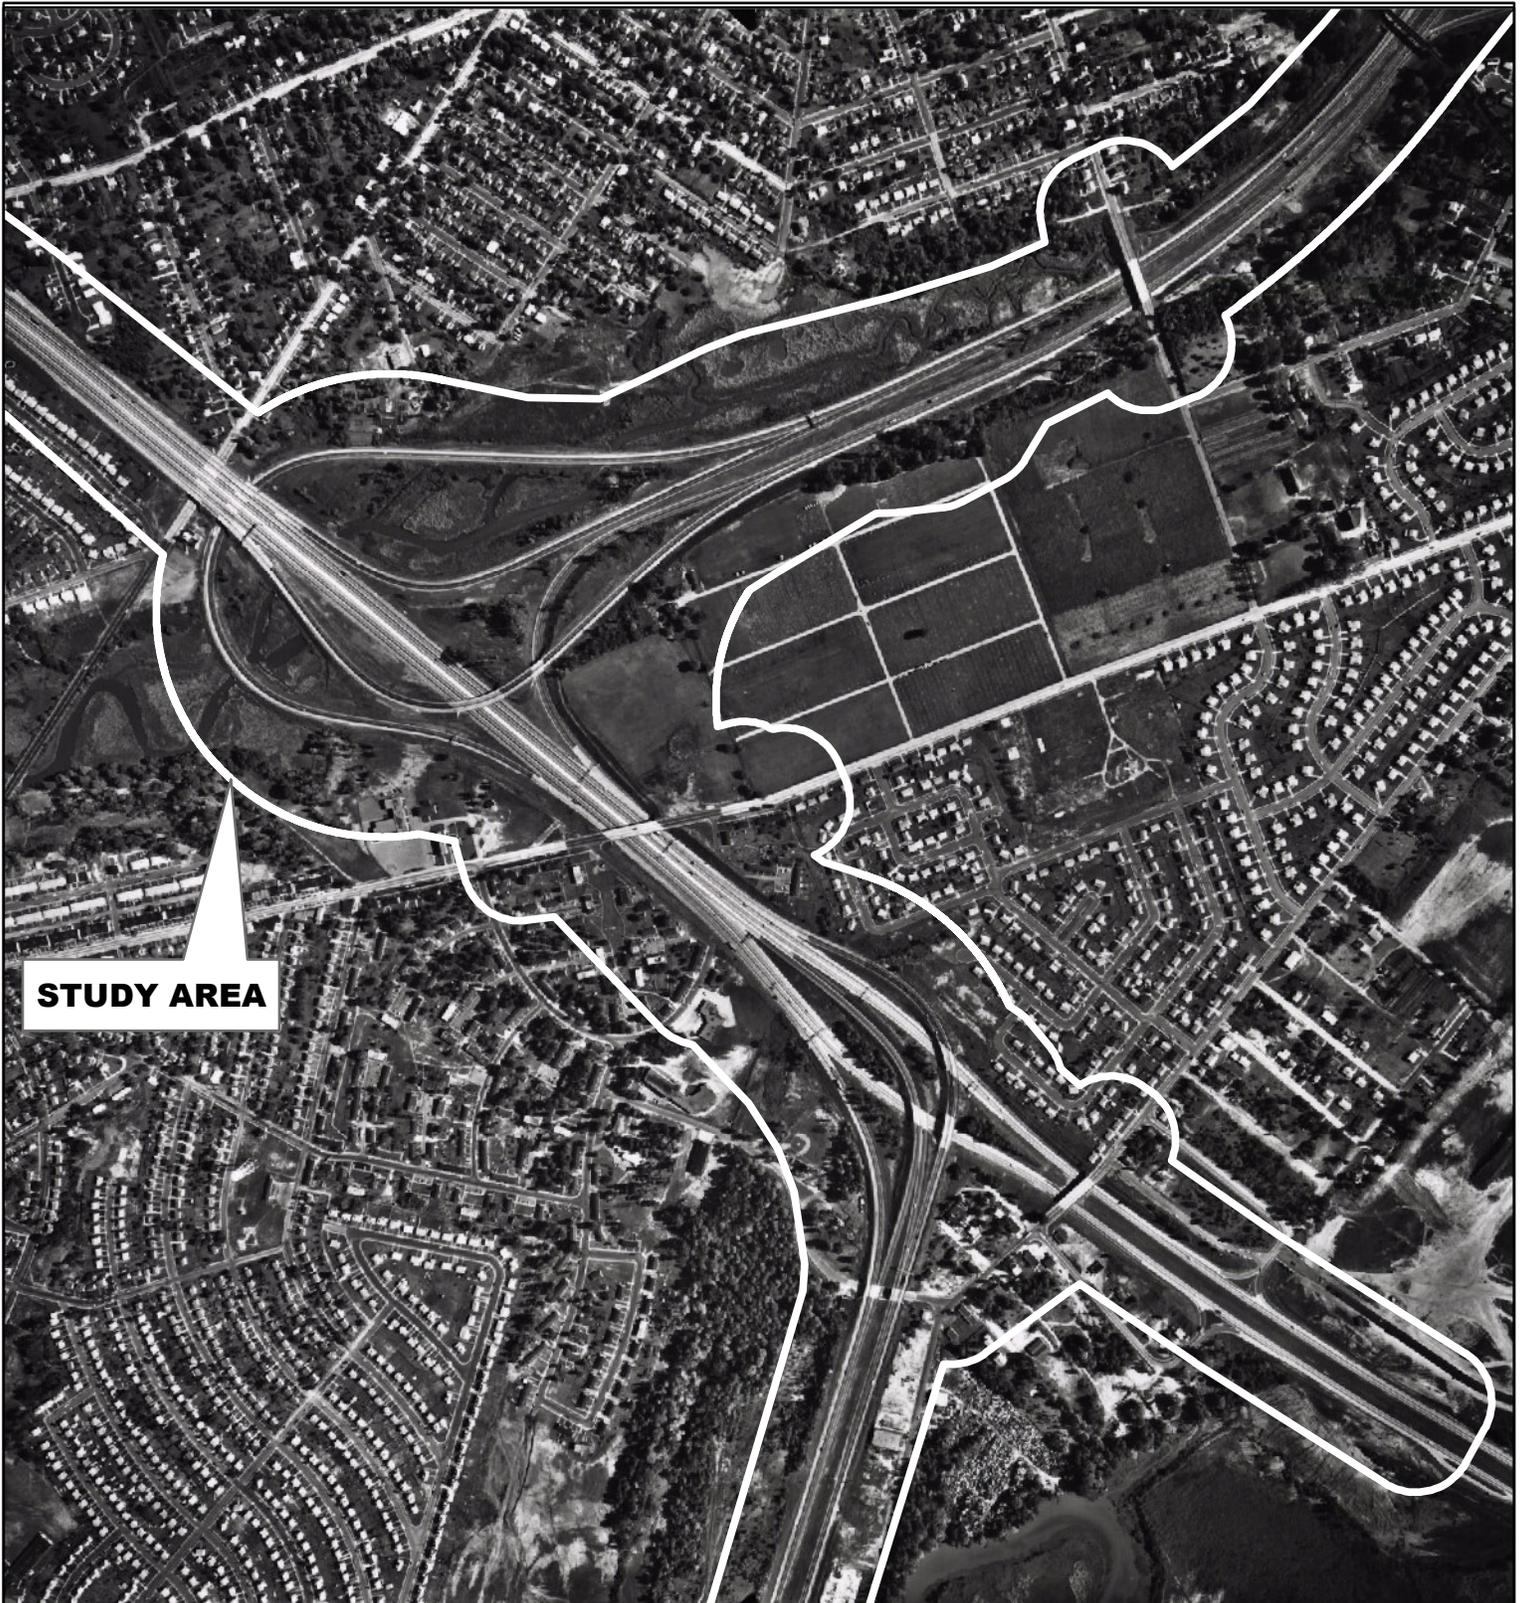
Figure C4

Historical Aerial Photograph - 1963 A

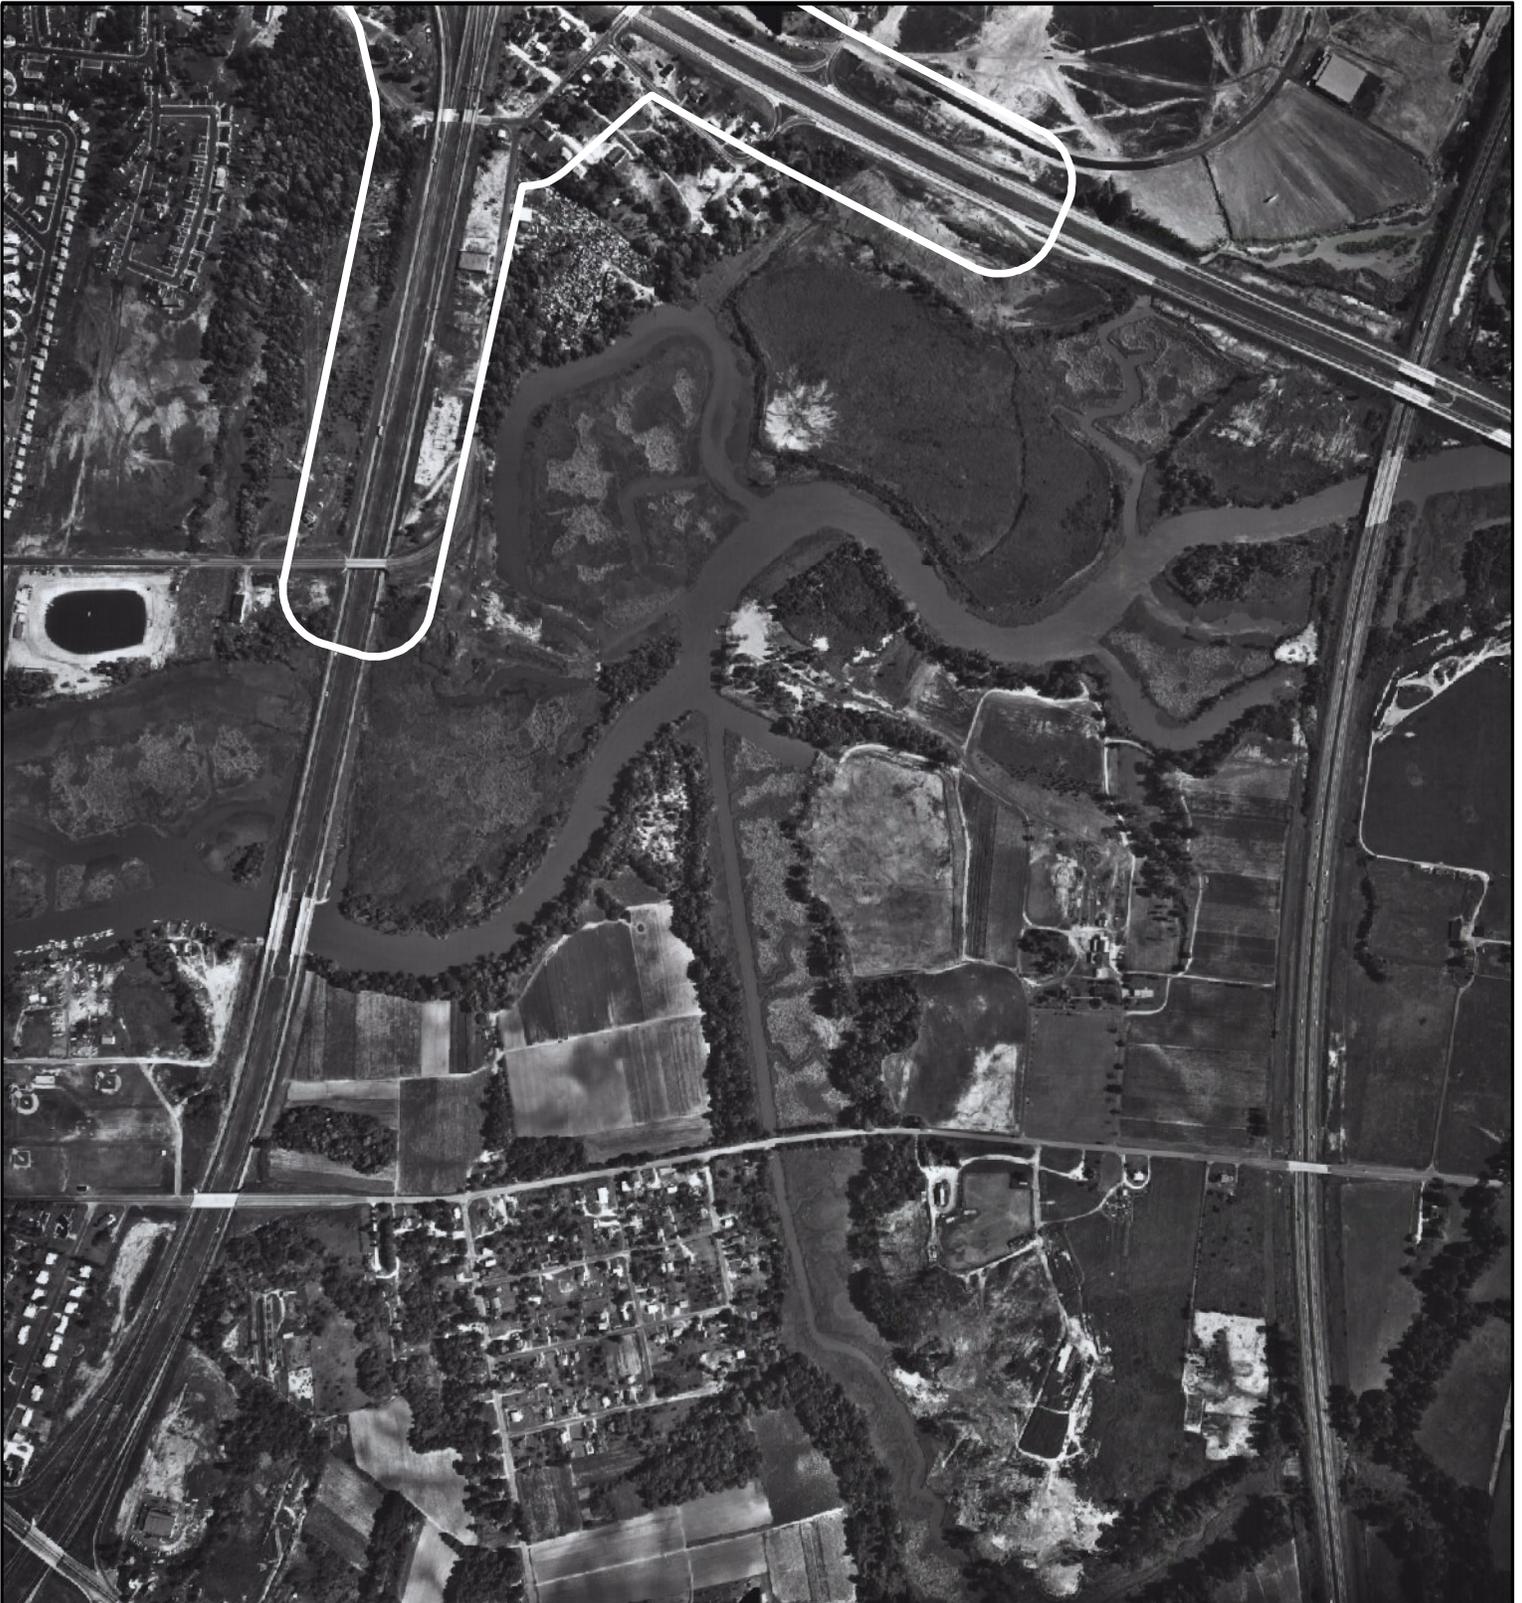
Figure C5

Historical Aerial Photograph - 1963 B

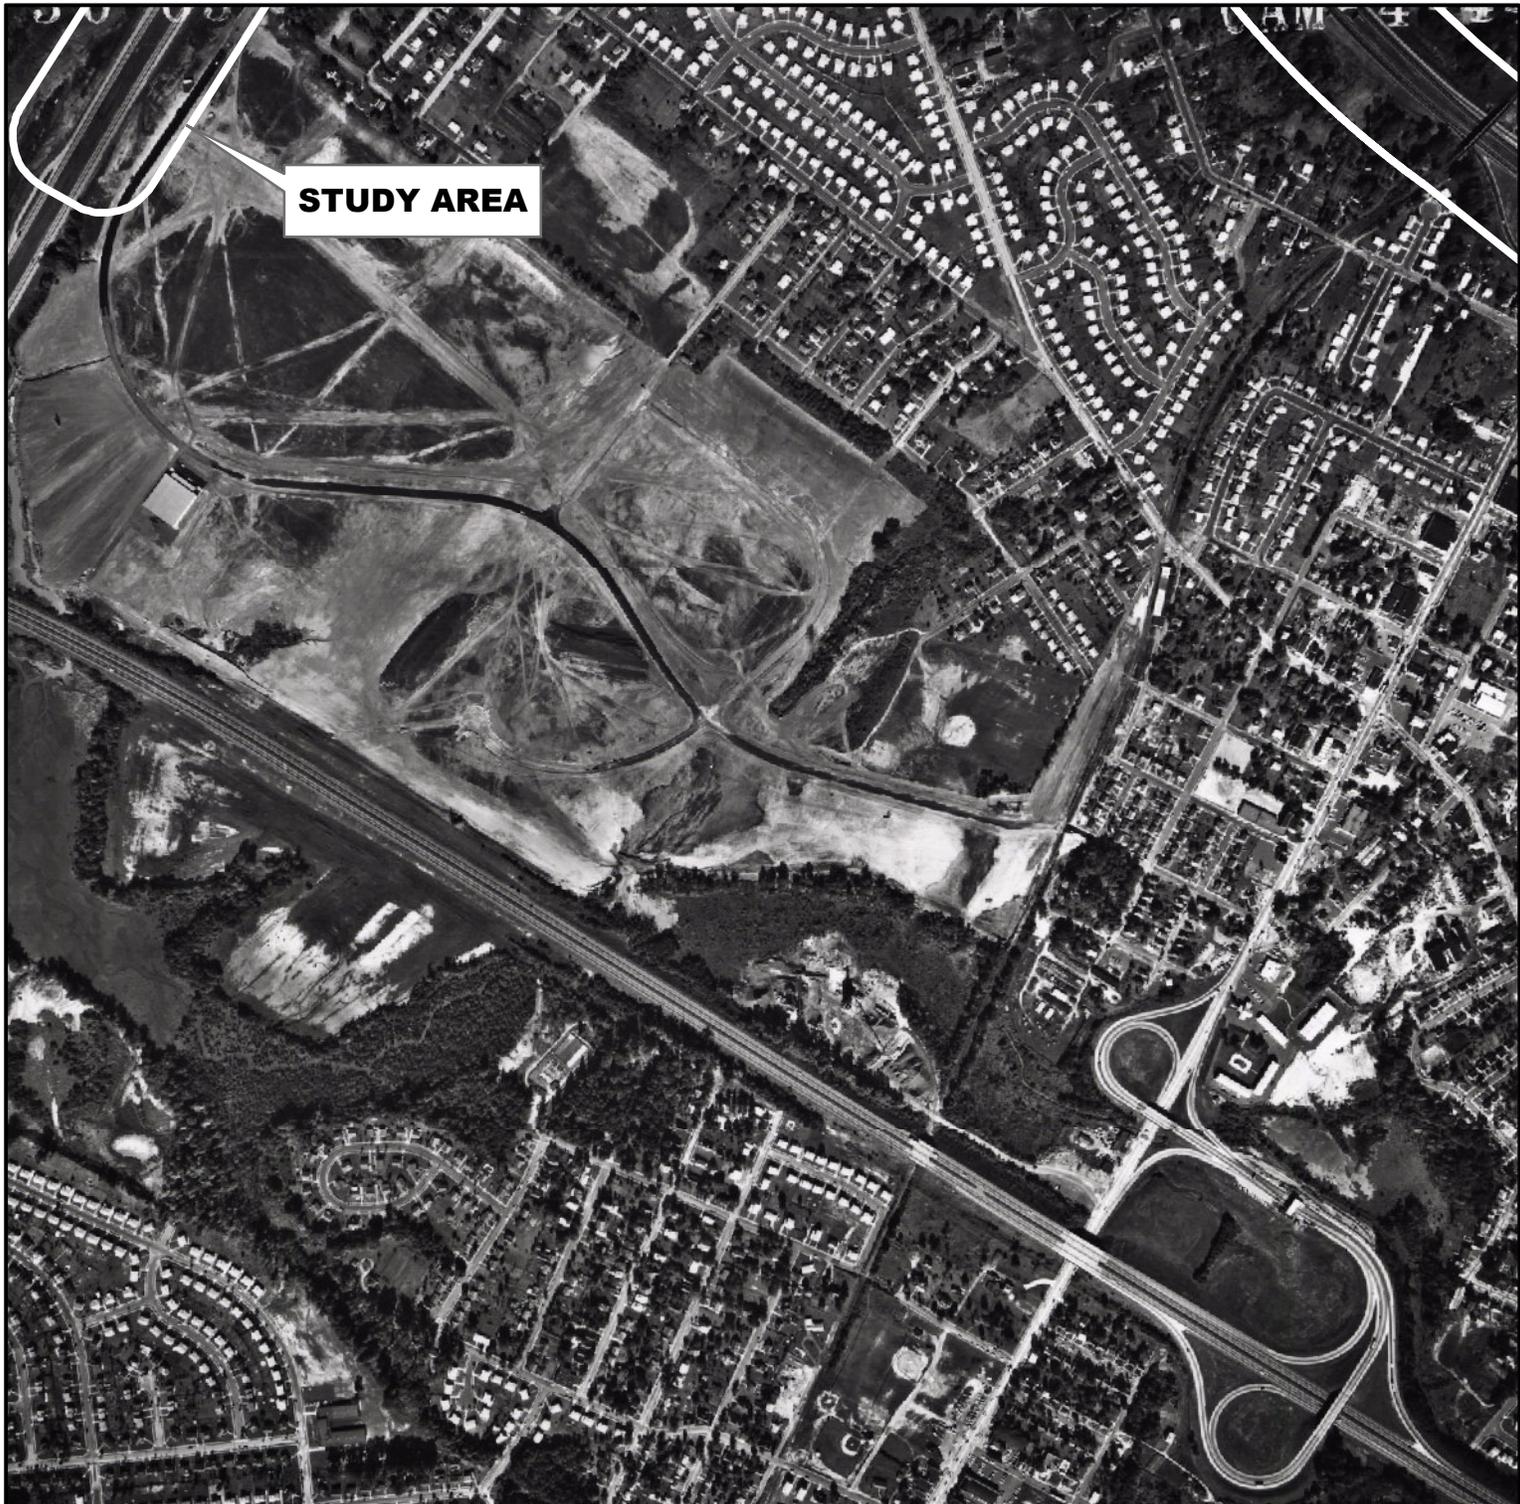
Figure C6

Historical Aerial Photograph - 1963 C

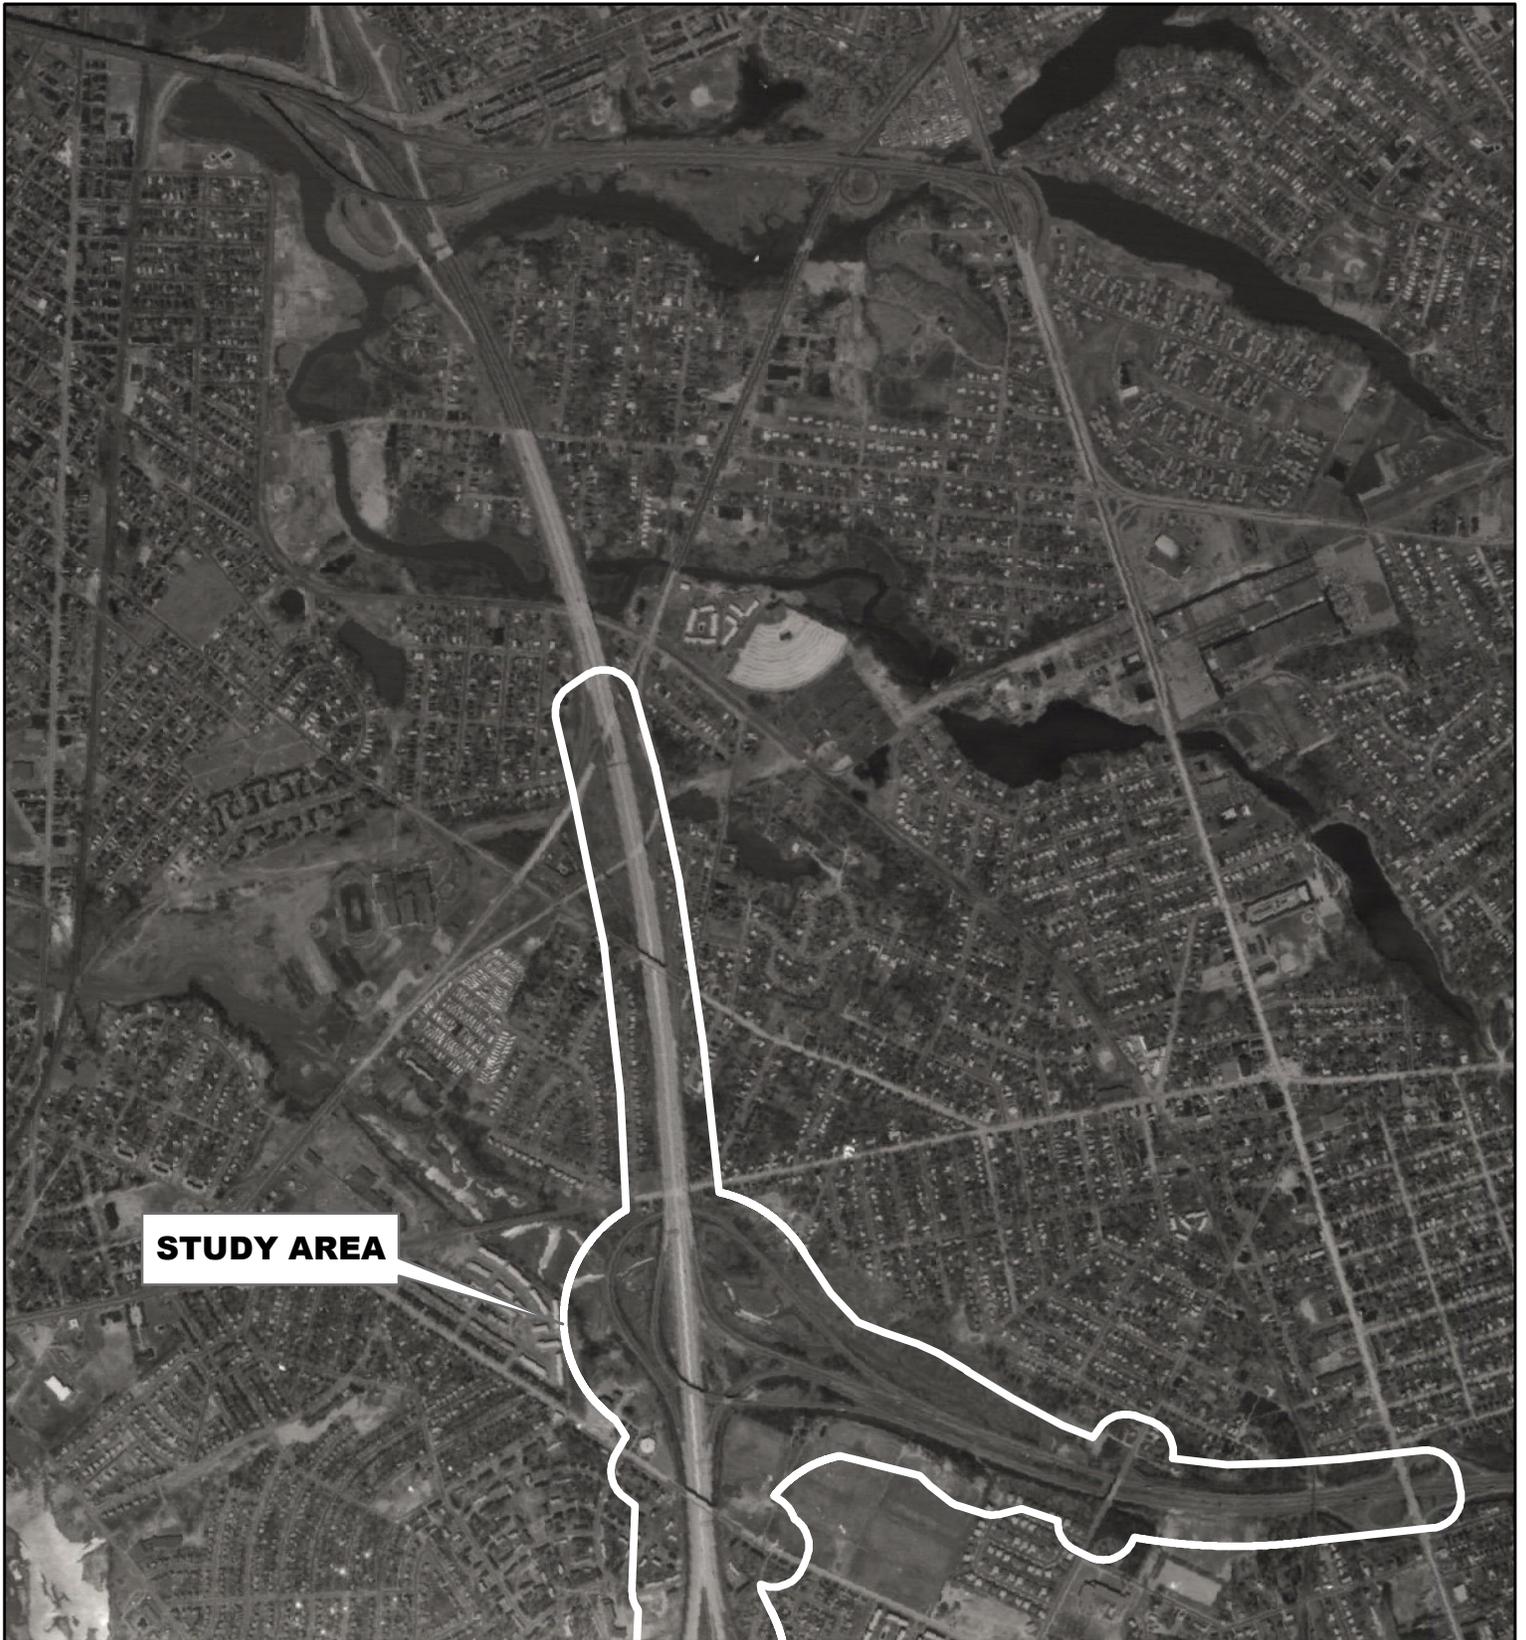
Figure C7

Historical Aerial Photograph - 1970

No significant changes were noted in Gloucester City from the 1963 and 1970 aerial photographs.

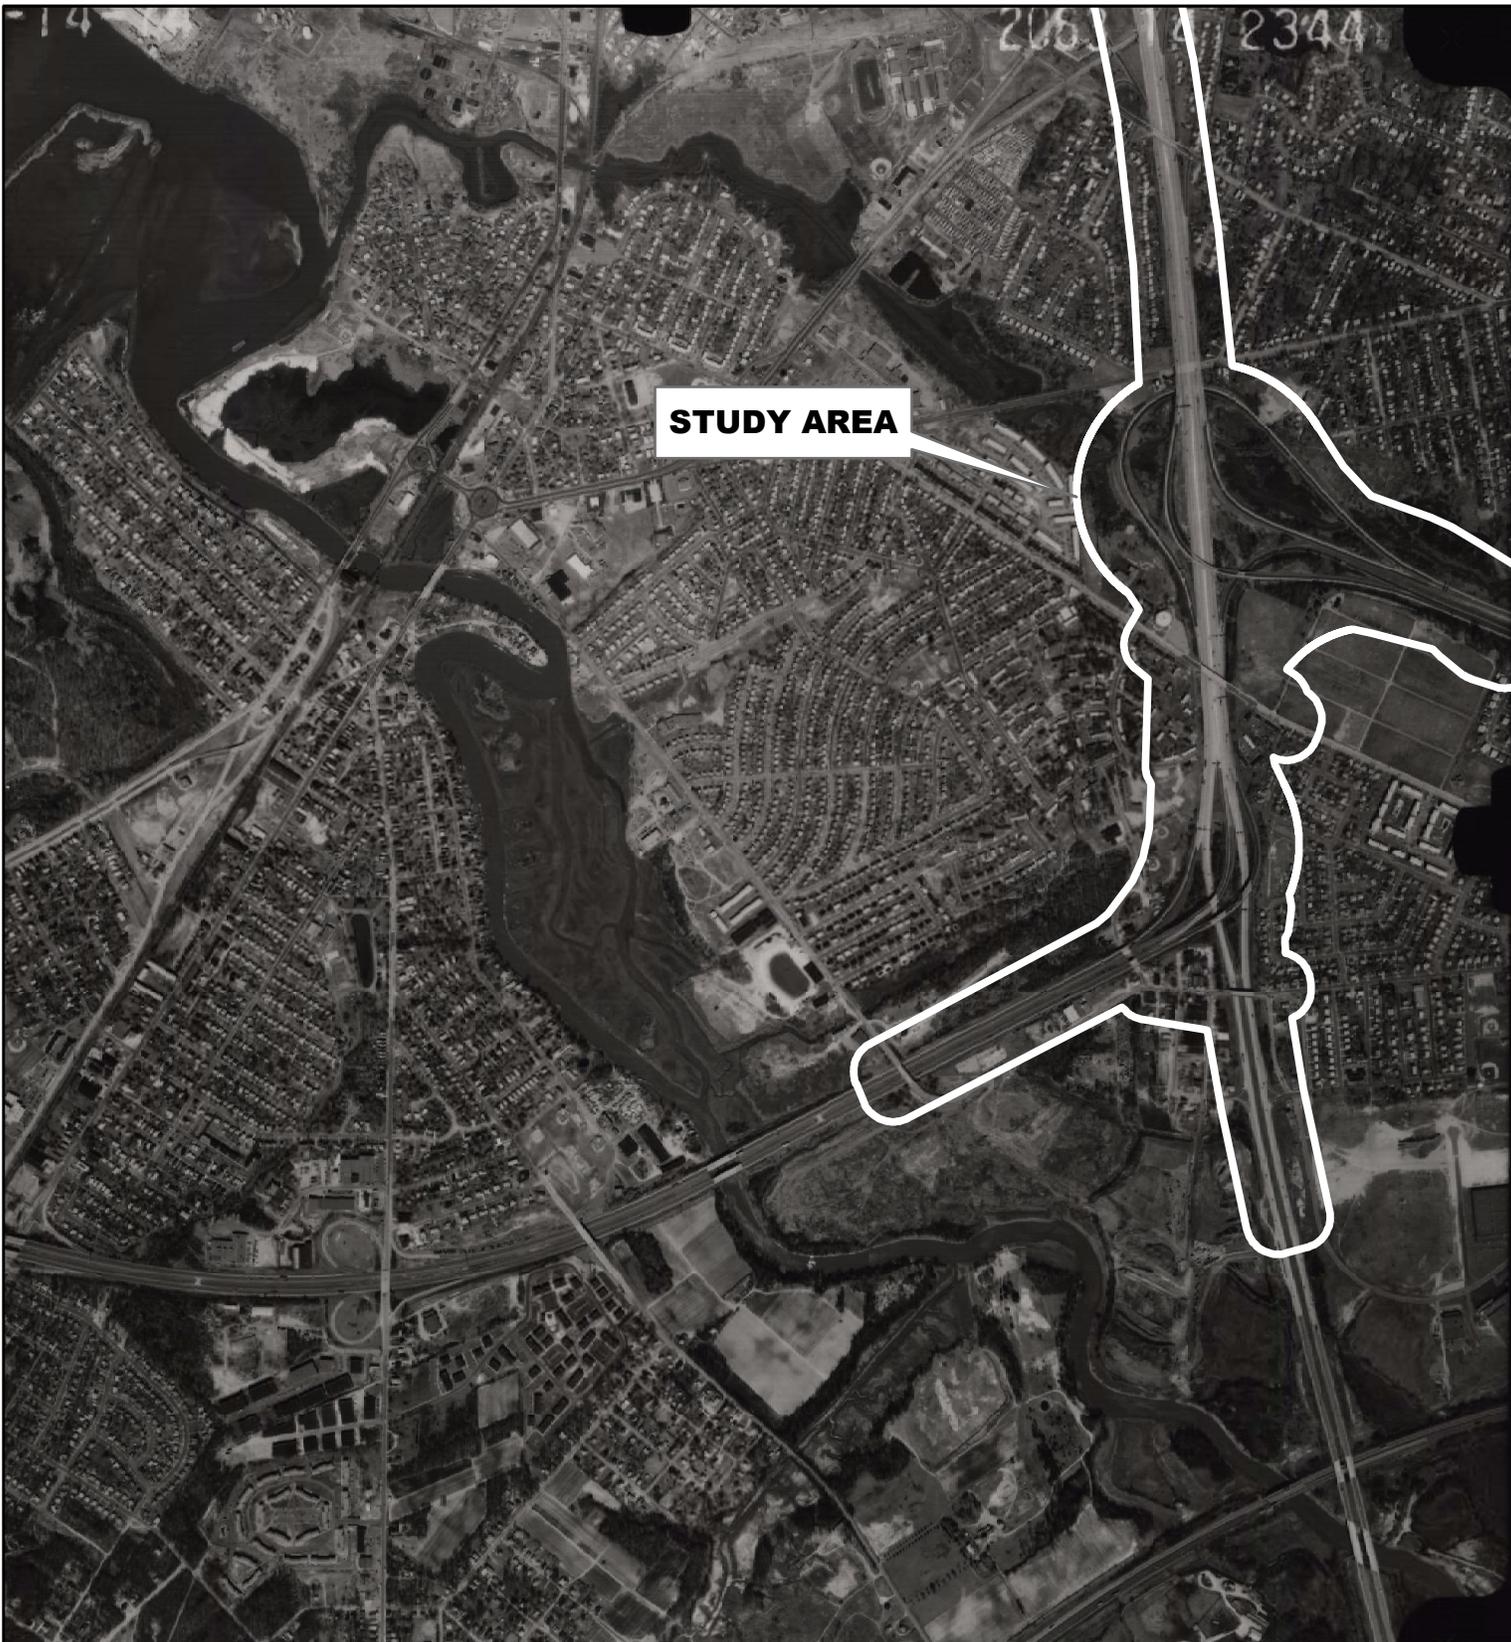
I-295 / I-76/ ROUTE 42
Direct Connection
Camden County
Figure C8

Historical Aerial Photograph - 1974 A

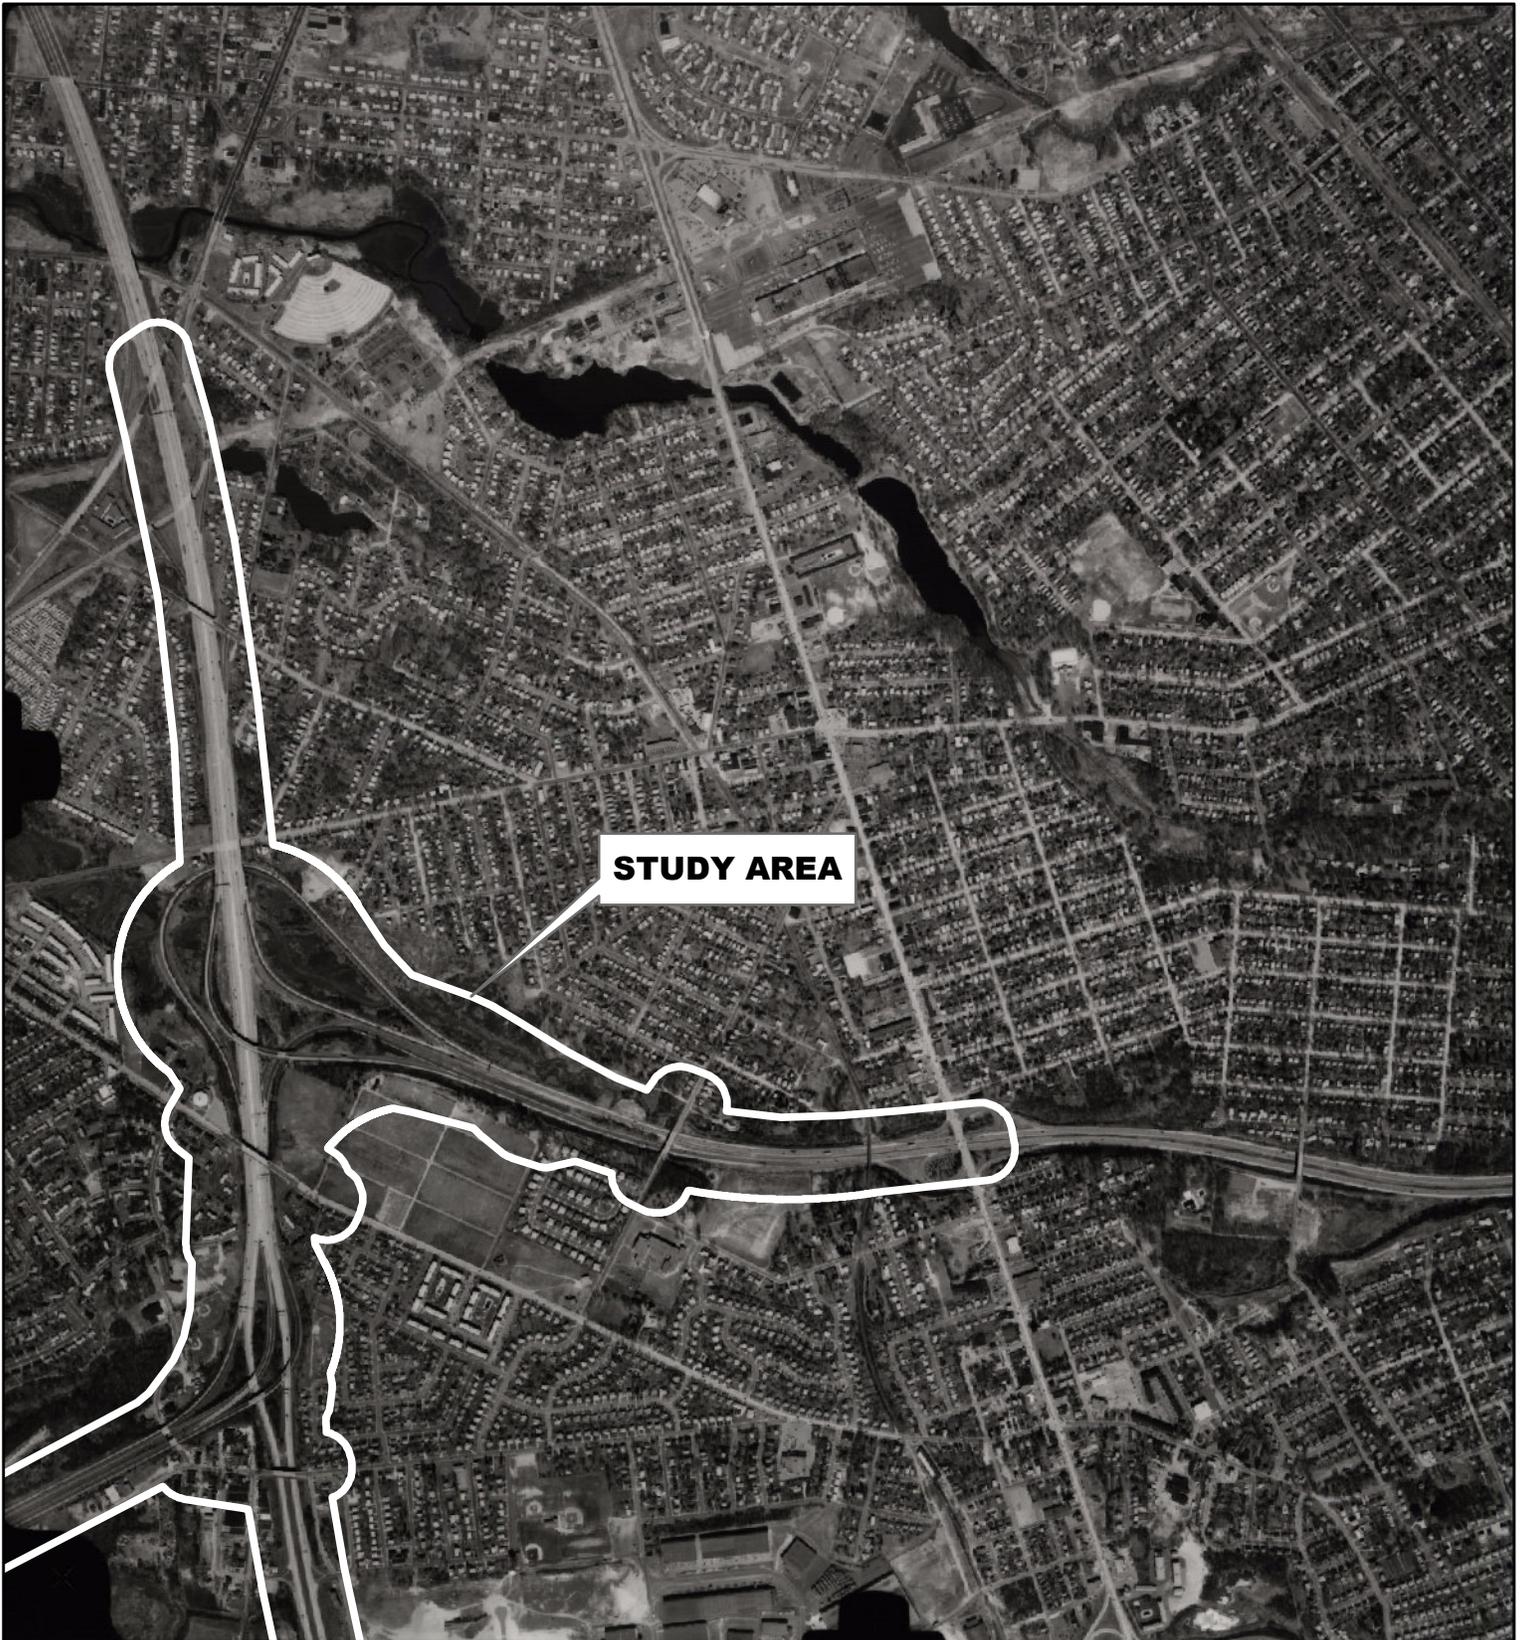
Figure C9

Historical Aerial Photograph - 1974 B
