Southern Pinelands Natural Heritage Trail Scenic Byway Corridor Management Plan

Task 10: Transportation Safety and Accident Record Study

August 2008

Howard/Stein-Hudson Associates, Inc.

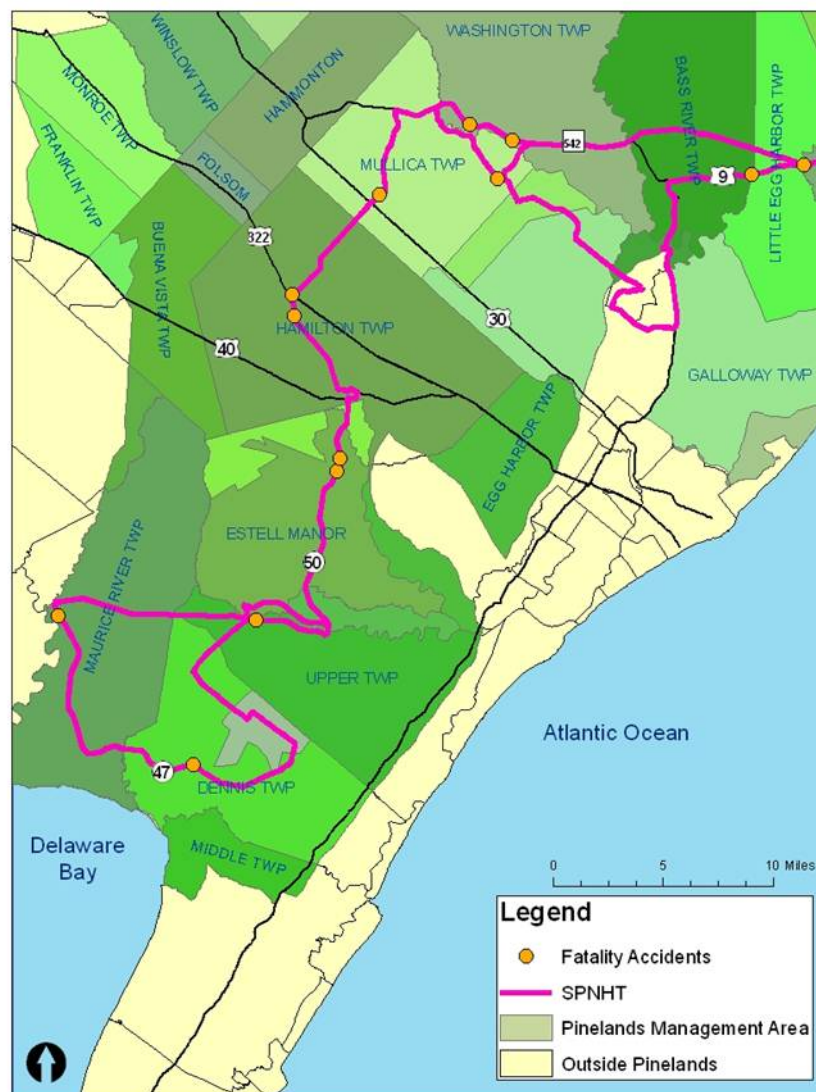
Map 1: Fatal Crashes

In the years 2006–2007, 14 fatal accidents occurred along the byway route (see **Map 1**). Of these, 1 accident resulted in 2 fatalities, and 13 accidents had single fatalities. Alcohol was involved in 2 of the 14 accidents; mobile phone usage was involved in none.

Of the 14 crashes, 6 involved a **fixed object** as the first event. These accidents occurred in various locations on the byway: 1 on Route 47, 2 on Route 50, 1 on Route 559, 1 on Route 623, and 2 in the Borough of Tuckerton on Route 9. Review of these segments did not reveal any attributable conditions. Of these fixed object fatalities, 3 occurred after dusk, and 2 of those 3 were on segments without streetlights; 1 occurred on Route 50 in Estell Manor, while the other occurred on Route 559, just south of Weymouth.

Of the fatal crashes, 3 were characterized as **head-on collisions**. These 3 accidents occurred on different roads, and there was no spatial pattern. Each occurred in daylight. One head-on fatality accident occurred on Route 47, just south of Port Elizabeth, in the rain, at a curve that features guide rails on both the interior and exterior lanes and is signed with yellow chevrons.

- 1 on County Route 561 (Moss Mill Road) at its intersection with the byway on Route 623 (Weymouth Road). This intersection is signalized, and sightlines on Route 623 seem to be relatively clear. Though the accident occurred at dusk, there were no attributable environmental conditions cited. A review of the crash data indicated no other potential cause of this accident; it could have been caused by the motorist running a red light. Further investigation such as a Road Safety Audit may be warranted. It is possible that the clearance intervals are too short or that the signal heads are not very visible at certain times of day.

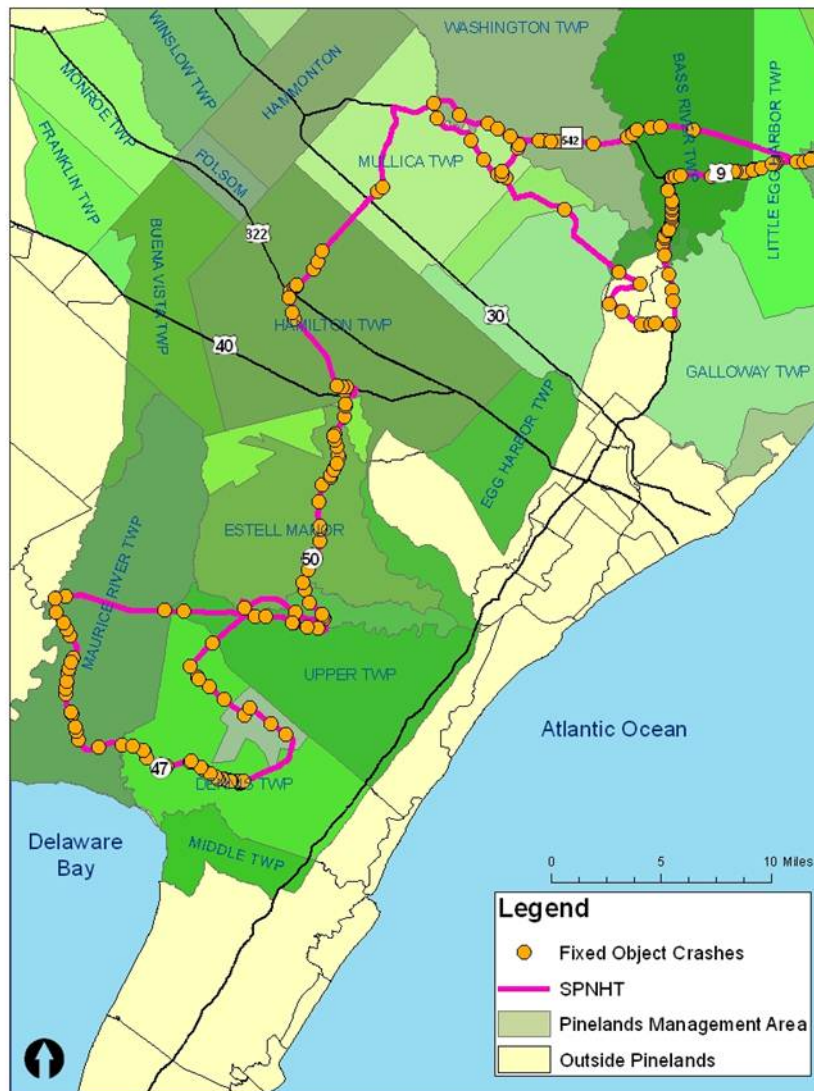
Map 2: Fixed Object Crashes

In the 2 study years, 254 crashes on or along the byway involved a fixed object as the first event (31% of all crashes) (see **Map 2**). Alcohol was involved in 44 of those crashes. Mobile phone use was involved in 1 fixed object crash.

Over half (140) of fixed object crashes occurred on roadway sections where the speed limit is 50 mph. This is not surprising, since much of the byway features a posted speed limit of 50 mph. However, further investigation of possible speed limit reductions may be warranted on segments with particularly high concentrations of this type of accident. This includes all of Route 47 (with emphasis on the segments between Port Elizabeth and Delmont, and between its intersection with State Route 347 and Dennisville); Route 50 between Mays Landing and Corbin City (with emphasis between 17th Street and Walkers Forge Road south of Belcoville); Route 542 between Batsto and Route 653; and on Route 9 between Munion Field Road and Otis Bog Road.

Of fixed object crashes, 86 occurred in curves; 52 of these occurred on dry roads, and 23 on wet roads. These wet roadway crashes on curves were geographically spread along the byway. One small cluster occurred on Route 559 just west of Mays Landing; another on the exit ramp where Route 9 departs the Garden State Parkway toward Port Republic.

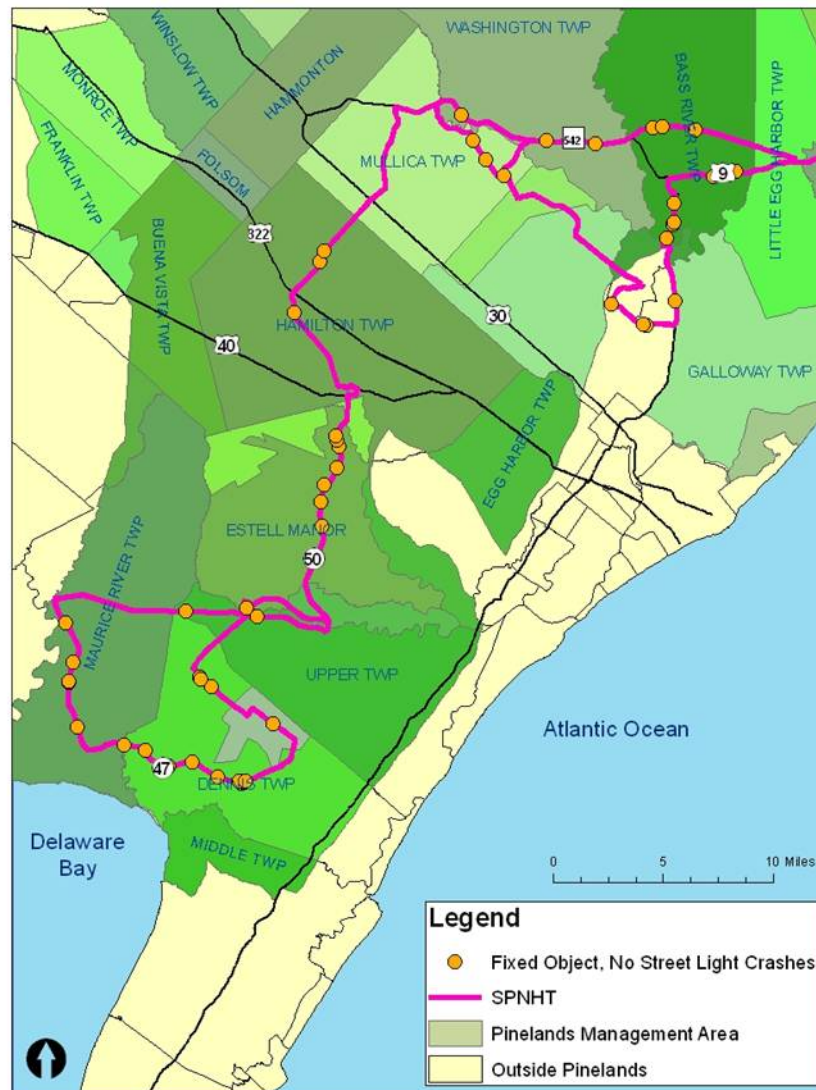
Map 3: Fixed Object Crashes on Roads Without Streetlights

Of fixed object crashes, 56 occurred at night on segments of road without street lights (see **Map 3**). These crashes are generally concentrated on road segments with high overall levels of fixed object crashes. Route 50 south of Mays Landing and Route 47 feature clusters of crashes with these characteristics. These areas may warrant further investigation for increased or improved street lighting.

During daylight hours, 87 fixed object crashes occurred in clear weather on dry roads. Of these, 56 met those criteria, occurred on straight segments of road, and did not involve alcohol or mobile phones. In short, these 56 crashes are not attributable to factors contained in the available data. These accidents are most concentrated on Route 47 between its intersection with Route 347 and Dennisville, and on Route 9 between Munion Field Road and Otis Bog Road, although others occur elsewhere along the byway. A Road Safety Audit may be warranted for Route 47.

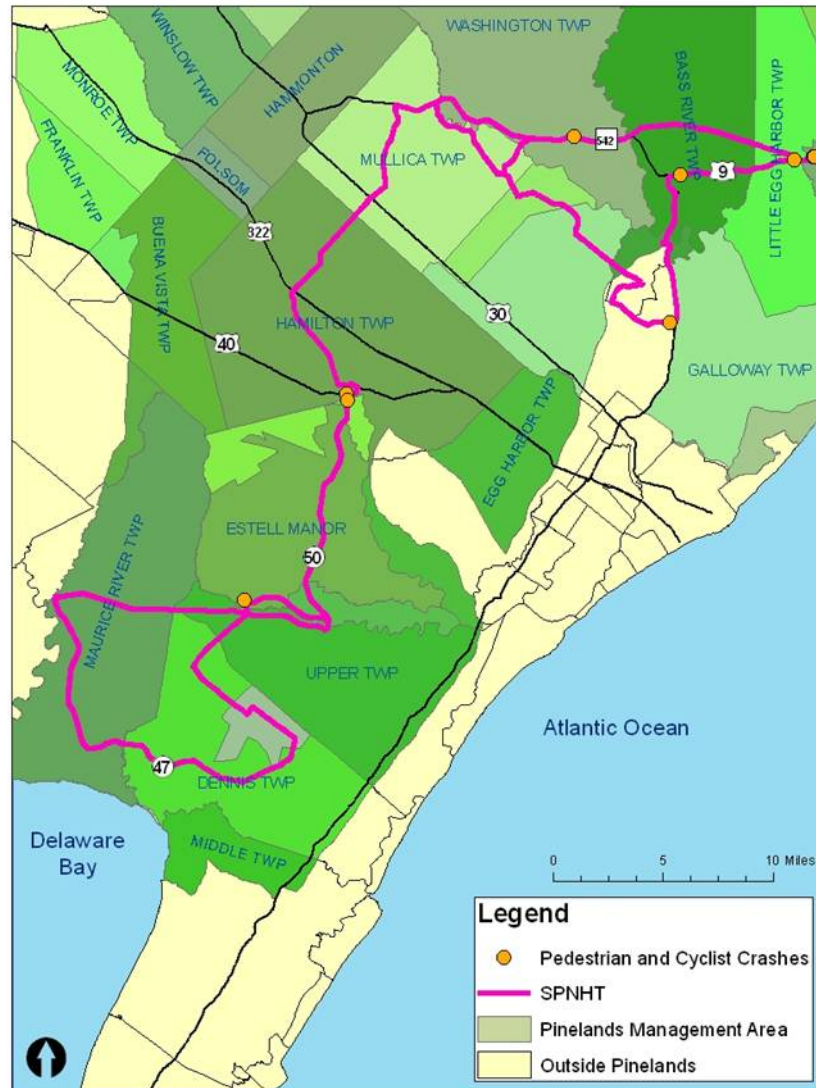
Map 4: Crashes Involving Pedestrians or Cyclists

As **Map 4** shows, few crashes along the Trail involved pedestrians and/or cyclists.

Though specific accommodations for bicyclists are relatively few along the byway, vehicle/cyclist conflicts are relatively uncommon, representing less than 1% of all crashes along the byway. It is unclear whether this is due to a low volume of bicycle traffic in the area or other determining factors. For instance, much of the byway does feature ample paved shoulders of 6 feet to 8 feet. Cyclists probably use these facilities regardless of whether they are designated bicycle facilities.

Similarly, pedestrian conflicts are uncommon in relation to the total number of accidents. Spot inspection of crash locations failed to indicate factors contributing to these disparate incidents for both bicycles and pedestrians.

Both of these types of conflicts generally occurred at intersections. Route 9 was the site of 3 conflicts, 2 of which occurred in Tuckerton; and 1 cyclist crash occurred on Route 542, an NJDOT-recommended bicycle route.

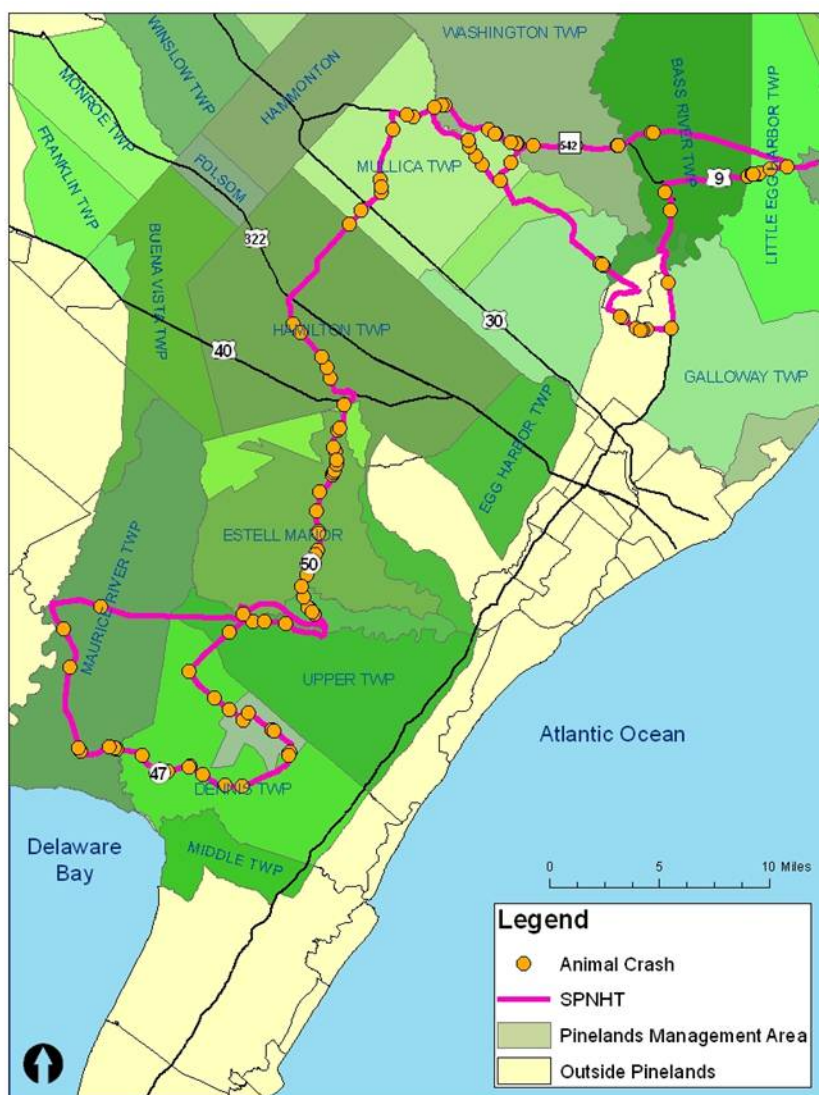
Map 5: Crashes Involving Animals

In the study years, 123 crashes occurred in which the first event involved an automobile/animal conflict (see **Map 5**).

The loop created by County Routes 542, 563, and 643 features a concentration of this type of crash, as does Route 50 between Mays Landing and Corbin City.

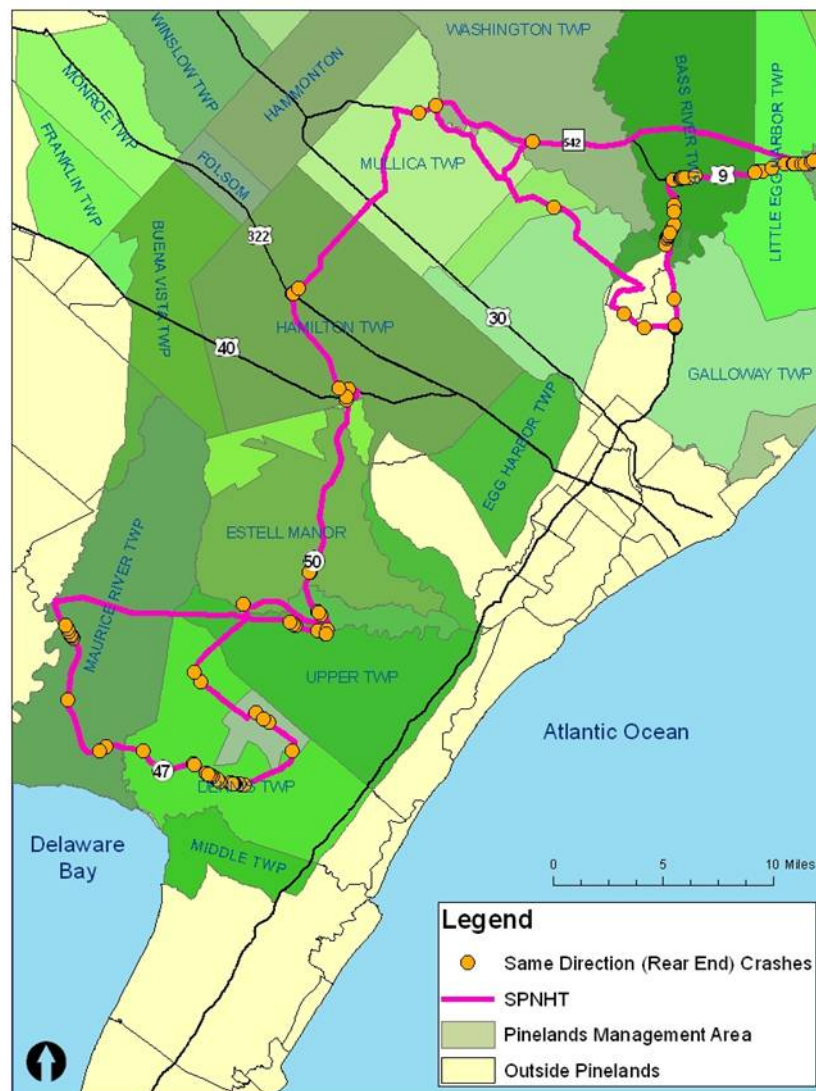
Map 6: Rear-End Crashes

In the study years, 184 rear end crashes occurred along the Trail, generally clustered around intersections and traffic signals (see **Map 6**). Areas with the highest concentration of this type of accident include Route 9 in Tuckerton to Ash Road in the west; along Route 47 near Dennisville and at the intersection with Cumberland County Road 670; on Route 50, around the intersection with Route 49; and on Route 9 where it runs concurrent with the Garden State Parkway. This portion of Route 9 has no traffic signals, and intersections are limited to on- and off-ramps.

Of the 184 rear end crashes, 57 involved at least 1 injury; 27 involved 2 or more injuries. Further study of the red and yellow clearance intervals at the signals at intersections along Route 47 and Route 9, and in populated places such as Mays Landing and Tuckahoe may be warranted.

Problematic “dilemma zones” may also exist in higher speed (40 mph or greater) areas. A “dilemma zone” is a no-man’s land in which a driver must decide whether to stop for a yellow light or proceed through it. After a certain point, the driver no longer has the required distance to stop safely and must proceed through the signal. Traffic signal technology is available to ensure that such dilemma zones are minimized.

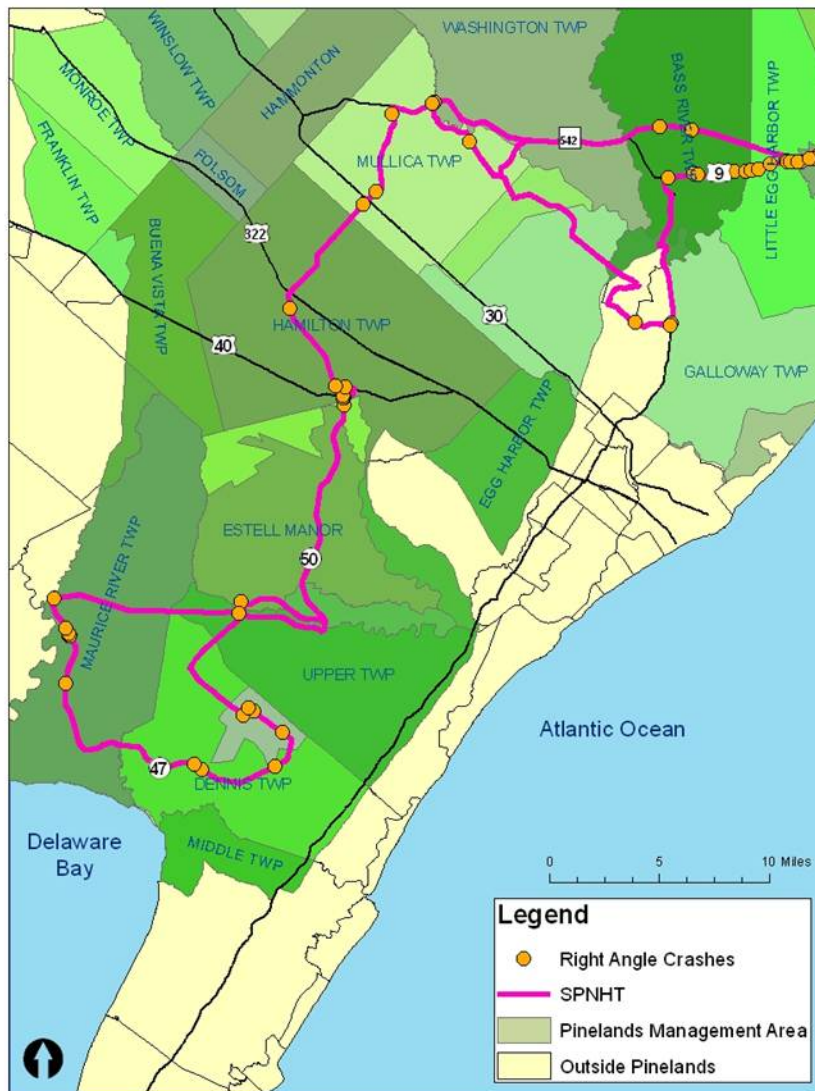
Map 7: Right-Angle Crashes

During the study years, 81 right angle crashes occurred along and around the Trail (see **Map 7**). Though some locations along the byway feature scenic turnouts with limited signage, visibility, and—in some cases—require backing out into traffic (e.g., Route 623 near the Makepeace Lake WMA), few if any right angle crashes can be attributed to these locations. The vast majority of these crashes appear to have occurred at roadway intersections. Those that have not occurred at roadway intersections seem to have occurred at private driveways and parking lot entrances.

These accidents are particularly concentrated on Route 9 in and close to Tuckerton, on Route 47 at Bricksboro and near Dennisville, in Woodbine, Corbin City, and Mays Landing.
