SECOND GENERATION PAVEMENT OVERLAYS

A Final Report

Prepared By
New Jersey Department of Transportation
Bureau of Transportation Structures Research

1. Report No. FHWA/NJ-86-013-7778		2. Government Accession No.		3. Recipient's Catalog No.	
4. Title and Subtitle Second Generation Pavement Overlays				5. Report Date July 1987

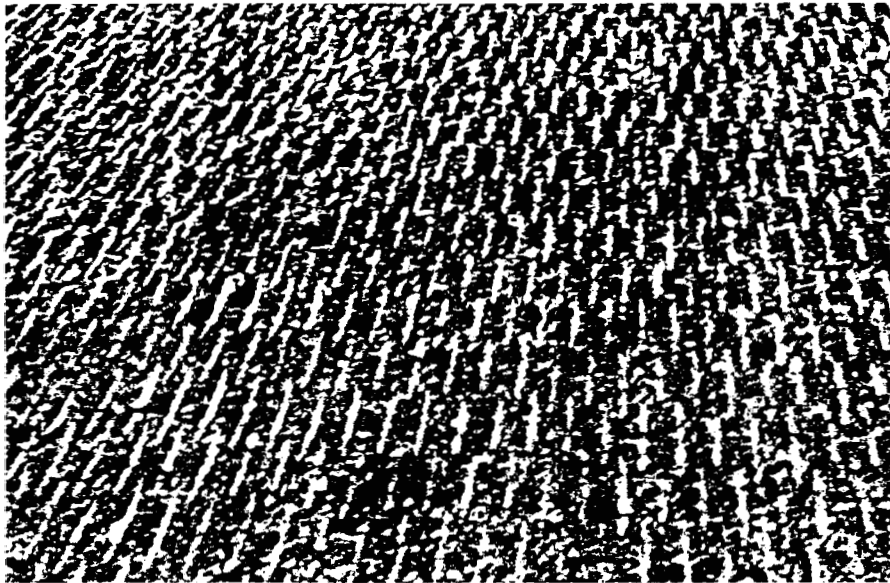
PHOTO 1
GOOD MILLING TEXTURE

a. Poor Texture: The milled surface as exhibited in brochures from equipment manufacturers shows a nicely textured surface (Photo 1). In reality this is the exception rather than the rule. More often the surface is heavily striated as shown in Photo 2. There are several reasons why striations occur: the forward speed of the machine, the density of the material, the ambient temperature, and variations in the hardnesses of asphalt pavements.

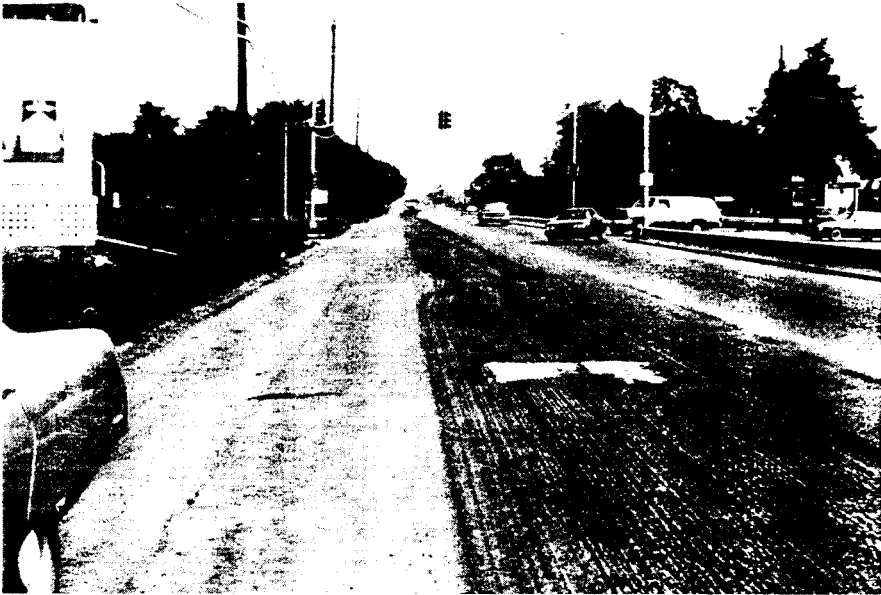
As mentioned previously, on the southbound roadway the normal 5/8" milling depth was increased to 1 1/2" 500' before and through the intersection to remove corrugations in the stopping areas. The milling machine operator would swing the machine in 2' and mill the additional depth with no interruption in milling. The procedure was then reversed at the end of 500'. This weaving procedure, combined with the striated texture, caused a driving control problem with small cars. Photos 9 & 10 demonstrate how the texture is effected when the milling equipment is used improperly.

PHOTO 9
WEAVING OF MILLING MACHINE

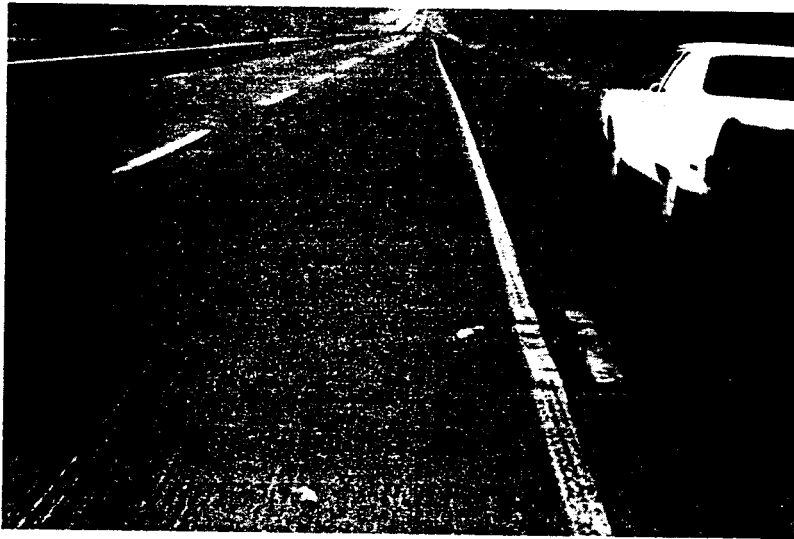
The last 3/4 of a mile was milled with a new drum and all new teeth. The results may be seen in Photo 11. Photo 12 is more representative of what the project was like and is shown for comparison.

PHOTO 12
POOR QUALITY MILLING REPRESENTATIVE OF THE ROUTE 1 PROJECT

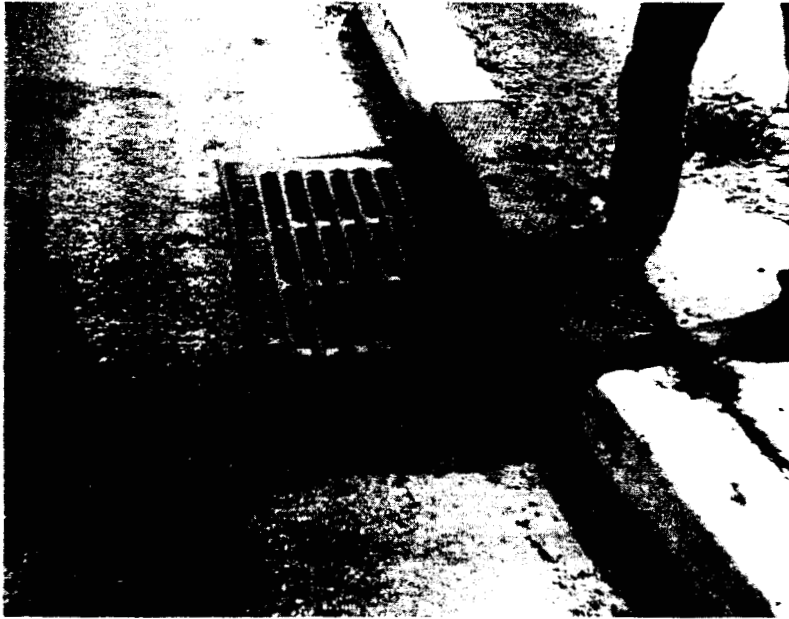
The original design called for the grate to butt up against the curb piece. However, on this installation, due to the way the curb piece was placed, a 5/8" gap appeared between the frame and the front of the grate (Photo 21). A piece of steel was brazed to the rear cross member of the extension frame to prevent the grate from receding (Photo 22). (Subsequently, the extension frame was redesigned to include cast stops on the rear cross bar.)

PHOTO 21
OPENING BETWEEN GRATE AND FRAME

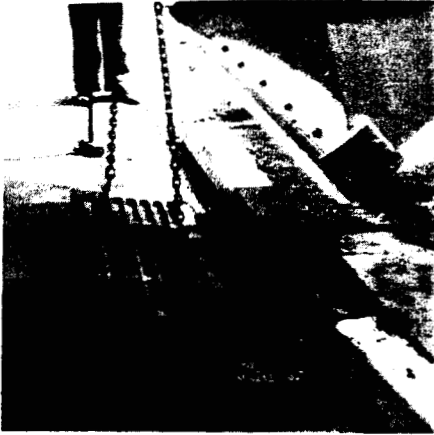
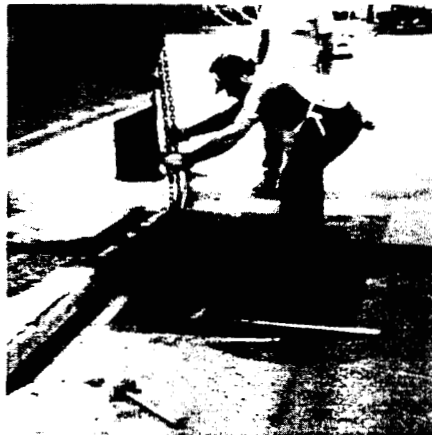
After three years exposure to traffic (AADT 37,600-21% trucks), the extension frames were removed, inspected, and put back in place (Photo 23). All 4 units were in excellent condition and have been problem-free after 9 years of service.

PHOTO 23
INSPECTION OF IN-SERVICE INLET EXTENSION FRAME

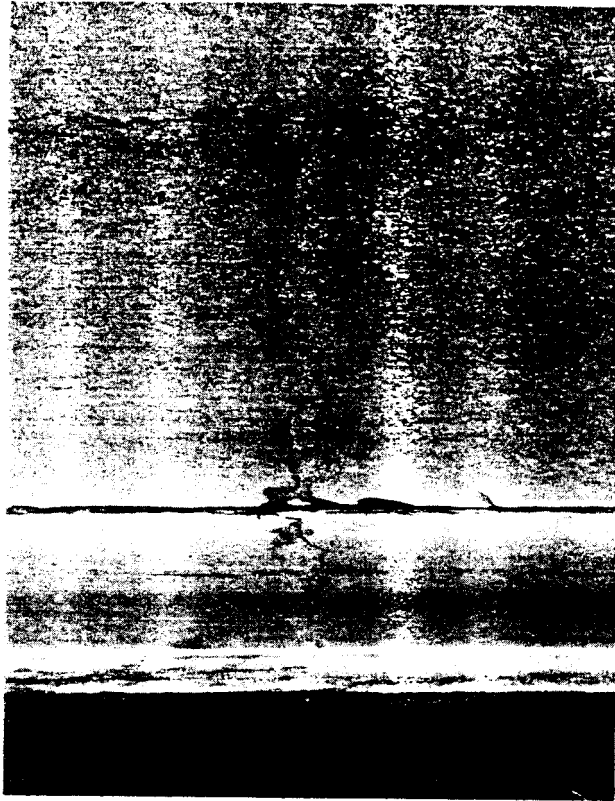
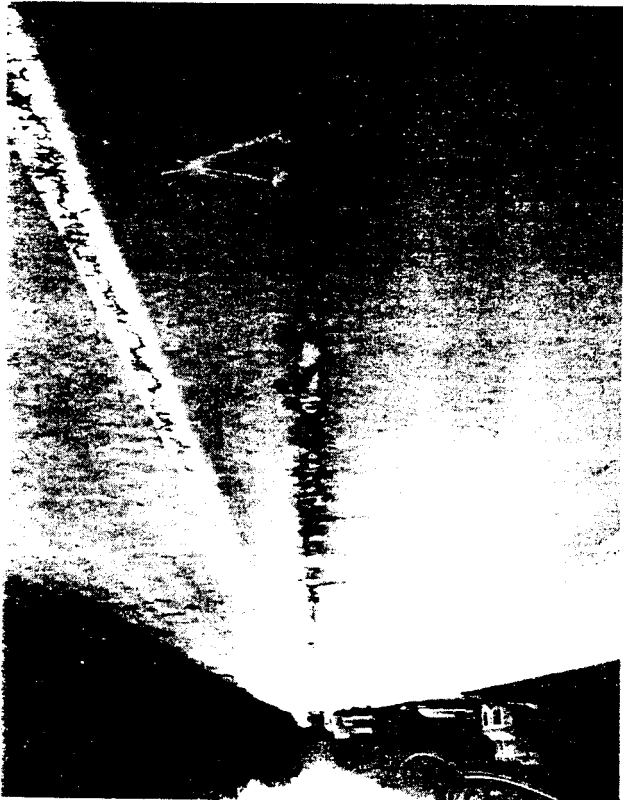
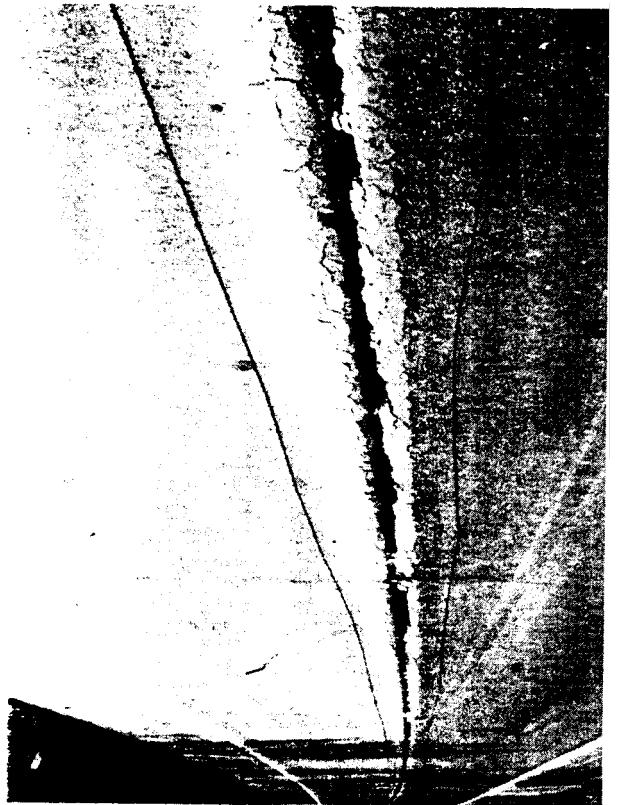
PHOTO 30

Reflection cracking of asphaltic overlays placed over portland cement concrete pavements has been a problem confronting maintenance forces over the past five decades. Photo 30 shows the various manifestations of the problem. As discussed previously, a critical review of the literature suggested that the saw and seal technique offered the greatest promise for providing a definitive solution to this problem.

a1 : CENTERLINE CRACKING

b1 : EDGELINE CRACKING

TYPES OF REFLECTION CRACKING

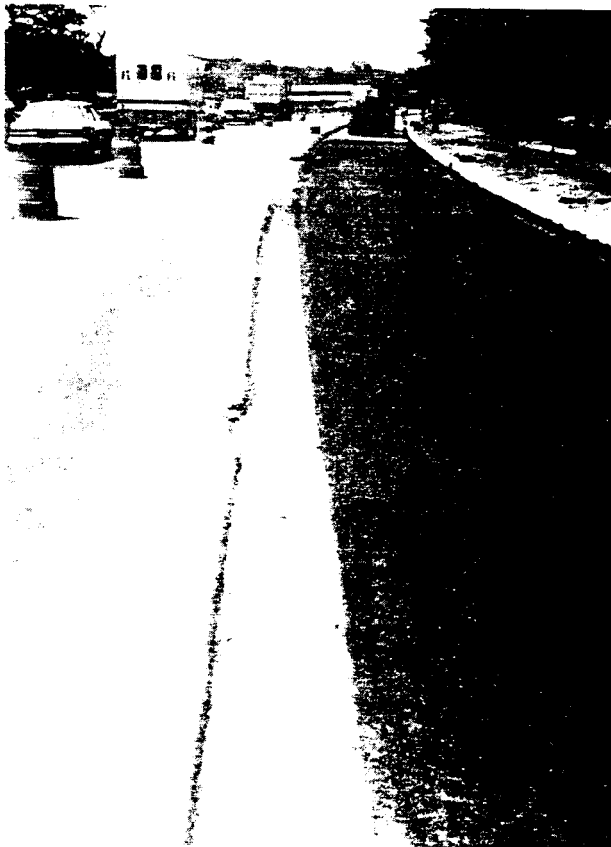
PHOTO 34
JAGGED EDGE CUT BACK OVER CONCRETE ON ROUTE 10

One other precaution was taken in these test sections, that is the edge of the milled pavement was cut back 10" from the composite pavement-bituminous pavement interface (see Technique E, Figure 7). This precaution was taken prior to excavation of the shoulder to eliminate the loose and/or jagged edge produced during excavation. Examples of the forementioned are shown in Photos 33 and 34. The balance of the 7-mile overlay on both sides of the test section served as control.

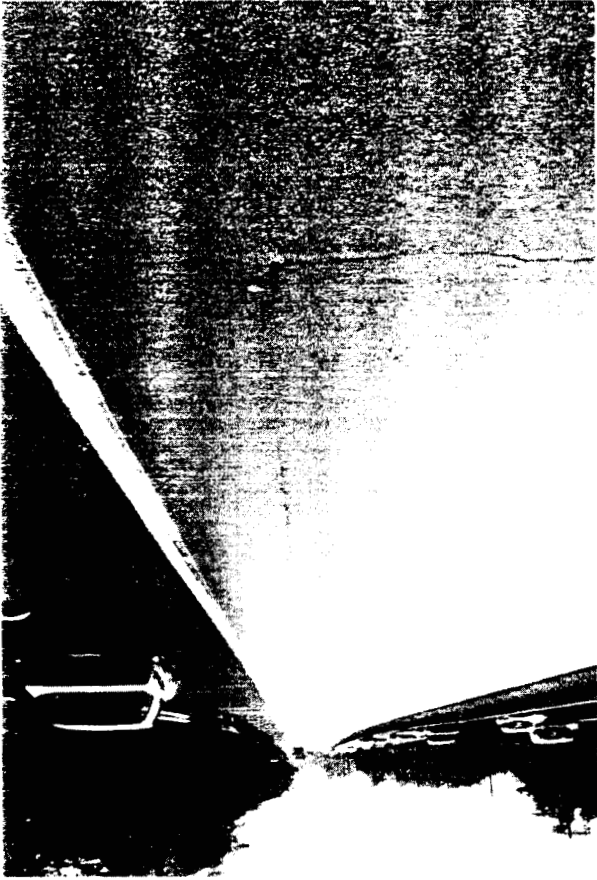
PHOTO 41

EDGE CRACK FORMATION IN CONTROL SECTION

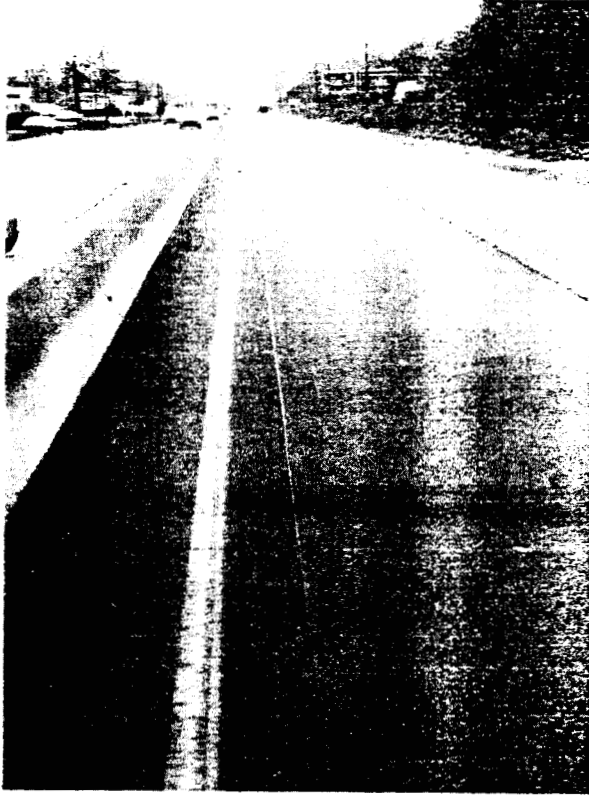
PHOTO 43

APPEARANCE OF LONGITUDINAL JOINT ON ROUTE 22 AFTER 7 YEARS SERVICE

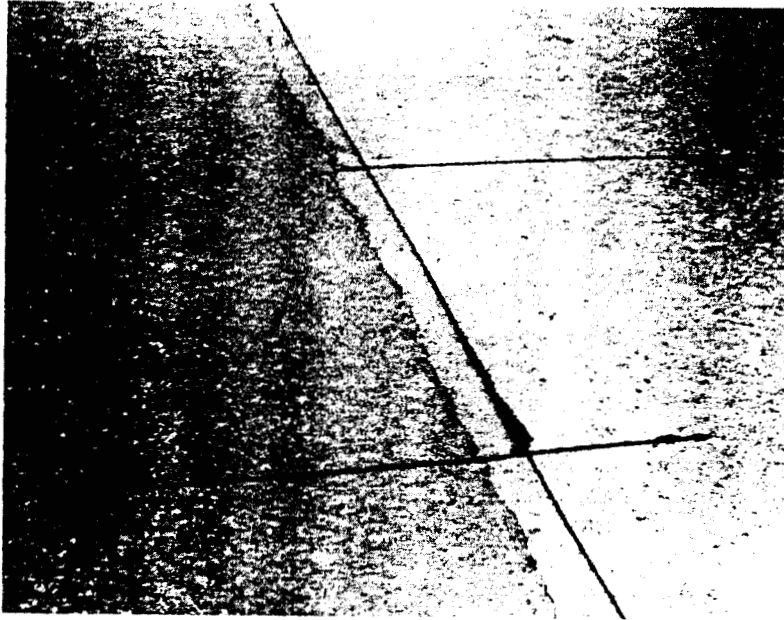
PHOTO 44

b) Longitudinal Joints: Three longitudinal saw cuts were made over the underlying concrete pavement. Two were over the untied concrete lanes, the third over the edge of outside lane. Photo 40 shows the uncracked edge joint in the test section and Photos 41 and 42 show the open edge joint forming in the control section after seven years of service. During this period approximately 6000' of cracking occurred in the control section and none in the test section. (All of the longitudinal and transverse reflection cracks in the control section were sealed by Maintenance during the winter of 1984.) The sawn joint in the vicinity of the inner shoulder (Photo 43) is also performing very well. Photo 44 is shown for comparison purposes of what happened to the previous overlay after about twelve years.

APPEARANCE OF LONGITUDINAL JOINT IN PREVIOUS OVERLAY

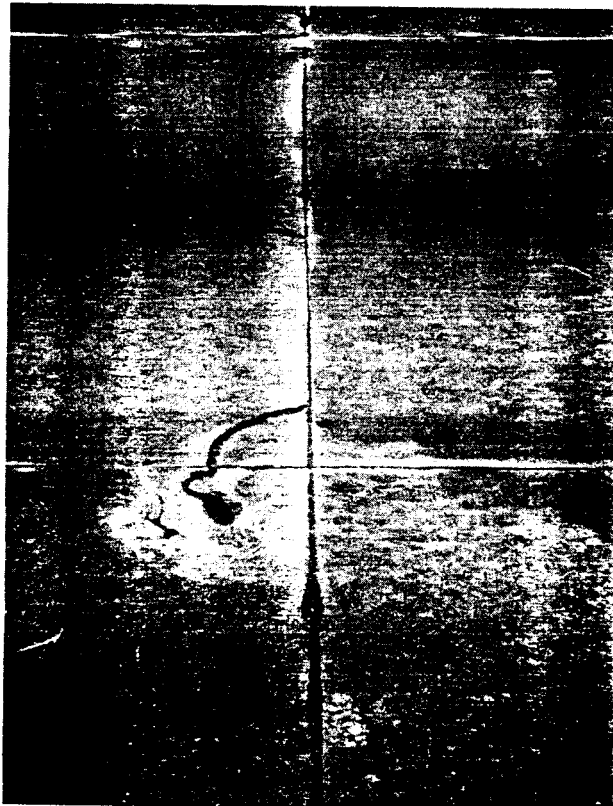
7. The sealing material should be applied by a special "Wand" having the shut off valve within 4" of the tip. A sealing pot either hand or wheeled should not be permitted. Both the regular wand and the pouring pot have been responsible for both under-and overpouring (see Photos 52 and 53).

PHOTO 52
UNDERPOURING OF JOINT SEALANT ON ROUTE 40 & 322 PROJECT

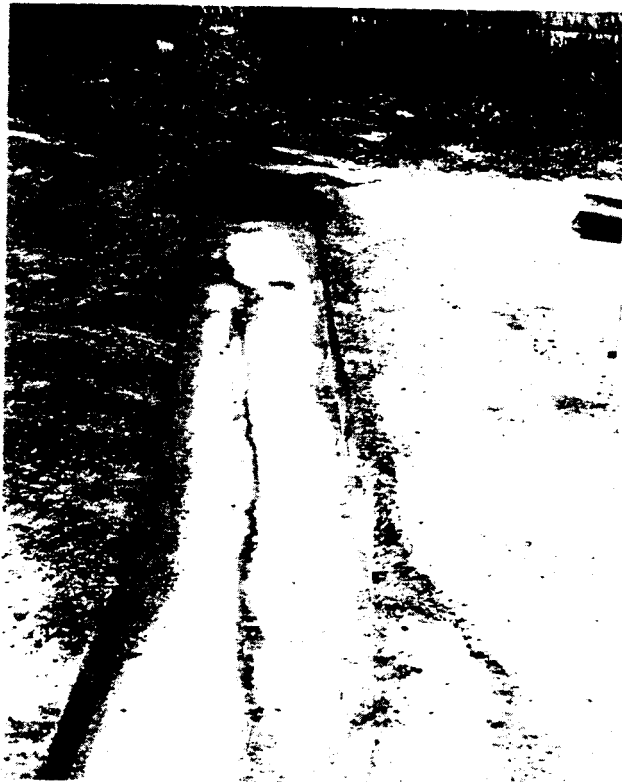
is obviously a needless expense. An example of this was recently encountered on the Route 10, Section 2G and 3G project. On that project, many joints were scheduled to be cut out and patched with bituminous mix based on the distressed appearance of the overlay (see Photo 64). In fact, after the overlay was milled off in the vicinity of the joint, the overlying concrete was found to be sound (Photo 65). While not all of the joints uncovered on this project were in as sound a condition, in some cases the concrete in the vicinity of the joint was only partially deteriorated (Photo 66). Hence, while the joint needed some patching prior to overlay, the practice of cutting out the slabs was not required.

PHOTO 64
ROUTE 10 PROJECT: APPEARANCE OF OVERLAY SURFACE

The lesson to be learned from the foregoing is that prior to undertaking joint repairs, a "prospect" hole should be dug or cored to determine the extent of the damage to the joint to decide what the appropriate treatment is. The usual "eyeball" method of evaluating a tented joint generally presumes that the slabs are pressing against one another and are in imminent danger of creating a blowup. As illustrated in Photos 64 and 65, this is not the fact in all cases. Rather, the reason for the tenting is that incompressibles have entered the reflection crack in the bituminous overlay and on expansion of the slabs, the only place for the bituminous material to go is up, i.e., the stresses exerted by the hardened asphalt have caused delamination between the overlay and the underlying rigid pavement.

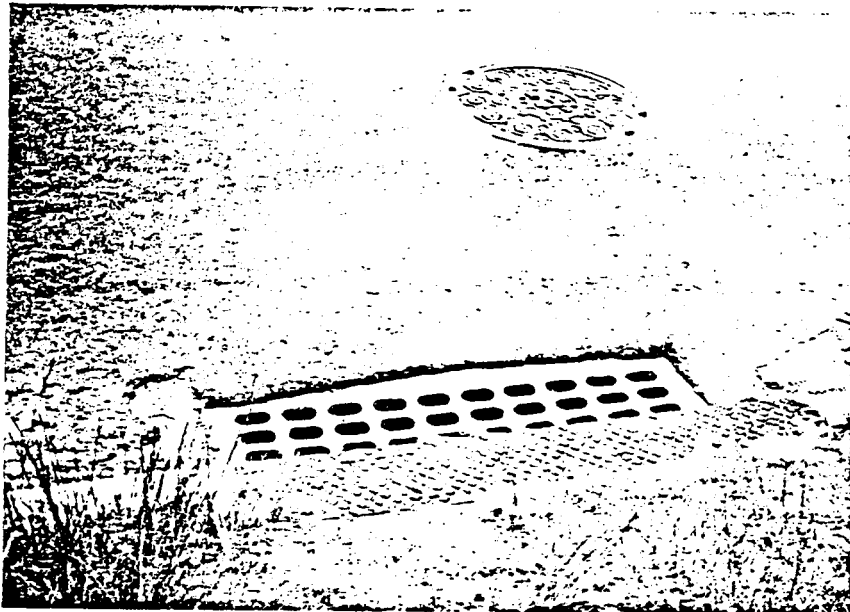
In some cases, even less care is taken around inlets. Some grates have been observed to be 2 to 3 1/2 inches below the surrounding pavement (see photo 15 & 16). This creates a hazardous condition as well as a litter trap.

PHOTO 15
FEATHERED INLET, LITTER TRAP

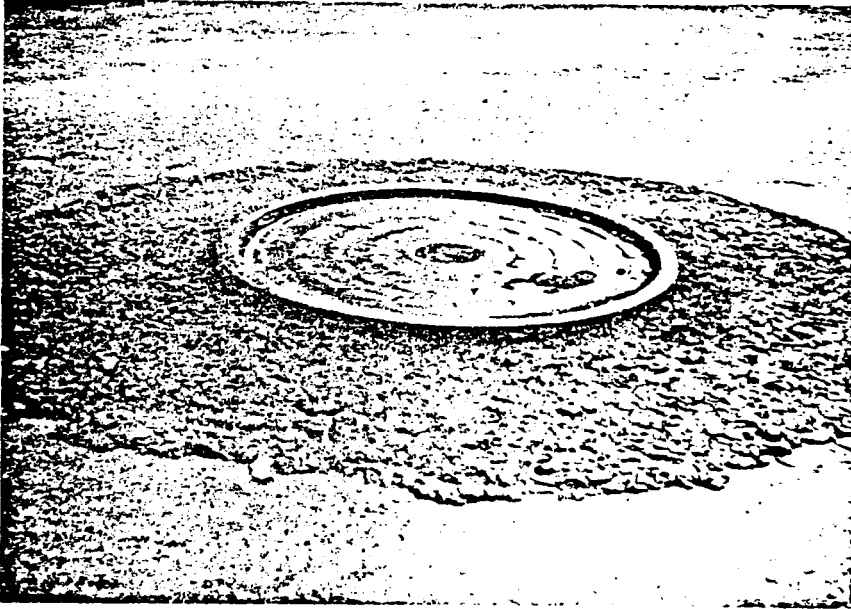
PHOTO 19

Besides producing a rough ride, worn covers present a safety hazard. Photo 19 shows an old frame with a badly worn cover that was reset without the benefit of a bituminous ramp about the head. This condition imparted dynamic jump to the wheels of the truck which landed on the cover, breaking it. (Photo 20). Trucks riding over worn covers in the finished surface or unramped resets during construction create a source of annoyance to residents in the form of irksome noise (Photo 21).

DEPRESSED COVER ON RESET MANHOLE FRAME
