FIELD EVALUATION OF A FUSION-BONDED WHITE
POLYESTER COATED GUIDERAIL

Initial Report

August, 1986

New Jersey Department of Transportation
Bureau of Transportation Structures Research

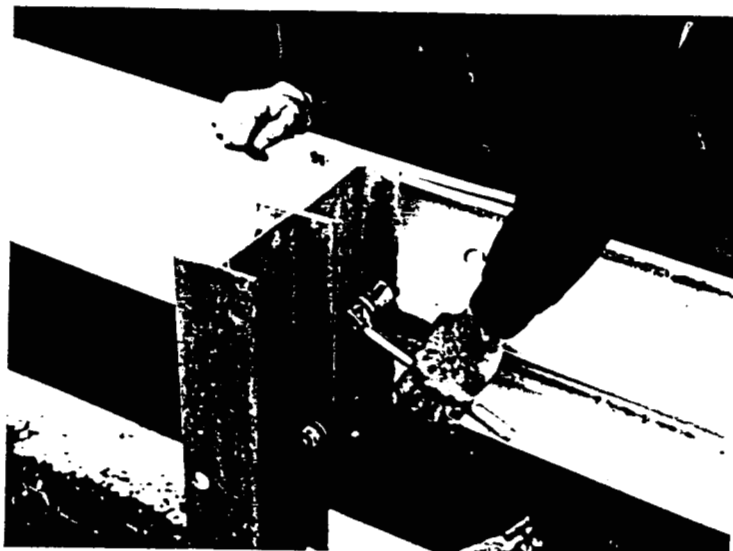
Figure 6. Installation of Polyester Coated Guiderail

The polyester coated guiderail was installed in January, 1985. The galvanized guiderail section was existing, installed approximately one year earlier. The experimental sections were off-loaded by hand and bolted together using hand tools. Much care was taken to avoid damaging the polyester coating. Neoprene washers were placed under the galvanized bolt heads. See Figures 6 and 7. Even so, some damage was inflicted, since pry bars were needed to line up the holes in the guiderail elements.
