Compatibility of Highway Railroad Crossing Gates with  
Overhead Catenary System High Voltage Power for Trains

Final Report  
June 2010

This report describes an investigation to determine the root cause of the incidents. Using information from known incidents along with site investigations, analysis is presented to identify crossings with the potential for line-to-earth faults or gate arm entanglement. Modifications are suggested for sites identified as having potential problems are presented.

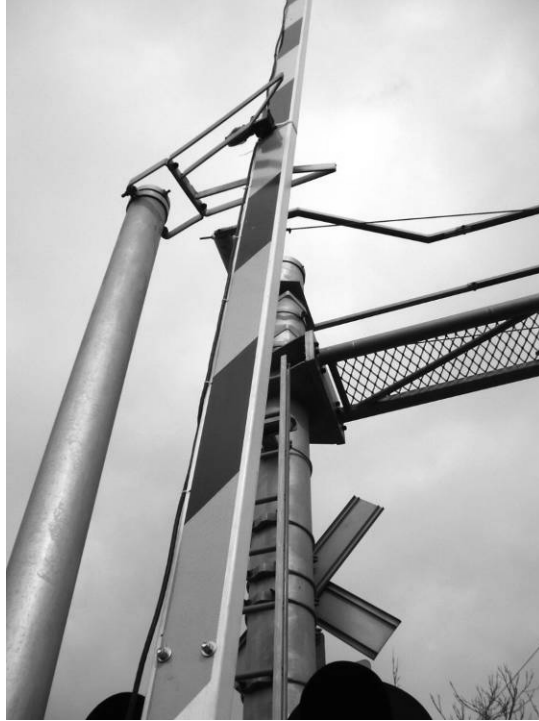
Figure 12. Wind bracket, wind bracket mast, and crossing gate arm at the Broad Street crossing on the NJCL

Many crossing gate mechanisms have wind brackets attached to prevent excessive sway of the gate arm when in the upright position. An example of a wind bracket is shown in Figure 12. Gate arms sometimes become entangled in wind brackets. Although not confirmed, it is likely that the wires for the flashing light units, or the flashing light units themselves, may be the primary cause for this.

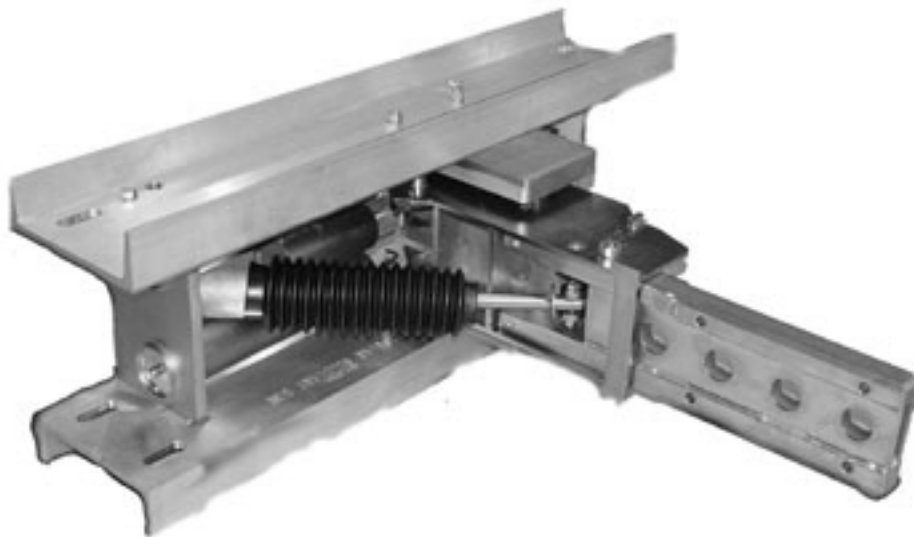
Figure 15. Gate saver

NJ Transit has implemented several solutions to avoid line-to-earth faults. Gate arms are physically removed when high winds are predicted as the result of impending hurricanes or Northeaster Storms. The length of gate arms was reduced to the minimum allowed. Many early catenary incidents were the result of the shear pins failing in fatigue due to wind loads. As a result of this failure, the gate arm would fall onto the catenary line. NJ Transit welded these pins to prevent fatigue failures. Wind brackets also appear to help this situation. However, when a gate with welded shear pins is struck by a car, the entire gate arm mechanism can rotate, allowing the gate arm to contact the catenary when the gate is raised. Gate savers, shown in Figure 15, were then employed (date unknown) to prevent the gate mechanism from rotating. Instead, the gate arm swings and then returns to its original position on its own. However, NJ Transit employees recounted that this solution still resulted in an incident involving gate arm contact with catenary lines. It was believed that this incident happened when the gate mechanism lifted the gate arm before the gate saver returned to its normal position.

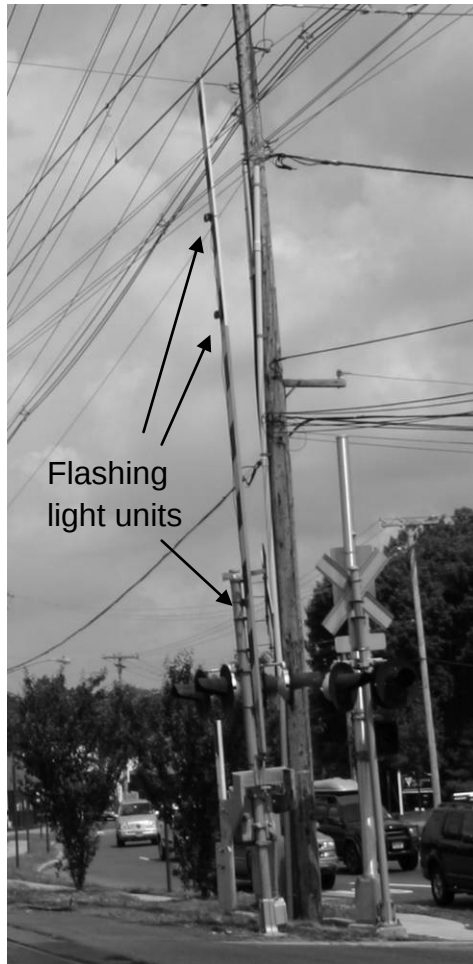
Figure 31. NW crossing gate arm and mechanism

A close-up view of the northwest crossing gate arm is shown in Figure 31. A more extreme close-up view, focusing on the flashing light units, is shown in Figure 32. The placement of the flashing light units on this arm is not typical. The flashing light units are usually placed at the tip of the gate arm. Apparently, the flashing lights have been lowered to avoid contact with the signal power wires, perhaps resulting in a “bunching” of the wire. Clearance between this gate arm and the signal power lines is between approximately one to three inches.

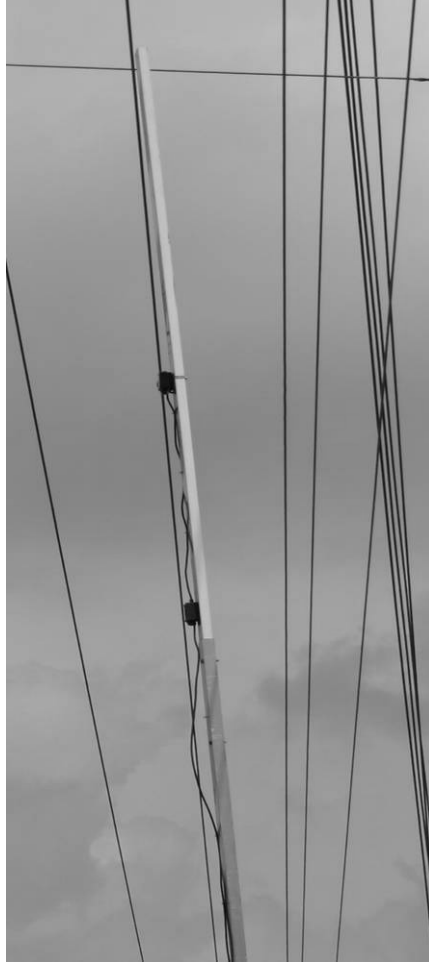
Figure 32. Wires for flashing lights on NW gate arm

During a site visit on June 13, 2005 at approximately 10:30 AM it was observed that the northwest bound gate arm made repeated contact with the signal power wires. This was the result of swaying of the arm in the wind. Weather information provided for the previous mentioned date has the maximum wind speed approximately being 10 mph and at the time of the visit, the recorded average wind speed was approximately 6 mph. As these wind speeds are not unusual for this location, it appears as though this contact occurs regularly. However, with the tip flashing light relocated below the level of the signal power lines, it appears to be unlikely that this contact will lead to entanglement.

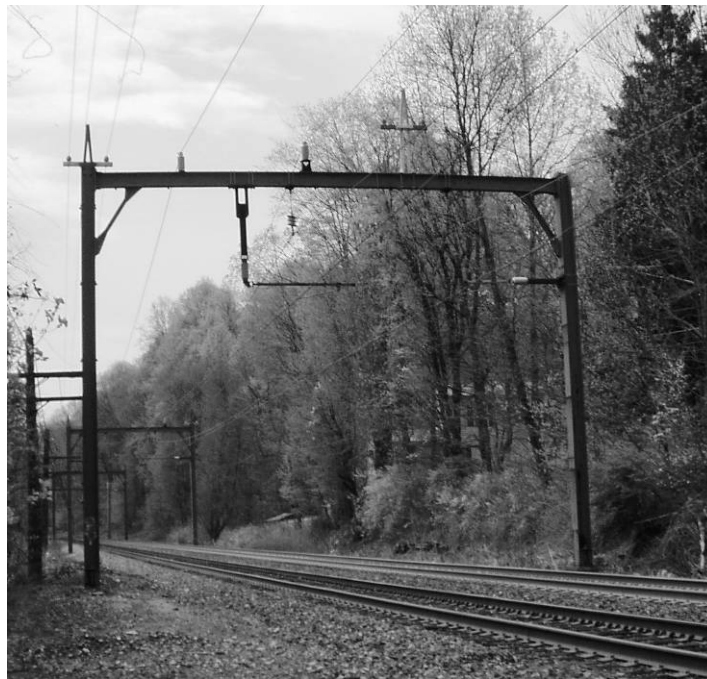
Figure 35. Support structure to the south of Station Rd. crossing

The support structure to the south of the crossing is shown in Figure 35. The catenary, feeder, messenger, signal, and static wires are depicted. For track 2, though not apparent in the figure, the signal power wires are about 2 to 3 feet higher than the signal power wires on track 1, due to the raised white cross on the top of the support structure.

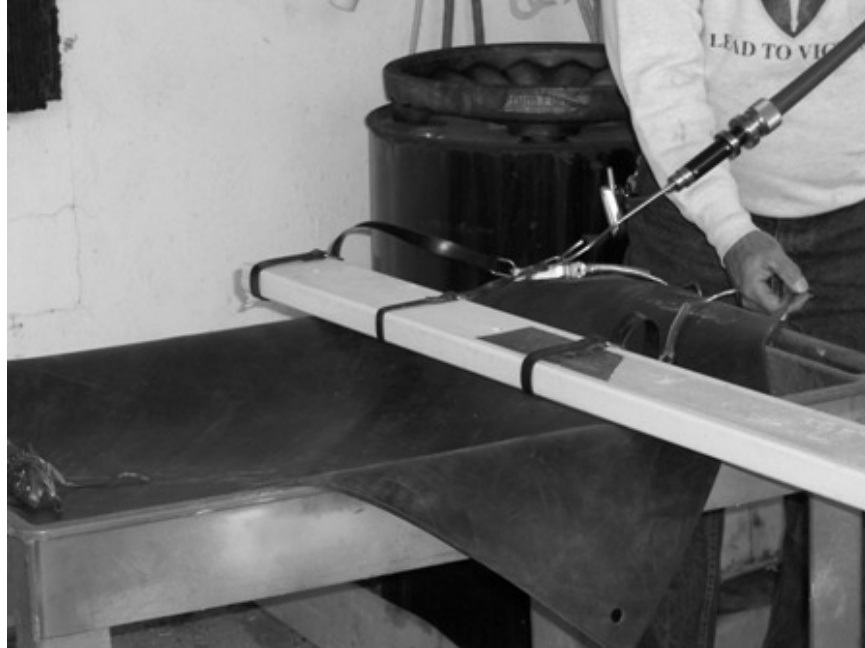
Figure 45. Doble testing of gate arm

A protocol was generated to perform the testing. The maximum voltage applied to the surface of the gate arm was 10 kV. Depending on certain samples, the voltage applied to the gate arm ranged from 1 kV to 10 kV. Three rubber conducting straps were placed on the gate arm on key spots. The two outer bands were placed equivalent distances away from the energized center band, ranging from one foot to three feet. Figure 45 shows of the placement of the bands.

The previous figures depict the first initial test run on the gate arm. The center strap, energized band, is placed one foot from the base of the gate arm, while the other two straps are placed approximately one foot apart on either side of the energized band. Tests were then run moving up the gate arm, varying the distances of the outside straps with respect to the energized band. The following sections of this appendix show the results of testing each pre-made sample of gate arms.

The first sample gate arm tested was treated with salt water. A total of eight trials were run on the sample. During each trial, the center conducting band was energized with 10 kV and the two other bands were placed one foot on either side from the center band. It was noted that during the testing process such occurrences as tracking, arcing, over current, burning, sparking, and fire could happen. With that in mind, all observations were recorded along with any leakage current or power loss.
