State Channel Maintenance Capacity

FINAL REPORT

January 2015

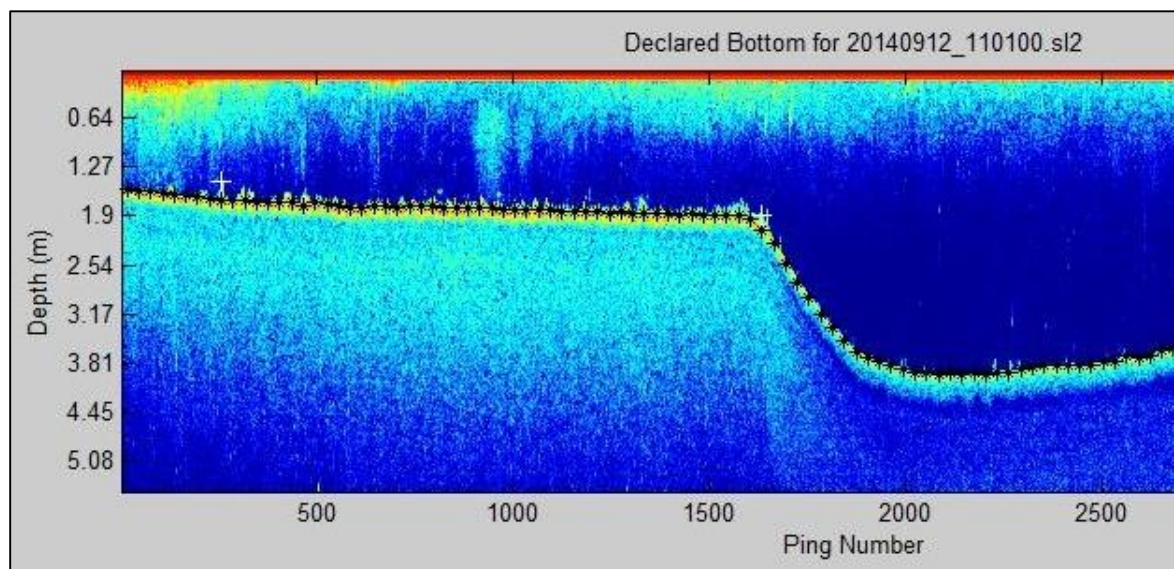
Figure 3, Colorized echogram from SAVEWS Jr. Bottom detection is symbolized by black stars and the SAV detection is symbolized by white crosses at the top of the canopy. High reflectivity is symbolized by warmer red and yellow colors while lower reflectivity is symbolized by cooler blue colors. False occurrences using canopy height to detect SAV occurrences tend to occur in areas of steep drop offs as seen near ping 1600 with a single detection of SAV indicated by a white cross. Macroalgae can be seen as low areas of weak reflectivity just above the bottom. In some instances macroalgae canopies are above the canopy height threshold and a false occurrence of SAV is present as seen near ping 300. When visually compared to the characteristics of known SAV occurrences as seen in the echogram in Figure 2 and drop camera video used to verify similar instances and echograms from other transects, it is evident the location near ping 300 is a false occurrence of SAV.

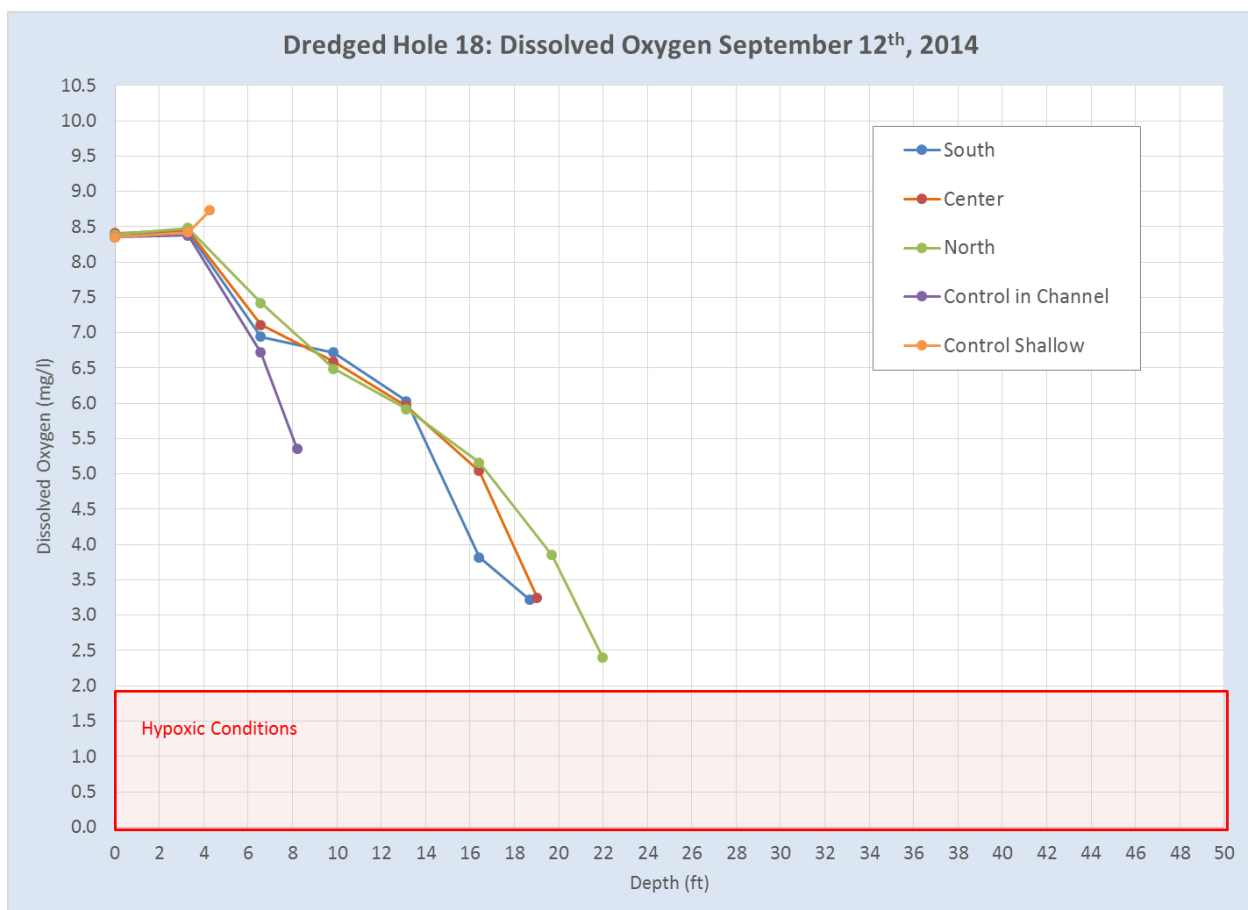
Three separate water quality surveys were performed on Dredged Hole 18 (August 7, 2014, September 12, 2014 and October 28, 2014) and a single observation of dissolved oxygen content at the deepest section of the feature during the bathymetric survey on October 24, 2013. During the September and October (2014) surveys, the dissolved oxygen content was significantly less than the control sites and decreased rapidly with water depth to near hypoxic conditions. The lowest observed dissolved oxygen content at this site was near hypoxic with a reading of 2.4 mg/l during the September survey. Additionally, surveys displayed a distinct increase in salinity of ~3.5 ppt that occurred between 3 and 9ft (1 and 3 meters) and ~4.5ppt between 6.5 and 13ft (2m and 4m), respectively, during the September and October (2014) surveys. Additionally, Murawski (1969) found anoxic conditions at the bottom of this dredged hole during his 1969 investigation.

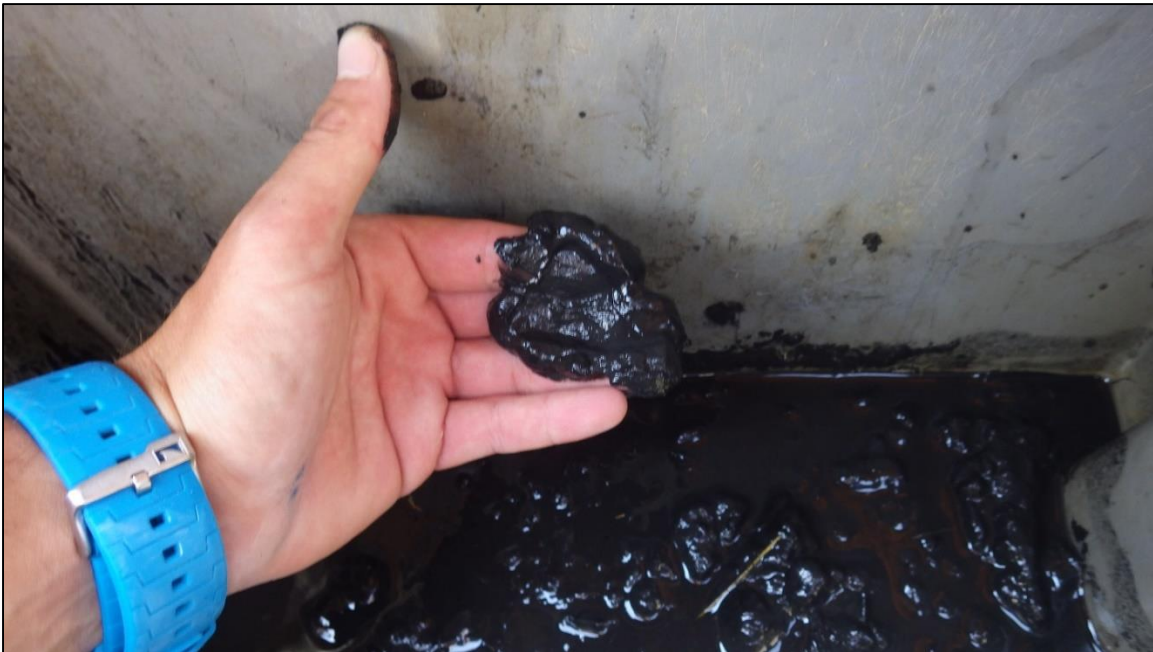
At each of the five water quality sampling locations in Dredged Hole 18 (three in the interior of the feature and two controls outside) benthic grab samples were taken using a hand-deployed Ponar grab sampler and visually inspected for the presence of SAV and benthic organisms during the August 7, 2014 water quality survey. All three interior benthic grab samples taken within the dredged hole were azoic and smelled of hydrogen sulfide. The samples were mainly comprised of black mud with some plant debris present in two of the samples. The shallow control sample (depth of 1m) contained grey sand with plant debris and the control in the channel contained black sandy mud with black stained plant debris and few pebbles. No SAV or macroalgae were present in any samples.

Figure 6. The grab sample from the deepest (north) sampling location. Grab samples within Dredged Hole 18 were mainly comprised of black mud with some plant debris present in two of the samples.

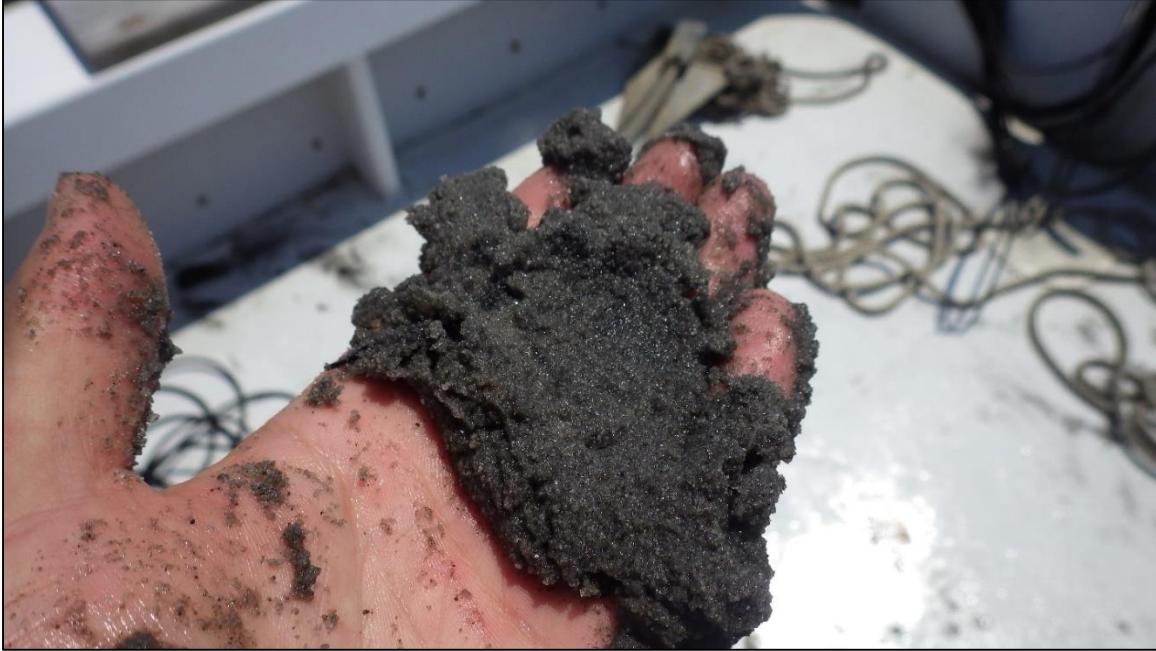
Figure 7, The shallow control sample (depth of 1m) for Dredged Hole 18 contained grey sand with plant debris.

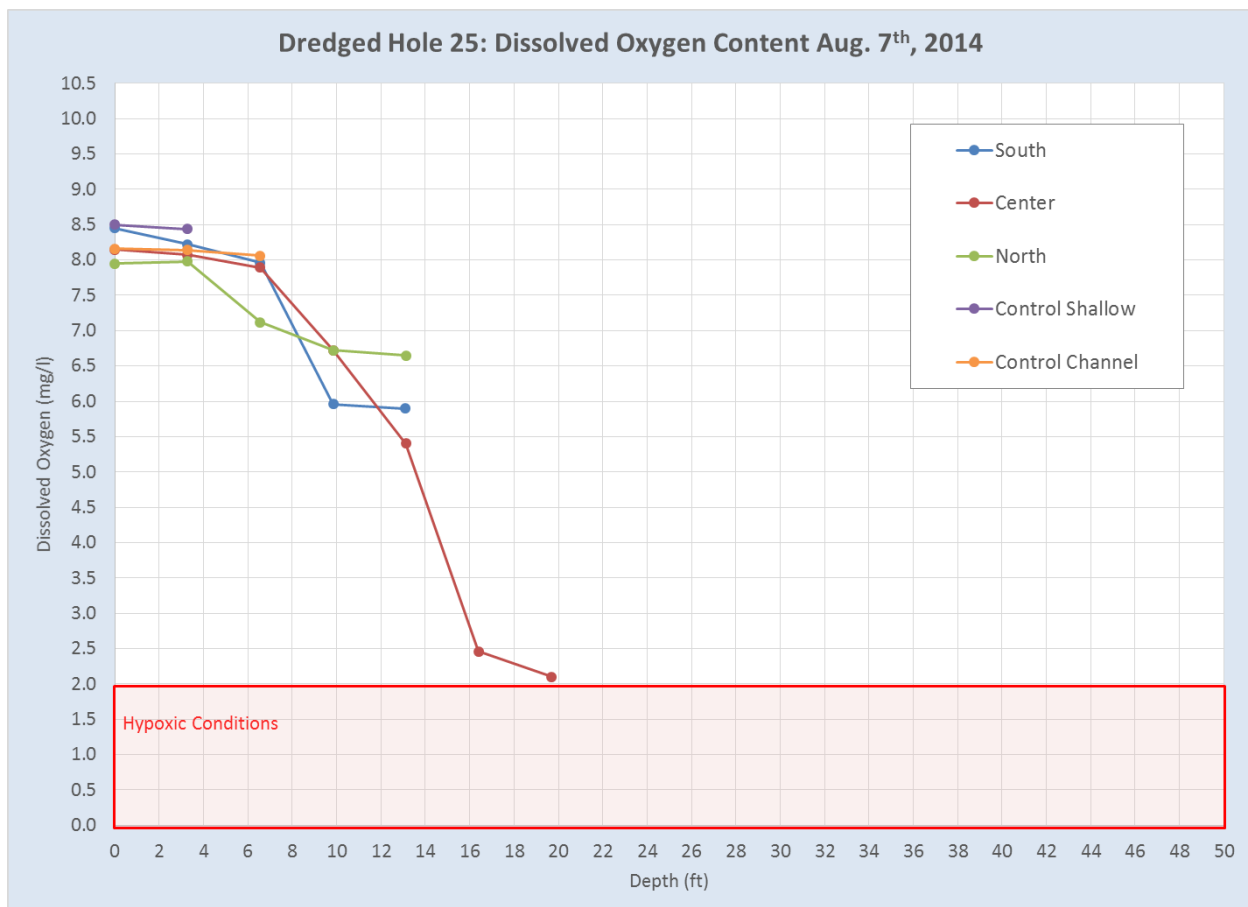
Three separate water quality surveys were performed on Dredged Hole 25 (August 7, 2014, September 12, 2014 and October 28, 2014) and a single observation of dissolved oxygen content at the deepest section of the feature during the bathymetric survey on October 22, 2013. This series of water quality surveys indicate that Dredged Hole 25 is hypoxic for periods of time and dissolved oxygen content throughout the water column is dynamic. During the October 2013 spot check, Dredged Hole 25 was hypoxic with dissolved oxygen observed at its lowest level of 1.13mg/l. The water column in the dredged hole was stratified during the August 2014 survey and dissolved oxygen content was near hypoxic dropping from 8.15mg/l at the surface to 2.10mg/l at the deepest location. A sharp decline in pH correlated with the decrease of oxygen content during this survey, ranging from 8.1 at the surface to 7.25 at the bottom. However, during the September and October 2014 surveys dissolved oxygen content ranged from 8.1mg/l to 7.4mg/l and 9.5mg/l to 9.1mg/l, respectively, and the water column was not clearly stratified.

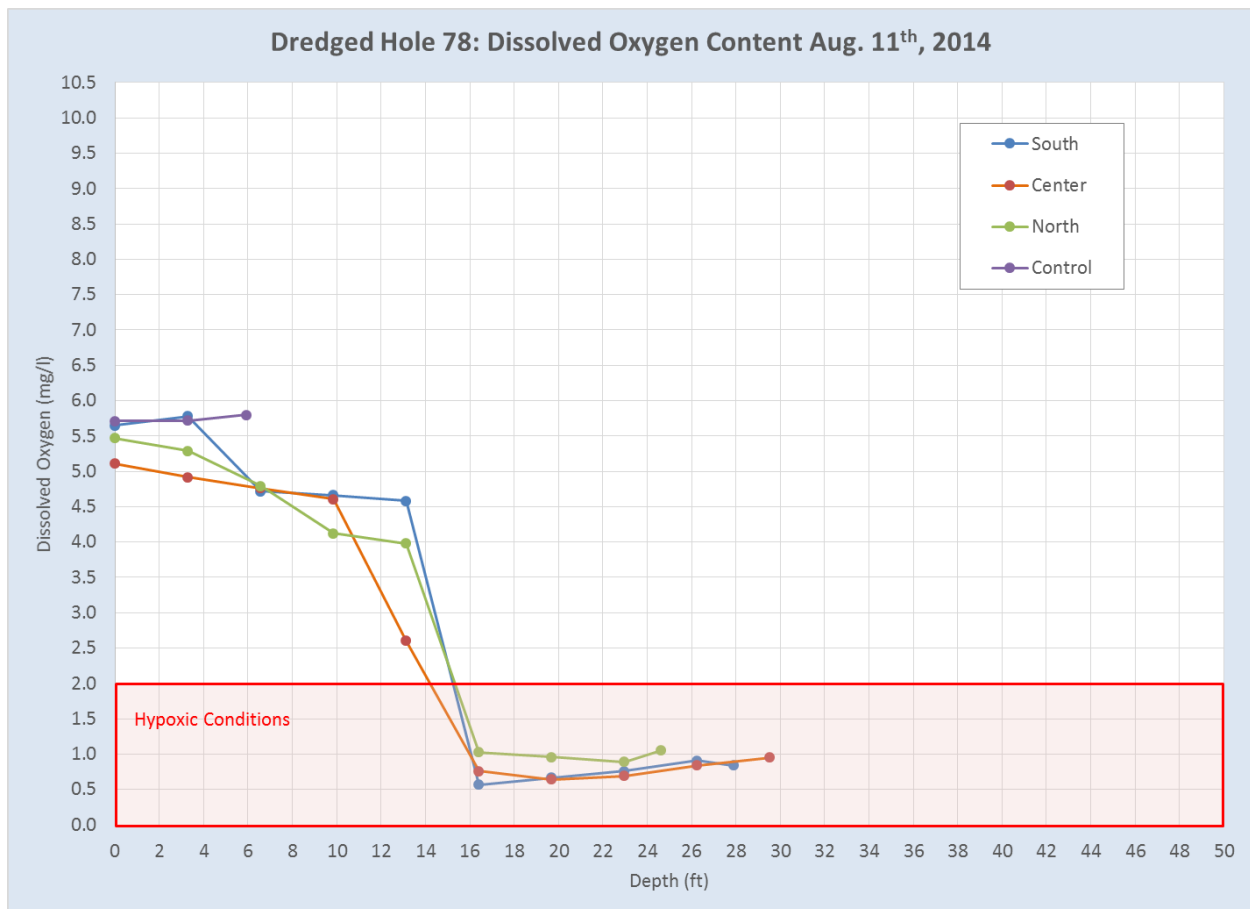
Hypoxic conditions were documented at Dredged Hole 78 during a water quality survey on August 11, 2014. All three sample locations within the feature displayed uniform results, and the control location exhibited contrasting conditions. While dissolved oxygen began to decline at a depth of 3 feet in the three sample locations within the dredged hole, dissolved oxygen at the control location slightly increased. The water column in Dredged Hole 78 was markedly stratified, which was evident as dissolved oxygen, pH, and temperature decreasing sharply at a depth of ~13ft. Conversely, salinity began to rise at the 13ft depth mark by 1ppt from ~29.9ppt to ~31ppt. Hypoxia occurred between depths of ~15ft to the bottom of the feature (~30ft) with the lowest recorded dissolved oxygen content nearing anoxia (0.84 mg/l). Temperature decreased from near 77°F (25°C) at the surface to near 64°F (18°C) at the bottom of the hole. Additionally, pH decreased from 7.7 at the surface to 6.8 at the bottom of the feature.

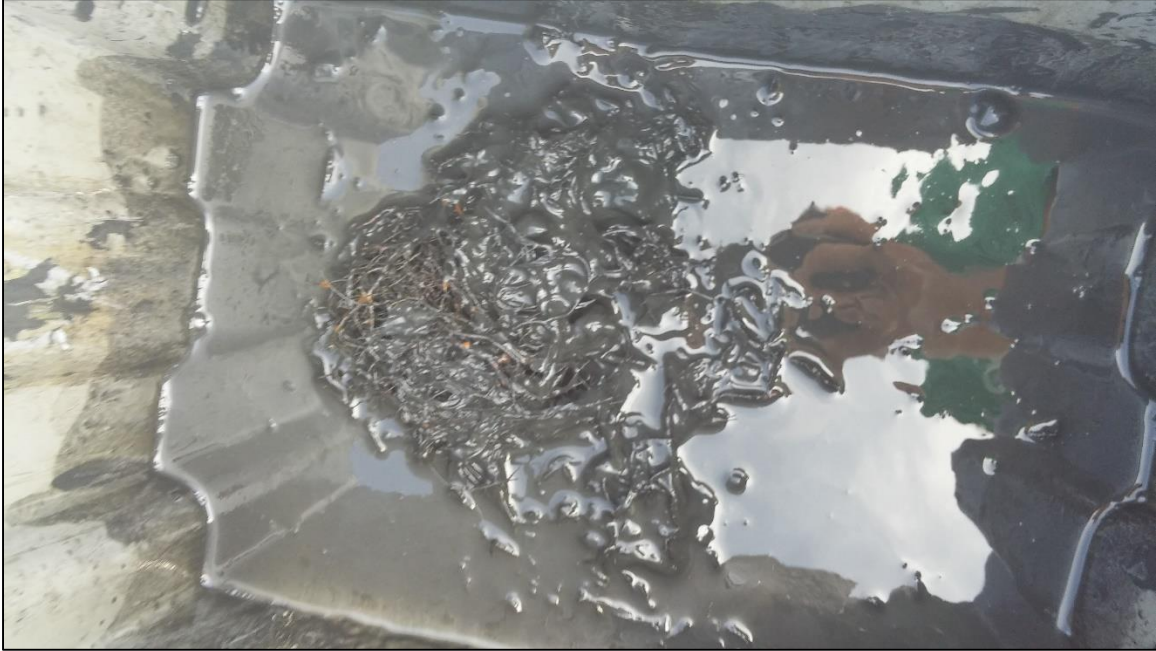
All three benthic grab samples from Dredged Hole 78 had consistent findings during an August 11, 2014 field visit. Samples within the feature were azoic and consisted of dark grey silt with some black stained detritus and had a distinct sulfur odor. The grab sample at the control location differed from samples within the dredged hole. The control sample contained grey sandy silt with some shell fragments and contained the macroalgae, (*false agardhiella*).

Figure 16, The control sample for Dredged Hole 78 consisted of dark grey sandy silt and shell fragments, and contained macroalgae.

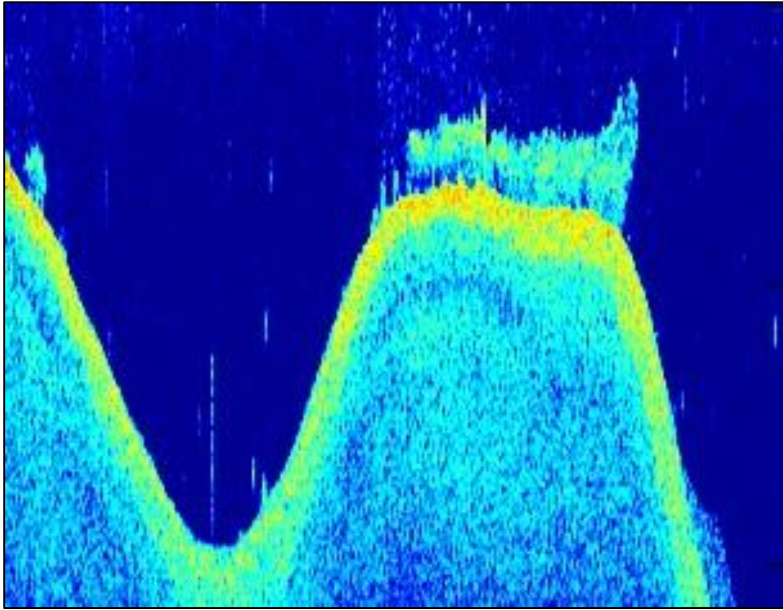
A survey to map SAV was conducted using SAVEWS Jr. on September 12, 2014 which found an absence of SAV within 328ft (100m) of Dredged Hole 78. Large areas were covered by macroalgae which were below the 0.5ft (0.15m) canopy height threshold set for the detection of SAV. There were several instances where SAV were falsely detected due to canopy heights of macroalgae greater than 0.5ft (0.15cm). These occurrences of SAV we deemed false by visual inspection of the echogram and analysis of drop camera video in the vicinity of the readings. Analyzing the echogram, the false SAV occurrences exhibited weaker acoustic reflectivity (indicated by light blue) and in most instances lacked a continuous vertical echo return between the bottom and canopy (Figure 17 and Figure 18). When compared to echograms of known SAV at the control site

Figure 18, A closer view of ping numbers 3300 through 4500 from the echogram in Figure 17 without canopy and bottom symbolized. In the area on top of the hump had several false SAV canopy detections. These detections were deemed false due to the echo return (non-continuous from the top of the canopy to the bottom as it would be if SAV were present). Video from a drop camera near this area confirms the interpretation of the echogram.

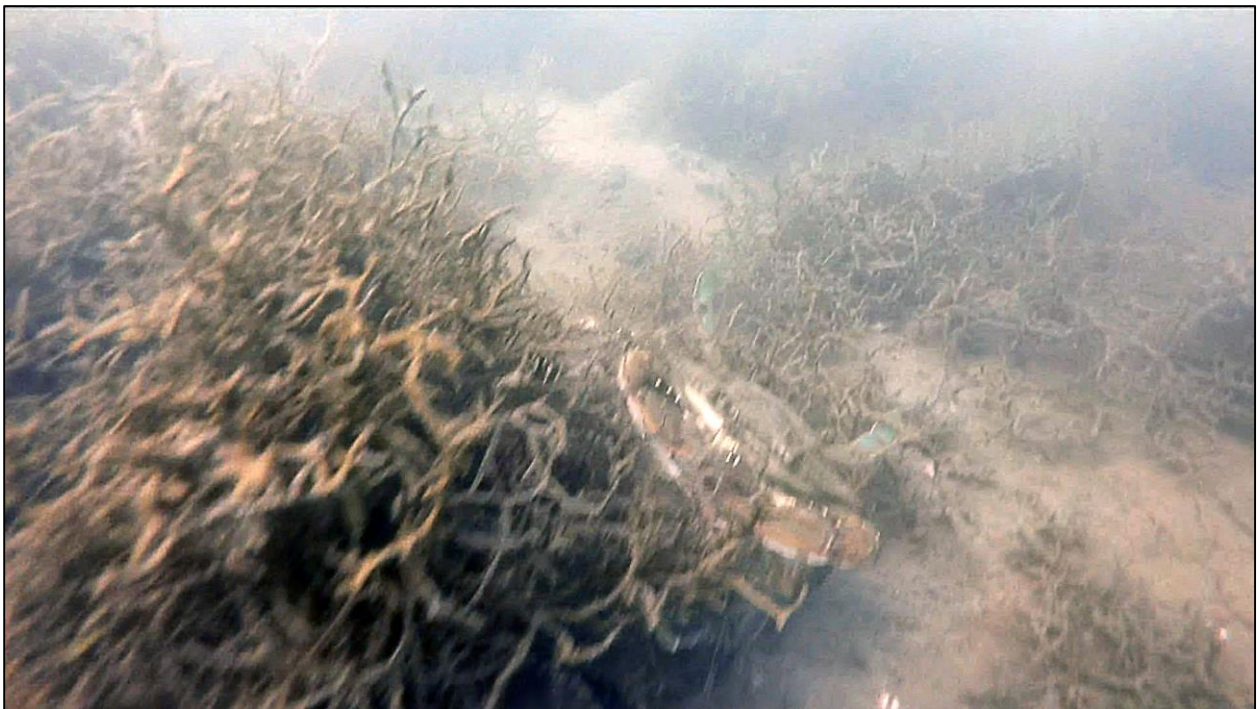
Figure 19, Macroalgae and a blue claw crab can be seen in an image from drop camera video within 100m of Dredged Hole 78.

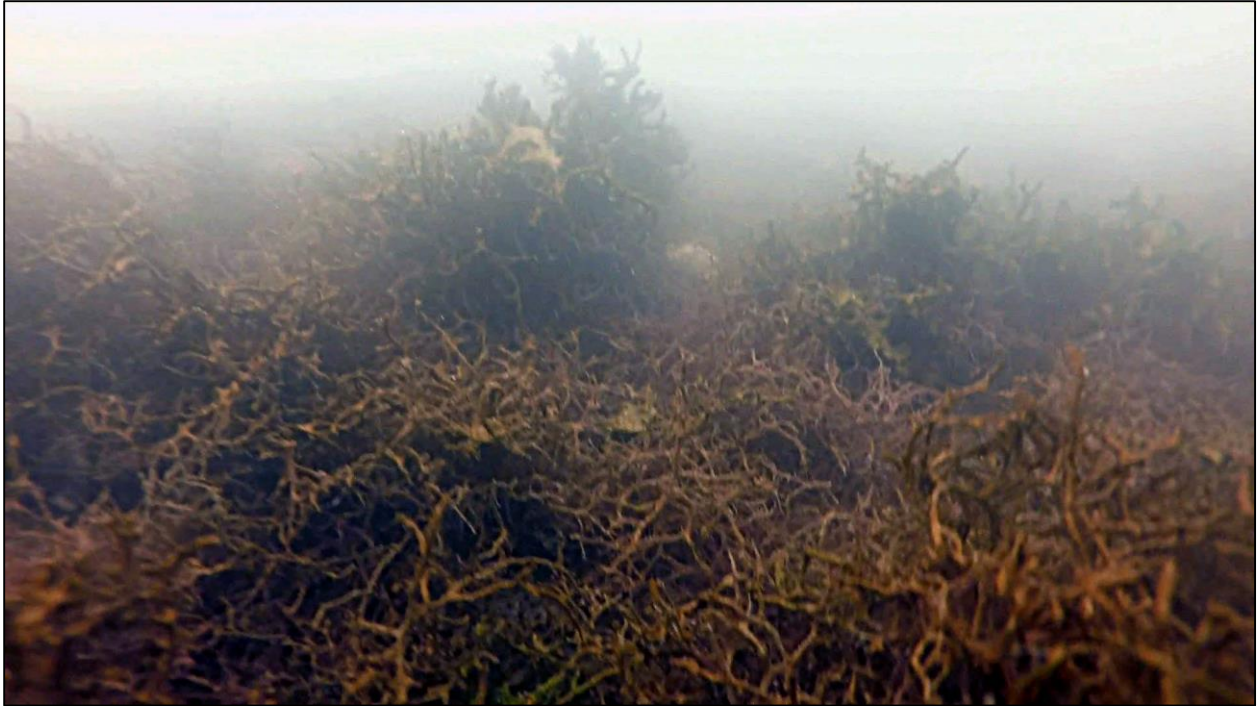
Figure 20, Dense macroalgae can be seen in an image from drop camera video within 100m of Dredged Hole 78.

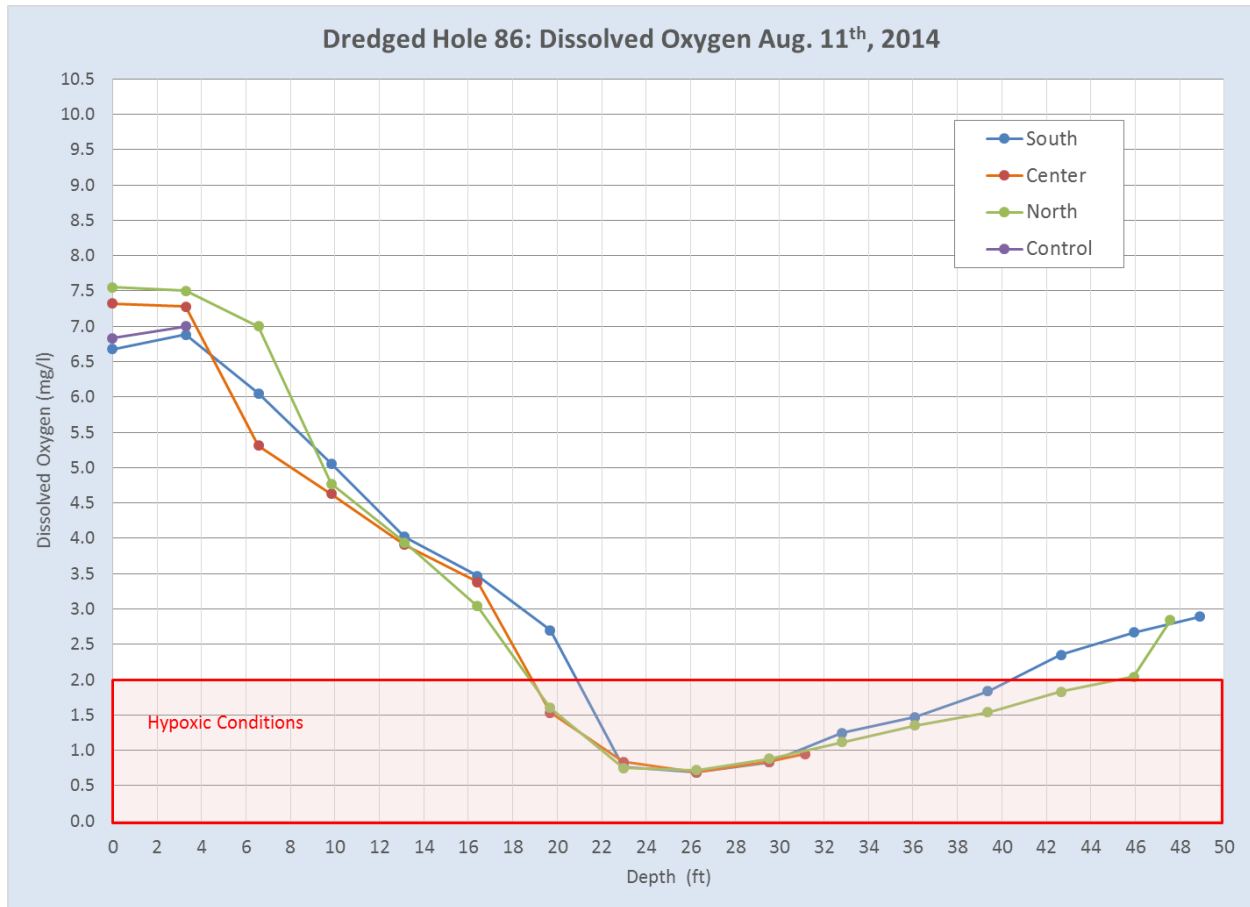
During an August 11, 2014 water quality survey Dredged Hole 86 was found to have degraded water quality with hypoxia beginning at depths of 19ft (5m). Dissolved oxygen content, pH, and water temperature began to decline below water depths of 3ft (0.9m). Dissolved oxygen content fell sharply to depths of 26ft (8m) where the lowest oxygen content (0.69mg/l) was recorded and began to gradually increase to 2.89mg/l at the bottom of the hole. This gradual increase of dissolved oxygen coincided with a drastic decrease of water temperature, the surface water temperature steadily decreased from 80°F to 72°F (27°C to 22°C) at 26ft (8m) where it then sharply fell to 52°F (11°C) at the bottom of the dredged hole. Additionally, pH progressively dropped from 7.8 at the surface to 6.8 at the bottom. Salinity increased by 1ppt from a surface reading of 29.1 to a bottom reading 30.1 with the sharpest gain seen between depths of 19ft and 26ft (5.8m and 8m).

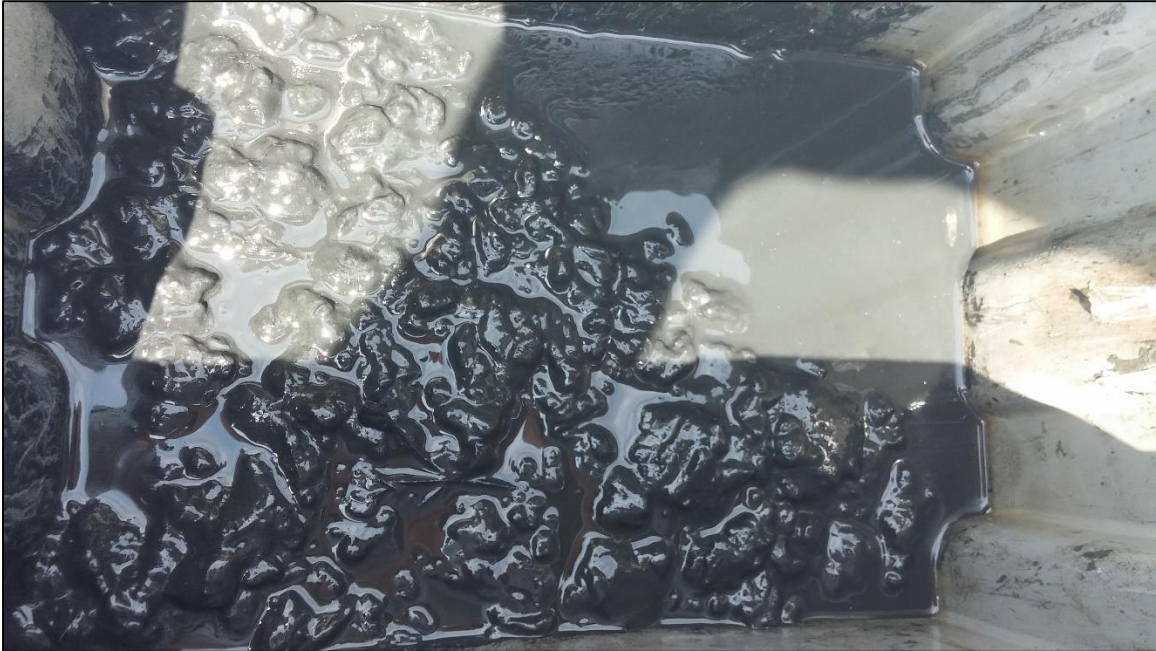
All three benthic grab samples from Dredged Hole 86 had consistent findings during an August 11, 2014 field visit. Samples within the feature were azoic and consisted of black silt and had a distinct sulfur odor. The grab sample at the control location differed from samples within the dredged hole. The control sample contained grey silt and sand.

Figure 23, Grab sample taken in the southwest portion of Dredged Hole 86 at a depth of 55ft.

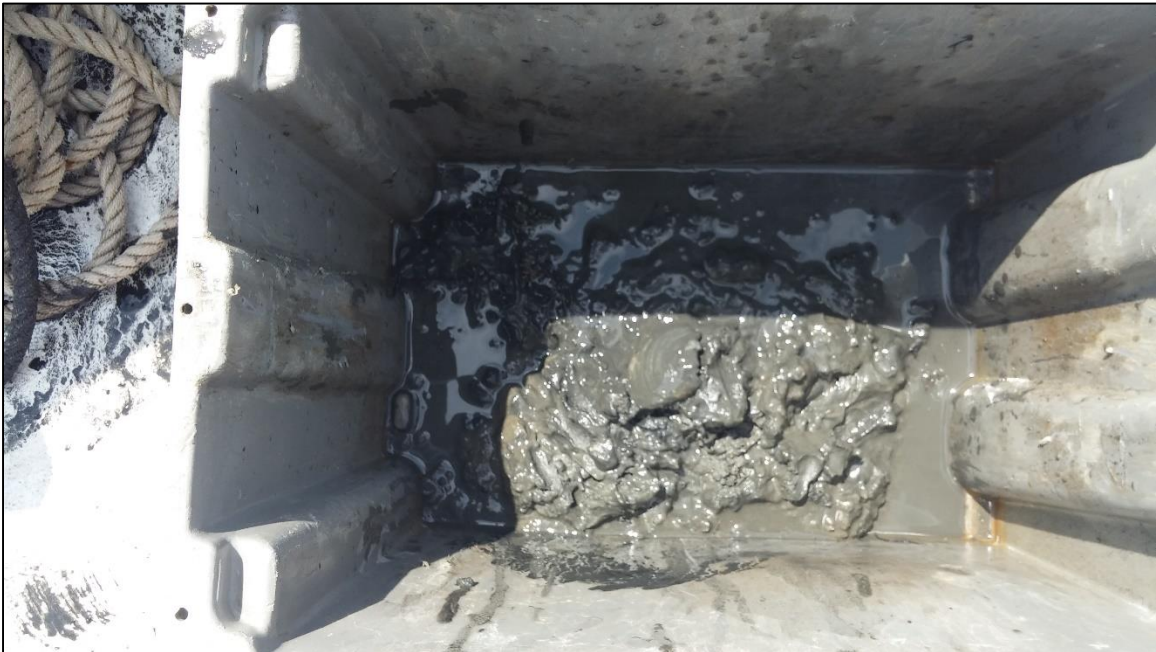
Figure 24, Grab sample taken at the control location in the vicinity of Dredged Hole 86.

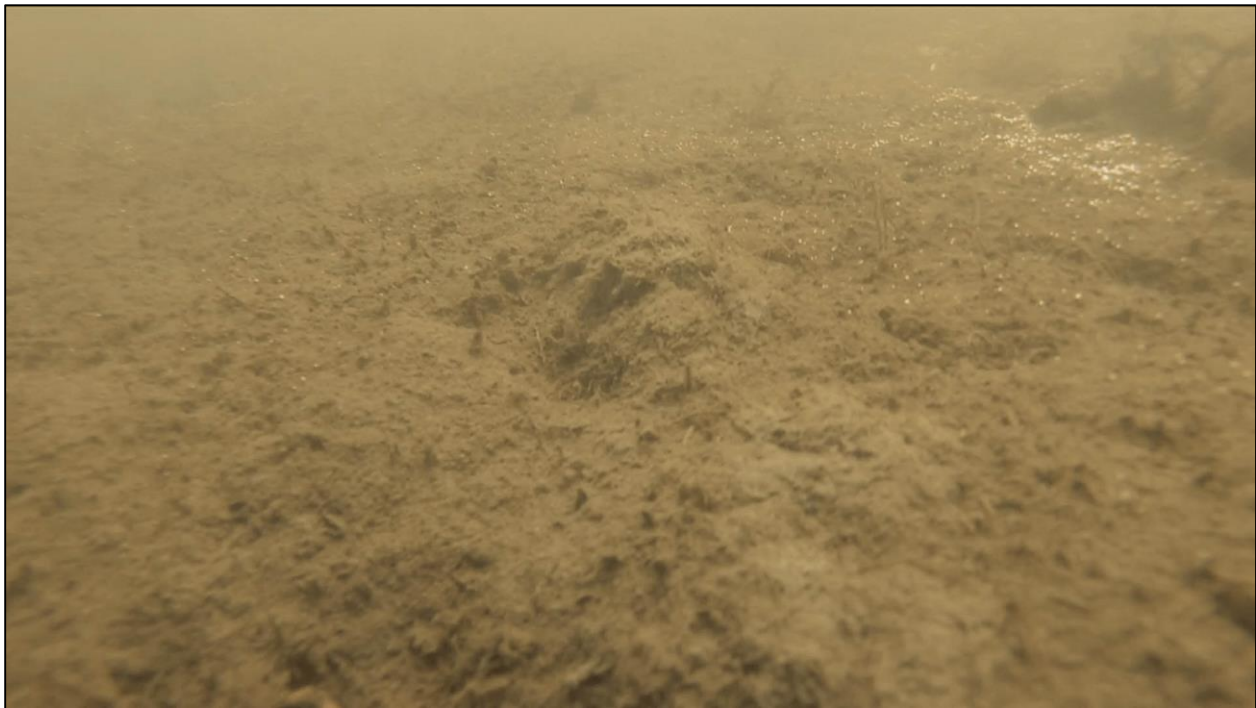
Figure 26, Barren bay floor within 328ft (100m) of Dredged Hole 86.

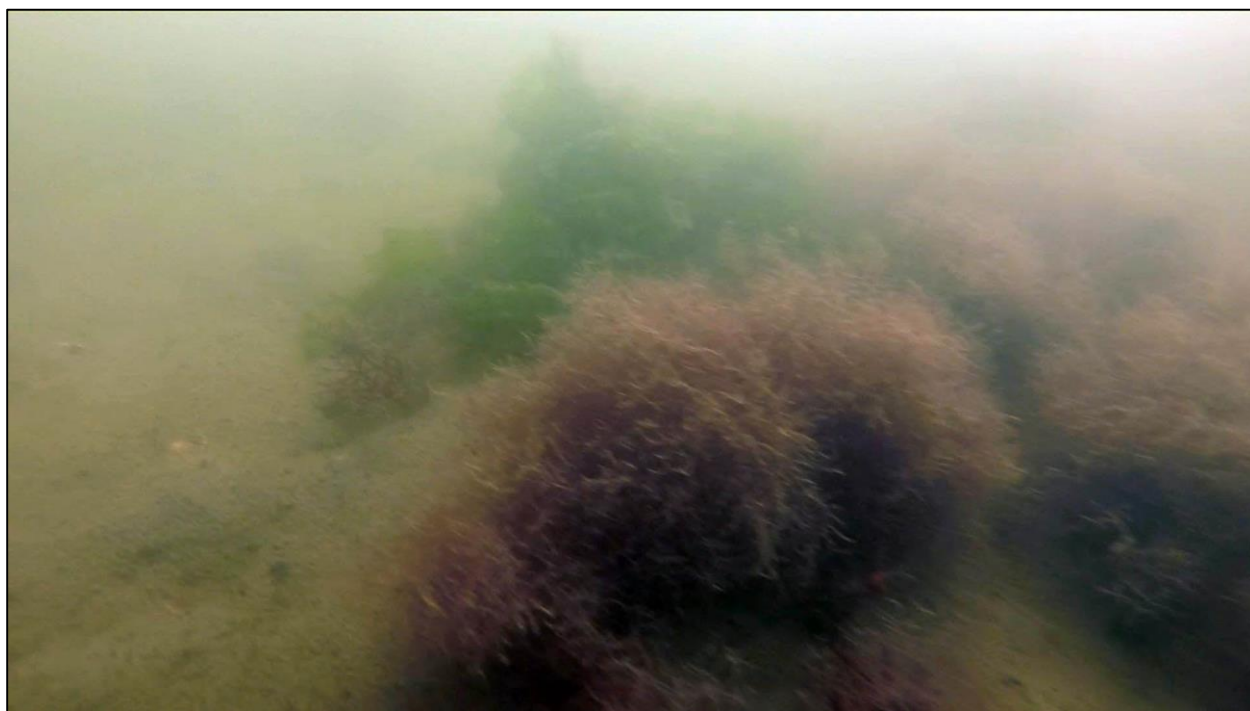
Figure 27, An image from a drop camera shows macroalgae within 328ft (100m) of Dredged Hole 86.

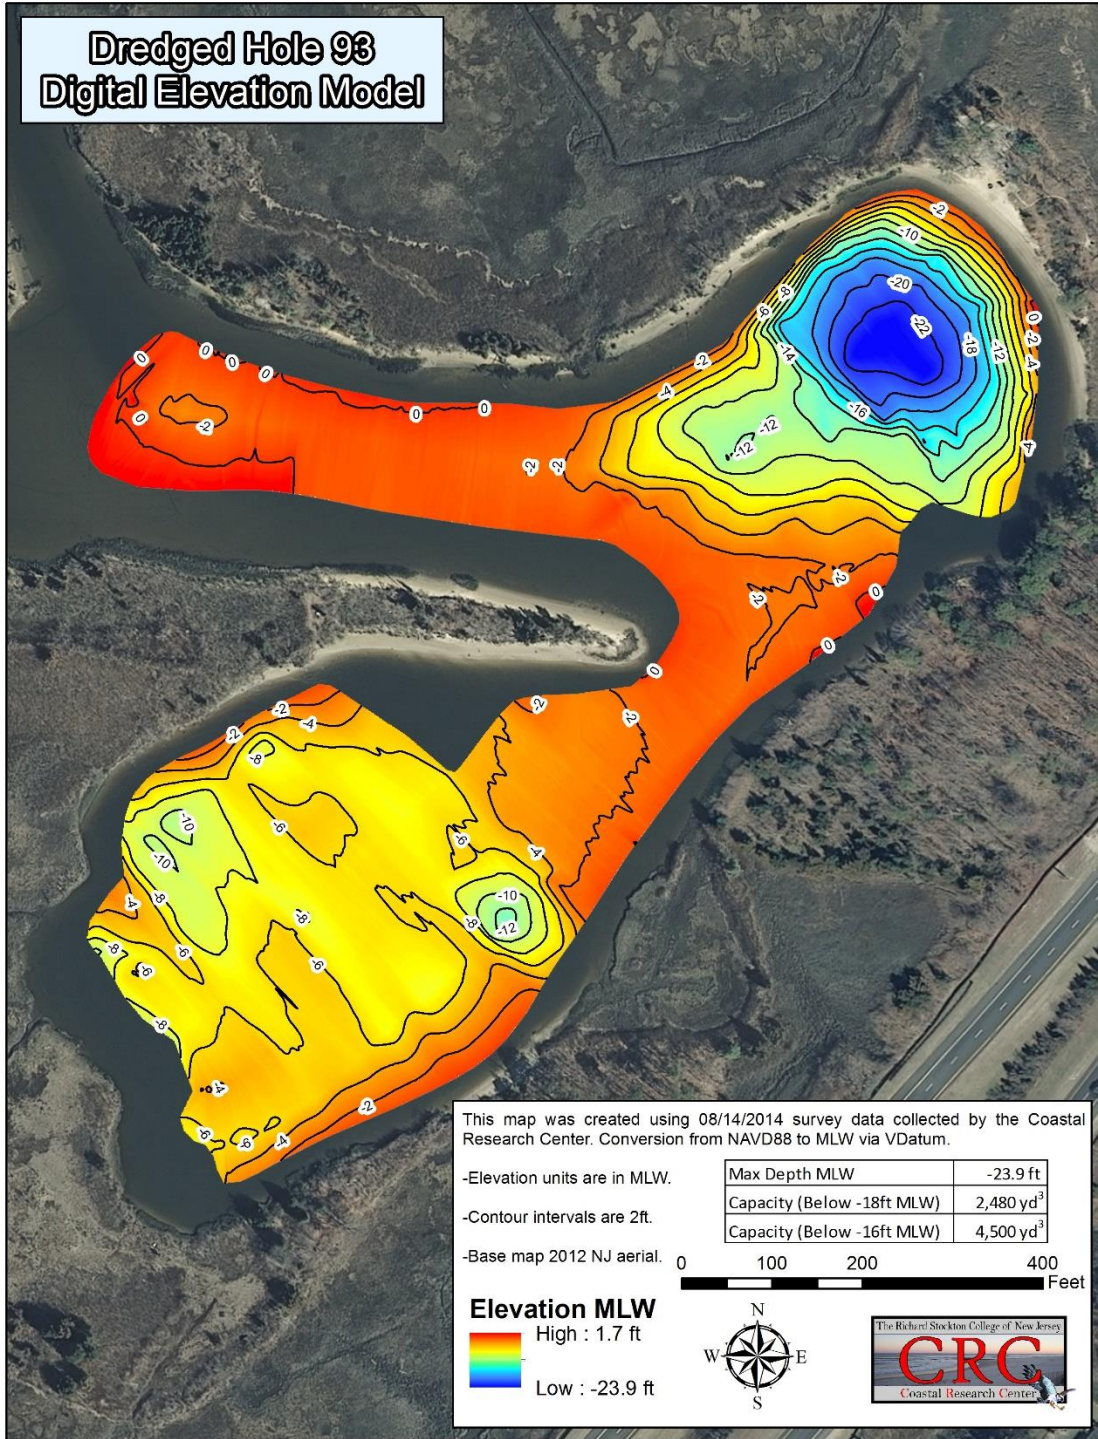
Figure 29

Bathymetric data collected by the CRC on August 14, 2014 was used to create the DEM for Dredged Hole 93 and the surrounding area (Figure 29). Dredged Hole 93 reaches depths of -23.9ft (-7.2m) MLW, however only the northern portion of the feature reaches depths greater than -18ft (-5.4m) MLW while the southern portion averages near -8ft (-2.4m) MLW. This feature is completely surrounded by saltmarsh with only a single channel connecting to Patcong Creek.

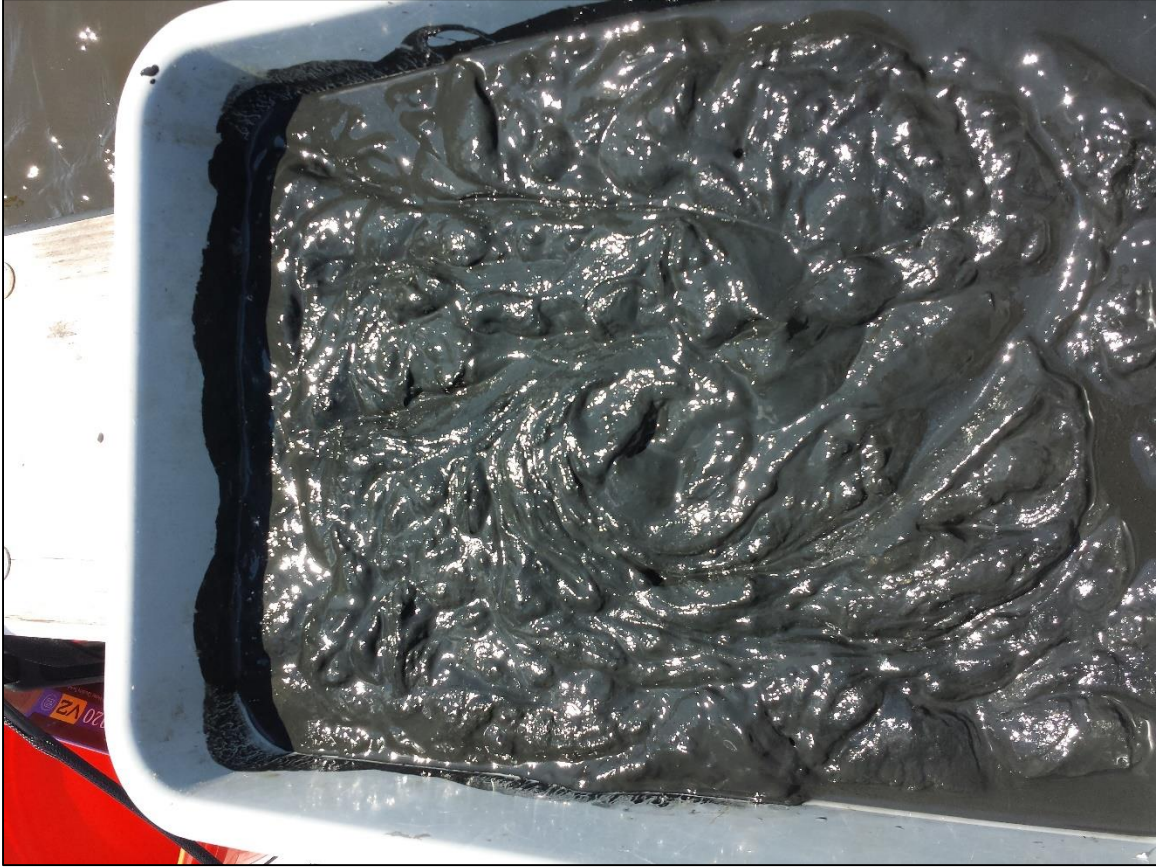
During an August 11, 2014 field visit of Dredged Hole 93 all three benthic grab samples within the feature were azoic and had a distinct sulfur odor. Samples from within the feature consisted of black or dark grey silt and only the northern sample contained some detritus. The grab sample at the control location differed from the samples within the dredged hole. The control sample contained dark brown silt with some shells and detritus.

Figure 30, The grab sample from the center of Dredged Hole 93 consisted of dark grey silt with some detritus, and black or dark grey silt.

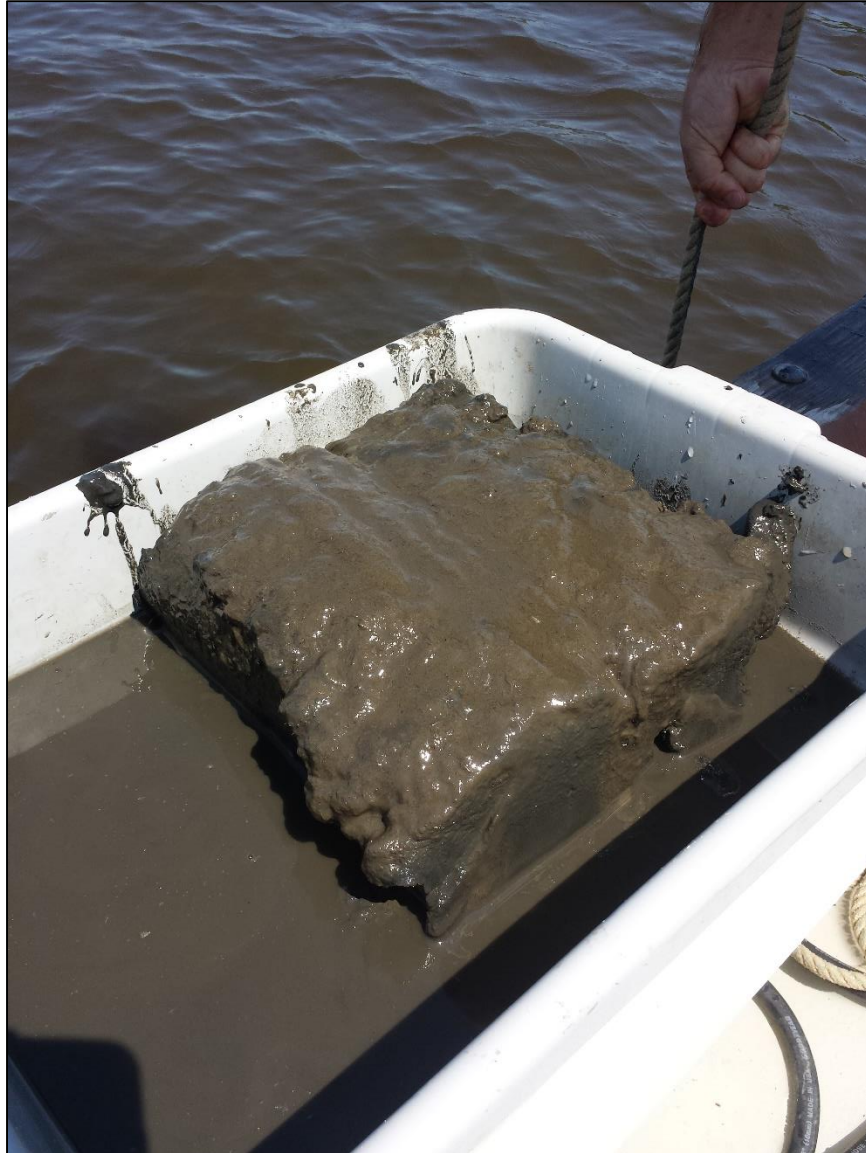
Figure 31, The benthic grab sample from the shallow control location consisted of dark brown silt with some shells and detritus.

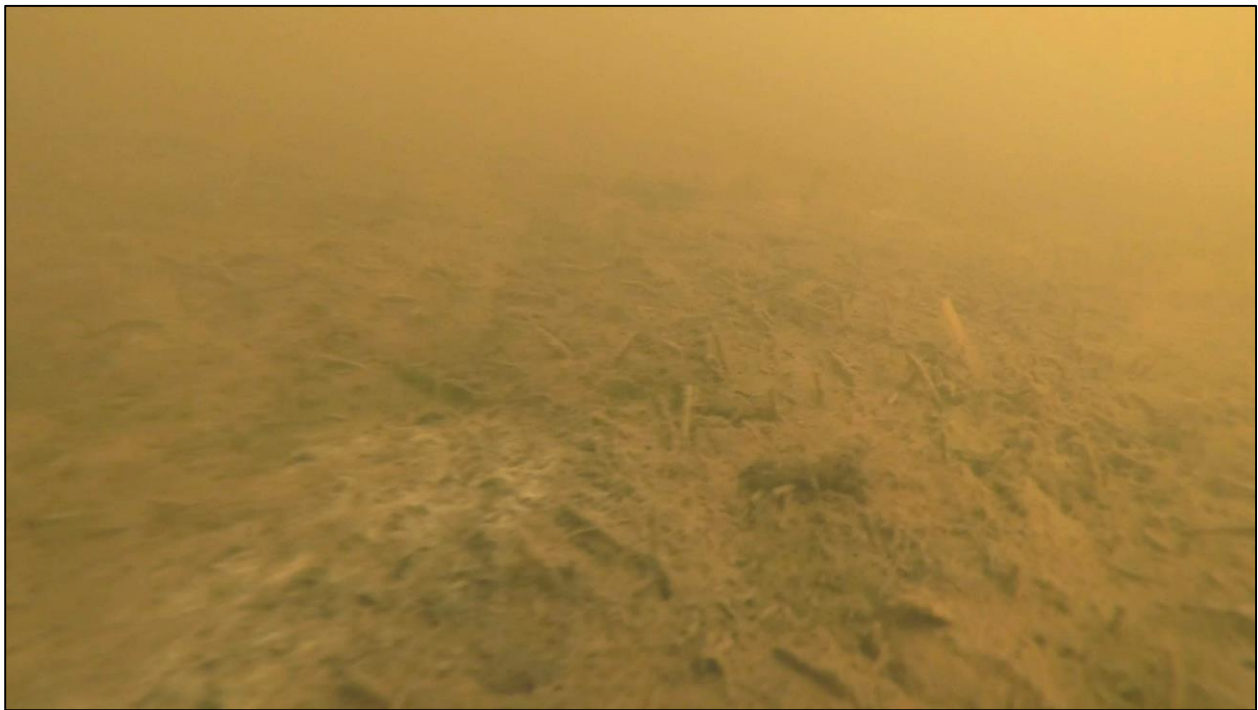
The area around Dredged Hole 93 was nearly completely barren and lacking of SAV, as well as macroalgae during a September 10, 2014 survey utilizing SAVEWS Jr. There were only two instances where SAVEWS falsely identified SAV due to improper bottom tracking where the bay floor was highly irregular. These occurrences of SAV were clearly false when visually inspecting the echograms (Figure 32).

Figure 33, An image from video taken during the SAV survey representing the typical bay floor within 328ft (100m) of Dredged Hole 93. SAV and macroalgae are absent and detritus litters the bay floor.

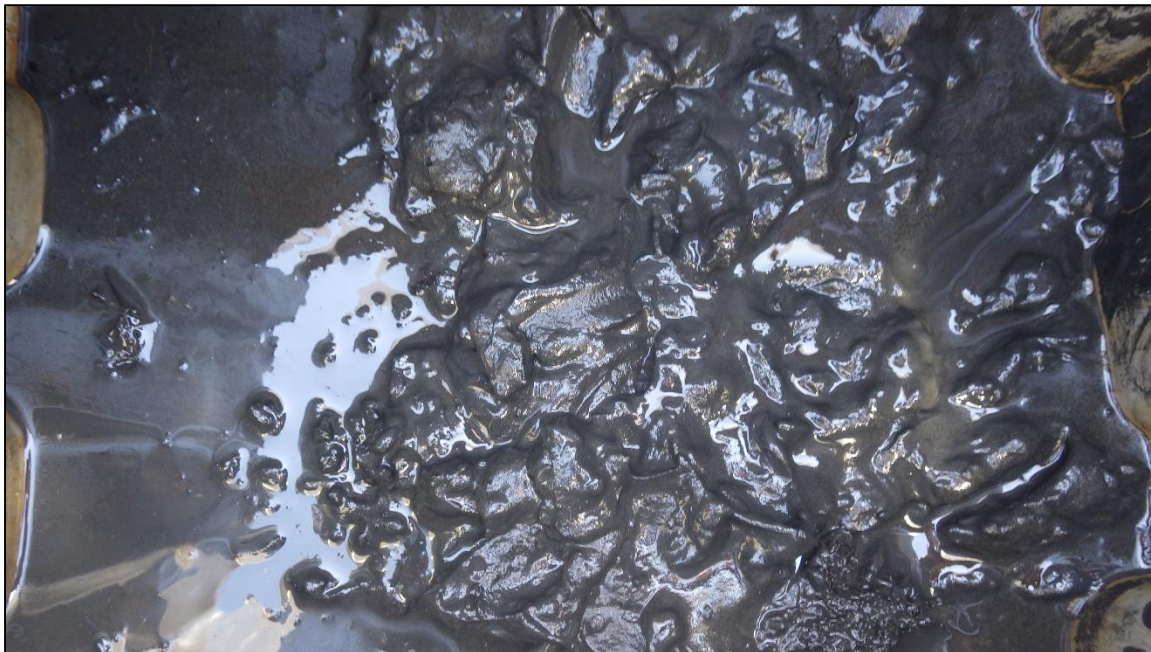
Water quality was sampled in Dredged Hole 55 on February 2014 and July 2014 and a benthic grab sample was taken along with the July water quality sample. Dissolved oxygen content was measured at 13.4mg/l and 5.08mg/l on February 6, 2014 and July 1, 2014, respectively. The benthic grab sample revealed black silt and plant debris with no living organisms.

Figure 40, A benthic grab sample from Dredged Hole 55 consisted of black silt and plant debris with no living organisms.

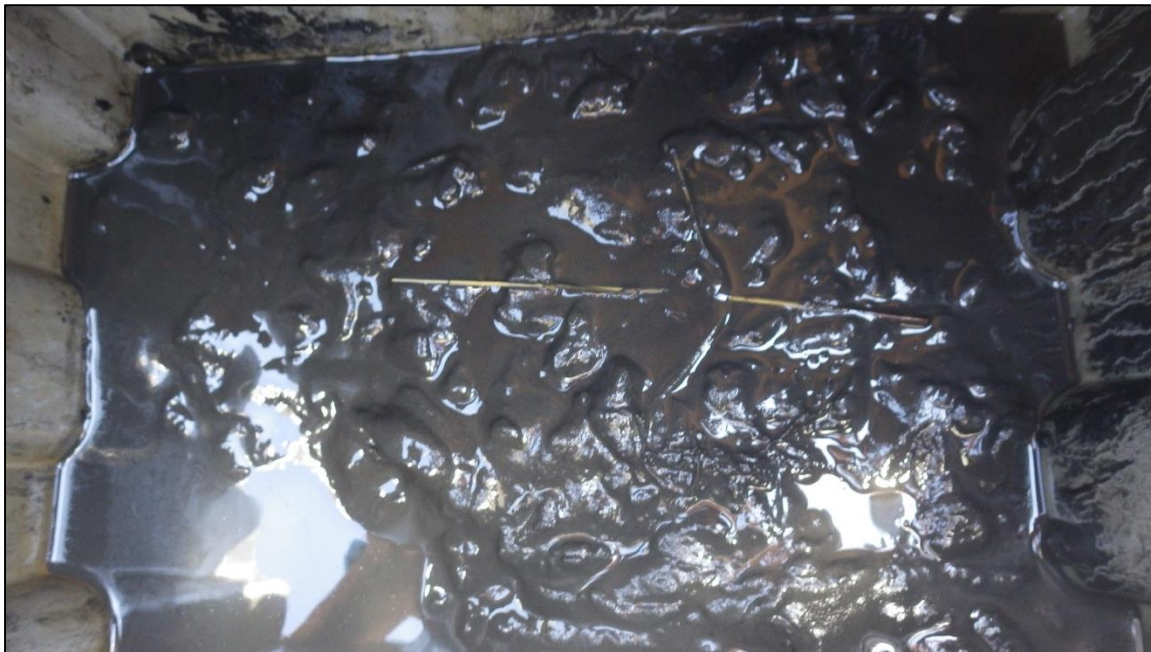
A water quality sample was taken in Dredged Hole 59 in December 2013 and July 2014 and a benthic grab sample taken along with the July water quality sample. Dissolved oxygen content was measured at 13.03mg/l and 5.75mg/l on December 17, 2013 and July 1, 2014, respectively. The benthic grab sample revealed black/grey silt with some fine sand and plant debris with no living organisms.

Figure 43, A benthic grab sample from Dredged Hole 59 consisted of black/grey silt with some fine sand and plant debris with no living organisms.
