State Channel Maintenance Capacity

FINAL REPORT

January 2015

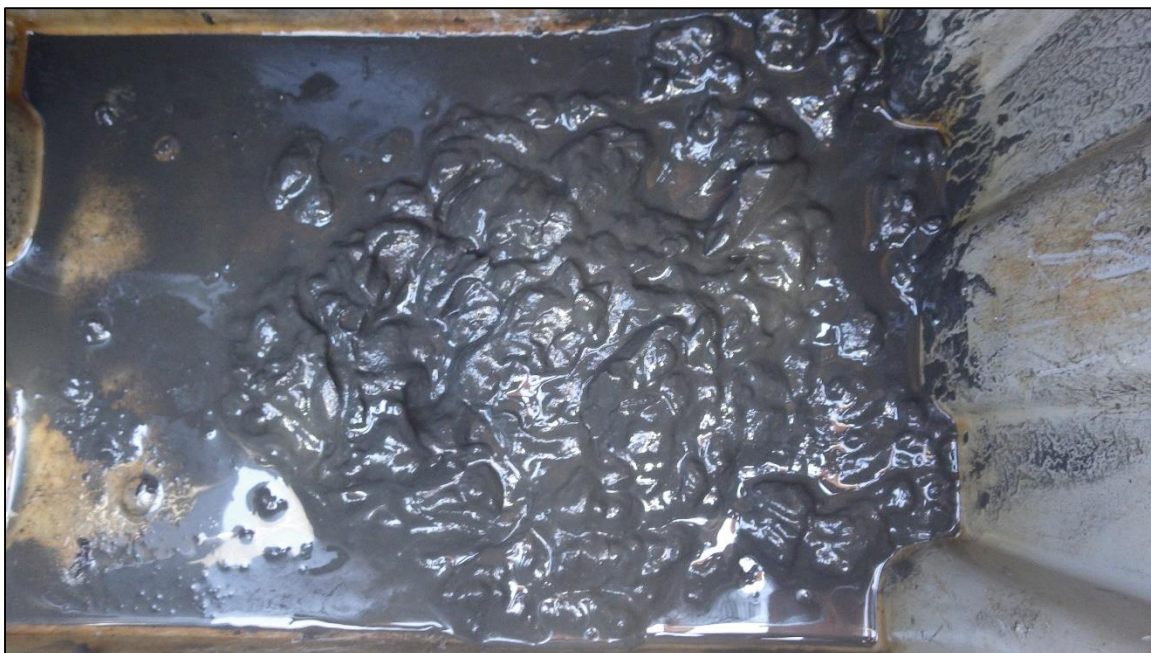
A water quality sample was taken in Dredged Hole 61 in January 2014 and in July 2014 and a benthic grab sample taken along with the July water quality sample. Dissolved oxygen content was measured at 13.5mg/l and 6.05mg/l on January 13, 2014 and July 1, 2014, respectively. The benthic grab sample revealed black silt with no living organisms.

Figure 46, A benthic grab sample from Dredged Hole 61 consisted of black silt with no living organisms.

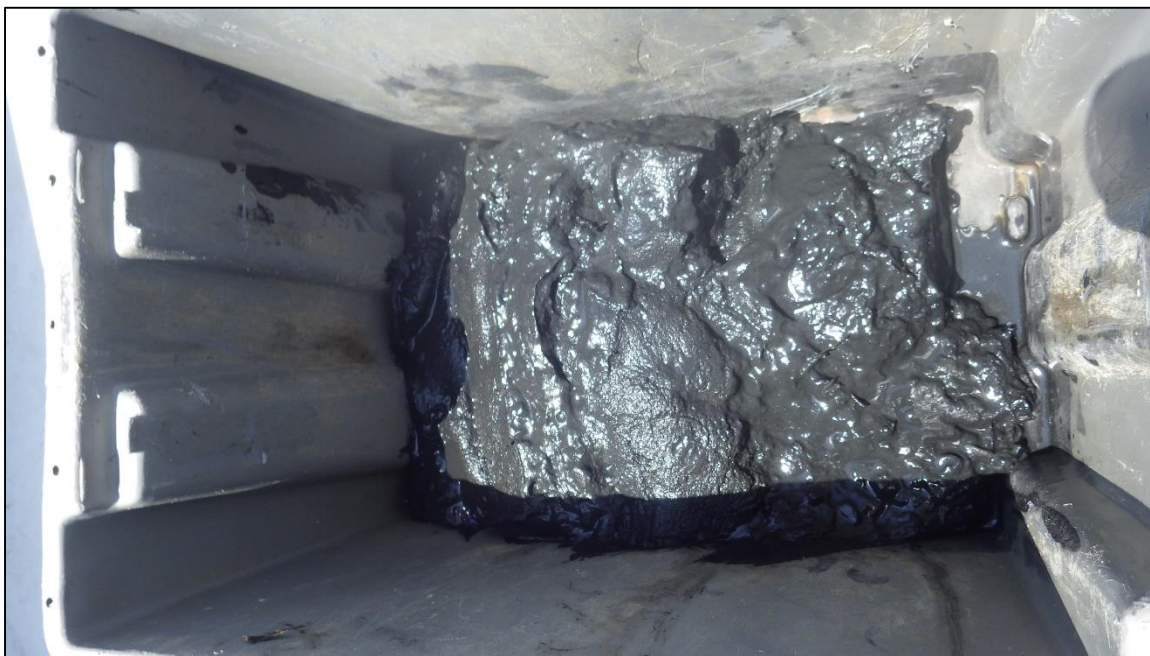
A water quality sample was taken in Dredged Hole 83 in October 2013 and in June 2014 and a benthic grab sample was taken along with the June water quality sample. Dissolved oxygen content was measured at 11.7mg/l and 6.3mg/l on a January 20, 2014 and June 30, 2014, respectively. The benthic grab sample consisted of black silt with small amounts of sand and no living organisms.

Figure 49, A benthic grab sample from Dredged Hole 83 consisted of black silt with small amounts of sand and no living organisms.

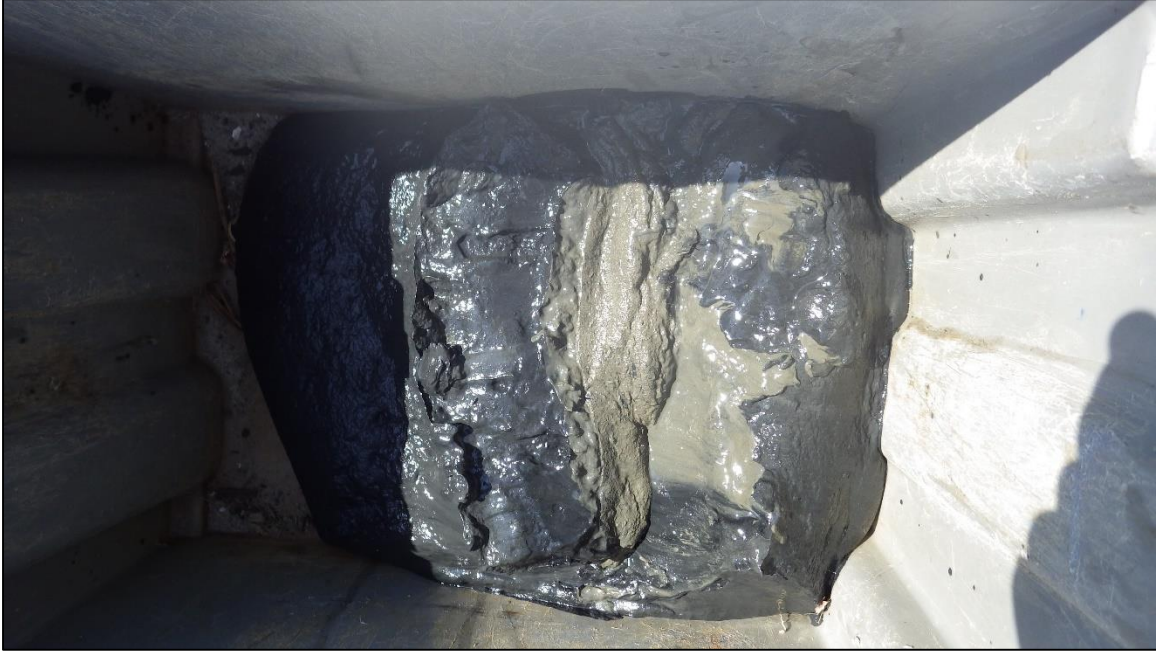
A water quality sample was taken in Dredged Hole 85 in October 2013 and in June 2014 and a benthic grab sample taken along with the June water quality sample. Dissolved oxygen content was measured at 8.5mg/l and 4.8mg/l on October 26, 2013 and June 30, 2014, respectively. The benthic grab sample consisted of black/grey silt with small amounts of sand and no living organisms.

Figure 52, A benthic grab sample from Dredged Hole 85 consisted of black/grey silt with small amounts of sand and no living organisms.

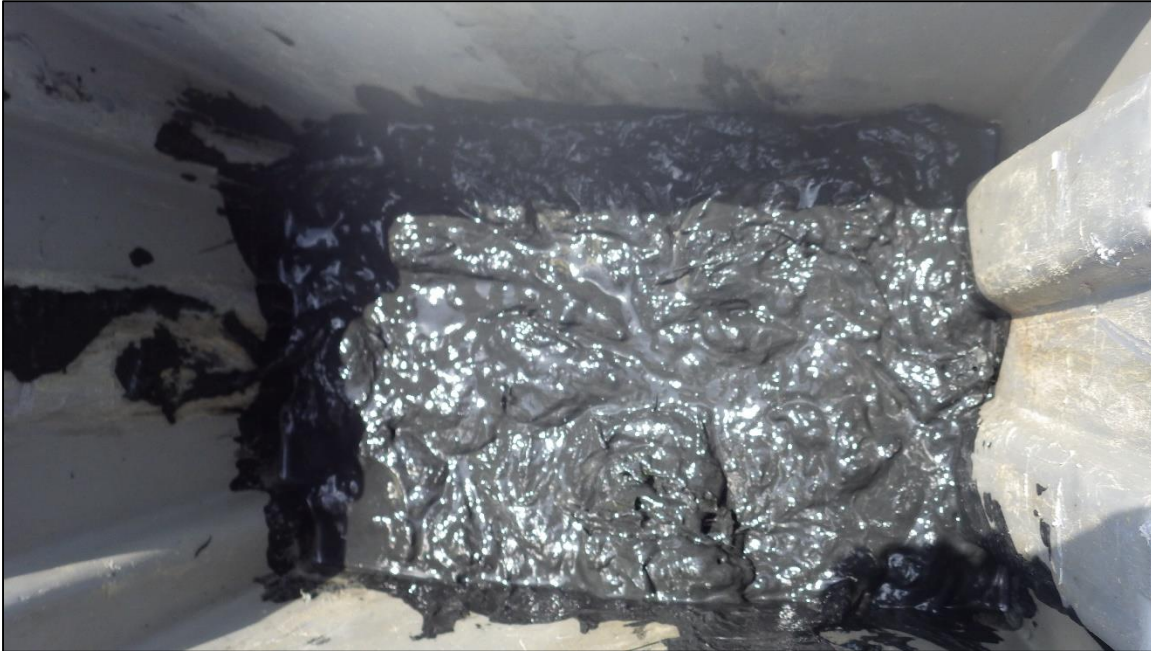
A water quality sample was taken in Dredged Hole 89 in February 2014 and in June 2014 and a benthic grab sample taken along with the June water quality sample. Dissolved oxygen content was measured at 11.6mg/l and 6.4mg/l on February 19, 2014 and June 30, 2014, respectively. The benthic grab sample consisted of black silt with plant debris and no living organisms.

Figure 55, A benthic grab sample from Dredged Hole 89 consisted of black silt with plant debris and no living organisms.

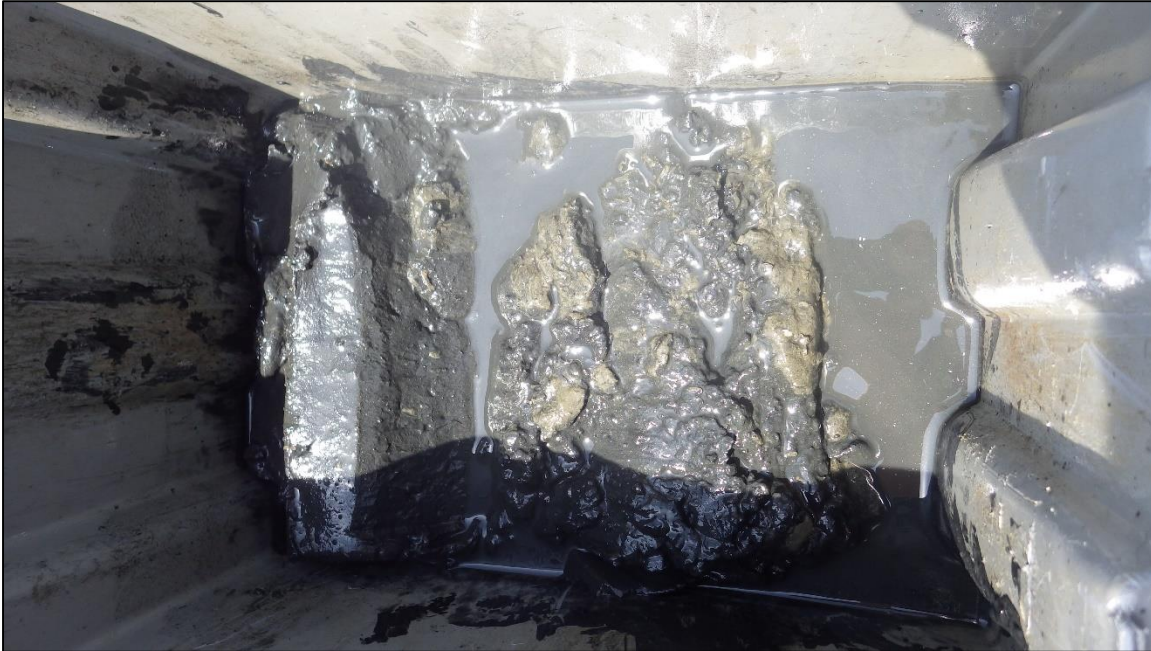
A water quality sample was taken in Dredged Hole 90 in February 2014 and in June 2014 and a benthic grab sample taken along with the June water quality sample. Dissolved oxygen content was measured at 11.5mg/l and 5.37mg/l on February 19, 2014 and June 30, 2014, respectively. The benthic grab sample consisted of black/grey silt with few shell fragments and no living organisms.

Figure 58, a benthic grab sample from Dredged Hole 90 consisted of black/grey silt with few shell fragments and no living organisms.

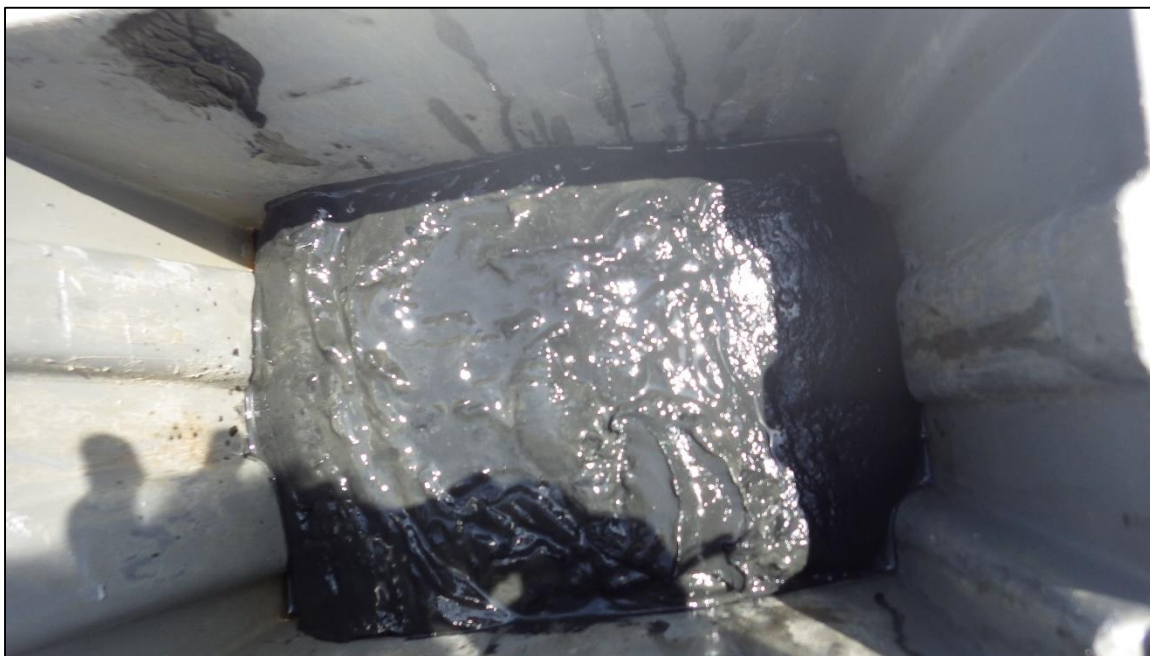
A water quality sample was taken in Dredged Hole 95 in November 2013 and in June 2014 and a benthic grab sample taken along with the June water quality sample. Dissolved oxygen content was measured at 7.4mg/l and 0.49mg/l on November 5, 2014 and June 30, 2014, respectively. The benthic grab sample consisted of black silt and no living organisms.

Figure 61, A benthic grab sample from Dredged Hole 95 consisted of black silt and no living organisms.

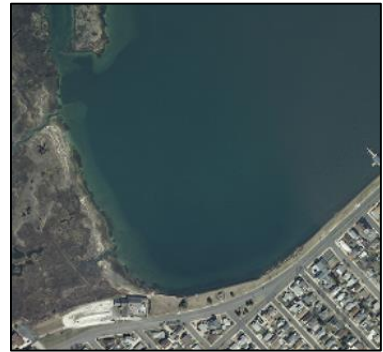
Figure 62, Dredged Hole 118 is located in the center of the above 2012 aerial imagery bordered by saltmarsh to the west and open bay waters to the north.

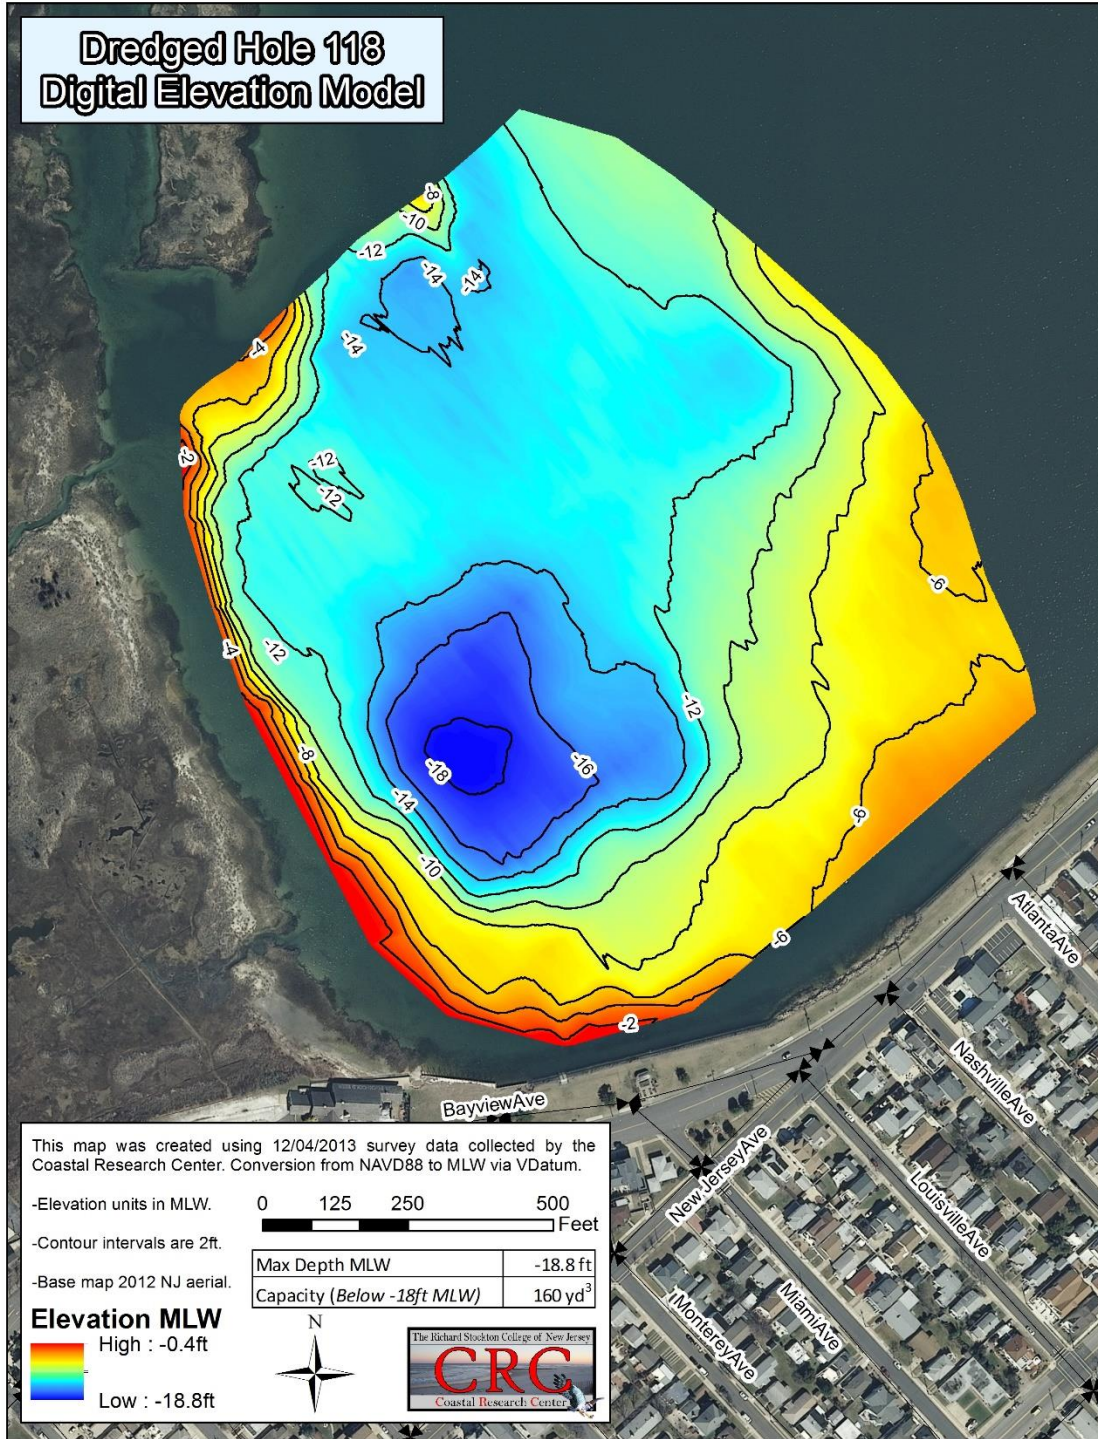
Figure 63

Bathymetric data collected by the CRC on December 4, 2014 was used to create the DEM for Dredged Hole 118 and the surrounding area (Figure 63). Dredged Hole 118 reached depths of -18.3ft (-5.5m) MLW. Deep bay waters (-14ft [-4.2m] MLW) border the feature to the north while the steep banks on the east side rise dramatically to the elevation of the saltmarsh.

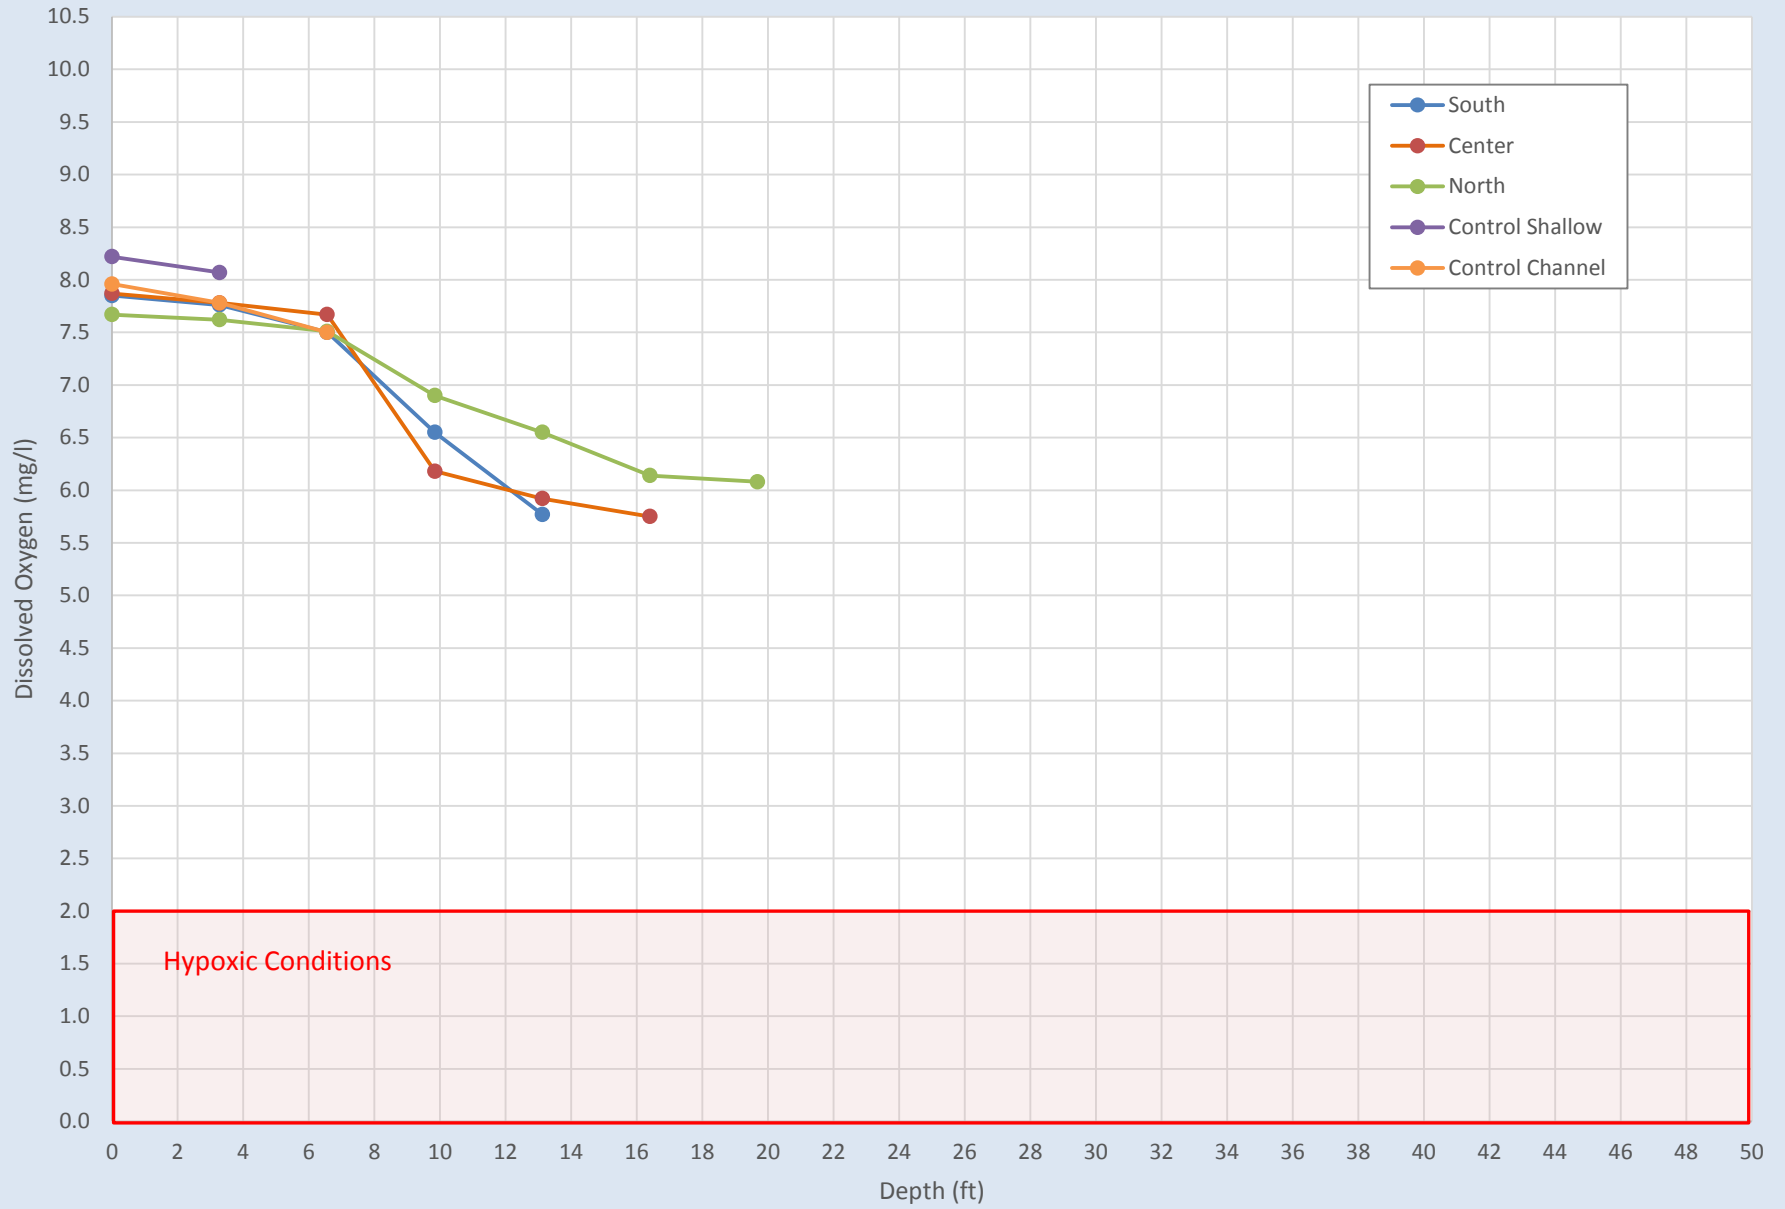
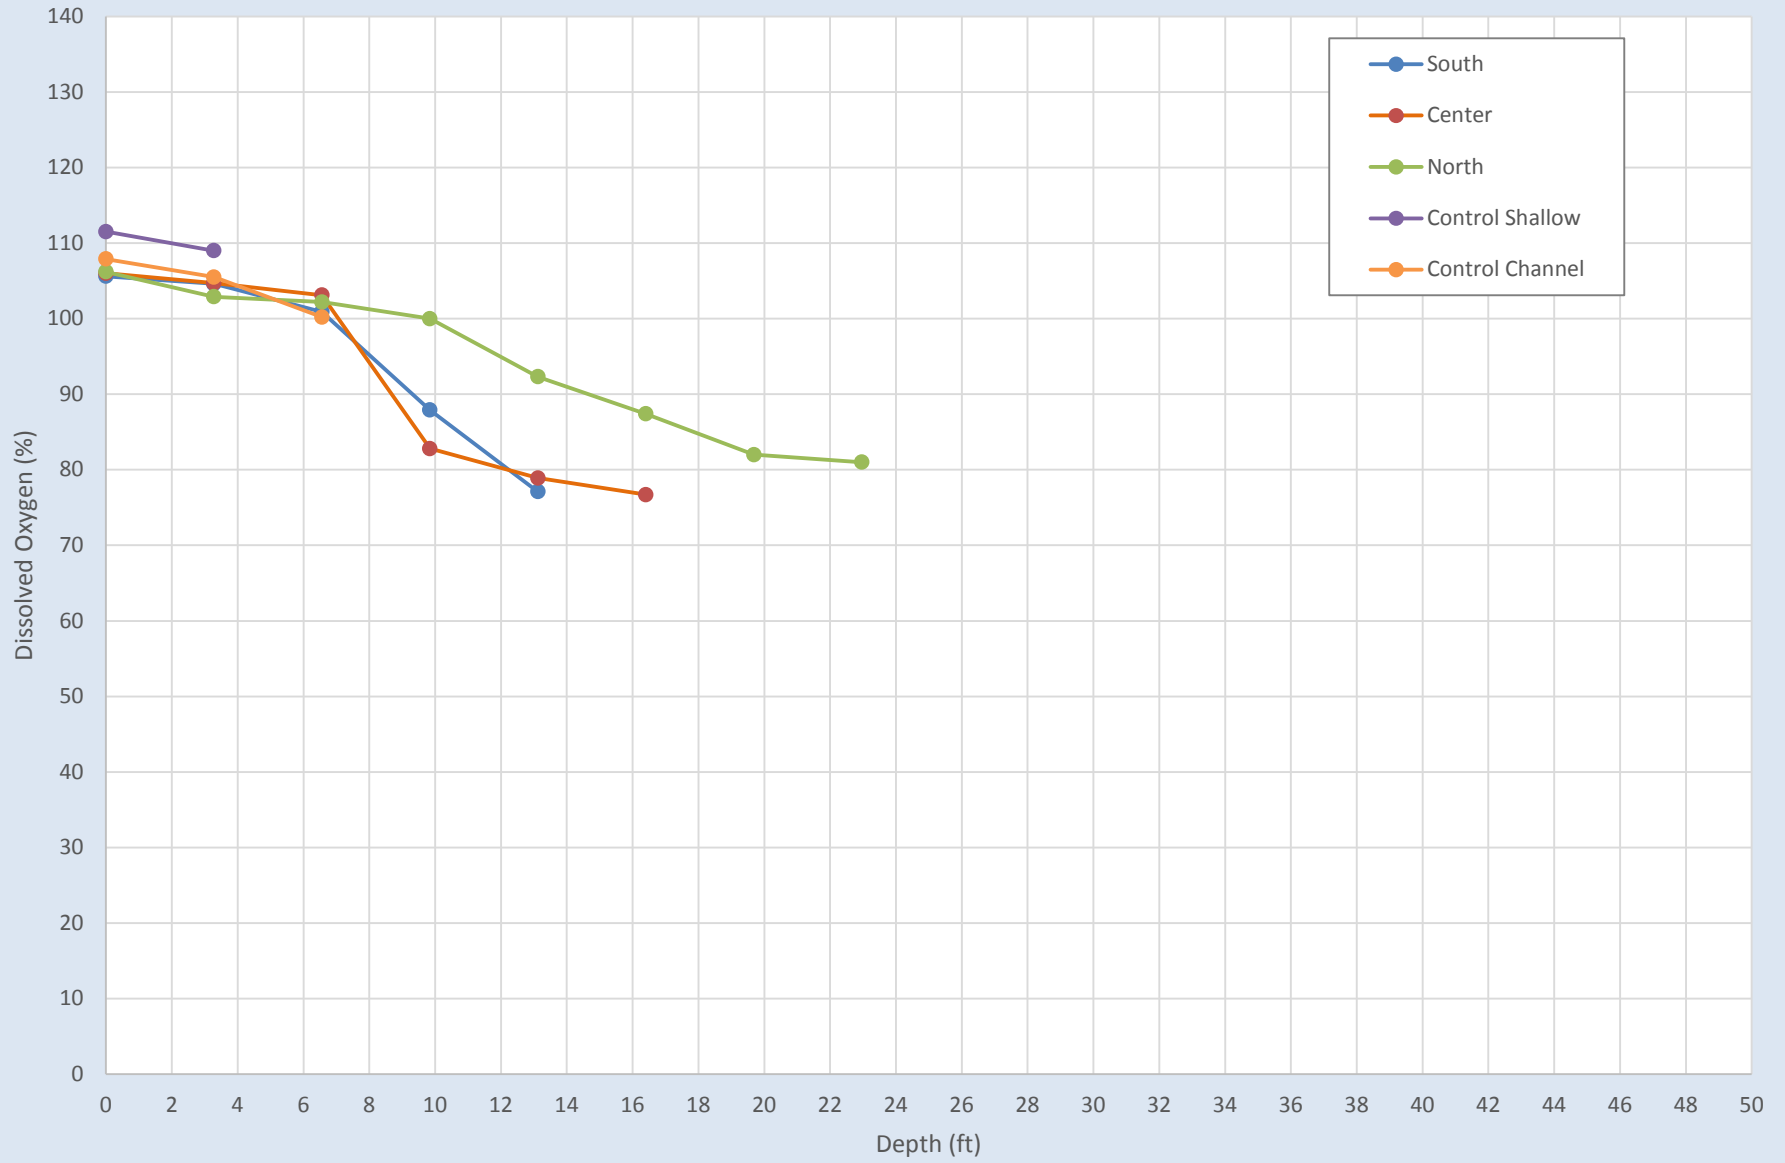
Dredged Hole 18: Dissolved Oxygen Content Aug. 7th, 2014

Black sandy mud with black stained plant debris few pebbles.

Hydraulic and mechanical placement methods are feasible from an engineering standpoint. Due to the shallow surrounding waterways, mechanical placement of dredged material will have a reduced production rate. Due to the capacity and relatively steep side slopes, OCC recommends hydraulic dredging with a discharge diffuser and silt curtain surrounding Dredged hole 18.

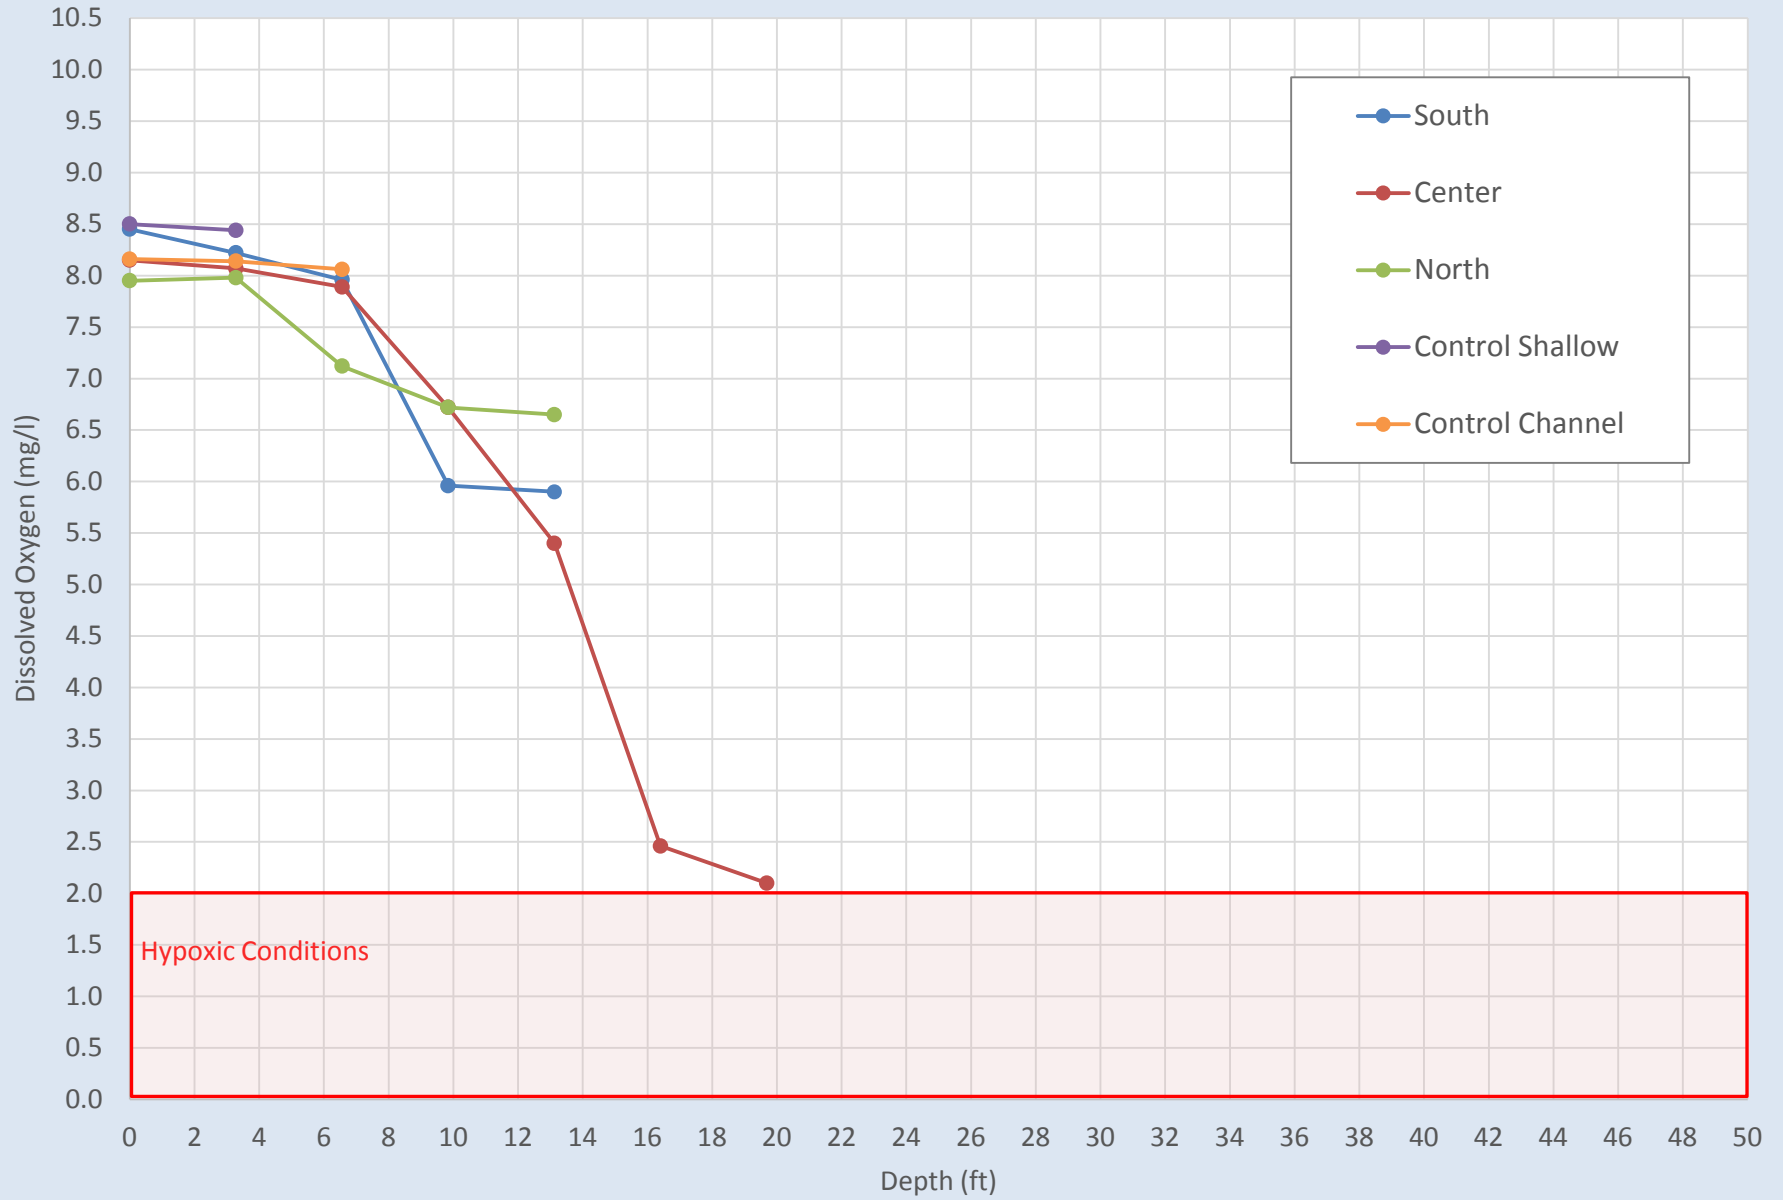
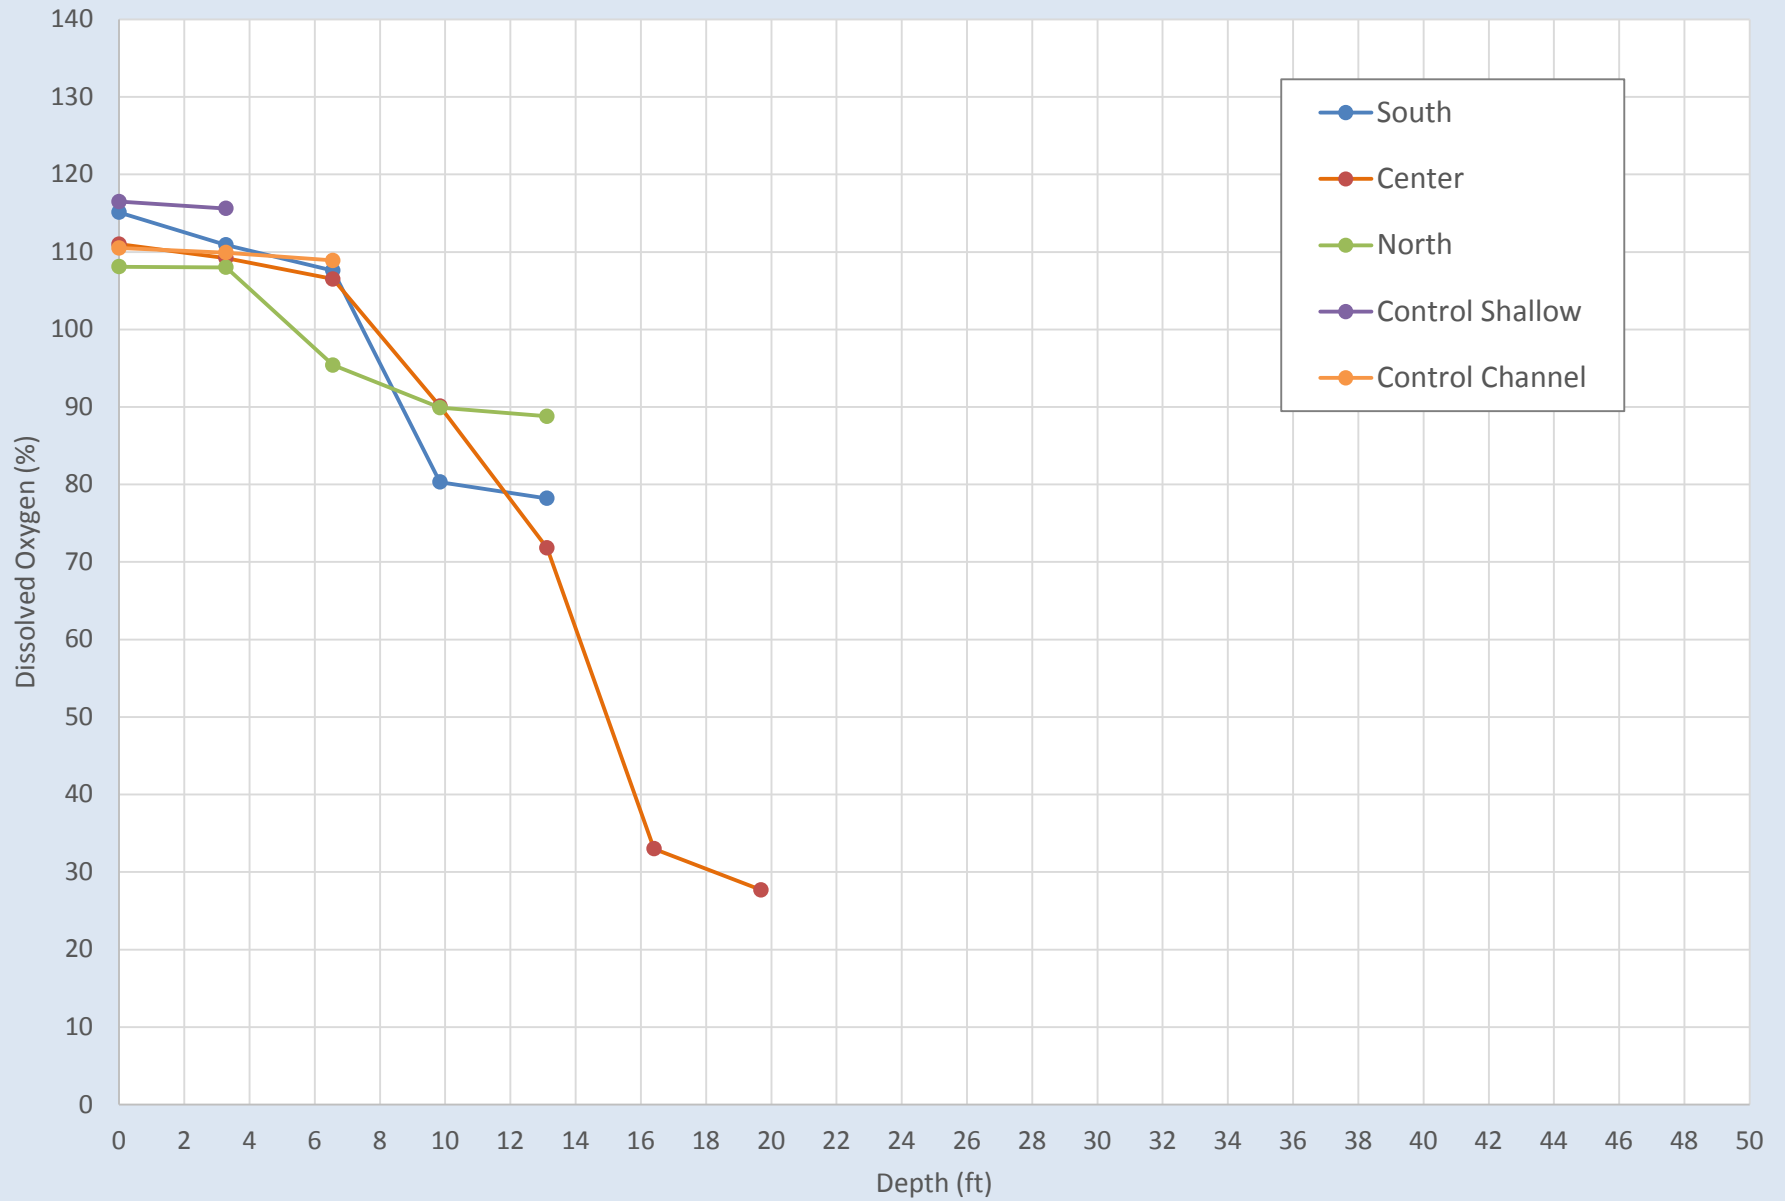
Dredged Hole 25: Dissolved Oxygen Content Aug. 7th, 2014

Dredged Hole ID: DH25		Date: 8/7/14		Time: 1:45pm			
Site name: DH 25 Shallow 12ft South							
Alt name: South							
YSI Readings							
Depth (m)	Depth (ft)	DO (mg/L)	DO (%)	Sal	Ph	Temp C	NTU
0.0	0.00	8.45	115.1	19.22	8.16	25.62	2.8
1.0	3.28	8.22	110.9	19.22	8.16	25.35	2.3
2.0	6.56	7.96	107.6	19.20	8.14	25.17	2.3
3.0	9.84	5.96	80.3	19.20	7.95	24.72	3.6
4.0	13.12	5.90	78.2	19.23	7.86	24.39	4.3
Sediment Sample Description :							
Black mud w/ plant debris							
Weather conditions/ other notes:							
Sunny, wind NW 10-15mph

Sediment Sample Description : Black mud w/ plant debris
Weather conditions/ other notes: Sunny, wind NW 10-15mph

Hydraulic and mechanical placement methods are feasible from an engineering standpoint. Due the proximity to Jacobsen Park, and the limited placement capacity, OCC recommends mechanical placement with a silt curtain deployed between the dredged hole and Jacobsen Park at Dredged hole 25.

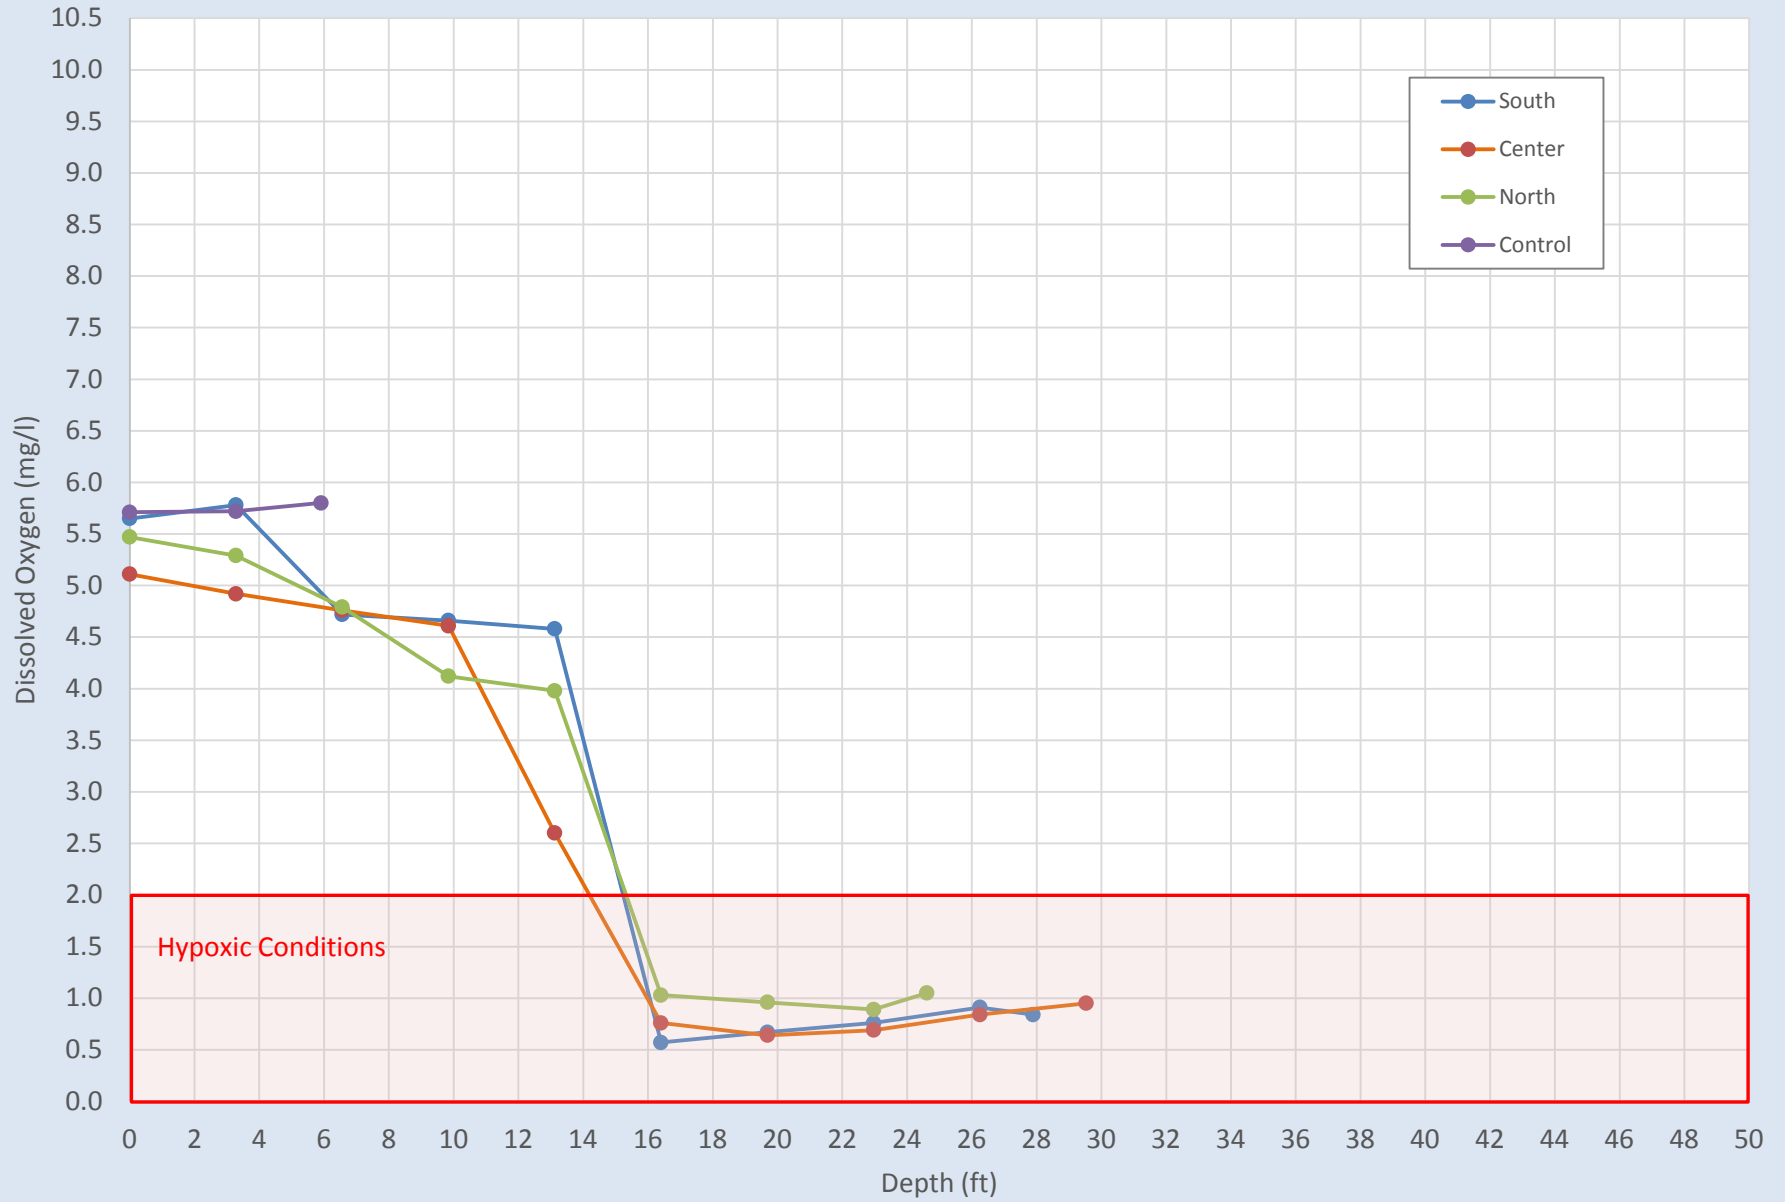
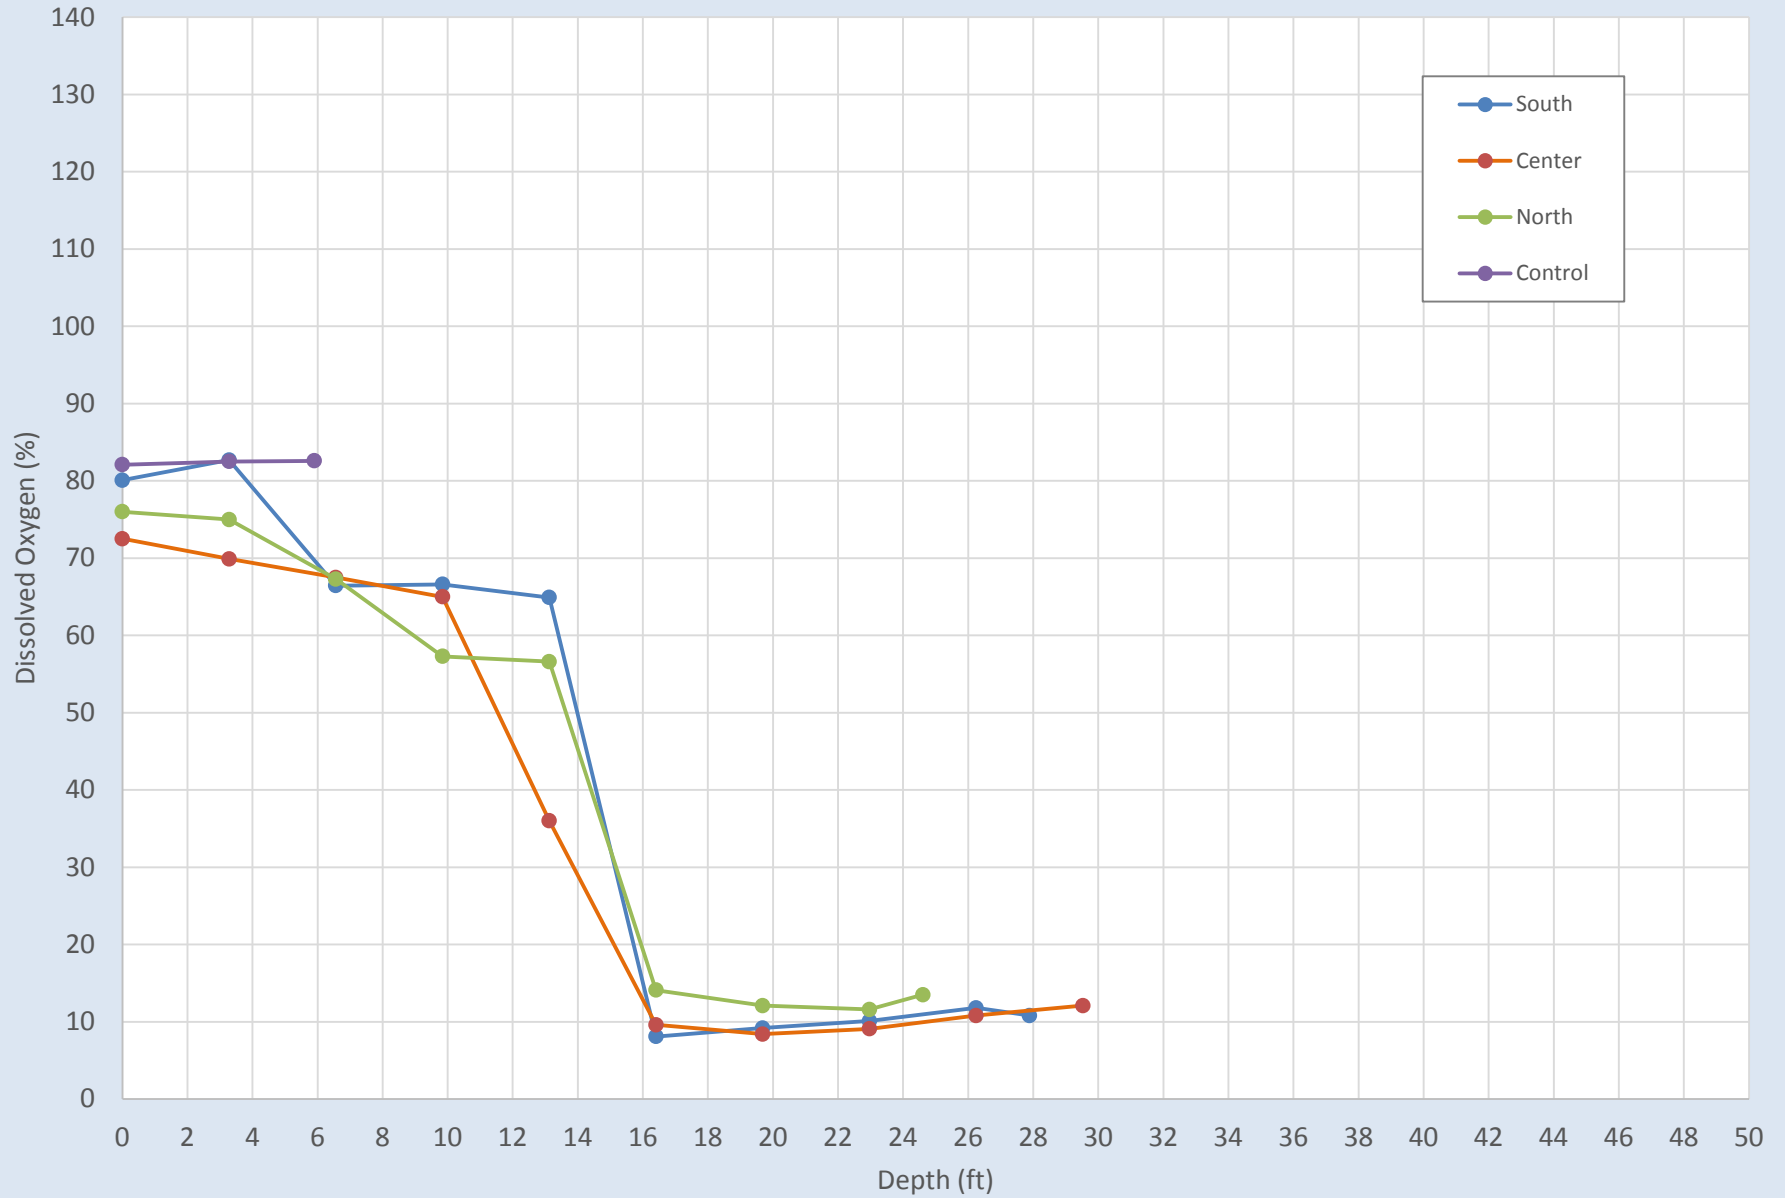
Dredged Hole 78: Dissolved Oxygen Content Aug. 11th, 2014

Dredged Hole ID: 78		Date: 8/11/14		Time: 9:45am			
Site name: dh 78 Deepest - most southern location							
Alt name: South							
YSI Readings							
Depth (m)	Depth (ft)	DO (mg/L)	DO (%)	Sal	Ph	Temp C	NTU
0.0	0.00	5.65	80.1	29.99	7.77	25.08	2.8
1.0	3.28	5.78	82.7	30.01	7.79	24.88	3.5
2.0	6.56	4.72	66.4	30.05	7.69	24.69	3.5
3.0	9.84	4.66	66.6	30.05	7.71	24.60	3.3
4.0	13.12	4.58	64.9	30.11	7.67	24.43	3.5
5.0	16.40	0.57	8.1	30.56	7.12	22.96	3.5
6.0	19.68	0.67	9.2	31.04	6.96	21.16	9.7
7.0	22.97	0.76	10.1	31.18	6.81	19.84	5.6
8.0	26.25	0.91	11.8	31.11	6.77	19.22	2.8
8.5	27.89	0.84	10.8	31.06	6.76	18.99	2.5
Sediment Sample Description :							
Dark Gray Silt, detritus, sulfer odor.							
Weather conditions/ other notes:							
80°F Sunny

and partial containment from the surrounding wetlands, OCC recommends hydraulic placement with a discharge diffuser and silt curtain along the southern perimeter of Dredged hole 78. Additionally, because of the likely seabed instability created by the hole, filling this site could reduce sediment erosion along the tidal wetlands.
